## SUMMARY

2946 Glenridge Dr , Raleigh, NC 27604  
Helene Headington  
12/16/2024

Logan Brown  
NCHILB # 5618  
OpenWindow Home Inspections  
(910)898-2626

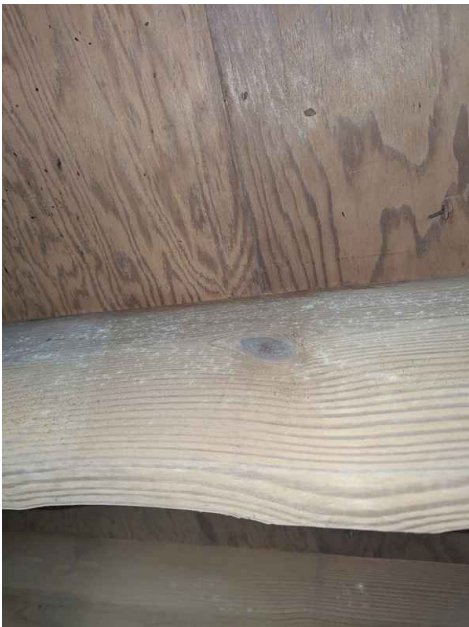
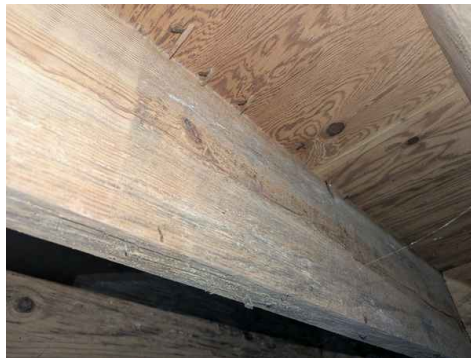
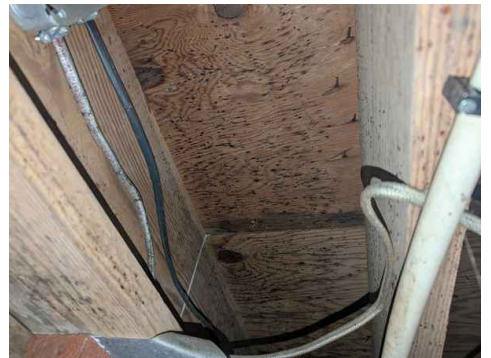
#### 10.4.2 Floor Structure

##### **ORGANIC GROWTH - CRAWL SPACE**

The home inspector observed signs of organic growth in one or more areas of the flooring structure in the crawlspace. This can lead to, but is not limited to, deterioration of the flooring system and may pose a health hazard. The home inspector recommends having a qualified specialist for further evaluation, identifying the source for the organic growth, and making repairs to all as necessary.

Mold cleaned in 2025

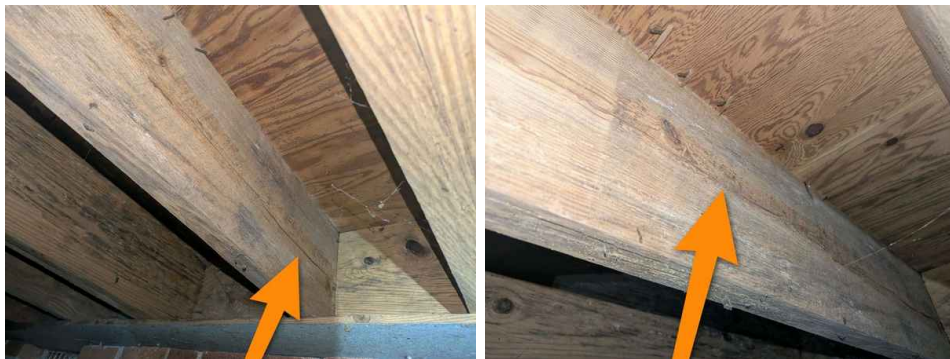
#### 10.4.3 Floor Structure

##### **JOIST DAMAGED**

A joist at the left side area in the crawlspace was observed to have damage that may lead to decreased integrity of the joist or floor system. This may cause the joist to become weak and lead to but is not limited to twisting, sagging, or cause structural integrity of the joist. The home inspector recommends a qualified specialist for repair or replacement as necessary.

Floor joists sistered in 2025
