May 20, 2026

Re: Limited Structural Inspection  
5808 Caledonia Street  
Raleigh, NC

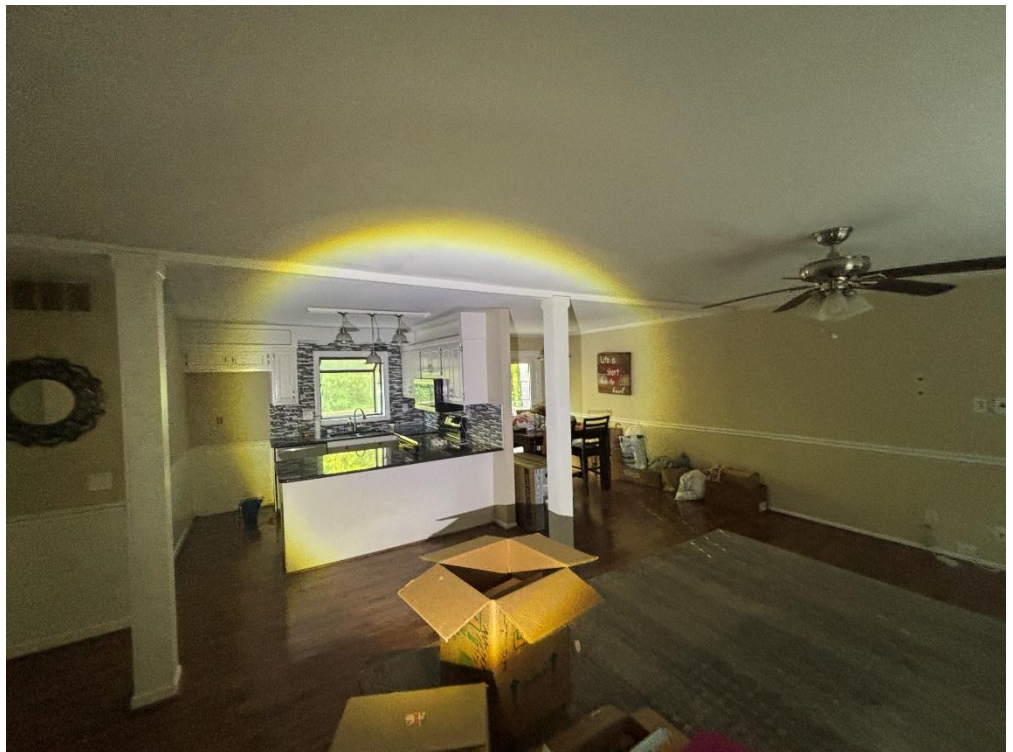
**Photo No.**  
**2**

4. An approximately 2" drop was noted in the ceiling running left-to-right located approximately 13'-0" from the front exterior wall. Columns were noted in line with the drop in the ceiling approximately 9'-0" and 18'-0" from the right exterior wall.

We could not determine the size of the existing beam installed for the reported previous wall removal noted above (Observation #4). We have assumed the second level floor framing to be comprised of floor joists spanning front-to-rear and bearing at a beam located at the drop in the ceiling at the front and rear of the home. Additionally, the wood supports appeared to have been installed in the crawlspace to accommodate the new load path. No significant deflections were noted in the assumed beam or significant floor sloping related to the columns. We have provided recommendations to verify the beam sizing below.

View of where previous wall was removed.

4. We recommend verifying the presence of a minimum 2-ply 1.75"x9.25" LVL beam at the location of the reported wall removal noted above (Observation #4). The beam should be supported on a minimum of (3) 2x4 jack studs at each bearing point. If it is discovered the existing beam is smaller than prescribed above, we recommend replacing the beam with an adequately sized member.

- a) We recommend verifying the second level floor framing at the front and rear of the beam is spanning front-to rear and bears onto the beam.
  - b) If it is desired to move the column as reported above (Observation #4b), the maximum span of a 2-ply 1.75"x9.25" LVL beam based on the assumptions above is 10'-6". We recommend ensuring there are no splices at the existing column locations before relocation of the columns. The new column should be supported by a pier matching the provisions outlined in Recommendation #1. Ensure vertical compression blocking is installed in the floor cavity between the pier and the subfloor directly below the column.

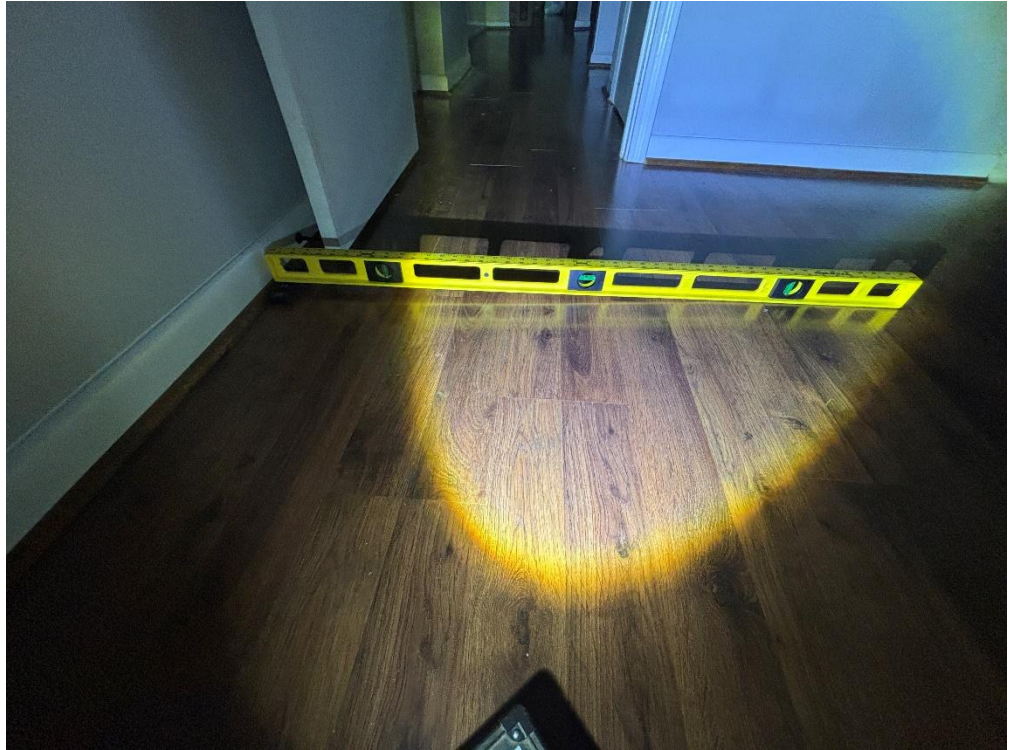
Photo No.  
3

- b. Multiple additional minor cracks/separations (less than 1/16" wide) were observed in the wall/ceiling finish materials throughout the home.
2. Floor slope (up to 7/8" vertical over 4'-0" horizontal) was measured sloping front to rear in the left living room located approximately 7'-6" from the left exterior wall and 12'-0" from the front exterior wall.

The boxout framing noted above (Observation #13) is at the location of the floor slope noted above (Observation #2). The single-ply trimmer joists are likely inadequate to support the additional loading from the wall above and the boxout headers. The framing configuration is considered a structural concern. If left in the existing condition, additional vertical displacement resulting in interior floor slope and interior finish material damages may occur. We have provided a recommendation below to address the issue.

View of floor slope front to rear in the left living room of the home.

- a) Note, relocation/resizing of the attic access will likely be required for proper installation of this repair.
3. We recommend fully sistering (bearing point to bearing point) the boxout trimmer joists noted above (Observation #13) with new equivalently sized members, attached with (3) 10d common nails at 16" on-center. Ensure a snug condition against the subfloor/damaged member(s) and proper bearing at the ends.

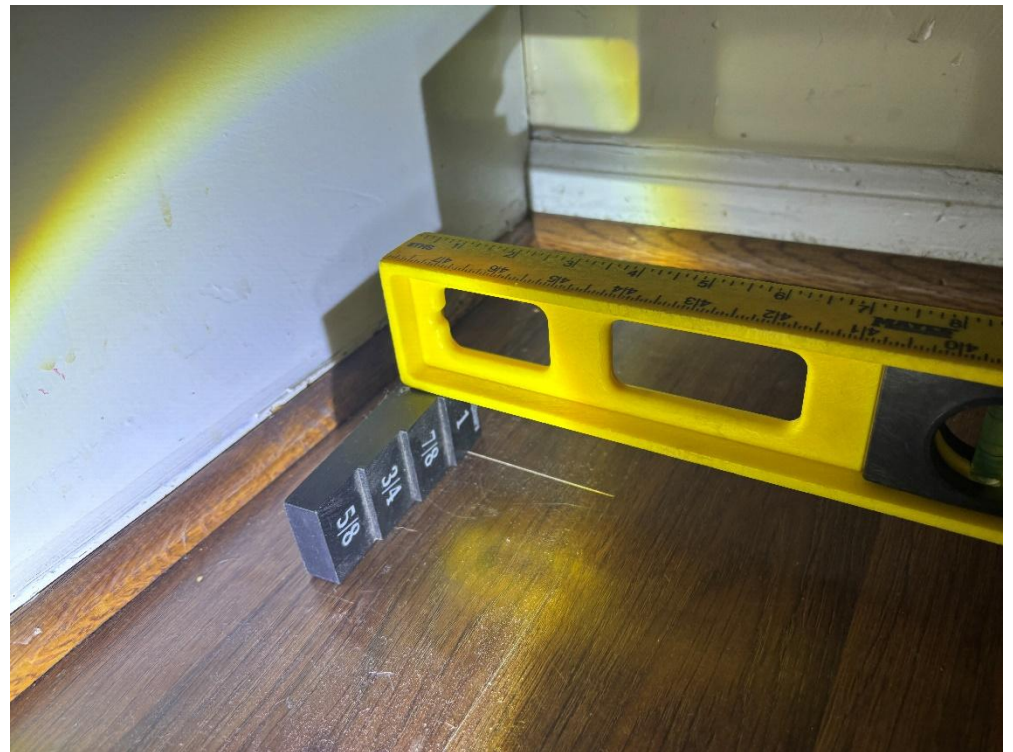
Photo No.  
4

3. A crown (high spot) in the floor was noted running from left to right approximately 13'-0" from the front exterior wall between the kitchen and living room. Floor slope (up to 1-1/2" vertical over 4'-0" horizontal) was measured sloping to the rear of the crown approximately 11'-0" from the right exterior wall.

The crown in the floor and associated floor slope noted above (Observation #3) is likely the result of limited deflection in the framing below exacerbated by the damaged pier noted above (Observation #11). Deflection of supporting members can occur with sustained loads. The crown occurs at the location of a girder, which are often composed of built-up members with short spans. This combination of a rigid member with a short span length greatly reduces the imposed deflection on the member. Alternatively, deflection of the adjacent floor framing will be greater due to the longer spans and reduced cross-sectional area. This framing configuration naturally creates crowns (high spots) in the floor system. While crowns are typical in most floor framing systems, the floor slope noted is indicative of excessive deflection due to the unsupported girder condition. We have provided a recommendation below to address the damaged pier and support the girder.

Crown in the finish flooring located next to the rightmost column and kitchen counter.

1. We recommend removing and replacing the damaged pier noted above (Observation #11) with a new mortared and fully grouted 16x16 CMU block pier bearing on a minimum 24"x24"x12"-thick concrete footing. Install flat pressure-treated blocking (min. 3/4" thick) and/or flat metal shims as required to provide full-width, uniform bearing for the floor framing onto the piers. Care should be taken to not excessively jack the framing during the installation process. Attention should be given to the framing bearing conditions at the nearby piers; adjust as necessary to provide full-width, uniform bearing for the floor framing onto the piers. Re-shimming of piers throughout the crawl space will likely be required in the future.

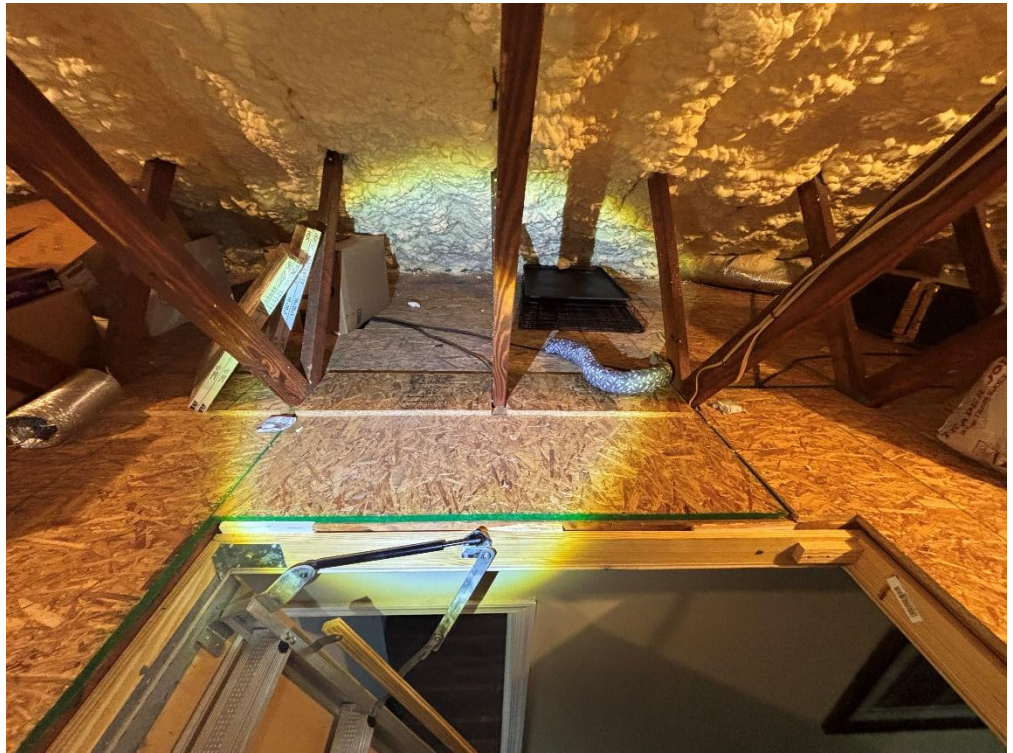
Photo No.  
5

5. The attic framing was noted to be comprised of open-web roof trusses spanning front to rear generally spaced at 24" on-center.
6. Cut roof truss bottom chords were noted at the attic access located approximately 13'-6" and 15'-6" from the right perimeter wall. At least 20" of the original bottom chord remains on each side of the cut/removed section.

Trusses are an engineered system, and as such, any damage or modification to the trusses must have a repair sufficient for supporting the design loads incurred on the trusses. The truss conditions noted above (Observation #6) are considered structural concerns and we have provided recommendations below to address these issues.

View of the cut roof  
truss bottom chords.

2. We recommend removing the attic access and infilling the cut bottom chords noted above (Observation #6). The bottom chords should be sistered for the full length (node to node) with new 2x4 members on both sides. The original and infilled truss bottom chord shall be re-positioned to align flush with the truss profile. Attach the sistering 2x4s to the truss members with (2) 3/8" beads of Loctite PL Premium polyurethane adhesive and (2) rows of 4" Simpson SDS screws alternating sides staggered at 4" on-center.

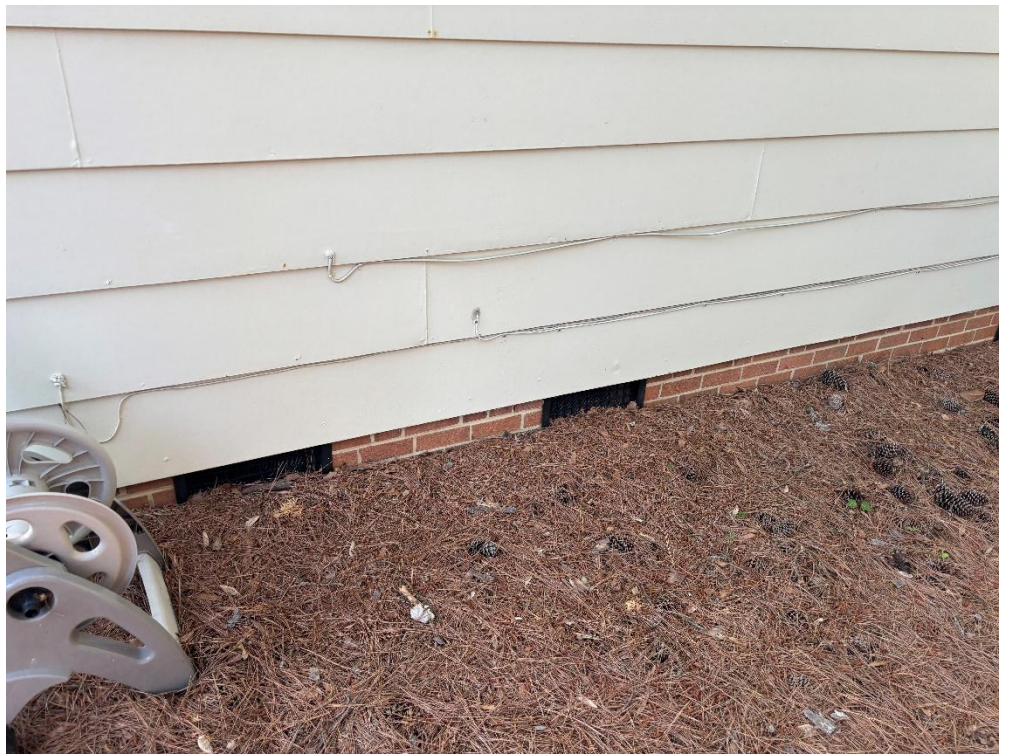
Photo No.  
6

7. Separations (up to 1/4" wide) were noted between the base of the chimney and left exterior wall of the home. Larger separations were noted near the top of the chimney.
  - a. The chimney was measured to be leaning (approximately 1/2" horizontal over 4'-0" vertical).
8. Three (3) foundation vents along the right side of the home were noted to be close to grade with no vent wells installed.
9. Gutters and downspouts (with leaders) were noted installed on the home. Grade was noted with a relatively neutral slope along the rear and left perimeter walls and a relatively negative slope towards the front and right perimeter walls of the home.

The foundation vents close to grade with no vent wells noted above (Observation #8) are considered a moisture intrusion concern. Current code standard requires vent wells where the foundation vent is within 4" of finished grade. The current state of the foundation vent may allow for stormwater runoff and drainage to flow into the crawlspace. This moisture intrusion could lead to framing damages or fluctuations in the floor framing resulting in interior finish material cracks/separations.

View of crawlspace  
vents close to grade.

6. We recommend consulting with a qualified contractor to install foundation vent wells at all locations where the vent well is located within 4" of the finished grade elevation of the site topography.

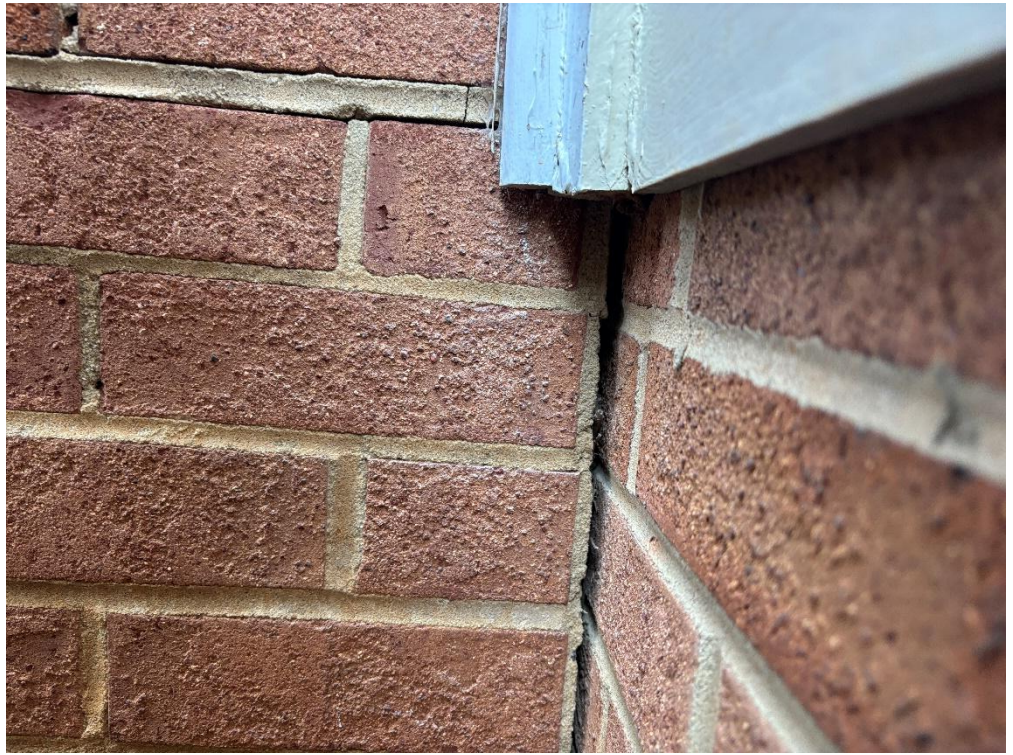
Photo No.  
7

The separations and lean in the chimney noted above (Observation #7) are likely due to limited differential foundation settlement. The clay soils in this area are considered "expansive" type soils and will typically expand and contract with fluctuations in the moisture content. This expansion and contraction of load bearing soil materials below foundations can lead to soil consolidation and settlement. If conditions around the foundation remain relatively dry, the likelihood of future significant settlement will be reduced, but we cannot predict the extent of future settlement. Improving exterior drainage and monitoring the chimney for additional settlement is an acceptable approach at this time. Note, additional movement will result in the need for underpinning of the chimney foundation.

View of a minor separation at the base of the chimney

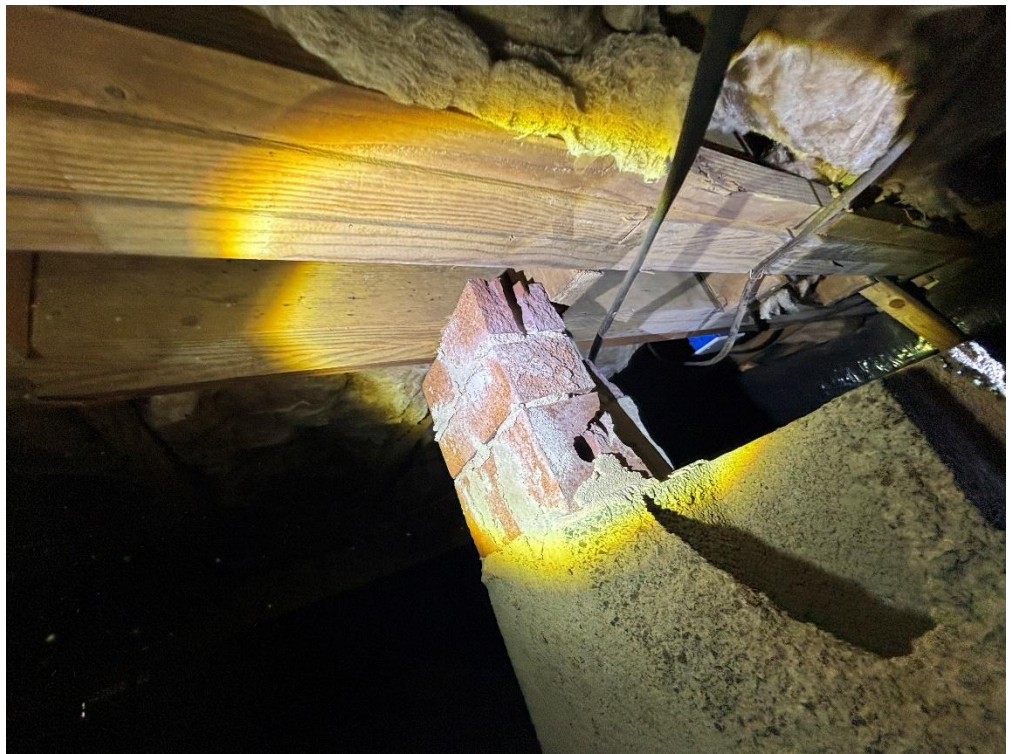
Photo No.  
8

10. The floor framing was noted to consist of 2x8 floor joists spaced at 16" on-center generally spanning front to rear supported by 2-ply 2x10 flush split girders bearing on masonry piers.
11. A damaged pier was noted below the central split girder located approximately 12'-0" from the front foundation wall and 11'-0" from the right foundation wall.

View of damaged pier.

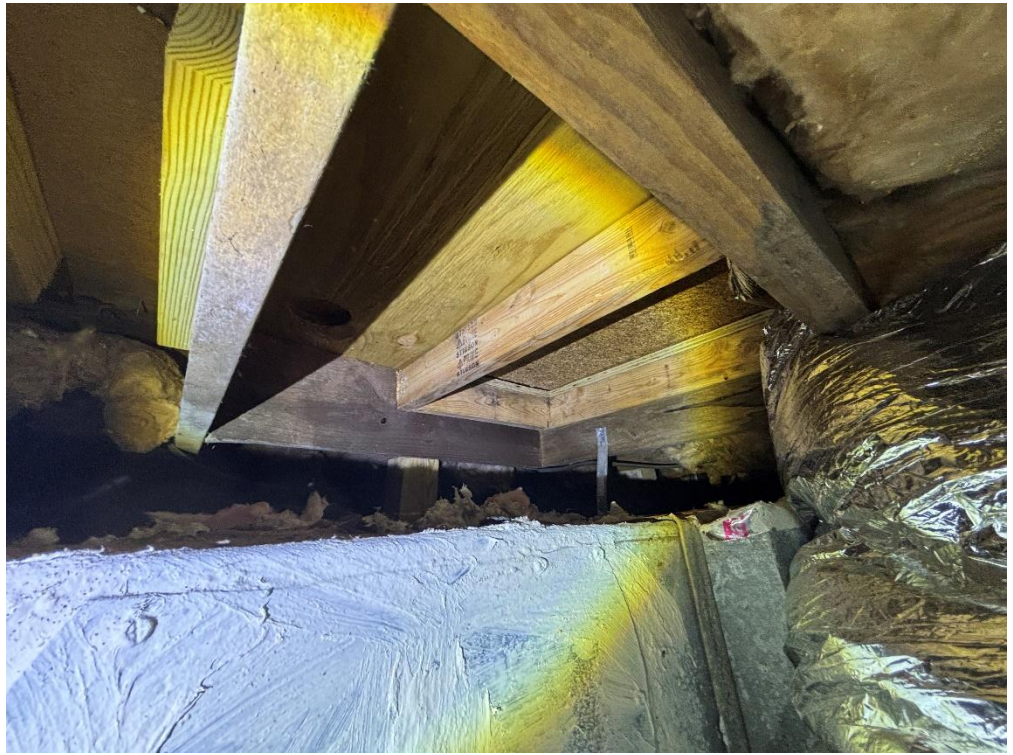
Photo No.  
9

- a. The wood posts were noted to be embedded into concrete footings. We could not verify the size of the footings.
13. Boxout framing was noted above an HVAC exchange approximately 17'-0" from the front foundation wall and 9'-0" from the left foundation wall. The trimmer joists and headers of the boxout framing were noted to be single-ply members.

View of inadequate  
boxout framing.

- a) If installation of a full-length sister is not feasible due to the presence of utility obstructions, installing a discontinuous sister is permitted. If the sister member is discontinuous, install a 4x4 post bearing on a minimum 12"x12"x8"-thick footing centered below the splice in the sister member.

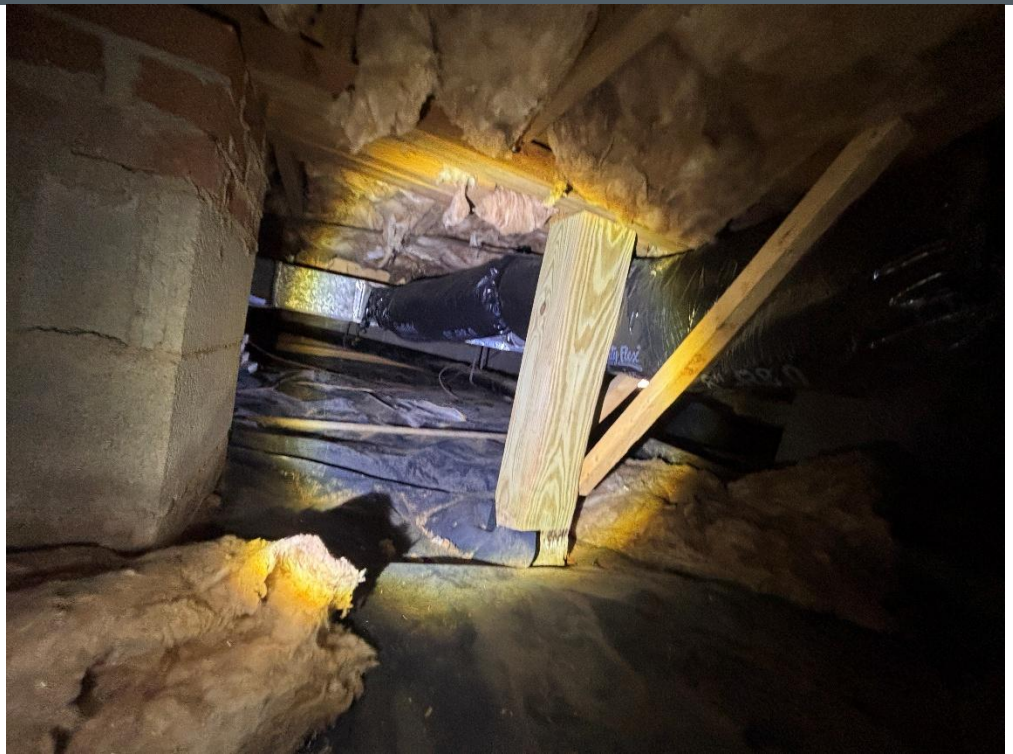
Photo No.  
10

12. Two (2) 6x6 wood support posts (with compression blocking above) were noted below the central girder approximately 8'-6" and 15'-6" from the right foundation wall. A CMU pier was noted in the general vicinity of the column located approximately 18'-6" from the right foundation wall.

Typical view of 6x6  
support post in  
crawlspace.

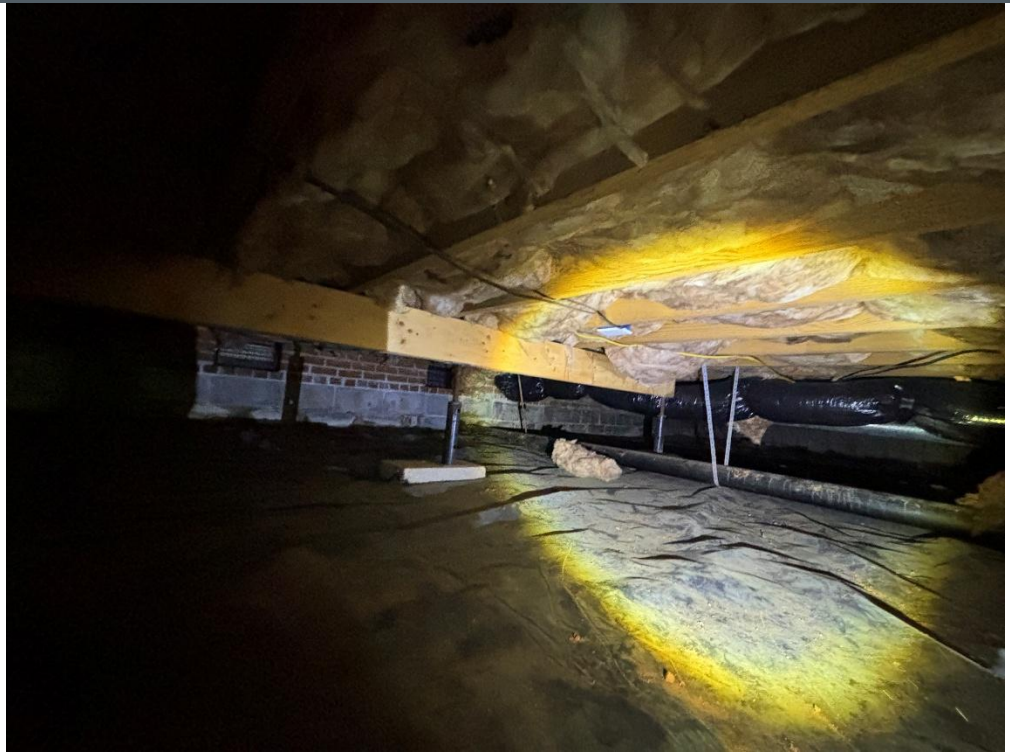
Photo No.  
11

- a. Note, a left-to-right spanning wall was located above the general vicinity of the boxout framing.
14. Multiple supplemental drop girders bearing on steel screw jack supports with limited bearing were noted throughout the crawlspace.

We do not consider the supplemental drop girders and adjustable steel screw-jack posts noted above (Observation #14) to be permanent supports. These were likely installed to alleviate minor deflection or "bounce" in the floor and are not required for the structural integrity of the home. We have provided an optional repair below to replace the temporary supports with permanent supports to enhance the structural performance.

Typical view of supplemental drop girder with steel screw jack supports.

5. We recommend adjusting the supplemental screw jack posts noted above (Observation #14) to restore bearing of the drop girders to the framing above.
  - a) As an optional repair to improve the structural performance, the drop girders and supports may be replaced with new 3-2x8 drop girders supported by fully mortared and fully grouted 8x16 masonry piers on 20" x 20" footings. The piers should be spaced at up to 6' on center. Any floor jacking should be performed slowly over several days, and care should be taken not to over-lift the framing. We do not expect fully level floors, and re-shimming of all piers may be required in the future. Note, this is not required for the structural integrity of the home.

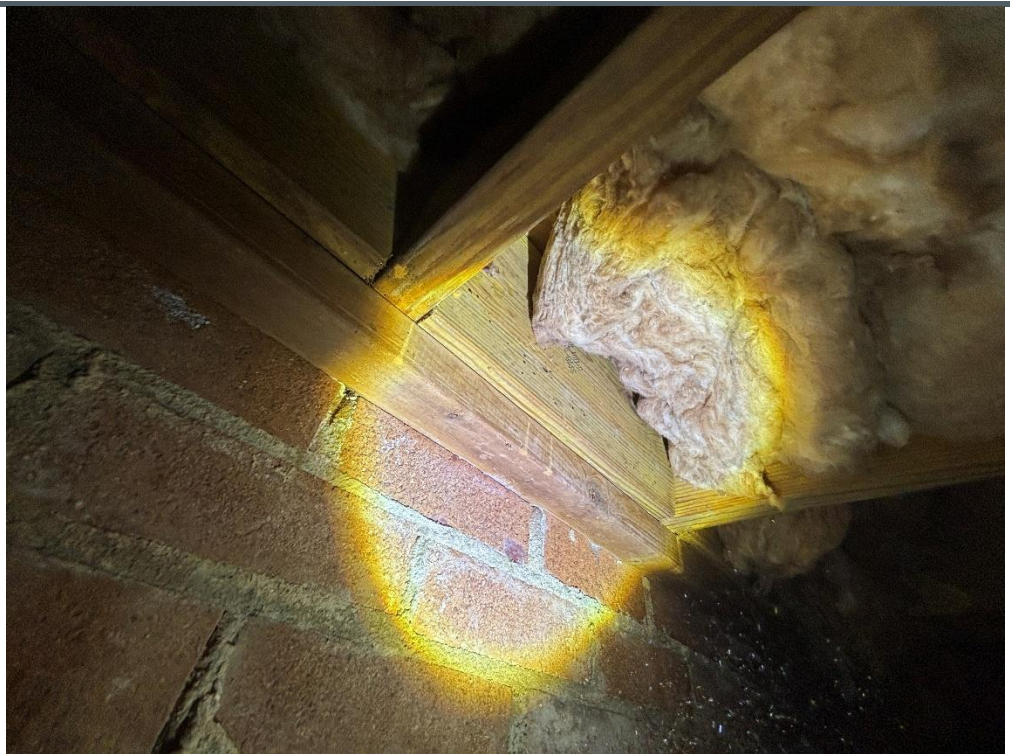
Photo No.  
12

15. Multiple instances of blocking installed against the face of the perimeter band were noted along the front and rear foundation walls. No evidence of damage was noted in the framing adjacent to the blocking.

The previous blocking repairs noted above (Observation #15) may be the result of previous damage to the perimeter bands. Alternatively, the blocking may have been installed for reasons we cannot determine. We did not observe evidence of significant structural distress in these areas and no concerns exist with the blocking at the time of this inspection. No structural repairs are required.

Typical view of perimeter band blocking.
