### Material facts

Below are the material facts from the previous home inspection. The seller has not yet made the repairs. He is willing to make repairs or give money in lieu of repairs based on a buyer's preference. If the buyer would like repairs made, they can be made as part of the contract through an additional provisions addendum or DDRA.

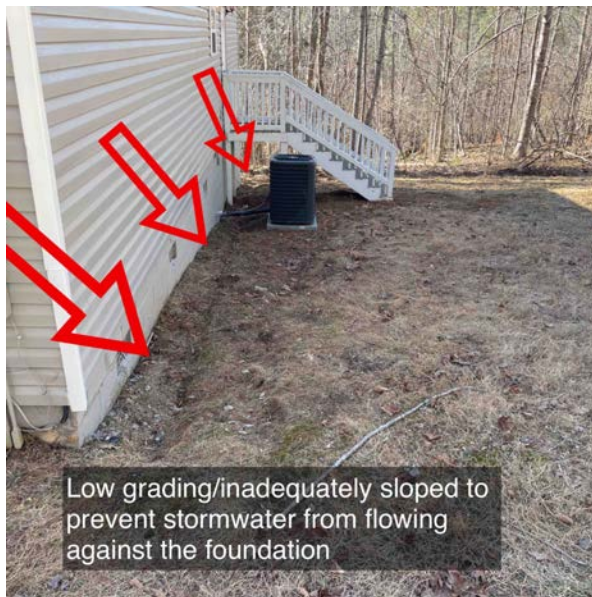
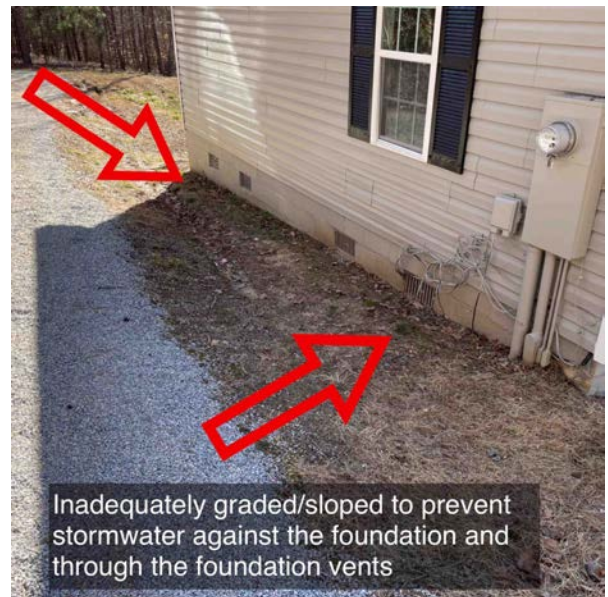
2.1.2 Areas around the home were observed inadequately graded. For examples please see the pictures below. This may allow water to collect next to the homes foundation, allow excessive rates of erosion, allow moisture into the crawlspace, affect the support of foundation/footings, and/or leave components/materials exposed. Have a qualified contractor further evaluate and take all actions needed to stop future/further issues. **(Throughout - Issues/concerns were noted in four or more areas.)**

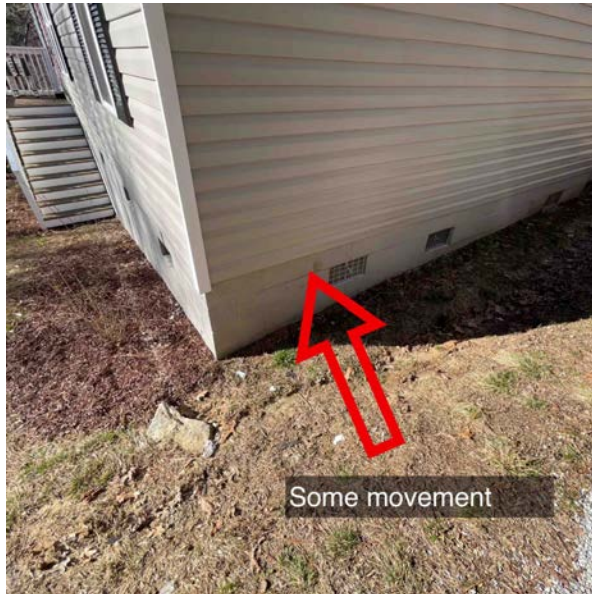
- Exterior Front
- Exterior Right

3.1.1 Movement of the foundation wall/skirt was observed around the home. Further damage/movement may occur which can allow openings into the crawlspace and/or allow blocks to fall causing damage/injuries. This is not a structural concern. Recommend having a qualified contractor evaluate the exterior foundation wall and repair as needed.

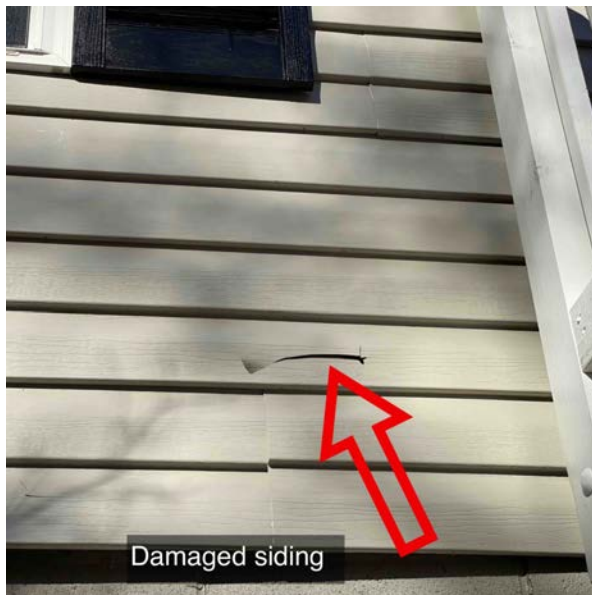
3.2.2 Several concerns were observed with the exterior cladding. For examples of some of the issues please see the pictures below. Any loose, misaligned, missing, or damage siding/cladding may not provide the proper protection of the materials underneath. Recommend having a qualified contractor or a qualified siding specialist evaluate all exterior cladding and repair as needed to prevent future damage/issues. **(Throughout - Issues/concerns were noted in four or more areas.)**

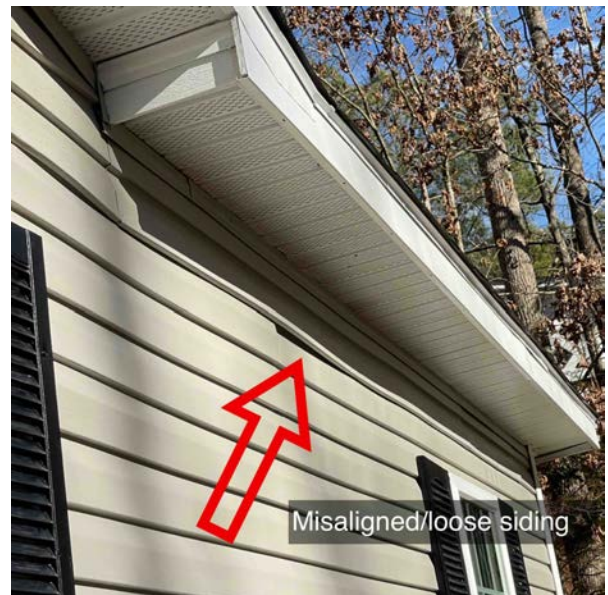
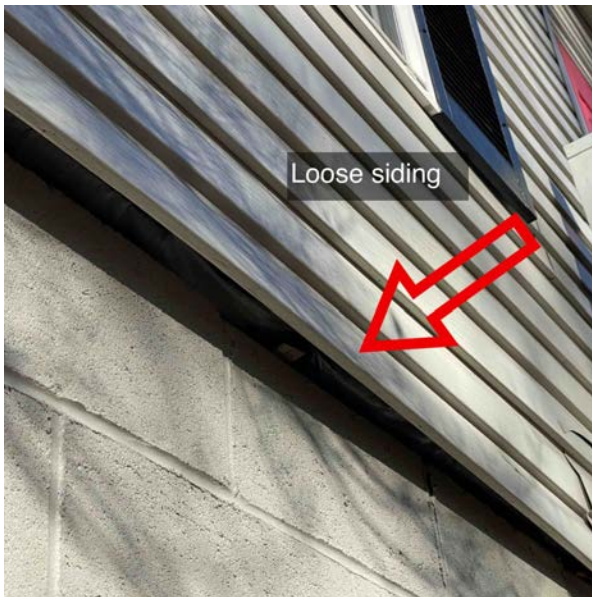
Loose siding

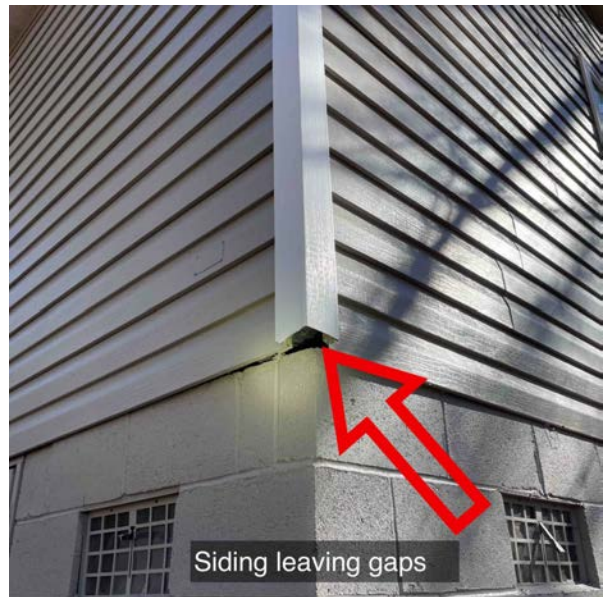
Siding leaving gaps

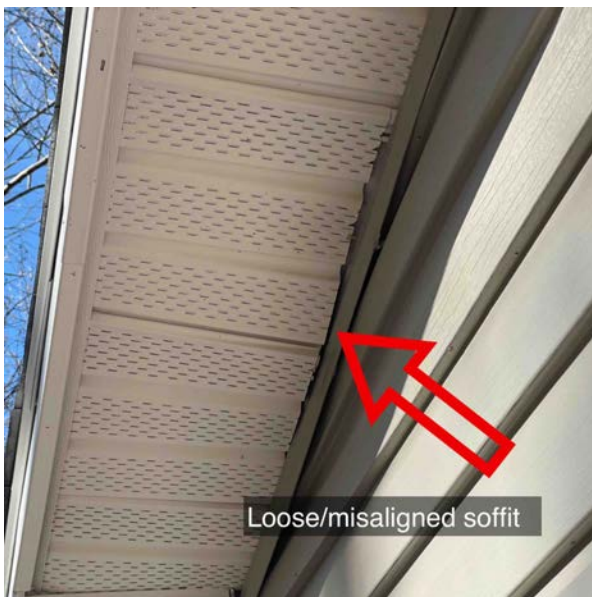
Loose/misaligned soffit

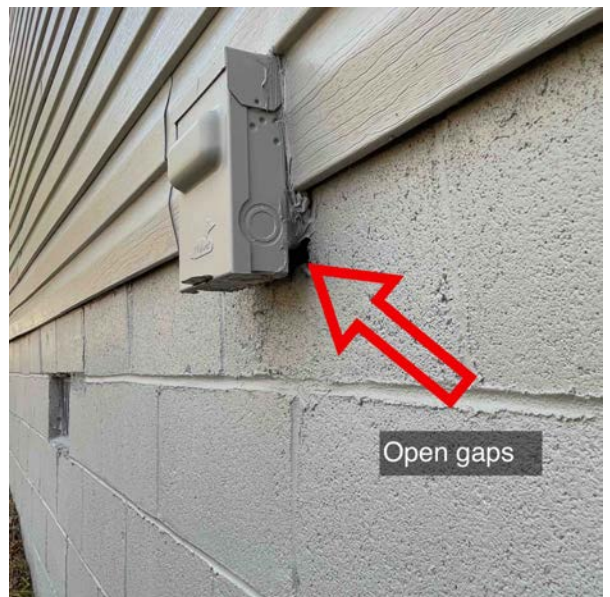
Open gaps

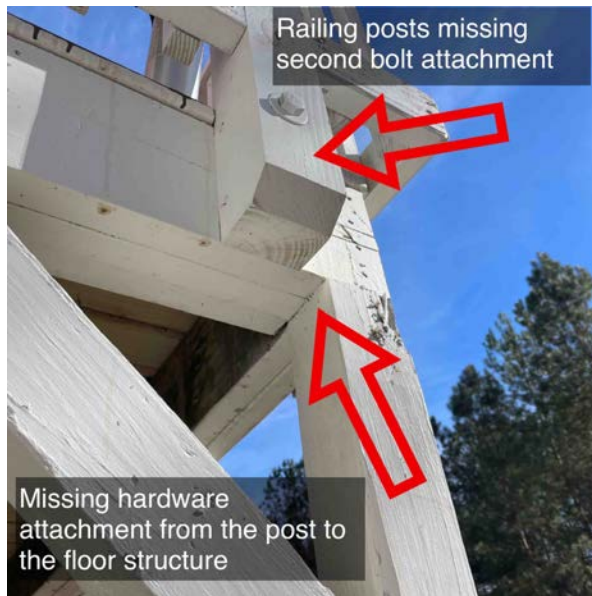
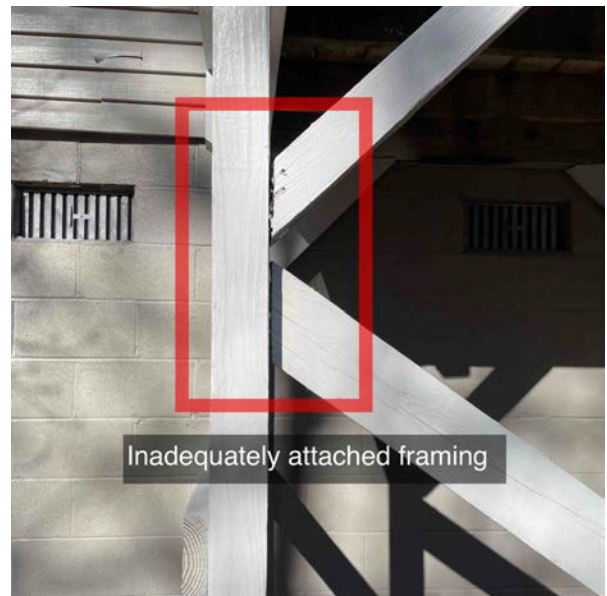
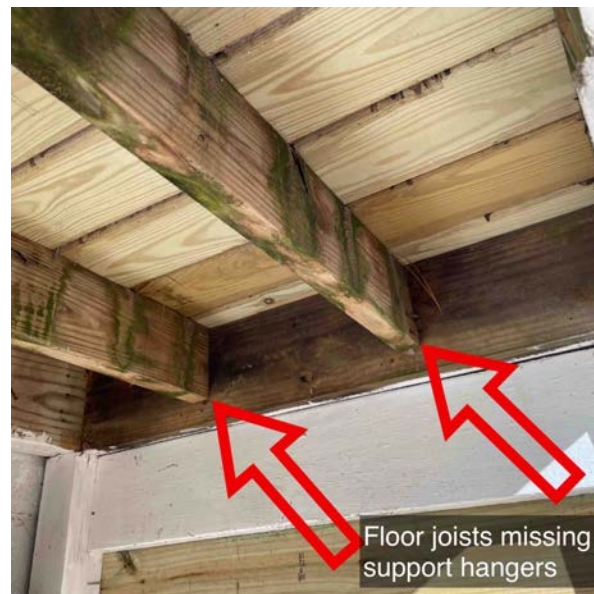
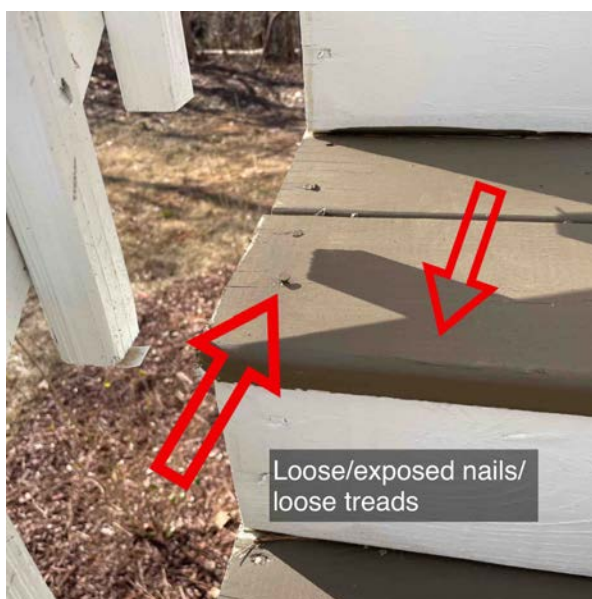
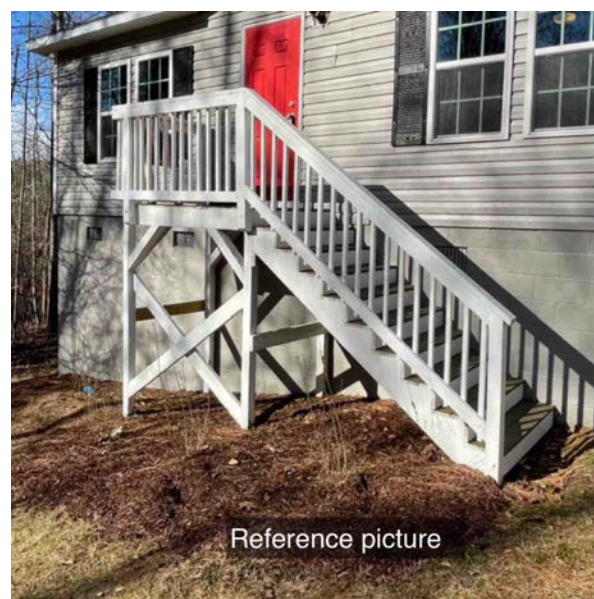
3.6.2 Several concerns were observed with the porch structure. For examples please see the pictures below. These items may affect the support of framing, allow movement of materials, and/or are safety concerns. Recommend having a qualified contractor evaluate the porch and repair/replace/secure all components/materials as needed to ensure safe/proper construction is achieved. **(Exterior Front)**

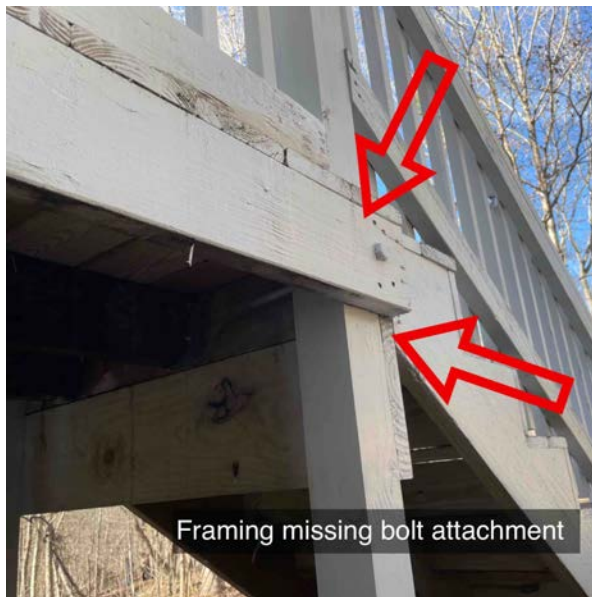
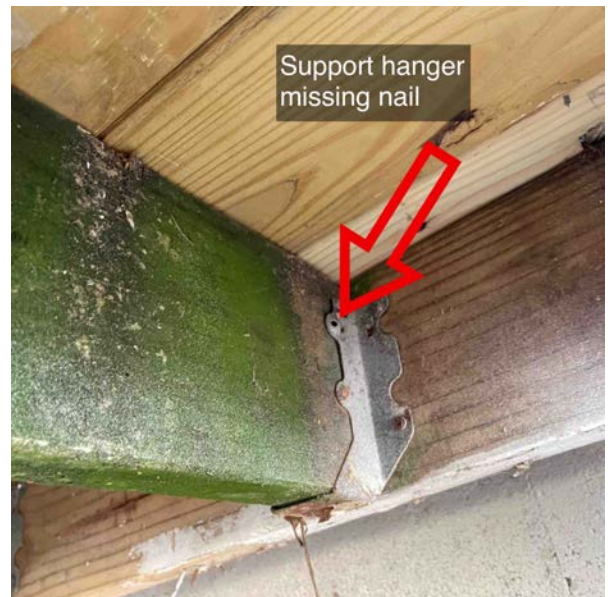
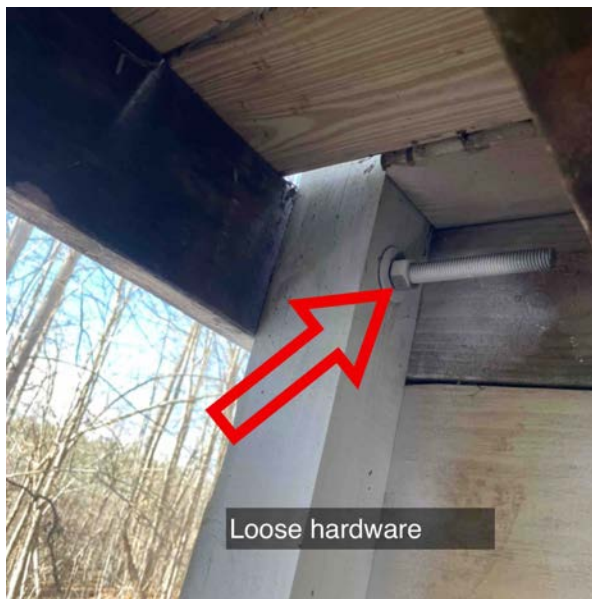
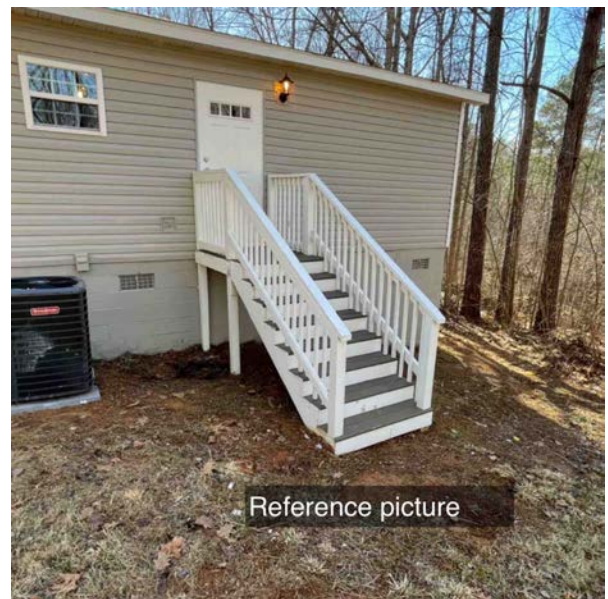
3.6.3 Several concerns were observed with the porch structure. For examples please see the pictures below. These items may affect the support of framing, allow movement of materials, and/or are safety concerns. Recommend having a qualified contractor evaluate the porch and repair/replace/secure all components/materials as needed to ensure safe/proper construction is achieved. **(Exterior Back)**

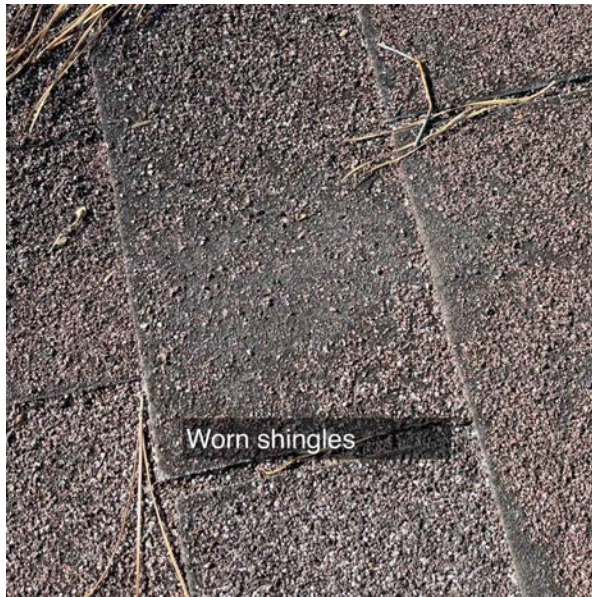
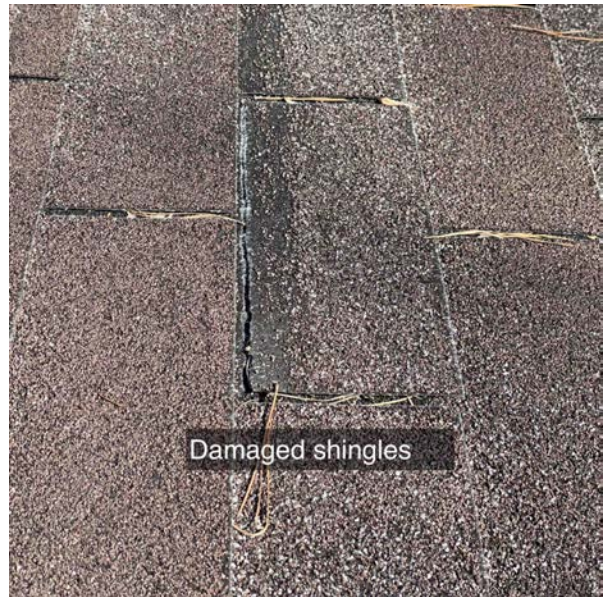
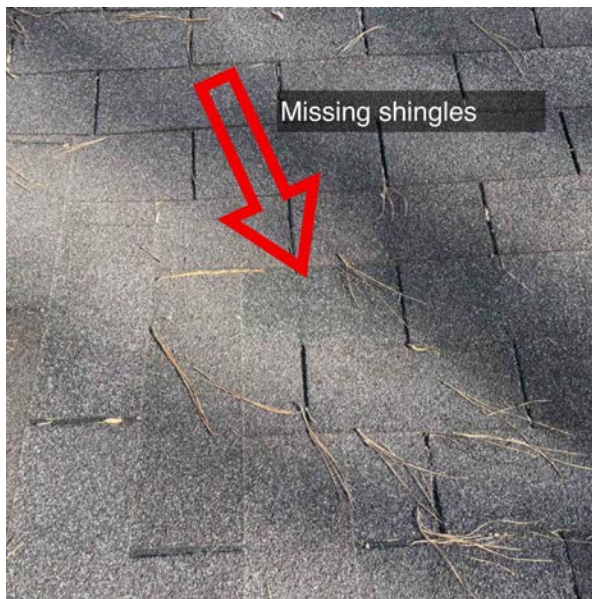
4.3.2 The roof covering materials have reached the end of their serviceable life. You are strongly encouraged to have your insurance company and a certified, licensed roofing contractor to physically inspect the roof, prior to closing, to fully evaluate the insurability and condition of the roofing material. The roof covering is in need of replacement or extensive repairs and a certified roof covering specialist should be consulted. **(Throughout - Issues/concerns were noted in four or more areas.)**

Missing shingles

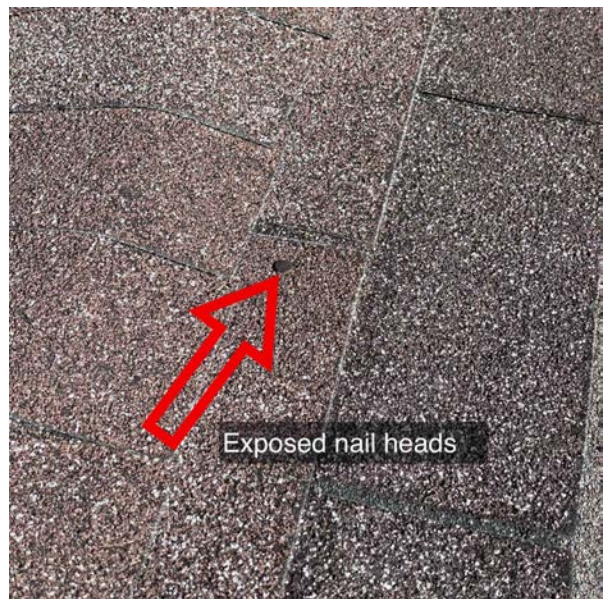
Exposed nail heads

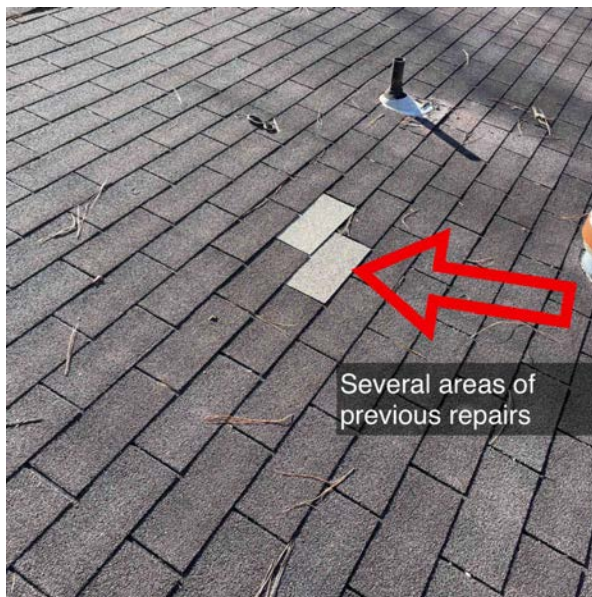
Several areas of previous repairs

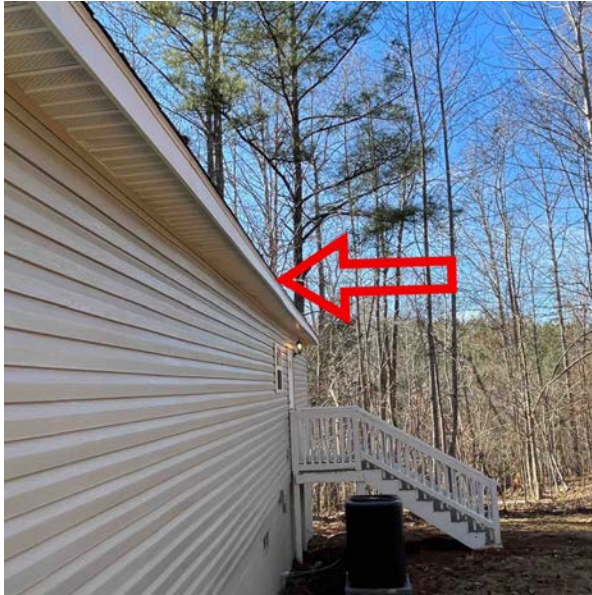
4.4.1 Recommend installation of gutters, although not required, to promote proper drainage away from the home and stop ground erosion. **(Throughout - Issues/concerns were noted in four or more areas.)**

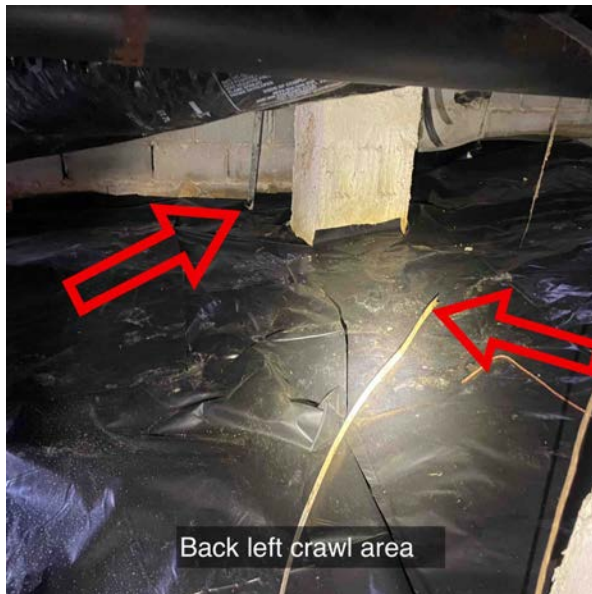
7.2.1 A structural/hurricane strap was observed damaged in the crawlspace. This does not adequately secure the home/structure to the ground/foundation. Recommend having a licensed structural engineer further evaluate and direct/instruct repairs as needed to ensure adequate attachment is achieved. **(Crawlspace)**

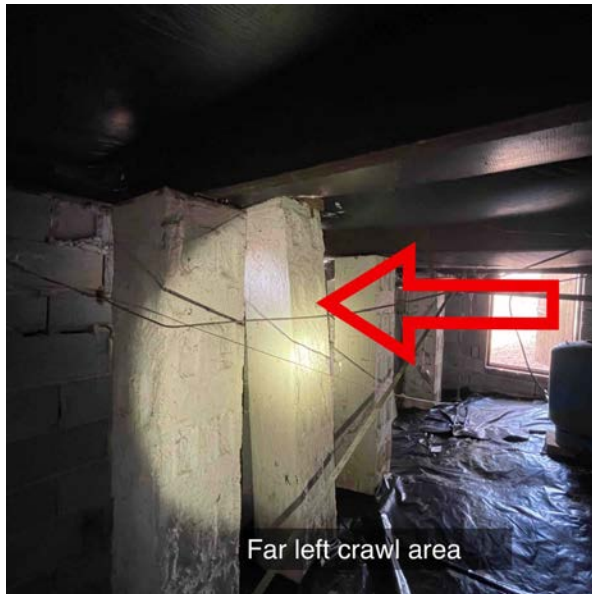
7.3.1 The foundation pier in the crawlspace was observed leaning. This may not provide the proper/intended support of the home. No current damage or adverse effects were observed with the floor structure at the time of inspection. A licensed structural engineer should be consultant to further evaluate and instruct repairs as/if needed. **(Crawlspace)**

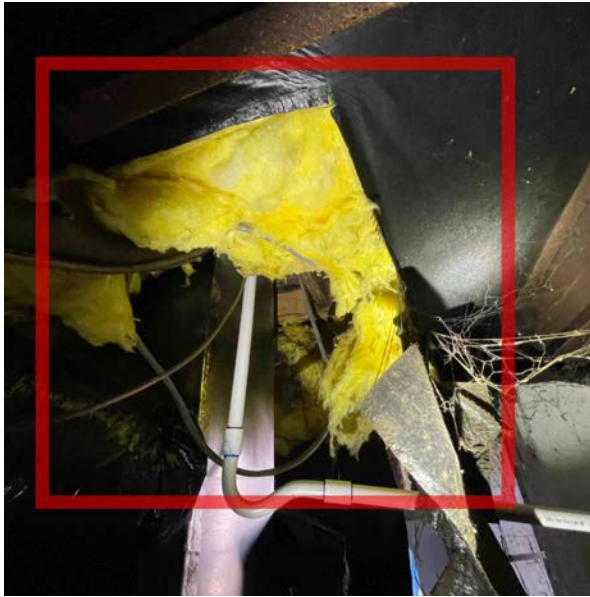
7.5.1 Several areas of the floor structure vinyl barrier/bladder were observed damaged in the crawlspace. For examples please see the pictures below. This does not provide the proper protection/efficiency of the floor structure and associated materials. Recommend having a qualified contractor evaluate and repair/replace all insulation/vinyl as needed. **(Throughout - Issues/concerns were noted in four or more areas.)**

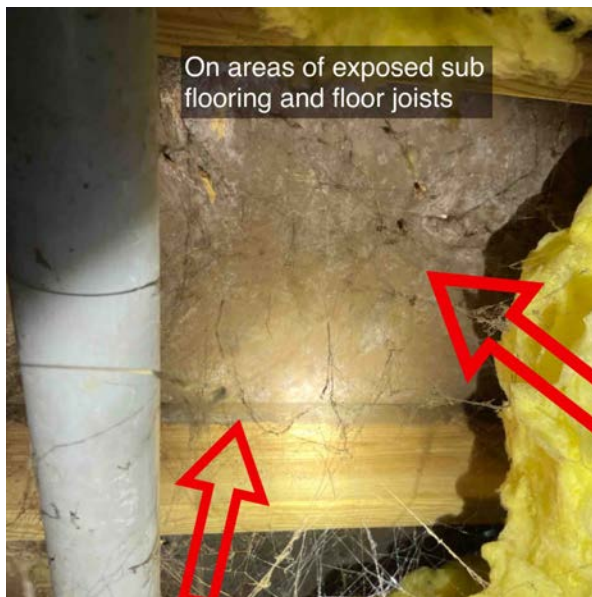
- Crawlspace
- Throughout - Issues/concerns were noted in four or more areas.

7.5.2 There is a fungal growth-like substance on the floor structure. The fungal growth should be mitigated/cleaned/removed as necessary to reduce health hazards. Determine the source of any fungal growth and correct those conditions as necessary to reduce the risk of any future growth and secondary damage. The wood moisture levels were at acceptable ranges at the time of inspection.

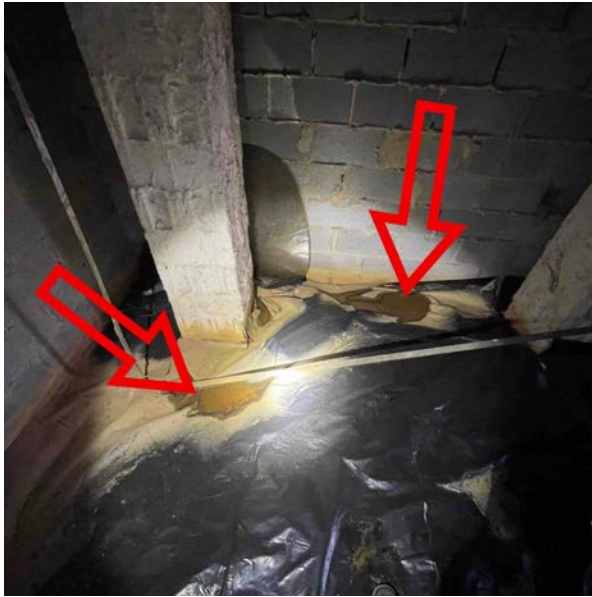
**(Throughout - Issues/concerns were noted in four or more areas.)**

8.1.1 Standing water was observed in the crawlspace. Any water entry into the crawlspace can lead to moisture related damage to the structure and create a conducive environment for fungal growth. The wood moisture levels were at acceptable ranges at the time of inspection. Recommend having a qualified contractor determine the sources of moisture and take the appropriate actions to mitigate them.

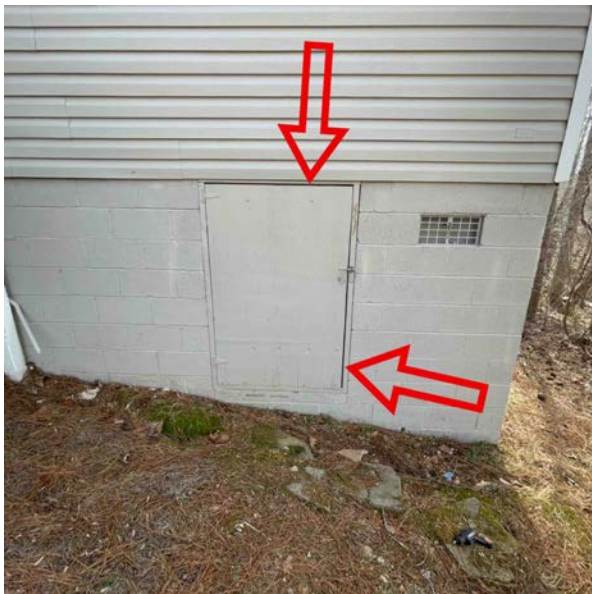
**(Exterior Back)**

8.2.1 Gaps were observed between the crawlspace access door and the door frame. This can allow pests and moisture into the crawlspace. Recommend having a qualified door specialist evaluate and repair/adjust all components/materials as needed.

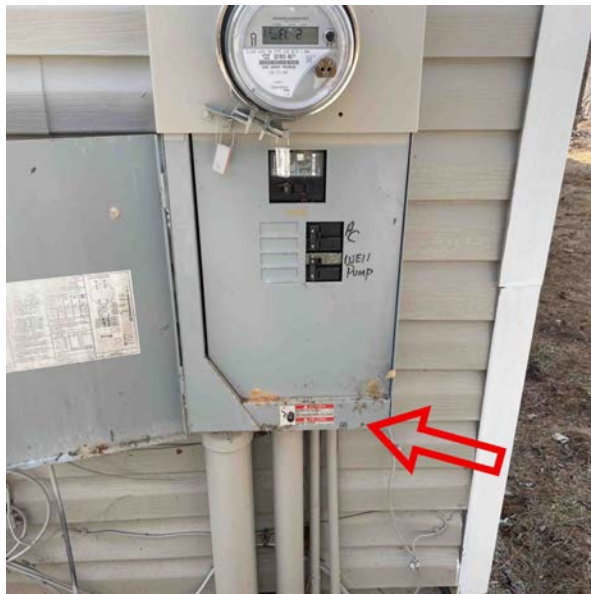
9.4.1 The electrical distribution panel cover was observed missing screw(s). This is a safety concern. Recommend having a licensed electrician replace the missing screws as needed for safety purposes. **(Exterior Right)**

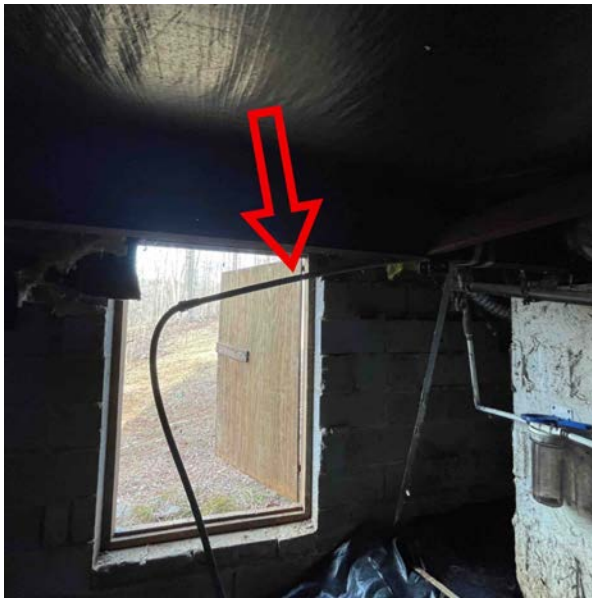
**(Crawlspace)**

9.7.1 The electrical conduit was observed inadequately secured/supported. This may not provide the proper/intended protection of the electrical. Recommend having a licensed electrician or a qualified contractor secure all conduit as needed.

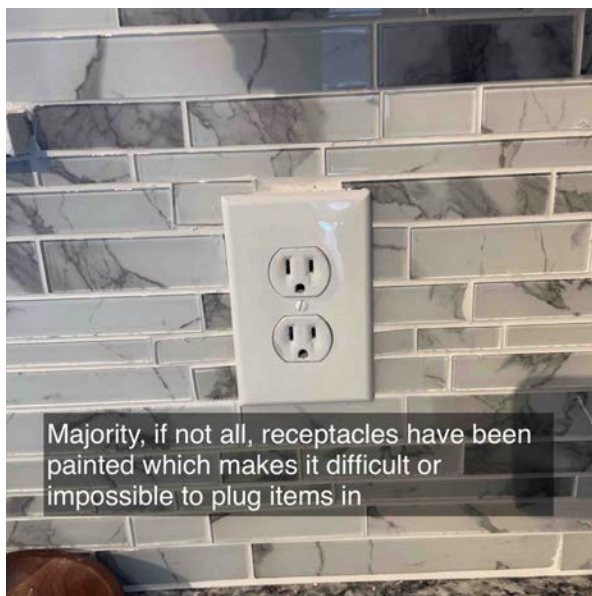
**(Throughout - Issues/concerns were noted in four or more areas.)**

9.8.1 The receptacle was observed painted over. This prevents use/operation of the receptacle. Have a licensed electrician further evaluate the electrical and repair/replace as needed to ensure safe/proper functionality/installation/use is achieved.

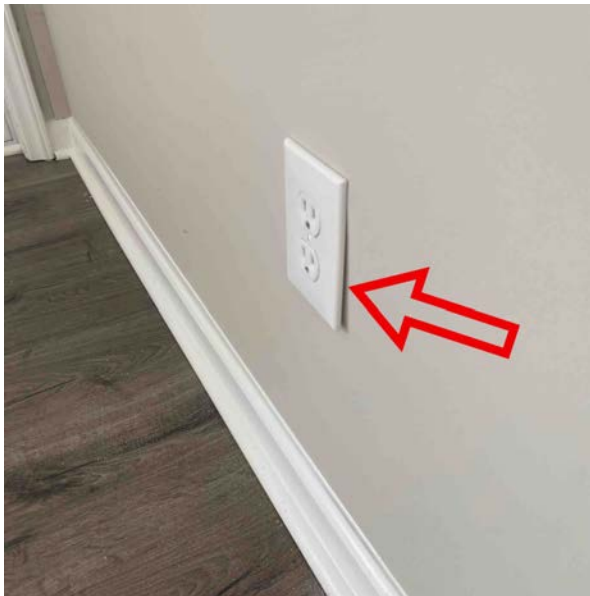
9.8.3 Several receptacles were loose in the wall/junction box and/or had a gap between the cover plate and the wall. This may result in loose and/or exposed wires which is a safety concern. Recommend having a licensed electrician secure/adjust all receptacles as required to mitigate electric shock/fire hazards. **(Living Room)**

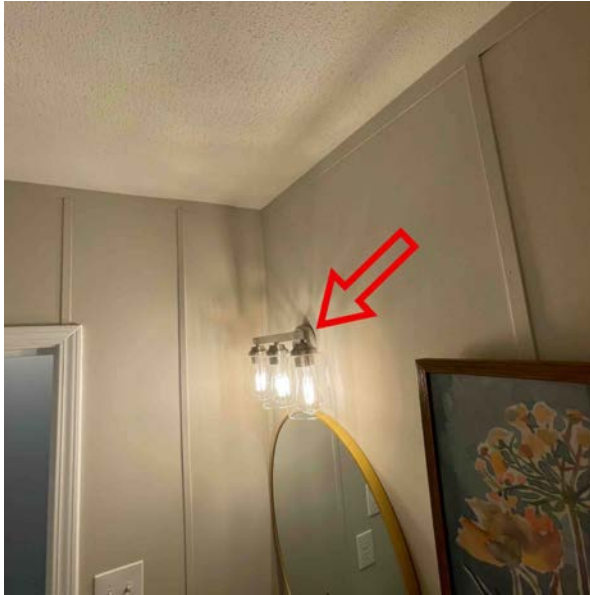
- Hallway Bathroom
- Kitchen

9.9.2 The light fixture was loose and/or inadequately positioned with/from the wall/ceiling. This can cause a strain on the wiring resulting in loose wires and/or may not provide the proper barrier with the electrical junction box. Recommend having a licensed electrician secure fixture to reduce strained wires and potential fire hazard.

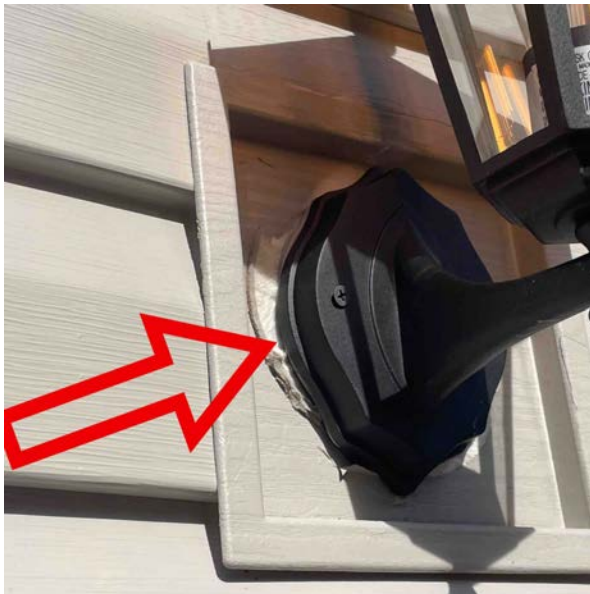
9.9.3 The exterior light fixture was loose and/or inadequately secured to/from the wall. This can cause a strain on the wiring resulting in loose wires and/or allow moisture/pest intrusion. Recommend having a licensed electrician repair/secure/adjust all exterior lights as needed. **(Exterior Front)**

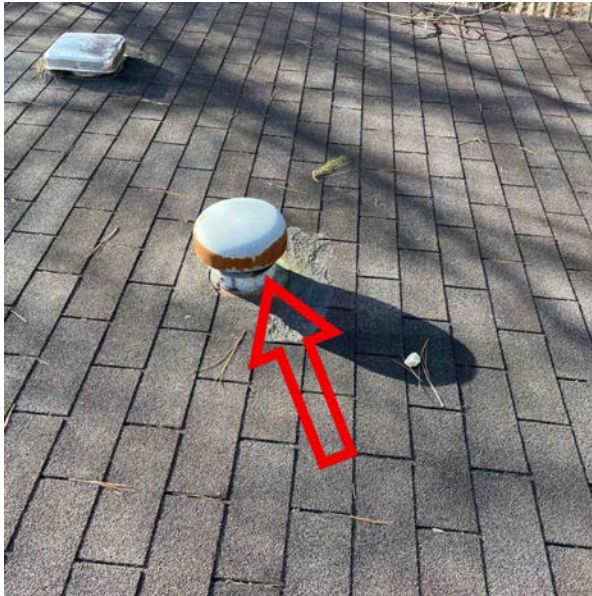
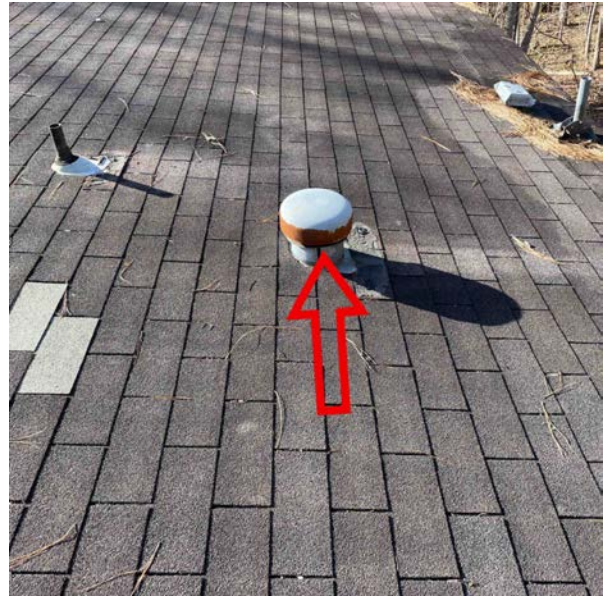
9.10.1 Inadequate amount of airflow was observed coming out of the bathroom vent. This does not allow proper ventilation of the bathroom. Recommend having a qualified contractor or a licensed plumber evaluate and repair as needed to ensure proper operation of the bathroom vent system. **(Roof)**

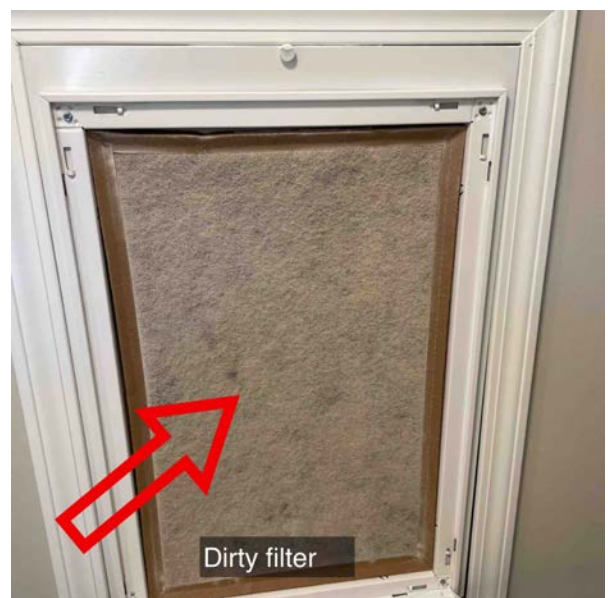
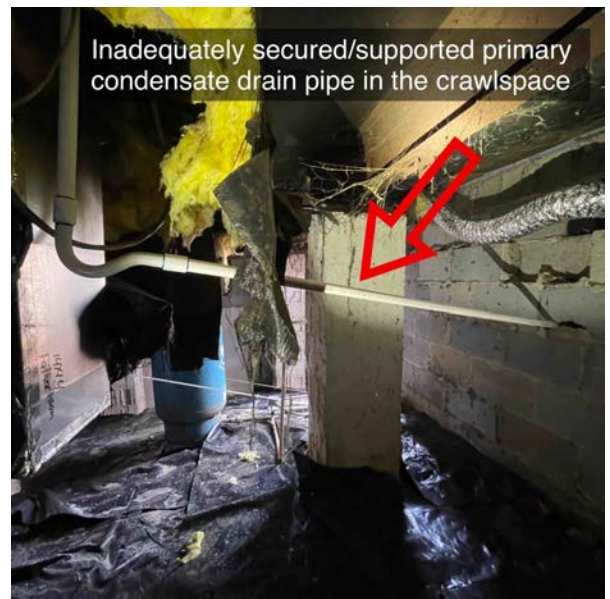
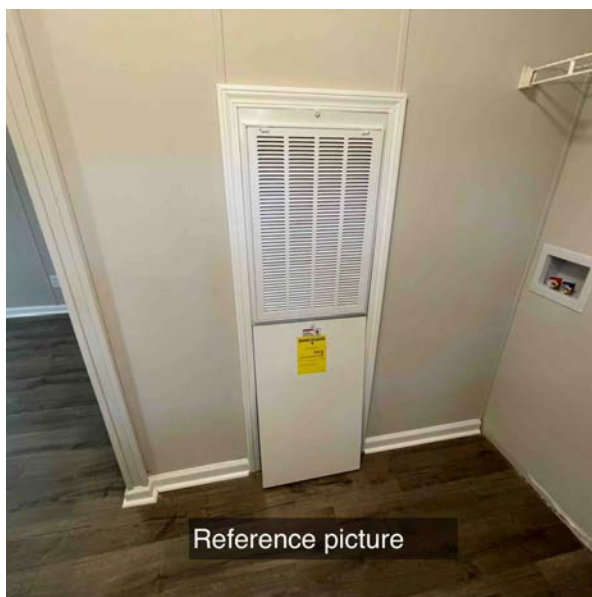
10.5.3 Several concerns were observed with the air handler/HVAC system. For examples please see the pictures below. These issues can affect the proper functionality of the HVAC system, allow accumulation of condensation on components, and/or allow further/future damage/issues. Recommend having a qualified HVAC technician evaluate the entire HVAC system and take all actions needed to ensure safe/proper installation/functionality is achieved. **(Laundry area)**

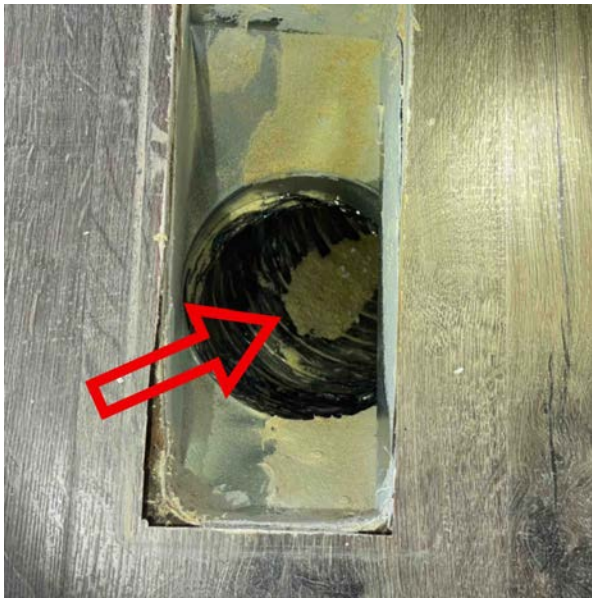
10.6.1 Debris was noted in several HVAC air ducts/registers. This can obstruct the airflow through the register. Recommend having a qualified HVAC technician evaluate and clean the air distribution system to ensure proper/clean airflow is achieved.  
**(Throughout - Issues/concerns were noted in four or more areas.)**

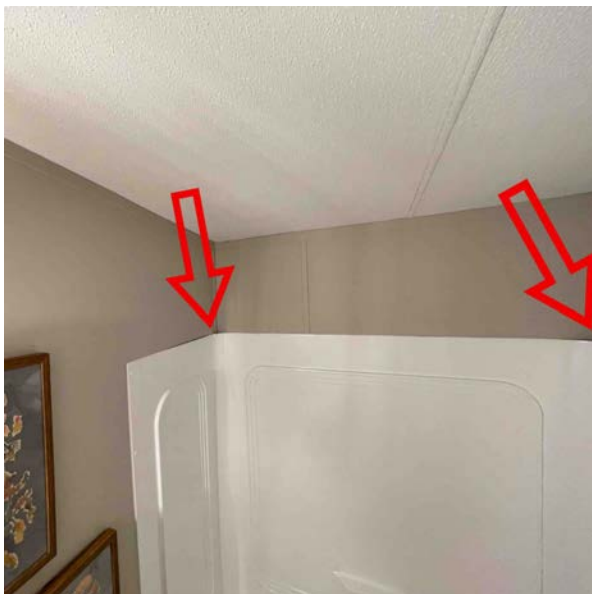
- Hallway Bathroom
- Master Bathroom

11.1.1 Open gaps and/or cracks were observed at water exposed surfaces in the home. For examples of some of the issues please see the pictures below. These may allow moisture intrusion resulting in subsequent damage to the surrounding materials. Recommend having a licensed plumber repair/seal all areas in the home as needed to prevent future damage.

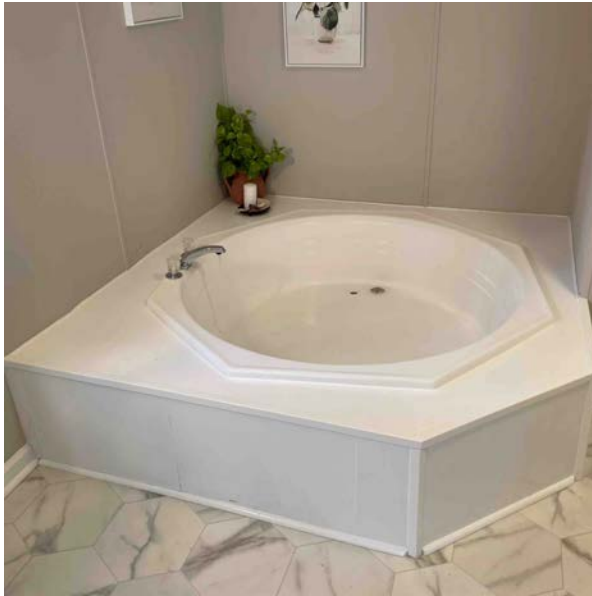
11.1.2 Sulfur smell was coming from the hot water while running it at the fixtures in the home. This is a health concern and may indicate bacteria growth inside the water heater. Have a licensed plumber further evaluate the hot water heater/system and address as needed to mitigate any sulfur smells/bacteria in the system. **(Throughout - Issues/concerns were noted in four or more areas.)**

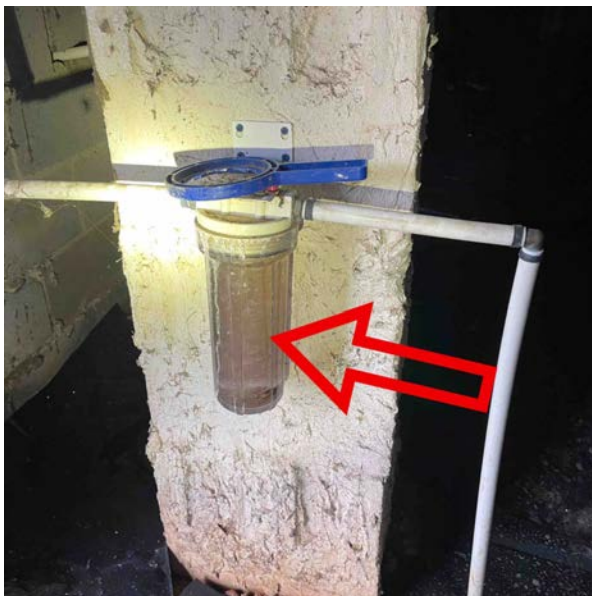
11.2.2 The well water supply to the home was observed missing the filter element in the crawlspace. This may allow contaminants/minerals to enter the homes water piping and fixtures. Recommend installing a filter. **(Crawlspace)**

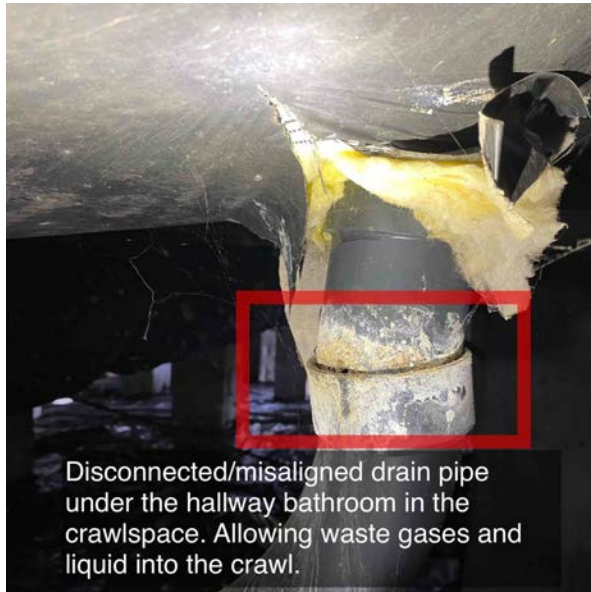
11.4.2 Several concerns were observed with the homes plumbing drain/vent piping. For example's please see the pictures below. These items may affect the proper drainage/venting of the plumbing system, lead to future/further damage, and/or are health concerns. A licensed plumber should evaluate the homes entire drain/vent plumbing system and take all actions needed to ensure proper installation of all drain/vent piping is achieved. **(Throughout - Issues/concerns were noted in four or more areas.)**

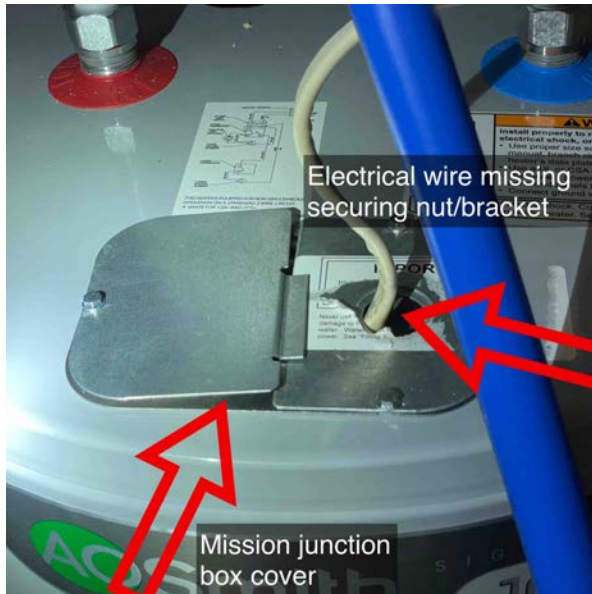
11.5.3 Several concerns were observed with the water heater. For example's please see the pictures below. These items may affect the proper operation of the water heater and/or are safety concerns. Recommend having a licensed plumber evaluate the system and repair/replace all materials/components as needed to ensure safe/proper functionality is achieved. **(Master Closet)**

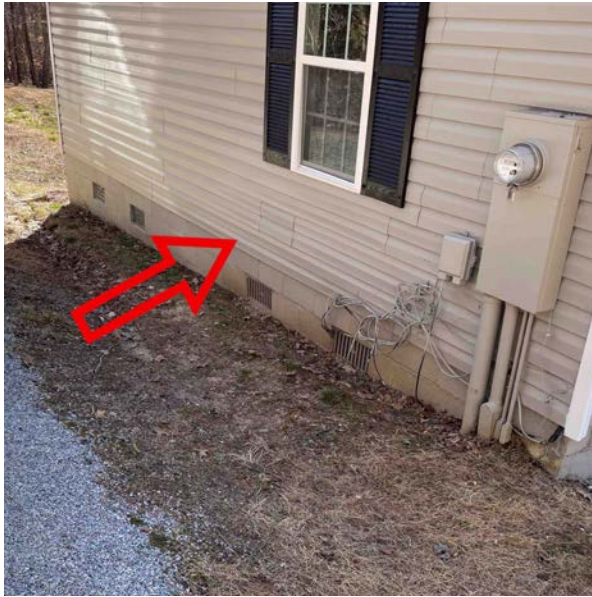
11.6.1 The home was observed with no exterior hose bibs. Recommend having a licensed plumber install hose bibs for easy exterior water use.

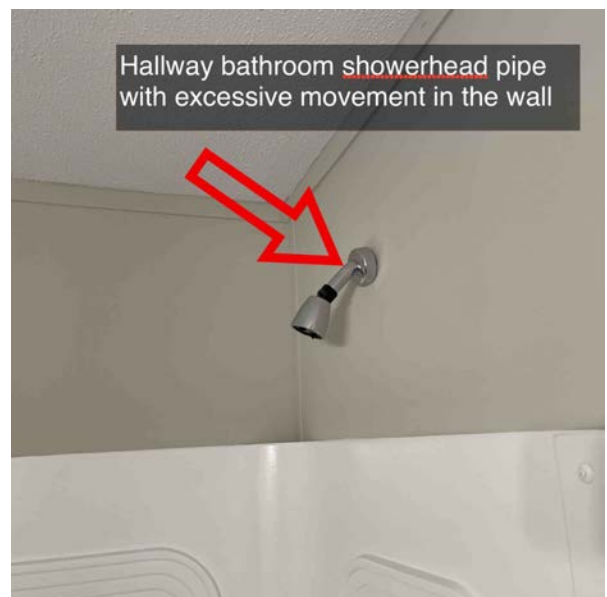
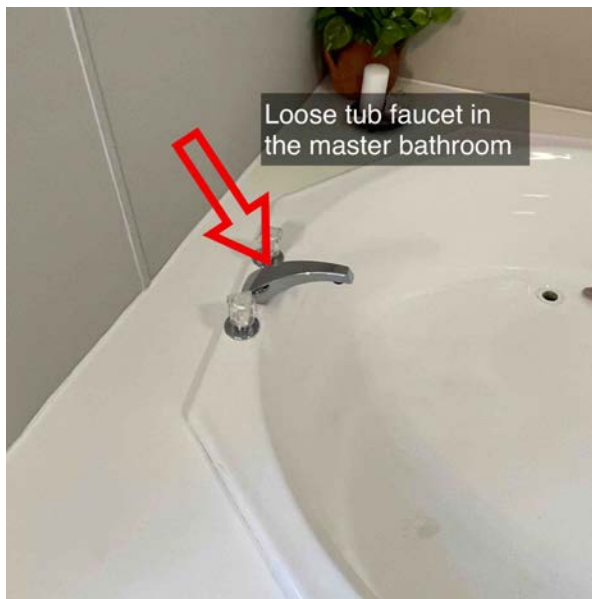
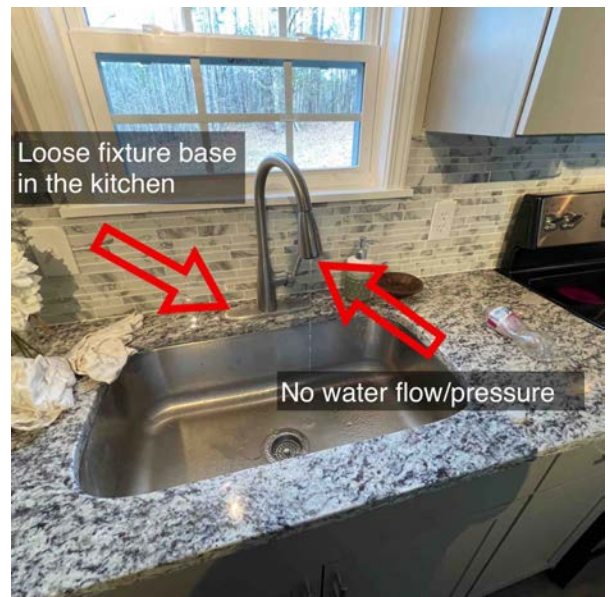
11.7.1 Several concerns were observed with the sink/tub/shower fixtures in the home. For examples please see the pictures below. These issues can affect normal operation/functionality/use of the fixture/sink/tub/shower and/or cause moisture damage to the surrounding materials. A licensed plumber should evaluate all sink/tub/shower fixtures and repair/replace/secure/adjust all components as required to ensure proper functionality/installation. **(Throughout - Issues/concerns were noted in four or more areas.)**

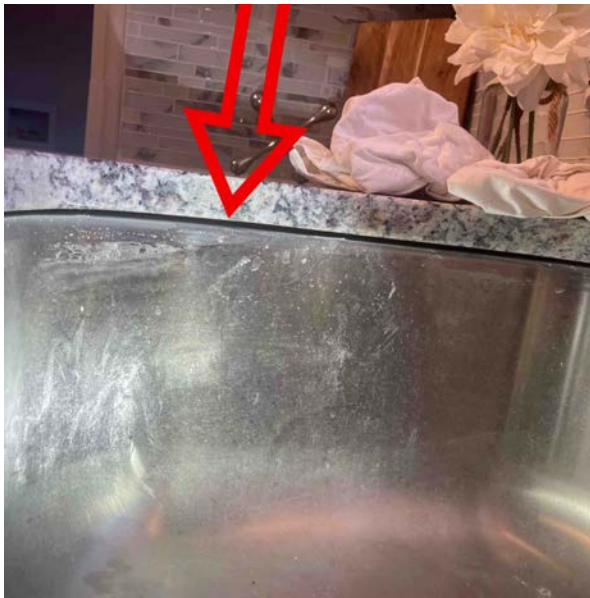
**(Kitchen)**

11.8.1 The kitchen sink was loose from the counter top. This may add extra stress to the plumbing piping and/or allow moisture into the cabinet below. Recommend having qualified contractor secure the sink as needed to prevent future damage/issues.

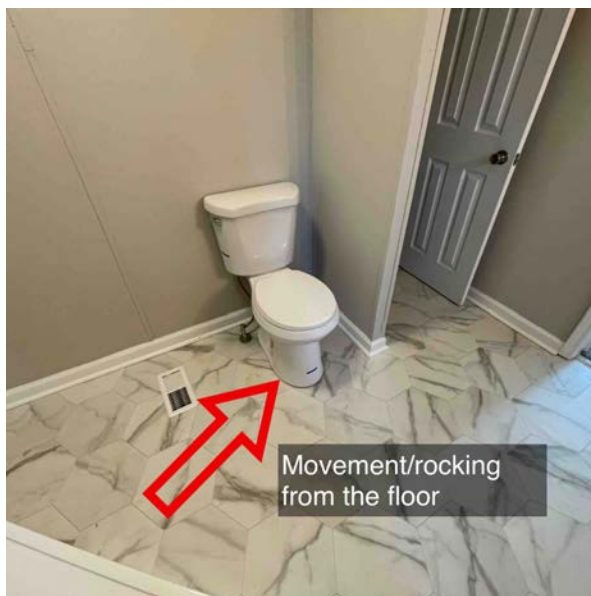
11.9.1 The toilet bowl was observed loose from the floor and/or the reservoir was loose from the bowl. Over time this can allow leaks causing subsequent damage to the structure. Recommend having a licensed plumber evaluate and repair/secure as needed to prevent future damage. **(Master Bathroom)**

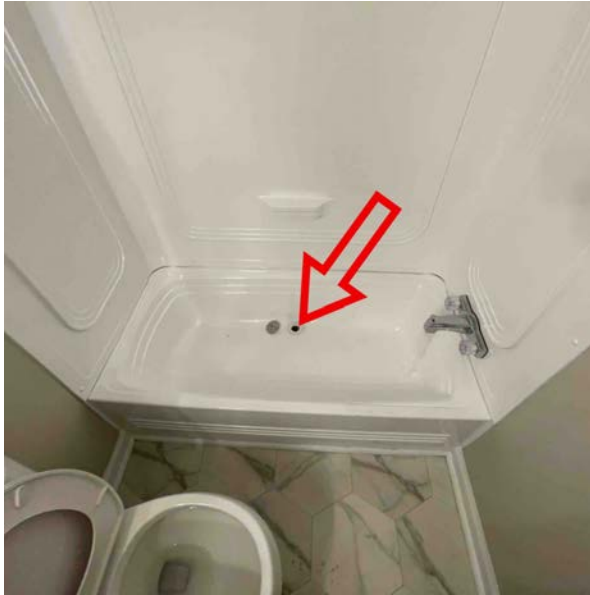
- Hallway Bathroom
- Master Bathroom

11.10.2 The bathtub drain plug was damaged/missing. This does not allow for normal operation to fill the bathtub. Recommend having a licensed plumber repair as needed to ensure proper functionality is achieved.
