### Material facts

Below are the material facts from the previous home inspection. The seller has not yet made the repairs. He is willing to make repairs or give money in lieu of repairs based on a buyer's preference. If the buyer would like repairs made, they can be made as part of the contract through an additional provisions addendum or DDRA.

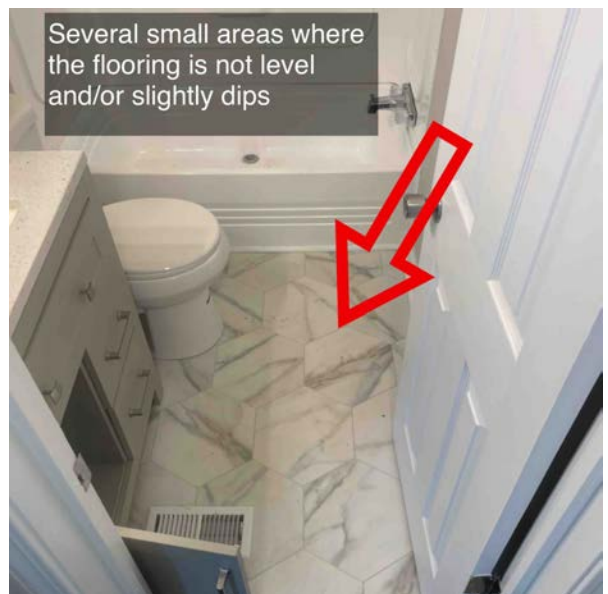
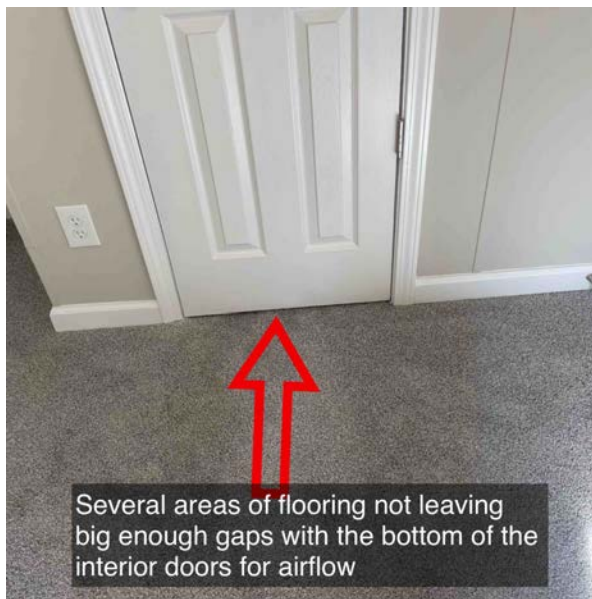
12.1.1 Several concerns were observed with the interior finished flooring in the home. For examples please see the pictures below. These issues may lead to further/future damage, indicate inadequate installation of materials, and/or affect the moisture/dirt barrier. Recommend having a qualified contractor further evaluate and address all areas of flooring as needed. **(Throughout - Issues/concerns were noted in four or more areas.)**

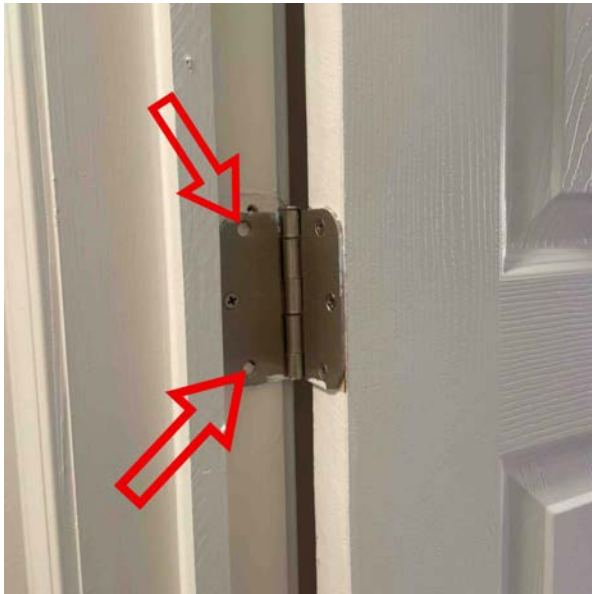
12.2.1 The interior door hinges were observed missing screws. This can allow the hinge to come loose affecting the operation of the door. Recommend installing all missing screws. **(Master Closet)**

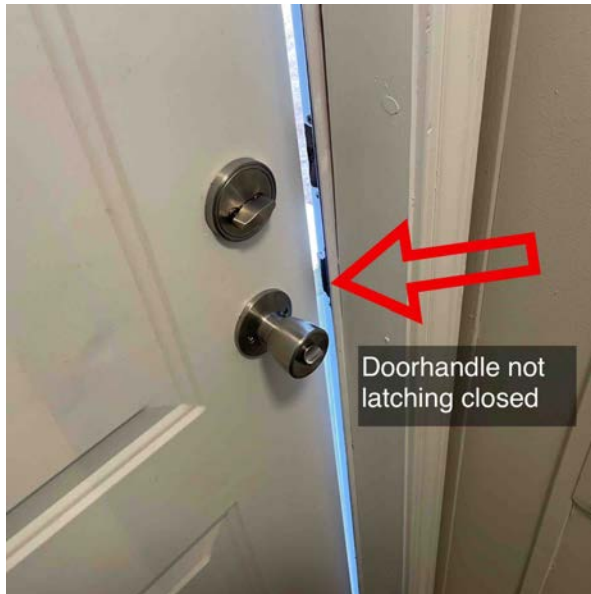
12.3.1 Several concerns were observed with the exterior entrance door. For examples of some of the issues please see the pictures below. These concerns may affect the operation of the door, affect the efficiency of the home, and/or cause future damage. Recommend having a qualified contractor further evaluate and repair/adjust/secure all components/materials as needed. **(Exterior Back)**

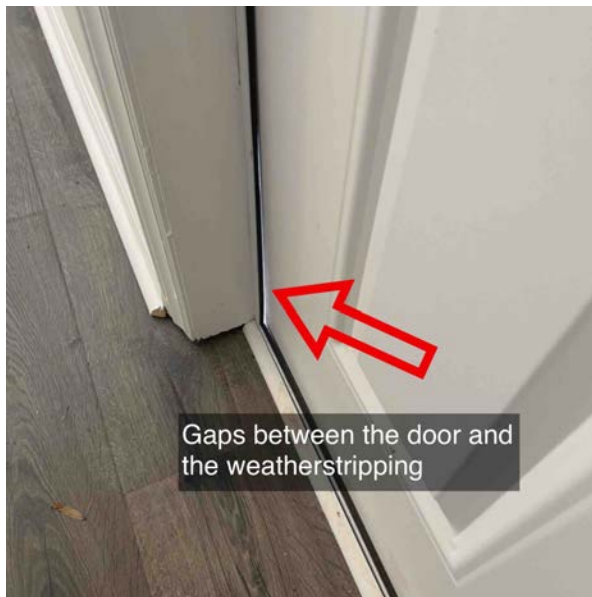
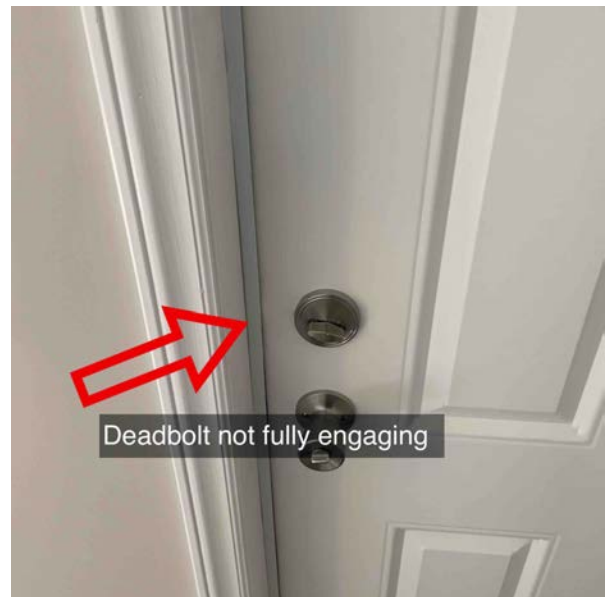
12.3.2 Several concerns were observed with the exterior entrance door. For examples of some of the issues please see the pictures below. These concerns may affect the operation of the door, affect the efficiency of the home, and/or cause future damage. Recommend having a qualified contractor further evaluate and repair/adjust/secure all components/materials as needed. **(Exterior Front)**

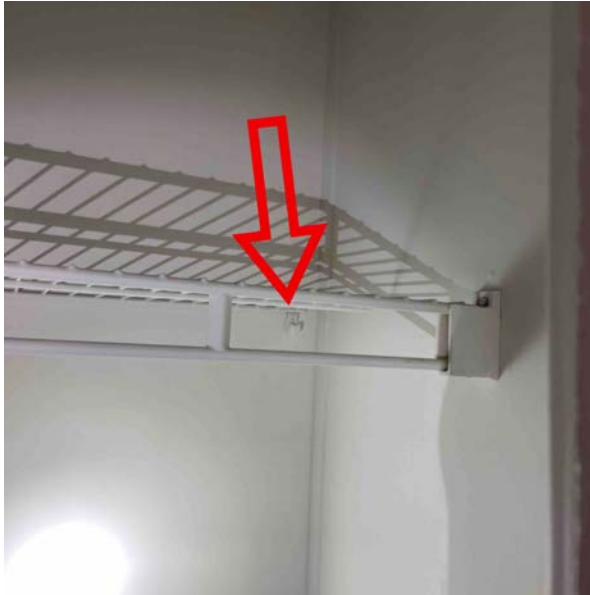
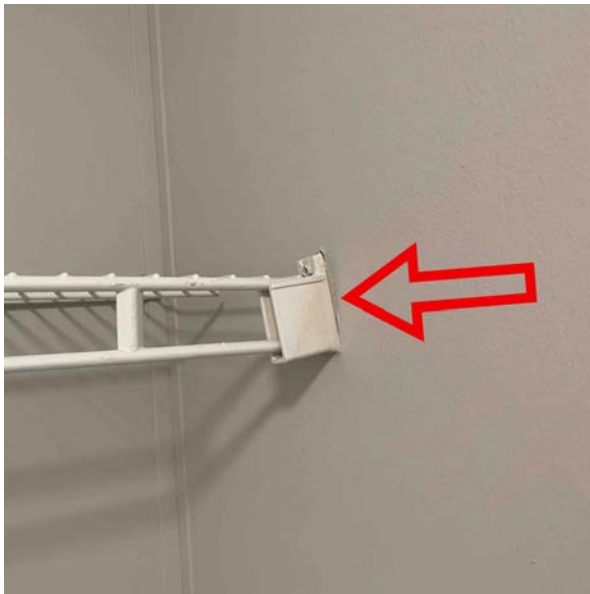
- Back Right Bedroom Closet
- Laundry area

12.4.1 The shelf/shelf supports were observed with loose hardware. This may not secure the shelf or items as intended. Recommend repairing/security/replacing all shelf hardware as needed.

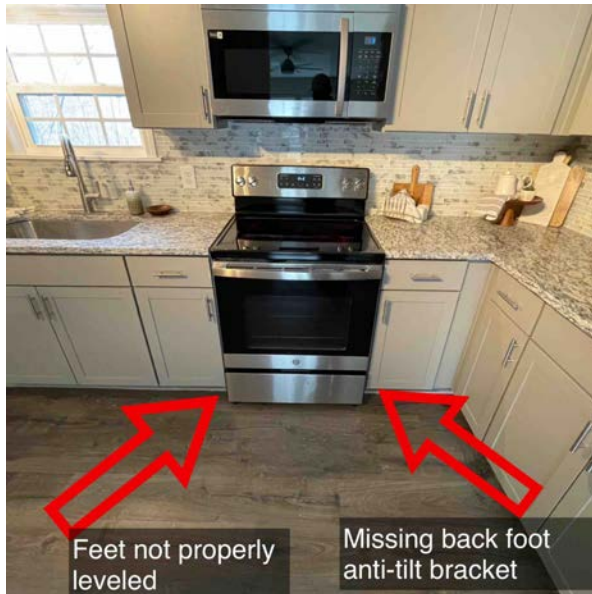
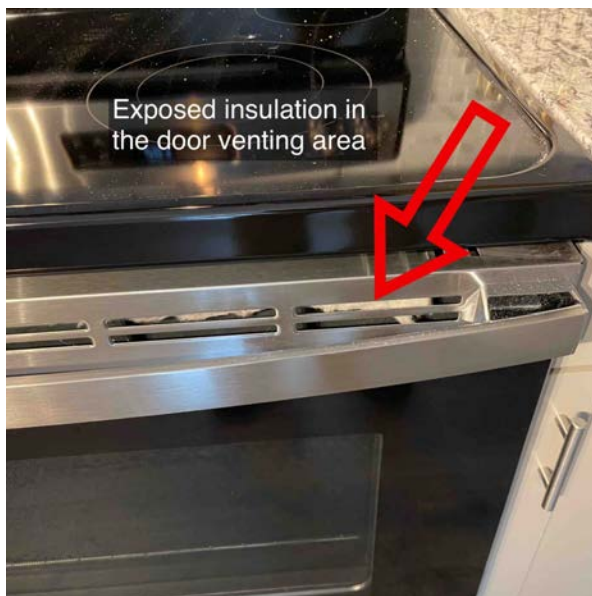
13.3.1 -Several concerns were observed with the range. Please find the image(s) below for reference, keeping in mind that they may not encompass all areas or concerns. These items can affect the functionality of the range and/or may be safety concerns. The builder/site supervisor should be consulted to determine the significance of the concern(s) and any actions, if needed, required to address. **(Kitchen)**

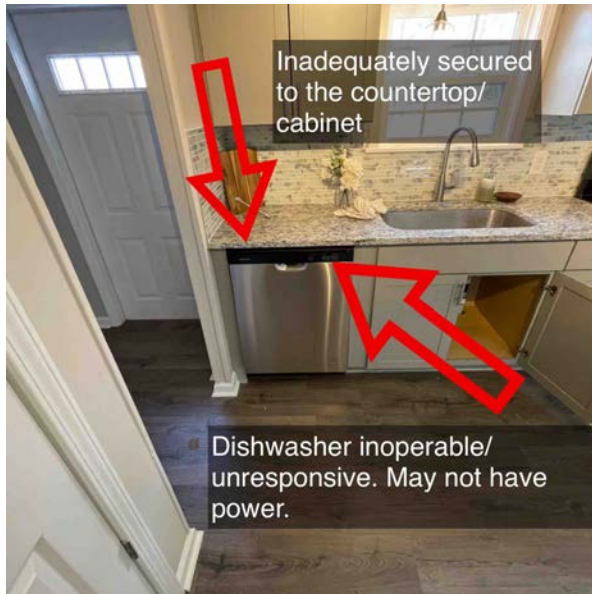
13.4.1 -Several concerns were observed with the dishwasher. Please find the image(s) below for reference, keeping in mind that they may not encompass all areas or concerns. These issues may affect the functionality/operation of the dishwasher. The builder/site supervisor should be consulted to determine the significance of the concern(s) and any actions, if needed, required to address. **(Kitchen)**

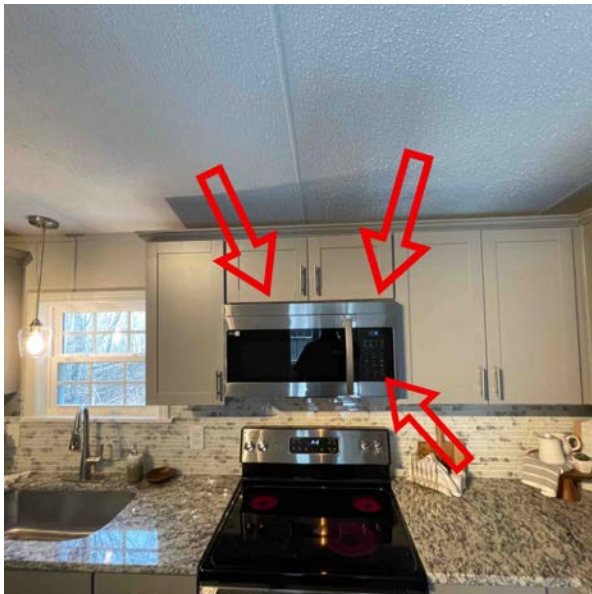
13.5.1 The microwave cooktop exhaust fan was inoperable/unresponsive. This does not allow normal/proper ventilation of the cooktop area. Have a qualified appliance technician further evaluate and repair/replace the microwave as needed. **(Kitchen)**
