# Inspection Report

1101 Water St  
Henderson NC 27536

**Inspect Co. L.L.C.**

| Date: 7/2/2024 | Time: 09:30 AM | Report ID: JPwaterst722024 |

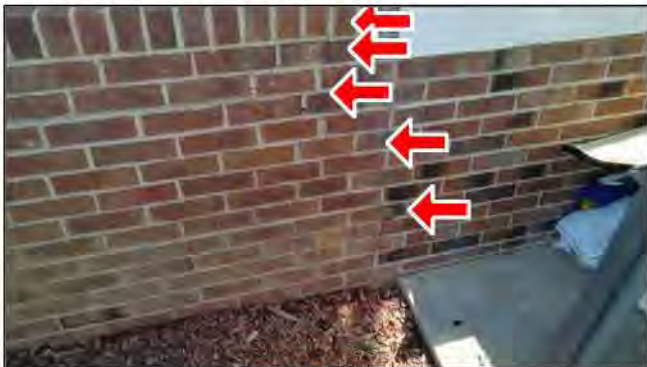
The foundation wall at the front porch and garage wall connection of the home has cracks noted that may have structural implications with through brick cracks and / or long cracks and needs to be reviewed and repaired under the guidance of a licensed structural engineer or a licensed general contractor specializing in foundation structural repairs. A clear structural letter and warranty should be received from the company performing the work.

1.0 Item 1(Picture) Long cracking in the brickwork

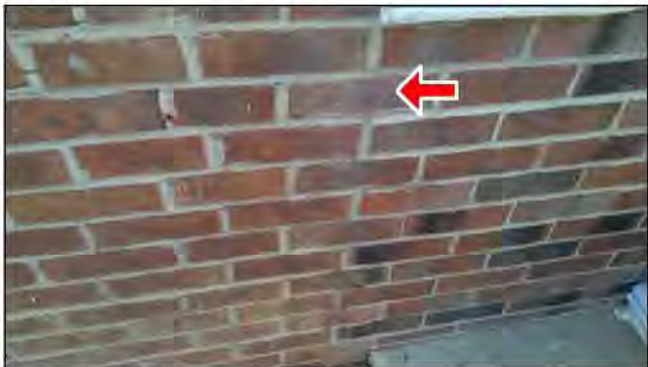
1.0 Item 2(Picture) Structural cracks in brickwork with cracked bricks noted

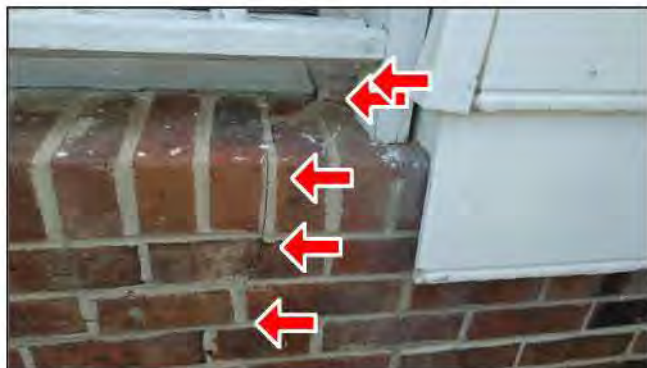
1.0 Item 3(Picture) Structural crack has settlement in the front porch noted

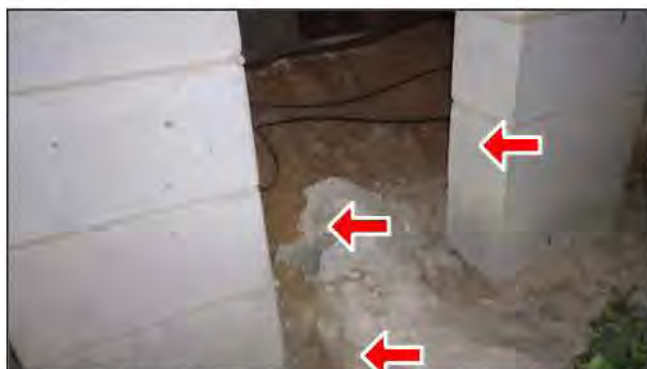
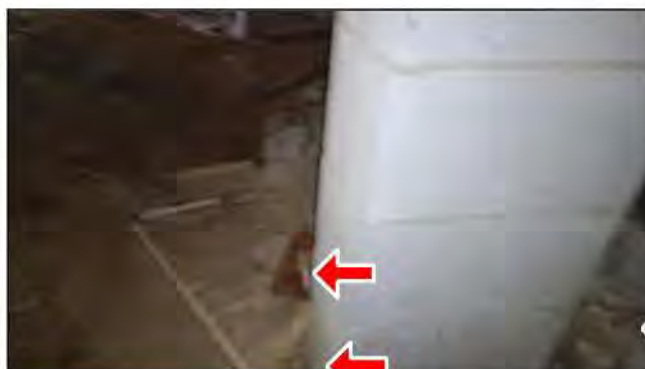
The foundation columns footers in areas at the center of the crawlspace has not been back filled and is not allowing for proper drainage of these areas, can hold water, and these areas needs to be back filled and made to properly drain all water from the crawlspace.

1.1 Item 1(Picture) The foundation piers footers have not been back filled

1.1 Item 2(Picture) Footers have not been back filled

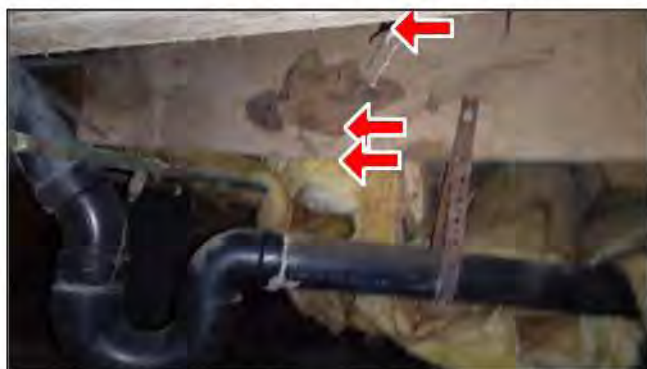
(1) The floor framing has broken floor joists noted under the hall bathroom and the bathroom floor has a large dip noted. This area needs to be evaluated and repaired and or replaced and all areas of the floor framing made functional by a licensed general contractor.

1.2 Item 1(Picture) Broken floor joist at a knot in the wood

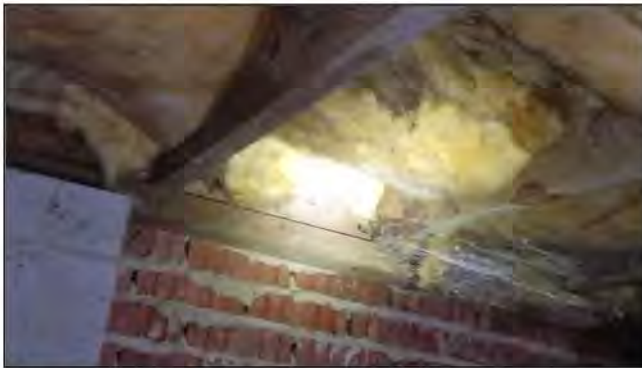
(2) The floor framing at the rear of the crawlspace has deterioration and fungus growth from radiant moisture and needs proper repairs in these areas (May not be limited to these areas / check during repairs). These areas of the floor framing needs to be reviewed and all necessary repairs performed by a licensed general contractor.

1.2 Item 2(Picture) Heavy fungal growth on the floor framing

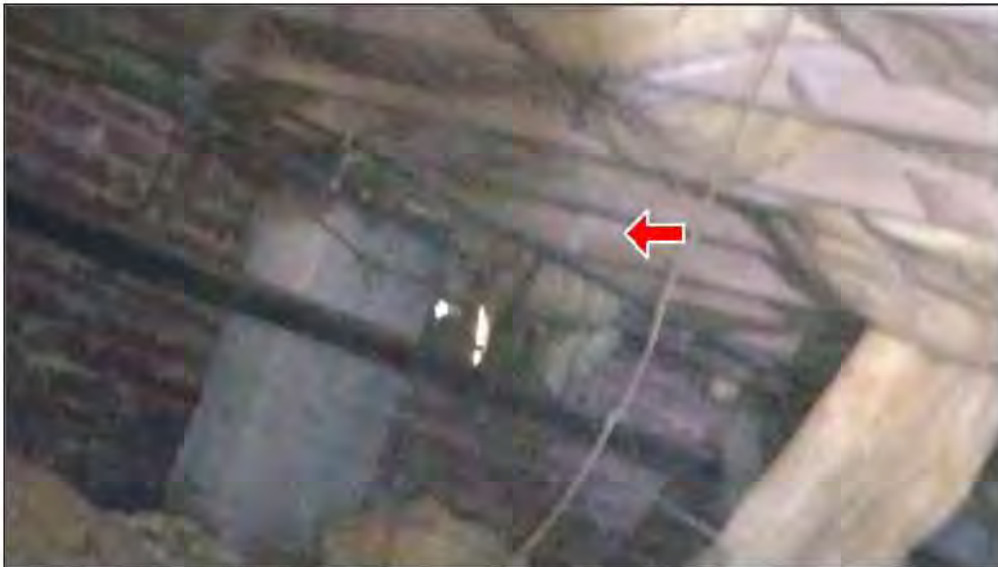
1.2 Item 3(Picture) Sistered floor framing not supported on the ends

(3) Repairs have been made in the crawlspace under or near the rear door and these repairs were not done using proper building techniques (floor joists are not supported to the ends) This can cause uneven floors and possible failure. These repairs need to be reviewed by a licensed general contractor and all areas make functional.

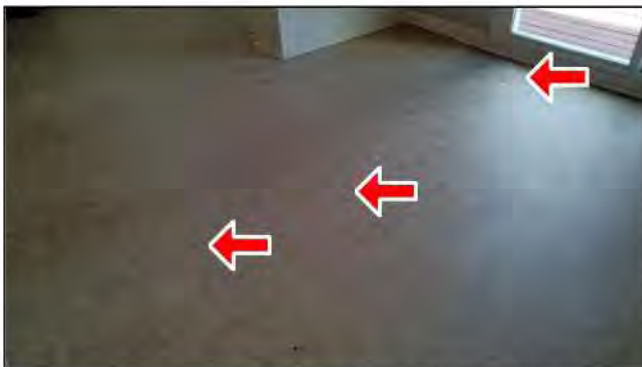
1.2 Item 4(Picture) Large dip in the kitchen floor

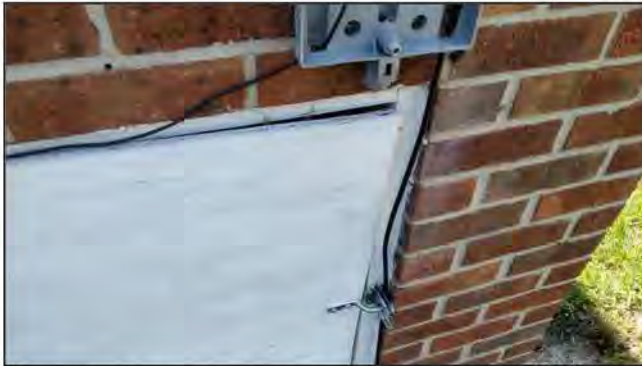
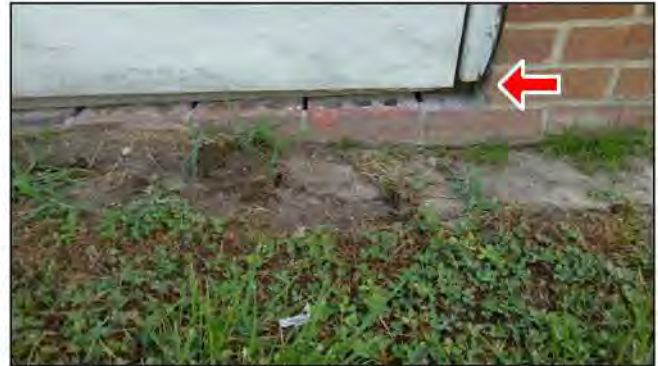
(2) The crawlspace door has gaps noted and is not sealed and can allow water and pests to enter the crawlspace and can cause damage and this crawlspace door needs to be repaired and sealed and made functional by a qualified contractor.

1.3 Item 2(Picture) Gaps at the crawlspace door

1.3 Item 3(Picture) Gaps at the crawlspace door

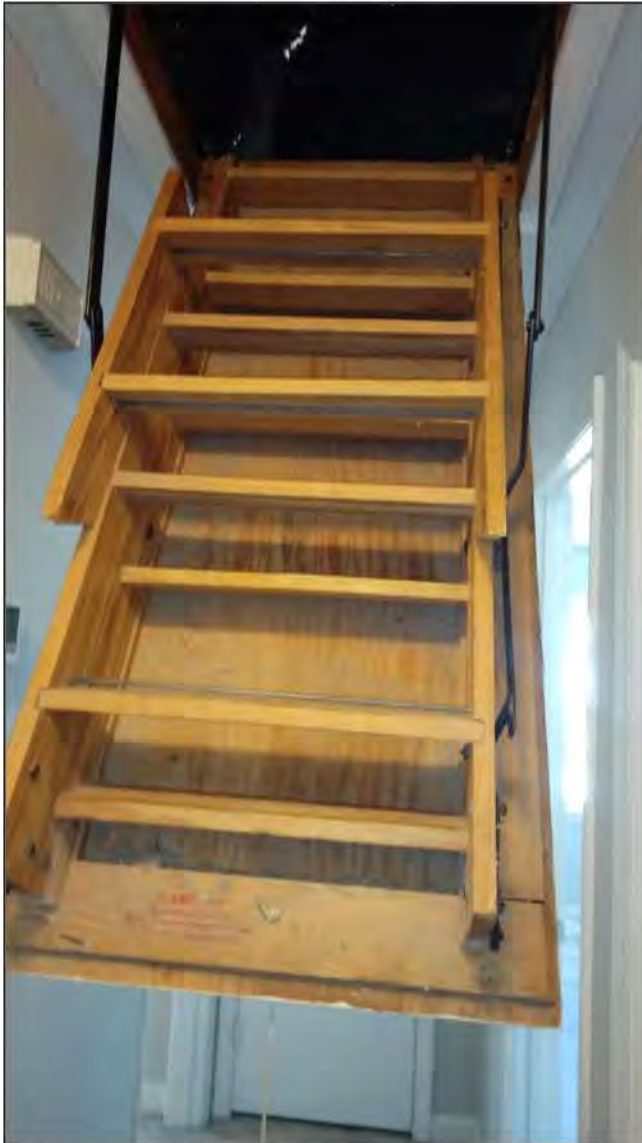
1.7 Item 1(Picture) Door missing insulation and weather stripping

The attic access is not sealed or insulated and these gaps are allowing conditioned air to escape the home. This can cause higher than normal energy bills and excessive wear on the HVAC components. This access door should have weather stripping and insulation installed by a qualified contractor to stop air loss in this area.

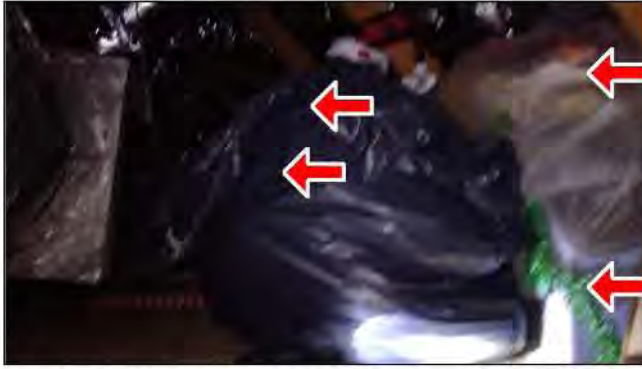
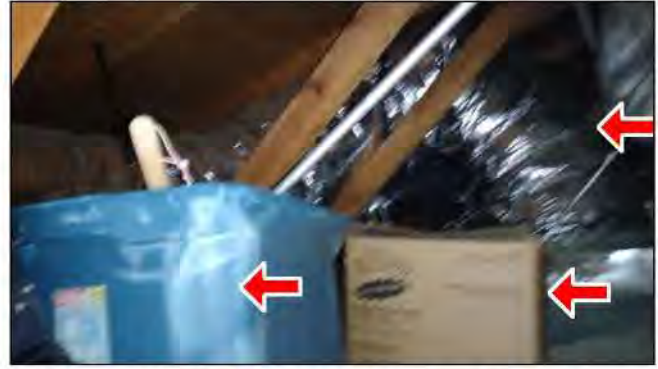
The attic service flooring was covered with stored items making the attic inaccessible and the attic was only viewed from the entry. No representations are made of the inaccessible areas.

1.8 Item 1(Picture) Stored items in the attic

1.8 Item 2(Picture) Stored items in the attic

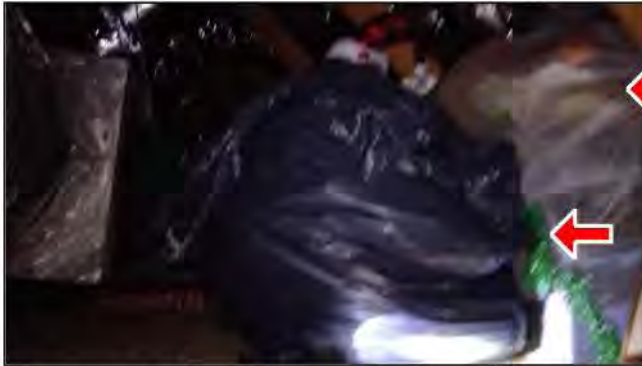
(1) The attic was inaccessible in areas and could only be viewed from the attic entry and this attic should be cleaned and inspected before closing with all needed repairs performed. No representations are made of these areas of this attic.

1.9 Item 1(Picture) Stored items in the attic block access

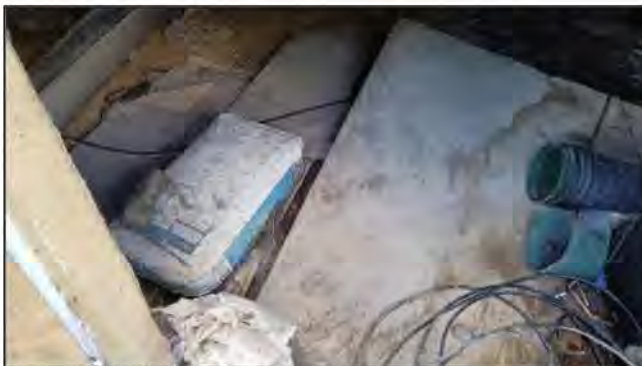
(2) The crawlspace has wood and construction debris noted in various areas making areas inaccessible for inspection and no representations are made of these areas. Remove these items from the crawl space to prevent pest infestation and to increase accessibility for inspection and ventilation and to make the crawl space clean.

1.9 Item 2(Picture) Wood and stored items in the crawl space

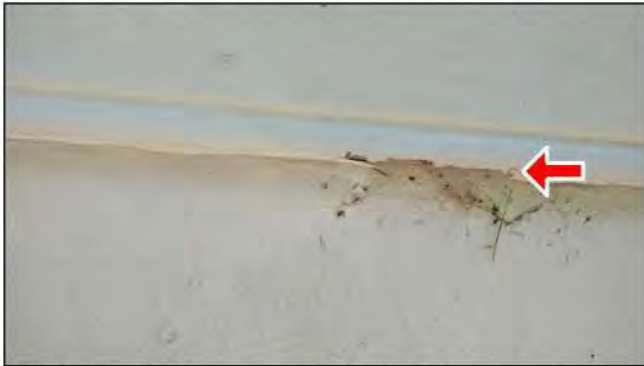
**Comments:** Repair or Replace  
The hard board siding has deterioration noted in multiple areas around the home. The framing in affected areas need to be checked for obvious and / or concealed damage and all necessary repairs performed by a licensed general contractor.

2.0 Item 2(Picture) Deteriorated siding

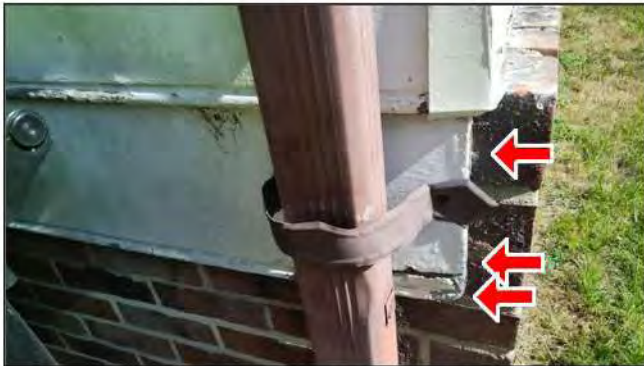
2.0 Item 4(Picture) Deteriorated siding in the lower areas.

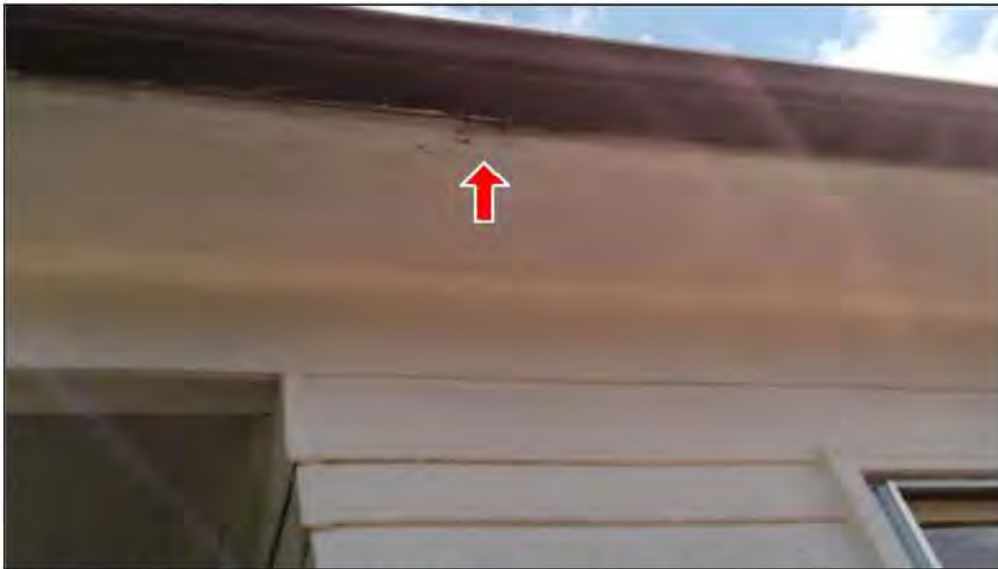
2.1 Item 1(Picture) Deterioration noted at the front and rear fascia boards

The fascia, rake boards and trim at the front, rear and ends of the home deterioration noted from moisture running between the gutter and the fascia boards and this area needs to have the fascia boards repaired or replaced and the gutter properly re-secured and all areas made functional by a licensed general contractor.

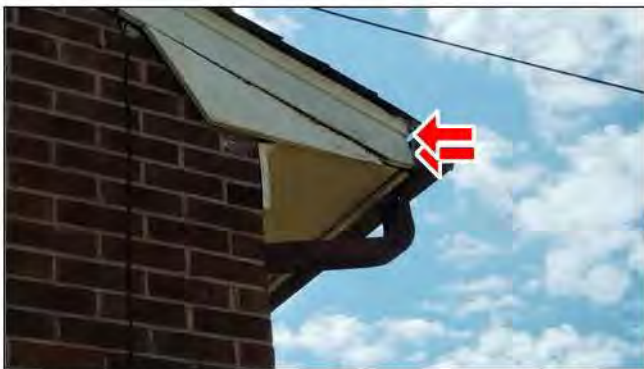
2.1 Item 2(Picture) Deterioration noted in the rake boards

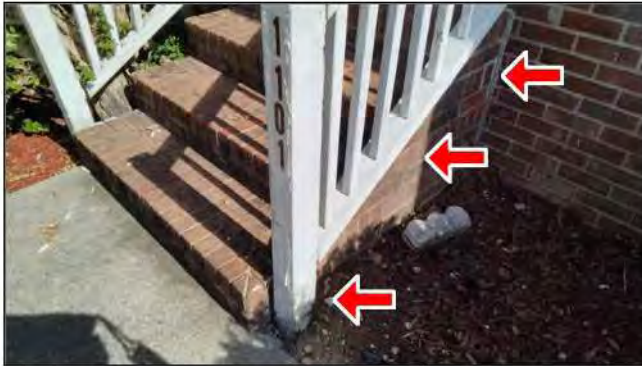
The entry doors, windows, trim, gable vents handrails and other areas of the home have failing paint

and failing caulk in areas and all exposed substrates needs functional paint and all gaps need to be properly sealed. This is needed to prevent leakage and damage to the substrates and needs to be made functional by a qualified painting contractor.

2.2 Item 1(Picture) Failing paint on the front porch railing

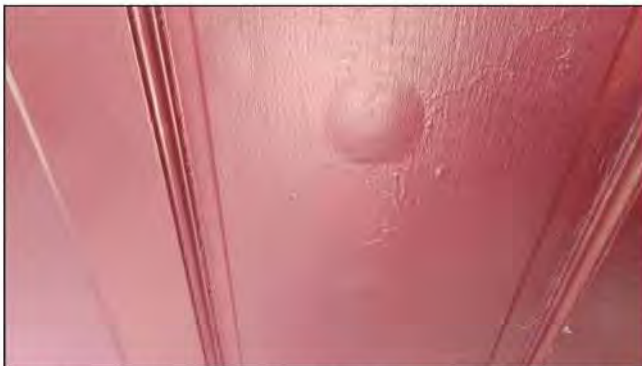
2.2 Item 3(Picture) Bubbling paint on the front door

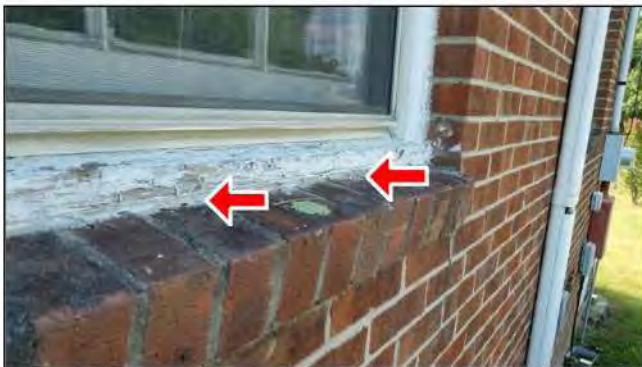
2.2 Item 5(Picture) Failing paint at the windows

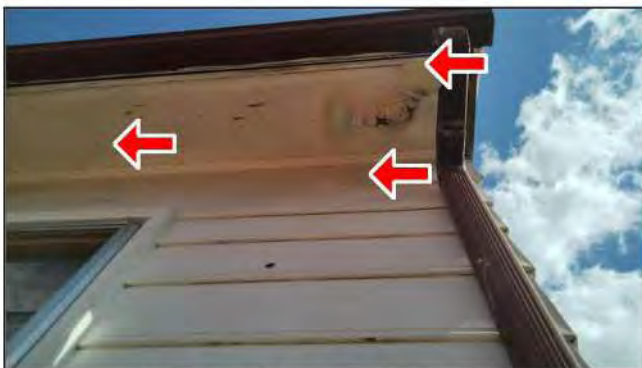
2.2 Item 10(Picture) Failing paint noted

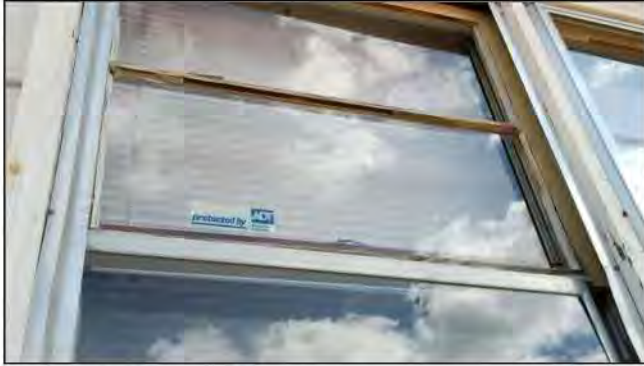
(1) The glazing and paint in many areas of the homes windows failing / missing in areas. This glazing holds the glass into place and needs repairs to prevent the glass from pulling loose and leaking and made functional by a window company.

2.3 Item 1(Picture) Failing and missing glazing

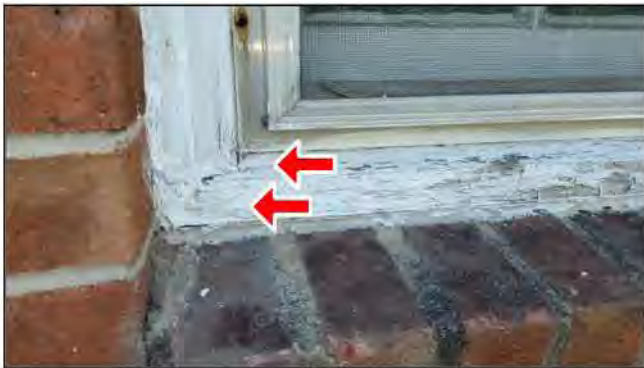
(2) The windows at the left side window has deterioration noted to the outer sash, threshold, frame and trim and these areas can allow water to enter the home and can cause further damage and deterioration. All windows should be evaluated and probed for concealed damage with all areas made functional by a licensed general contractor.

2.3 Item 2(Picture) Deterioration noted

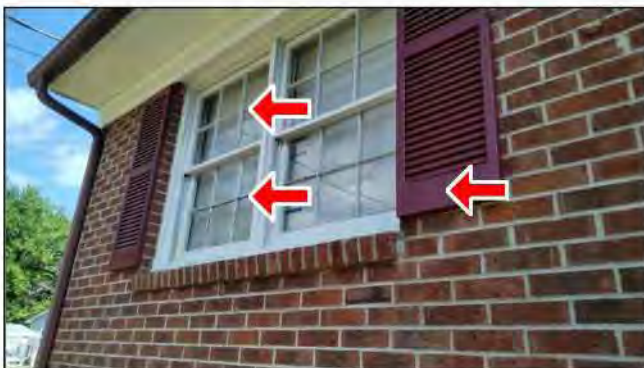
(3) The storm window screens and glass at various areas around the house have torn screens / bent frames in areas and all damaged screens need repairs / replacement as needed. These screens are not required structural components unless no cooling system is in place for the home.

2.3 Item 3(Picture) Missing screens and glass

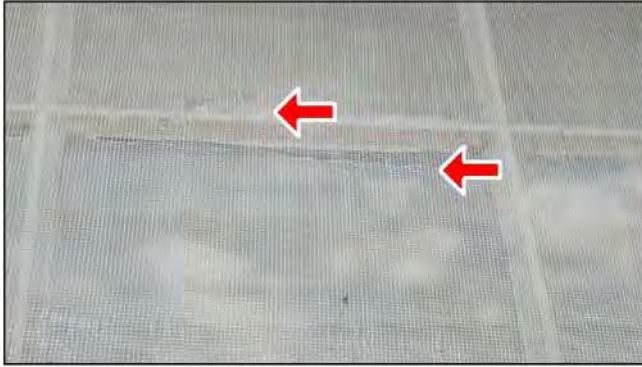
2.3 Item 5(Picture) Torn screens

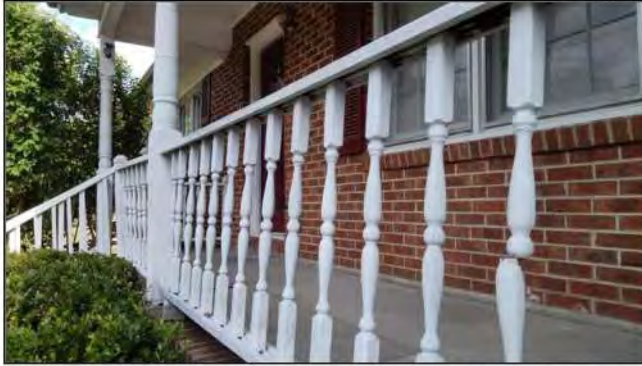
(1) The handrails and / or pickets around the front porch have deterioration noted in areas and these handrails needs proper repairs by contractor to prevent further damage and to correct the damage in place.

2.5 Item 1(Picture) Loose deteriorated rails and pickets

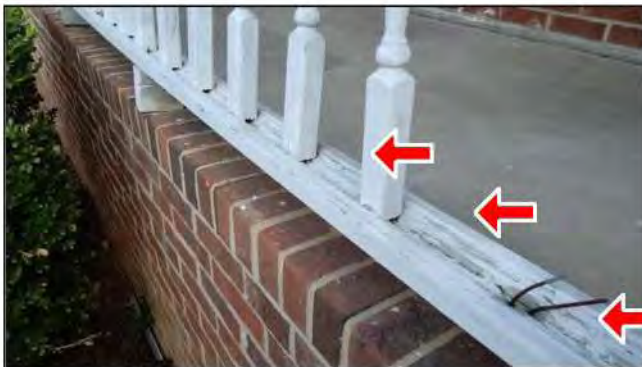
2.5 Item 3(Picture) Deteriorated railing and pickets

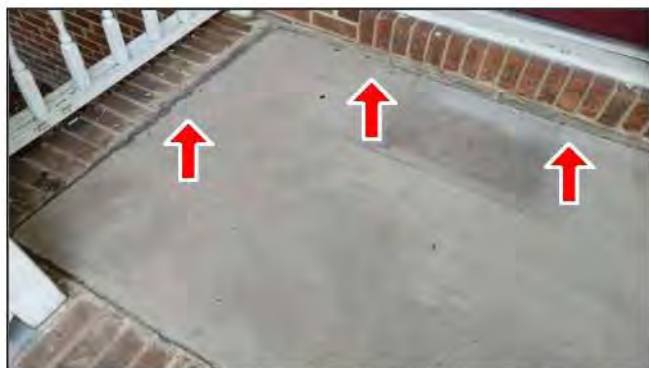
(2) The front porch slab has settled and is slopping back toward the house. This can allow damage to the structure or cause further damage to the framing for the house. This slab can settle further and needs repairs by concrete company / equivalent. This has the potential to get worse and needs to be made functional.

2.5 Item 4(Picture) Front porch has settled and is slopped towards the home

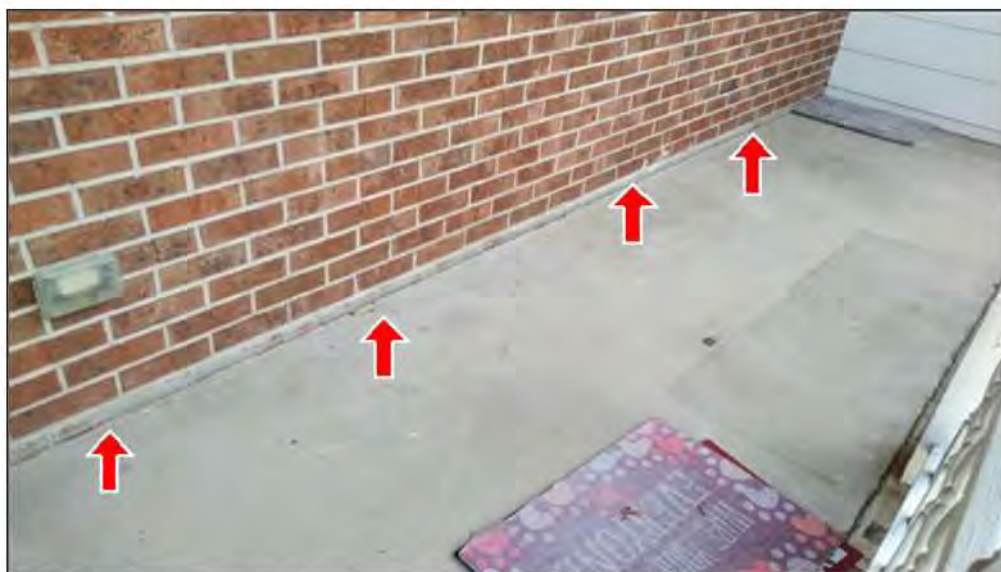
2.5 Item 5(Picture) Settled front porch

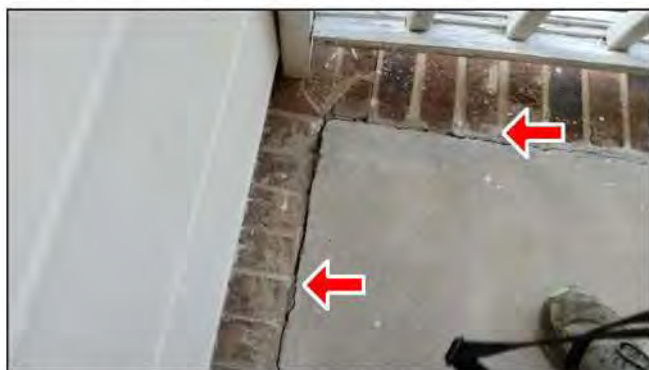
2.5 Item 6(Picture) Outer brickwork is higher than the concrete and will hold water

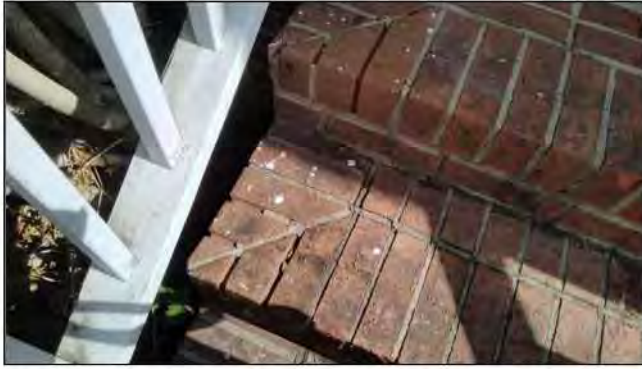
The front steps has cracked / or missing mortar and is leaving gaps noted in areas. The mortar needs to be pointed up or replaced in affected areas by a mason and all areas made functional.

2.6 Item 1(Picture) missing mortar noted

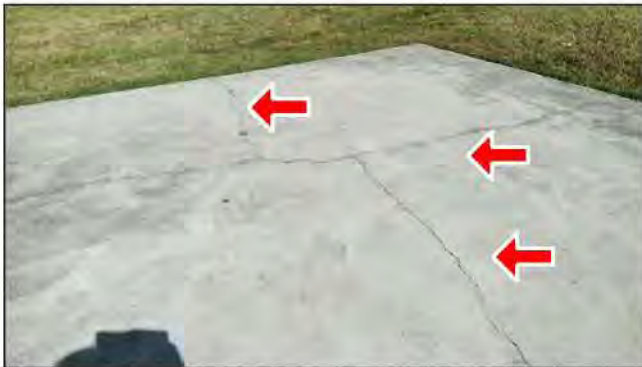
(1) The concrete driveway / walkway has cracks noted in various areas under 1/4" wide. All cracks under 1/4" wide are considered common cracking by the engineering department of North Carolina and needs to have the gaps sealed and evaluated on a regular basis for further movement or damage and needs general repairs by a qualified mason.

2.7 Item 1(Picture) Common cracks noted in the driveway

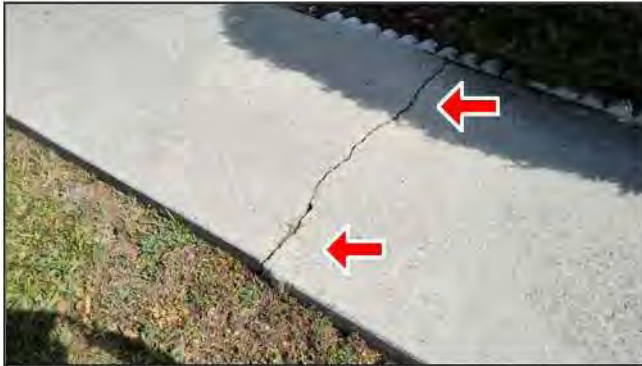
(3) The walkway has cracking with raised areas and is not on the same plane as other areas of the walkway and this is a tripping concern. This is a tripping hazard or safety concern and can allow further settling of this walkway and needs repairs performed and the area made functional and safe qualified contractor.

2.7 Item 4(Picture) Cracking with raised areas noted

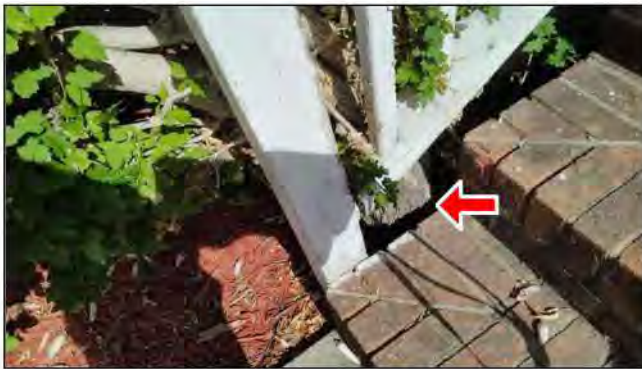
(4) The tree at the front steps has roots that are growing against the brick front steps and can cause damage. This tree should be removed and any necessary repairs performed and all areas made functional.

2.7 Item 5(Picture) Tree root growing against and under the front steps

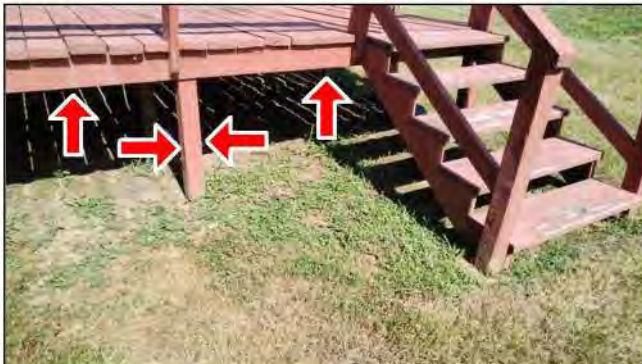
(1) No 45 degree lateral bracing is in place on the porch posts that supports the movement between the posts and framing and needs proper lateral bracing to support these posts properly. Installed by a qualified contractor to offer proper support and to prevent movement in the deck for these areas.

2.8 Item 1(Picture) Missing 45% angle braces

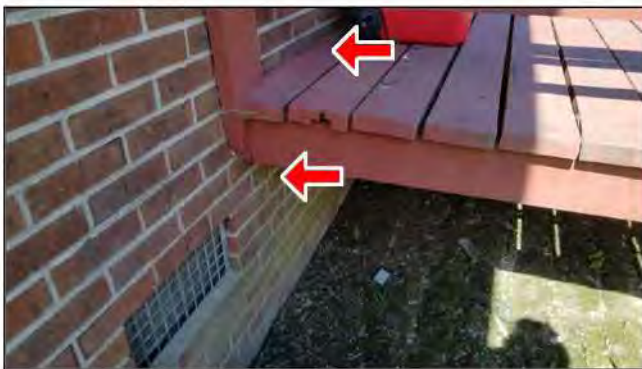
(2) The porch has no visible flashing against the house, can allow water seepage and / or deterioration to the wood members / framing, needs to be checked for concealed damage, and needs proper flashing installed. Any and all damage needs to be located and repaired by a licensed general contractor and made functional.

2.8 Item 3(Picture) No flashings installed

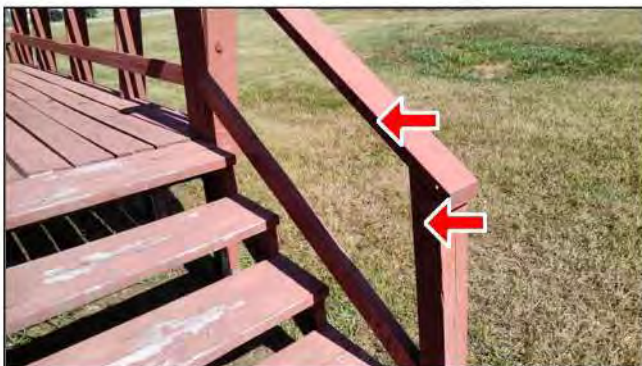
(3) The handrails and pickets for the deck / steps at the rear deck are loose and is a safety concern. These rails need to be secured and made functional by a licensed general contractor.

2.8 Item 4(Picture) Loose hand rail

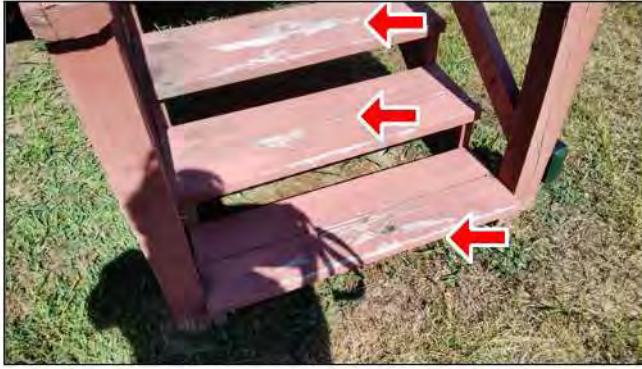
(4) The deck needs cleaning with a deck wash and seal with a waterproof sealant to prevent damage and deterioration to the deck components. Always do the underside of deck as well if accessible.

2.8 Item 5(Picture) Deck and steps need to be cleaned and sealed

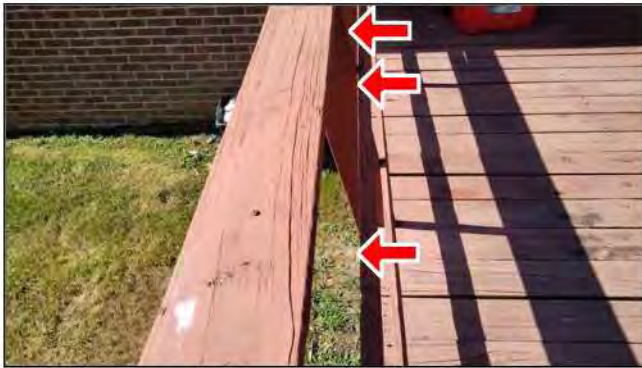
(5) The porch handrails have splintering and / or have raised areas and needs repairs to allow use of the handrails by a licensed contractor and made functional.

2.8 Item 7(Picture) Splintering hand rails

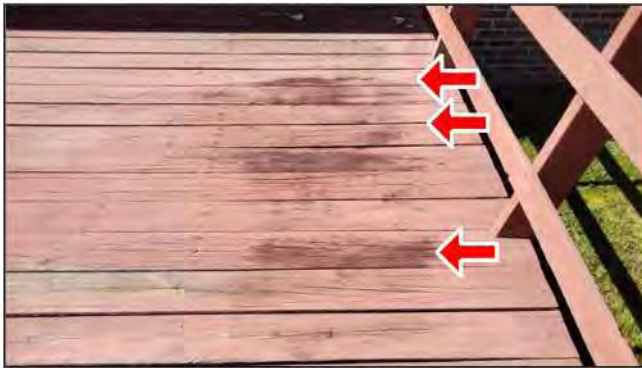
(6) The deck floor boards has significant cracking, deterioration and damage noted, and is a step through concern. These areas need proper replacement by a licensed general contractor and made functional.

2.8 Item 9(Picture) Deteriorated decking boards

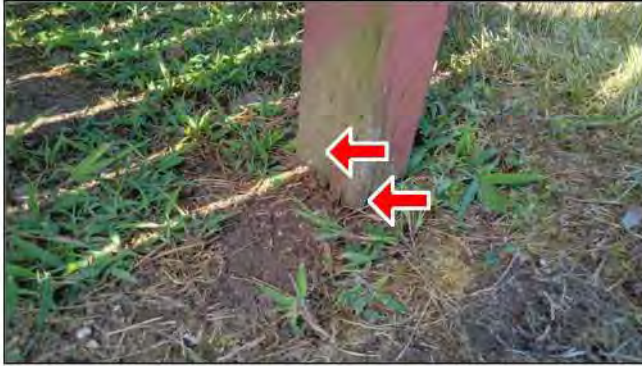
(7) The lower areas of the deck posts is in direct contact with the ground and is causing deterioration in these areas. This deterioration will get worse over time if not corrected and these posts should be evaluated and made functional by a licensed general contractor.

2.8 Item 11(Picture) Deteriorated deck posts

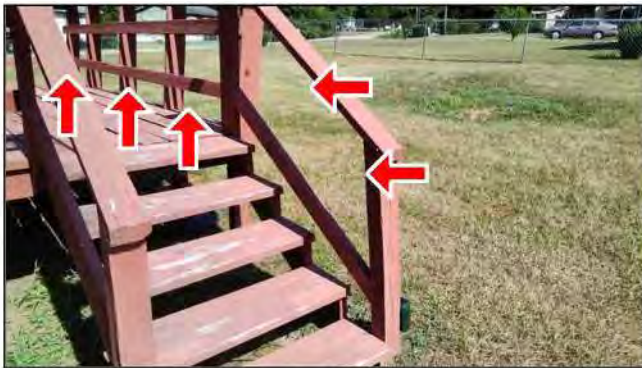
(8) The rear deck has no railings or pickets improperly spaced pickets and can allow persons or pets to fall through these areas. Screen will not prevent persons from falling through and needs pickets on all areas over 30" off of the ground as well as any other areas deemed to high as to cause damage.

2.8 Item 13(Picture) Improperly spaced pickets

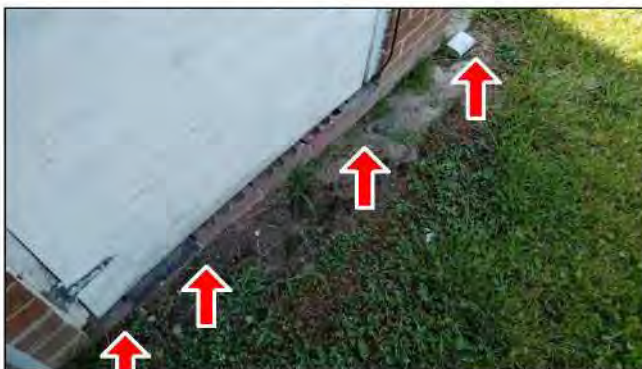
The yard at the left side of the house has significant erosion and washed out areas and these areas need repairs to prevent erosion and to hold the soil in place. This repair needs to be performed by a qualified landscaper and all erosion controls installed and washed out areas re-graded.

2.10 Item 1(Picture) Erosion along the foundation

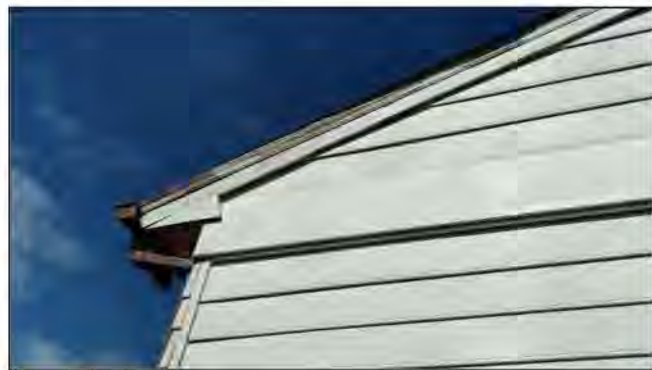
3.0 Item 1(Picture) Shingles are not covering the drip edge or trim

The shingles at the front right corner of the home are not properly overhanging the drip edges, can allow water behind the rake boards or fascia boards, and these areas need proper repairs by a qualified contractor.

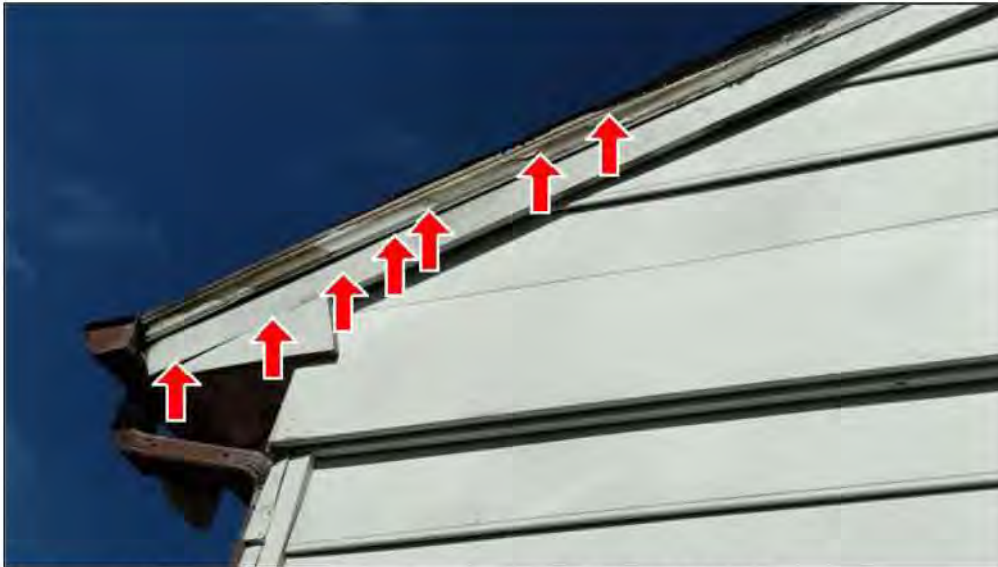
3.0 Item 2(Picture) Shingles are not covering the drip edge

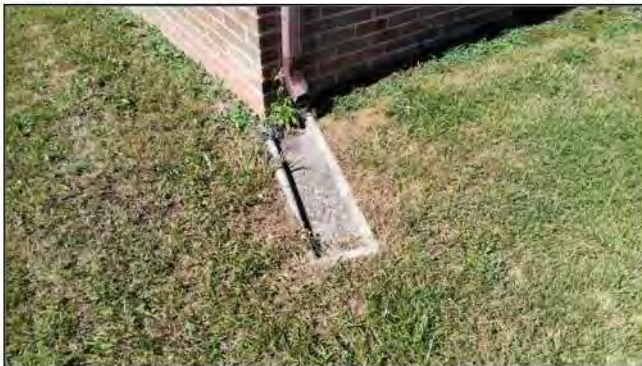
(1) The downspout at the right rear corner of the home has a splash block installed that is not properly located under the downspout to drain away from the home and can hold water against the foundation. These downspouts needs the splash block properly located to allow for proper drainage and to prevent damage.

3.1 Item 1(Picture) water draining back against the home

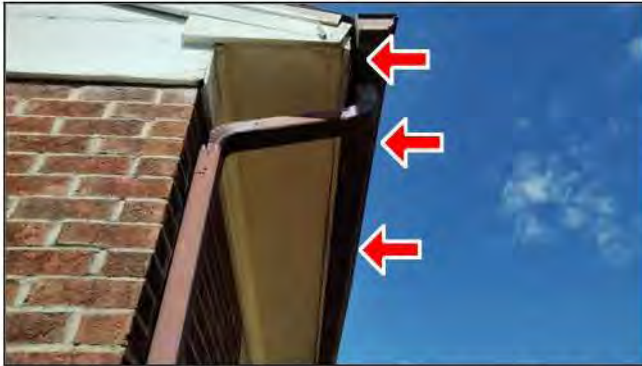
(2) The gutter across the front and rear of the house is loose on both ends and has water flowing between the gutter and fascia board. This can cause the fascia board to rot. A gutter specialist should be consulted to repair or replace the gutter or fascia boards.

3.1 Item 2(Picture) Loose gutters noted on the home

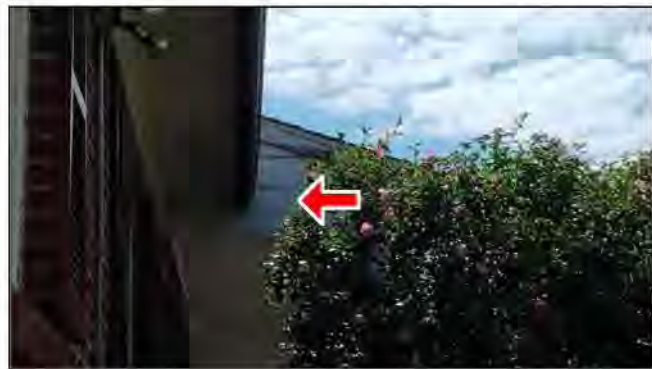
3.3 Item 1(Picture) Missing kickout flashings with deteriorated siding

The kick out flashing at the front wall coverings where it meets the roof line over the front porch are not installed / could not be verified to bring the water back out from behind the siding and needs repairs / installation to prevent leakage in these areas and made functional by a a licensed general contractor or roofing contractor. These areas need to be checked for concealed damage and all necessary repairs need to be performed.

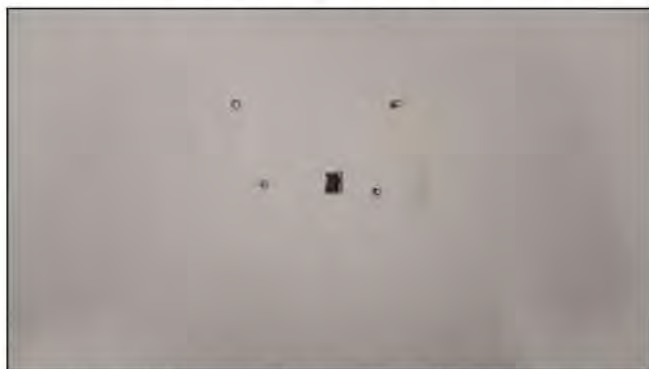
(1) The drywall has common cracks and defects noted in several rooms of the home and needs general cosmetic repairs and all areas made functional.

4.1 Item 1(Picture) Holes and damage in the wall

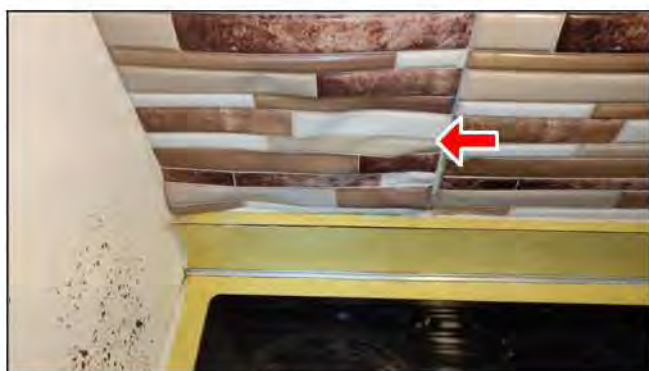
4.1 Item 2(Picture) Stick on tile are loose

(2) The stick on tile in the kitchen is peeling and is no longer functional and these stick on tile need to be repaired or removed and all areas made functional by a qualified contractor.

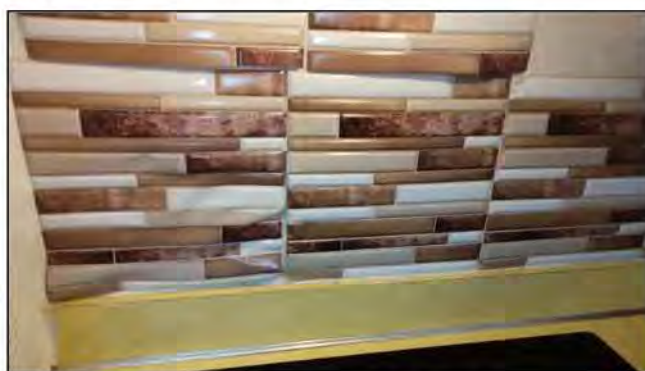
4.1 Item 3(Picture) Stick on tile are loose

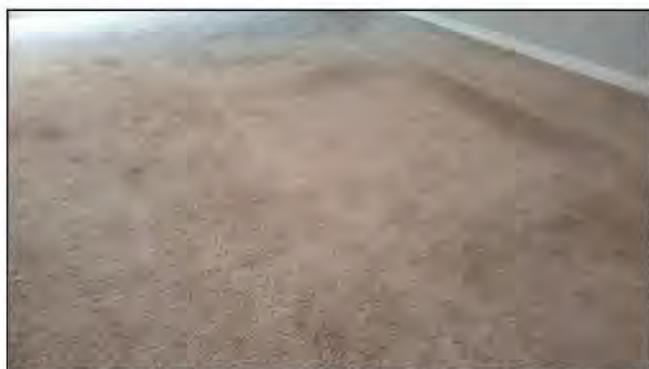
(1) The carpet is loose/torn in areas and is a tripping concern / safety issue. This carpet needs to be stretched / secured or replaced in areas to prevent this tripping hazard.

4.2 Item 1(Picture) Loose carpet noted

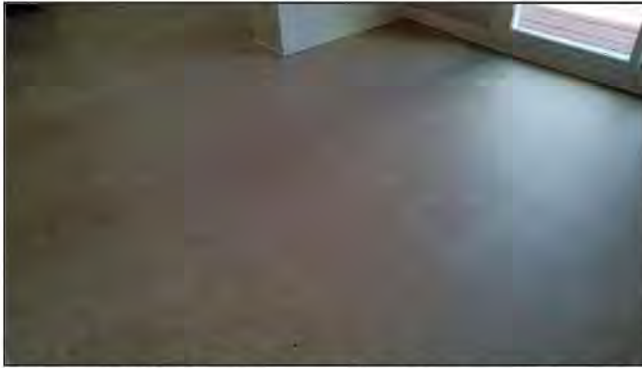
(2) The kitchen and bathroom floor has a dip in the flooring noted. This can be from settlement, a missing pier shim, or the floor framing not being properly supported in this area and all accessible areas of the floor structure were functional. The crawl space under the kitchen was not accessible in areas due to the heating unit and duct work and no representations were made of these areas.

4.2 Item 2(Picture) Large dip noted in the kitchen floor

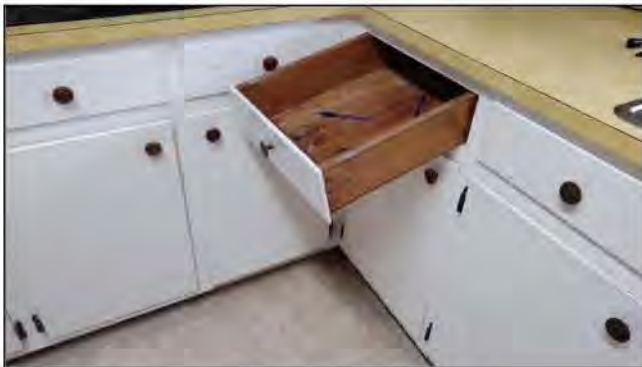
The kitchen cabinet drawers are pulling off the track when opening and closing and no longer pull out and support themselves. These drawers need repairs and made functional by a cabinetry specialist and made functional.

4.4 Item 1(Picture) Drawers off track

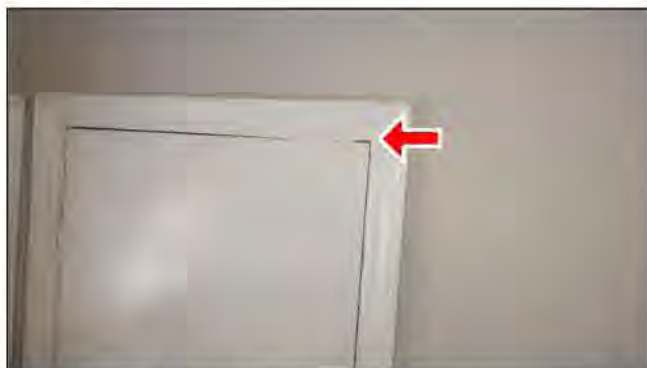
(1) The closet entry door behind the front door would not open and is scraping the door frame when opening and closing, the door will not close in the opening from this scraping, and this door, frame, and / or framing needs adjustment / repair to work properly. This unit needs repairs by a licensed general contractor.

4.5 Item 1(Picture) Door will not open

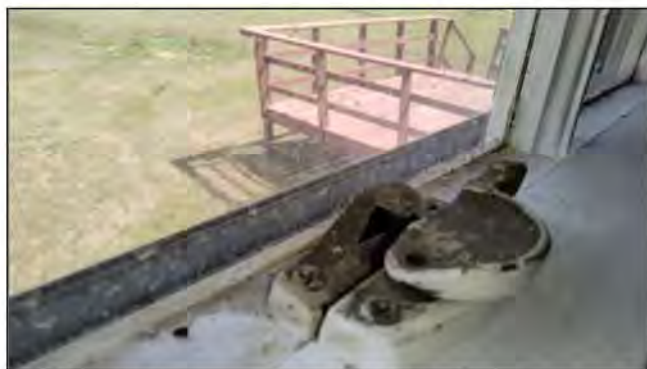
The locks on the windows are broken and do not allow these windows to lock into place and be secured. These window locks should be repaired or replaced and the windows made functional.

4.6 Item 1(Picture) Window latches are not aligning

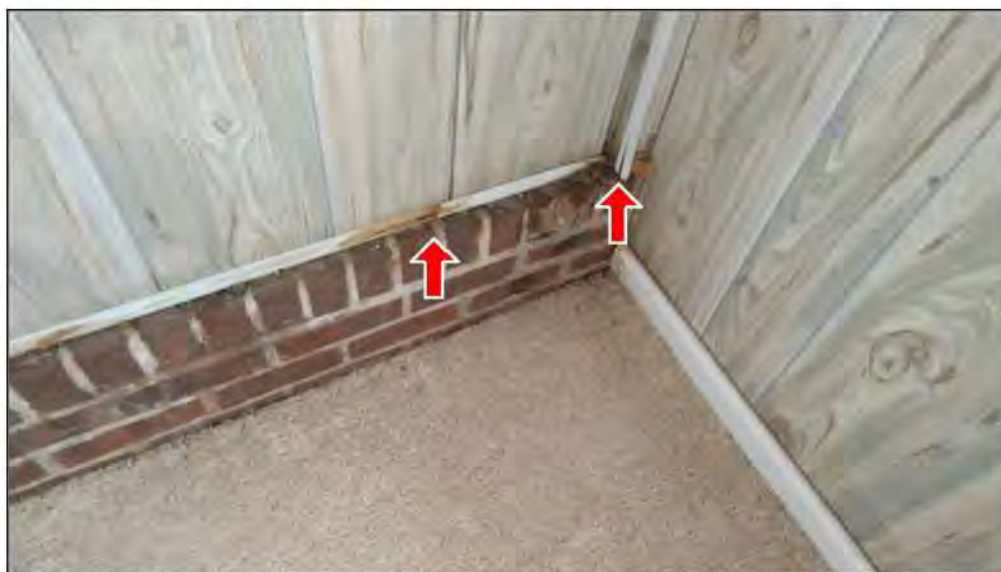
4.7 Item 1(Picture) moisture stains and damage indicate later water leaking into the home in these areas

Moisture stains were noted in the lower walls of the converted garage and appears to be from a past or present leak but the cause could not be determined. This area needs should be evaluate to determine the cause of the stains, if the issue is active and the extent of the damage and all areas made functional by a licensed general contractor.

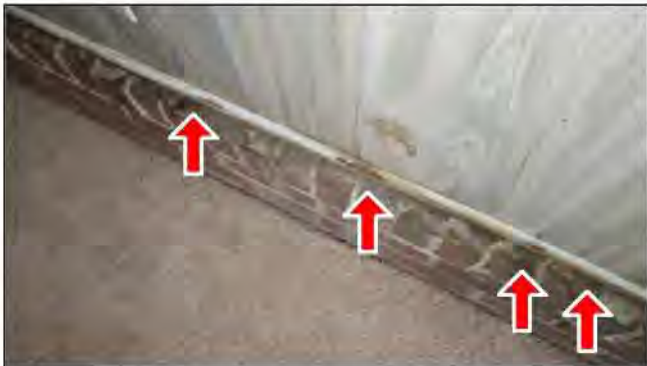
4.7 Item 3(Picture) Moisture stains noted

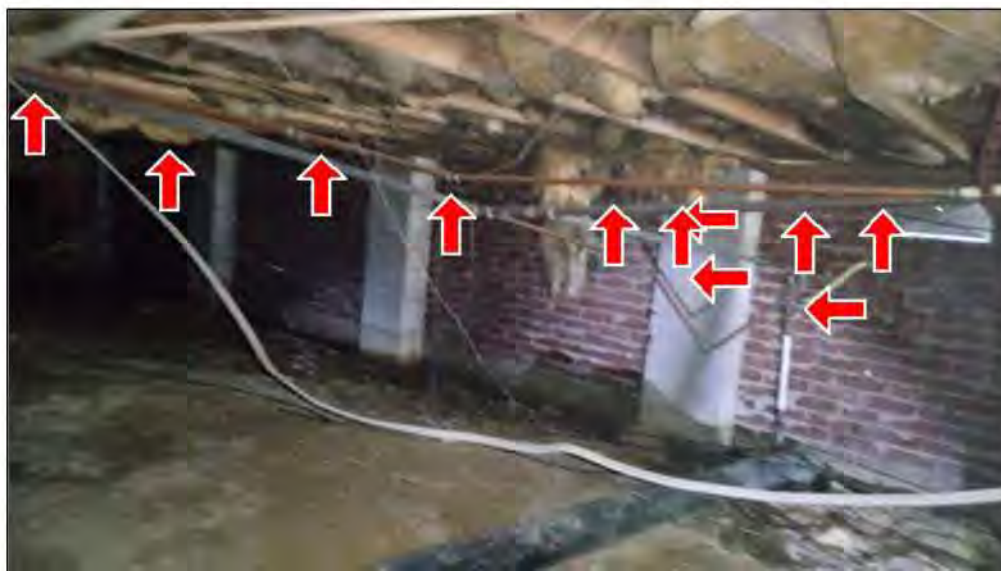
5.1 Item 1(Picture) Water supply lines not strapped or supported

The water lines in the crawlspace are not strapped up properly to the wood member and is sagging in areas. These plumbing lines need to be properly strapped and supported every 4 feet and should not sag and rest on the ground and needs to be made functional by a licensed HVAC contractor.

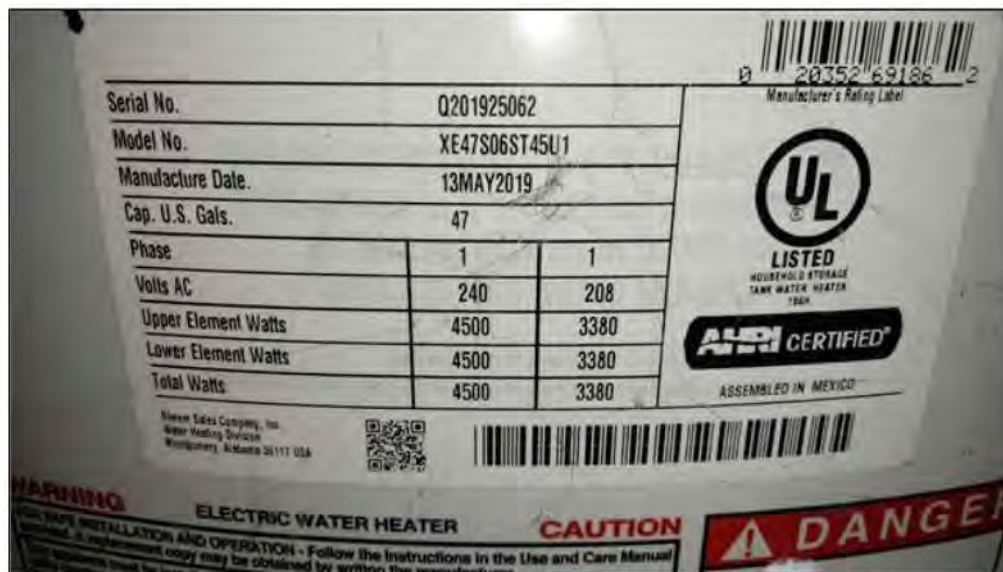
Model # XE47S06ST45U1

6.1 Item 1(Picture) The water heater Mfg. label
