# Inspection Report

1101 Water St  
Henderson NC 27536

**Inspect Co. L.L.C.**

| Date: 7/2/2024 | Time: 09:30 AM | Report ID: JPwaterst722024 |

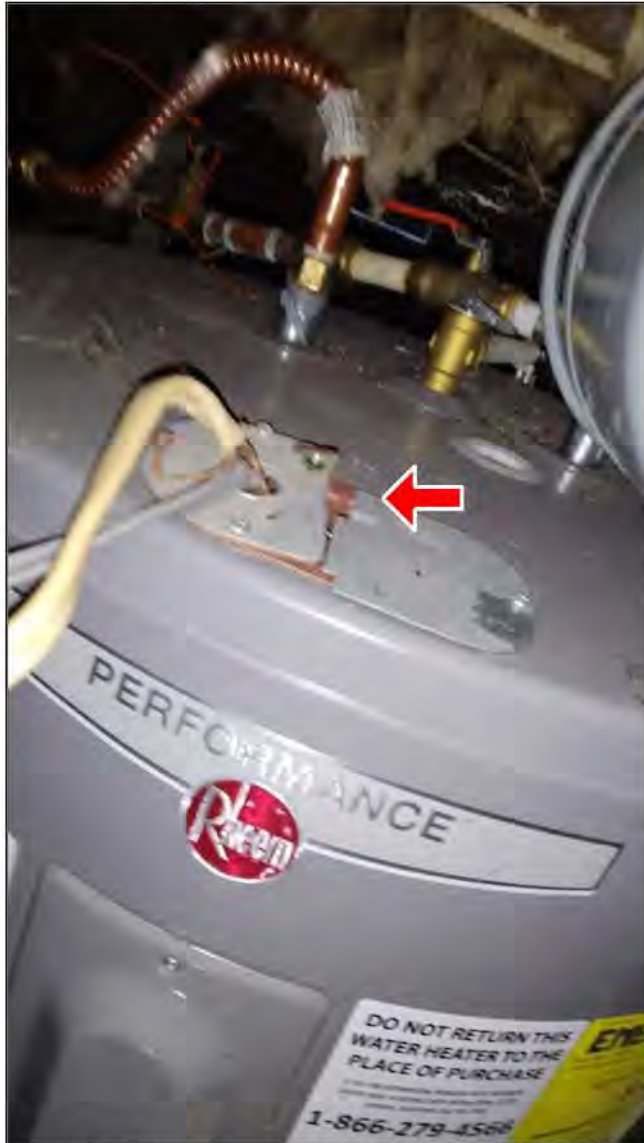
6.3 Item 1(Picture) Wiring not properly connected

The water heater electrical line conduit is loose from the water heater cabinet and this conduit line needs repairs to cover all areas of the wiring and to be properly secured to the water heater and made functional by a licensed electrician.

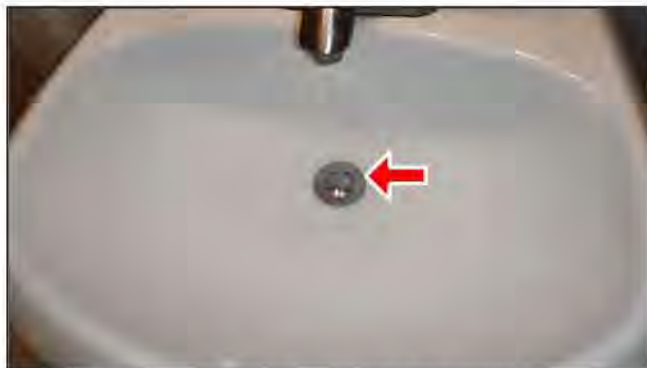
The hall bathroom sink stopper is not opening and closing properly to hold water or release water in the sink at the drain and needs repairs or replacement by a licensed plumbing contractor and made functional.

7.1 Item 1(Picture) Damaged sink stopper not functional

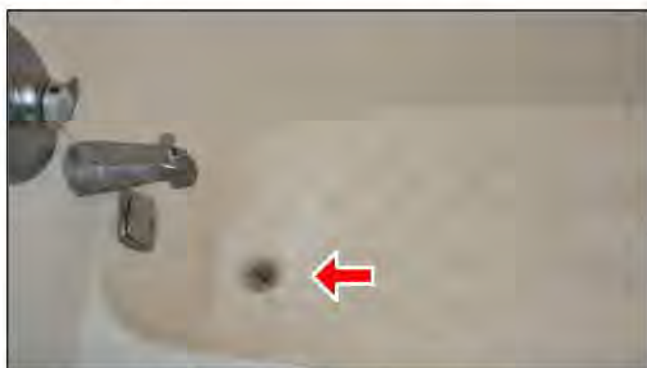
(1) No permanently installed drain stopper or drain cover is in place in the bathroom tub, will not properly hold water, and needs proper repairs performed by a licensed plumbing contractor and made functional.

7.2 Item 1(Picture) Tub stopper missing

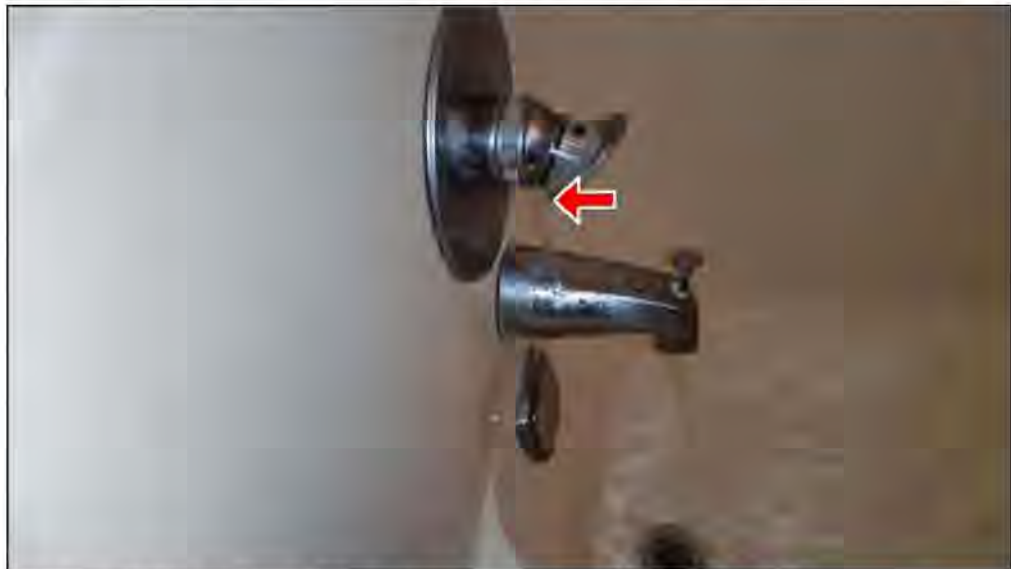
7.2 Item 2(Picture) Leak noted at he shower faucer handle

(2) The master bathroom shower faucet handle has a leak noted at the knob that can leak into the wall and cause further damage. This diverter valve should be evaluated and repaired or replaced by a licensed plumbing contractor with all areas made functional.

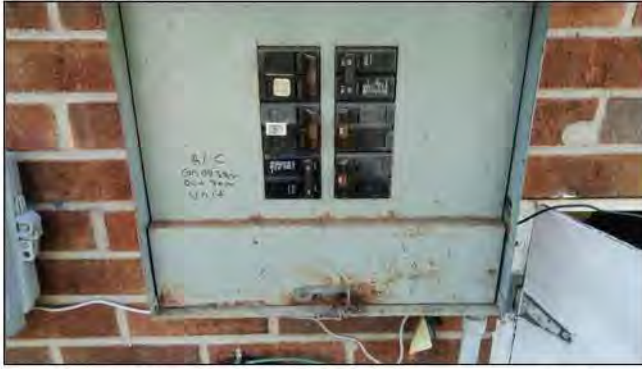
The breakers in the panel box are not clearly / properly identified or labeled for use, is a safety concern, and needs to be properly labeled for individual use by a qualified electrician.

8.3 Item 1(Picture) Breakers are not labeled

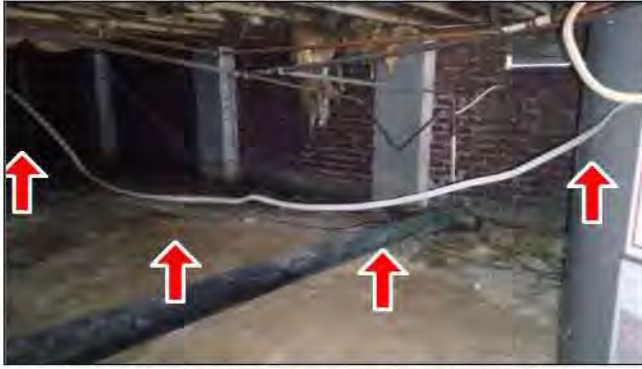
(1) The wiring in the crawlspace is not properly secured and is hanging from the floor framing. This wiring should be evaluated and properly installed and secured and all wiring made functional.

8.6 Item 1(Picture) Wiring not secured in the crawlspace

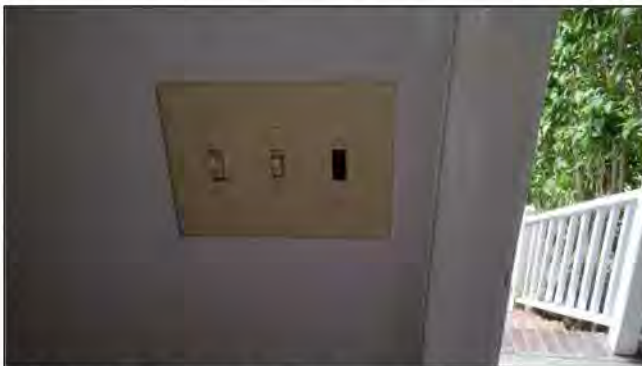
A switch was missing from the switch panel by the front door and this panel should be evaluated and all switches made functional by a licensed electrical contractor.

8.7 Item 1(Picture) Switch missing leaving exposed wiring

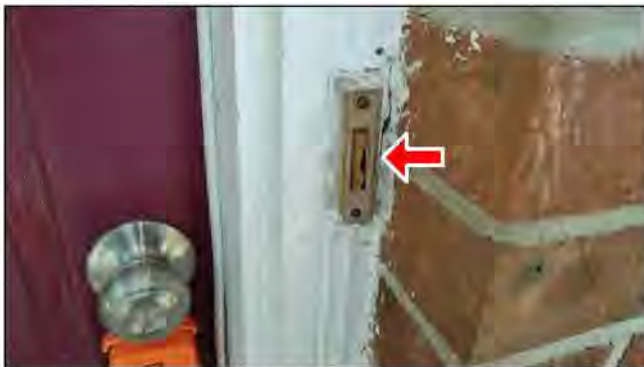
The cover over the front entry door bell is broken / loose / cracked, is damaged, and this unit is not functional. The door bell needs proper repairs / replacement by a qualified contractor.

8.11 Item 1(Picture) Broken door bell cover

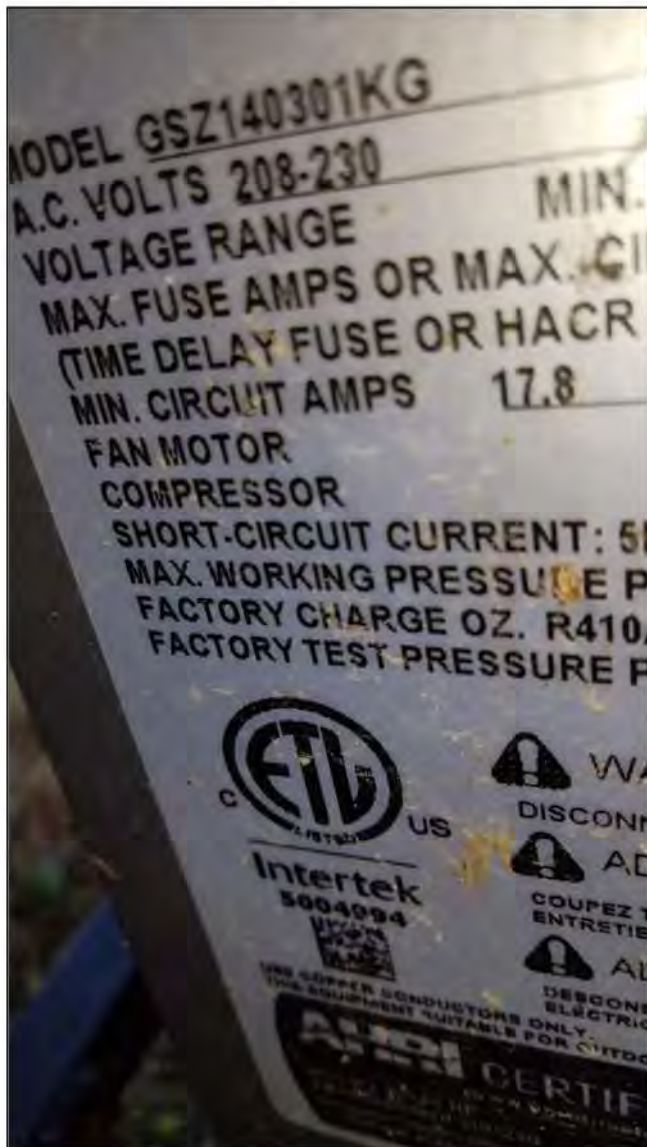
Model # GSZ140301KG

9.1 Item 1(Picture) AC condenser unit Mfg. label

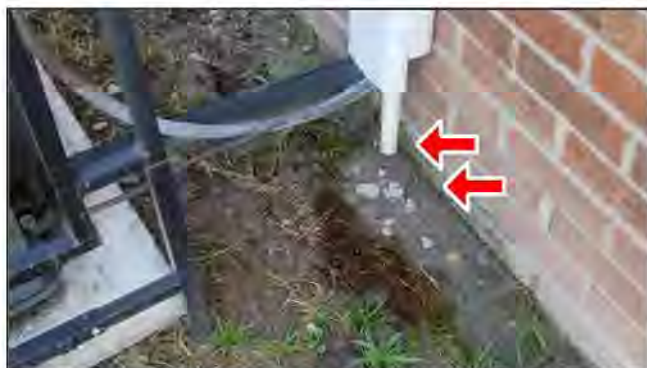
The condensation tube is draining against the foundation behind the condenser unit and is / can allow standing water in this area and allow water to enter the crawlspace or to penetrate under the slab foundation. This condensation tube needs to be extended or made to drain away from the structure to prevent damage to components of the home.

9.5 Item 1(Picture) The condensation tube is draining against the foundation

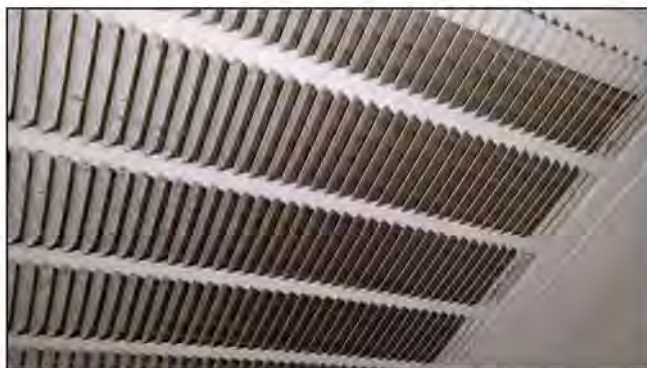
The filters are clogged with lint and debris, is restricting air flow, and the filter needs to be changed out to allow proper use of the units. This may require cleaning the unit if clogged.

10.6 Item 1(Picture) Clogged filters noted

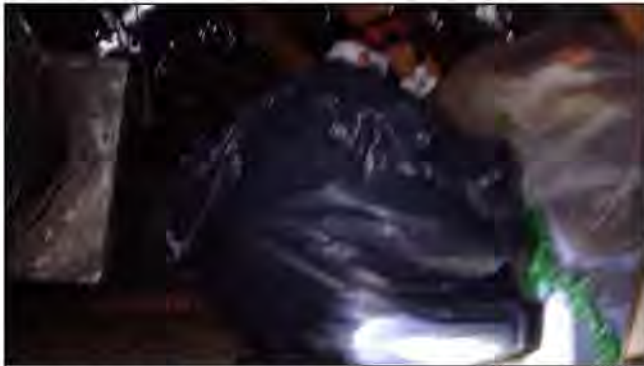
(2) The attic area is very hot due to a lack of ventilation in the attic and this can be caused by the amount of stored items in the attic space. Hot attics can affect the HVAC system and ductwork, the framing , roof coverings, and other components. This attic needs to be cleaned out and then evaluated for proper ventilation with all needed repairs performed and all areas made functional by a licensed contractor specializing in ventilating attics.

11.0 Item 1(Picture) Stored items from floor to roof rafters in the attic is stopping proper ventilation

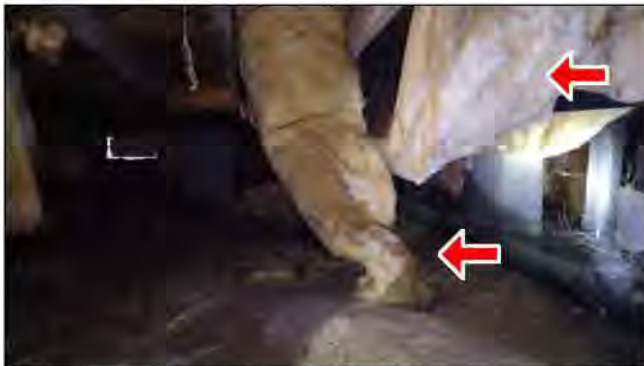
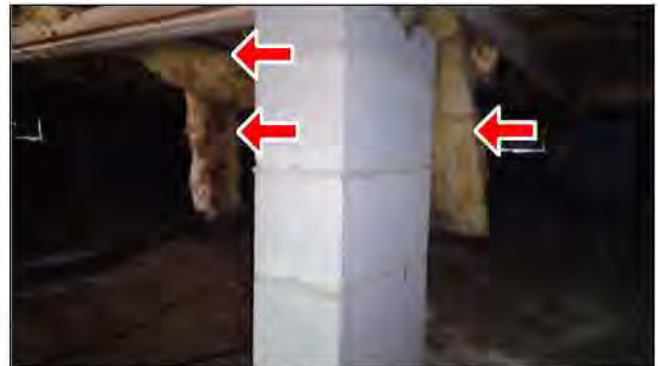
The insulation has fallen and or is missing in areas of the crawl space and needs to be re-installed or replaced in all affected areas. All areas need insulation to offer proper insulating R value and needs proper installation by a qualified insulation contractor.

11.1 Item 1(Picture) The flooring insulation has fallen in areas of the crawlspace

11.1 Item 2(Picture) The flooring insulation has fallen in areas of the crawlspace

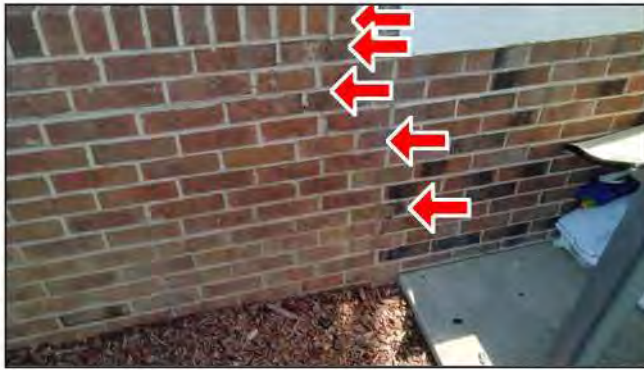
The foundation wall at the front porch and garage wall connection of the home has cracks noted that may have structural implications with through brick cracks and / or long cracks and needs to be reviewed and repaired under the guidance of a licensed structural engineer or a licensed general contractor specializing in foundation structural repairs. A clear structural letter and warranty should

be received from the company performing the work.

1.0 Item 1(Picture) Long cracking in the brickwork

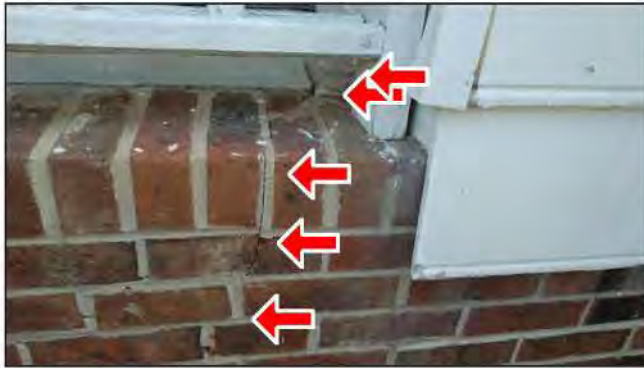
1.0 Item 3(Picture) Structural crack has settlement in the front porch noted

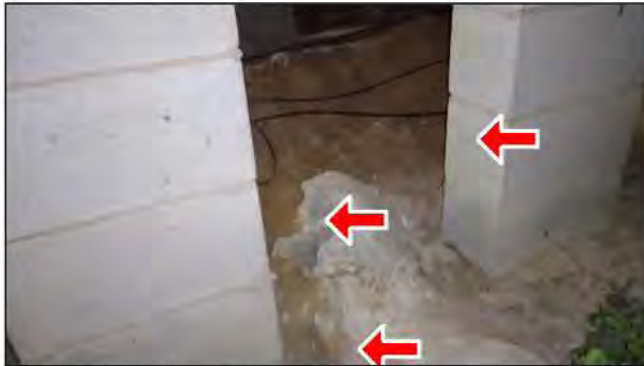
The foundation columns footers in areas at the center of the crawlspace has not been back filled and is not allowing for proper drainage of these areas, can hold water, and these areas needs to be back filled and made to properly drain all water from the crawlspace.

1.1 Item 1(Picture) The foundation piers footers have not been back filled

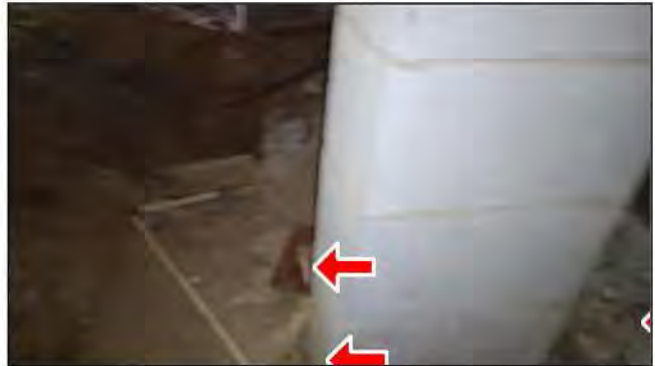
1.1 Item 2(Picture) Footers have not been back filled

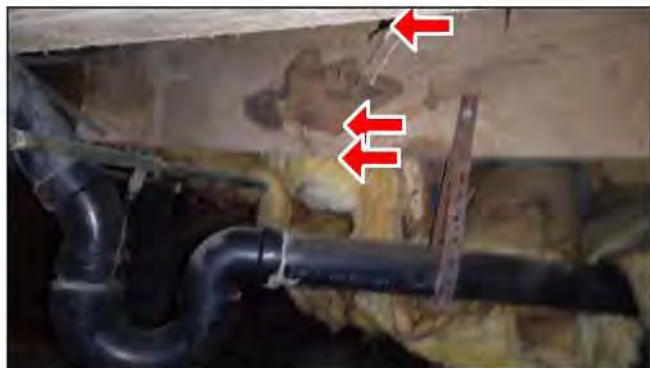
(1) The floor framing has broken floor joists noted under the hall bathroom and the bathroom floor has a large dip noted. This area needs to be evaluated and repaired and or replaced and all areas of the floor framing made functional by a licensed general contractor.

1.2 Item 1(Picture) Broken floor joist at a knot in the wood

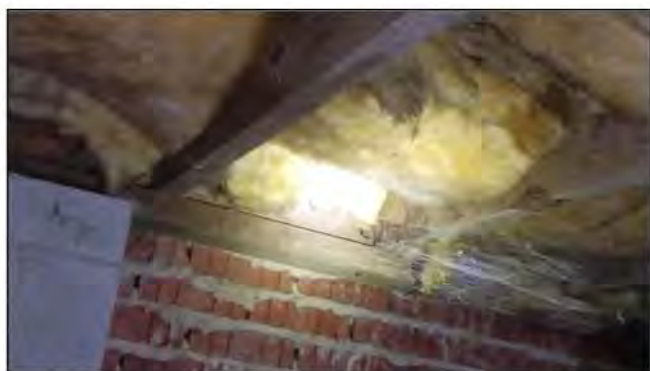
1.2 Item 2(Picture) Heavy fungal growth on the floor framing

(2) The floor framing at the rear of the crawlspace has deterioration and fungus growth from radiant moisture and needs proper repairs in these areas (May not be limited to these areas / check during repairs). These areas of the floor framing needs to be reviewed and all necessary repairs performed by a licensed general contractor.

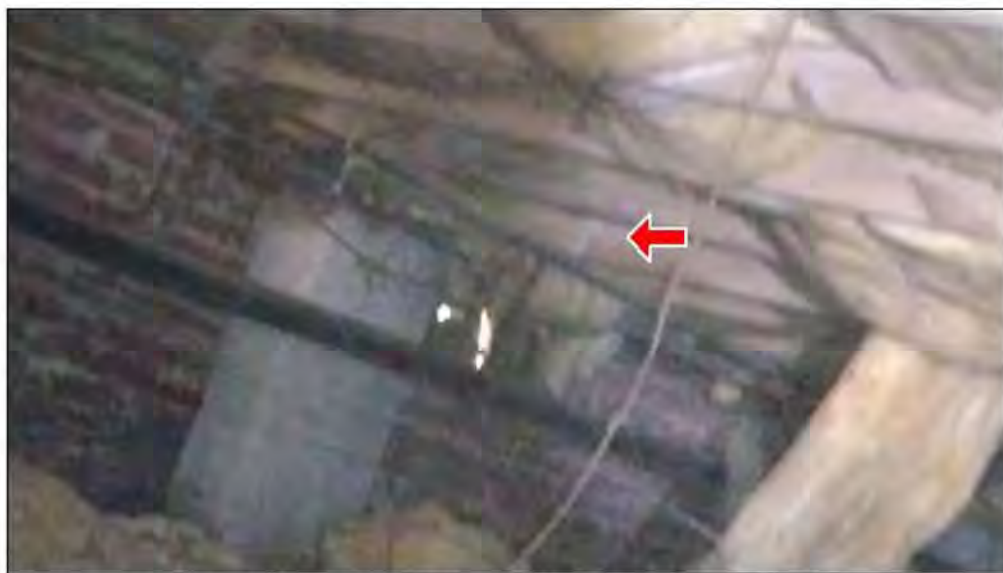
1.2 Item 3(Picture) Sistered floor framing not supported on the ends

(3) Repairs have been made in the crawlspace under or near the rear door and these repairs were not done using proper building techniques (floor joists are not supported to the ends) This can cause uneven floors and possible failure. These repairs need to be reviewed by a licensed general contractor and all areas make functional.

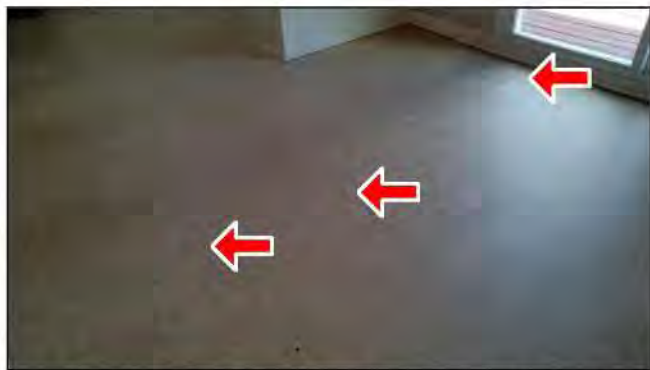
1.2 Item 4(Picture) Large dip in the kitchen floor

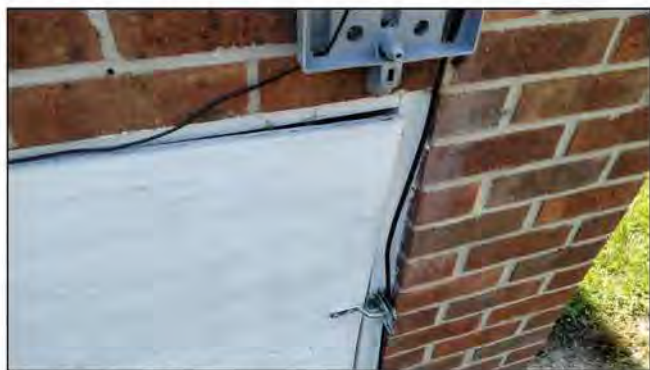
1.3 Item 2(Picture) Gaps at the crawlspace door

(2) The crawlspace door has gaps noted and is not sealed and can allow water and pests to enter the crawlspace and can cause damage and this crawlspace door needs to be repaired and sealed and made functional by a qualified contractor.

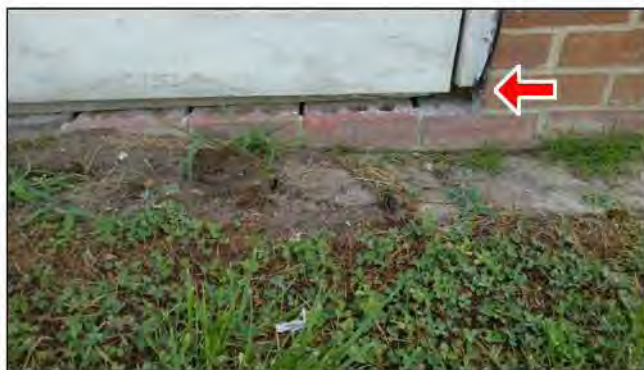
1.3 Item 3(Picture) Gaps at the crawlspace door

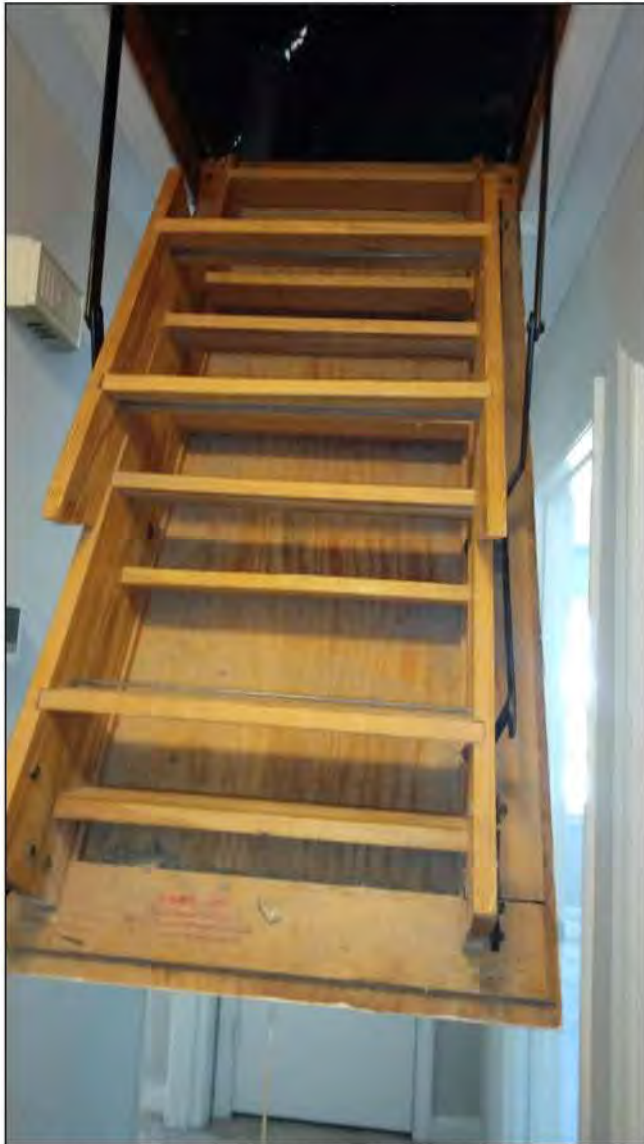
1.7 Item 1(Picture) Door missing insulation and weather stripping

The attic access is not sealed or insulated and these gaps are allowing conditioned air to escape the home. This can cause higher than normal energy bills and excessive wear on the HVAC components. This access door should have weather stripping and insulation installed by a qualified contractor to stop air loss in this area.

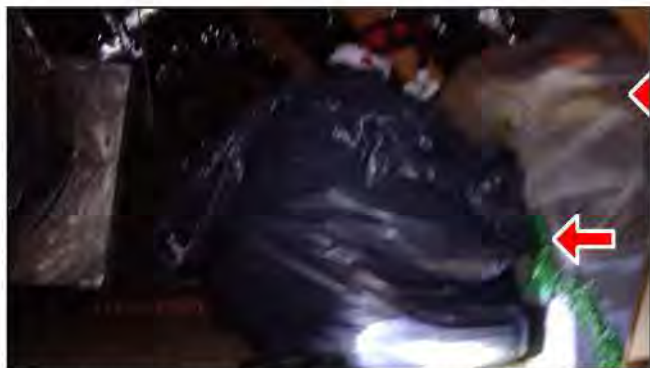
(1) The attic was inaccessible in areas and could only be viewed from the attic entry and this attic should be cleaned and inspected before closing with all needed repairs performed. No representations are made of these areas of this attic.

1.9 Item 1(Picture) Stored items in the attic block access

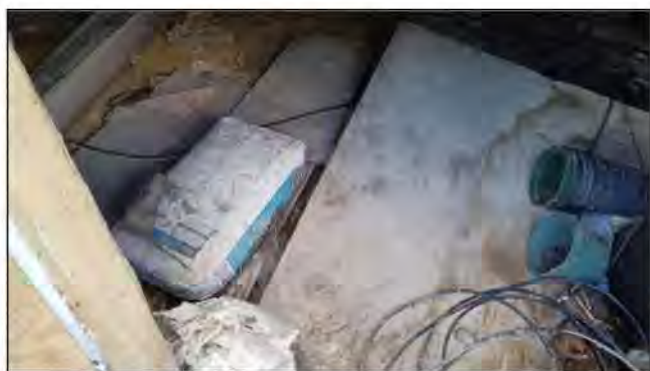
1.9 Item 2(Picture) Wood and stored items in the crawl space

(2) The crawlspace has wood and construction debris noted in various areas making areas inaccessible for inspection and no representations are made of these areas. Remove these items from the crawl space to prevent pest infestation and to increase accessibility for inspection and ventilation and to make the crawl space clean.

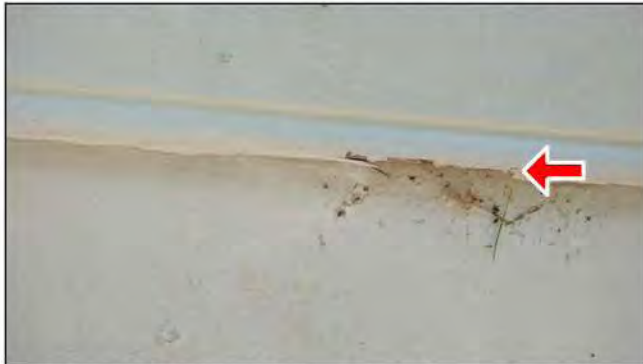
The hard board siding has deterioration noted in multiple areas around the home. The framing in affected areas need to be checked for obvious and / or concealed damage and all necessary repairs performed by a licensed general contractor.

2.0 Item 2(Picture) Deteriorated siding

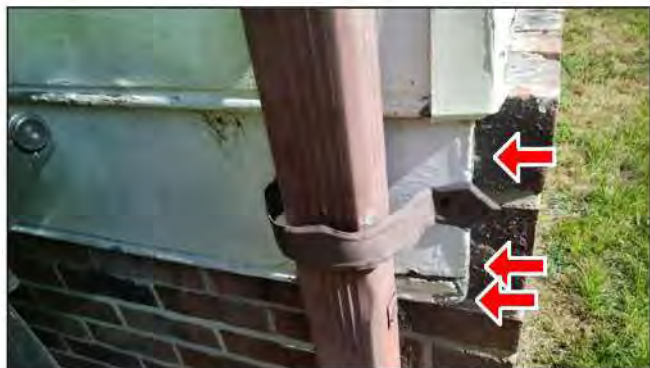
2.0 Item 4(Picture) Deteriorated siding in the lower areas.

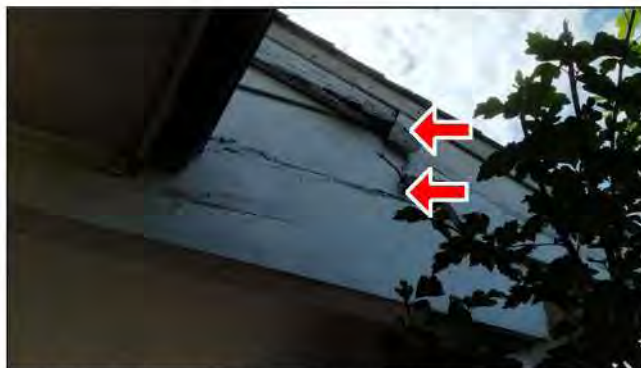
2.0 Item 5(Picture) Deteriorated siding and trim

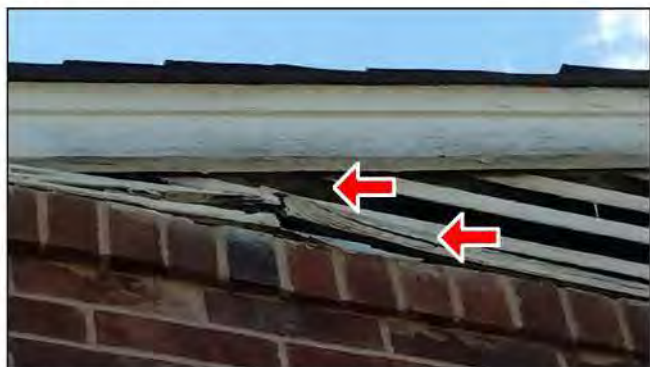
2.0 Item 6(Picture) Deterioration noted at the gable vent

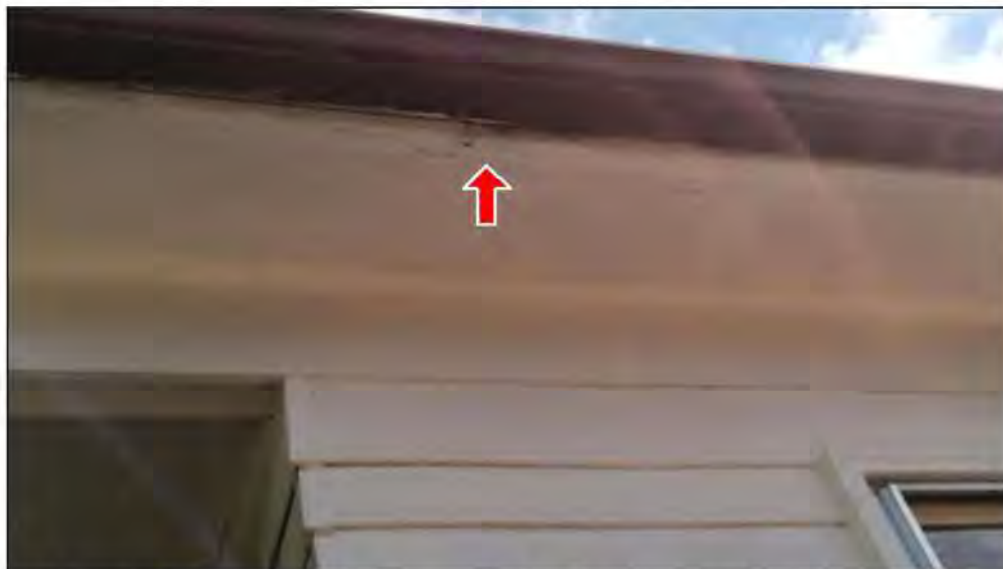
2.1 Item 1(Picture) Deterioration noted at the front and rear fascia boards

The fascia, rake boards and trim at the front, rear and ends of the home deterioration noted from moisture running between the gutter and the fascia boards and this area needs to have the fascia boards repaired or replaced and the gutter properly re-secured and all areas made functional by a licensed general contractor.

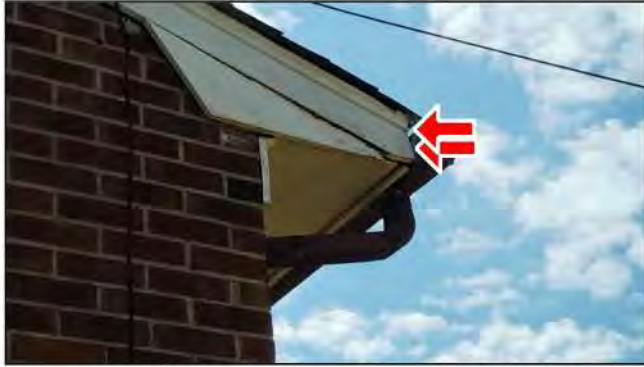
2.1 Item 2(Picture) Deterioration noted in the rake boards

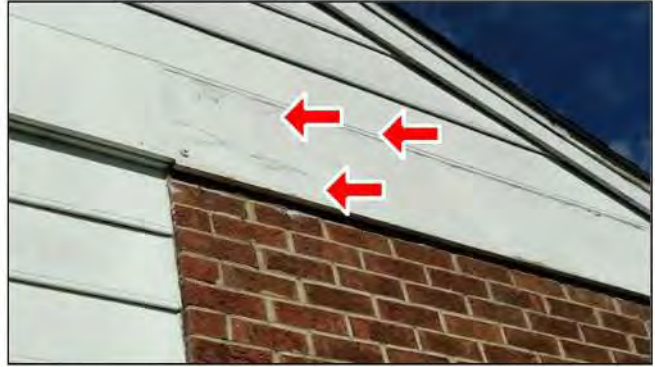
2.1 Item 3(Picture) Deterioration noted in the trim boards

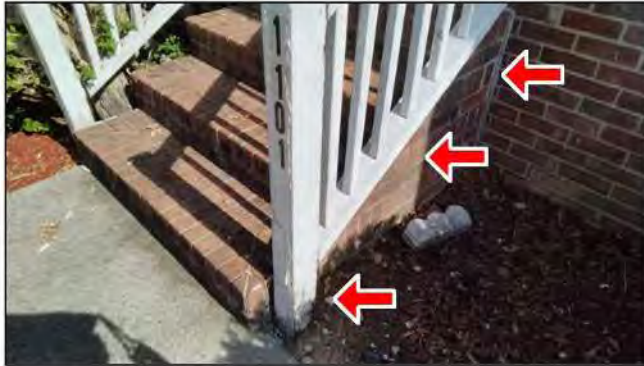
The entry doors, windows, trim, gable vents handrails and other areas of the home have failing paint and failing caulk in areas and all exposed substrates needs functional paint and all gaps need to be properly sealed. This is needed to prevent leakage and damage to the substrates and needs to be made functional by a qualified painting contractor.

2.2 Item 1(Picture) Failing paint on the front porch railing

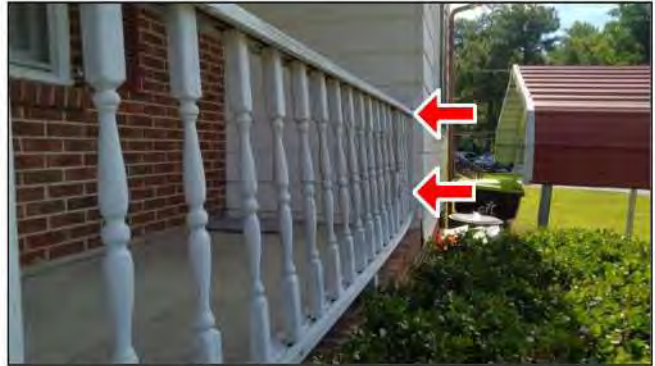
2.2 Item 2(Picture) failing paint on front porch rail

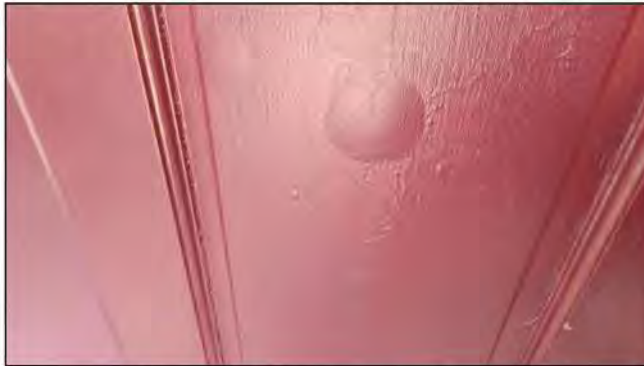
2.2 Item 3(Picture) Bubbling paint on the front door

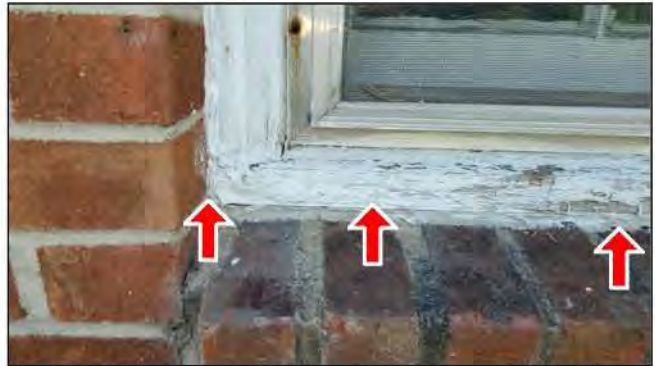
2.2 Item 4(Picture) Failing paint and caulk at the windows

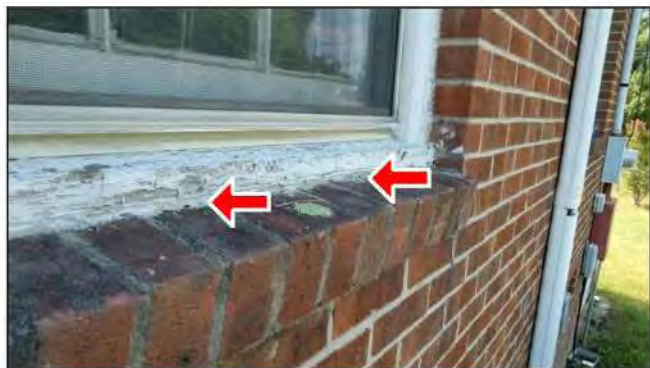
2.2 Item 5(Picture) Failing paint at the windows

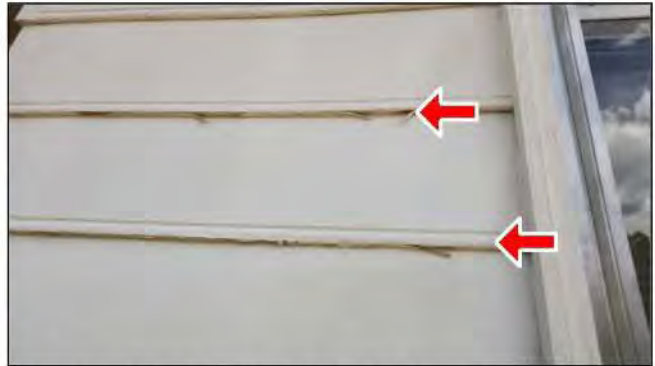
2.2 Item 9(Picture) Failing paint noted on the siding

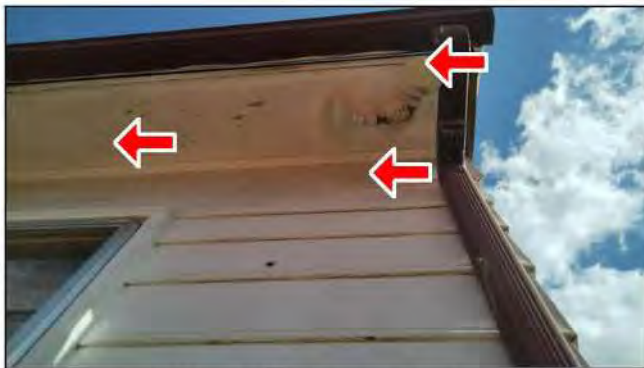
2.2 Item 10(Picture) Failing paint noted

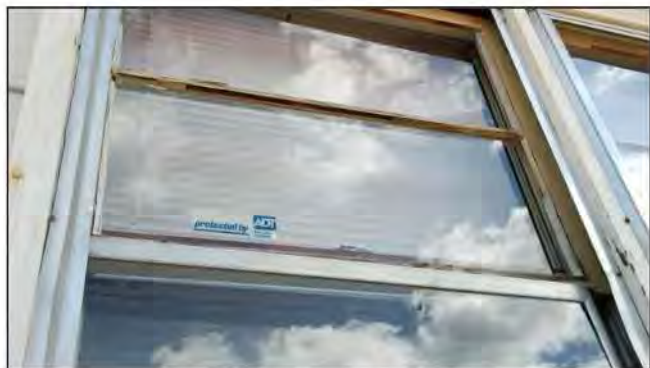
(1) The glazing and paint in many areas of the homes windows failing / missing in areas. This glazing holds the glass into place and needs repairs to prevent the glass from pulling loose and leaking and made functional by a window company.

2.3 Item 1(Picture) Failing and missing glazing

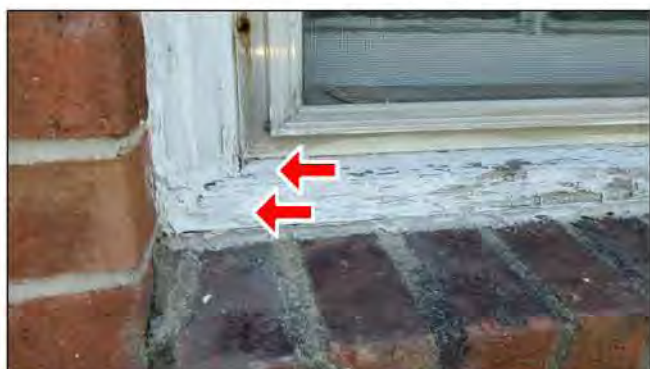
(2) The windows at the left side window has deterioration noted to the outer sash, threshold, frame and trim and these areas can allow water to enter the home and can cause further damage and deterioration. All windows should be evaluated and probed for concealed damage with all areas made functional by a licensed general contractor.

2.3 Item 2(Picture) Deterioration noted

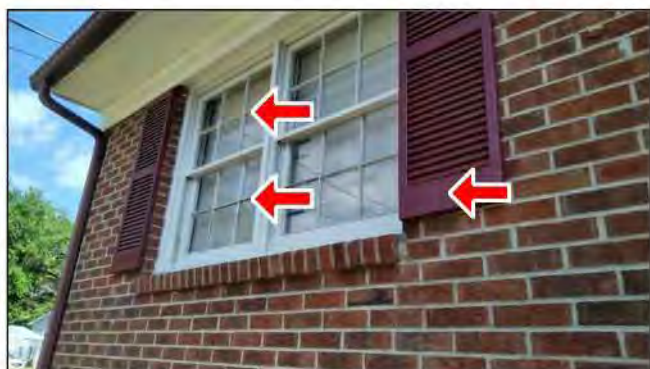
(3) The storm window screens and glass at various areas around the house have torn screens / bent frames in areas and all damaged screens need repairs / replacement as needed. These screens are not required structural components unless no cooling system is in place for the home.

2.3 Item 3(Picture) Missing screens and glass

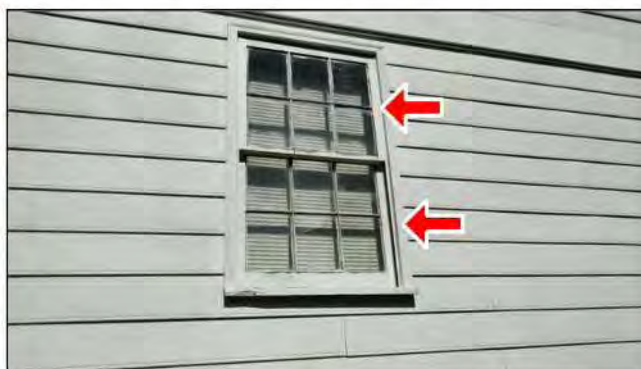
2.3 Item 4(Picture) Missing storm window

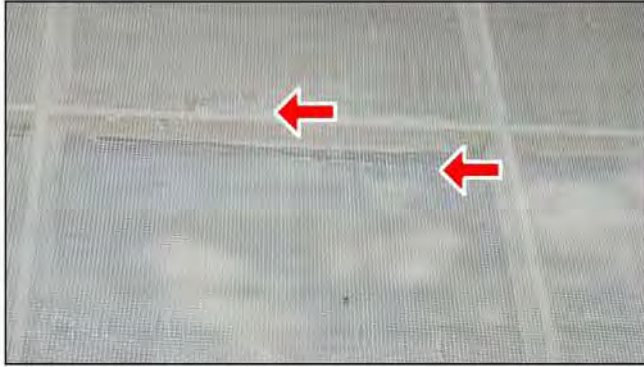
2.3 Item 5(Picture) Torn screens

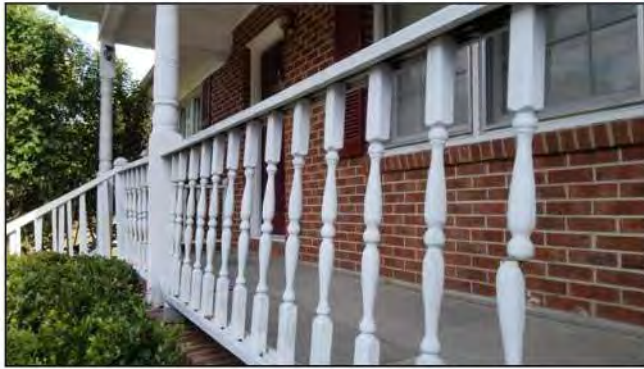
(1) The handrails and / or pickets around the front porch have deterioration noted in areas and these handrails needs proper repairs by contractor to prevent further damage and to correct the damage in place.

2.5 Item 1(Picture) Loose deteriorated rails and pickets

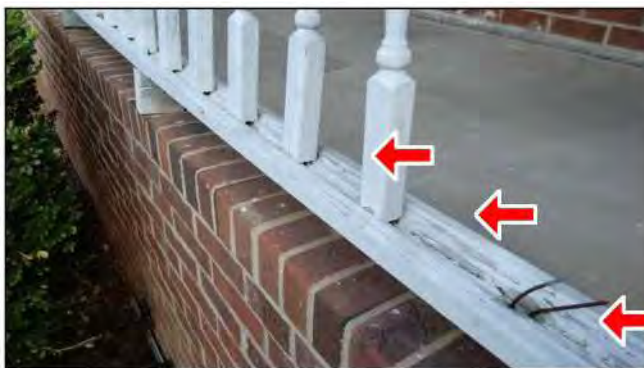
2.5 Item 3(Picture) Deteriorated railing and pickets

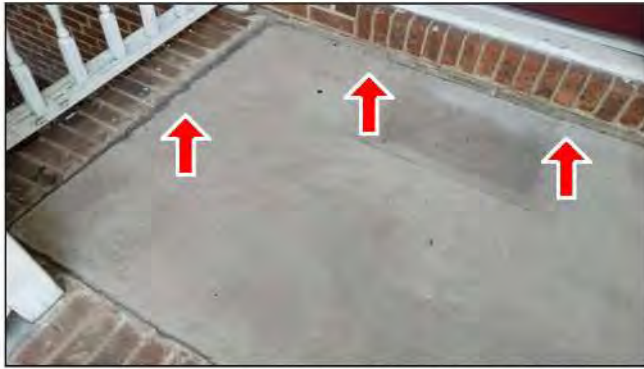
(2) The front porch slab has settled and is sloping back toward the house. This can allow damage to the structure or cause further damage to the framing for the house. This slab can settle further and needs repairs by concrete company / equivalent. This has the potential to get worse and needs to be made functional.

2.5 Item 4(Picture) Front porch has settled and is sloped towards the home

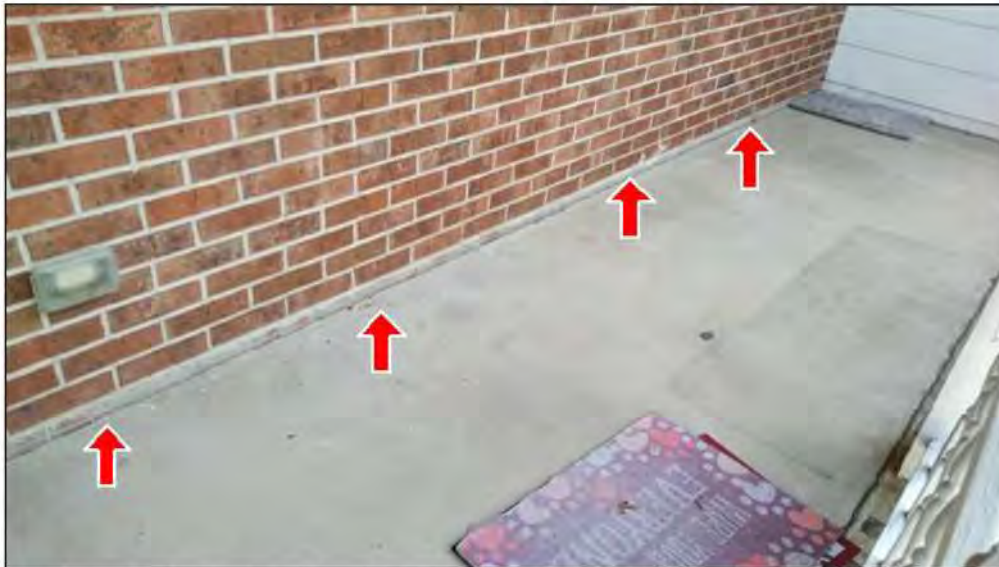
2.5 Item 5(Picture) Settled front porch

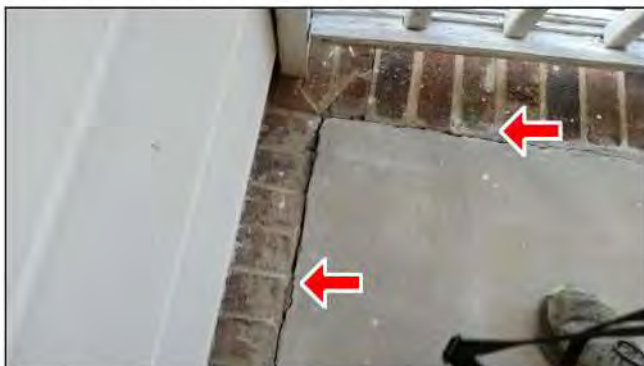
2.5 Item 6(Picture) Outer brickwork is higher than the concrete and will hold water

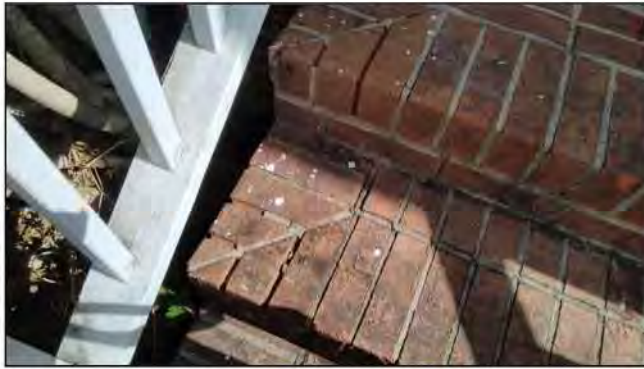
The front steps has cracked / or missing mortar and is leaving gaps noted in areas. The mortar needs to be pointed up or replaced in affected areas by a mason and all areas made functional.

2.6 Item 1(Picture) missing mortar noted

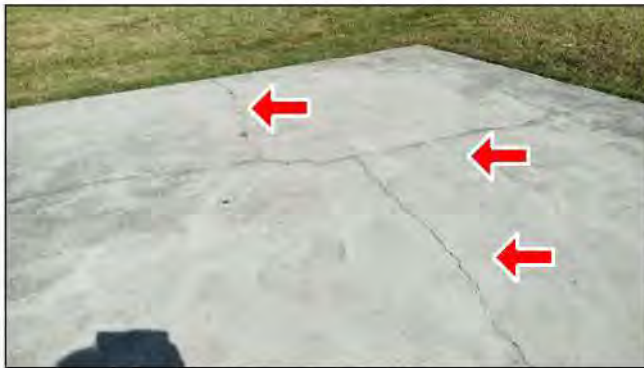
(1) The concrete driveway / walkway has cracks noted in various areas under 1/4" wide. All cracks under 1/4" wide are considered common cracking by the engineering department of North Carolina and needs to have the gaps sealed and evaluated on a regular basis for further movement or damage and needs general repairs by a qualified mason.

2.7 Item 1(Picture) Common cracks noted in the driveway

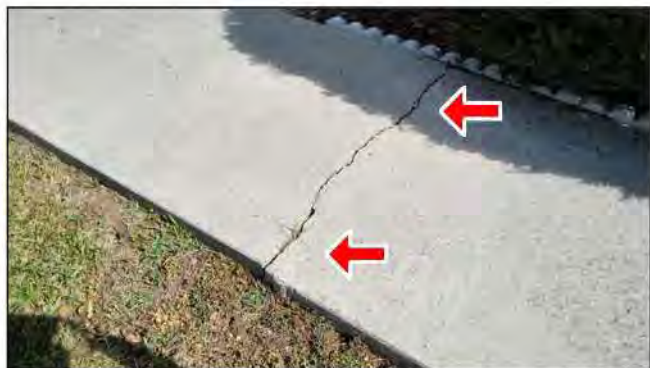
(3) The walkway has cracking with raised areas and is not on the same plane as other areas of the walkway and this is a tripping concern. This is a tripping hazard or safety concern and can allow further settling of this walkway and needs repairs performed and the area made functional and safe qualified contractor.

2.7 Item 4(Picture) Cracking with raised areas noted

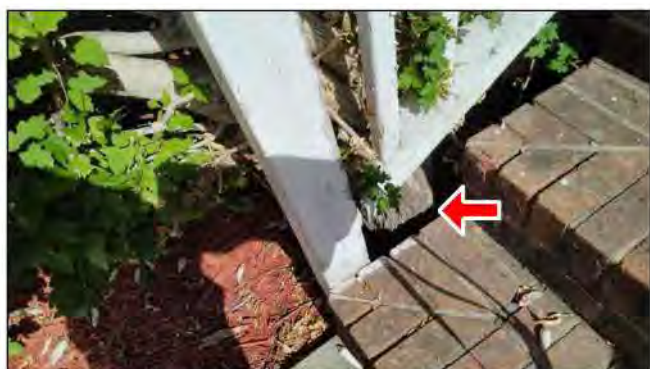
(4) The tree at the front steps has roots that are growing against the brick front steps and can cause damage. This tree should be removed and any necessary repairs performed and all areas made functional.

2.7 Item 5(Picture) Tree root growing against and under the front steps

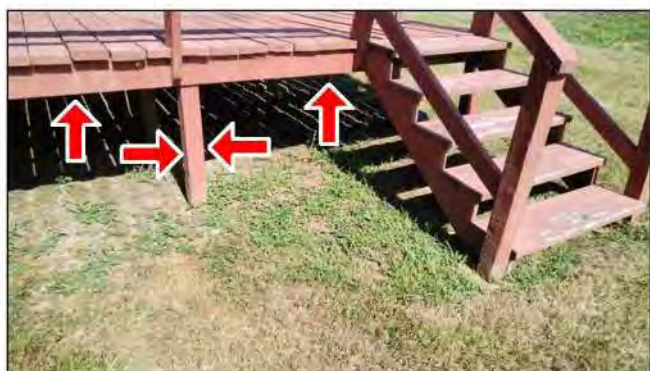
2.8 Item 1(Picture) Missing 45% angle braces

(1) No 45 degree lateral bracing is in place on the porch posts that supports the movement between the posts and framing and needs proper lateral bracing to support these posts properly. Installed by a qualified contractor to offer proper support and to prevent movement in the deck for these areas.

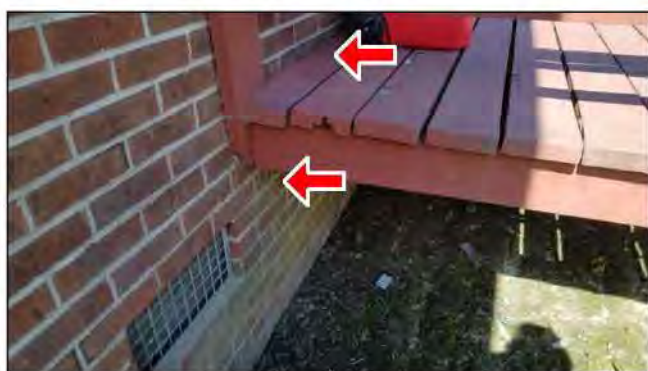
(2) The porch has no visible flashing against the house, can allow water seepage and / or deterioration to the wood members / framing, needs to be checked for concealed damage, and needs proper flashing installed. Any and all damage needs to be located and repaired by a licensed general contractor and made functional.

2.8 Item 3(Picture) No flashings installed

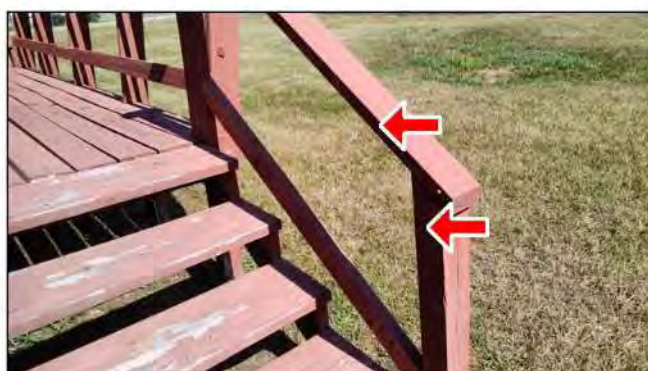
(3) The handrails and pickets for the deck / steps at the rear deck are loose and is a safety concern. These rails need to be secured and made functional by a licensed general contractor.

2.8 Item 4(Picture) Loose hand rail

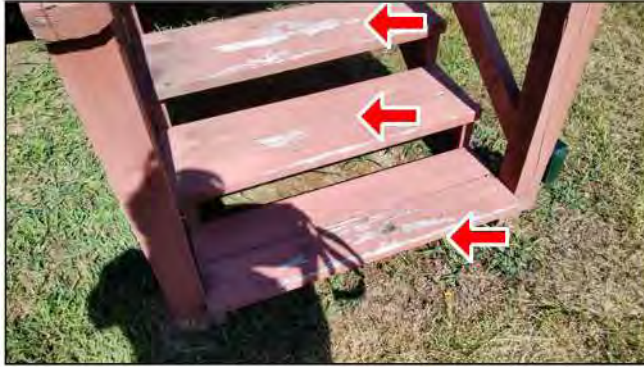
(4) The deck needs cleaning with a deck wash and seal with a waterproof sealant to prevent damage and deterioration to the deck components. Always do the underside of deck as well if accessible.

2.8 Item 5(Picture) Deck and steps need to be cleaned and sealed

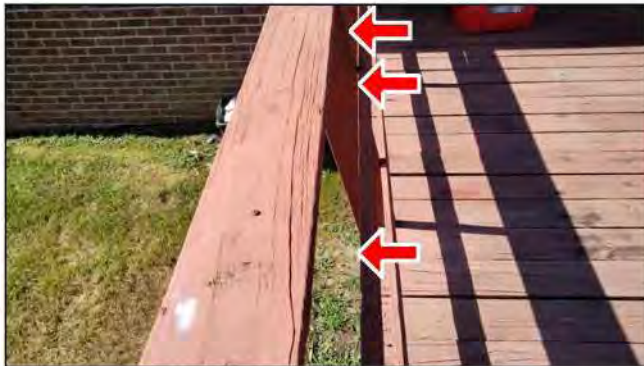
(5) The porch handrails have splintering and / or have raised areas and needs repairs to allow use of the handrails by a licensed contractor and made functional.

2.8 Item 7(Picture) Splintering hand rails

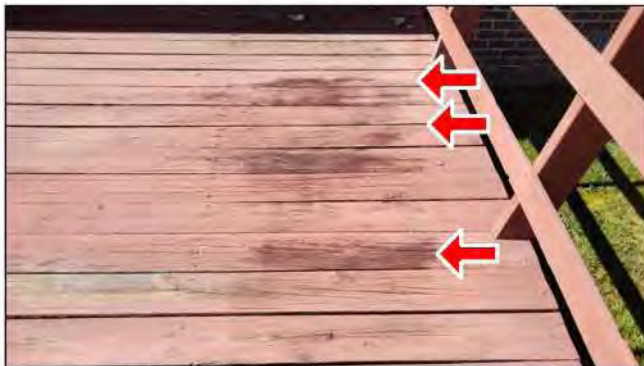
(6) The deck floor boards has significant cracking, deterioration and damage noted, and other defects, and is a step through concern. These areas need proper replacement by a licensed general contractor and made functional.

2.8 Item 9(Picture) Deteriorated decking boards

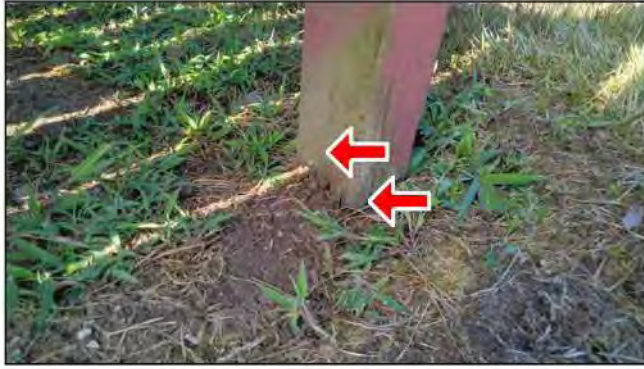
2.8 Item 11(Picture) Deteriorated deck posts

(7) The lower areas of the deck posts is in direct contact with the ground and is causing deterioration in these areas. This deterioration will get worse over time if not corrected and these posts should be evaluated and made functional by a licensed general contractor.

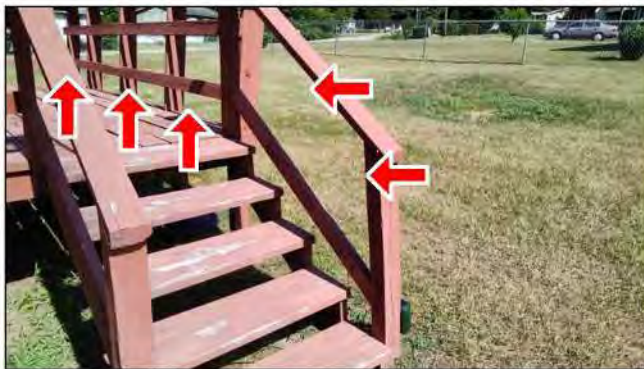
2.8 Item 13(Picture) Improperly spaced pickets

(8) The rear deck has no railings or pickets improperly spaced pickets and can allow persons or pets to fall through these areas. Screen will not prevent persons from falling through and needs pickets on all areas over 30" off of the ground as well as any other areas deemed to high as to cause damage.

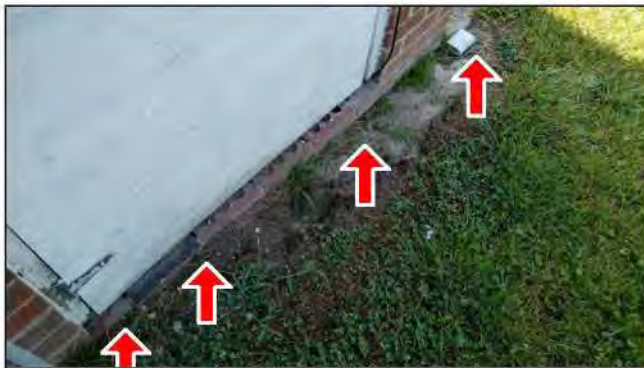
2.10 Item 1(Picture) Erosion along the foundation

The yard at the left side of the house has significant erosion and washed out areas and these areas need repairs to prevent erosion and to hold the soil in place. This repair needs to be performed by a qualified landscaper and all erosion controls installed and washed out areas re-graded.

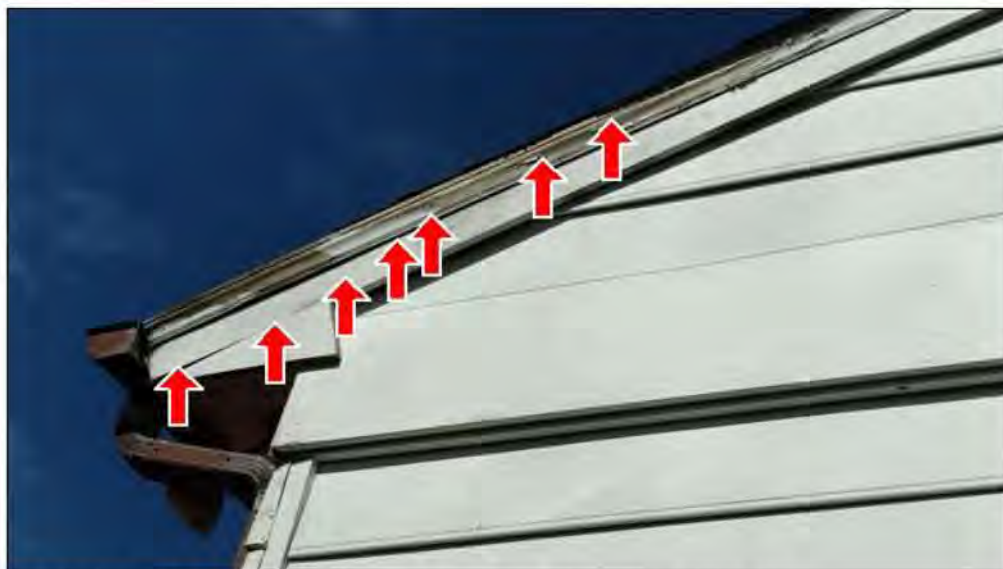
3.0 Item 2(Picture) Shingles are not covering the drip edge

The shingles at the front right corner of the home are not properly overhanging the drip edges, can allow water behind the rake boards or fascia boards, and these areas need proper repairs by a qualified contractor.
