# Inspection Report

1101 Water St  
Henderson NC 27536

**Inspect Co. L.L.C.**

| Date: 7/2/2024 | Time: 09:30 AM | Report ID: JPwaterst722024 |

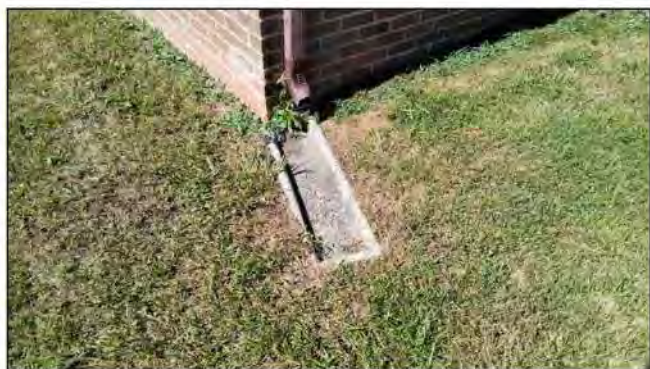
3.1 Item 1(Picture) water draining back against the home

(1) The downspout at the right rear corner of the home has a splash block installed that is not properly located under the downspout to drain away from the home and can hold water against the foundation. These downspouts needs the splash block properly located to allow for proper drainage and to prevent damage.

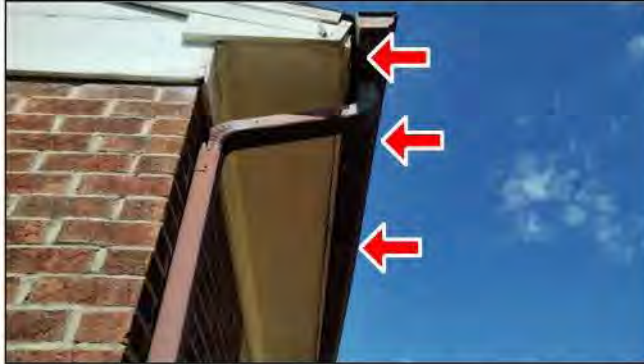
3.1 Item 2(Picture) Loose gutters noted on the home

(2) The gutter across the front and rear of the house is loose on both ends and has water flowing between the gutter and fascia board. This can cause the fascia board to rot. A gutter specialist should be consulted to repair or replace the gutter or fascia boards.

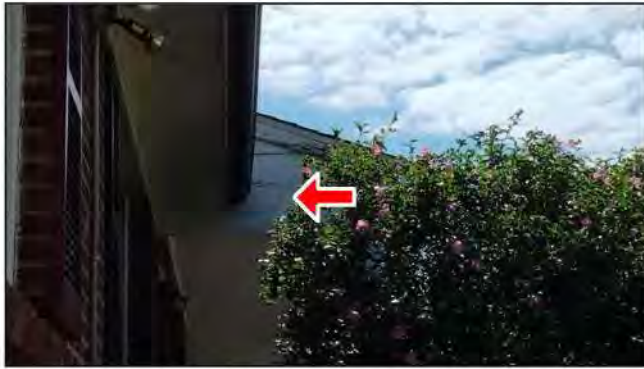
3.3 Item 1(Picture) Missing kickout flashings with deteriorated siding

The kick out flashing at the front wall coverings where it meets the roof line over the front porch are not installed / could not be verified to bring the water back out from behind the siding and needs repairs / installation to prevent leakage in these areas and made functional by a a licensed general contractor or roofing contractor. These areas need to be checked for concealed damage and all necessary repairs need to be performed.

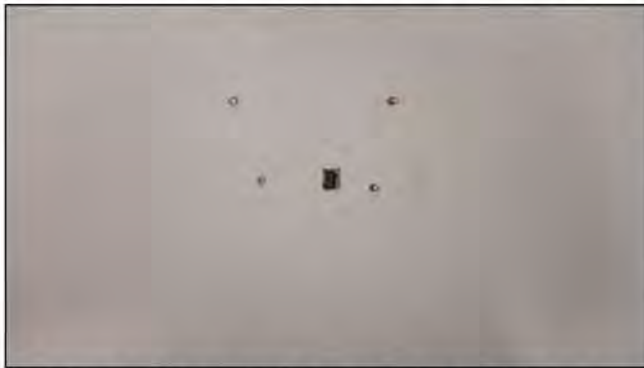
4.1 Item 1(Picture) Holes and damage in the wall

(1) The drywall has common cracks and defects noted in several rooms of the home and needs general cosmetic repairs and all areas made functional.

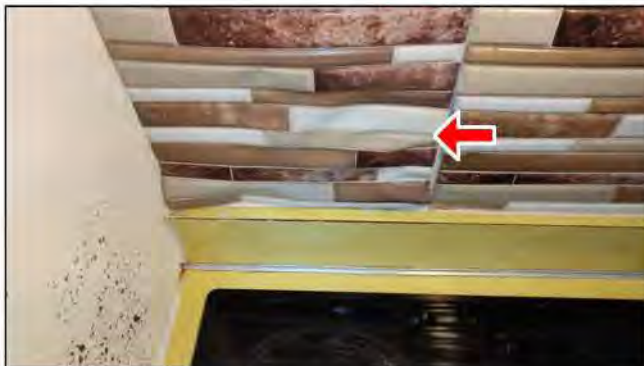
4.1 Item 2(Picture) Stick on tile are loose

(2) The stick on tile in the kitchen is peeling and is no longer functional and these stick on tile need to be repaired or removed and all areas made functional by a qualified contractor.

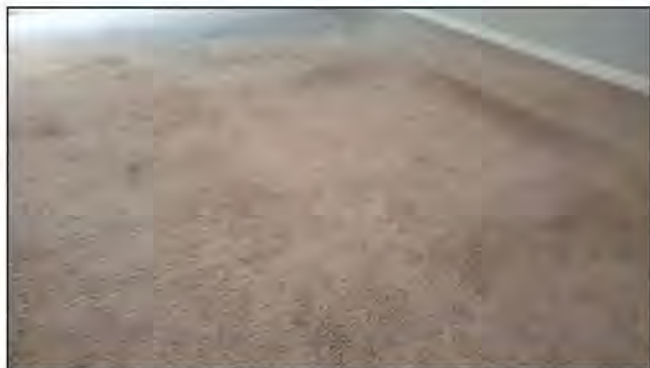
4.2 Item 1(Picture) Loose carpet noted

(1) The carpet is loose/torn in areas and is a tripping concern / safety issue. This carpet needs to be stretched / secured or replaced in areas to prevent this tripping hazard.

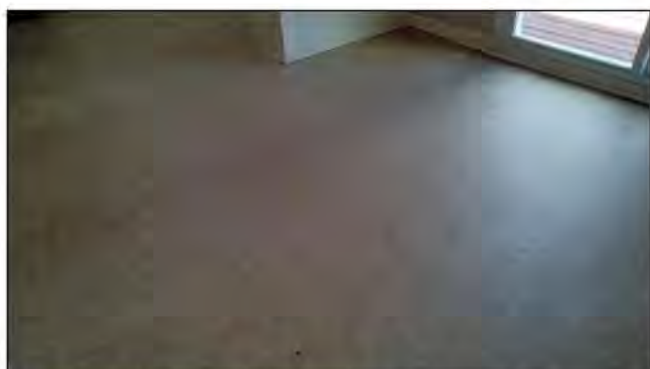
(2) The kitchen and bathroom floor has a dip in the flooring noted. This can be from settlement, a missing pier shim, or the floor framing not being properly supported in this area and all accessible areas of the floor structure were functional. The crawl space under the kitchen was not accessible in areas due to the heating unit and duct work and no representations were made of these areas.

4.2 Item 2(Picture) Large dip noted in the kitchen floor

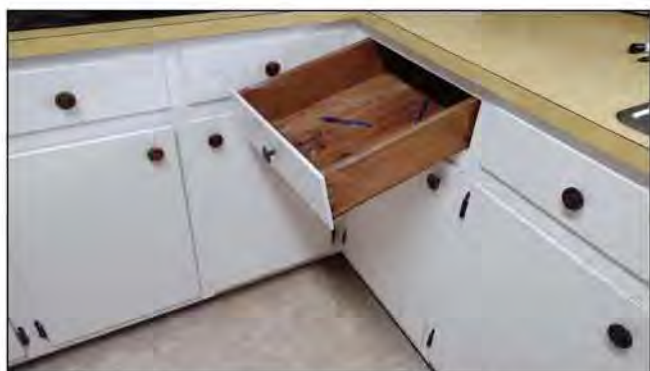
4.4 Item 1(Picture) Drawers off track

The kitchen cabinet drawers are pulling off the track when opening and closing and no longer pull out and support themselves. These drawers need repairs and made functional by a cabinetry specialist and made functional.

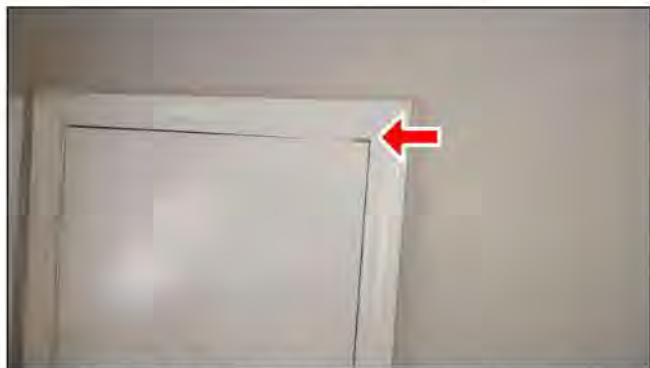
4.5 Item 1(Picture) Door will not open

(1) The closet entry door behind the front door would not open and is scraping the door frame when opening and closing, the door will not close in the opening from this scraping, and this door, frame, and / or framing needs adjustment / repair to work properly. This unit needs repairs by a licensed general contractor.

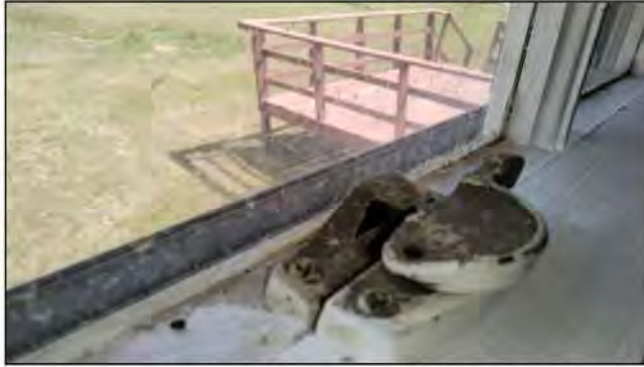
4.6 Item 1(Picture) Window latches are not aligning

The locks on the windows are broken and do not allow these windows to lock into place and be secured. These window locks should be repaired or replaced and the windows made functional.

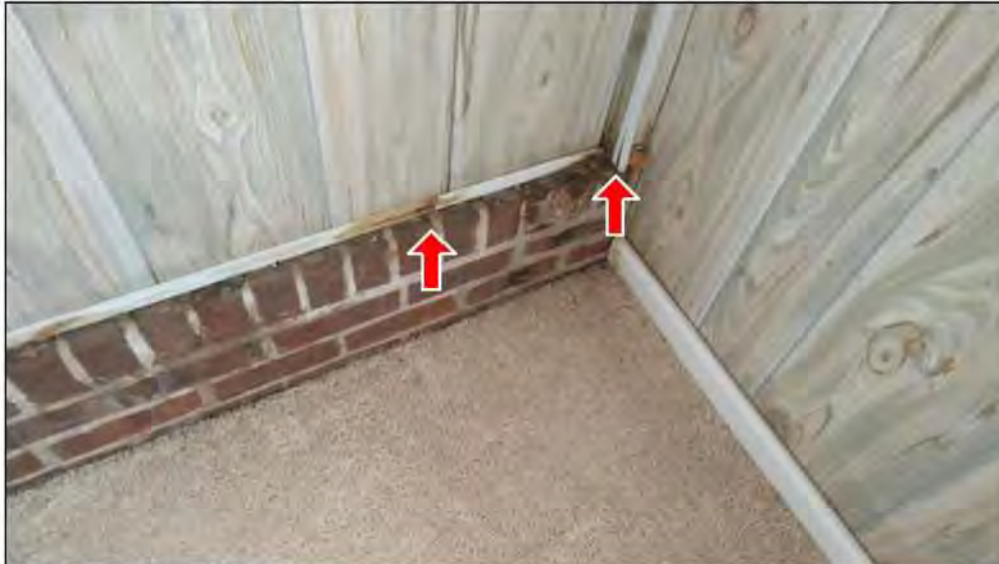
4.7 Item 1(Picture) moisture stains and damage indicate later water leaking into the home in these areas

Moisture stains were noted in the lower walls of the converted garage and appears to be from a past or present leak but the cause could not be determined. This area needs should be evaluate to determine the cause of the stains, if the issue is active and the extent of the damage and all areas made functional by a licensed general contractor.

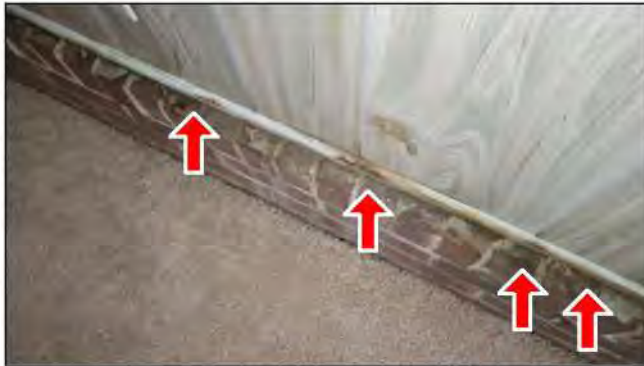
4.7 Item 3(Picture) Moisture stains noted

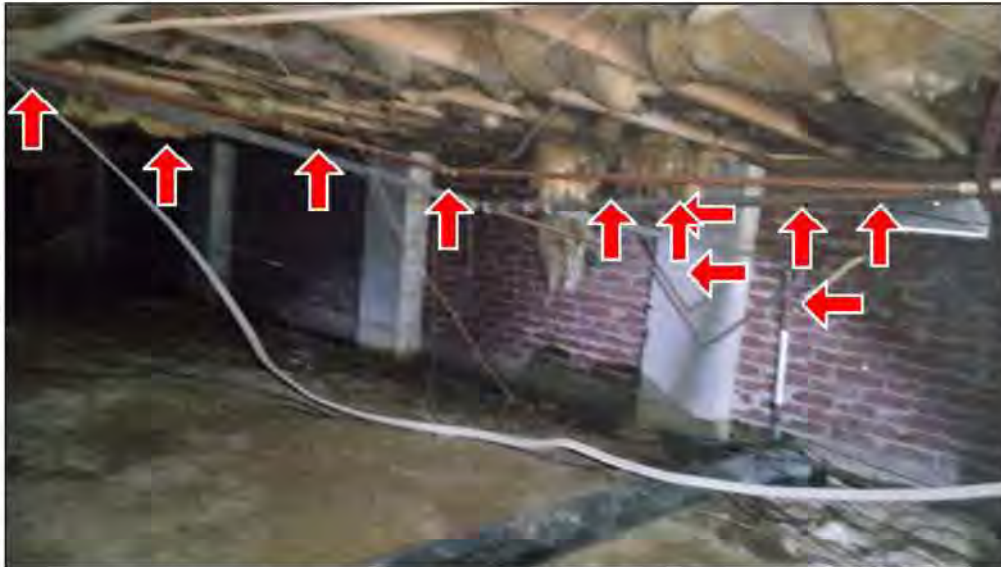
5.1 Item 1(Picture) Water supply lines not strapped or supported

The water lines in the crawlspace are not strapped up properly to the wood member and is sagging in areas. These plumbing lines need to be properly strapped and supported every 4 feet and should not sag and rest on the ground and needs to be made functional by a licensed HVAC contractor.

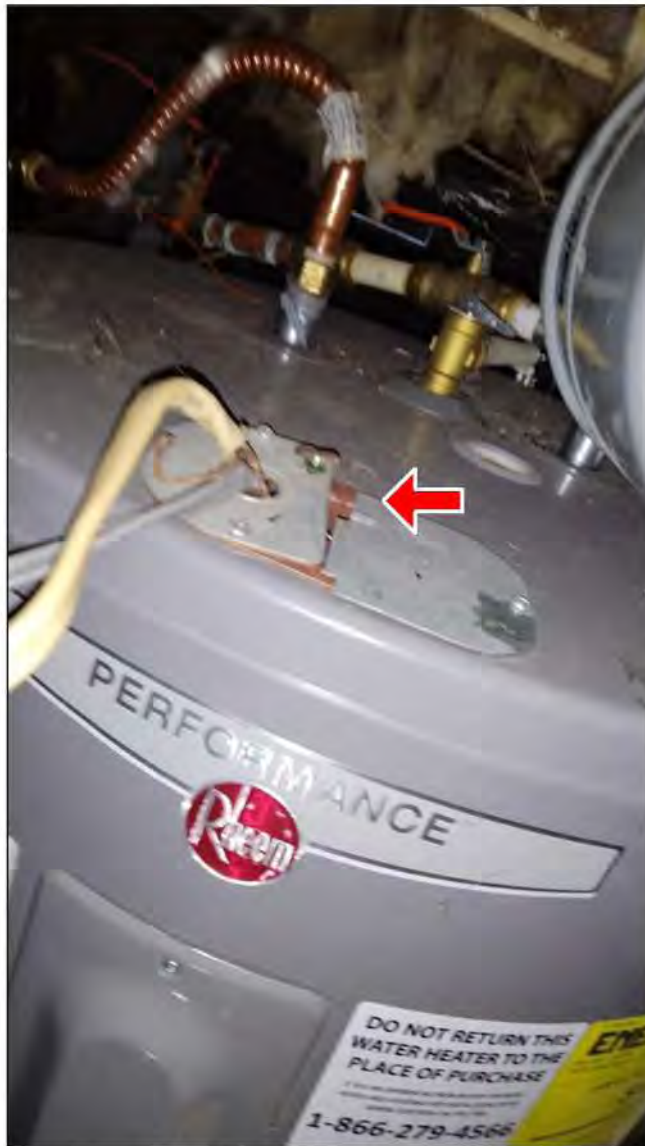
6.3 Item 1(Picture) Wiring not properly connected

The water heater electrical line conduit is loose from the water heater cabinet and this conduit line needs repairs to cover all areas of the wiring and to be properly secured to the water heater and made functional by a licensed electrician.

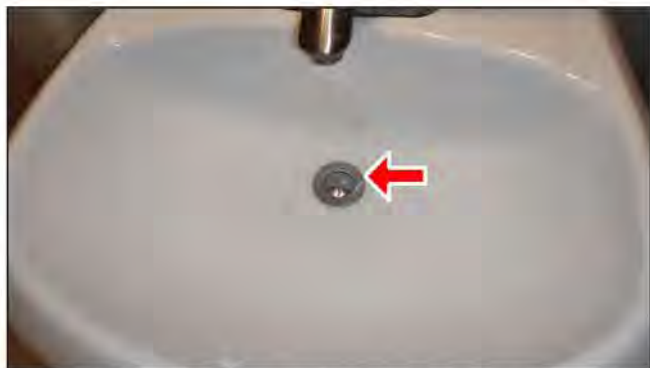
7.1 Item 1(Picture) Damaged sink stopper not functional

The hall bathroom sink stopper is not opening and closing properly to hold water or release water in the sink at the drain and needs repairs or replacement by a licensed plumbing contractor and made functional.

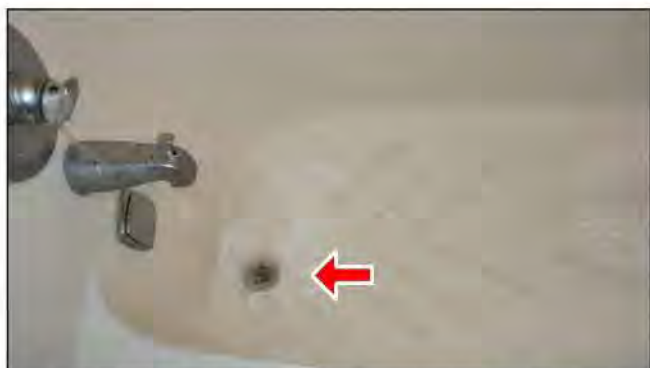
7.2 Item 1(Picture) Tub stopper missing

(1) No permanently installed drain stopper or drain cover is in place in the bathroom tub, will not properly hold water, and needs proper repairs performed by a licensed plumbing contractor and made functional.

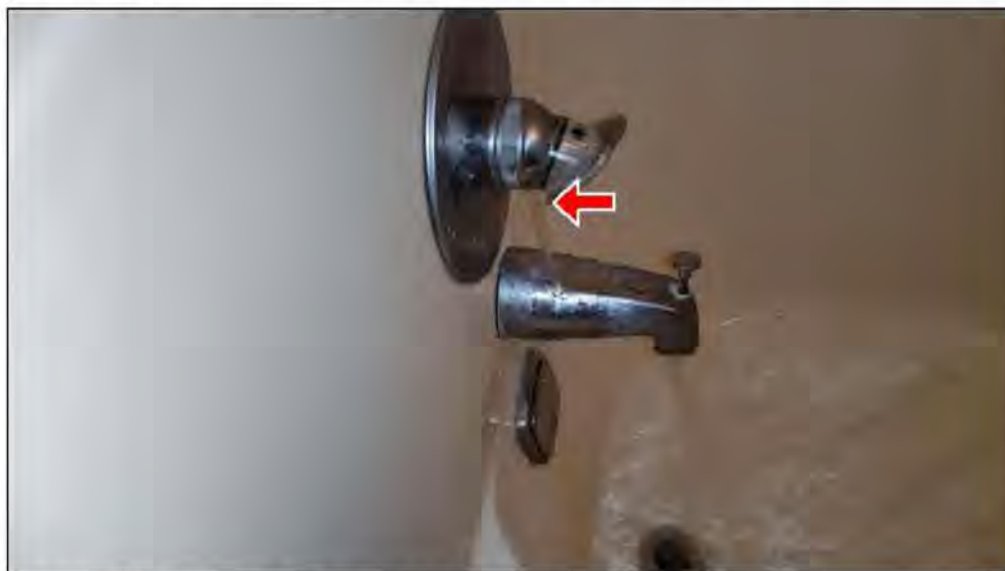
7.2 Item 2(Picture) Leak noted at he shower faucer handle

(2) The master bathroom shower faucet handle has a leak noted at the knob that can leak into the wall and cause further damage. This diverter valve should be evaluated and repaired or replaced by a licensed plumbing contractor with all areas made functional.

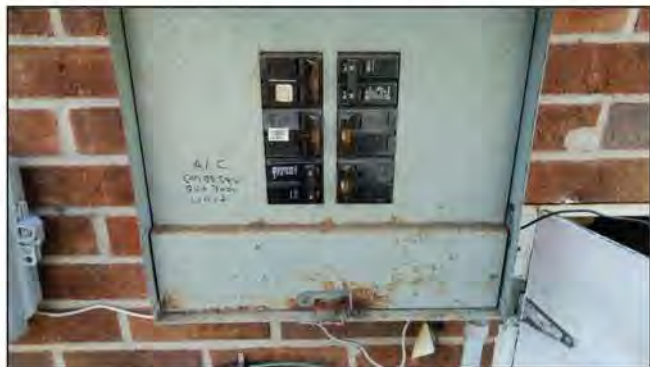
8.3 Item 1(Picture) Breakers are not labeled

The breakers in the panel box are not clearly / properly identified or labeled for use, is a safety concern, and needs to be properly labeled for individual use by a qualified electrician.

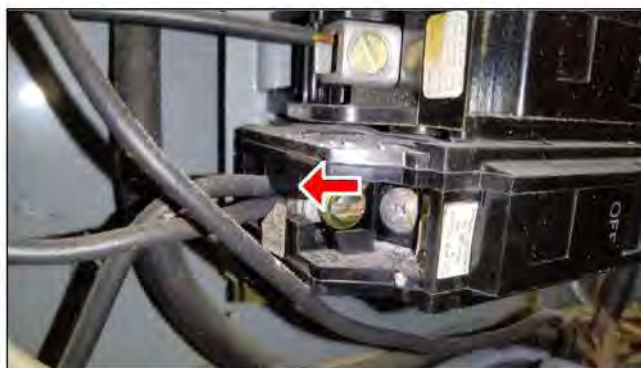
8.5 Item 2(Picture) Double tapped breakers noted

Multiple double tapped breakers were noted in the electrical distribution box and this is a safety concern and this can cause arcing inside the box and damage. This installation should be reviewed by a licensed electrical contractor and made functional.

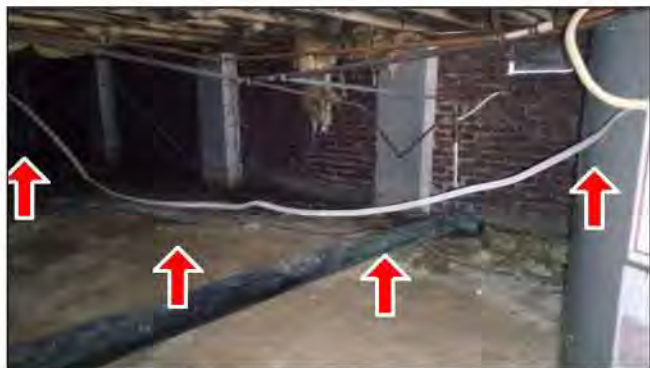
8.6 Item 1(Picture) Wiring not secured in the crawlspace

(1) The wiring in the crawlspace is not properly secured and is hanging from the floor framing. This wiring should be evaluated and properly installed and secured and all wiring made functional.

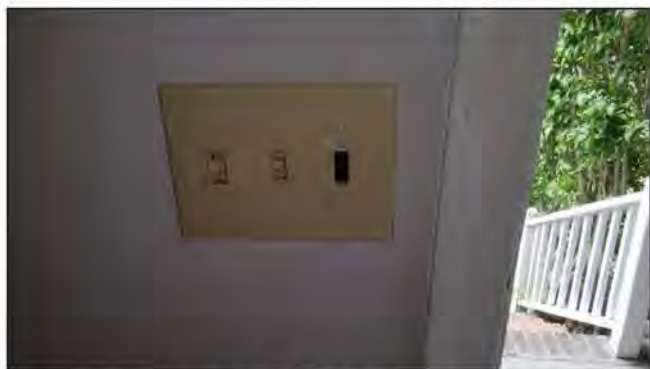
8.7 Item 1(Picture) Switch missing leaving exposed wiring

A switch was missing from the switch panel by the front door and this panel should be evaluated and all switches made functional by a licensed electrical contractor.

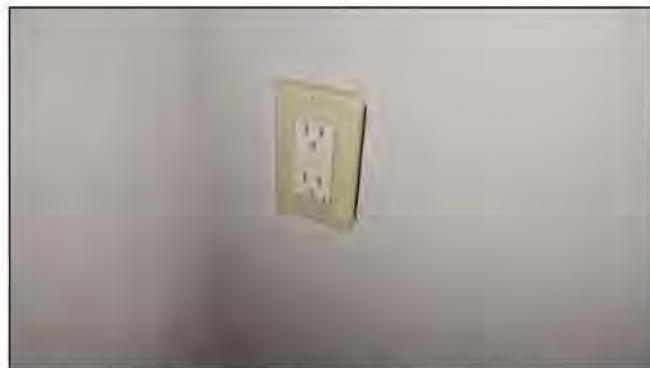
8.9 Item 1(Picture) GFCI's not resetting

The GFCI's in the bathrooms would not re-set, causes the power to remain off, and needs repair and made functional by a licensed electrician.

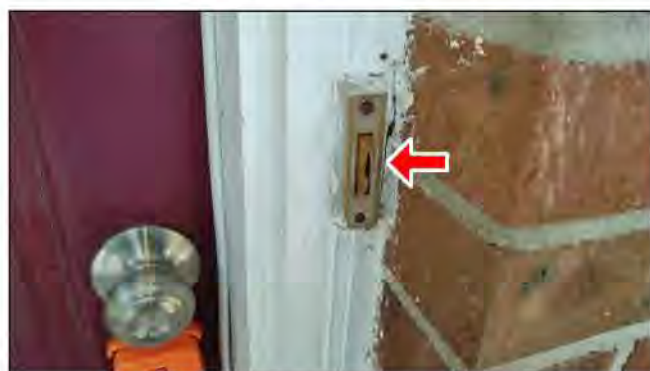
8.11 Item 1(Picture) Broken door bell cover

The cover over the front entry door bell is broken / loose / cracked, is damaged, and this unit is not functional. The door bell needs proper repairs / replacement by a qualified contractor.

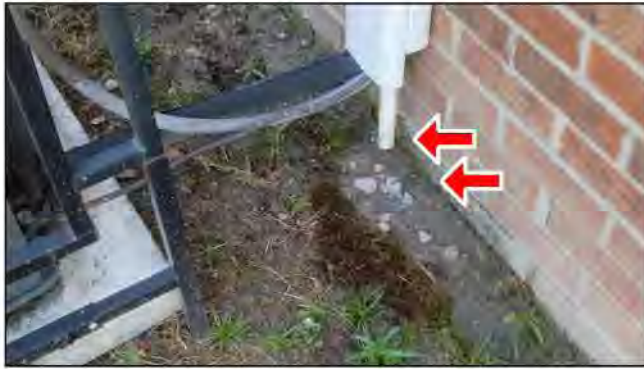
9.5 Item 1(Picture) The condensation tube is draining against the foundation

The condensation tube is draining against the foundation behind the condenser unit and is / can allow standing water in this area and allow water to enter the crawlspace or to penetrate under the slab foundation. This condensation tube needs to be extended or made to drain away from the structure to prevent damage to components of the home.

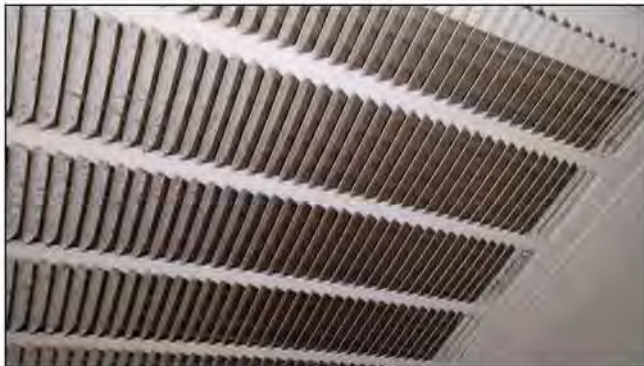
10.6 Item 1(Picture) Clogged filters noted

The filters are clogged with lint and debris, is restricting air flow, and the filter needs to be changed out to allow proper use of the units. This may require cleaning the unit if clogged.

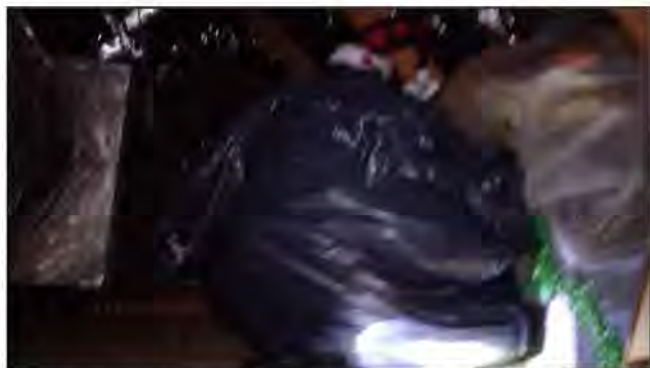
11.0 Item 1(Picture) Stored items from floor to roof rafters in the attic is stopping proper ventilation

(2) The attic area is very hot due to a lack of ventilation in the attic and this can be caused by the amount of stored items in the attic space. Hot attics can affect the HVAC system and ductwork, the framing, roof coverings, and other components. This attic needs to be cleaned out and then evaluated for proper ventilation with all needed repairs performed and all areas made functional by a licensed contractor specializing in ventilating attics.

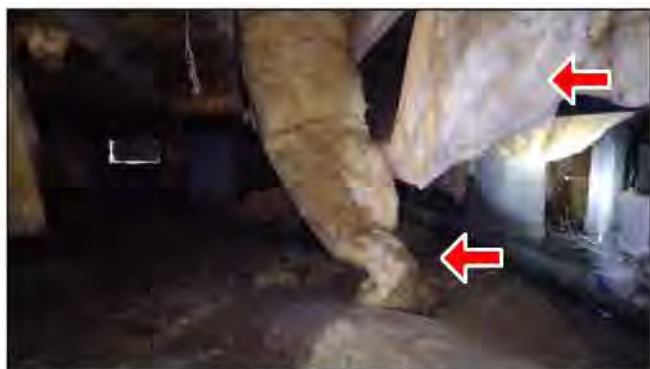
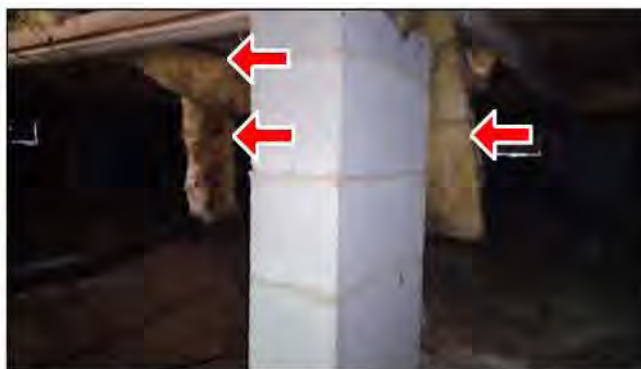
11.1 Item 1(Picture) The flooring insulation has fallen in areas of the crawlspace

11.1 Item 2(Picture) The flooring insulation has fallen in areas of the crawlspace

The insulation has fallen and or is missing in areas of the crawl space and needs to be re-installed or replaced in all affected areas. All areas need insulation to offer proper insulating R value and needs proper installation by a qualified insulation contractor.
