RE: Underground Storage Tank (UST) Closure Assessment Report  
601 Lake Road, Creedmoor, North Carolina  
Cedar Rock Project Number 383922590

**UNDERGROUND STORAGE TANK  
CLOSURE ASSESSMENT REPORT FOR  
601 LAKE ROAD  
CREEDMOOR, NORTH CAROLINA**

**CR #383922590**

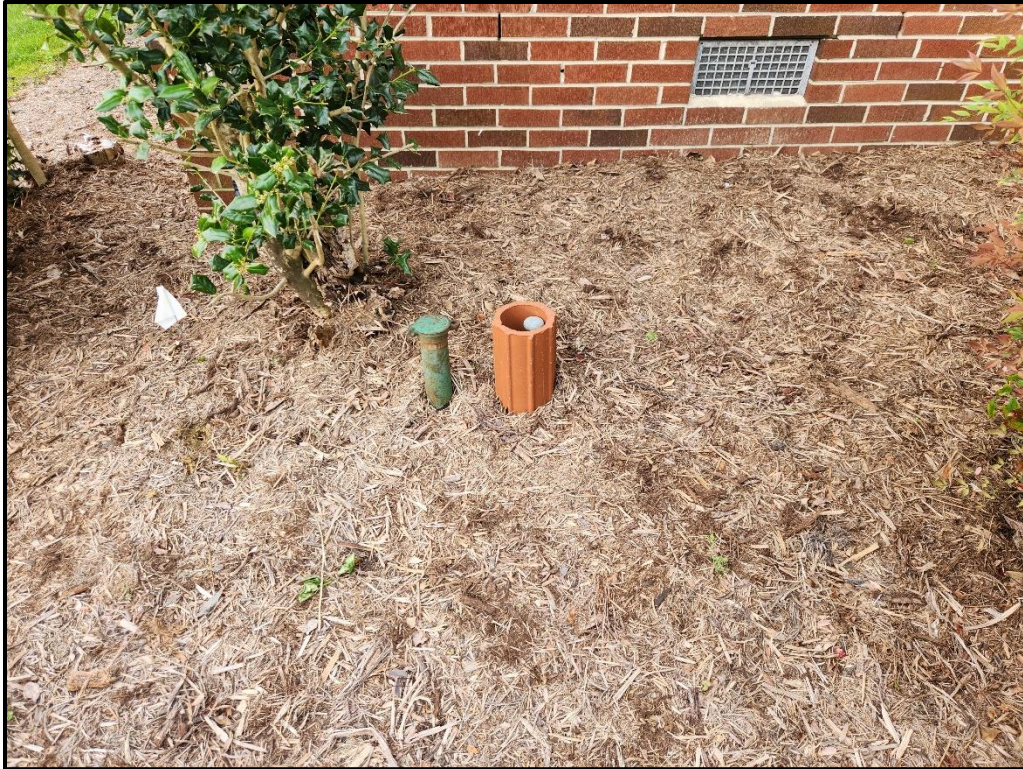
**Photo 1.** View of the UST site prior to abandonment activities.

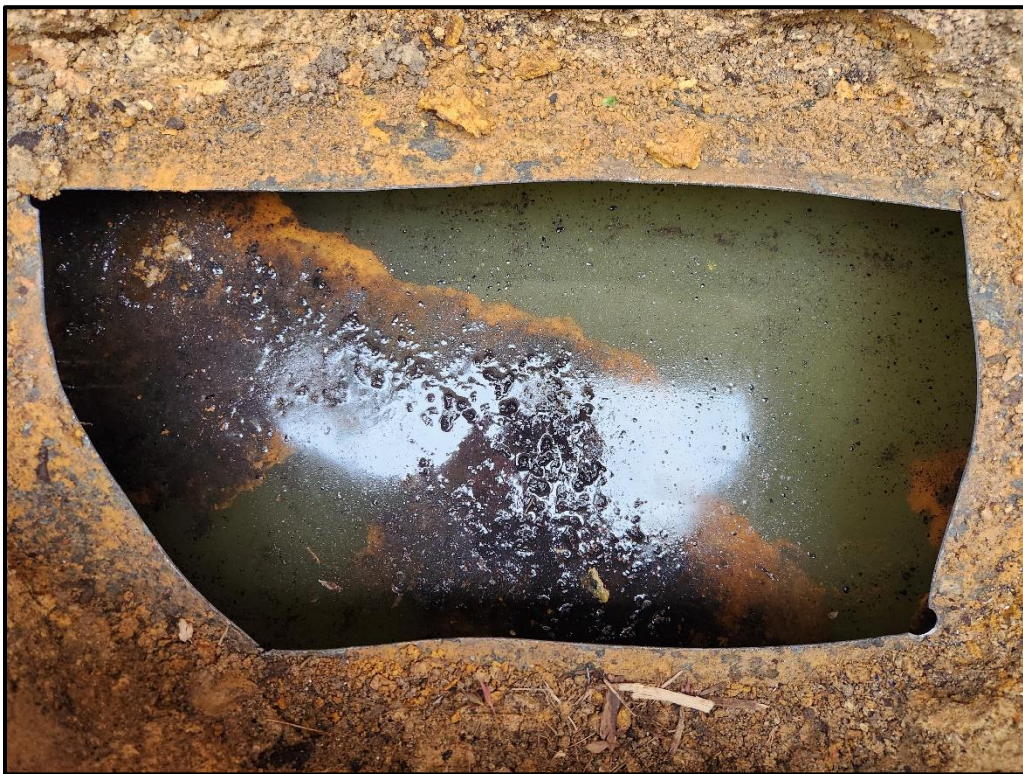
**Photo 2.** View of the UST interior prior to the removal of tank contents.

The in-place abandonment of the UST was performed on April 9, 2024. The abandonment consisted of the hand excavation of the soils overlying the southeastern end of the UST to expose the topside of the tank. A hole approximately 1.5 feet in diameter was then cut on the top of the UST to allow for removal of the tank contents, cleaning and visual inspection of the UST interior, and subsequent filling. The tank was pressure washed to remove all residual petroleum sludge. Residual oil in the fuel lines was also removed by vacuum. The fuel lines were removed from the crawlspace. Approximately 519 gallons of fluid and sludge (including rinsate) were removed from the UST. The fluid disposal manifest for the tank contents is included in Appendix A.

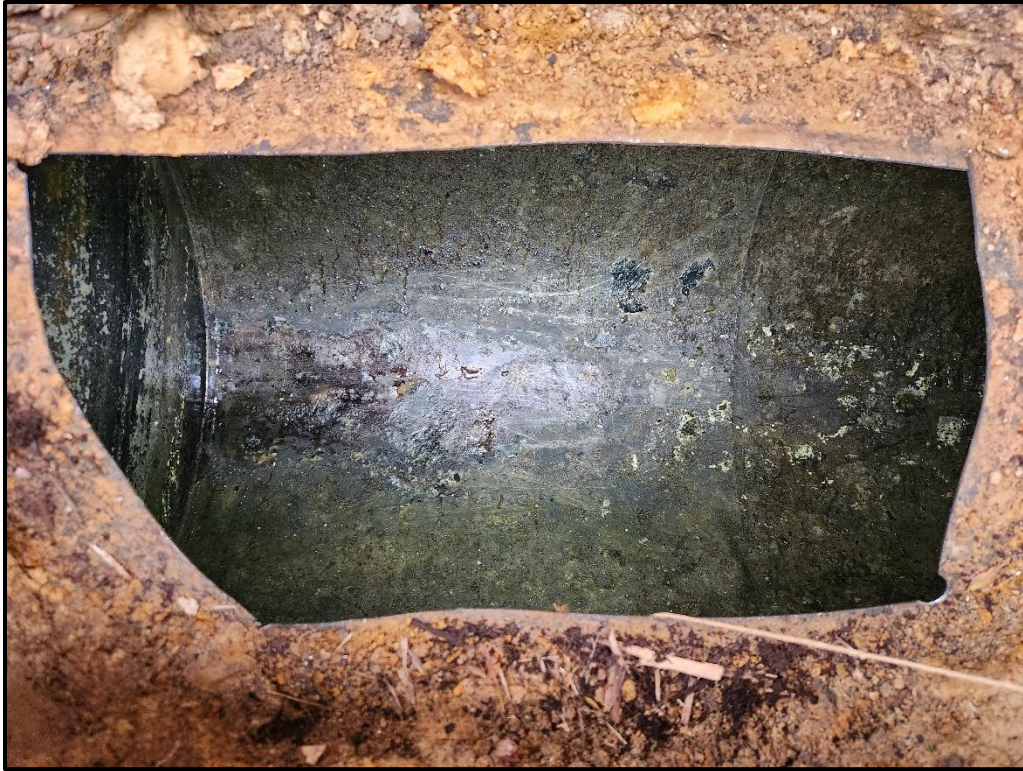
**Photo 3.** View of the UST interior after the removal of UST contents and pressure wash cleaning of the tank interior.

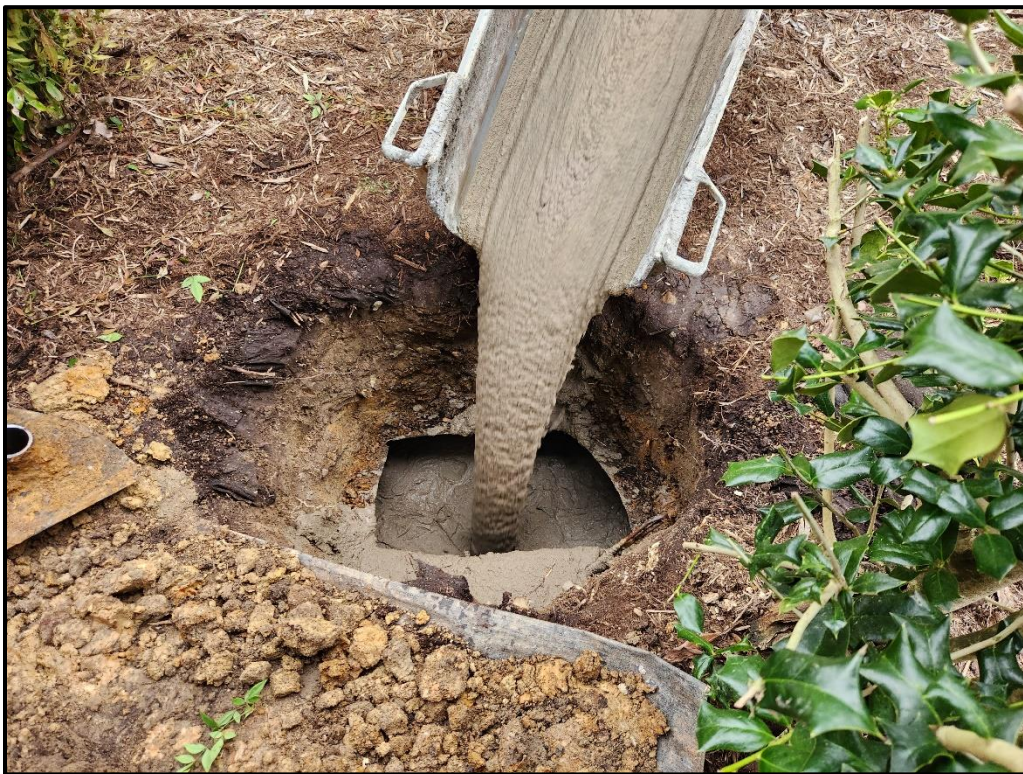
**Photo 4.** View of the UST being filled with flowable fill cement slurry.

After the interior of the UST was cleaned, the tank was then entirely filled with an excavatable flowable fill cement slurry. Once filled, the exposed portion of the UST was then covered with site soils (see Appendix B - Photographic Documentation).

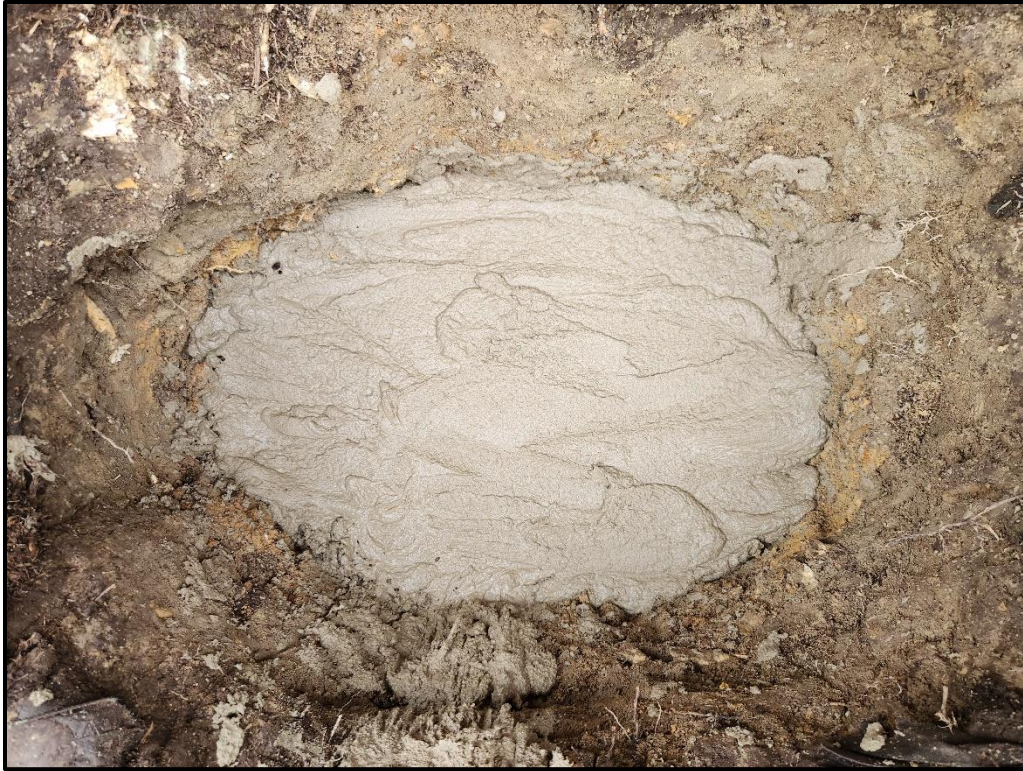
**Photo 5.** View of the UST after filling with flowable fill cement slurry.

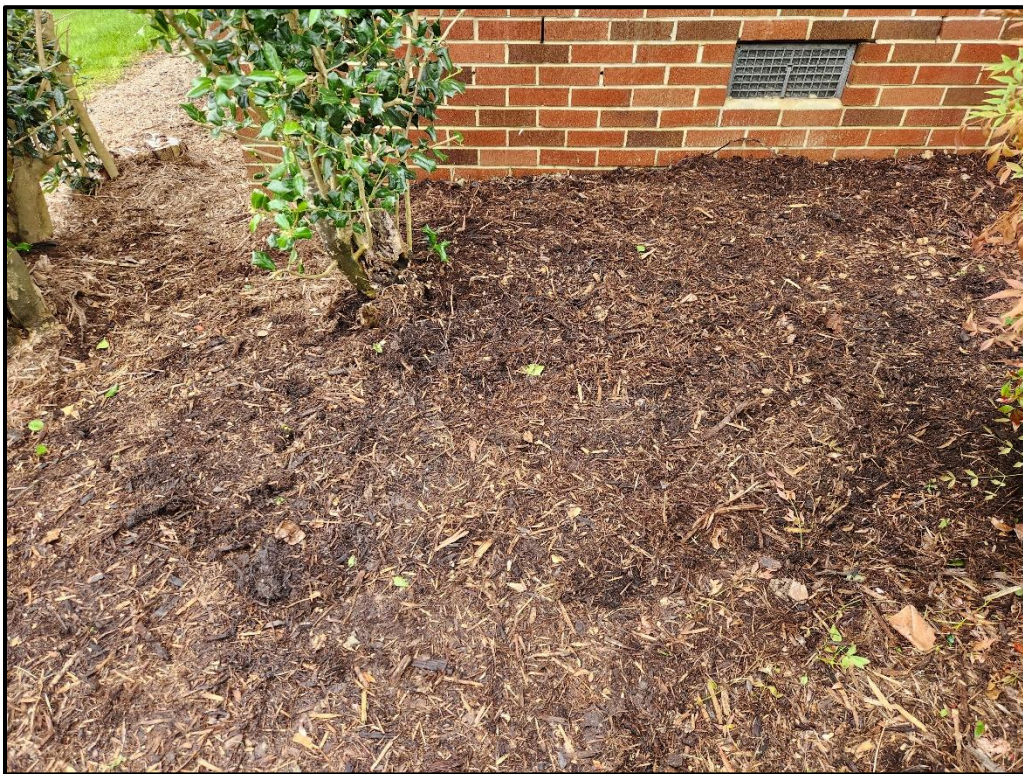
**Photo 6.** View of the UST site after the completion of abandonment activities.
