**STATE OF NORTH CAROLINA  
RESIDENTIAL PROPERTY AND OWNERS' ASSOCIATION DISCLOSURE STATEMENT**

## ERC Relocation Property Assessment Images

**Property Address: 2053 Montgomery Drive Franklinton NC 27525**

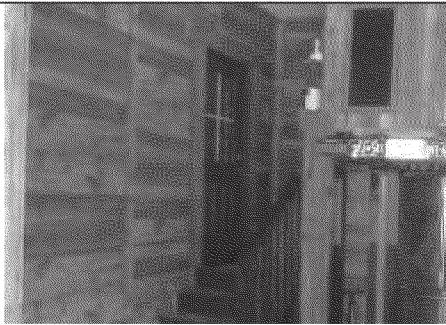
(G/C) 4 Condition: The garage service door is not fire-rated.

| 4 | <input type="checkbox"/> | <input type="checkbox"/> | <input type="checkbox"/> | <input checked="" type="checkbox"/> | Condition: The garage service door is not fire-rated. |

Non Fire-Rated Garage Service Door

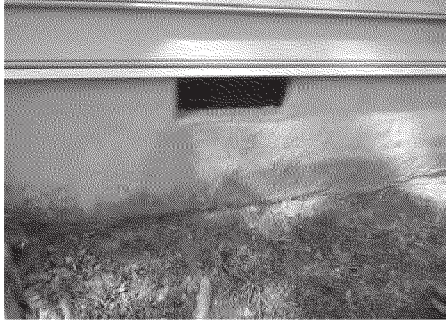
(S) 1 Foundation: A crack was observed at the right rear foundation wall.

| | Acceptable | Not Present | Not Assessed | Defective | Item | Remarks |
|---|---|---|---|---|---|---|
| <div style="display: flex;"> <div style="margin-left: 10px;"> <p>Crack at Foundation Wall</p> </div> </div> | | | | | | |

Corrective Action: Contractor to repair/seal the crack at the right rear foundation wall.

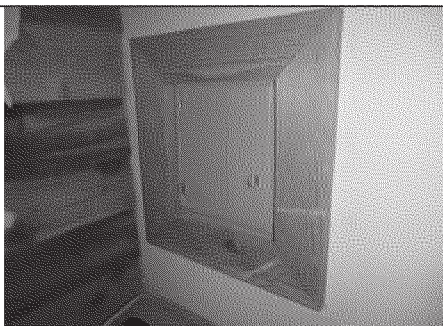
(E) 3 Panel: The sub panel in the second floor bar area was inaccessible (blocked by finishings), a wire clamp is missing at the bottom of the garage sub panel, and improper screws were observed at the garage sub panel cover.

Inaccessible Electric Panel

Corrective Action: Electrician to inspect the sub panel in the second floor bar area when full access is provided and make repairs as needed, install a wire clamp at the bottom of the garage sub panel, and install proper screws at the garage sub panel cover.

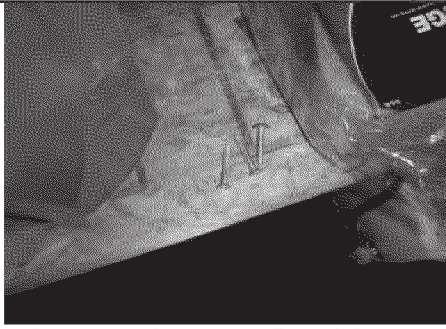
Improper Screws at Panel Cover

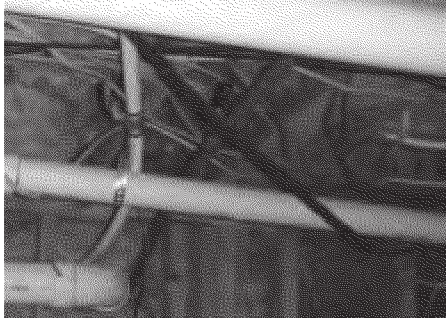
(HS) 9 Fuel Tank/Lines: Corrugated stainless steel tubing (CSST) is present.

| CSST Piping | Underground Propane Tank | |

Corrective Action: Further evaluation recommended. Licensed electrician to evaluate the for the proper bonding of the corrugated stainless steel tubing (CSST) fuel piping.

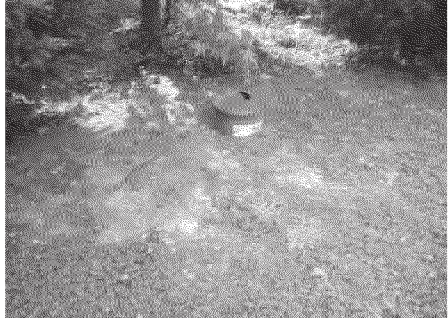
| 9 | <input type="checkbox"/> | <input type="checkbox"/> | <input type="checkbox"/> | <input checked="" type="checkbox"/> | Fuel Tank/Lines: Corrugated stainless steel tubing (CSST) is present. | |

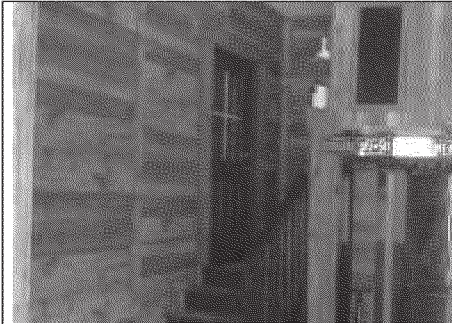
Non Fire-Rated Garage Service Door

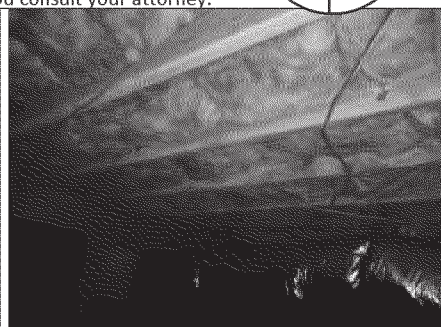
(CS) 4 Evidence of Water penetration: Suspect mold/fungal growth has been identified in the following visually observable areas of the home. Suspect mold was observed at the wood framing at the middle rear area of the main crawl space.

Suspect Mold at Framing

Corrective Action: Recommend a swab sample to confirm the presence of mold/fungal growth observed at the wood framing at the middle rear area of the main crawl space.

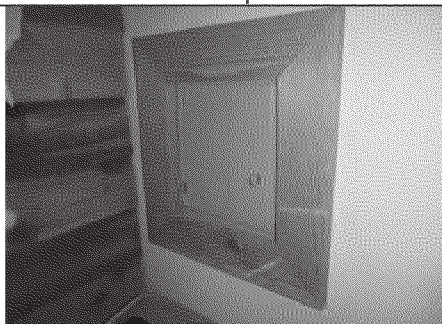
| 3 | <input type="checkbox"/> | <input type="checkbox"/> | <input type="checkbox"/> | <input checked="" type="checkbox"/> | Panel: The sub panel in the second floor bar area was inaccessible (blocked by finishings), a wire clamp is missing at the bottom of the garage sub panel, and improper screws were observed at the garage sub panel cover. |

Inaccessible Electric Panel

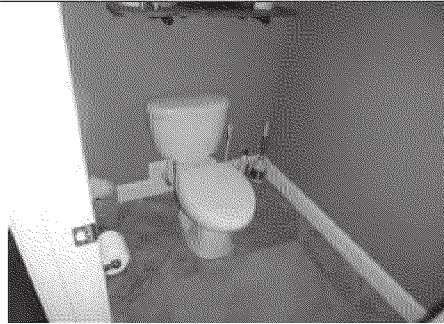
(P) 9 Toilet: The toilet in the main level master bathroom is loose at the base and is leaking at the fill valve assembly.

Loose Toilet in Master Bathroom

Corrective Action: Plumber to repair the toilet in the main level master bathroom which is loose at the base and is leaking at the fill valve assembly.

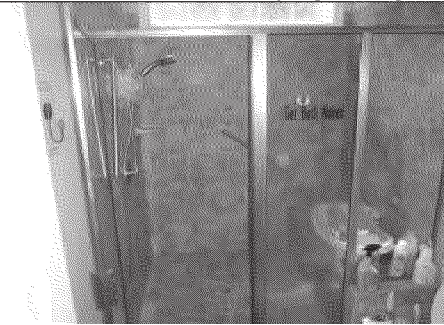
Hot/Cold Supply Lines Reversed

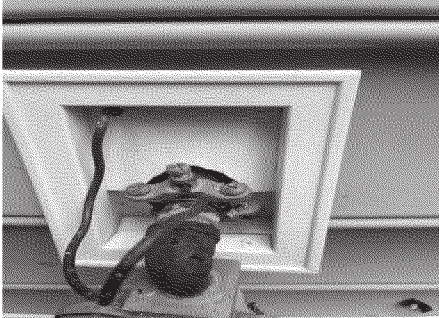
CSST Bonded

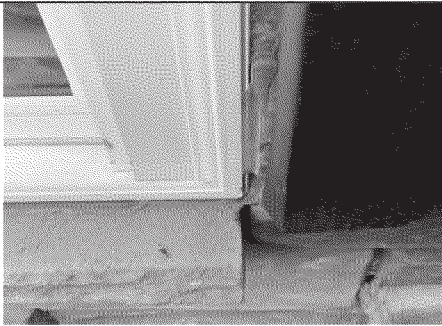
| Are sealant joints present at windows and doors? | | Sealant-Expansion joints have not been properly installed at the windows. Sealant joints are required at the intersection of the stucco/stone and all dissimilar construction materials and must be of a standard design method. The function of this joint is to provide a weather-seal and to accommodate movement between the two materials. | |

| Sealants cracked | Sealants cracked | | |

| Corrective Action | | Contractor to install properly designed sealant joints utilizing compatible caulk-sealant at all exterior penetrations. | |

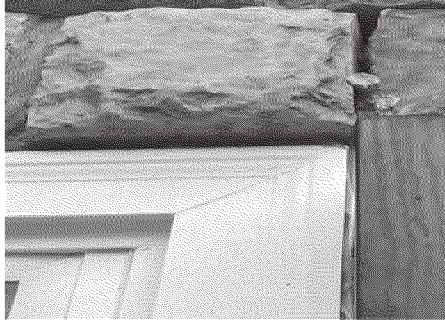
| <br>Overview | <br>Lack of head flashings |

| Corrective Action | Contractor to install properly designed flashing at all stucco/stone horizontal joints or apply sealant for proper drainage of surface water run-off. |
