# ROB WERNEKEN HOME INSPECTION SERVICES, LLC

## RESIDENTIAL REPORT

4082 Old Franklinton Rd  
Franklinton, NC 27525

JANUARY 14, 2025

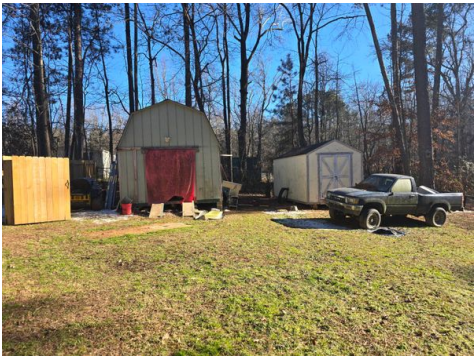
Unless otherwise stated, accessory buildings are not within the scope of the home inspection

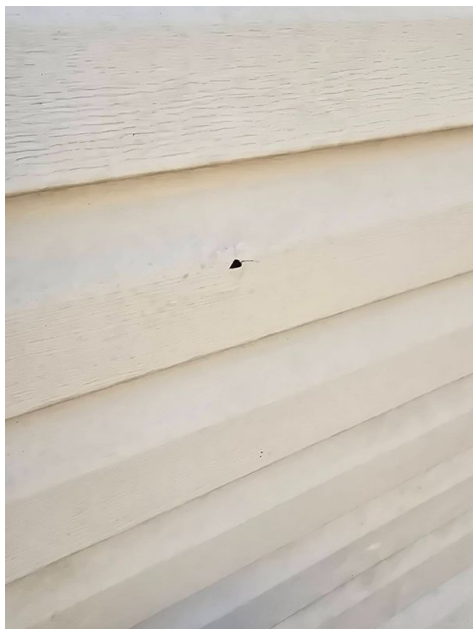
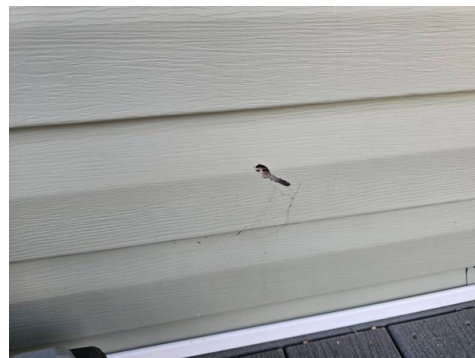
2.2.1 Siding, Flashing & Trim

**VINYL SIDING CRACKED**

FRONT PORCH, RIGHT SIDE

On the right wall a section of siding is cracked. This can allow water penetration and lead to decay in framing members. Recommend a licensed siding contractor address concerns.

Contact a qualified professional.

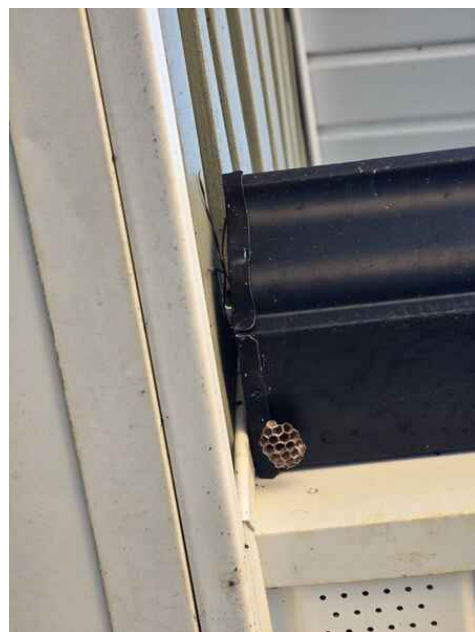
### 2.2.2 Siding, Flashing & Trim

#### **KICK-OUT FLASHING-MISSING**

The gutters were noted to be in contact with the siding at end points and without a flashing such as a kick out, typical recommended installations request a 1 inch gap and a kick out flashing to prevent excessive water from draining down the siding in the event of gutter overflow. A licensed general contractor should be consulted to review the siding installation to determine the significance of this concern and to make necessary repairs.

Contact a qualified general contractor.

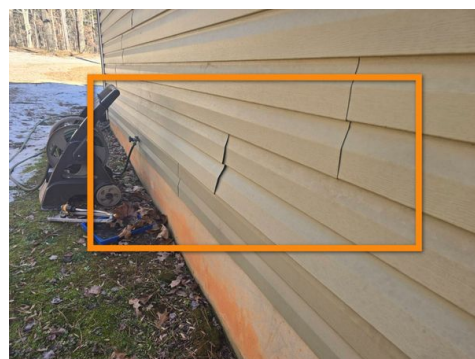
### 2.2.3 Siding, Flashing & Trim

#### **SIDING: IMPROPERLY SECURED**

#### RIGHT

During the home inspection, it was noted that there is an unsecured section of vinyl siding on the exterior of the property. This condition may lead to water intrusion, potential pest access, and could compromise the home's insulation and energy efficiency. It is recommended to secure the loose siding and perform a thorough inspection to ensure that there are no underlying issues. A qualified contractor should be consulted for repair to restore the integrity of the siding system.

Contact a qualified professional.

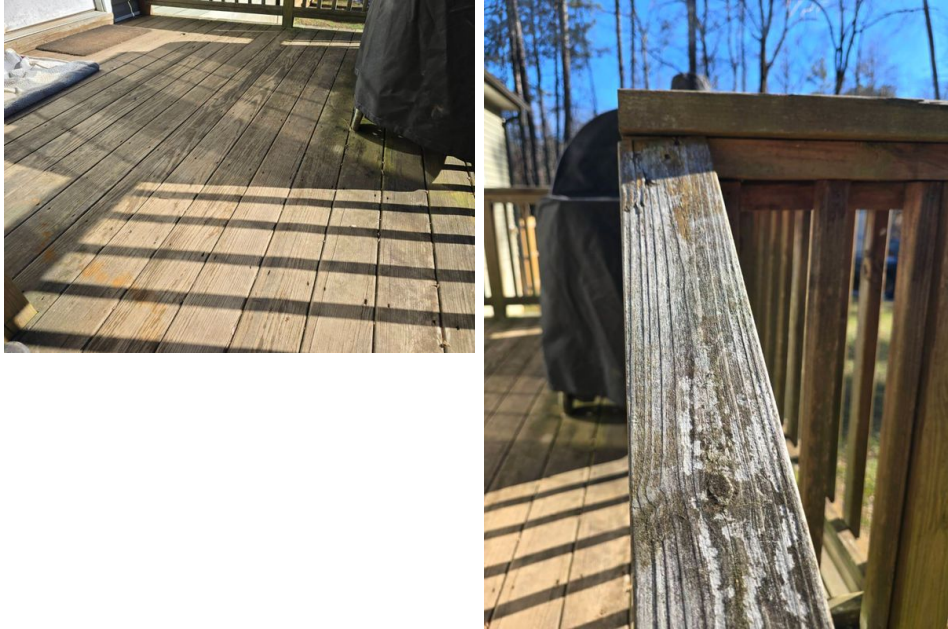
## 2.4.1 Decks, Balconies, Porches &amp; Steps

**DECK - WATER SEALANT REQUIRED**

Deck is showing signs of weathering and/or water damage. Recommend water sealant/weatherproofing be applied.

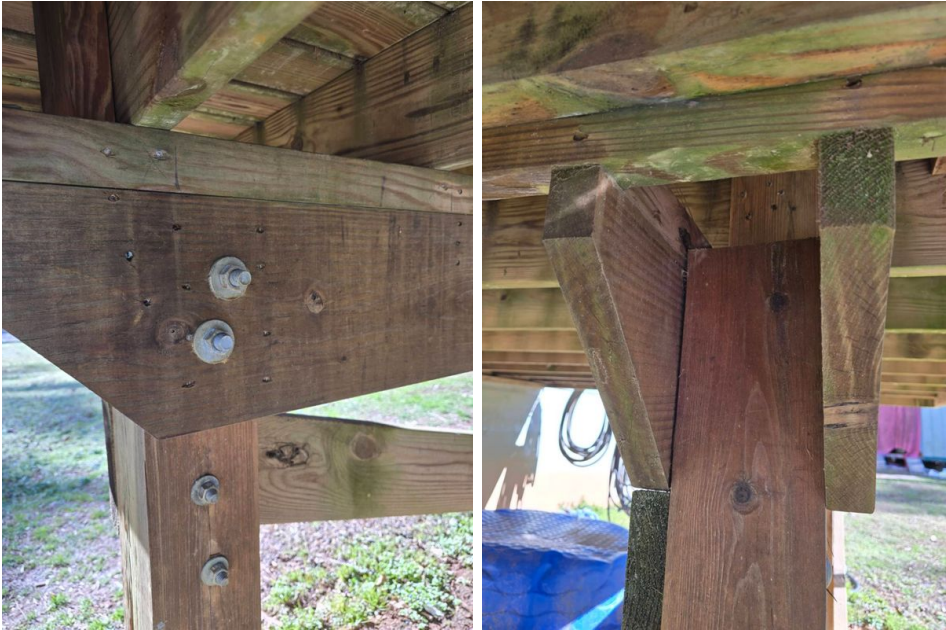
## 2.4.3 Decks, Balconies, Porches &amp; Steps

**DECK GIRDER CONNECTION TO POST**

During the home inspection, it was observed that the deck girder is bolted to the side of the vertical post. Bolts are supporting full weight of deck. It is recommended to consult with a licensed contractor to assess the condition of the connection and, if necessary, perform repairs or reinforcement to ensure it meets current building codes and safety standards.

Contact a qualified professional.

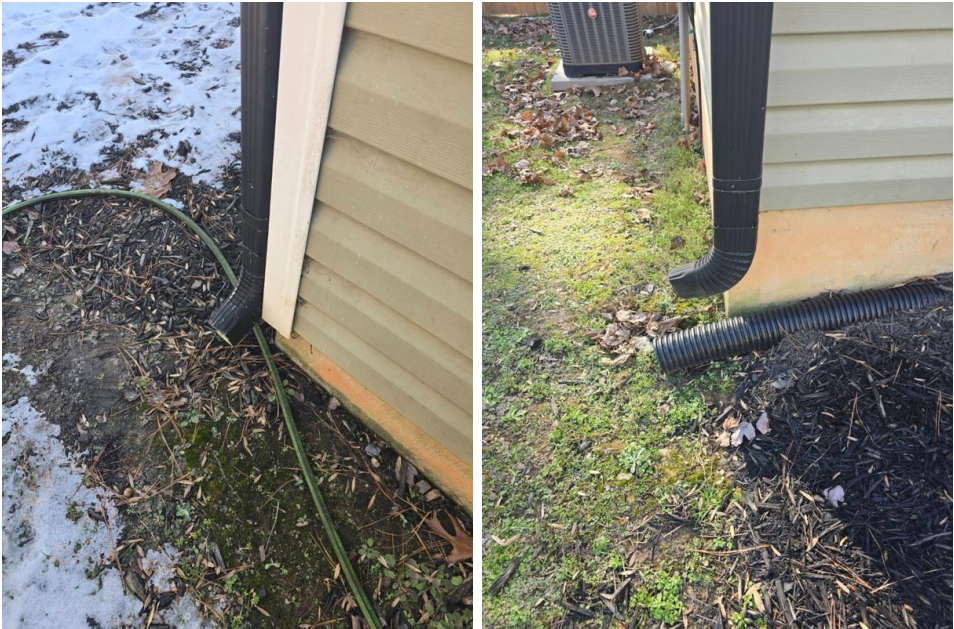
## 3.2.2 Roof Drainage Systems

**DOWNSPOUTS DRAIN NEAR HOUSE**

One or more downspouts drain too close to the home's foundation. This can result in excessive moisture in the soil at the foundation, which can lead to foundation/structural movement. Recommend a qualified contractor adjust downspout extensions to drain at least 6 feet from the foundation.

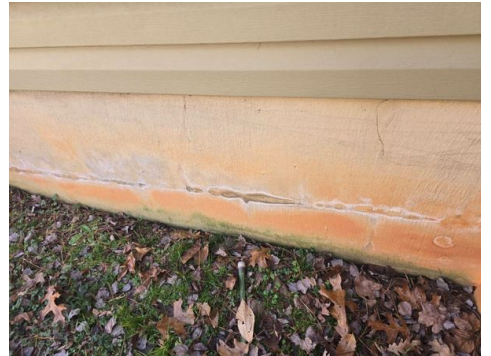
### 4.1.1 Foundation

## EFFLORESCENCE

Efflorescence (salt stains) and algae growth were noted on the foundation walls. The stains indicate that the foundation has been cyclically wet and dry. Water penetration into the foundation area can result in structural damage and undesirable environmental conditions. Water in the foundation area indicates an absent or damaged waterproofing and foundation drain systems. A licensed general contractor with experience in foundation drainage and waterproofing should be consulted for evaluation and to make necessary repairs.

Contact a qualified professional.

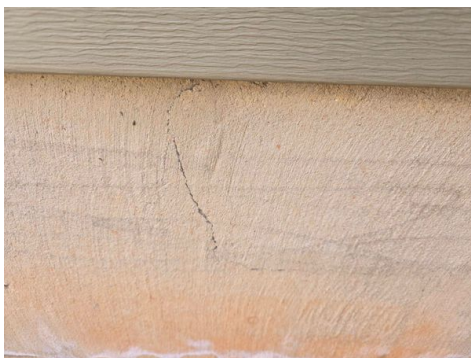
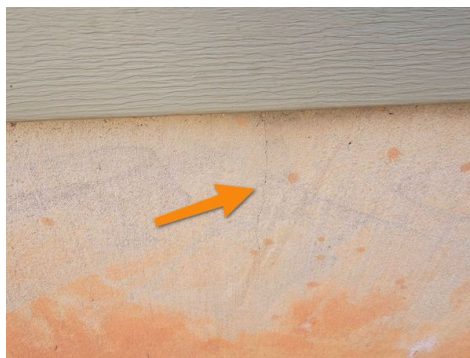
### 4.1.2 Foundation

## PARGING CRACKS

Fine cracking in parging covering exterior foundation wall observed. This is usually due to material shrinkage as material cures. This is likely a cosmetic issue but should be monitored.

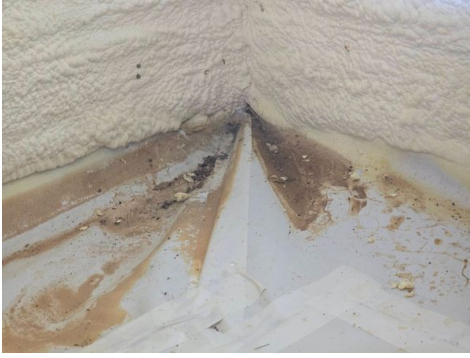
### 4.3.1 Basements & Crawlspaces

## STANDING WATER

RIGHT REAR

Observed signs that standing water may have been present on crawlspace floor. Recommend a qualified contractor evaluate and find potential source of moisture.

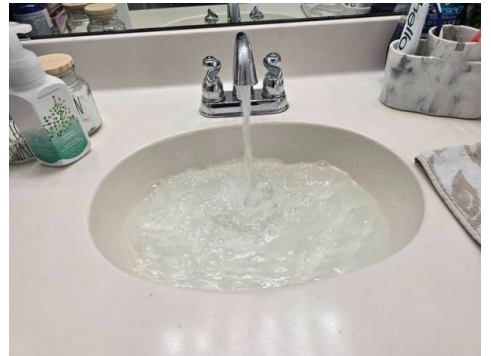
Sink had slow/poor drainage. Recommend a qualified plumber repair.

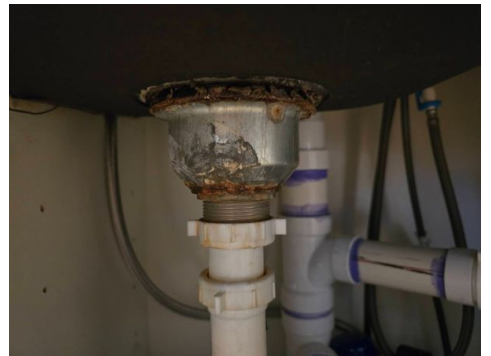
### 7.2.2 Drain, Waste, & Vent Systems

#### **DRAIN: CORROSION**

Sink drain found to be heavily corroded. This can lead to leaks and damage. Plumber should evaluate and repair/replace as needed.

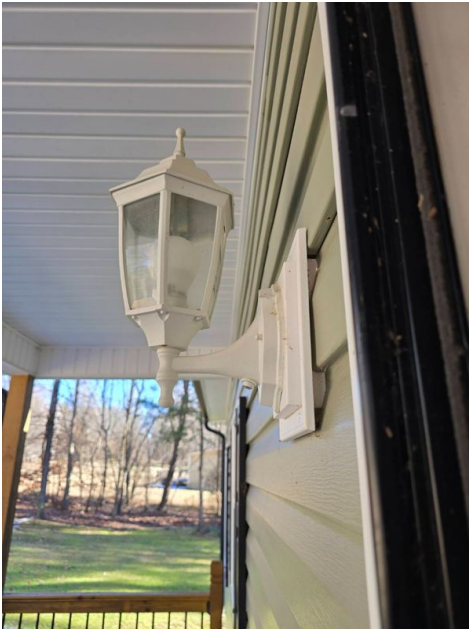
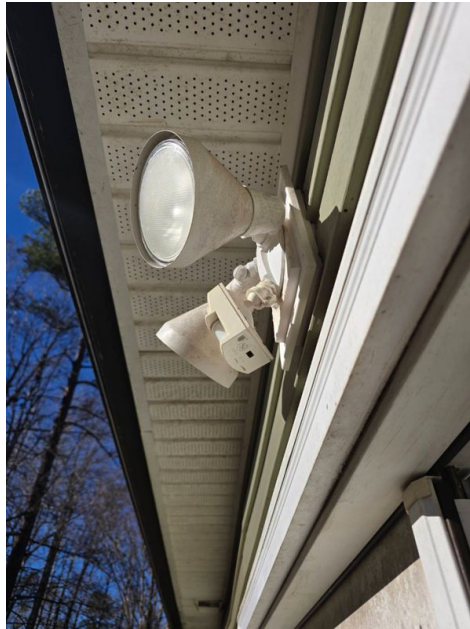
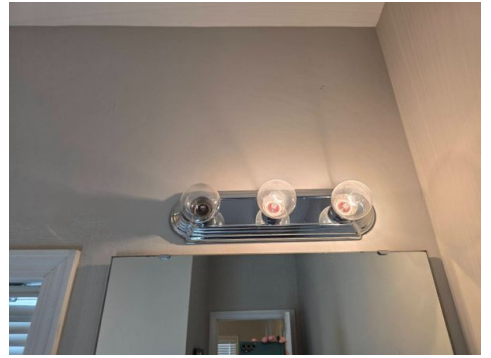
8.4.1 Lighting Fixtures, Switches & Receptacles

**LIGHT INOPERABLE**

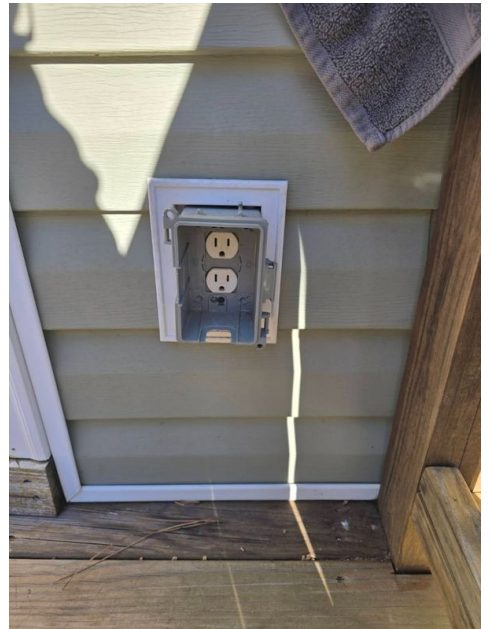
#### 8.4.2 Lighting Fixtures, Switches & Receptacles

The exterior receptacles of this home are not covered or protected to prevent electrical shock hazards if used in the rain or in damp conditions. The requirement for receptacles to have a protective cover to keep the receptacle and the cord connection of a device dry and protected was not in place in the era of this home, however, is an important safety feature that should be added if exterior receptacles are to be used regularly. A licensed electrical contractor should be consulted to repair as needed to ensure safe and reliable service.

Contact a qualified professional.

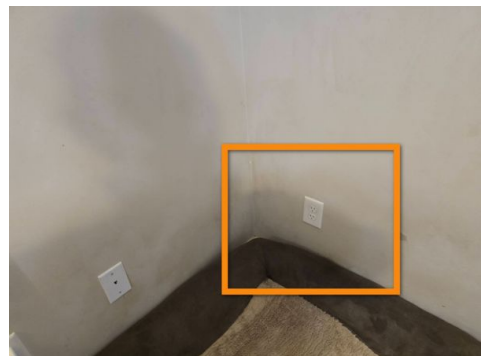
#### 8.4.3 Lighting Fixtures, Switches & Receptacles

### LOOSE RECEPTACLES

Receptacles were loose. Loose receptacles could result in electrical shock hazard or property damage. A licensed electrical contractor should be consulted to determine the significance of this concern and make necessary repairs to correct defects and prevent safety hazards.

Contact a qualified electrical contractor.

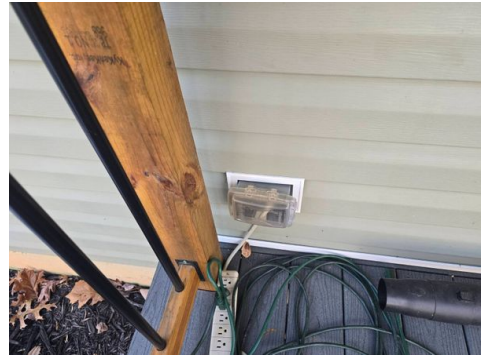
## 8.4.4 Lighting Fixtures, Switches &amp; Receptacles

**RECEPTACLE BOX: LOOSE**

During the home inspection, it was observed that the exterior electrical receptacle box is loose. This condition presents a potential safety hazard, increasing the risk of electrical shock or short circuits. It is recommended to have a qualified electrician assess the receptacle box and secure it properly to ensure safe operation and compliance with electrical codes.

Contact a qualified professional.

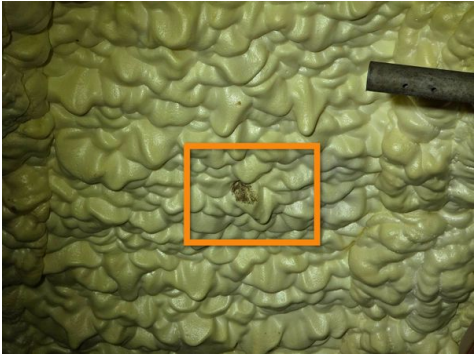
Attic showed areas of discoloration and possible mold growth. Recommend a mold lab analysis to prevent spread of potential mold and damage to home or health risk. I also recommend finding source of moisture or lack of ventilation in attic space.

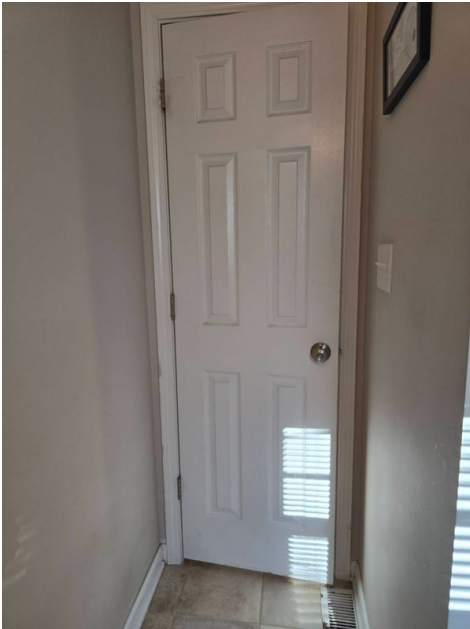
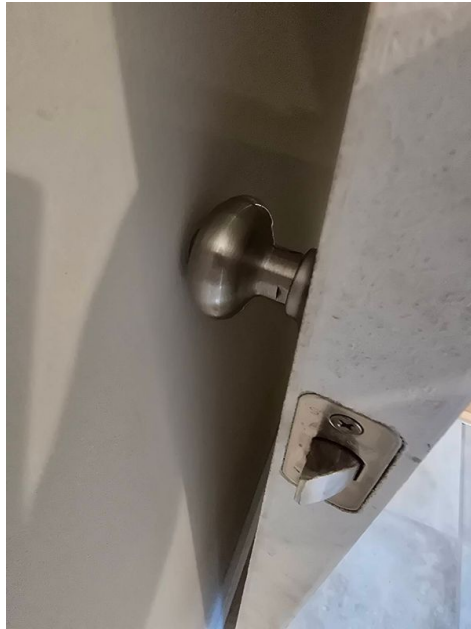
**MISSING DOORSTOP**

Doors are missing doorstops. Recommend installation to prevent wall damage.

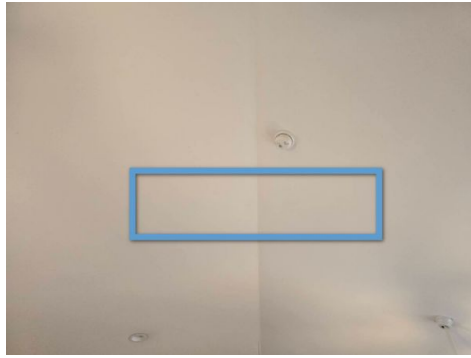
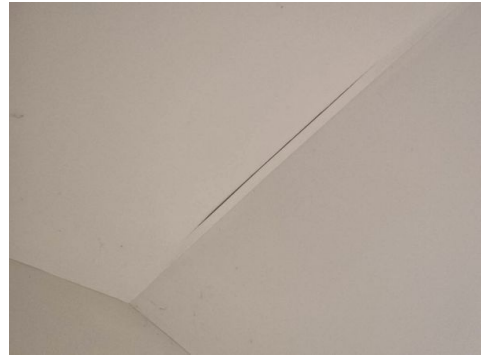
Drywall had holes/areas of damage

Taping at drywall seam split. Recommend qualified painter patch and paint to match.

Contact a qualified painting contractor.

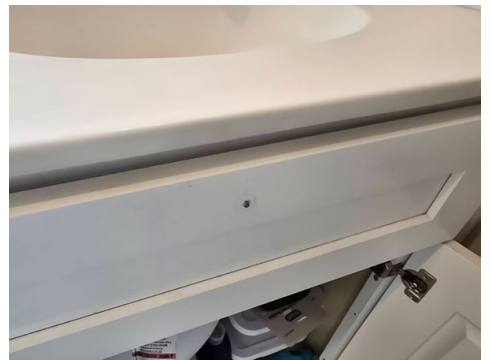
## 10.6.1 Countertops &amp; Cabinets

**CABINET HANDLE MISSING**

One or more cabinet handles were missing.
