## SUMMARY

2776 Jordan Ct, Creedmoor, NC 27522

Blue Harriss  
NC Licensed Home Inspector (license #  
2703)

Hilltop Home Inspections  
(919) 201-2387

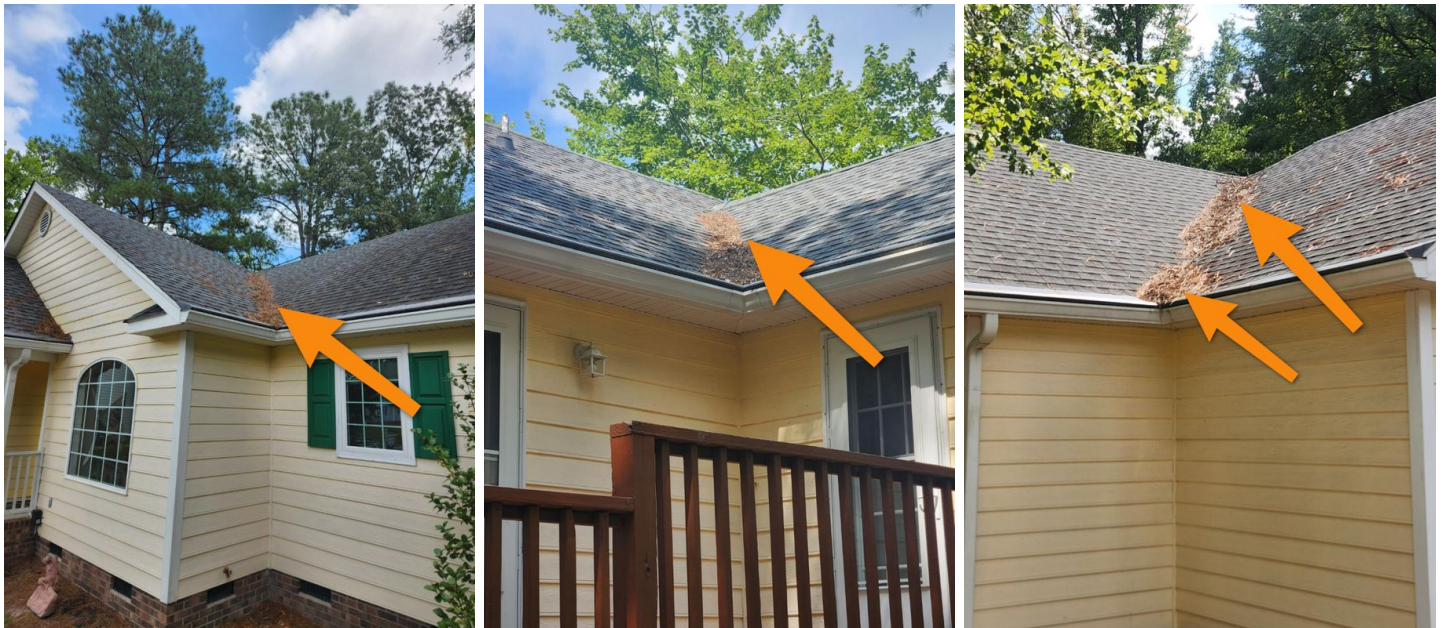
#### DEBRIS ON ROOF

Tree debris is accumulating on the roof. This can lead to water damming and eventually leaking. All debris should be removed seasonally to reduce the risk of leaks.

Contact a qualified professional.

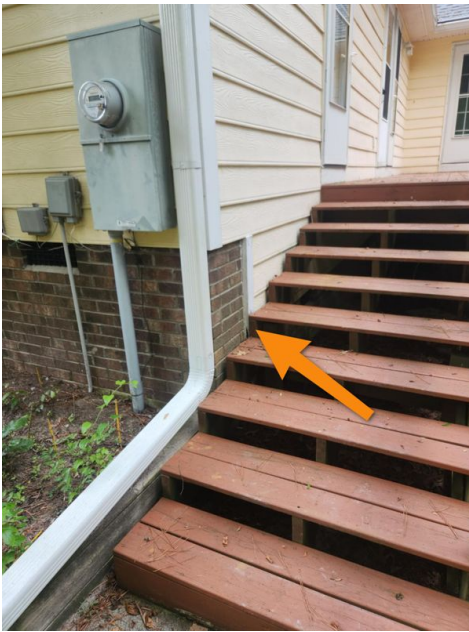
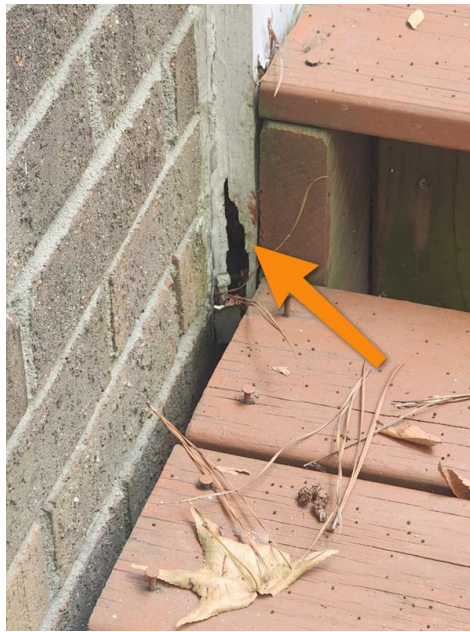
#### SOFT TRIM/SIDING

Several areas of trim or siding that are soft to the touch. This is due to long term moisture exposure. The areas should be repaired, caulked, and painted to prevent any future deterioration. Deteriorated siding could allow moisture intrusion which could damage the structure, interior surface or personal belongings.

Contact a qualified carpenter.

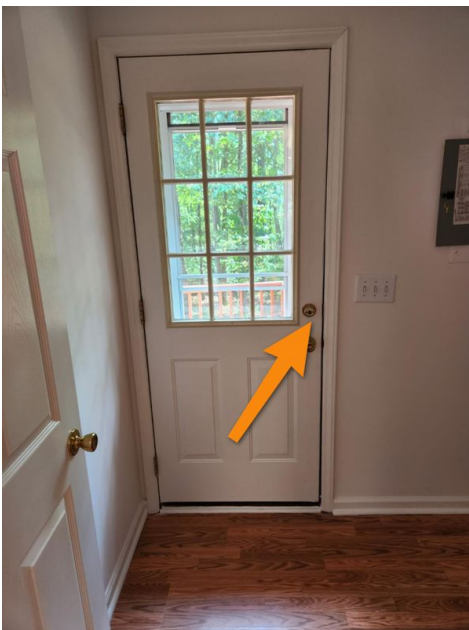
Laundry

The locking mechanism on the door is operated from the inside with a key. This should be operable with an easily accessible handle. This is important in case of an emergent need to escape the premises. A competent handyman or Locksmith should be able to install an proper deadbolt.

Recommendation  
Contact a handyman or DIY project

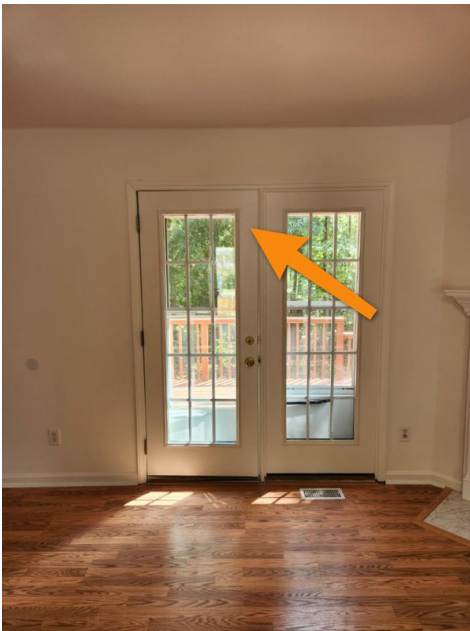
Back Porch

The door is binding at the edges. Over time this may make it difficult to operate and may cause damage to the door or door jam. The door should be adjusted to ensure proper operation.

Recommendation  
Contact a qualified professional.

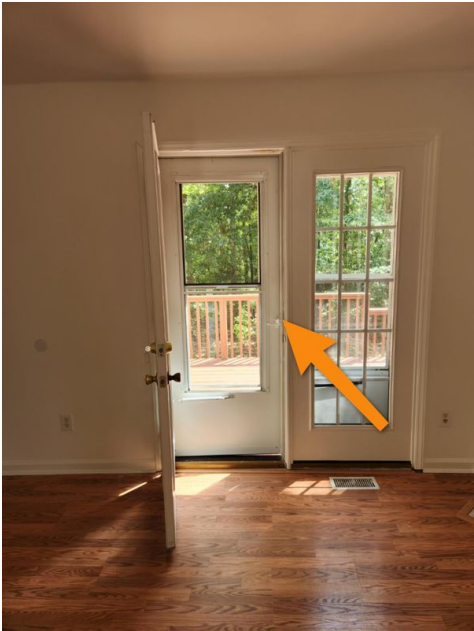
**SELF CLOSING DOOR NOT LATCHING**

The door is equipped with a damper making it a self closing door. The door should fully close and latch without assistance. Currently the door closer does not fully close and latch the door. The door should be adjusted so it fully closes on it's own.

Recommendation  
Contact a qualified professional.

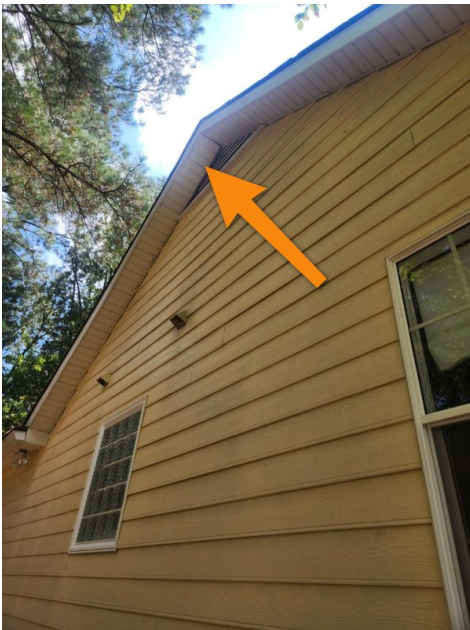
#### **OPENING**

There is opening in soffit which should be repaired. This can allow water or pest intrusion in to the attic area and wall cavity. Moisture and pest intrusion could lead to damage to the home's systems and finished surfaces. The opening should be repaired so no pests or moisture can enter.

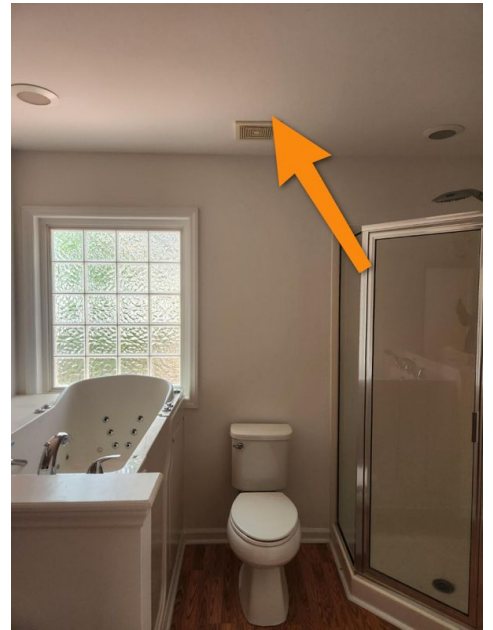
Primary Bathroom

The bathroom ventilation fan is unusually noisy. This could be due to a problem with the motor or housing. The fan should operate in a reasonable quiet fashion. The unit should be repaired or replaced to return to lower sound levels.

Recommendation  
Contact a qualified handyman.

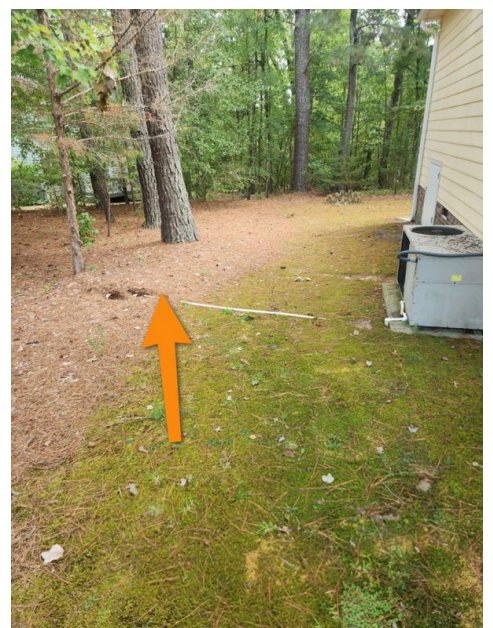
#### 7.1.2 Cooling Equipment **BURIED CONDENSATE LINE**

The condensate line is buried. This prevents the system from properly draining which could lead to premature failure of the unit and may cause the unit to shut down due to a perceived blockage. The pipe should be free and clear of all covering including the discharge opening.

Recommendation  
Contact a qualified professional.

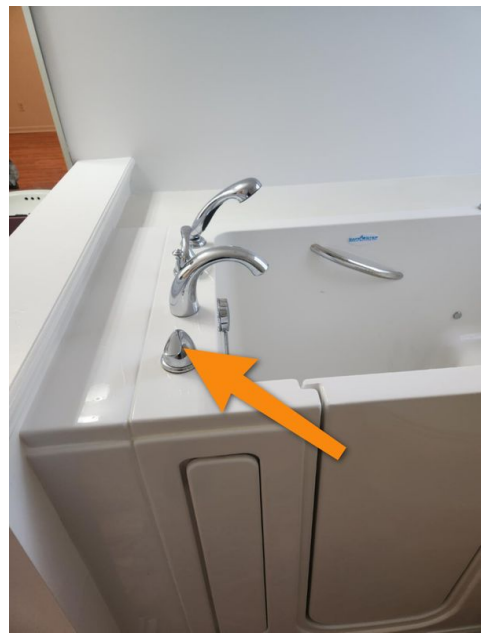
## HANDLE LOOSE

The handle is loose. Over time the handle may disconnect or strip the mechanism which may make the fixture inoperable. The handle should be secured so it is firmly affixed.

Contact a qualified plumbing contractor.

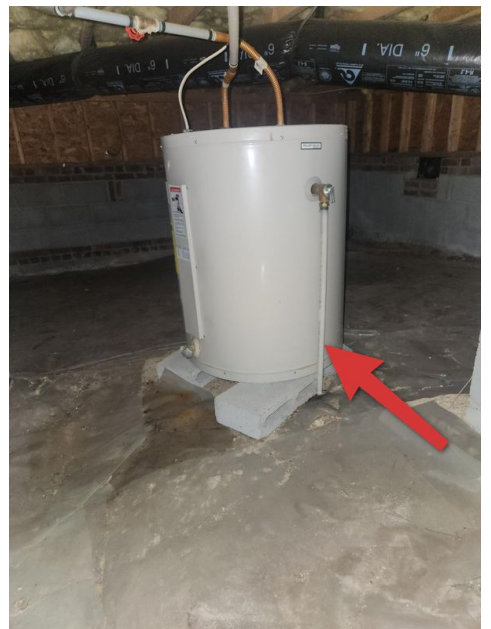
##### TPRV DISCHARGE PIPE NOT SECURE

Safety Hazard

The temperature and pressure relief valve is a safety device that will release extremely hot water under pressure from the vessel in the event of a mechanical failure. This device discharges through a pipe to 6" above the floor in order to keep super heated water from contacting a persons face or chest. The pipe that is installed should be secured to the water heater to prevent it from moving during a discharge event.

Contact a qualified plumbing contractor.

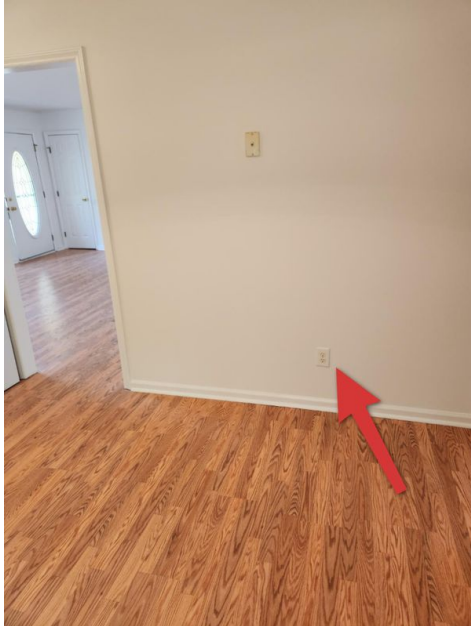
Dining Room

Several outlets are loose and have excessive movement when plugging in or removing a power cord. This may cause the wiring to become loose creating a short circuit. This can be a shock or fire hazard. All outlets should be secure so there is no play when plugging or unplugging a device.

Recommendation  
Contact a qualified electrical contractor.

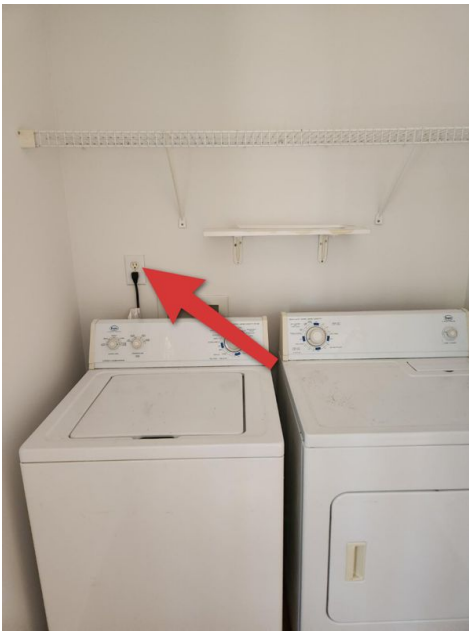
Laundry

Safety Hazard

No GFCI protection was present. GFCI protection is necessary in wet areas to prevent shock or electrocution. I recommend installing proper ground fault protection in all wet areas for safety. This includes kitchen, bathroom, garage, and exterior outlets.

Recommendation  
Contact a qualified electrical contractor.
