1. Structural Components

Styles & Materials

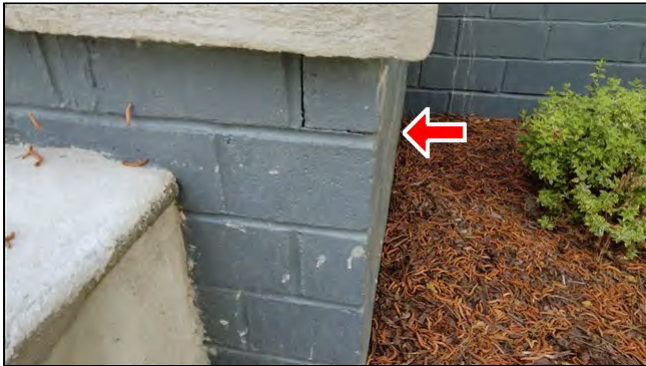
- 1.0 Foundations, Basement and Crawl space (Report signs of abnormal or harmful water penetration into the building or signs of abnormal or harmful condensation on building components.)
- Comments: Repair or Replace
- (1) The painted block foundation has cracks noted in various areas under 1/4" wide. Cracks under 1/4" wide with no visible displacement are considered common cracking by the engineering department of North Carolina. These cracks need to have the gaps sealed and evaluated on a regular basis for further movement or damage and needs general repairs by a qualified mason to seal all areas.

1.0 Item 1(Picture) Common cracks in the mortar joints

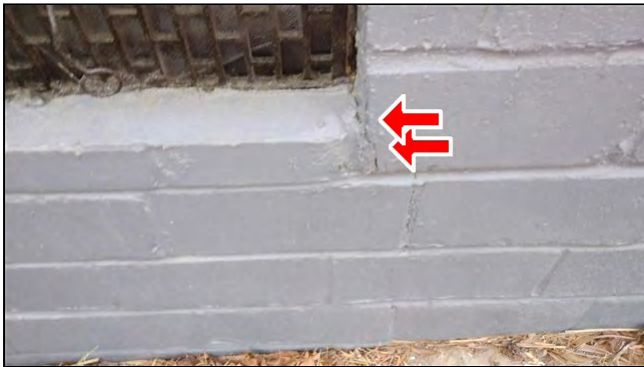
1.0 Item 3(Picture) Common cracks noted in the foundation at the foundation vents

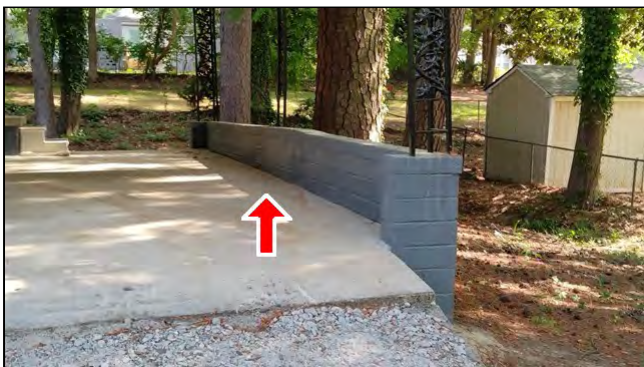
(2) The foundation walls at the carport area of the home has cracks noted that may have structural implications with through brick cracks, long cracks, and needs to be reviewed and repaired under the guidance of a licensed structural engineer or a licensed general contractor specializing in foundation structural repairs. A clear structural letter and warranty should be received from the company performing the work.

1.0 Item 4(Picture) Up heaving in the carport foundation wall

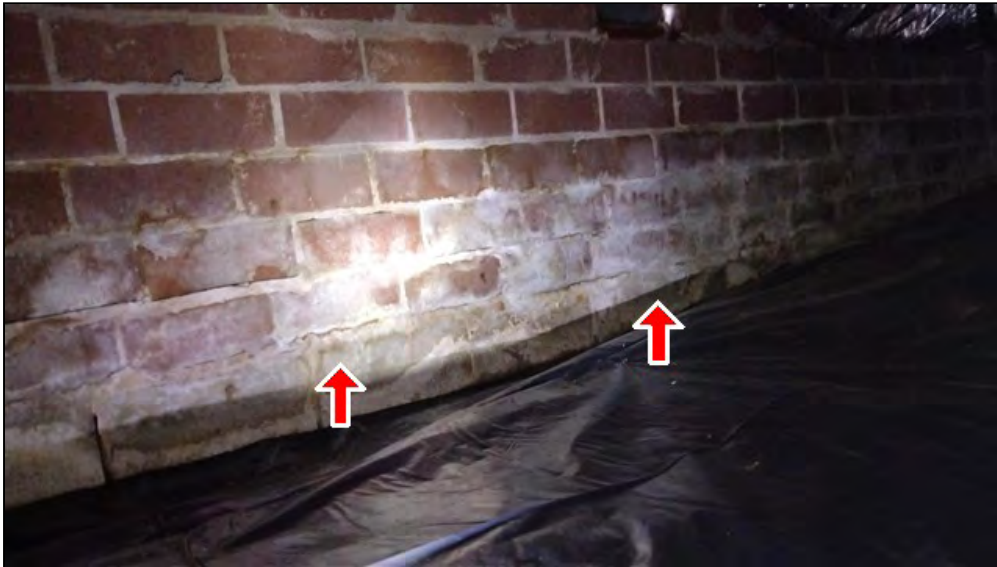
1.0 Item 9(Picture) Whited efflorescence on the foundation walls in the crawlspace

(3) This home has white efflorescence (powder substance) on the block wall which indicates moisture is in contact with the masonry. This does not necessarily indicate that intrusion will occur. It is recommend checking the gutters and the downspout drain lines for proper operation. Also, a water proofing paint could be applied to the interior side of the block if necessary. Efflorescence is found on many homes without water intrusion occurring inside the home. However, it should alert you to the possibility that future steps may be needed.

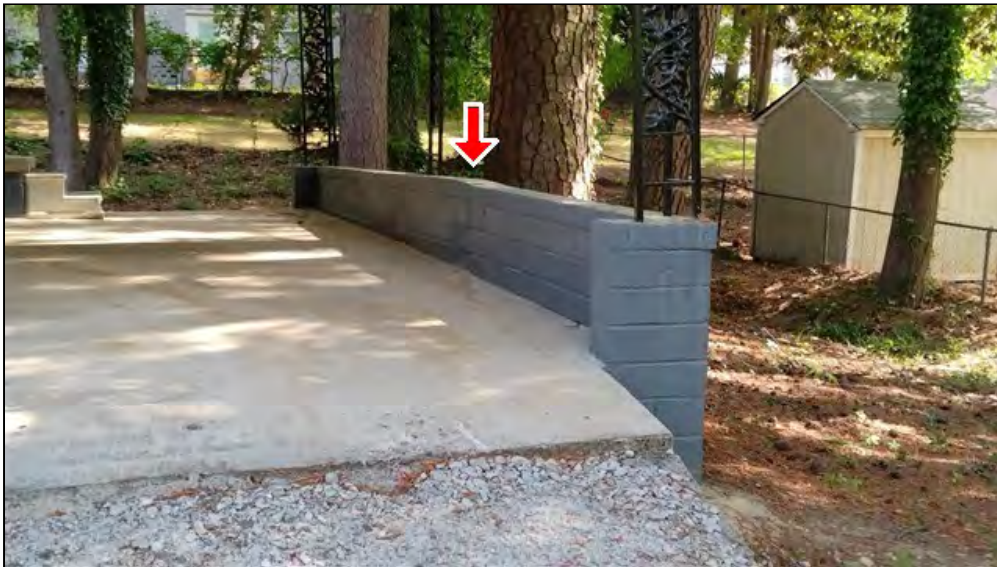
1.0 Item 10(Picture) Heaving foundation wall

(4) The carport foundation is leaning, and the metal piers are bowing out and this is a structural concern, and this wall and piers need evaluation with all repairs performed by a licensed general contractor or engineer to offer proper support. A list of repairs with a letter of warranty should be received on all repairs

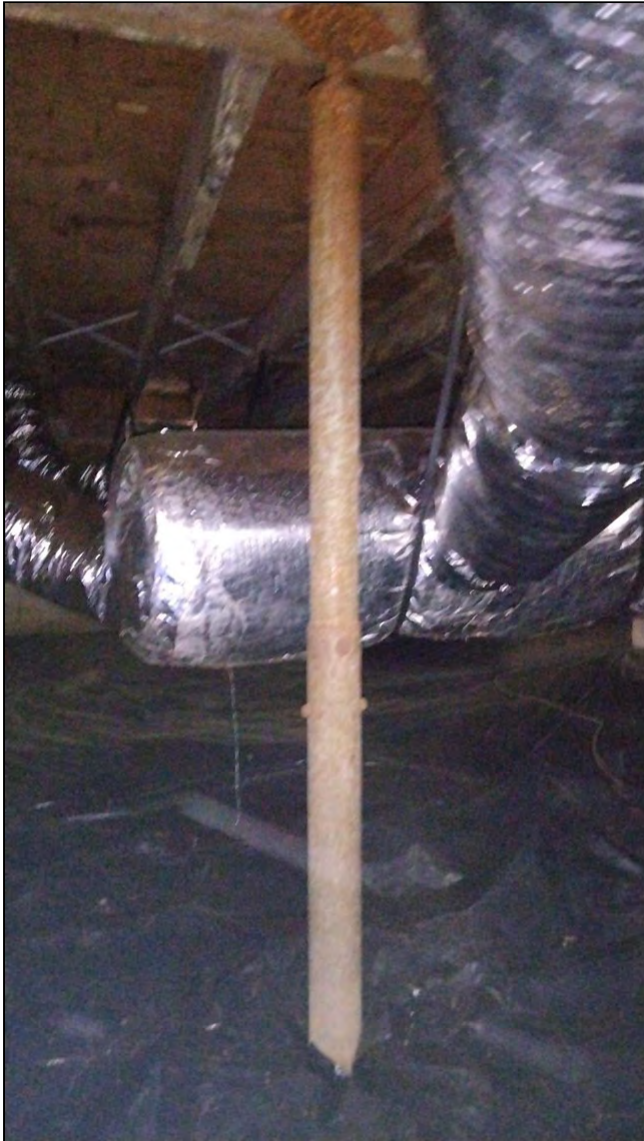
1.1 Item 1(Picture) Metal stand pier with no or improper footers

The metal jack stands used for primary / secondary support do not utilize the proper sized concrete footers and needs functional footers in place. The jacks are not allowed for primary support and have no functional footers / supports in place and needs to be made functional by a licensed general contractor.

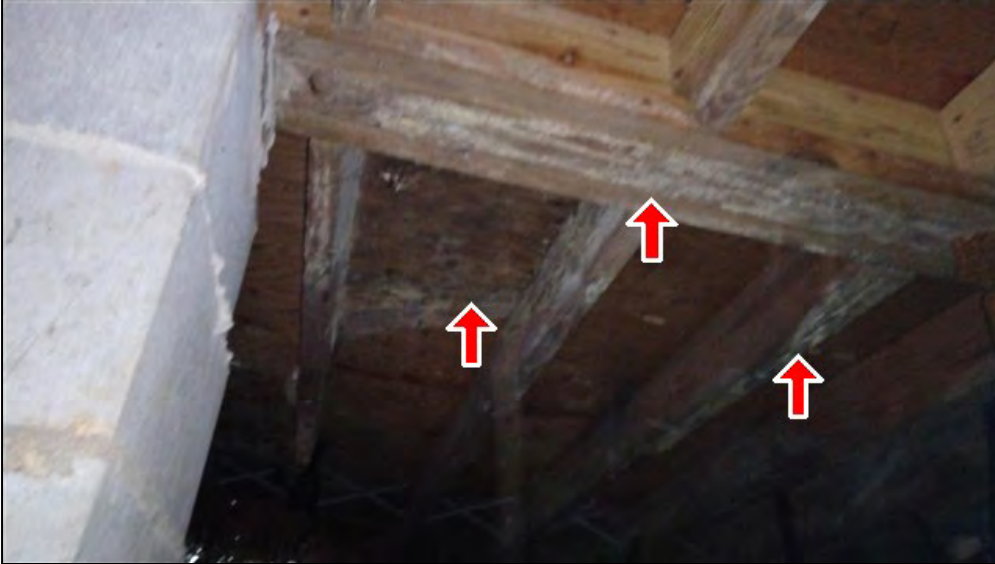
1.2 Item 1(Picture) The floor framing has fungal growth with some deterioration noted

(1) The floor framing in the crawlspace has deterioration and fungus growth from radiant moisture and this can be a health concern and this crawlspace and floor framing needs to be evaluated and probed for concealed damage with proper repairs performed by a licensed general contractor and all areas made functional and safe.

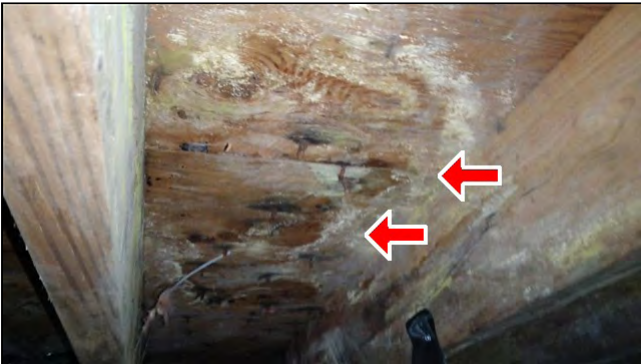
1.2 Item 2(Picture) Fungal growth noted

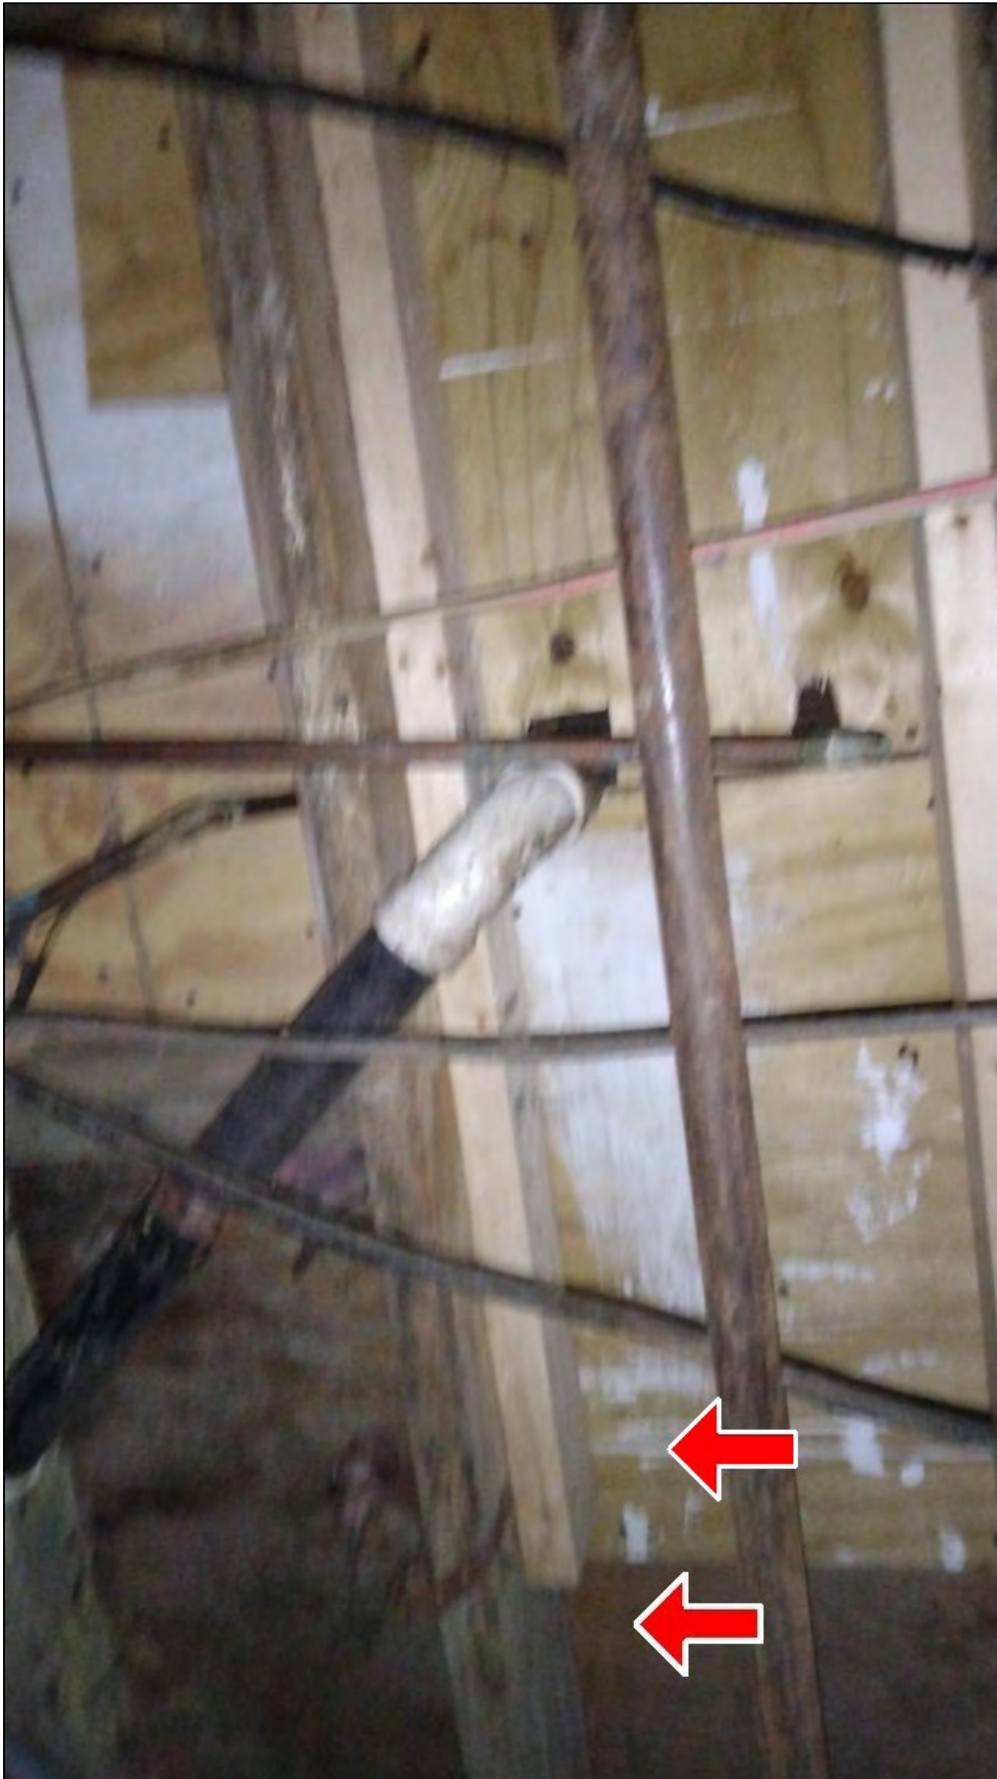
1.2 Item 10(Picture) The new floor joist is nailed to the deteriorated joist and is not supported to the ends

(2) Repairs have been made in the crawlspace under the bathroom and these repairs were not done using proper building techniques (floor joists are not supported to the ends) This can cause uneven floors and possible failure. These repairs need to be reviewed by a licensed general contractor and all areas make functional

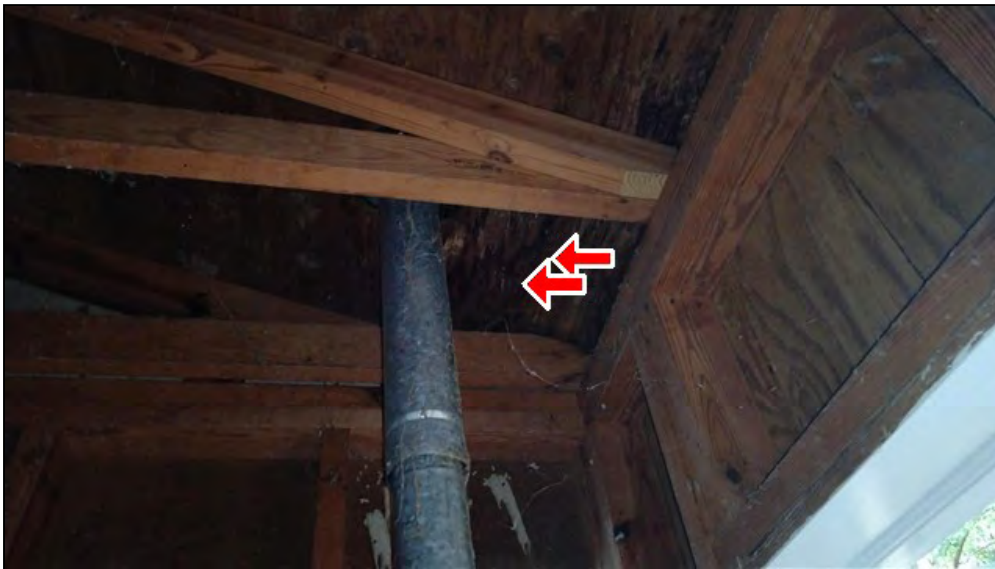
1.8 Item 1(Picture) Deteriorated sheathing noted in the storage room

The roof sheathing in the rear exterior storage room has deterioration noted from active / past roof leakage and these areas of the roof sheathing needs proper repairs / replacement by a licensed general contractor and made functional.

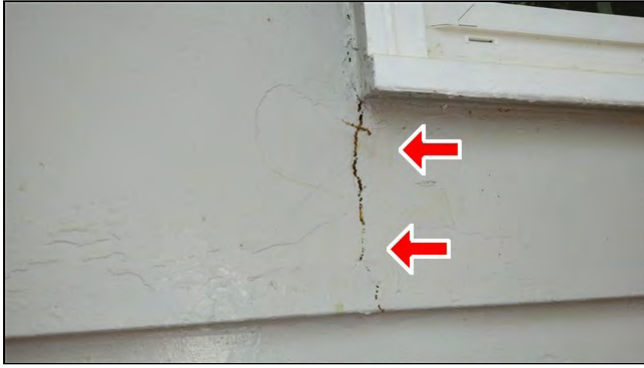
2.0 Item 3(Picture) Damaged siding noted

(2) The hard board siding has damage and deterioration noted in multiple areas around the home. The framing in affected areas need to be checked for obvious and / or concealed damage and all necessary repairs performed by a licensed general contractor.

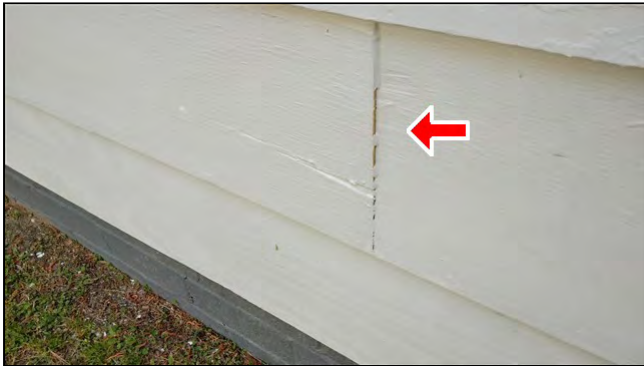
(3) The hard board siding / veneer at the side of the home is loose and can be pulled loose and can allow moisture/ water penetration and further damage/deterioration in these areas. This siding should be repaired/replaced by a qualified siding contractor with all areas checked for concealed damage and all areas made functional.

2.0 Item 4(Picture) Loose siding. Moves to the touch

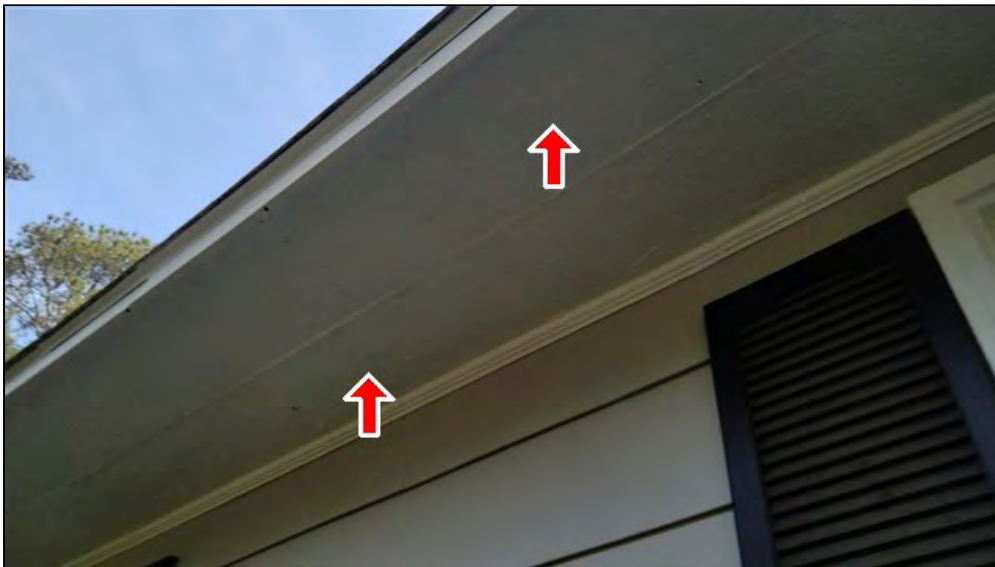
2.1 Item 1(Picture) Soffits are not a exterior grade material

(1) The soffits on the exterior of the home are not an exterior grade material. This material can be damaged by moisture and this soffit should be replaced and made functional by a licensed general contractor.

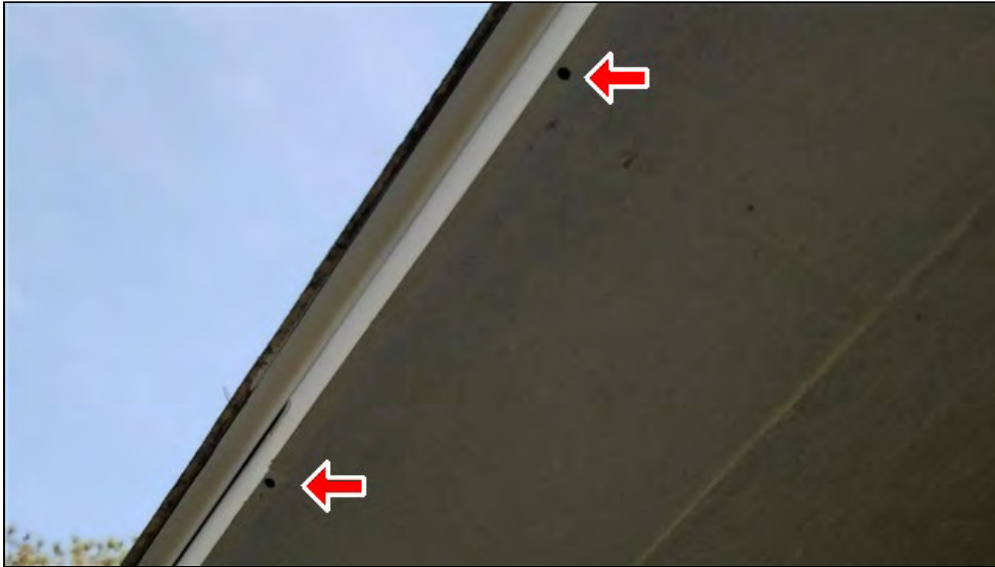
2.1 Item 2(Picture) Insect damage noted to the fascia boards

(2) The front fascia trim board has damage noted from animals (Possible Woodpecker) or insects (Possible Bees) and this board needs proper repairs to prevent water seepage or damage. These areas need to have the animals or insects stopped and made functional by a qualified contractor.

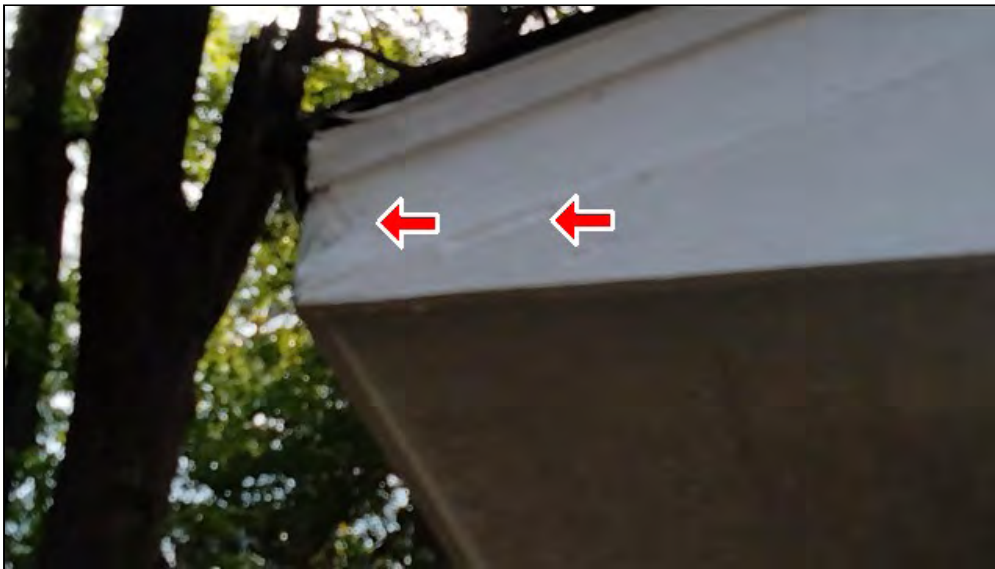
2.1 Item 3(Picture) Deterioration / damage noted

(3) The fascia / rake boards at the front right corner of the home have damage / deterioration noted. This area needs to be probed for concealed damage with the fascia boards repaired or replaced and all areas made functional by a licensed general contractor.

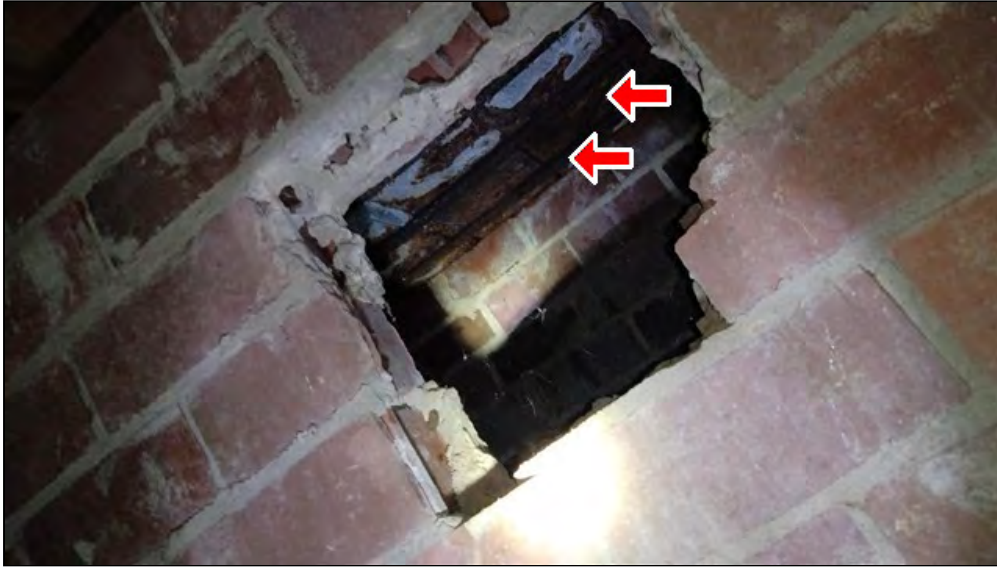
2.5 Item 1(Picture) Heavy rust damage to the front porch support metal

The metal under the front porch slab has heavy rust damage noted and this condition can cause settlement and damage to the front porch

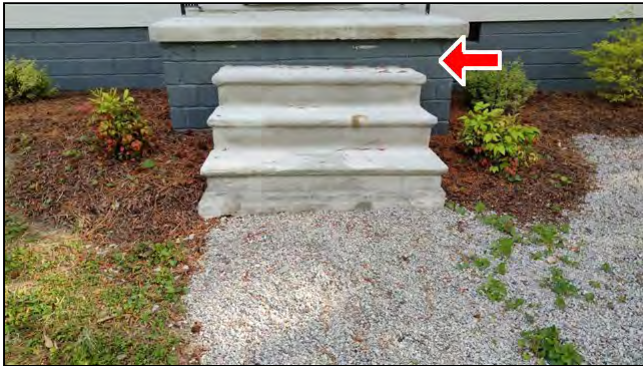
The front steps have settled in areas and / or has pulled loose away from the porch, and are leaning and is a tripping or safety concern and these steps are in need of proper repairs and made functional by a licensed general contractor to prevent further damage.

2.6 Item 1(Picture) The front steps have settled

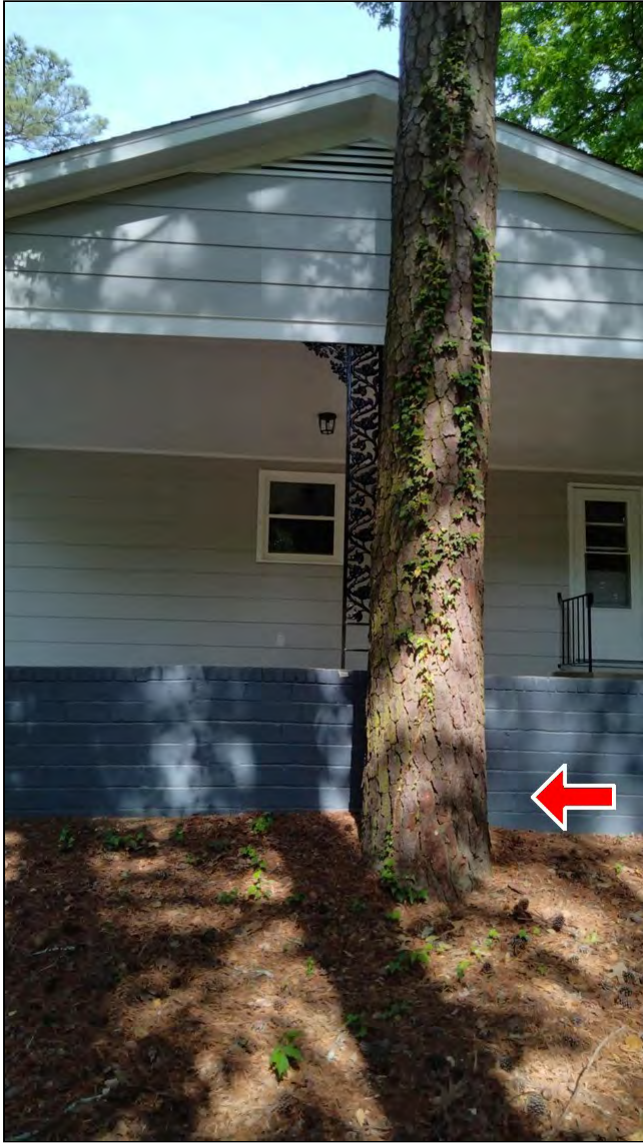
2.8 Item 1(Picture) A very large pine tree is growing against the foundation and the tree roots are causing damaged to the foundation

A large pine tree is growing against the foundation of the home and is causing damage and this tree should be evaluated for removal and all areas made functional by a qualified landscape contractor.

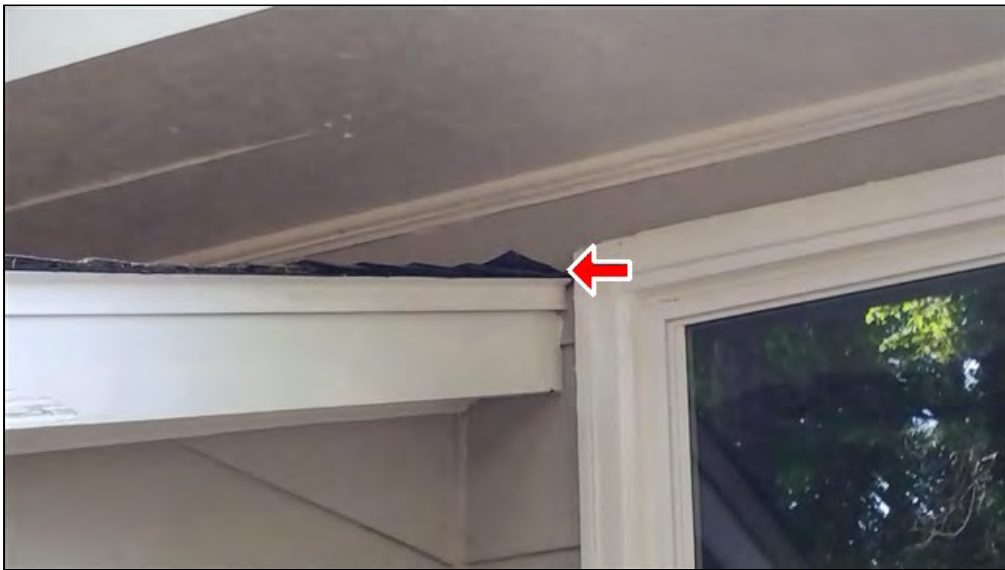
3.0 Item 1(Picture) Lifter shingle over the flashing on he rear storage room

The shingles installed over the flashing at the dormer over the garage and at the front of the house are loose and needs to be re-aligned and re-secured by a roofing professional and made functional.

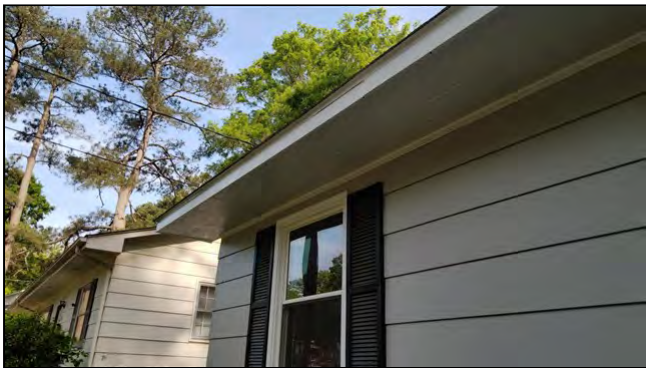
3.1 Item 1(Picture) No gutters are on the home

No gutters are in place on the structure and is not a required component but is highly recommended for proper drainage of the roof and to direct water away from the structure and foundation and areas below the house.

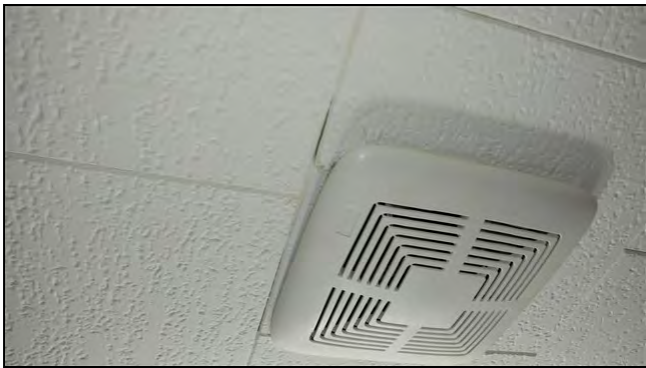
4.0 Item 1(Picture) Damaged ceiling tile

**Comments:** Repair or Replace  
A damage ceiling tile was noted at the bathroom vent and this damage can get worse with time and this ceiling should be repaired or replaced and made functional by a qualified contractor.

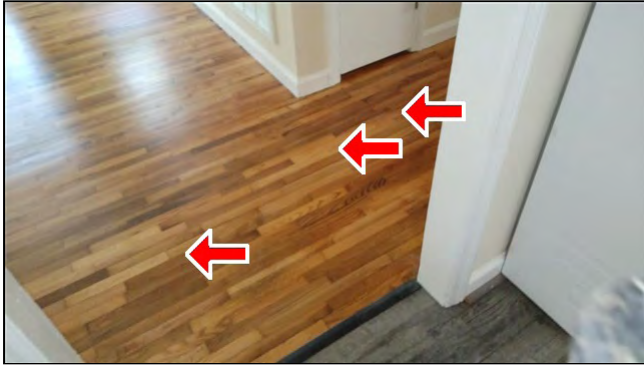
4.2 Item 1(Picture) Raised area in the flooring

The hall floor has a raised area in the flooring noted. This can be from settlement, a missing pier shim, or the floor framing not being properly supported in this area and all accessible areas of the floor structure were functional.

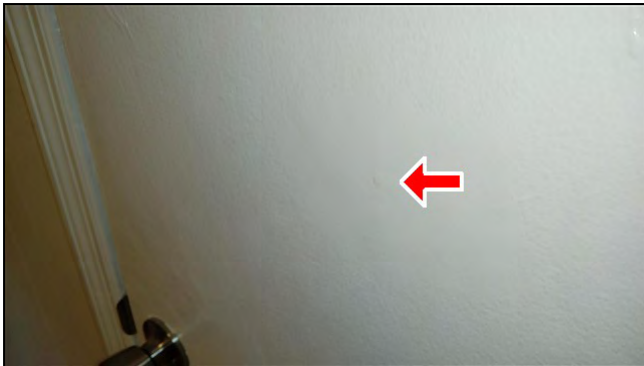
(1) The interior doors in the home have holes noted that have improper repairs and these doors need to be repaired or replaced and made functional by a qualified contractor.

4.4 Item 1(Picture) Holes with improper repairs noted

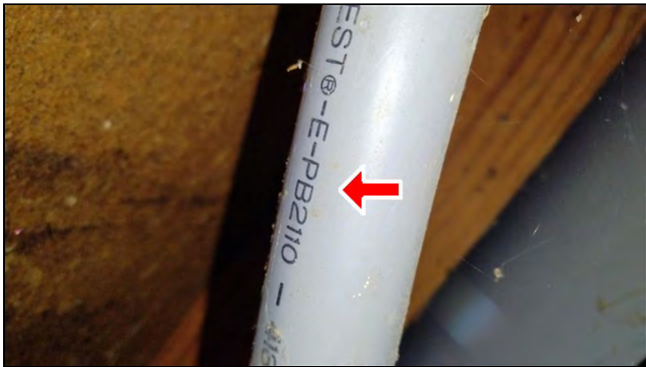
5.1 Item 1(Picture) Polybutylene Piping noted in the home

Polybutylene Pipe. Recommended language for Polybutylene piping(PB): Polybutylene plumbing supply line (PB) are installed in this house as the main water and distribution supply line. PB was used as water distribution piping in many homes built from the mid 1980's until the mid 1990's. The piping and associated fittings have had a failure rate and subsequent leakage sufficient to have been the subject of several nationwide class action lawsuits. Copper and brass fittings used in later years seem to have reduced the failure rate, but the piping may still fail due to problems with poor installation, improper handling, or chemical reaction with the water supply. The main entry piping in this house has copper fittings. You may wish to have the plumbing system evaluated by a licensed plumbing contractor. Standards of Practice/ Rules / Interpretations Committee of the North Carolina Home Inspection Licensure Board.

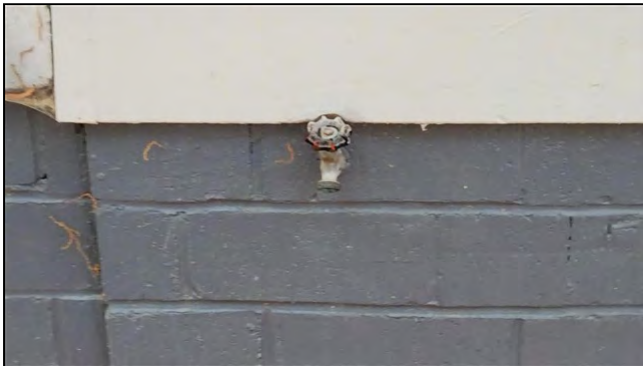
The hose faucet at the rear of the home is loose and needs to be properly secured. This can cause further damage to this unit, can allow leakage, and needs proper repairs by a licensed plumber and made functional.

5.2 Item 1(Picture) Loose hose bib noted

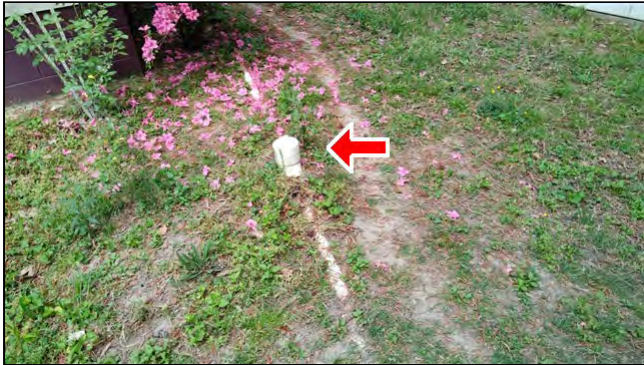
(1) The plumbing cleanouts in the side yard have not been trimmed to grade level and can allow these units to be damaged with lawn equipment. These cleanouts should be cut to grade level by a licensed plumber and made functional.

5.6 Item 1(Picture) Plumbing cleanout not trimmed

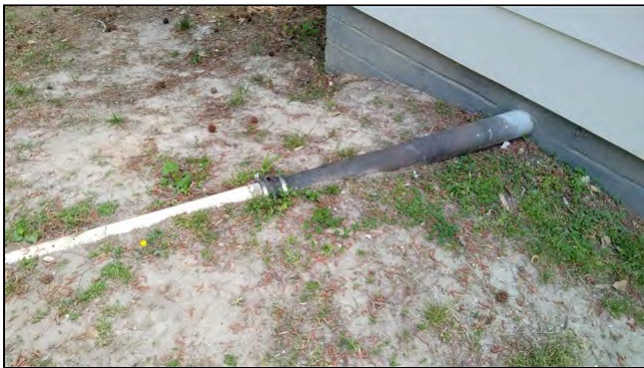
(2) The waster line where it leaves the home is exposed and can be damaged with lawn equipment and this line should be evaluated and made functional by a licensed plumbing contractor.

5.6 Item 2(Picture) Plumbing waste line is exposed in the yard

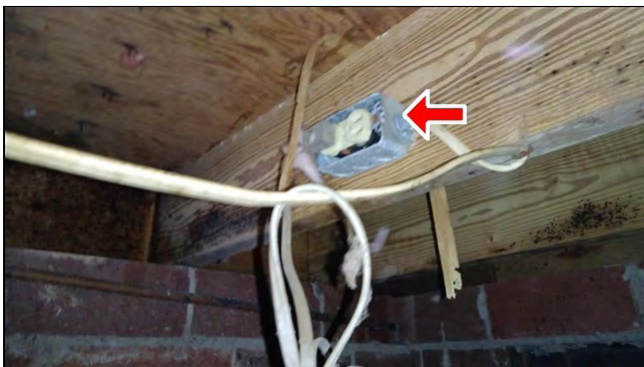
The existing sump pump uses an extension cord and should have its own GFCI outlet. All sump pumps should have its own GFCI and not be run on an extension cord. These electrical issues are considered a hazard until repaired. It is recommend a qualified licensed electrical contractor evaluated and make necessary repairs with all areas made functional.

5.7 Item 1(Picture) Sump pump is not powered by a GFCI for protection

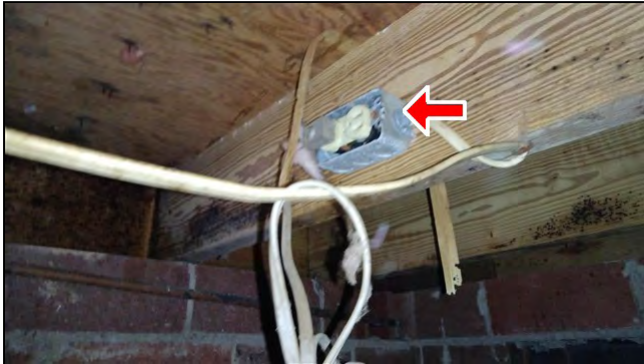
Wire splices were made inside junction / receptacle / or switch boxes at the sump pump but not limited to this area have no covers and leaves exposed wires in these areas. These areas are a safety concern and the splices need to be made in a junction box and / or made functional by a licensed electrician.

8.5 Item 1(Picture) Receptacle cover missing

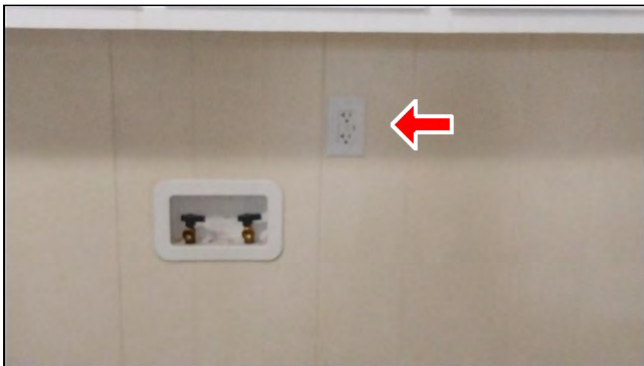
(1) The GFCI in the laundry room would not trip properly, is a safety and electrical concern and this receptacle needs repair or replacement by a licensed electrician and made functional.

8.8 Item 1(Picture) The GFCI at the laundry areas is not functional

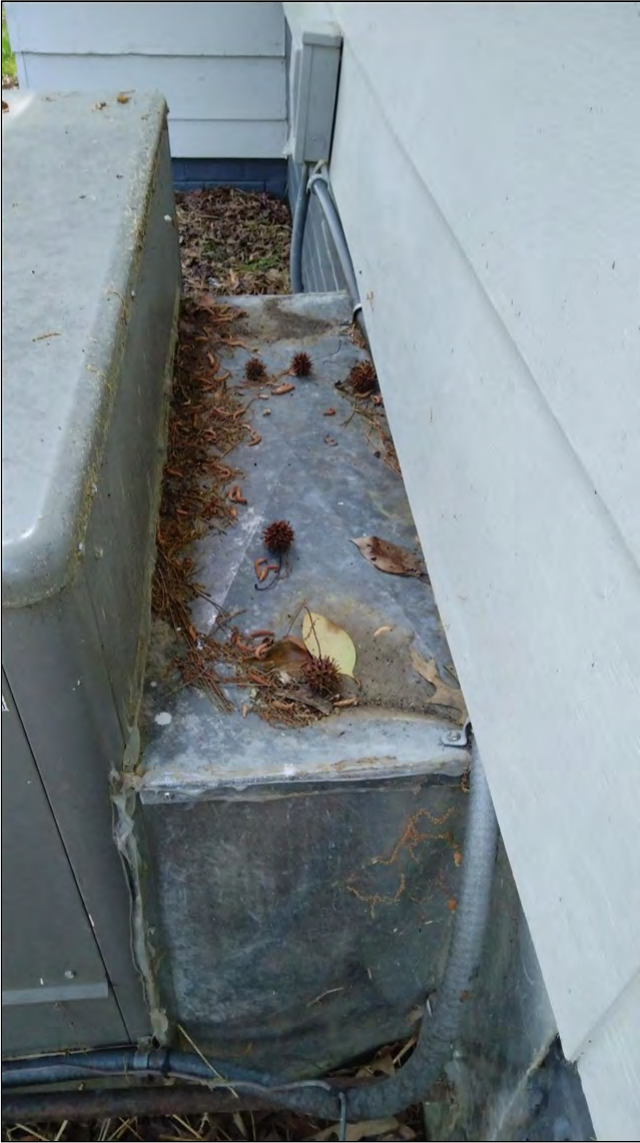
10.3 Item 1(Picture) Metal holding water and rusting

(1) The metal at the rear of the package unit is holding water and is rusting and this can damage the unit and this installation should be evaluated and made functional by a licensed HVAC contractor.

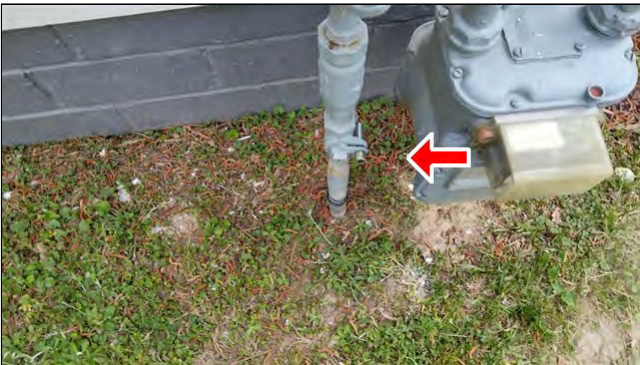
(2) The gas was off to the home and the gas heat and water heater could not be tested or inspected and no representations are made of these areas.

10.3 Item 2(Picture) The gas is off to the home

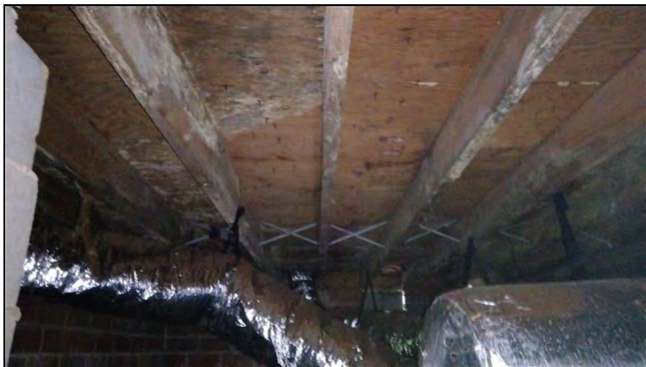
11.1 Item 1(Picture) Missing flooring insulation

Flooring insulation has been removed and there is no flooring insulation installed and this floor system needs insulation installed and all areas made functional by a qualified insulation contractor.

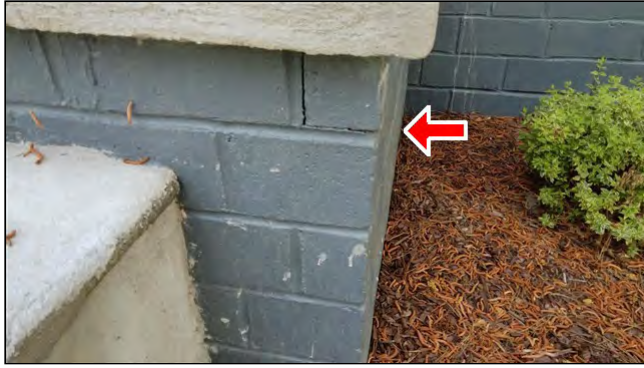
(1) The painted block foundation has cracks noted in various areas under 1/4" wide. Cracks under 1/4" wide with no visible displacement are considered common cracking by the engineering department of North Carolina. These cracks need to have the gaps sealed and evaluated on a regular basis for further movement or damage and needs general repairs by a qualified mason to seal all areas.

1.0 Item 1(Picture) Common cracks in the mortar joints

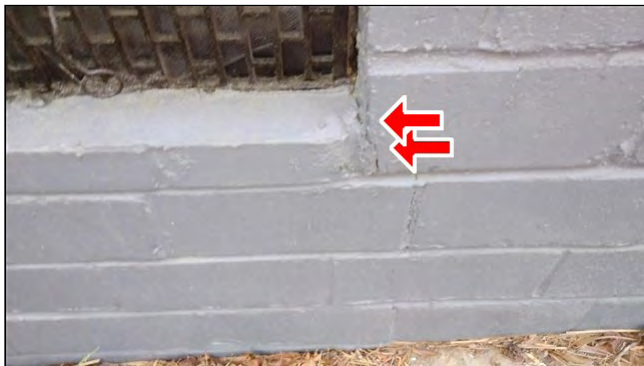
1.0 Item 3(Picture) Common cracks noted in the foundation at the foundation vents

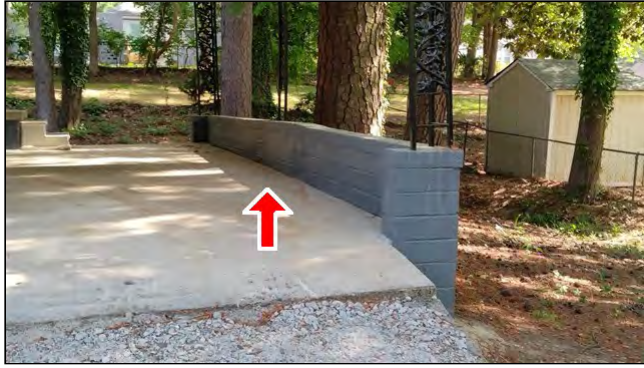
(2) The foundation walls at the carport area of the home has cracks noted that may have structural implications with through brick cracks, long cracks, and needs to be reviewed and repaired under the guidance of a licensed structural engineer or a licensed general contractor specializing in foundation structural repairs. A clear structural letter and warranty should be received from the company performing the work.

1.0 Item 4(Picture) Up heaving in the carport foundation wall

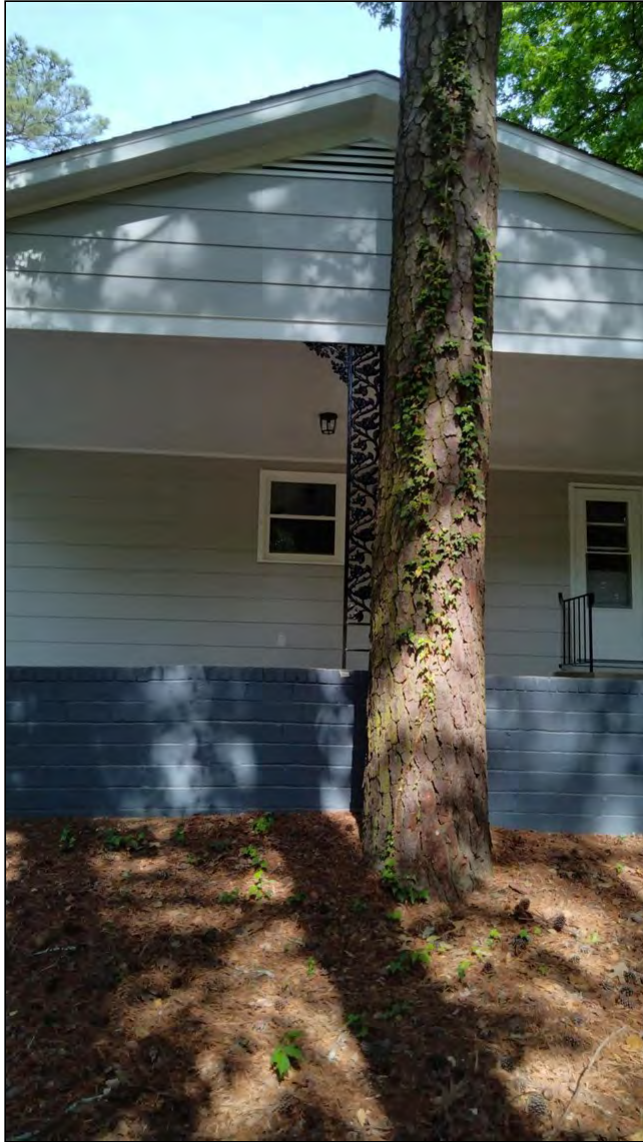
1.0 Item 6(Picture) A very large pine tree is growing against the foundation and the tree roots are causing damaged to the foundation

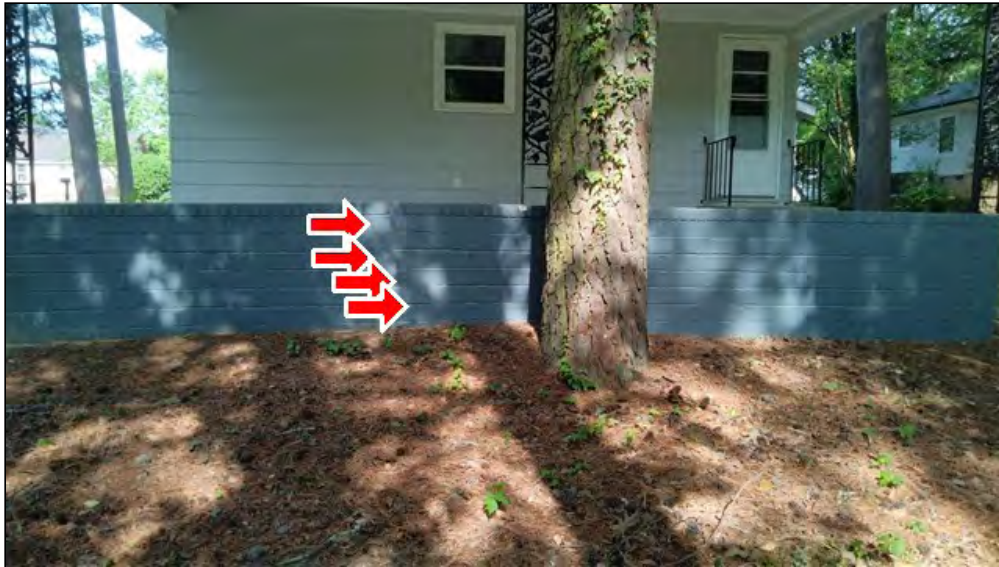
1.0 Item 7(Picture) Structural cracks in the carport foundation wall next to the large tree

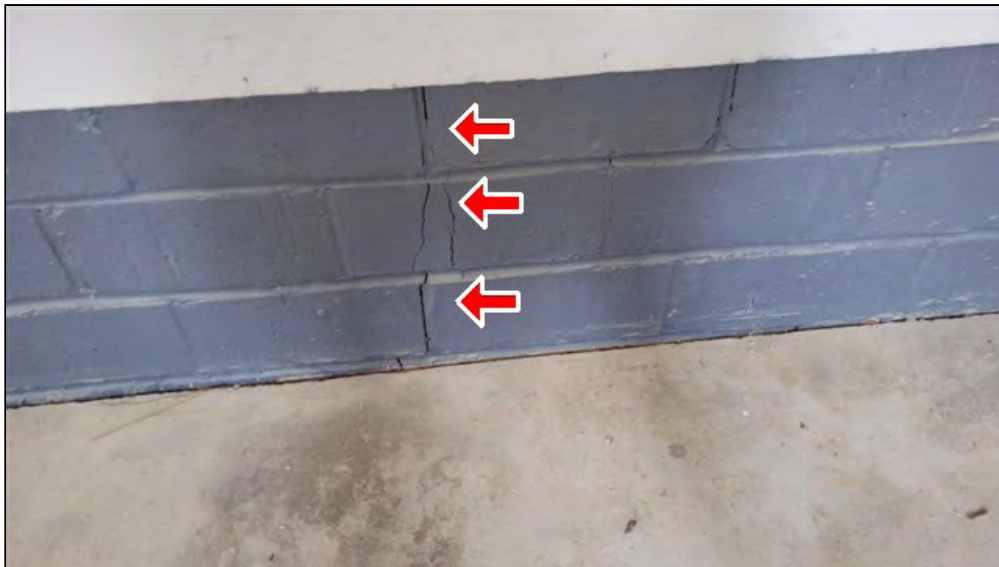
1.0 Item 8(Picture) Structural cracking noted in the homes foundation wall next to the carport concrete slab

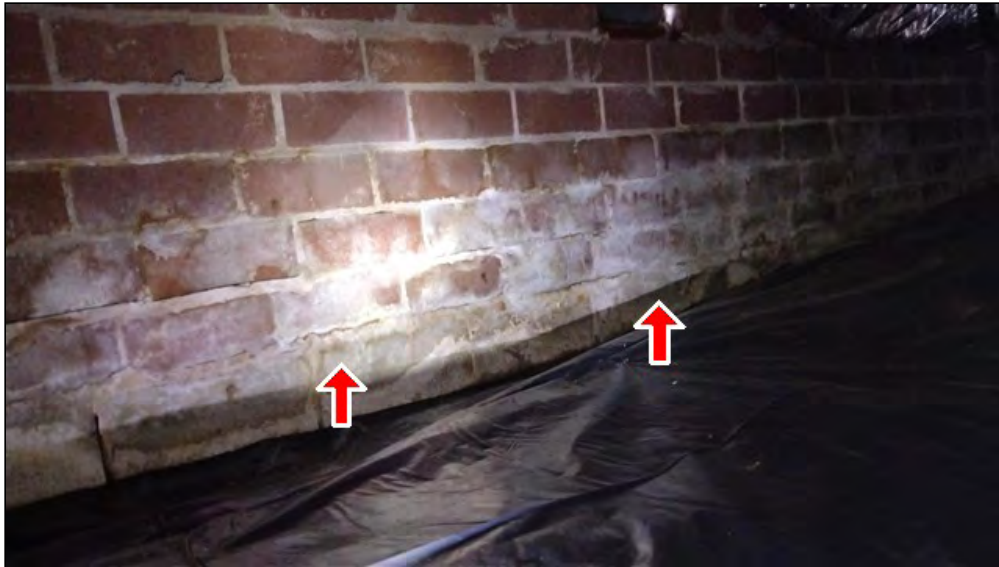
(3) This home has white efflorescence (powder substance) on the block wall which indicates moisture is in contact with the masonry. This does not necessarily indicate that intrusion will occur. It is recommend checking the gutters and the downspout drain lines for proper operation. Also, a water proofing paint could be applied to the interior side of the block if necessary. Efflorescence is found on many homes without water intrusion occurring inside the home. However, it should alert you to the possibility that future steps may be needed.

1.0 Item 9(Picture) Whited efflorescence on the foundation walls in the crawlspace

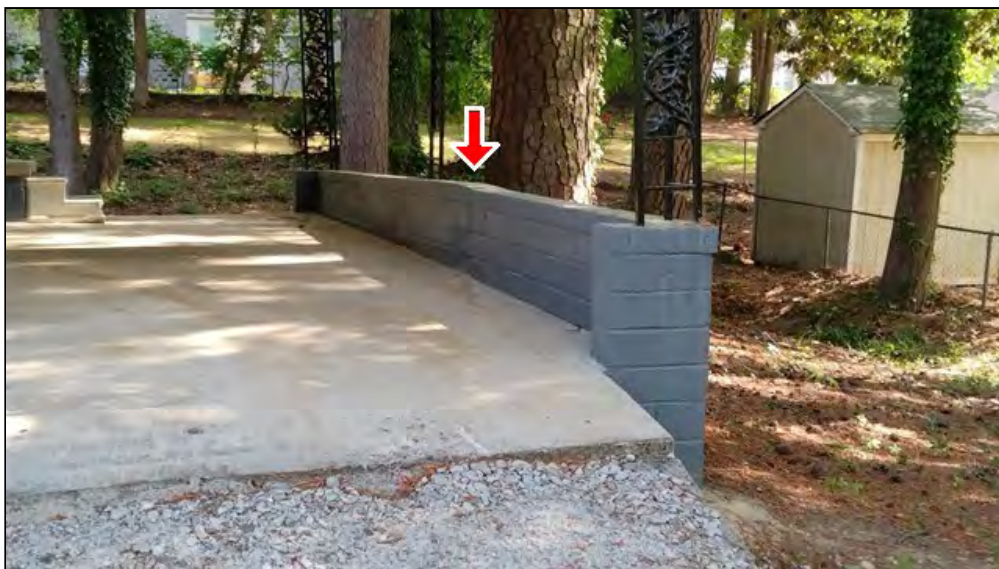
(4) The carport foundation is leaning, and the metal piers are bowing out and this is a structural concern, and this wall and piers need evaluation with all repairs performed by a licensed general contractor or engineer to offer proper support. A list of repairs with a letter of warranty should be received on all repairs

1.0 Item 10(Picture) Heaving foundation wall
