1. Structural Components

Styles & Materials

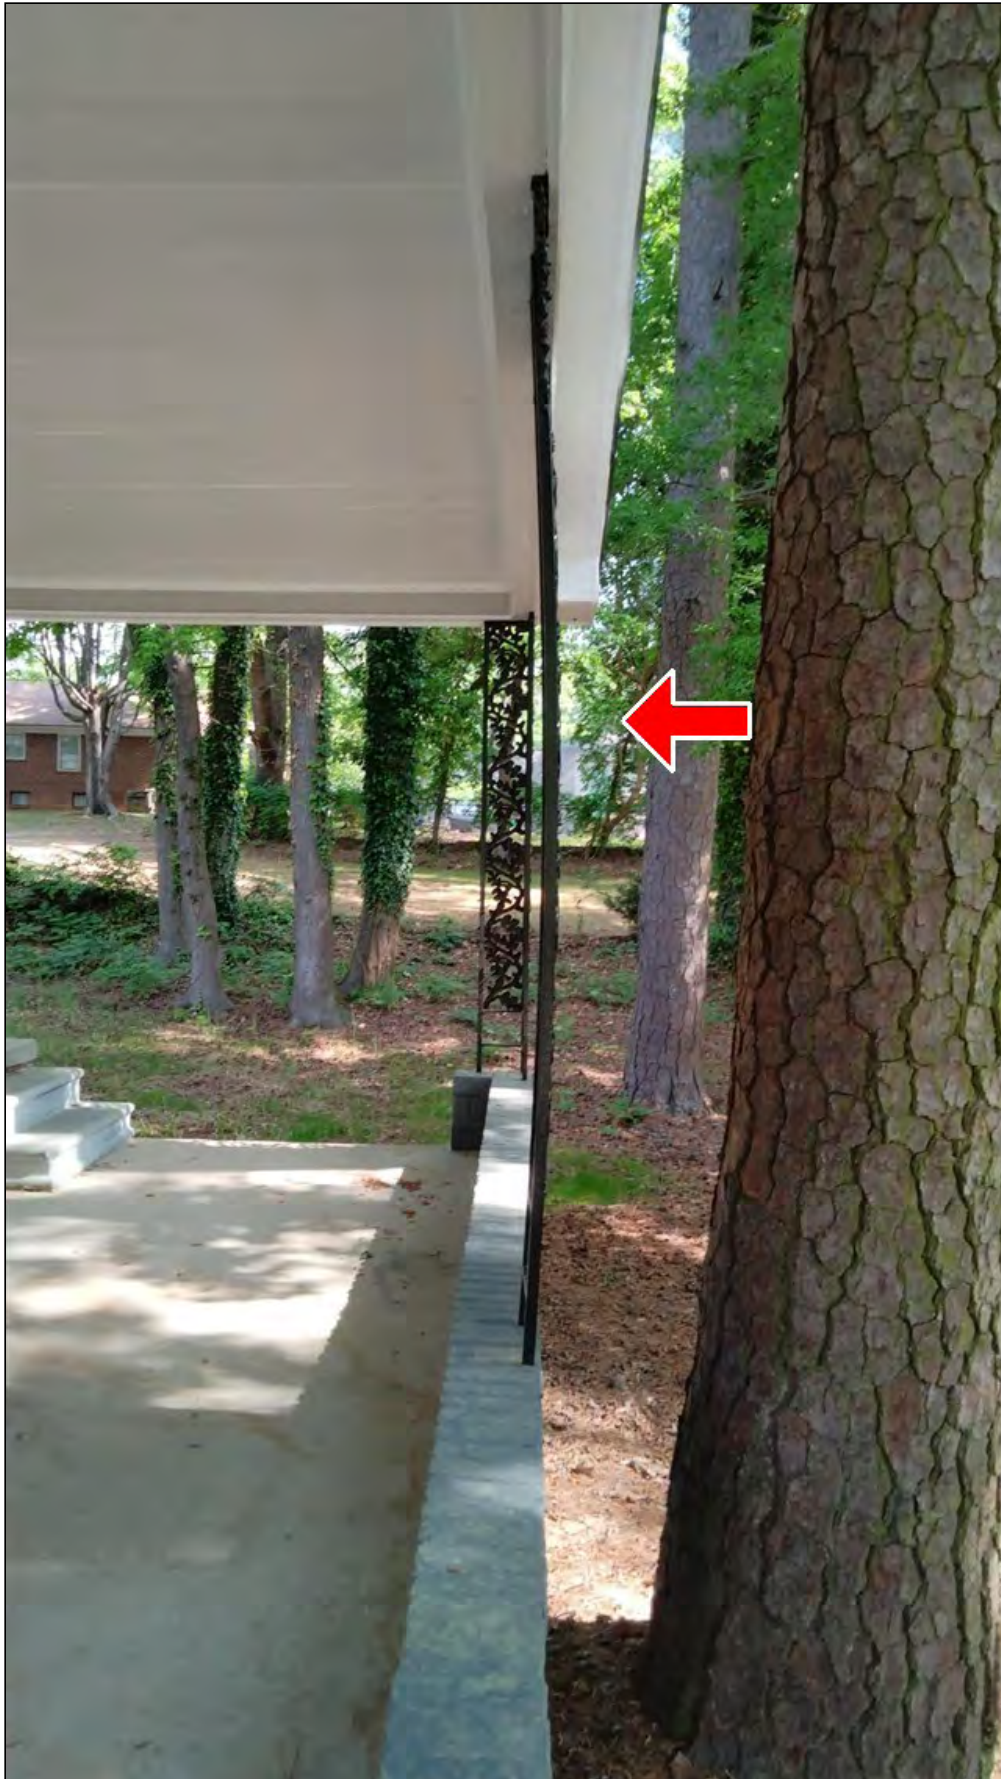
(4) The carport foundation is leaning, and the metal piers are bowing out and this is a structural concern, and this wall and piers need evaluation with all repairs performed by a licensed general contractor or engineer to offer proper support. A list of repairs with a letter of warranty should be received on all repairs

1.0 Item 11(Picture) Leaning and heaving carport foundation wall

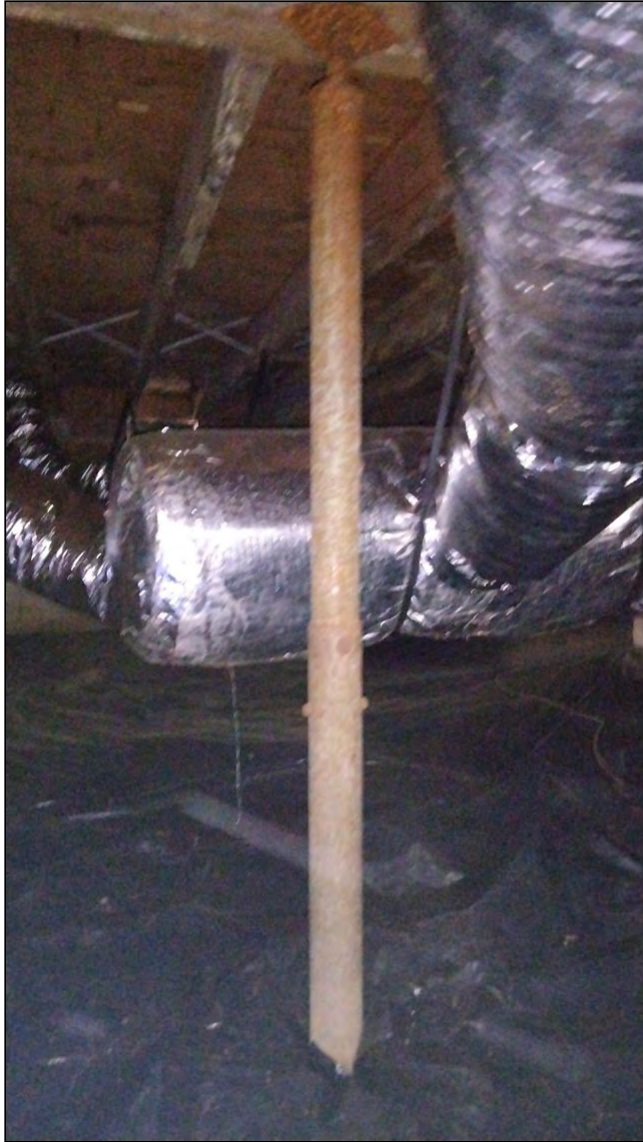
The metal jack stands used for primary / secondary support do not utilize the proper sized concrete footers and needs functional footers in place. The jacks are not allowed for primary support and have no functional footers / supports in place and needs to be made functional by a licensed general contractor.

1.1 Item 1(Picture) Metal stand pier with no or improper footers

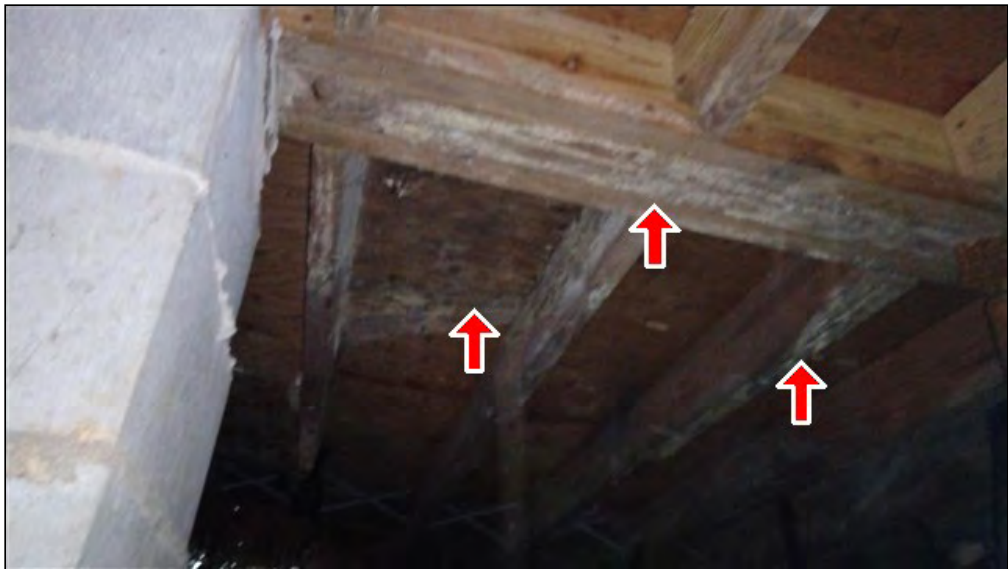
(1) The floor framing in the crawlspace has deterioration and fungus growth from radiant moisture and this can be a health concern and this crawlspace and floor framing needs to be evaluated and probed for concealed damage with proper repairs performed by a licensed general contractor and all areas made functional and safe.

1.2 Item 1(Picture) The floor framing has fungal growth with some deterioration noted

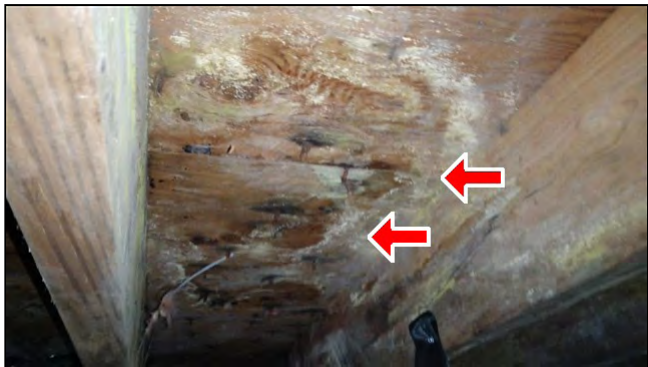
1.2 Item 2(Picture) Fungal growth noted

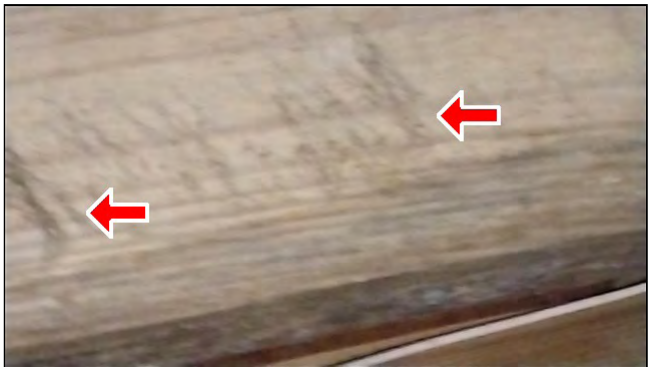
1.2 Item 3(Picture) Fungus growth on the floor joists

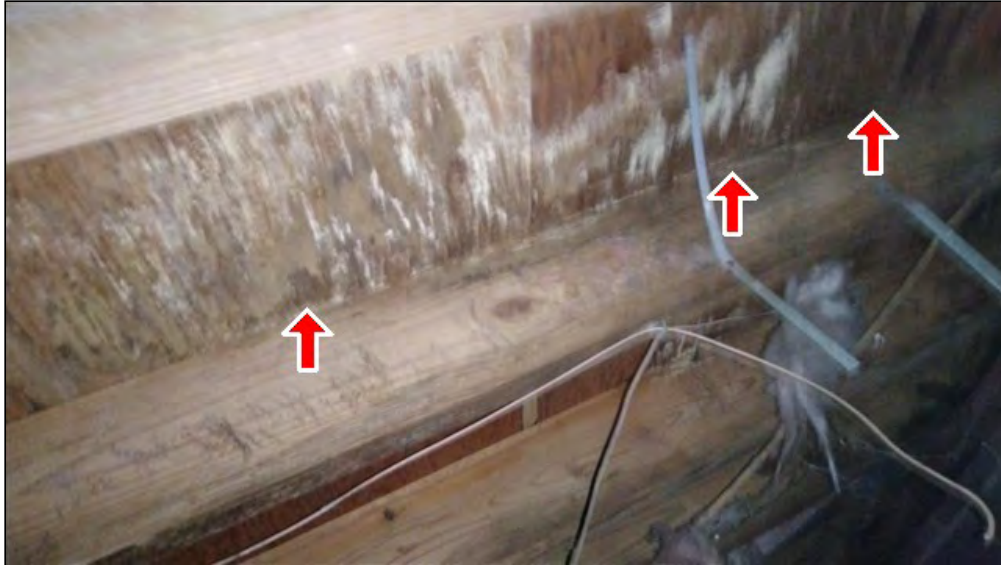
1.2 Item 4(Picture) Deteriorated floor sheathing and fungal growth

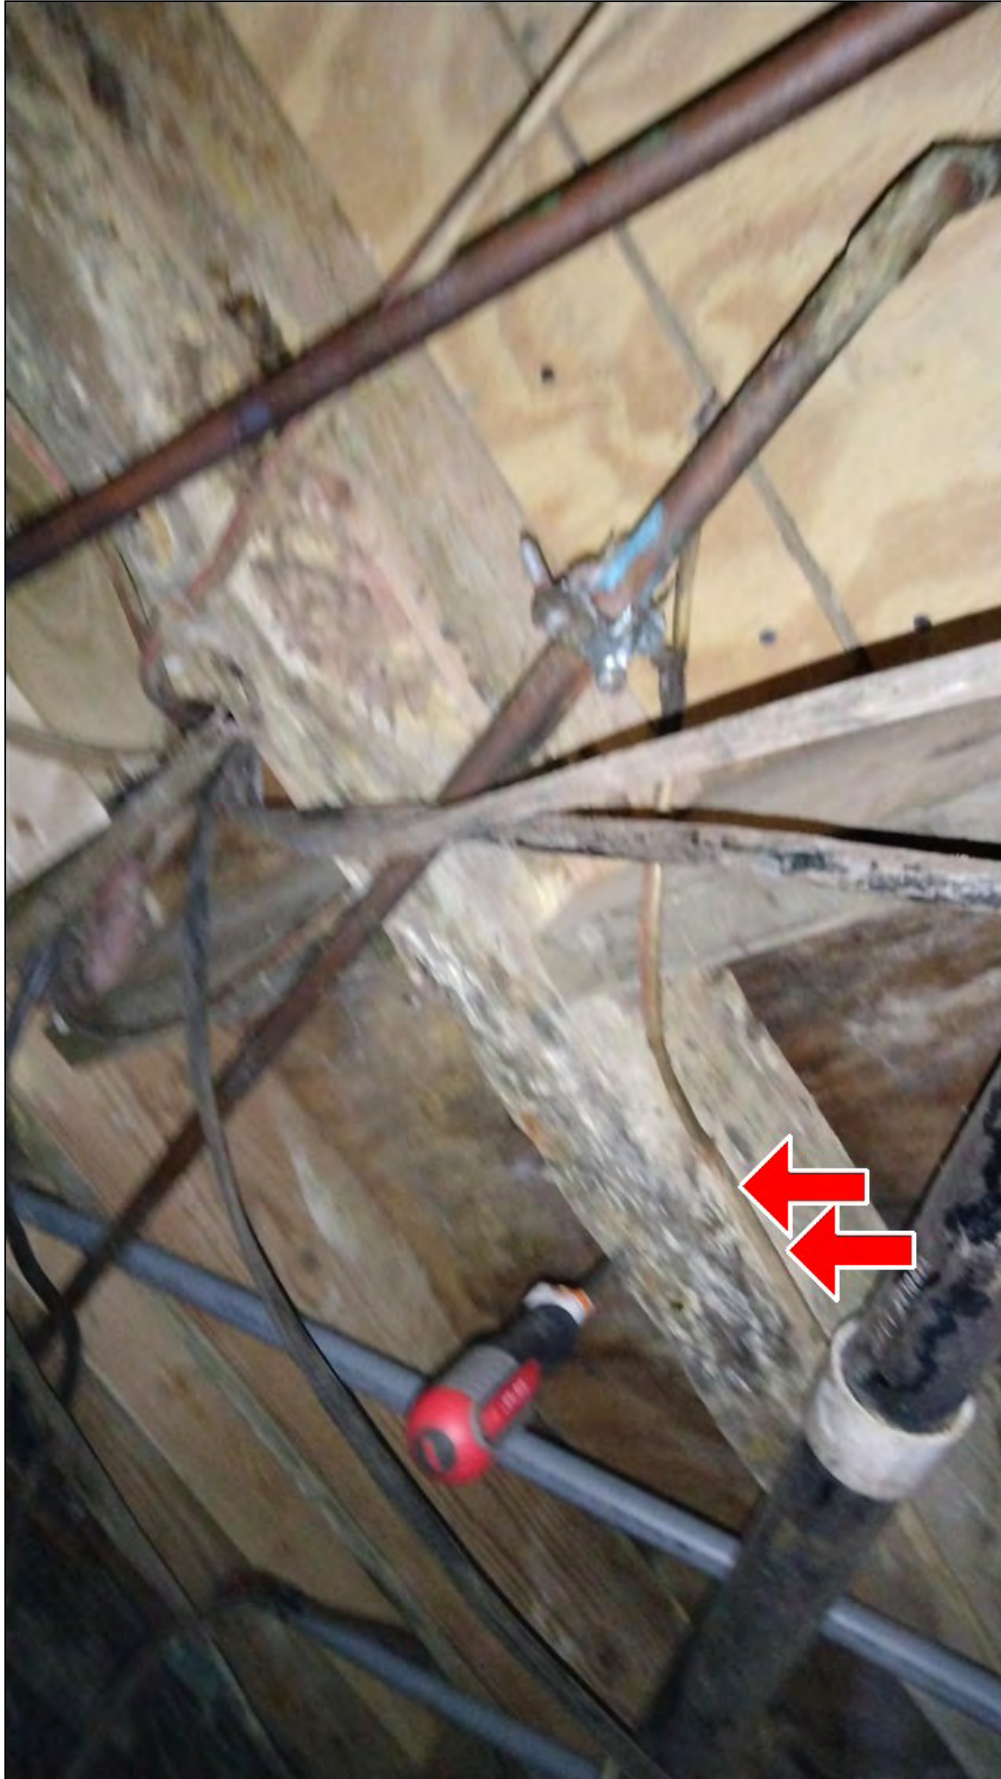
1.2 Item 5(Picture) Deteriorated floor joist noted

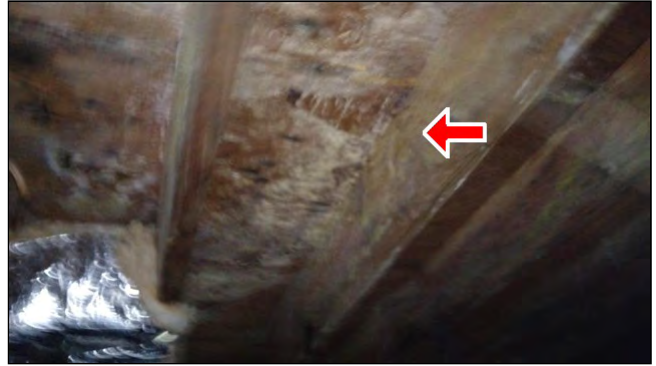
1.2 Item 7(Picture) Fungal growth on the floor sheathing

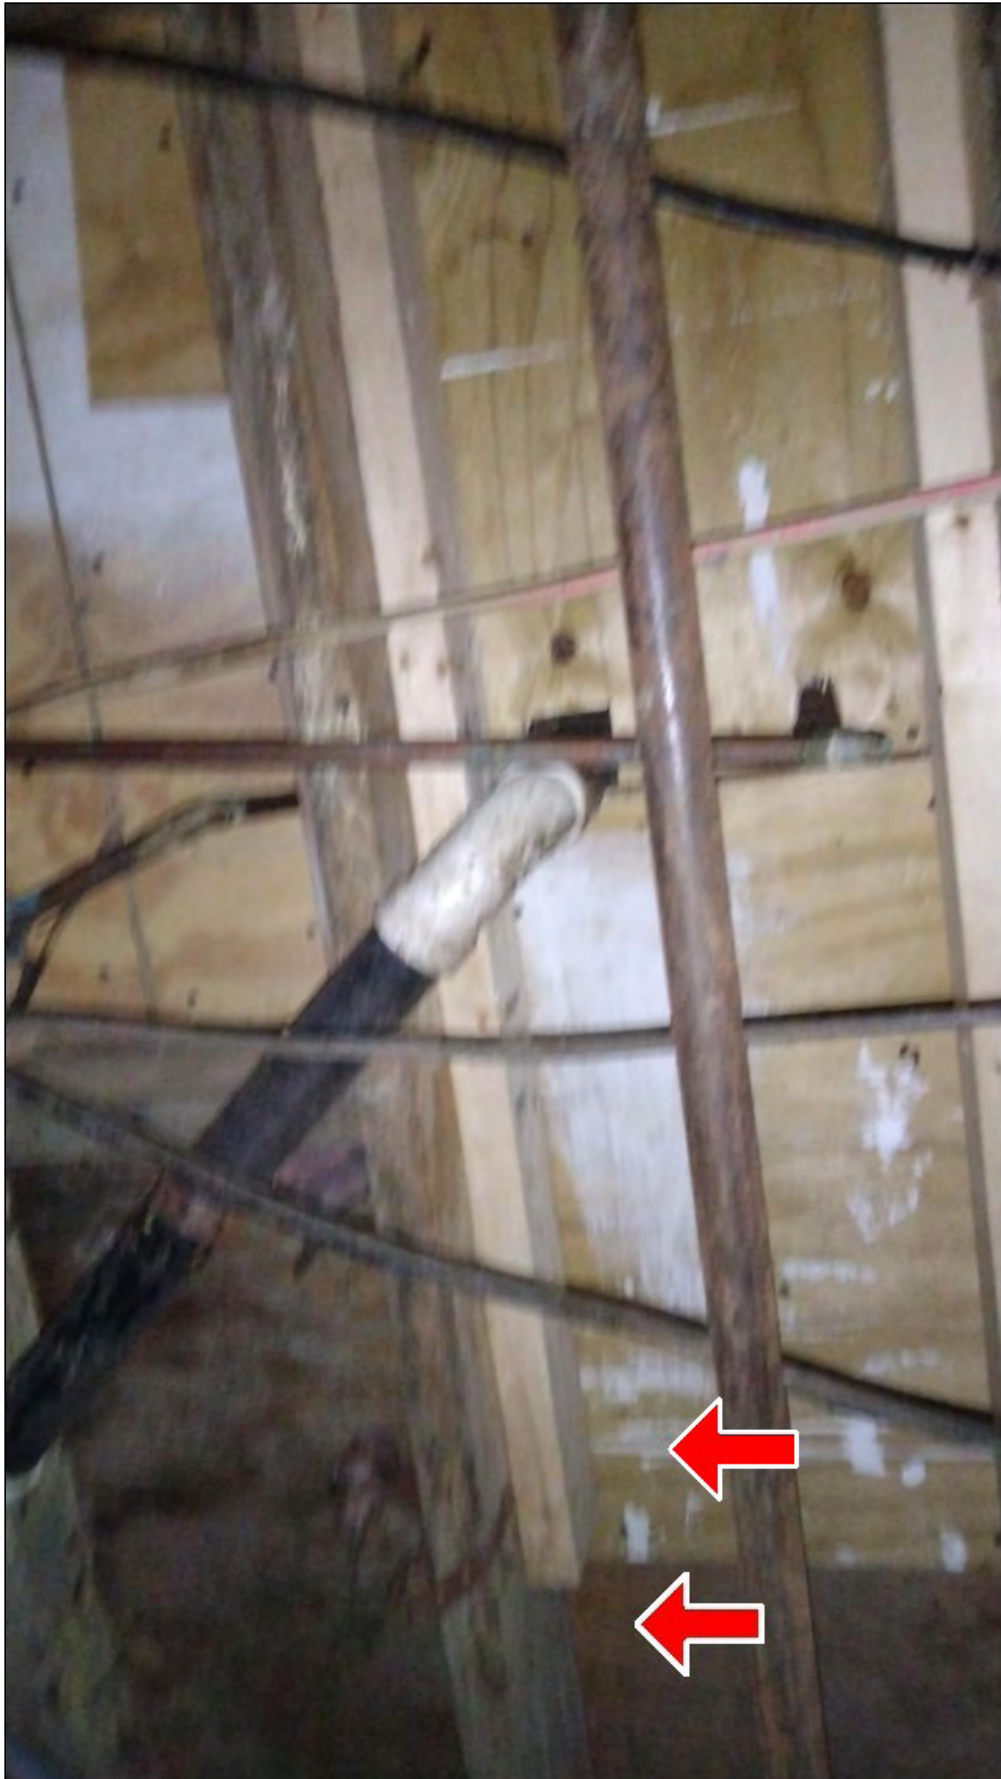
(2) Repairs have been made in the crawlspace under the bathroom and these repairs were not done using proper building techniques (floor joists are not supported to the ends) This can cause uneven floors and possible failure. These repairs need to be reviewed by a licensed general contractor and all areas make functional

1.2 Item 10(Picture) The new floor joist is nailed to the deteriorated joist and is not supported to the ends

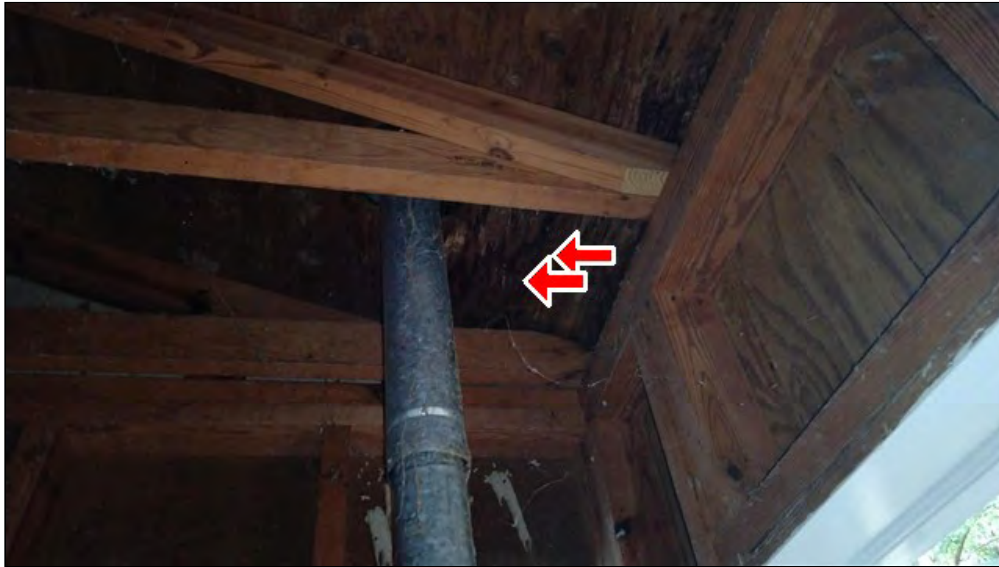
The roof sheathing in the rear exterior storage room has deterioration noted from active / past roof leakage and these areas of the roof sheathing needs proper repairs / replacement by a licensed general contractor and made functional.

1.8 Item 1(Picture) Deteriorated sheathing noted in the storage room

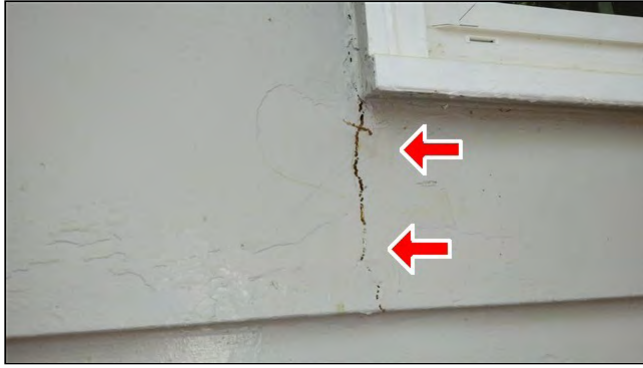
(2) The hard board siding has damage and deterioration noted in multiple areas around the home. The framing in affected areas need to be checked for obvious and / or concealed damage and all necessary repairs performed by a licensed general contractor.

2.0 Item 3(Picture) Damaged siding noted

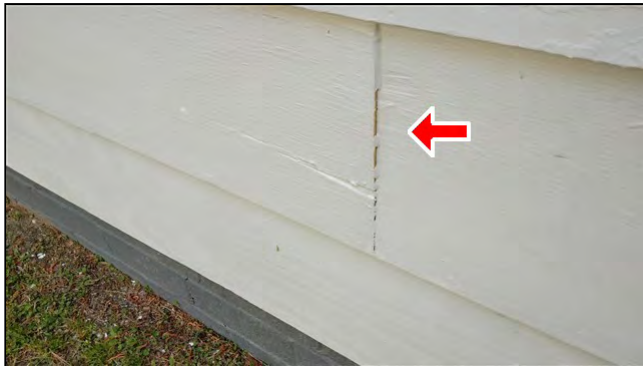
(3) The hard board siding / veneer at the side of the home is loose and can be pulled loose and can allow moisture/ water penetration and further damage/deterioration in these areas. This siding should be repaired/replaced by a qualified siding contractor with all areas checked for concealed damage and all areas made functional.

2.0 Item 4(Picture) Loose siding. Moves to the touch

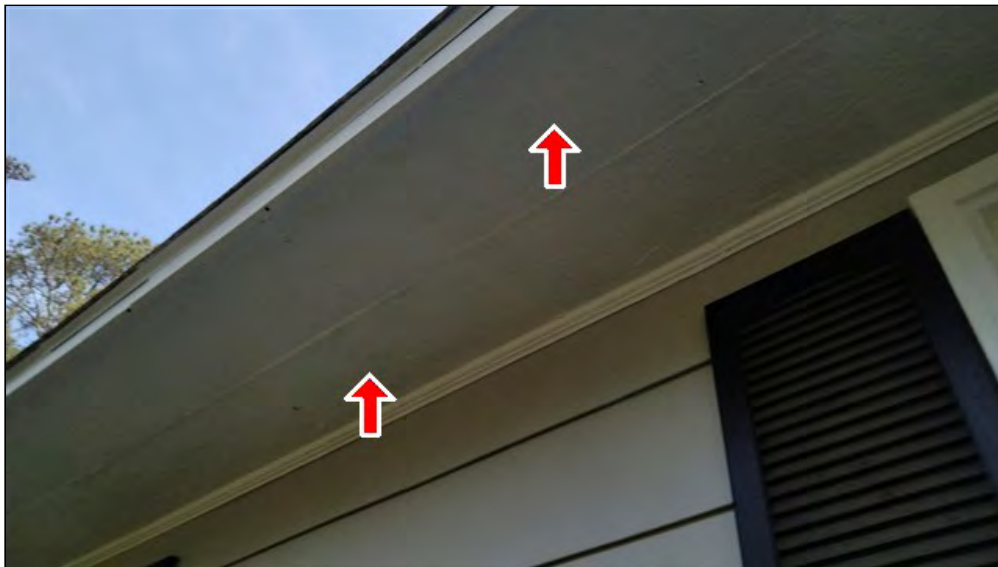
(1) The soffits on the exterior of the home are not an exterior grade material. This material can be damaged by moisture and this soffit should be replaced and made functional by a licensed general contractor.

2.1 Item 1(Picture) Soffits are not a exterior grade material

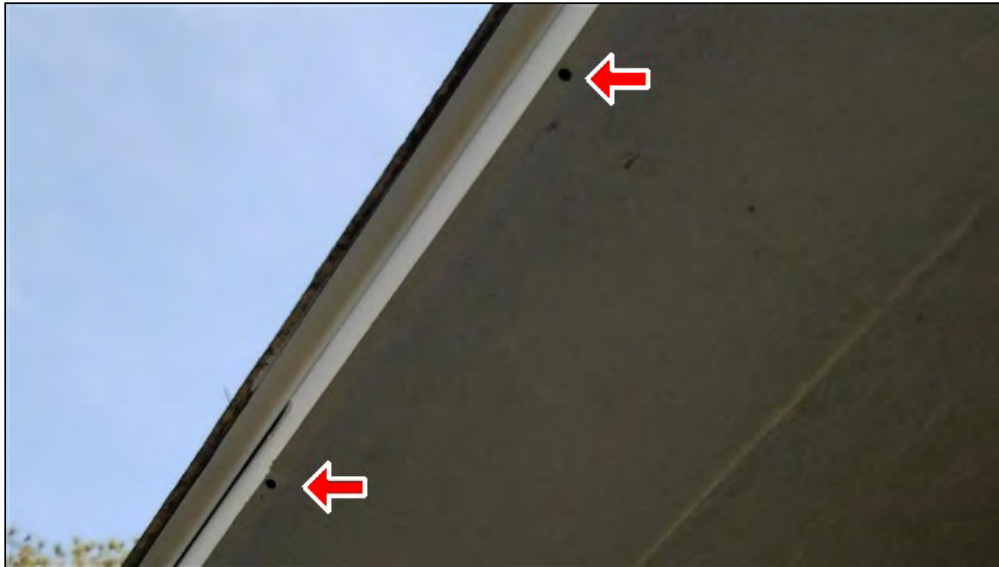
(2) The front fascia trim board has damage noted from animals (Possible Woodpecker) or insects (Possible Bees) and this board needs proper repairs to prevent water seepage or damage. These areas needs to have the animals or insects stopped and made functional by a qualified contractor.

2.1 Item 2(Picture) Insect damage noted to the fascia boards

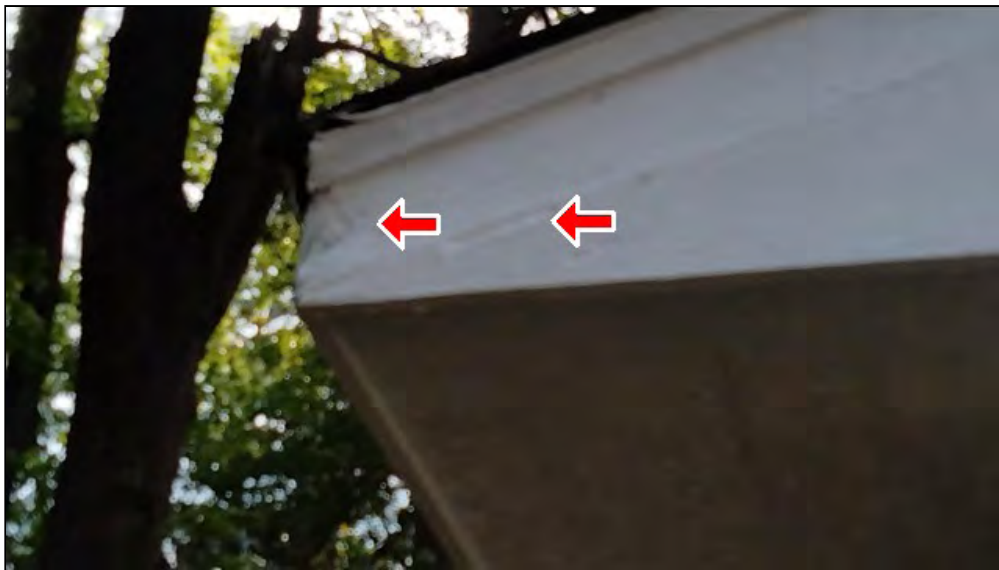
(3) The fascia / rake boards at the front right corner of the home has damage / deterioration noted. This area needs to be probed for concealed damage with the fascia boards repaired or replaced and all areas made functional by a licensed general contractor.

2.1 Item 3(Picture) Deterioration / damage noted

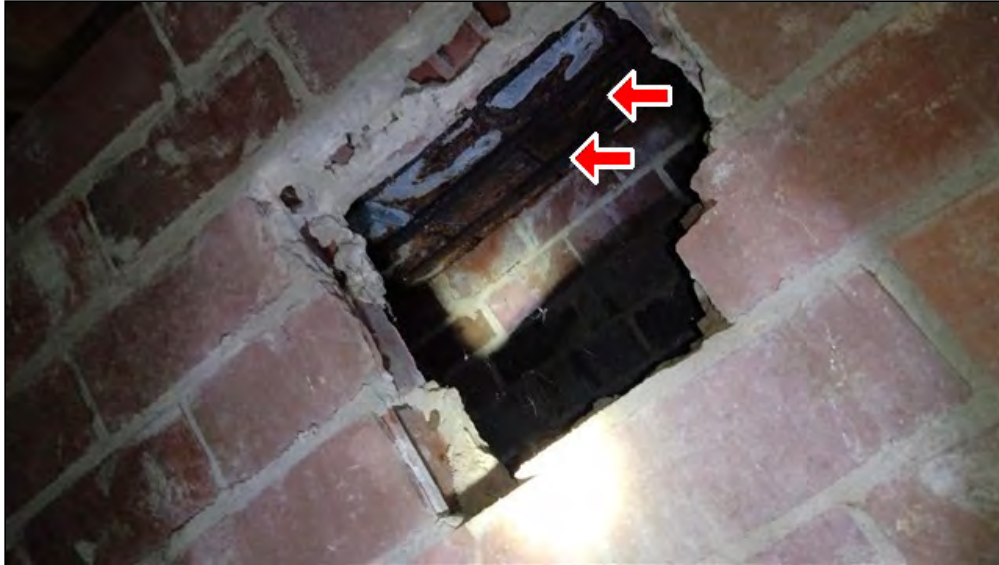
The metal under the front porch slab has heavy rust damage noted and this condition can cause settlement and damage to the front porch

2.5 Item 1(Picture) Heavy rust damage to the front porch support metal

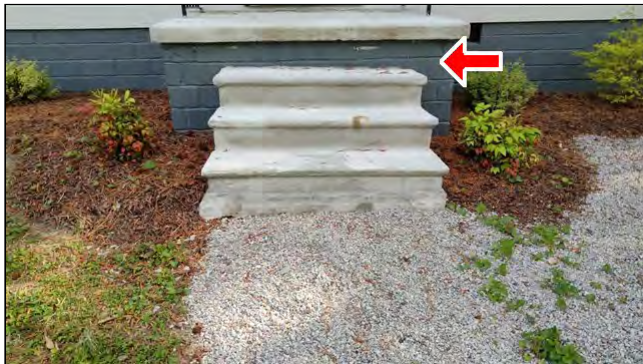
The front steps have settled in areas and / or has pulled loose away from the porch, and are leaning and is a tripping or safety concern and these steps are in need of proper repairs and made functional by a licensed general contractor to prevent further damage.

2.6 Item 1(Picture) The front steps have settled

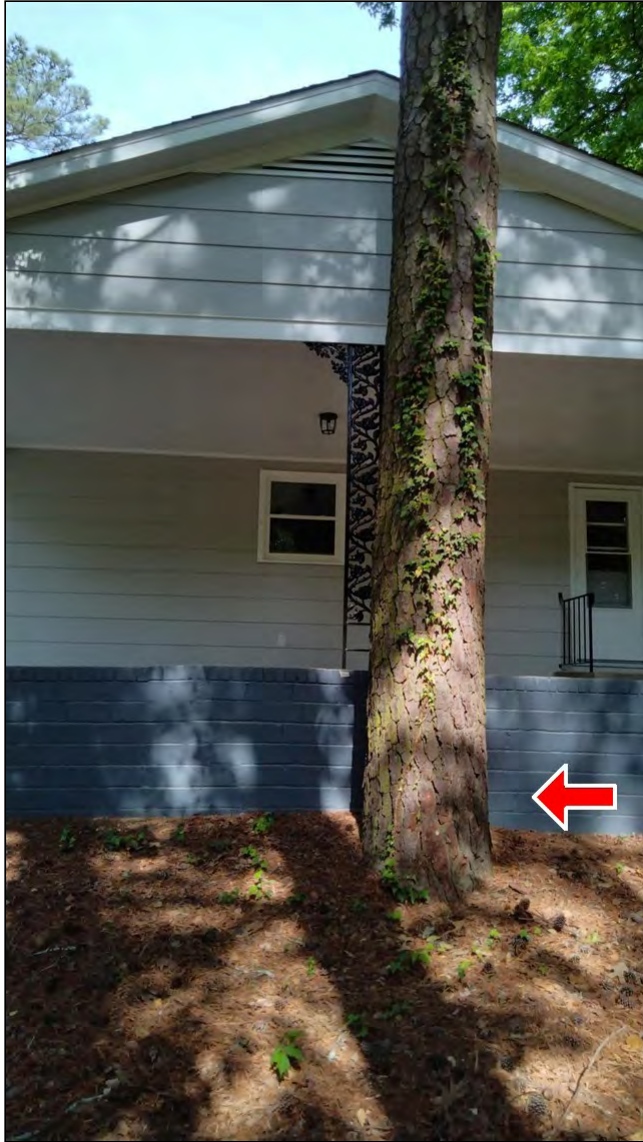
A large pine tree is growing against the foundation of the home and is causing damage and this tree should be evaluated for removal and all areas made functional by a qualified landscape contractor.

2.8 Item 1(Picture) A very large pine tree is growing against the foundation and the tree roots are causing damaged to the foundation

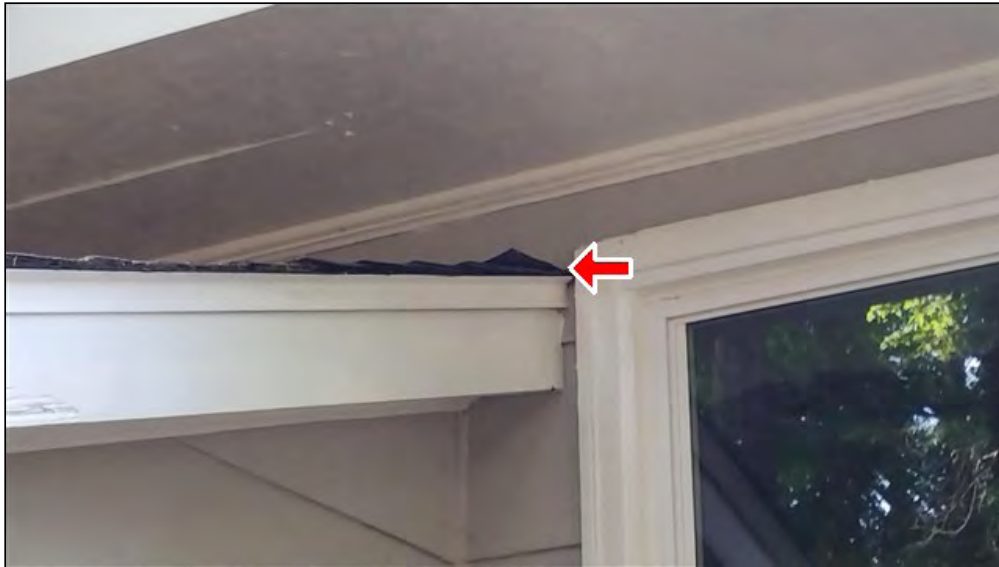
The shingles installed over the flashing at the dormer over the garage and at the front of the house are loose and needs to be re-aligned and re-secured by a roofing professional and made functional.

3.0 Item 1(Picture) Lifter shingle over the flashing on he rear storage room

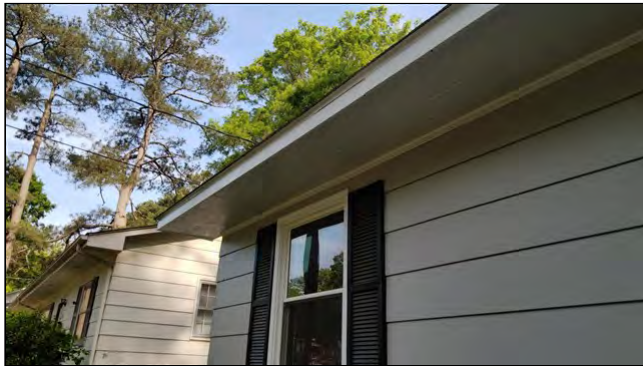
No gutters are in place on the structure and is not a required component but is highly recommended for proper drainage of the roof and to direct water away from the structure and foundation and areas below the house.

3.1 Item 1(Picture) No gutters are on the home

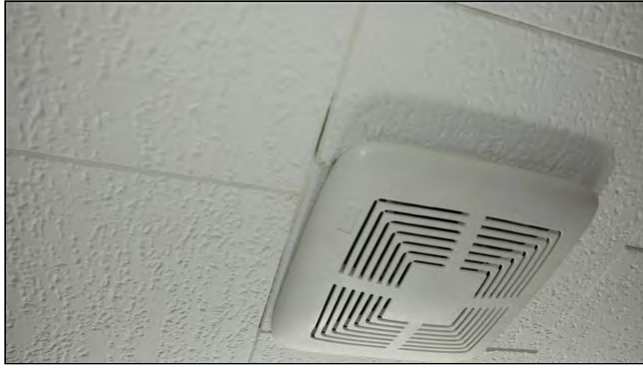
A damage ceiling tile was noted at the bathroom vent and this damage can get worse with time and this ceiling should be repaired or replaced and made functional by a qualified contractor.

4.0 Item 1(Picture) Damaged ceiling tile

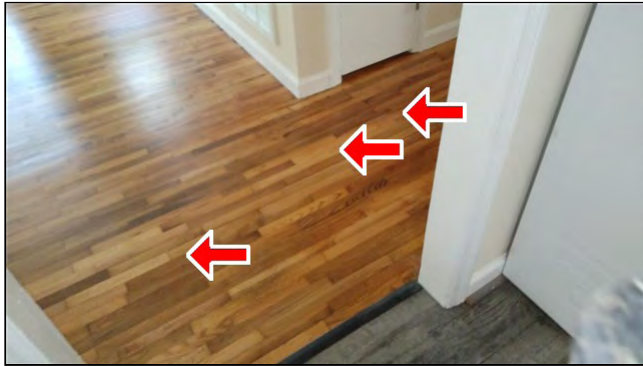
The hall floor has a raised area in the flooring noted. This can be from settlement, a missing pier shim, or the floor framing not being properly supported in this area and all accessible areas of the floor structure were functional.

4.2 Item 1(Picture) Raised area in the flooring

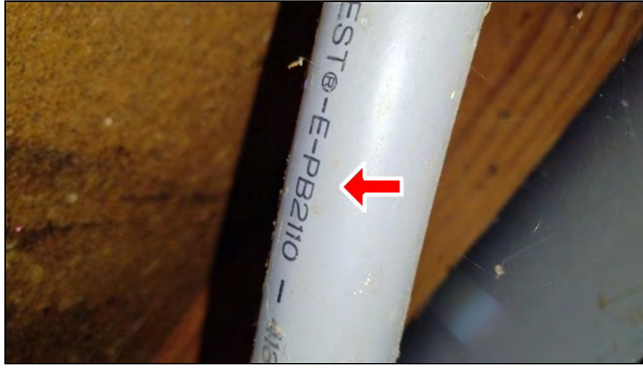
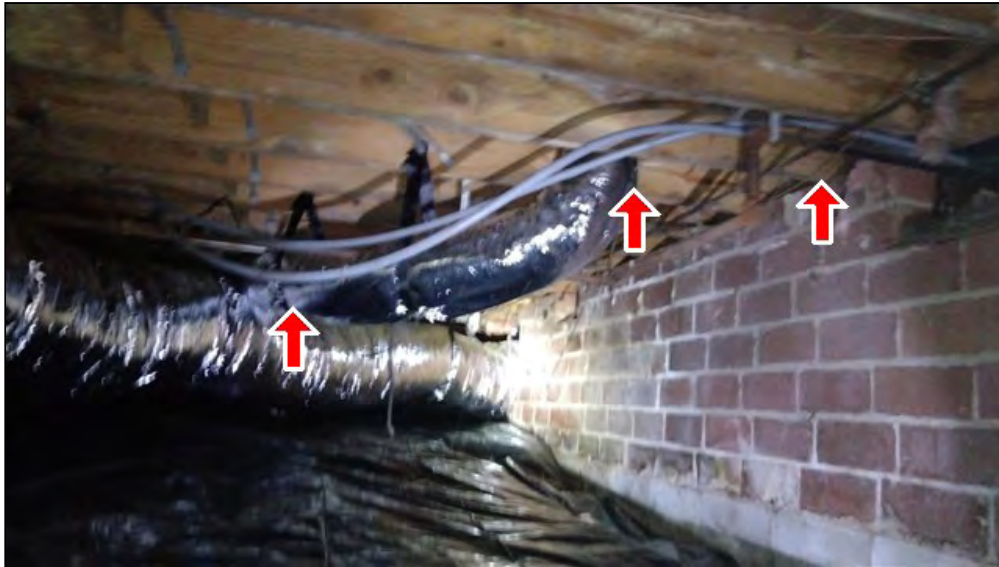
Polybutylene Pipe. Recommended language for Polybutylene piping(PB): Polybutylene plumbing supply line (PB) are installed in this house as the main water and distribution supply line. PB was used as water distribution piping in many homes built from the mid 1980's until the mid 1990's. The piping and associated fittings have had a failure rate and subsequent leakage sufficient to have been the subject of several nationwide class action lawsuits. Copper and brass fittings used in later years seem to have reduced the failure rate, but the piping may still fail due to problems with poor installation, improper handling, or chemical reaction with the water supply. The main entry piping in this house has copper fittings. You may wish to have the plumbing system evaluated by a licensed

5.1 Item 1(Picture) Polybutylene Piping noted in the home

5.1 Item 2(Picture) Polybutylene piping noted

plumbing contractor. Standards of Practice/ Rules / Interpretations Committee of the North Carolina Home Inspection Licensure Board.

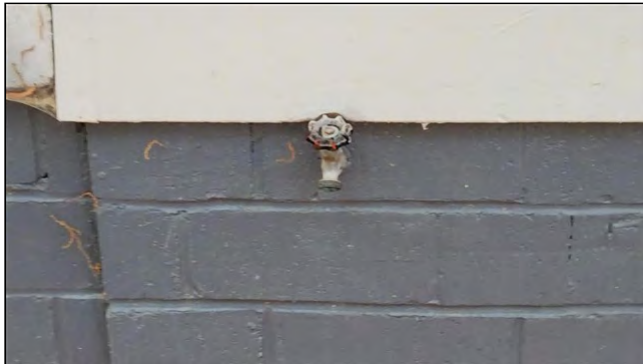
The hose faucet at the rear of the home is loose and needs to be properly secured. This can cause further damage to this unit, can allow leakage, and needs proper repairs by a licensed plumber and made functional.

5.2 Item 1(Picture) Loose hose bib noted

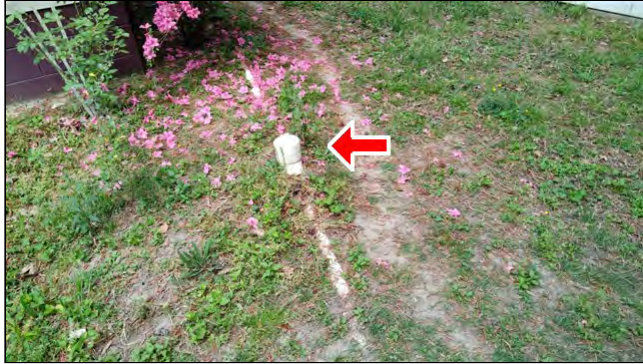
(1) The plumbing cleanouts in the side yard have not been trimmed to grade level and can allow these units to be damaged with lawn equipment. These cleanouts should be cut to grade level by a licensed plumber and made functional.

5.6 Item 1(Picture) Plumbing cleanout not trimmed

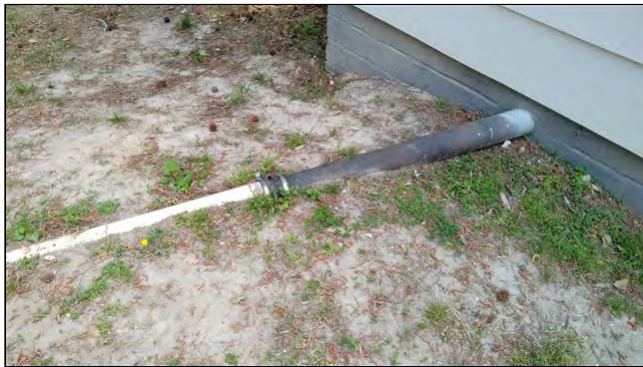
(2) The waster line where it leaves the home is exposed and can be damaged with lawn equipment and this line should be evaluated and made functional by a licensed plumbing contractor.

5.6 Item 2(Picture) Plumbing waste line is exposed in the yard

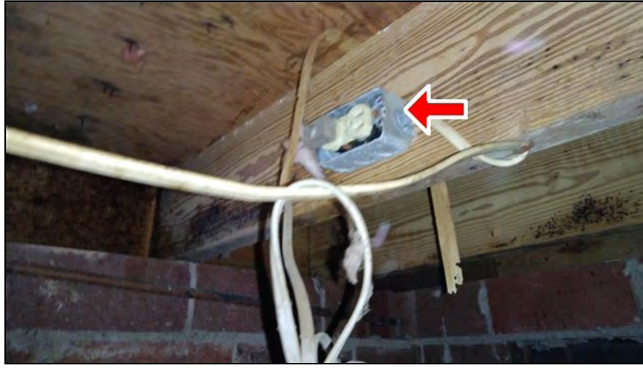
The existing sump pump uses an extension cord and should have its own GFCI outlet. All sump pumps should have its own GFCI and not be run on an extension cord. These electrical issues are considered a hazard until repaired. It is recommend a qualified licensed electrical contractor evaluated and make necessary repairs with all areas made functional.

5.7 Item 1(Picture) Sump pump is not powered by a GFCI for protection

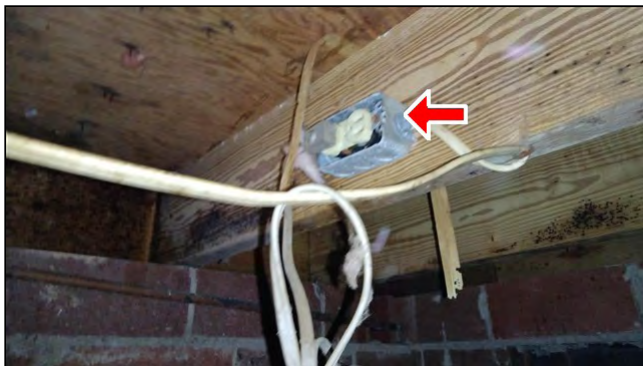
Wire splices were made inside junction / receptacle / or switch boxes at the sump pump but not limited to this area have no covers and leaves exposed wires in these areas. These areas are a safety concerns and the splices needs to be made in a junction box and / or made functional by a licensed electrician.

8.5 Item 1(Picture) Receptacle cover missing

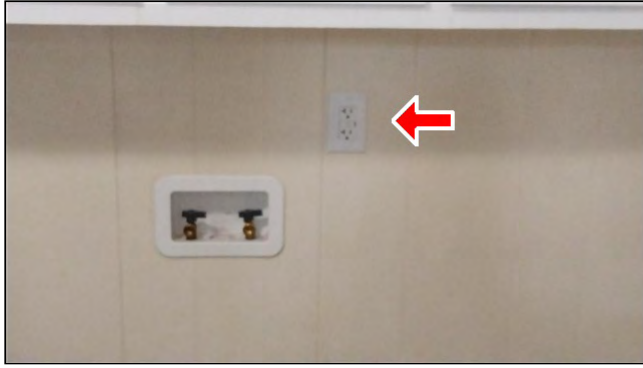
(1) The GFCI in the laundry room would not trip properly, is a safety and electrical concern and this receptacle needs repair or replacement by a licensed electrician and made functional.

8.8 Item 1(Picture) The GFCI at the laundry areas is not functional

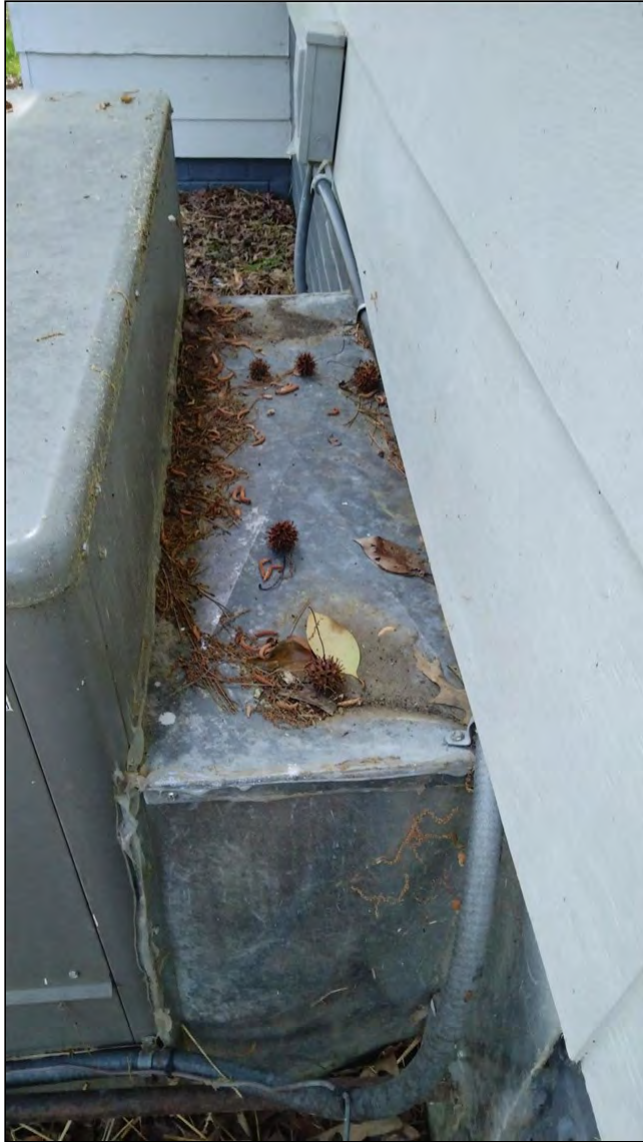
(1) The metal at the rear of the package unit is holding water and is rusting and this can damage the unit and this installation should be evaluated and made functional by a licensed HVAC contractor.

10.3 Item 1(Picture) Metal holding water and rusting

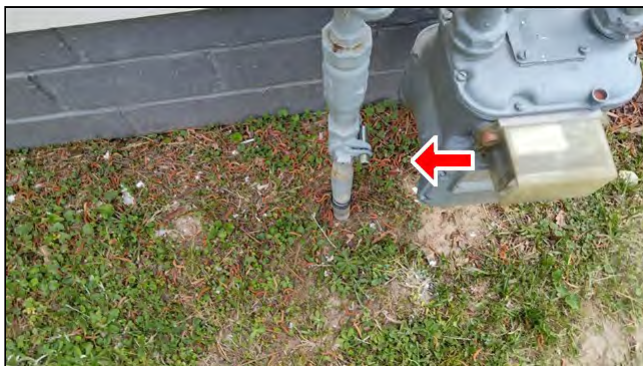
(2) The gas was off to the home and the gas heat and water heater could not be tested or inspected and no representations are made of these areas.

10.3 Item 2(Picture) The gas is off to the home

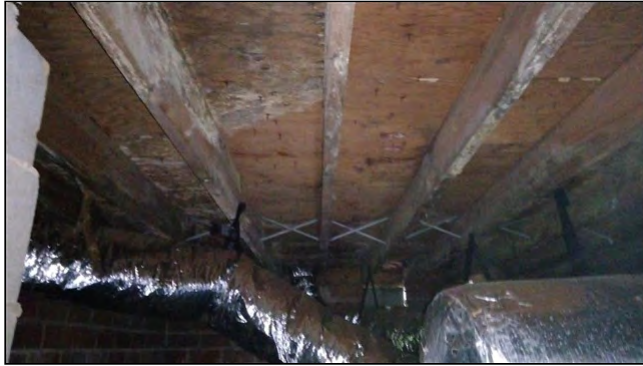
11.1 Item 1(Picture) Missing flooring insulation

Flooring insulation has been removed and there is no flooring insulation installed and this floor system needs insulation installed and all areas made functional by a qualified insulation contractor.

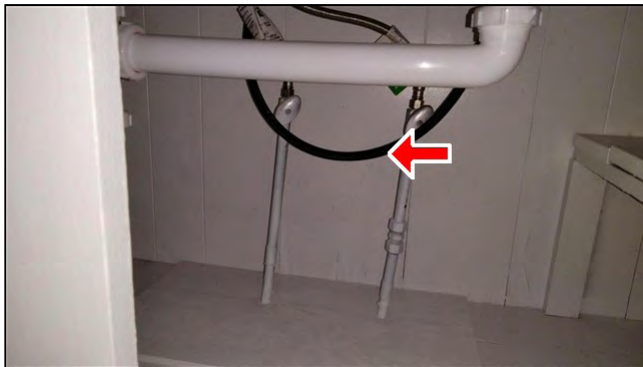
The kitchen sink sprayer is missing the weight on the sprayer line that helps pull the sprayer back into its mount when not in use and this sprayer needs to be made functional by a qualified contractor.

12.6 Item 1(Picture) Missing sprayers weight
