# Property Inspection Report

**Report Number: 041825henderson**

1512 Oxford Rd Right/Left  
Henderson, North Carolina 27536

Date of Inspection: Friday, April 18, 2025

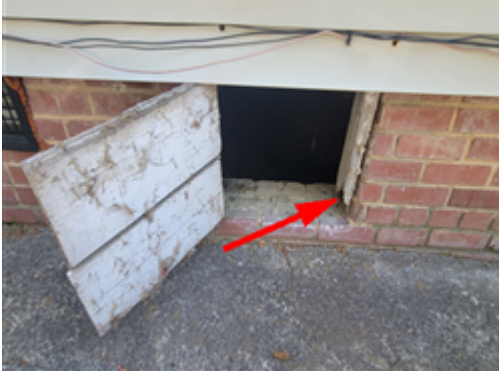
**(A1 - 1.1) Main House**

The crawlspace door is damaged. It appears to be termite damage. A qualified pest contractor should be contacted for evaluation and repairs.

The crawlspace door is damaged. It appears to be termite damage. A qualified pest contractor should be contacted for evaluation and repairs.

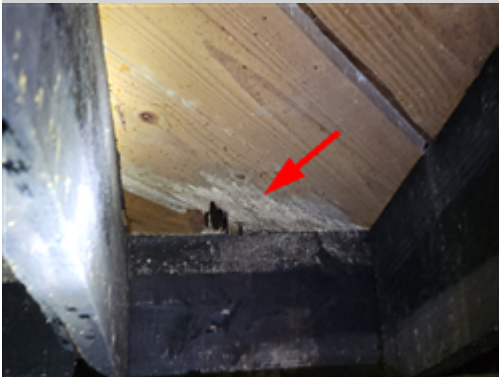
**(A1 - 1.2) Main House**

There is microbial growth in the crawlspace. A qualified contractor should be contacted for repairs.

There is microbial growth in the crawlspace. A qualified contractor should be contacted for repairs.

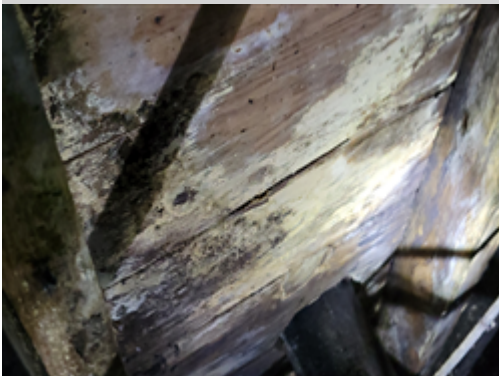
**(A1 - 1.3) Main House**

Additional Picture.

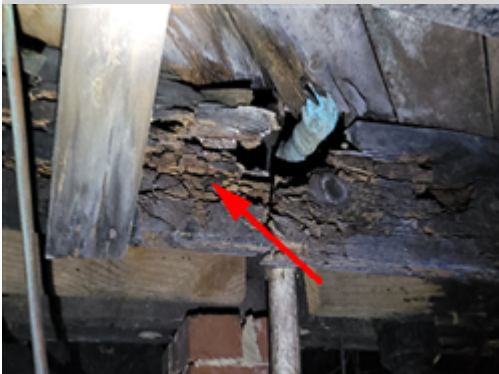
**(A1 - 1.4) Main House**

Some floor joists are damaged. It appears to be termite damage. A qualified contractor should be contacted for evaluation and repairs.

Some floor joists are damaged. It appears to be termite damage. A qualified contractor should be contacted for evaluation and repairs.

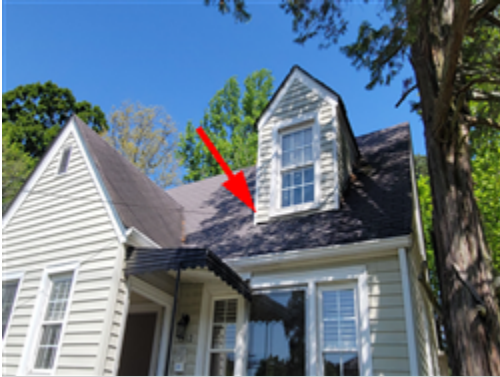
**(B1 - 1.1) Main House**

The siding is damaged in several places. This could allow water penetration. A qualified contractor should be contacted for repairs.

The siding is damaged in several places. This could allow water penetration. A qualified contractor should be contacted for repairs.

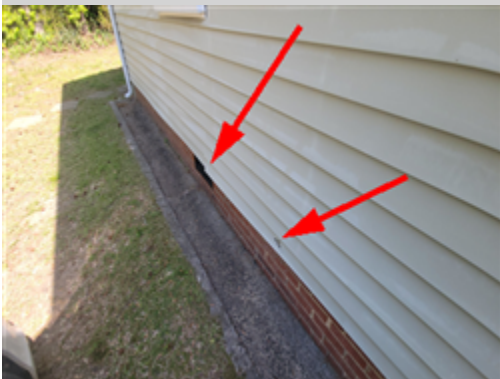
**(B1 - 1.2) Main House**

Additional Picture.

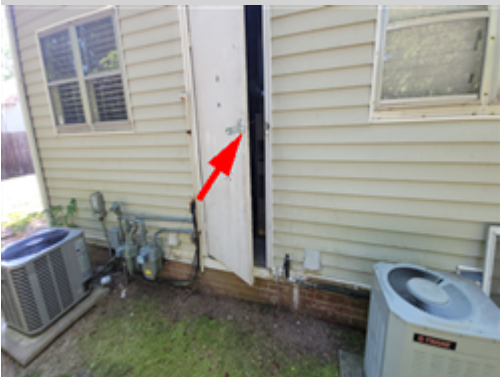
**(B2 - 2.1) Doors**

The door is damaged. A qualified contractor should be contacted for repairs.

The door is damaged. A qualified contractor should be contacted for repairs.

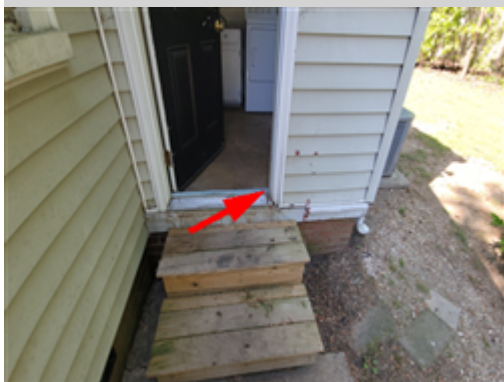
### (B2 - 2.2 ) Doors

The door trim is damaged. This could allow water penetration. A qualified contractor should be contacted for repairs.

The door trim is damaged. This could allow water penetration. A qualified contractor should be contacted for repairs.

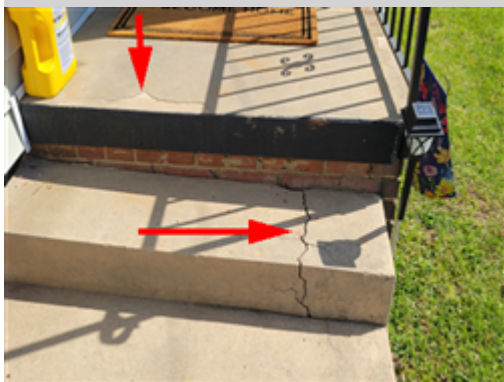
#### (B3 - 1.1 ) Porch

The porch is cracked. A qualified contractor should be contacted for repairs.

The porch is cracked. A qualified contractor should be contacted for repairs.

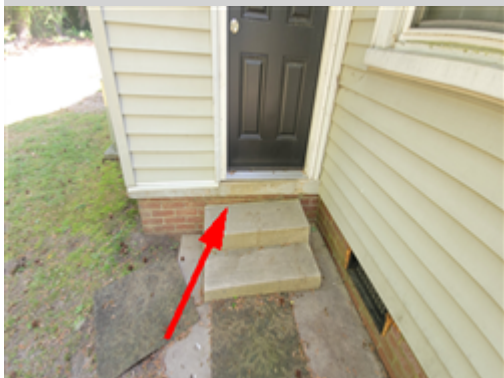
#### (B3 - 2.1 ) Rear Porch

The porch steps have shifted. A qualified contractor should be contacted for repairs.

The porch steps have shifted. A qualified contractor should be contacted for repairs.

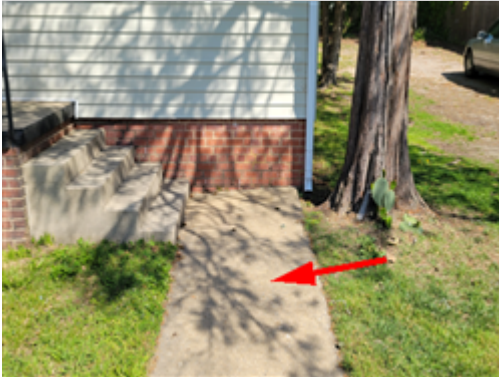
**(B4 - 1.1) Walk**

The walkway is uneven. This is a hazard.

The walkway is uneven. This is a hazard.

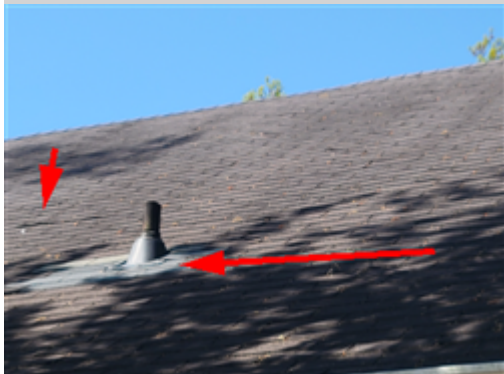
**(C1 - 1.1) Main House**

The roof is damaged/repared in several places. This could allow water penetration. A qualified contractor should be contacted for evaluation of the entire roof and repairs.

The roof is damaged/repared in several places. This could allow water penetration. A qualified contractor should be contacted for evaluation of the entire roof and repairs.

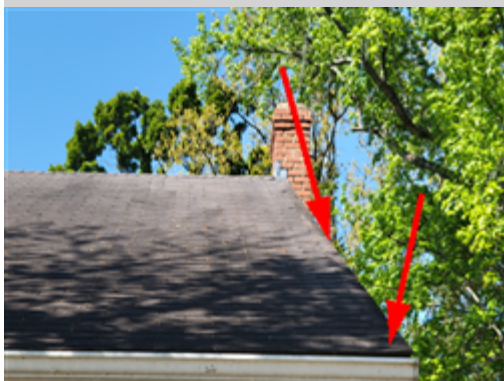
**(C1 - 1.2) Main House**

Additional Picture.

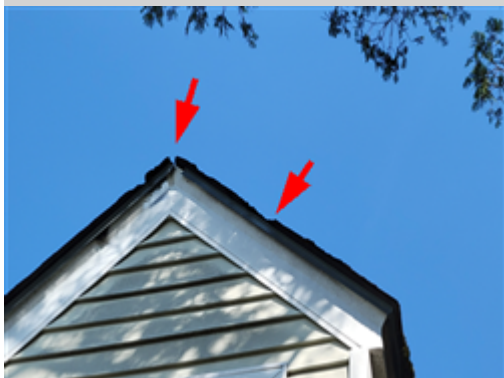
**(C1 - 1.3) Main House**

Additional Picture.

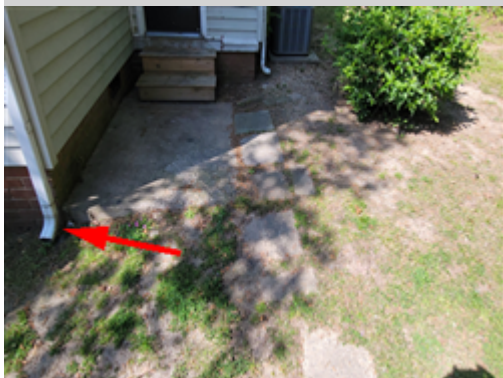
### (C2 - 1.1) Main House

The gutter downspouts are not extended or piped to direct roof drainage away from the foundation. Direct drainage to the foundation and cladding from the gutter system can result in water penetration into the foundation area and foundation deterioration. A qualified contractor should be contacted for repairs.

The gutter downspouts are not extended or piped to direct roof drainage away from the foundation. Direct drainage to the foundation and cladding from the gutter system can result in water penetration into the foundation area and foundation deterioration. A qualified contractor should be contacted for repairs.

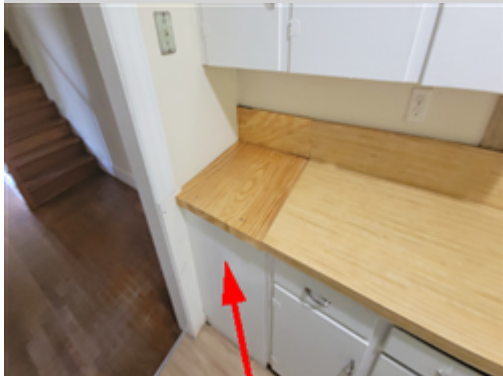
**(D3 - 1.1) Right side and Left side**

The water heaters can not be seen. There is no access to them.

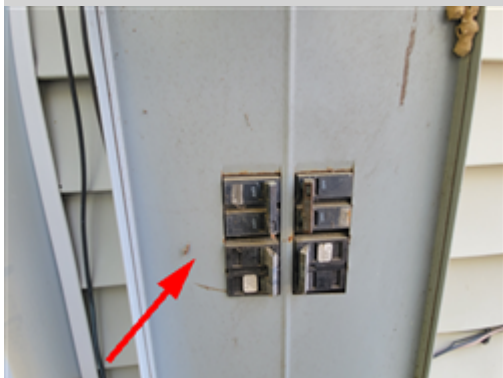
**(E2 - 1.1 ) Main Panel #1and #2**

The panels are not labeled. A qualified contractor should be contacted for repairs.

The panels are not labeled. A qualified contractor should be contacted for repairs.

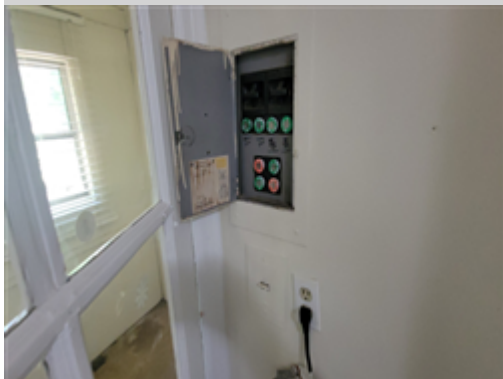
**(E3 - 1.1 ) Distribution Panel right side and Left side**

The panels are the old Edison bulb type.

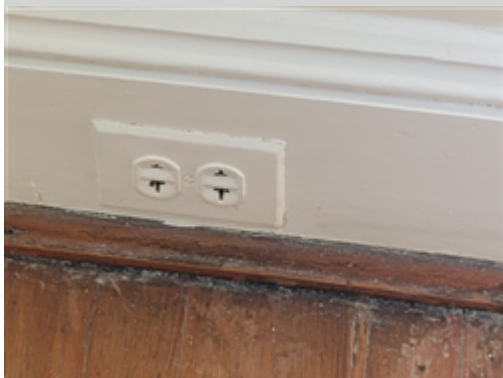
#### (E5 - 1.1 ) Rooms

The house has 2 prong outlets.

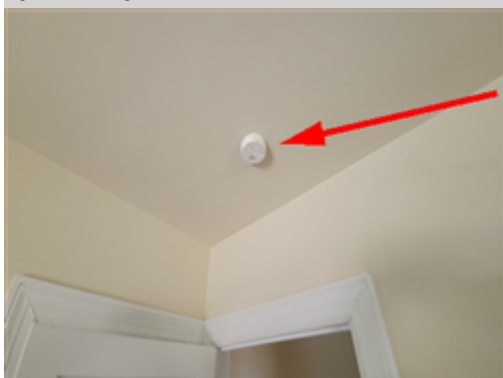
#### (E5 - 2.1 ) Bedroom

The smoke alarm is beeping.

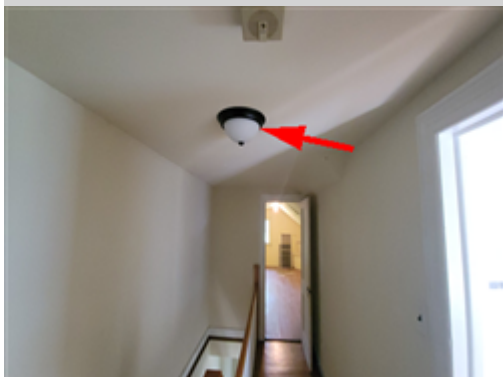
#### (E5 - 3.1 ) Hall

The light did not work when tested. Change the bulb and retest.

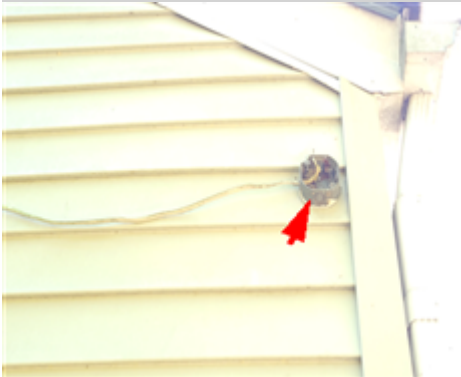
**(E5 - 4.1 ) Exterior**

There are open boxes. This is a hazard. A qualified contractor should be contacted for repairs.

There are open boxes. This is a hazard. A qualified contractor should be contacted for repairs.

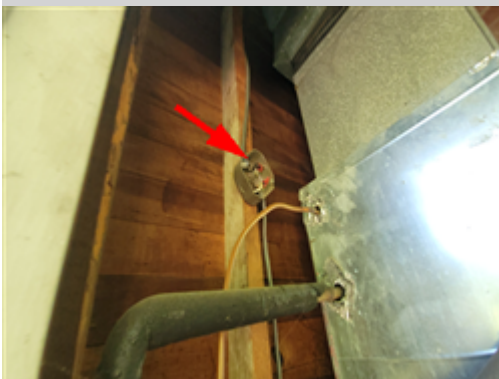
**(E5 - 4.2 ) Exterior**

Additional Picture.

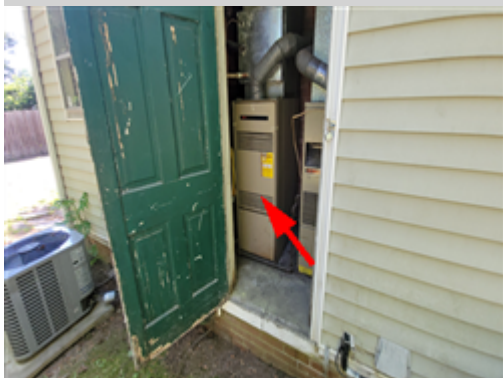
### (F1 - 1.1 ) Heating Unit #1 and #2

The heat for the right unit was not on. No gas was on to the unit.

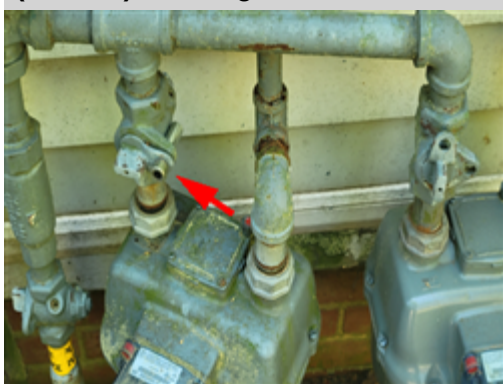
### (F1 - 1.2 ) Heating Unit #1 and #2

Lock on the gas meter.

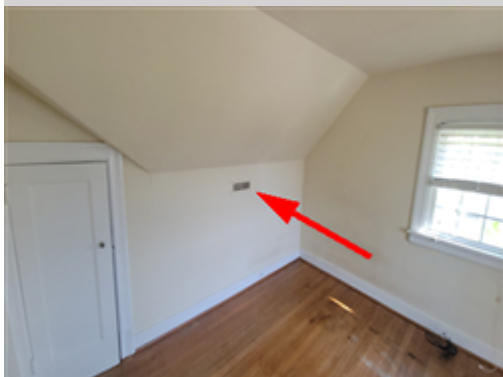
**(G2 - 1.1) Cooling Unit #1 and #2**

The air does not blow good in the upstairs rooms. A qualified contractor should be contacted for evaluation and repairs.

The air does not blow good in the upstairs rooms. A qualified contractor should be contacted for evaluation and repairs.

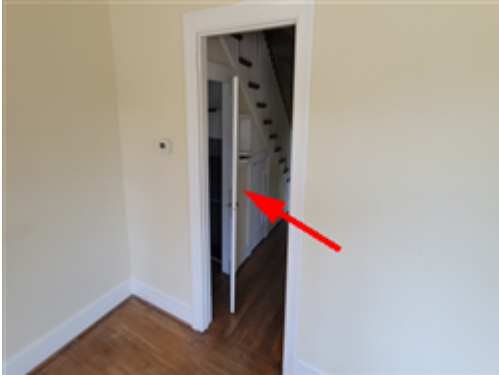
**(H1 - 1.1) Hall**

The door does not close/latch properly. It rubs the floor. Adjust or replace as needed.

The door does not close/latch properly. It rubs the floor. Adjust or replace as needed.

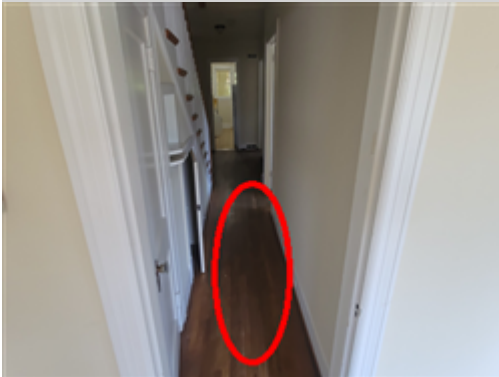
**(H1 - 1.2) Hall**

The floors are uneven. A qualified contractor should be contacted for evaluation and repairs.

The floors are uneven. A qualified contractor should be contacted for evaluation and repairs.

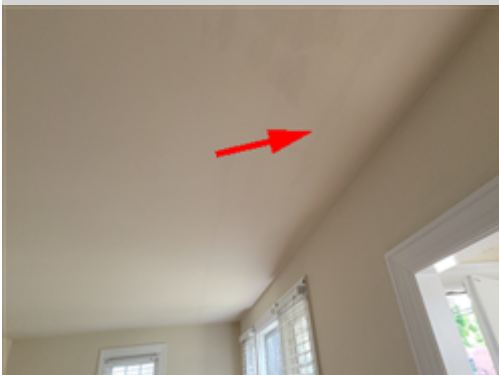
**(H1 - 2.1) Family Room**

There are cracks and stains on the ceiling. A qualified contractor should be contacted for repairs.

There are cracks and stains on the ceiling. A qualified contractor should be contacted for repairs.

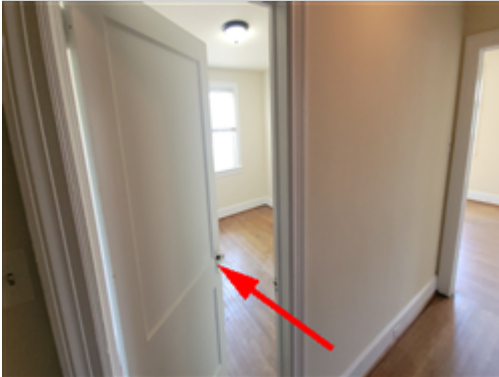
**(H1 - 3.1) Bedroom #1**

The door does not close/latch properly. Adjust or replace as needed. A qualified contractor should be contacted for repairs.

The door does not close/latch properly. Adjust or replace as needed. A qualified contractor should be contacted for repairs.

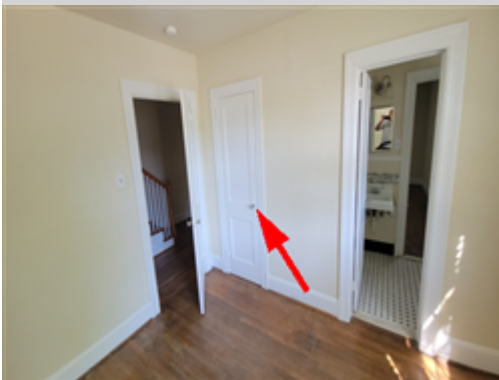
**(H1 - 3.2) Bedroom #1**

The door does not close/latch properly. Adjust or replace as needed. A qualified contractor should be contacted for repairs.

The door does not close/latch properly. Adjust or replace as needed. A qualified contractor should be contacted for repairs.

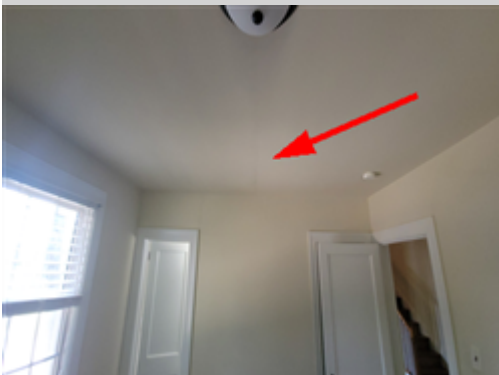
**(H1 - 4.1) Bedroom #2**

There are cracks on the ceiling. A qualified contractor should be contacted for repairs.

There are cracks on the ceiling. A qualified contractor should be contacted for repairs.

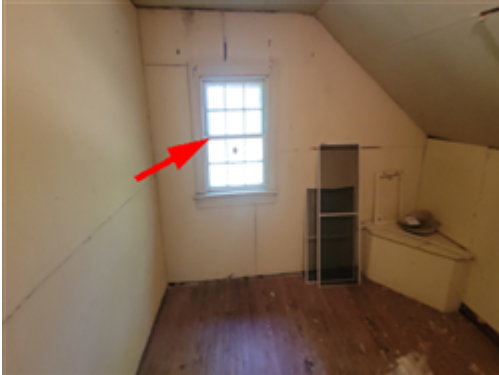
**(H1 - 5.1) Bonus/Storage Room**

The window is damaged. This could allow air and water penetration.

The window is damaged. This could allow air and water penetration.

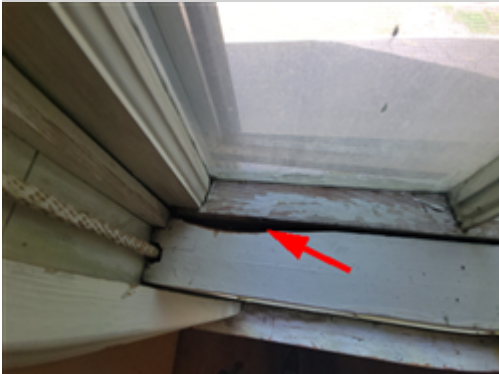
**(H1 - 5.2) Bonus/Storage Room**

Additional Picture.

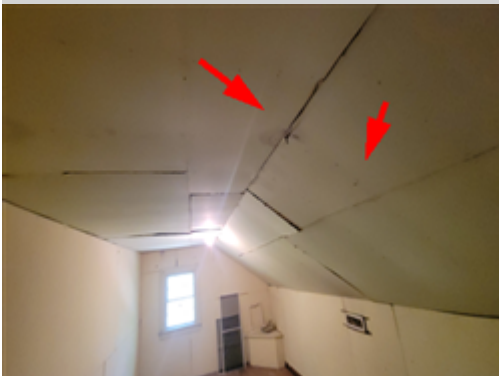
**(H1 - 5.3) Bonus/Storage Room**

There are stains on the ceiling and the sheetrock is damaged. A qualified contractor should be contacted for repairs.

There are stains on the ceiling and the sheetrock is damaged. A qualified contractor should be contacted for repairs.

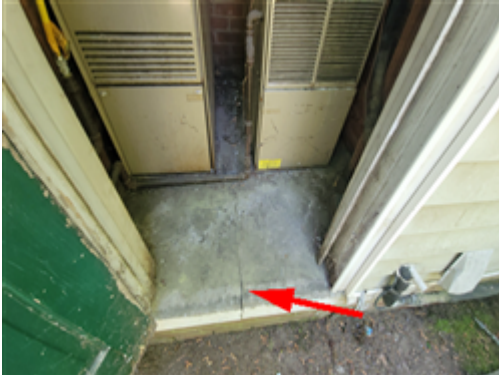
**(H1 - 6.1 ) Utility Room/Mech Room**

There is a crack in the concrete. A qualified contractor should be contacted for repairs.

There is a crack in the concrete. A qualified contractor should be contacted for repairs.

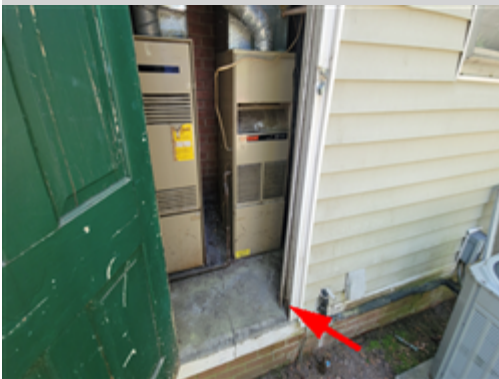
**(H1 - 6.2 ) Utility Room/Mech Room**

The trim at the bottom of the door is damaged/decayed. A qualified contractor should be contacted for repairs.

The trim at the bottom of the door is damaged/decayed. A qualified contractor should be contacted for repairs.

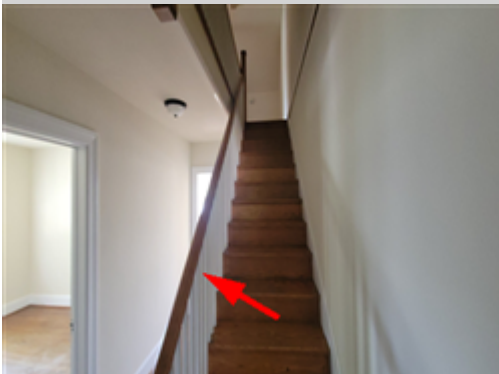
**(H1 - 7.1 ) Stairway**

The railing is loose. A qualified contractor should be contacted for repairs.

The railing is loose. A qualified contractor should be contacted for repairs.

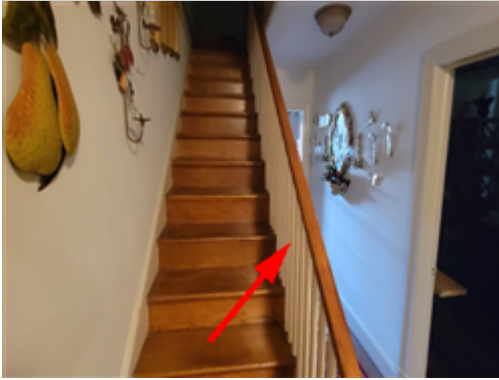
### (H1 - 7.2 ) Stairway

Left side railing is loose also. A qualified contractor should be contacted for repairs.

Left side railing is loose also. A qualified contractor should be contacted for repairs.

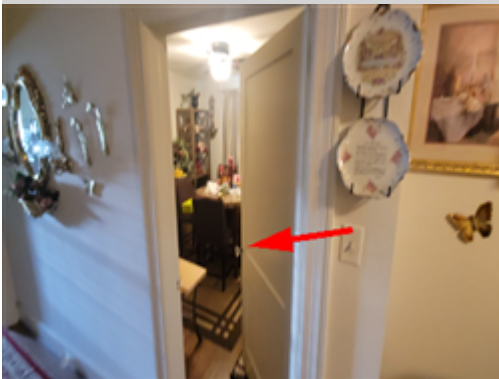
#### (H1 - 8.1 ) Dining Room

The dinning room door does not close/latch properly. A qualified contractor should be contacted for repairs.

The dinning room door does not close/latch properly. A qualified contractor should be contacted for repairs.

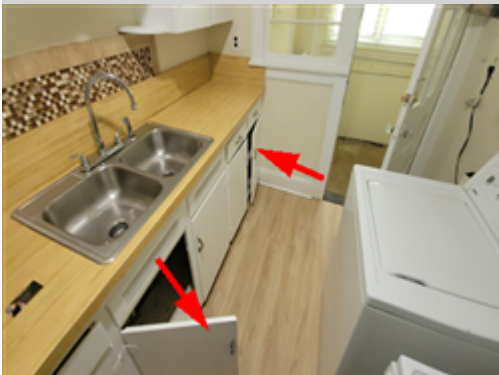
#### (H2 - 1.1 ) Kitchen Right

Several cabinets do not close latch properly. Adjust or replace as needed.

Several cabinets do not close latch properly. Adjust or replace as needed.

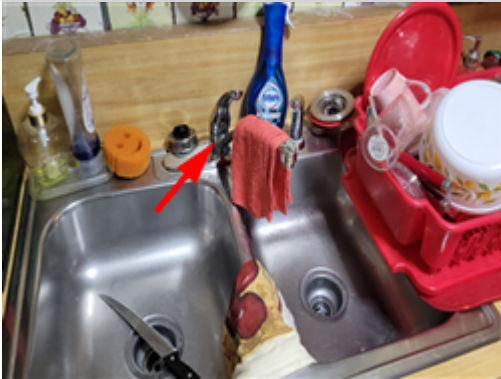
**(H2 - 2.1 ) Kitchen Left**

The knob leaks. This could damage the cabinets. A qualified contractor should be contacted for repairs.

The knob leaks. This could damage the cabinets. A qualified contractor should be contacted for repairs.

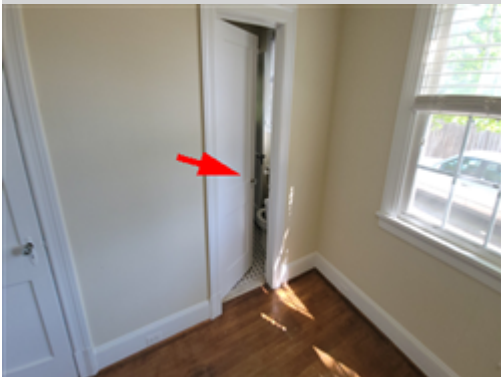
**(H3 - 1.1 ) Bathroom #1 Right**

The door does not close/latch properly. Adjust or replace as needed. A qualified contractor should be contacted for repairs.

The door does not close/latch properly. Adjust or replace as needed. A qualified contractor should be contacted for repairs.

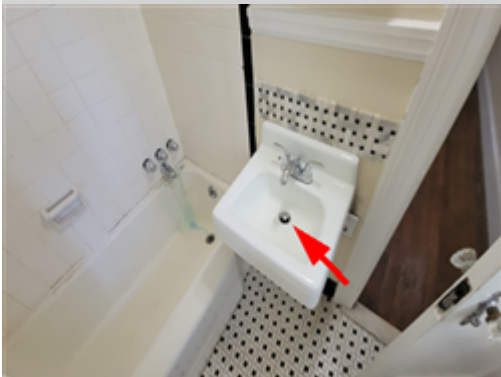
**(H3 - 1.2 ) Bathroom #1 Right**

The stopper does not work properly. A qualified contractor should be contacted for repairs.

The stopper does not work properly. A qualified contractor should be contacted for repairs.

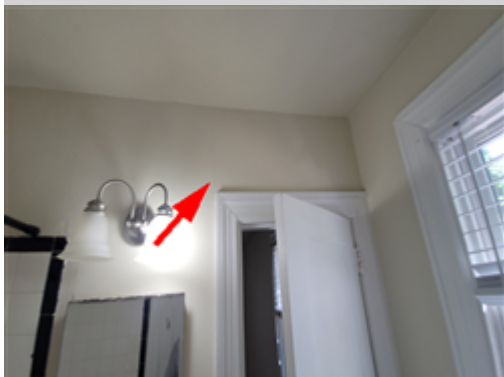
**(H3 - 1.3 ) Bathroom #1 Right**

There are cracks on the wall. A qualified contractor should be contacted for repairs.

There are cracks on the wall. A qualified contractor should be contacted for repairs.

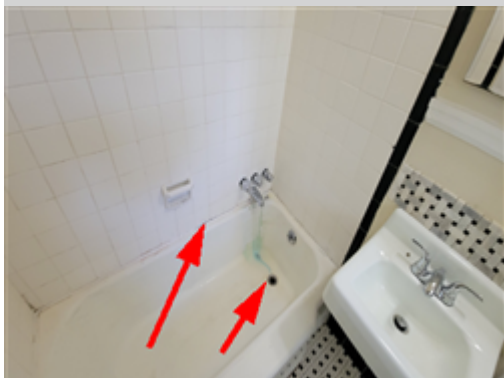
**(H3 - 1.4 ) Bathroom #1 Right**

The tub needs to be sealed and no stopper was present. A qualified contractor should be contacted for repairs.

The tub needs to be sealed and no stopper was present. A qualified contractor should be contacted for repairs.

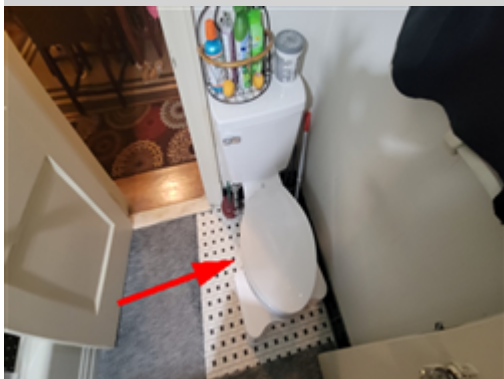
**(H3 - 2.1 ) Bathroom #1 Left**

The toilet is loose at the floor. This could lead to leaks. A qualified contractor should be contacted for repairs.

The toilet is loose at the floor. This could lead to leaks. A qualified contractor should be contacted for repairs.

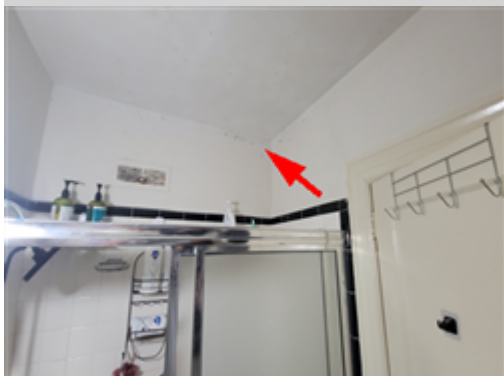
**(H3 - 2.3 ) Bathroom #1 Left**

There is microbial growth on the wall. A qualified contractor should be contacted for evaluation and repairs.

There is microbial growth on the wall. A qualified contractor should be contacted for evaluation and repairs.

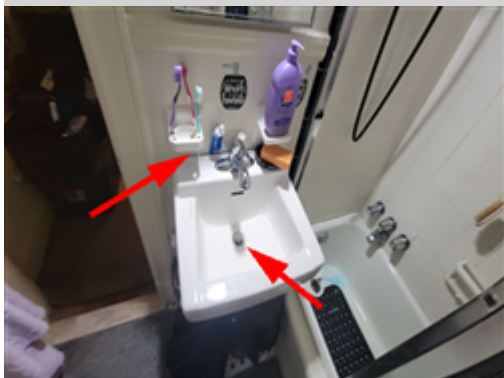
**(H3 - 2.4 ) Bathroom #1 Left**

The sink is loose at the wall and the stopper does not work. A qualified contractor should be contacted for repairs.

The sink is loose at the wall and the stopper does not work. A qualified contractor should be contacted for repairs.

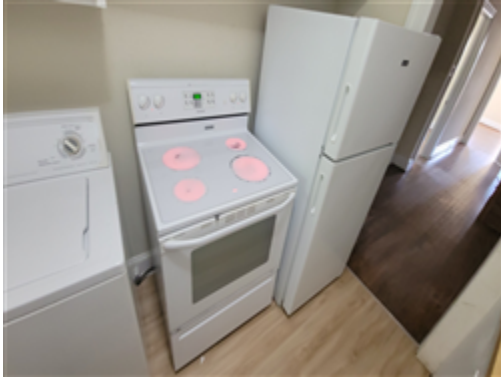
**(J1 - 1.1 ) Oven: Electric**

Both ovens move forward when the door is opened. The oven needs to be secured or anchored with an anti-tip bracket to prevent the unit from turning over when weight is applied to the door. A qualified contractor should be contacted for repairs.

Both ovens move forward when the door is opened. The oven needs to be secured or anchored with an anti-tip bracket to prevent the unit from turning over when weight is applied to the door. A qualified contractor should be contacted for repairs.
