## SUMMARY

15 Princeton Manor Dr, Youngsville,  
NC 27596

Walter Prillaman  
10/23/2025

Kyle McKeel  
NC Home Inspector License # 5602,  
NCOWCICB#119391 expires 12/31/2025  
Assurance Home Inspections  
336-218-6357  
[info@getassurance.net](mailto:info@getassurance.net)

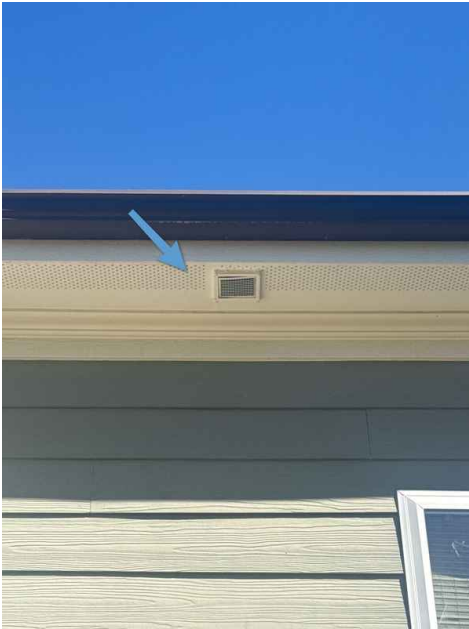
Rear Exterior

#### LOOSE WEATHERHOOD

Dryer vent weatherhood is not secured to the exterior of the home and can fall off. This can allow animals to enter the vent and create an obstruction which is a fire hazard. Recommend cleaning the vent duct and securing the vent by a general repair specialist.

Contact a qualified handyman.

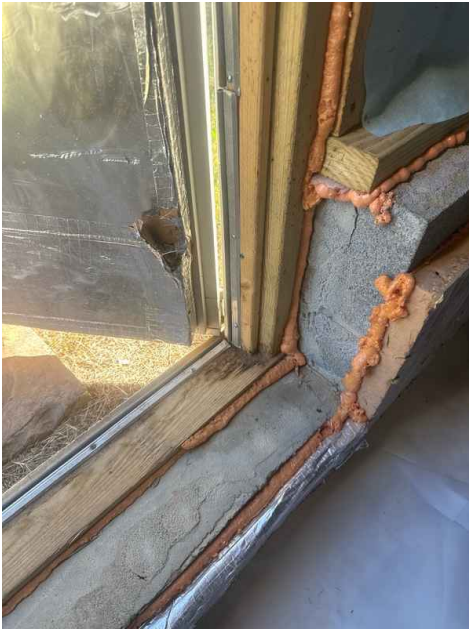
Crawlspace door

#### STAINS - MONITOR

Stains noted around the door. Tested dry on the day of inspection, but recommend monitoring and consult with a qualified contractor if elevated moisture or damage is noted.

Recommend monitoring.

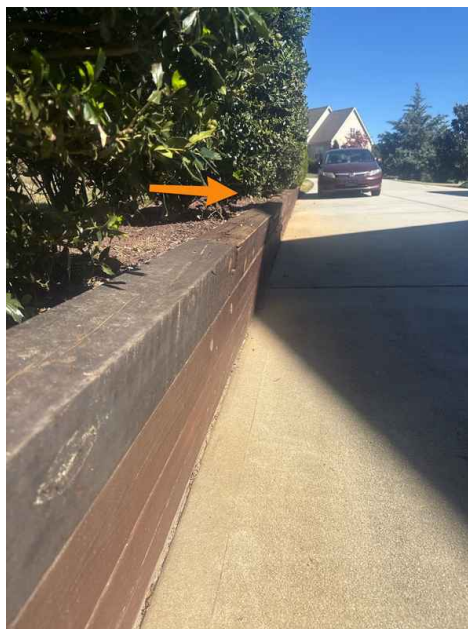
Driveway

#### LEANING AND/OR CRACKING

Retaining/landscaping wall is leaning and/or cracked which can lead to failure of the wall. Recommend a qualified contractor evaluate and repair. Typically a licensed structural engineer is recommended on walls more than 4 feet in height.

Contact a qualified professional.

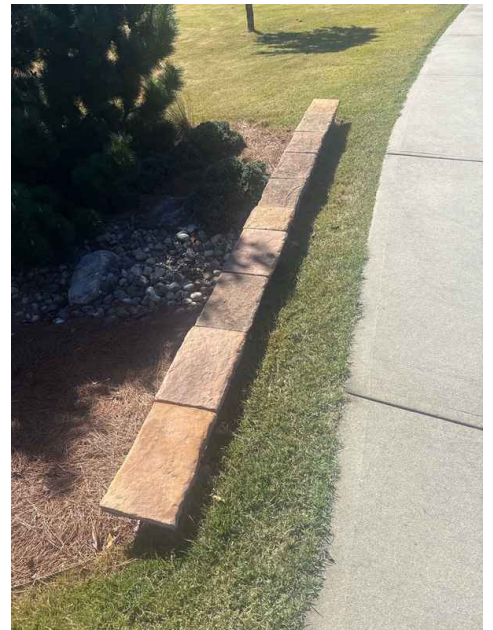
Driveway

#### LOOSE BRICK/BLOCKS

Recommend repair of the loose brick/blocks to help prevent damage to the wall.

Contact a qualified professional.

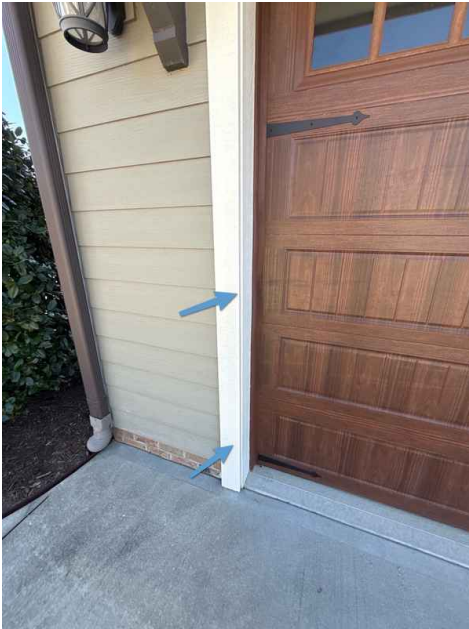
Front Right Exterior

#### TRIM - LOOSE

One or more pieces of trim/siding were loose, which could result in moisture intrusion and damage. Recommend properly securing the trim/siding by a qualified contractor.

Contact a qualified professional.

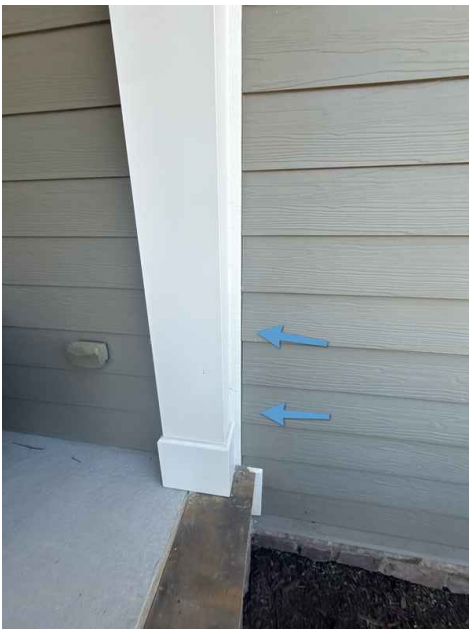
Front porch, Right

**PAINT/CAULKING**

Some areas noted on the exterior of the home that are not properly painted or sealed which could allow moisture penetration and cause damage. Recommend that all cladding/gaps/penetrations be properly maintained and sealed/painted by a qualified contractor.

Contact a qualified professional.

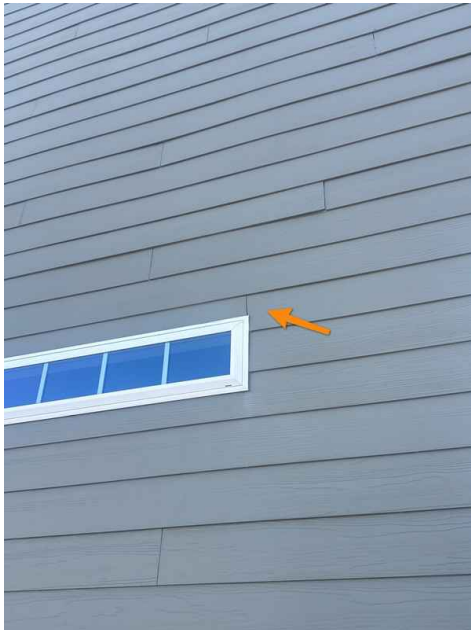
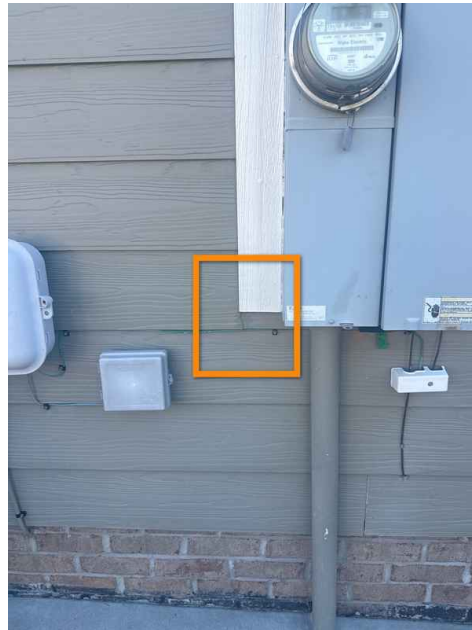
Right Exterior

3.5.1 Siding - Fiber Cement  
**SIDING CRACKED/LOOSE**

There were areas where the siding was found to be cracked and/or loose. This condition could allow for excessive air passage, pest entry and hidden moisture damage to structural components. It is recommended that a licensed general contractor repair as needed. Photos are limited examples and do not depict all areas of damage.

Contact a qualified general contractor.

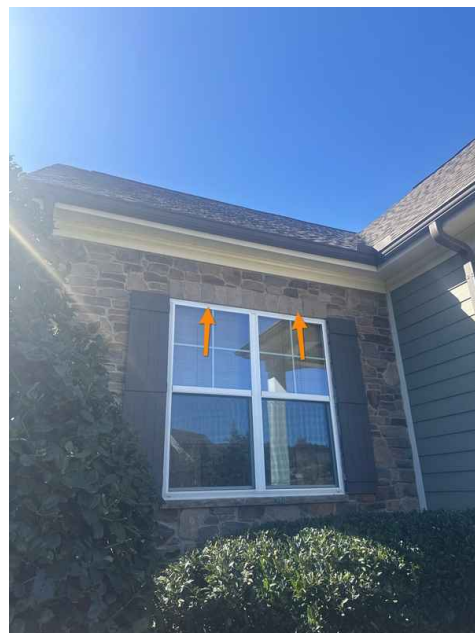
Left Exterior

#### **NO VISIBLE WEEP SYSTEM**

No visible weep system was noted at the tops of window and/or door openings. This condition may be conducive for water penetration. There was no evidence of staining or damage on the interior walls. Recommend monitoring this area, or contact a qualified siding, professional for further information if desired

Contact a qualified professional.

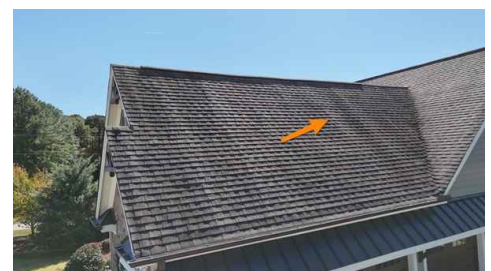
Front Right, Garage

**ROOF UNDULATIONS/UNEVEN AREAS**

Undulations/uneven areas were observed at areas of the roof when viewed from the exterior. This is a support and movement concern. Recommend review and repairs by a qualified roofing contractor.

Contact a qualified roofing professional.

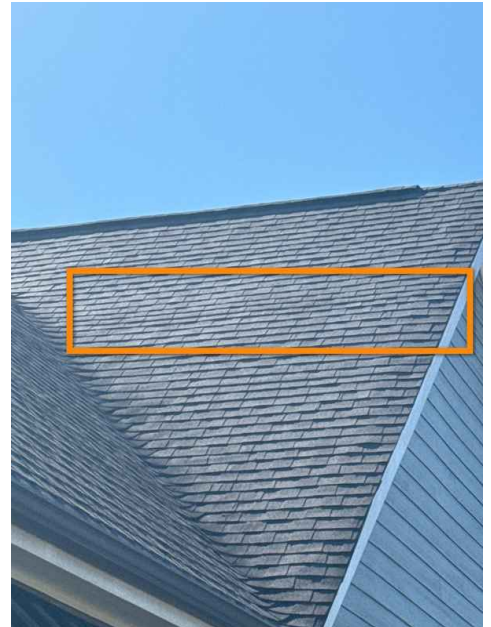
Front Right Roof

**IRREGULAR SHINGLE PATTERN**

Irregular shingle pattern noted in areas of the roof. This can cause damaged, or loose shingles, which may result in hidden damage. Recommend consulting with a roofing contractor for evaluation and repairs as deemed necessary.

Contact a qualified professional.

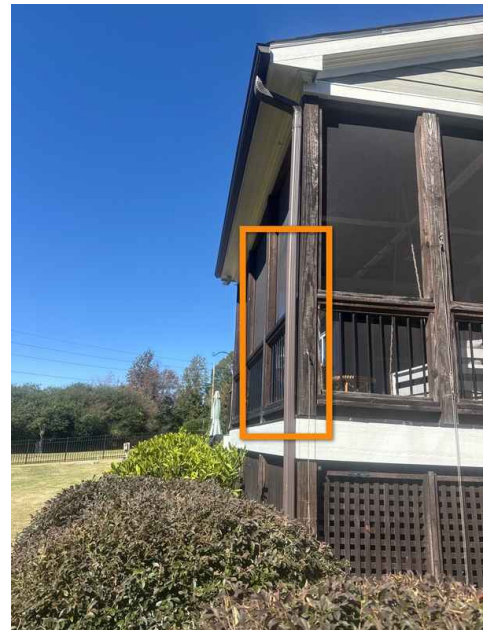
Rear Left

**DOWNSPOUT/GUTTER - LOOSE**

Gutter/downspouts are not securely installed which could result in improper drainage and moisture issues. Recommend properly securing and verifying proper drainage by a qualified contractor.

Contact a qualified gutter contractor

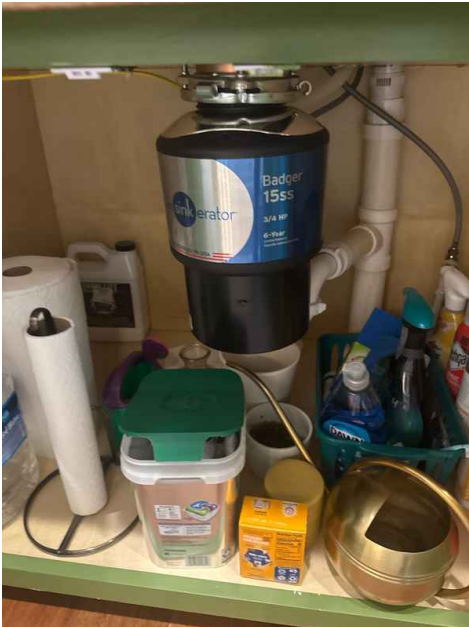
Kitchen

**DISPOSAL ON SEPTIC SYSTEM**

There is a food disposal noted under the kitchen sink, and it was observed. This house is on a septic system. Food disposals are not recommended on septic systems, and may cause damage to the system. Recommend exercising caution when using the sink drain, and client can have the disposal removed by a plumbing contractor at their discretion.

Recommend monitoring.

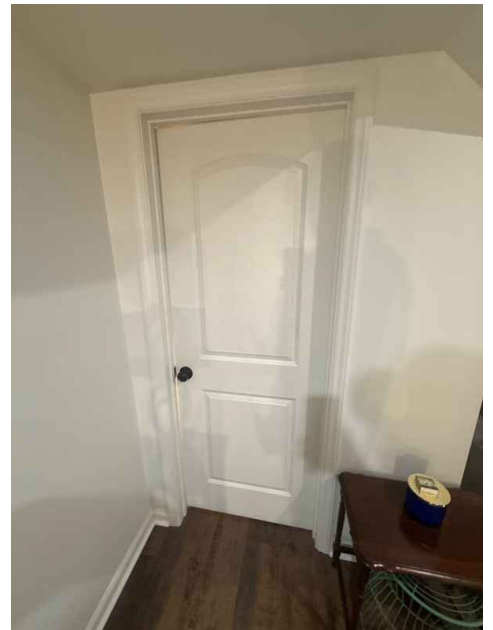
2nd Floor Bathroom

**DOOR STICKS/RUBS**

Door sticks and can be difficult to open and close or may cause damage. Recommend repair by a general repair specialist.

Contact a qualified professional.

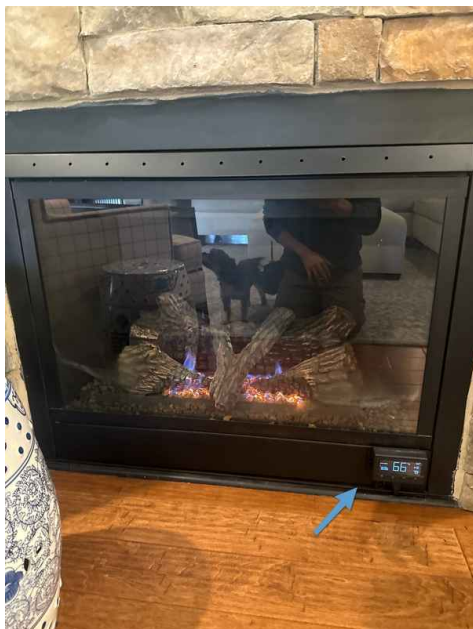
Living Room

**FIREPLACE FAN NOISE**

The fireplace fan did not turn on after the logs were lit for some time. Recommend further evaluation by a qualified fireplace contractor.

Contact a qualified professional.

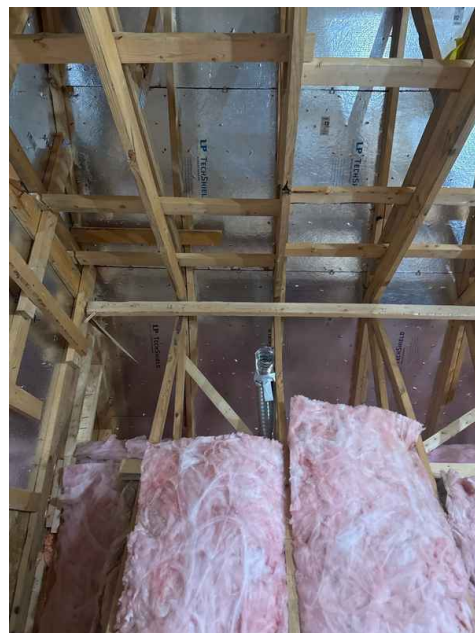
2nd Floor Bathroom

#### **BATHROOM FAN VENTS INTO ATTIC**

Bathroom fan vents into the attic, which can cause elevated moisture. Recommend a qualified contractor properly install exhaust fan to terminate to the exterior.

Contact a qualified professional.

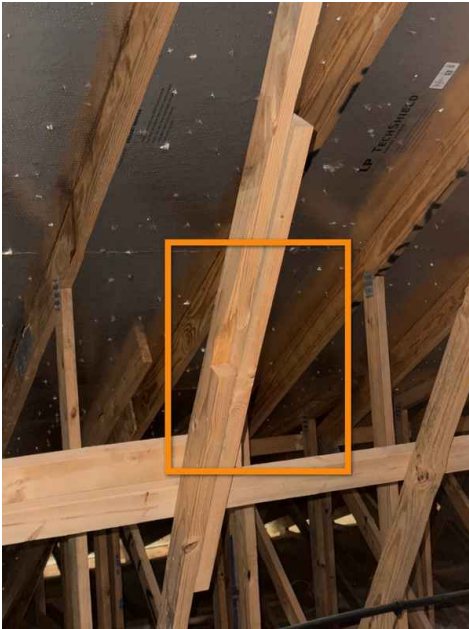
Rear Left Attic

#### **DAMAGED/MODIFIED TRUSS**

A truss was observed to be modified and/or damaged. A truss should not be modified without an engineering letter and recommend asking for any available engineering records. If the truss was not repaired per an engineer's instructions then recommend repair of the truss per a professional engineers direction and repairs should be performed by a qualified contractor.

Contact a qualified professional.

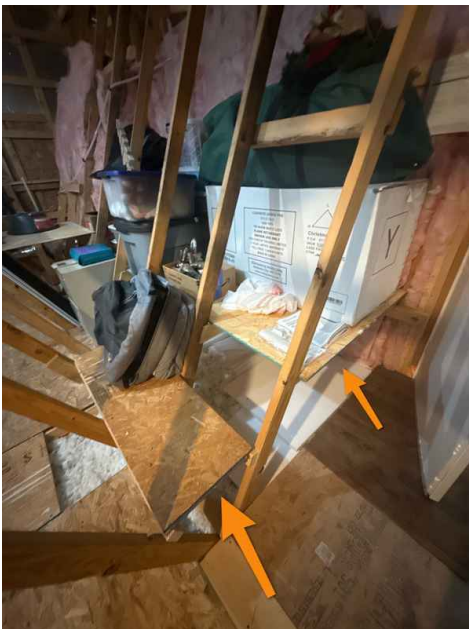
Attic entry

### SHELVING ON TRUSSES

Shelving was observed to be installed on the trusses in the attic. Trusses are an engineered product and designed to carry a specific load. Adding shelving to the trusses can increase the load and cause a support concern. Recommend removing shelving or having shelving removed by a qualified handyman.

Contact a handyman or DIY project

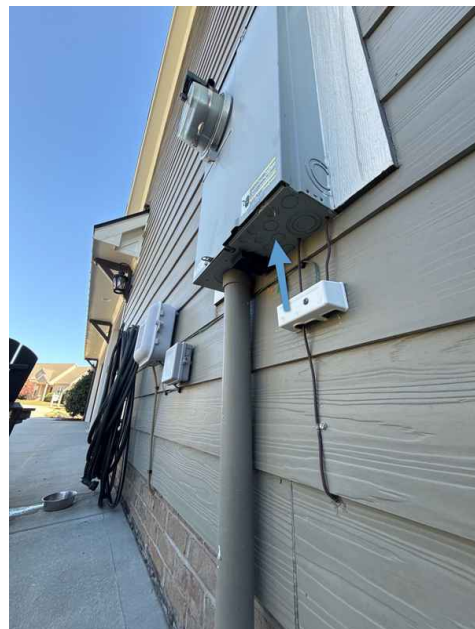
Right Exterior

### BROKEN LATCH

The latch on the cover panel is damaged and recommend repair by an electrical contractor so that the door will stay closed as intended.

Contact a qualified electrical contractor.

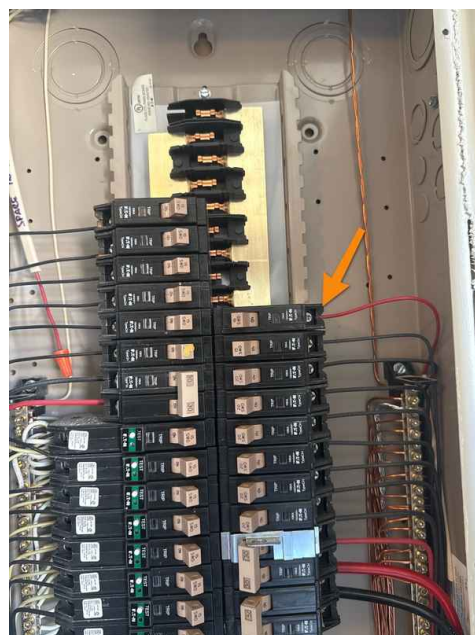
Garage

### MULTIWIRE BRANCH CIRCUIT

Although it may not have been required when the home was built, recommend that breaker handle ties be installed on the multi wire branch circuits by an electrical contractor for increased safety.

Contact a qualified electrical contractor.

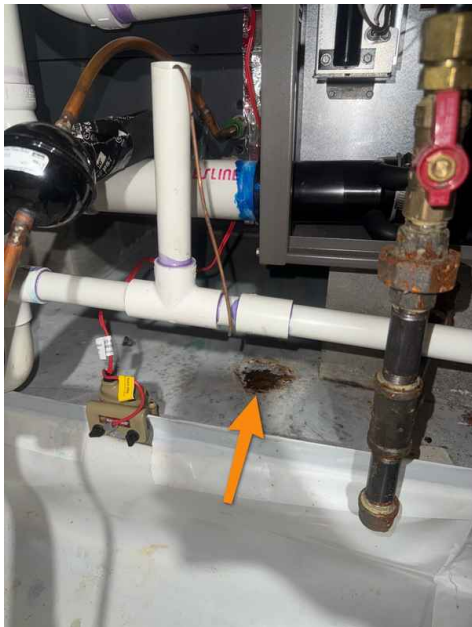
Crawlspace Middle Rear

### EVIDENCE OF PAST AND/OR PRESENT LEAK

Rust or corrosion observed which is evidence of a past and/or present leak in the system that can cause moisture damage. Recommend asking the homeowner for any available service records and further evaluation of the HVAC system by an HVAC contractor.

Contact a qualified heating and cooling contractor

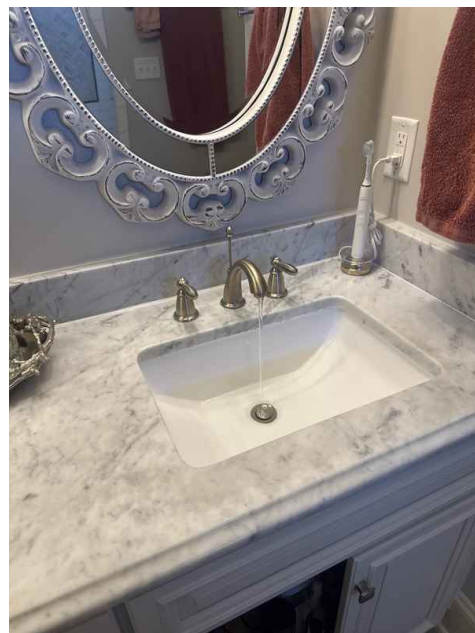
Master Bathroom

**STOPPER NOT PROPERLY INSTALLED**

The drain stopper did operate properly. This is a function concern. Recommend repair/adjustment of the drain stopper so that it will open and close as intended to allow for proper filling and draining of the basin.

Contact a qualified handyman.

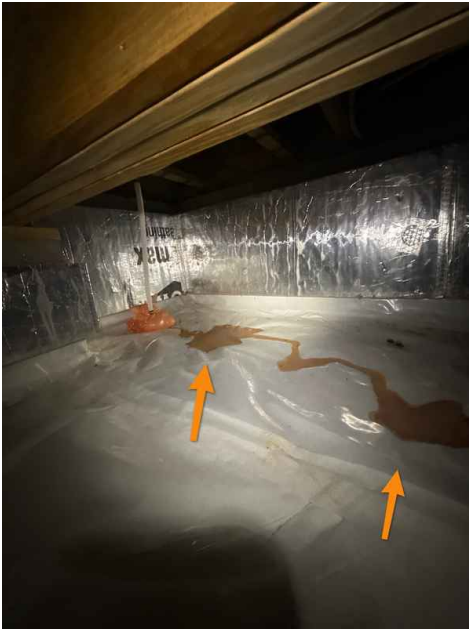
Front Right Crawlspace

**STAINING ON VAPOR BARRIER**

Moisture stains were observed on top of the vapor barrier during the crawlspace inspection. This is evidence of past or present water intrusion. Persistent moisture in a crawlspace can lead to wood rot, mold growth, and damage. Recommend evaluation by a qualified professional and repairs made as necessary.

Contact a qualified professional.
