NO PLACE LIKE HOME INSPECTION

## RESIDENTIAL INSPECTION

705 Hawksbill Dr  
Franklinton, NC 27525

11/20/2024

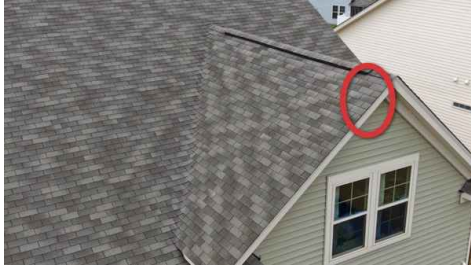
Front dormer, left edge

**LIFTED/DAMAGED SHINGLES**

Some shingles were observed to have been some minor damage or lifted. This is typical, however, it is recommended to make repairs in order to best protect against further damage or water intrusion. Recommend contacting a roofing professional for the best preventative measures.

Seller had roofing contractor evaluate and repair loose shingles that inspector noted on report. Pictures and notes available.

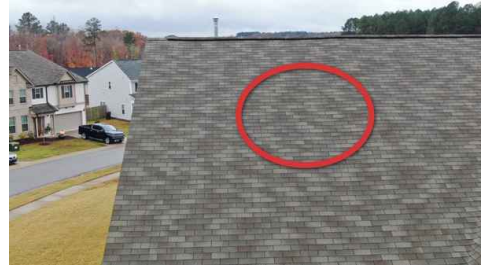
Front left valley

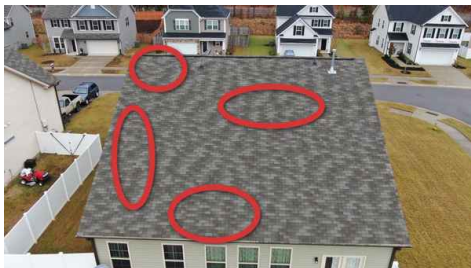
Front side of roof, some tabs with minor lifting

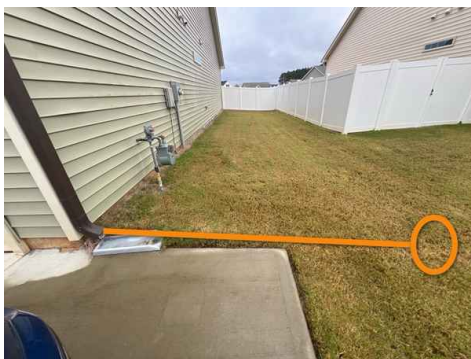
Recommend extending downspouts to move water/roof run-off away from the foundation a minimum 5 feet to prevent water intrusion at foundation.

Front Right Exterior

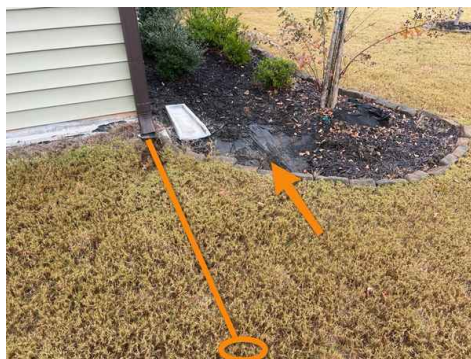
Front Left Exterior, arrow showing washout

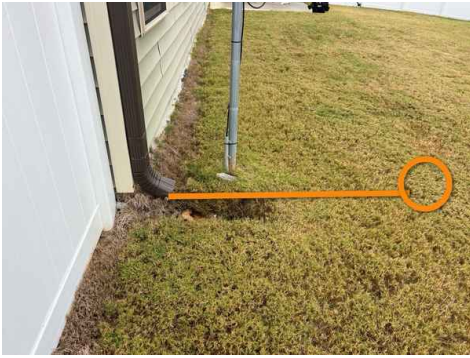
Rear Exterior

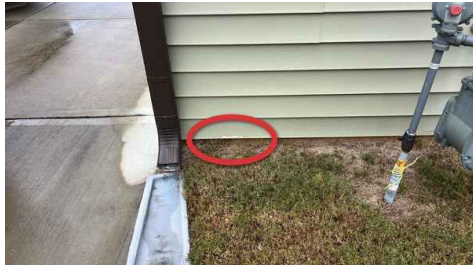
Front Right side of the house

3.1.1 Exterior - Wall Cladding Flashing and Trim: Loose/Damaged siding

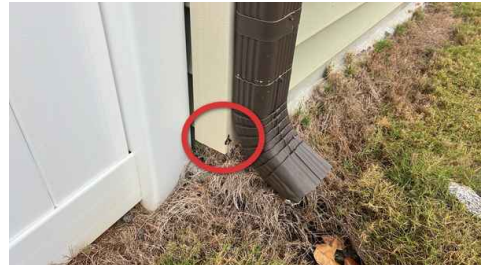
Loose/unsecured/damaged siding noted. This can become further damaged in inclement weather, and lead to water intrusion. Recommend to have a qualified siding contractor assess for corrections. .

Rear side of the house

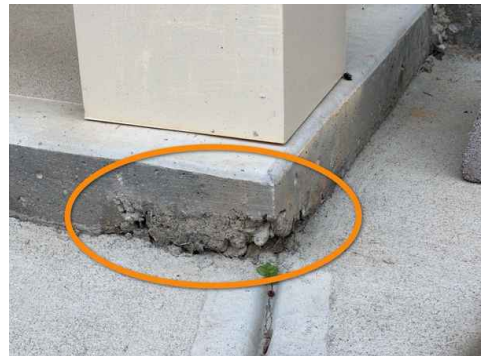
The parge coating is recommended in the area shown. Parge coating helps prevent water intrusion in areas of exposed aggregate. Recommend discussing with the builder on the adding of parge coating in the areas shown.

Front entry patio edge

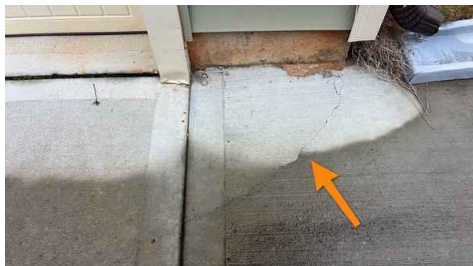
Front right of garage corner

3.4.1 Exterior - Vegetation, Grading, Drainage, Driveways, Patio Floor, Walkways and Retaining Walls (With respect to their effect on the condition of the building): Driveway typical crack

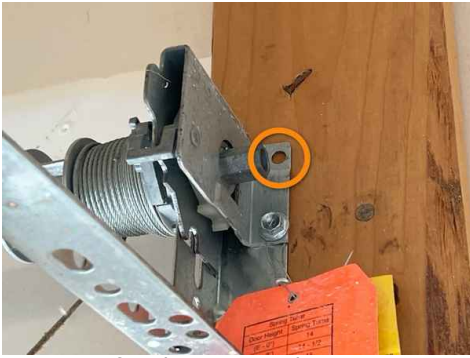
A fastener for the garage door frame is missing. This may loosen and cause damages in the future. Contact a garage door specialist to assess for repairs.

Fastener for the tension bar mount

Contact a qualified garage door contractor.

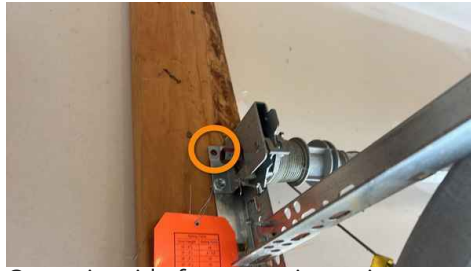
Opposite side from previous picture

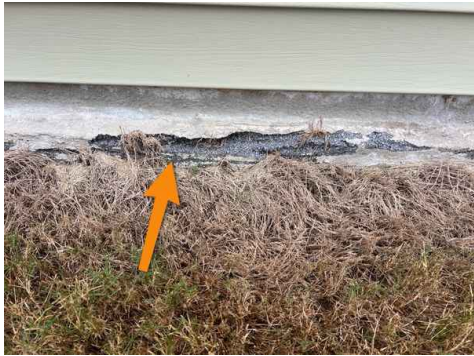
Rigid foam insulation is missing/damaged on the concrete foundation slab noted. Rigid foam insulation is installed to insulate the concrete slab from cold exterior temperatures, which can cause the floor in the home to be cold. Recommend a qualified licensed contractor inspect the rigid foam insulation further to determine and perform corrective measures deemed necessary.

For reference

Contact a qualified insulation contractor.

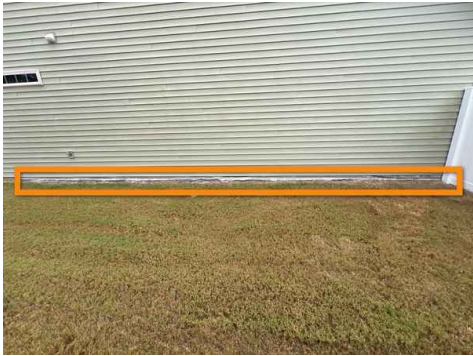
Right side of the house

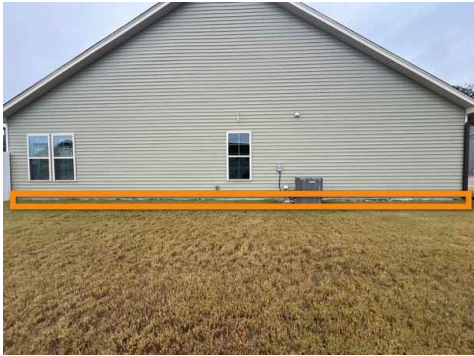
Left side of the house

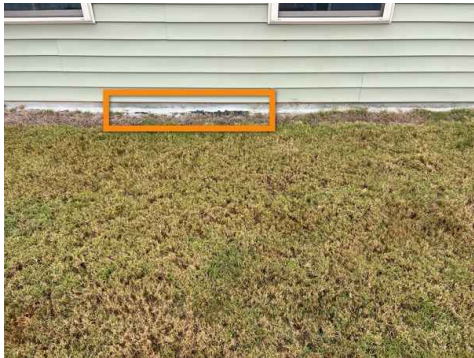
Rear side of the house

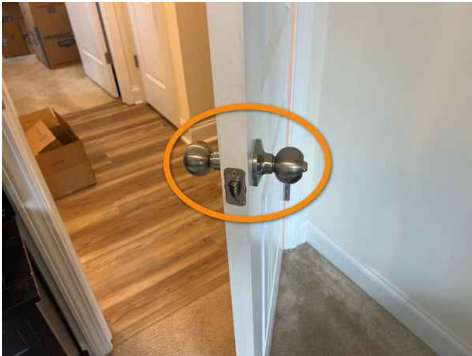
At the time of inspection noted door knob/handle was loose. This can damage the door and degrade the function of the knob and it's elements. Recommend diy/handyman to repair or replace knob/handle.

1st Floor Front Bedroom

Contact a handyman or DIY project

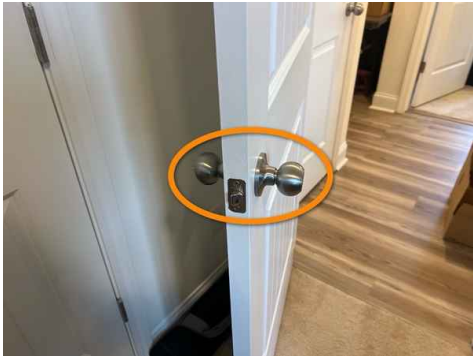
1st Floor Rear Left Bedroom

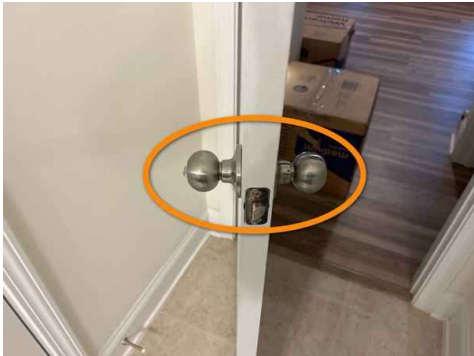
Master Bathroom

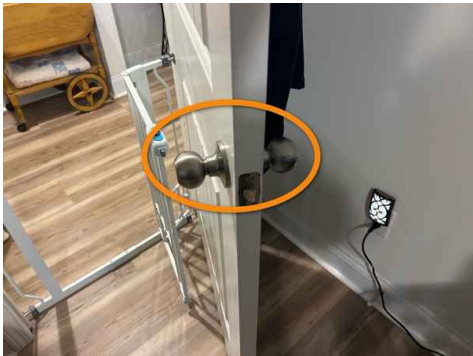
Master Bedroom

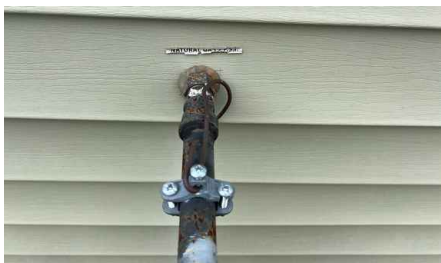
#### Fuel Storage and Distribution Systems (Interior fuel storage, piping, venting, supports, leaks): Distribution Gas line type

Bonded, Black Iron

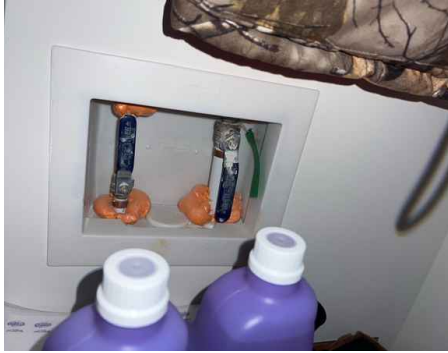
Lever

Note: The shut off valve is not operated during the home inspection. The effectiveness or condition of the valve was not determined.

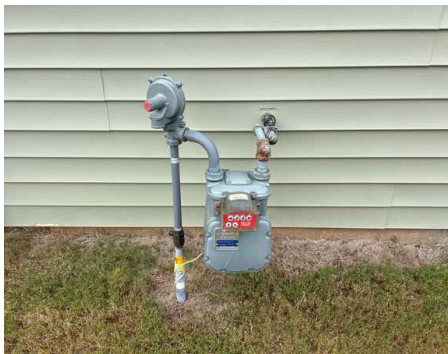
## Fuel Storage and Distribution Systems (Interior fuel storage, piping, venting, supports, leaks): Gas shut - off

Right side of the house

The main fuel shut off is at gas meter.

Note: The shut off valve is not operated during the home inspection. The effectiveness or condition of the valve was not determined.

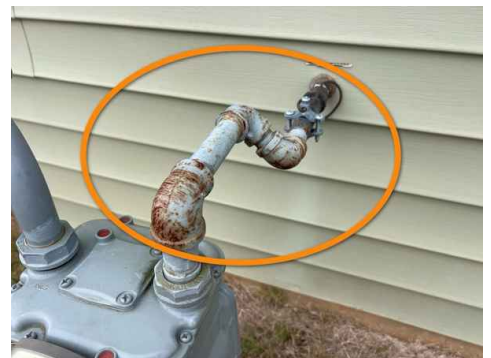
Rust/Corrosion present at gas meter. No active gas leak noted at the time of inspection. Condition is conducive to damage to gas line that can cause leakage. Recommend evaluate/repair/replace by qualified general contractor as directed.

Gas supply, outlet side of meter

Contact a qualified general contractor.

Seller contacted Dominion gas regarding surface rust. Theyint

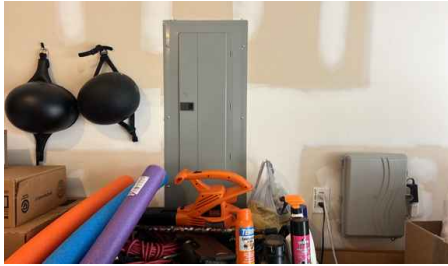
The main shut off is at the electric panel.

Note: The shut off was not operated during the home inspection. The effectiveness or condition of the valve was not determined.

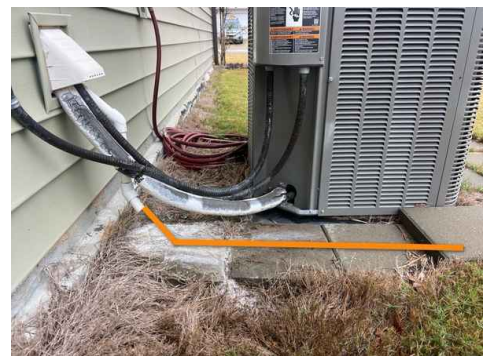
Recommend extending condensation/drain line to avoid water intrusion into the unit. Contact a handyman to extend the pvc line further from the foundation.

Left Exterior

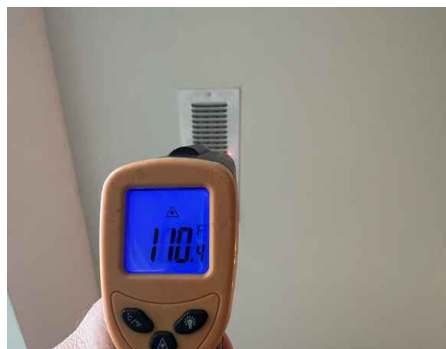
**General: Unit 1 Gas Furnace**  
**Heating cycle ambient test**  
 (supply register)

**Heating Equipment: Heat Type**  
 Furnace

**Heating Equipment: Energy Source**  
 Gas

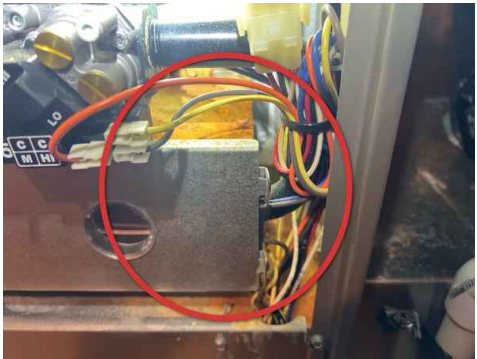
Rust/corrosion noted at and around heat exchanger. This is indicating possible improper combustion/exhaust process that can damage heating element and carbon monoxide concern. Recommend evaluate/repair/replace by qualified HVAC contractor as directed to prevent further damage.

Furnace on heat exchanger box

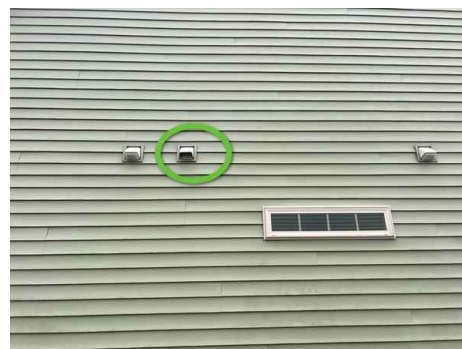
### Venting Systems (Kitchens, Baths and Laundry): Dryer vent hood location

Right side of the house

Dryer vent

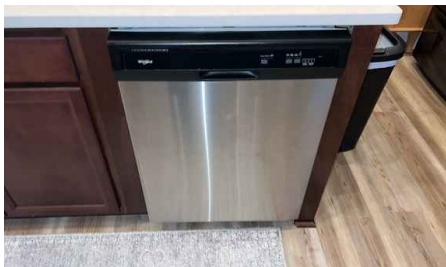
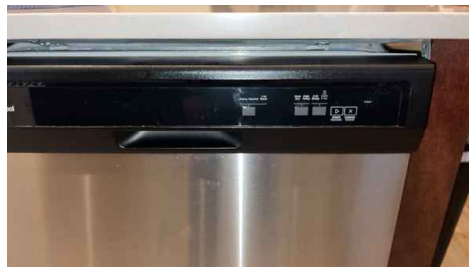
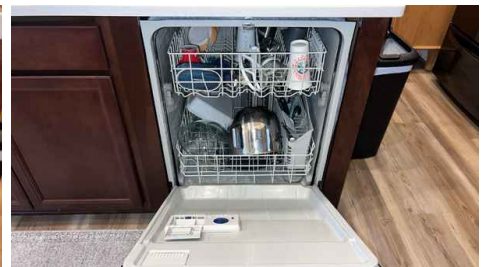
#### Dishwasher: Dishwasher Standard of Practice

Dishwashers - Any assessment of an installed dishwasher is limited to a single cycle operation of the motor and visual check of other readily accessible components. Dish washing/cleaning adequacy and soap dispenser function were not evaluated. This is a high maintenance item. Seal leaks may develop after vacancy or other inactive periods. If concerns, recommend evaluate by qualified appliance contractor and repair/replace as directed.

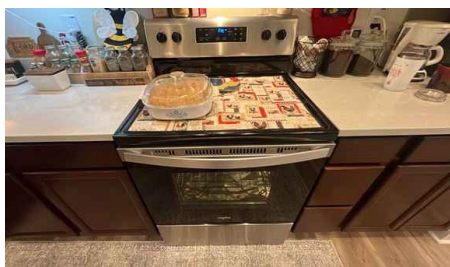
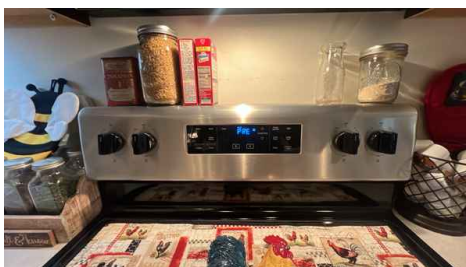
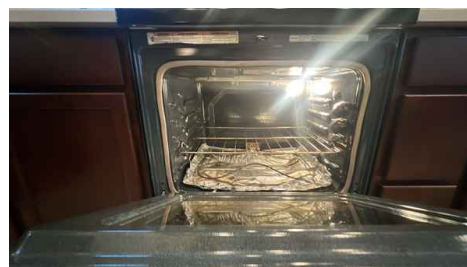
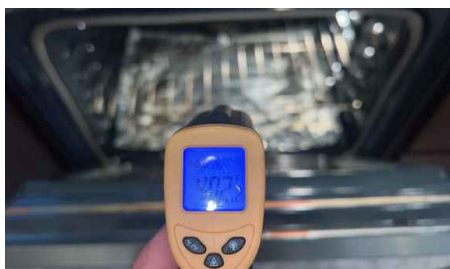
### Ranges/Ovens/Cooktops: Oven Inspection Method

The oven was operated by placing into "Bake" mode and heat was produced from the element(s). Temperature calibration, "clean" options, and other functions are not tested for. Client is recommended to seek further evaluation of additional functions if desired/needed.

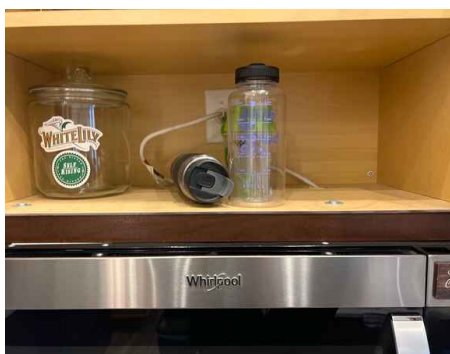
### Range Hood (s): Vent Hood Inspection Method

The exhaust fan was operated until a light suction was created. The effectiveness of the exhaust was not determined.

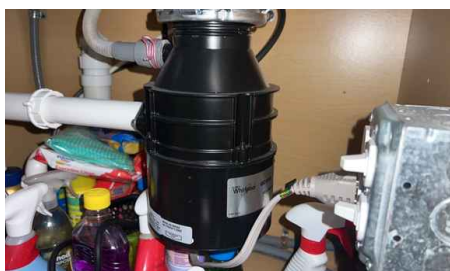
### Food Waste Disposer: Food Disposal Inspection Method

The garbage/sink disposal was inspected by activating it at normal controls and ensuring the motor ran, while also looking for leaks from the unit, an exposed power cord, heavy rust, or other deficiencies. The unit is not tested to determine if it can effectively "grind" food waste.

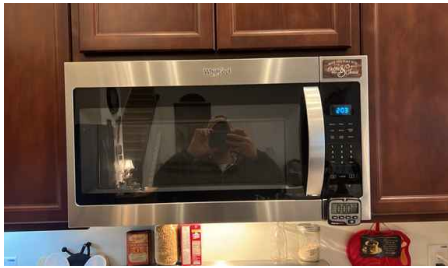
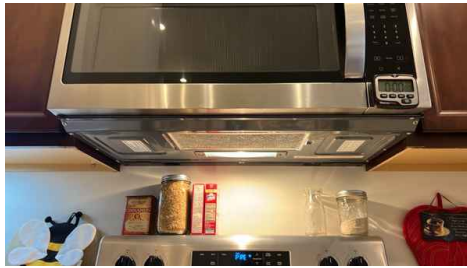
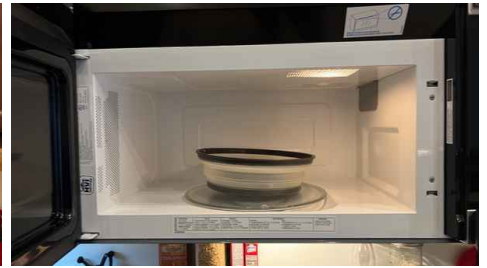
## Microwave Cooking Equipment: Microwave Inspection Method

The microwave was tested by initiating it on "Cook" mode for 10 second with a LED microwave tester, and the unit powered on at the time of inspection. The efficiency of the unit or other functions are not tested.
