## RESIDENTIAL REPORT

164 Pinto Dr  
Zebulon, NC 27597

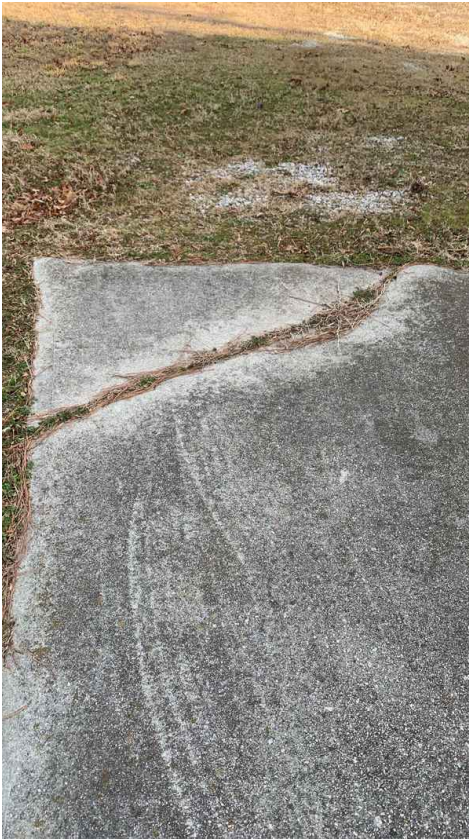
Exterior was inspected. There are signs of cracking in concrete. This can get worse over time, creating function issues. Contact a qualified contractor to repair.

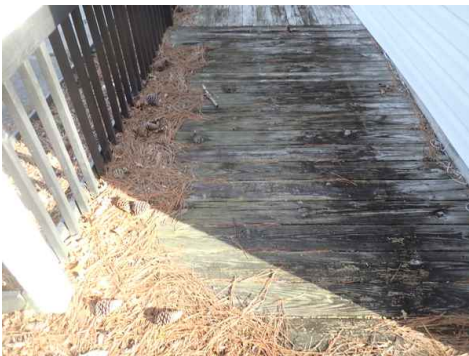
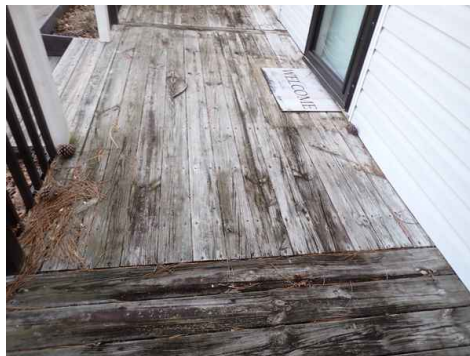
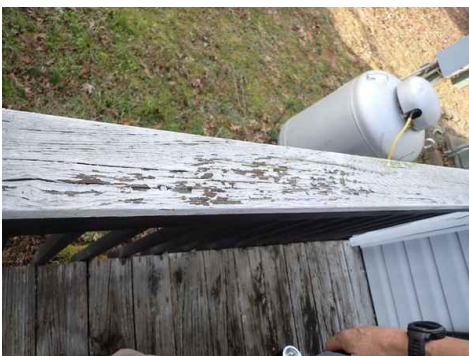
Inspected the deck. There are multiple areas that have damaged and/or worn materials. This can get worse over time, causing possible support issues. Contact a qualified contractor to repair.

Contact a qualified general contractor.

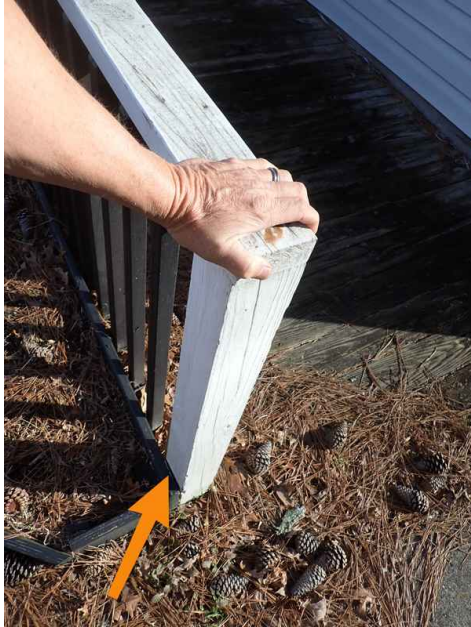
## 2.3.2 Decks, Balconies, Porches &amp; Steps

Porches and deck was inspected. There are loose handrails. This is can cause a fall hazard. Contact a qualified contractor to repair.

Contact a qualified general contractor.

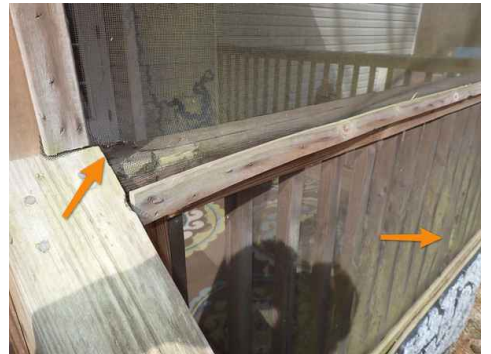
## 2.3.3 Decks, Balconies, Porches &amp; Steps

Screened porch was inspected. There are one or more areas where the screen is damaged/missing. This can allow wildlife to enter into porch area. Contact a qualified contractor to repair.

Contact a qualified general contractor.

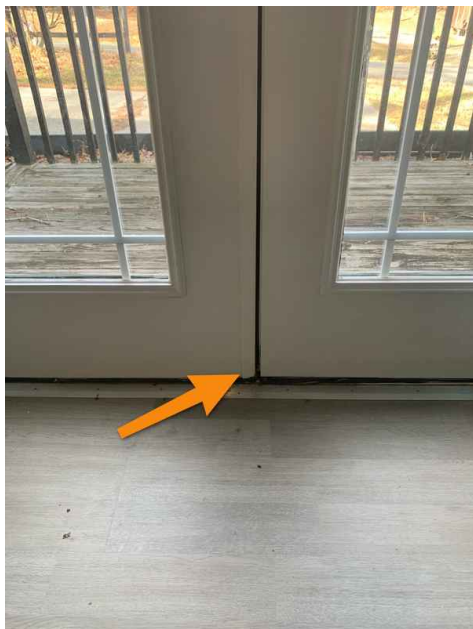
## 2.4.1 Exterior Doors

Exterior doors were inspected. There are one or more entry doors that have gaps around the frame. This can allow air, water and/or wildlife intrusion. Contact a qualified contractor to repair.

Contact a qualified general contractor.

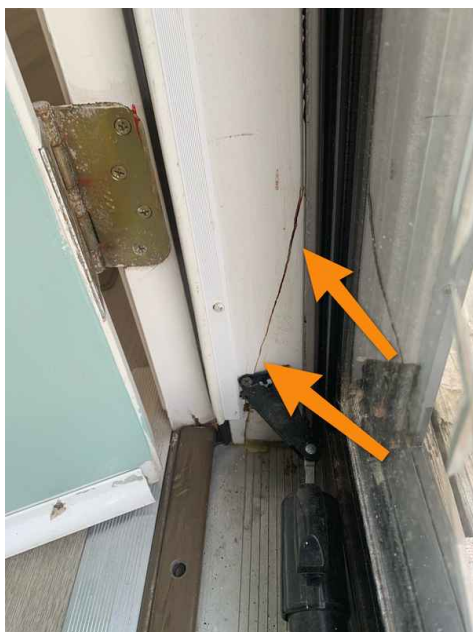
#### 2.4.2 Exterior Doors

Inspected exterior doors. There are one or more doors and/or frames that have damage. This can make it difficult to properly open/close doors. Contact a qualified contractor to repair.

Front entry door.

Contact a qualified general contractor.

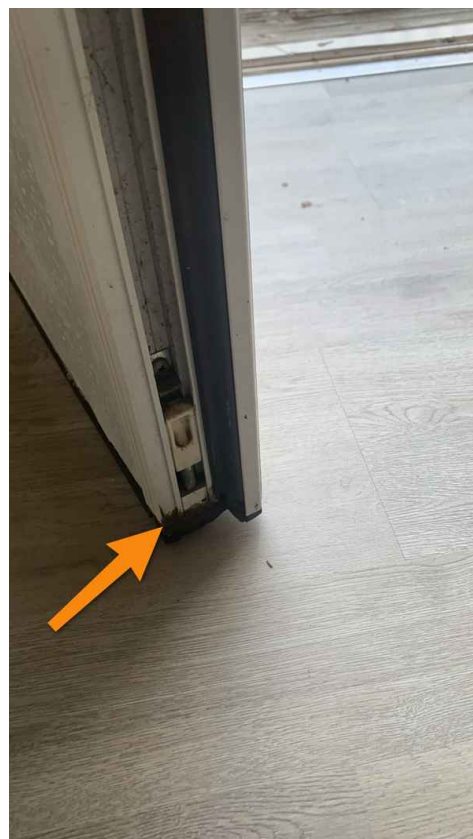
Front French door.

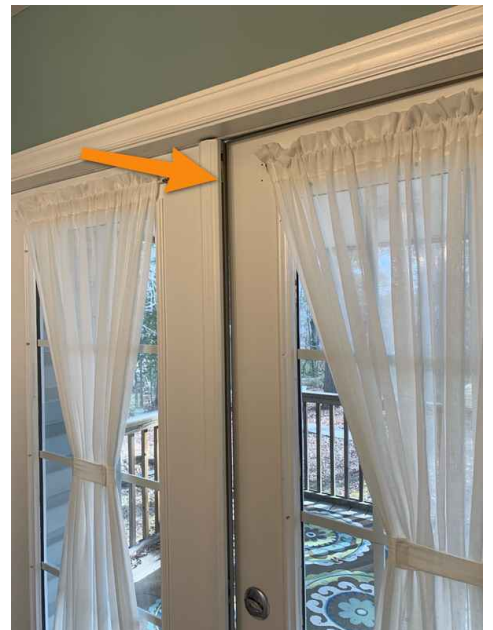
Inspected exterior doors. One or more doors rub on the frame. This can prevent proper operation of the door. Contact a qualified contractor to repair.

Back entry door.

Contact a qualified general contractor.

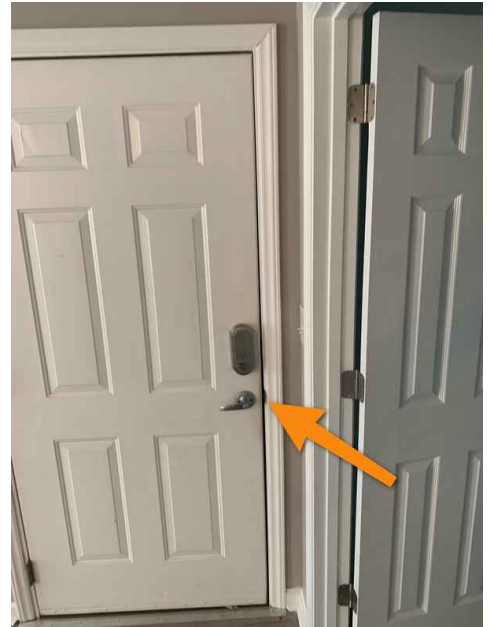
#### 2.4.4 Exterior Doors

Inspected exterior doors. One or more doors do not close or latch properly. This can make it difficult to properly operate door. Contact a qualified contractor to repair.

Passage lock does not latch at front entry door.

Contact a qualified general contractor.

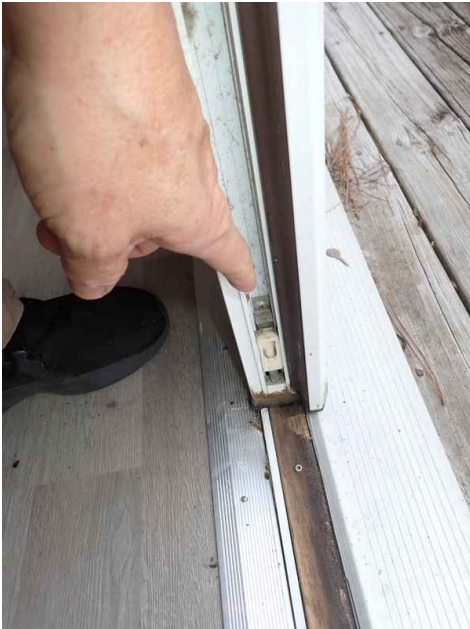
Inspected exterior doors. The passive french door panel does not lock at the bottom pin. This can prevent proper operation of the door. Contact a qualified contractor to repair.

Contact a qualified general contractor.

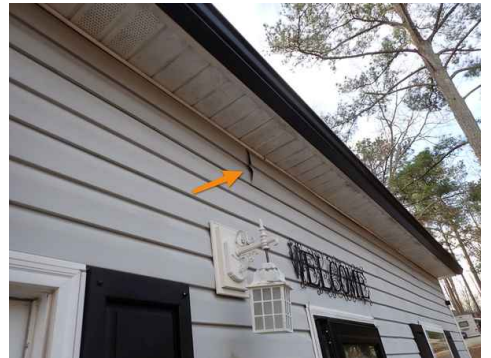
### 2.6.1 Siding, Flashing & Trim

Inspected siding and/or trim. There are one or more areas around the home where the siding is not properly secure. This can allow the siding/trim to become detached during high winds and allow moisture penetration in the affected area. Contact a qualified contractor to repair.

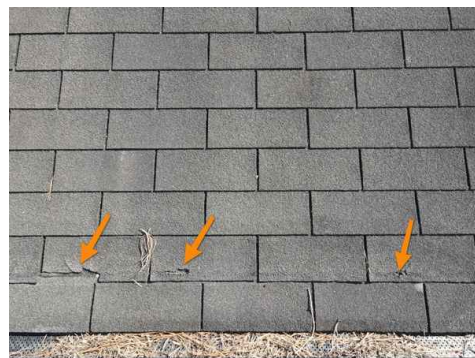
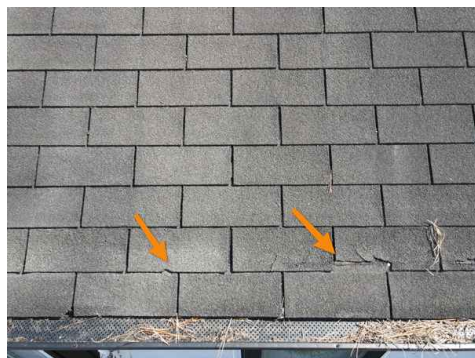
Roof coverings were inspected. There is damage to one or more areas of the roof covering. Damaged coverings can allow moisture infiltration and decrease the ability to shed water. Contact a qualified contractor to repair.

Contact a qualified roofing contractor

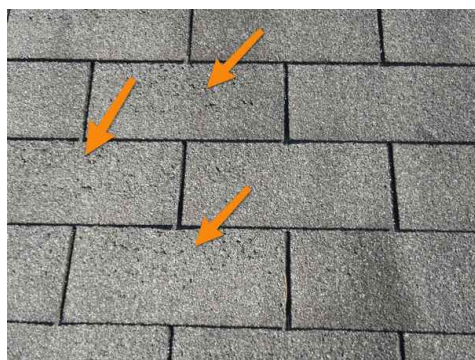
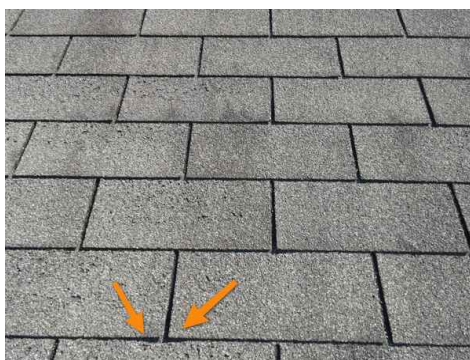
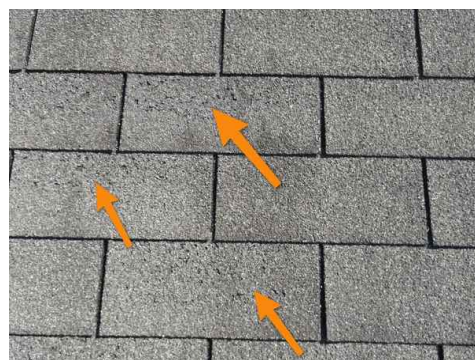
## 3.1.2 Coverings

Inspected roof coverings. The shingles are showing signs of wear. Excessive wear can affect the performance of the coverings and allow for leaks. Contact a qualified contractor to repair.

Shingle edges curling.

Contact a qualified roofing contractor

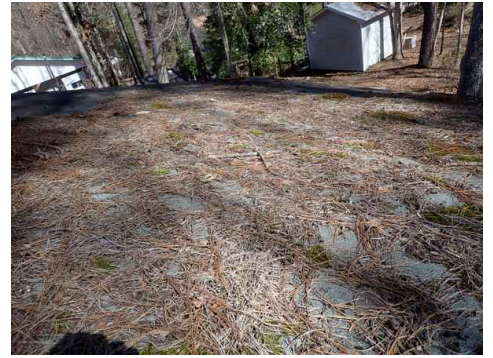
## 3.1.3 Coverings

Inspected roof coverings. There is debris on areas of the roof. This can damage roof coverings and prevent proper water shedding, cause leaks, and also limits inspection. Contact a qualified contractor to repair.

Contact a qualified general contractor.

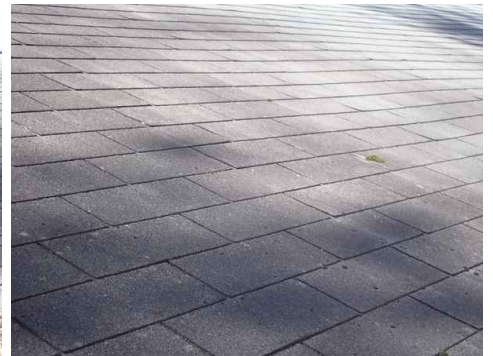
## 3.1.4 Coverings

Inspected roof coverings. Algae growth is present on shaded areas of the roof. Algae can decrease the life of the roof coverings. Contact a qualified contractor to repair.

Contact a qualified general contractor.

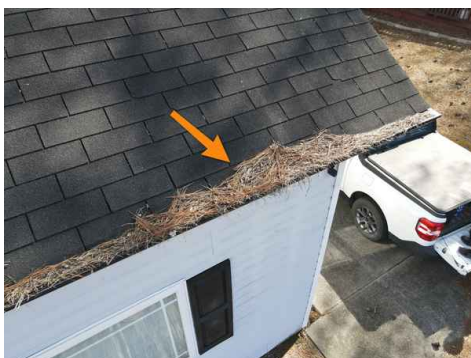
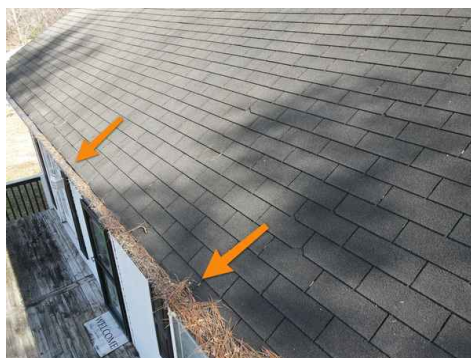
## 3.6.1 Roof Drainage Systems

Inspected the gutter system. Debris has accumulated in the gutters/downspouts. Water can roll over gutters and accumulate along the foundation. This can cause structural damage along the affected area. Contact a qualified contractor to repair.

Contact a qualified general contractor.

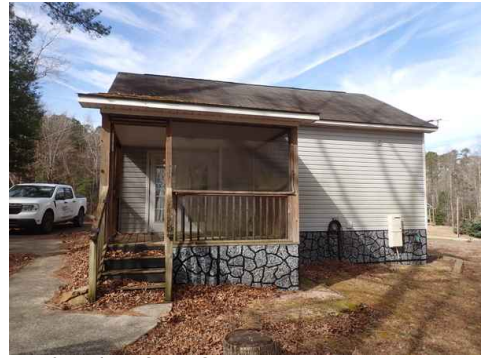
## 3.6.2 Roof Drainage Systems

Inspected gutter system. There are one or more areas where a gutter system is not installed. This can allow water run off near the foundation causing unwanted movement in structure. Contact a qualified contractor to repair.

Back side of roof.

Contact a qualified gutter contractor

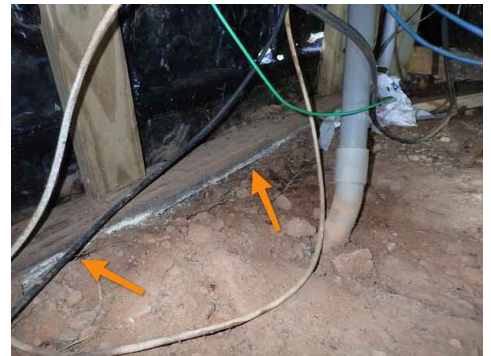
## 4.1.1 Foundation, Basement &amp; Crawlspaces

Inspected foundation. There are wood supports in contact with soil. This can cause wood rot to supports. Contact a qualified contractor to repair.

Contact a qualified general contractor.

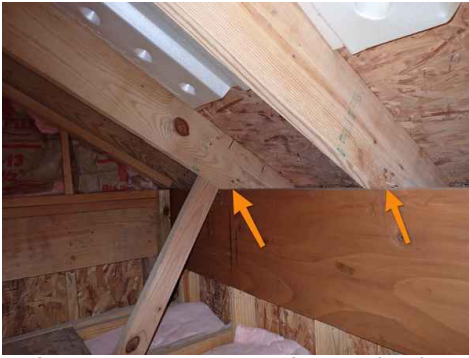
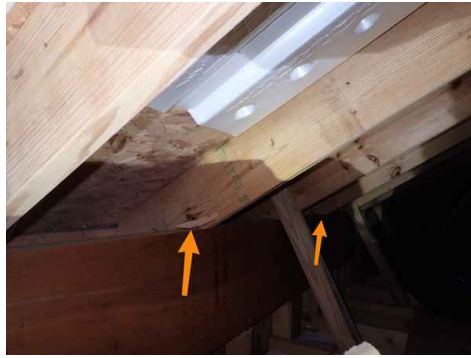
Rafter ties missing on rafters at back side of attic.

Contact a qualified general contractor.

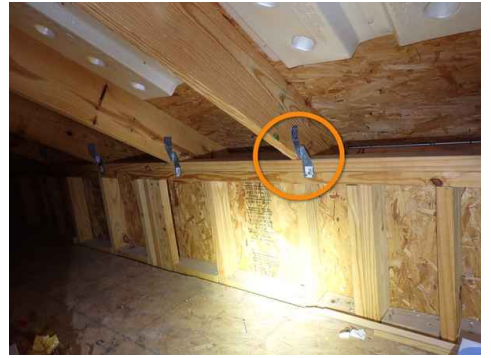
## 4.5.1 Attic Structure/Framing

Inspected attic structure. There are missing fasteners on trusses. This can decrease the structural integrity of support beam. Contact a qualified contractor to repair.

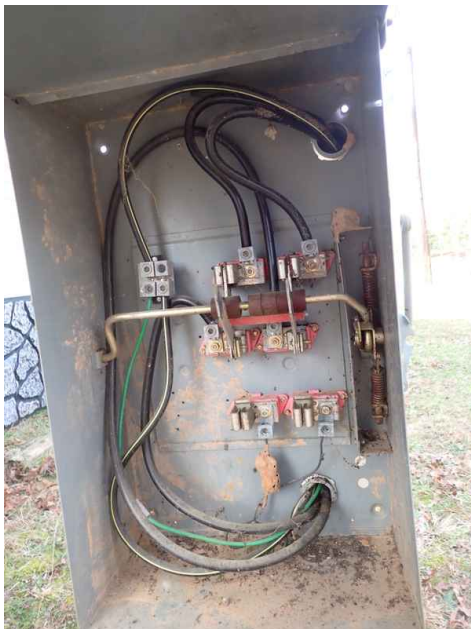
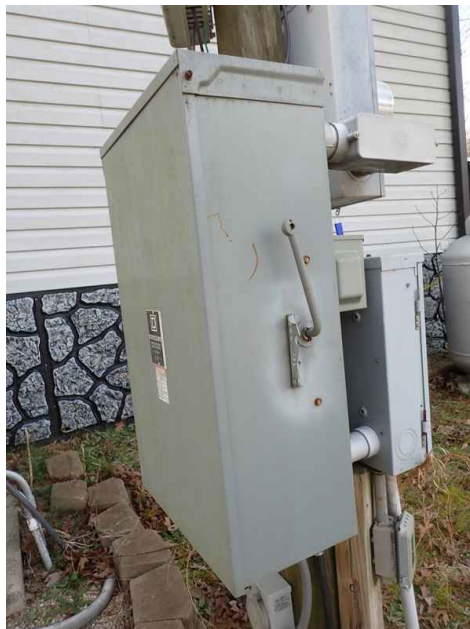
## 6.1.2 Service Entry

Inspected electrical system. The throw switch panel box cover door is not secure. This can allow access to energized components. Contact qualified electrical contractor to repair.

Contact a qualified electrical contractor.

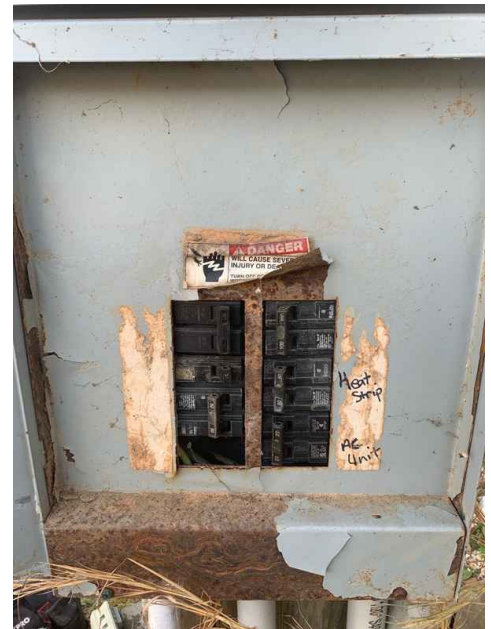
## 6.2.1 Service and Grounding Equipment, Main Over current Device, Main and Distribution Panels

Inspected the electrical panel. There are breakers that are not labeled. This can cause a safety hazard to contractors working with breakers and wiring. Contact a qualified contractor to repair.

Contact a qualified electrical contractor.

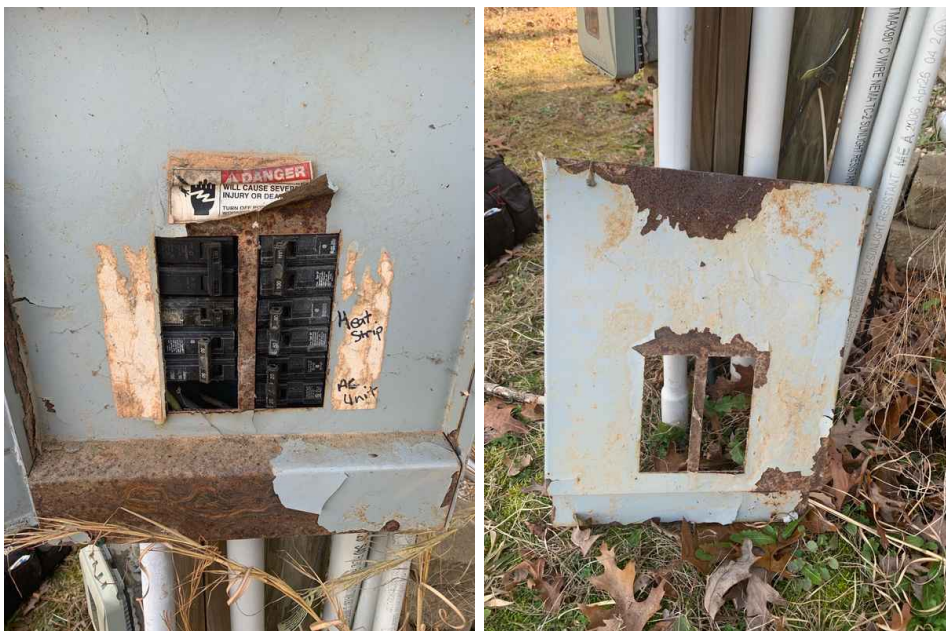
6.2.2 Service and Grounding Equipment, Main Over current Device, Main and Distribution Panels

Inspected electrical panels. There is corrosion on components in the panel. This can create a short and safety hazard. Contact a qualified contractor to repair.

Contact a qualified electrical contractor.

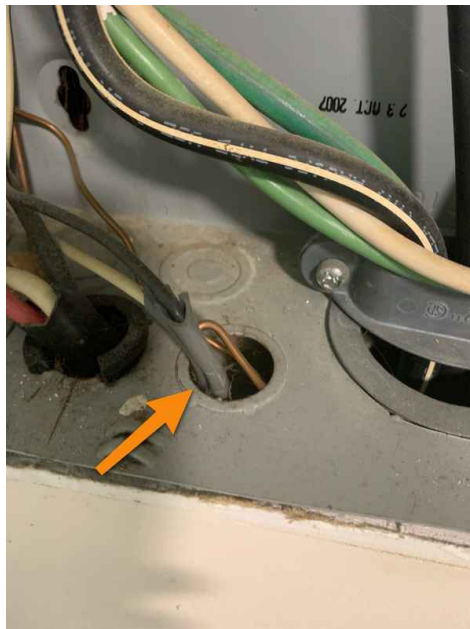
Laundry sub panel box.

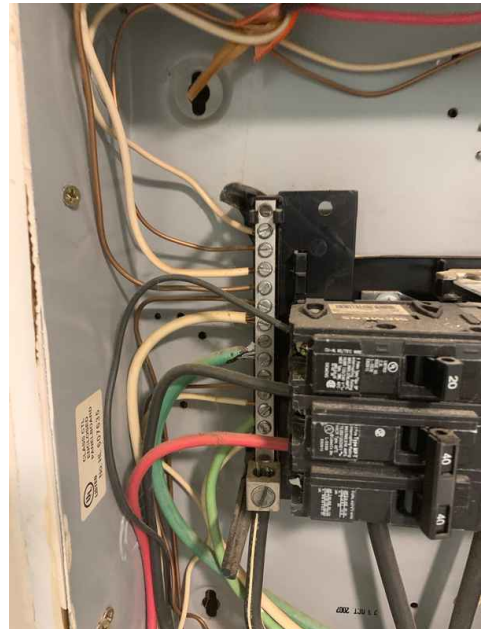
6.2.6 Service and Grounding  
Equipment, Main Over current  
Device, Main and Distribution Panels

Inspected the sub panel. A sub panel is not bonded and separated properly. The ground wires and neutral wires should be on separate bus bars. This can cause a safety hazard. Contact a qualified contractor to repair.

Neutral and ground wires on same bus bar at laundry sub panel box.

Contact a qualified electrical contractor.

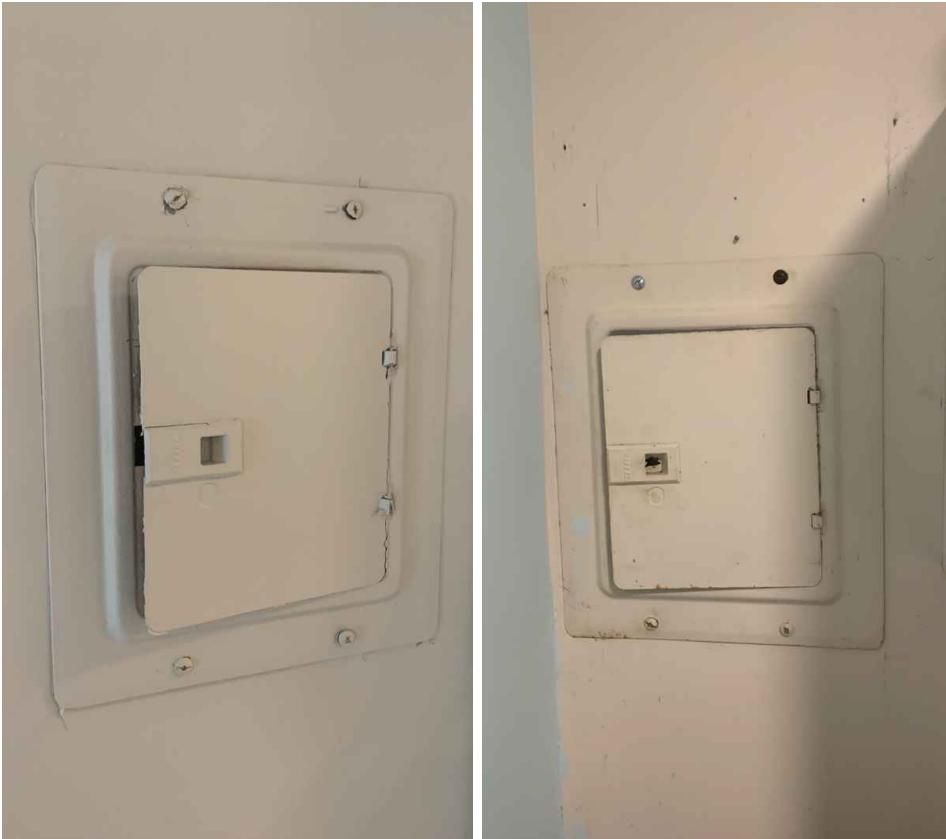
6.2.7 Service and Grounding Equipment, Main Over current Device, Main and Distribution  
Panels

Inspected electrical system. The panel cover appears to be painted and/or caulked to the drywall. This can make it difficult to remove panel without causing damage to the wall. Contact a qualified contractor to repair.

Contact a qualified electrical contractor.

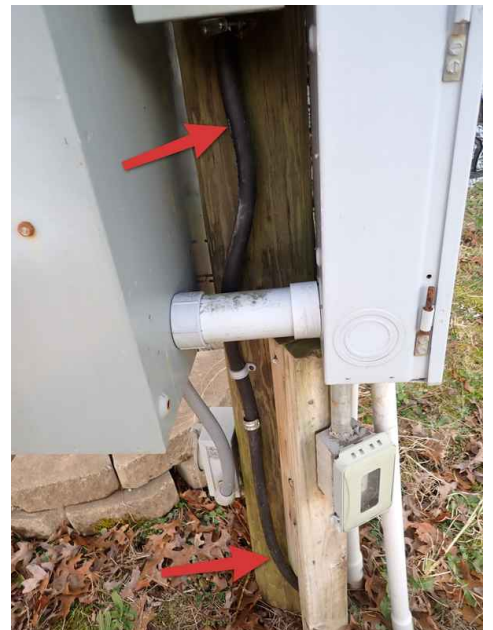
6.3.1 Branch Circuit Conductors, Over current Devices and Compatibility of Their Amperage & Voltage

Inspected branch wiring. There is branch wiring exposed. This can cause safety hazard if grabbed. Contact a qualified contractor to repair.

Circuit wiring not protected in conduit.

Contact a qualified electrical contractor.

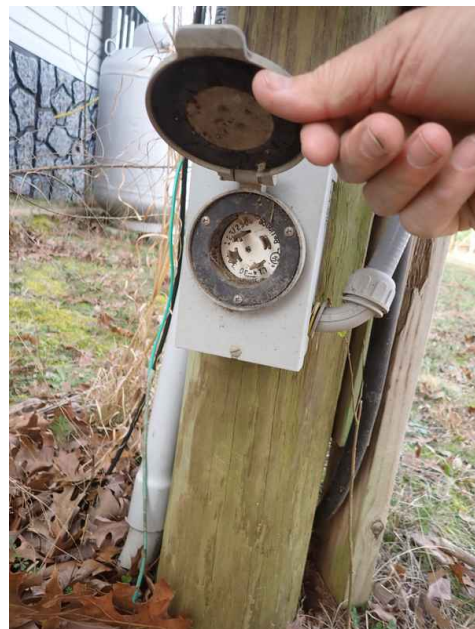
6.3.2 Branch Circuit Conductors, Over current Devices and Compatibility of Their Amperage & Voltage

Inspected electrical system and components. There are added accessory items to the home's electrical system. The accessory items were not part of the general home inspection. These items can cause a shock hazard if not installed correctly. Contact a qualified contractor to evaluate and repair.

Generator receptacle.

Contact a qualified electrical contractor.

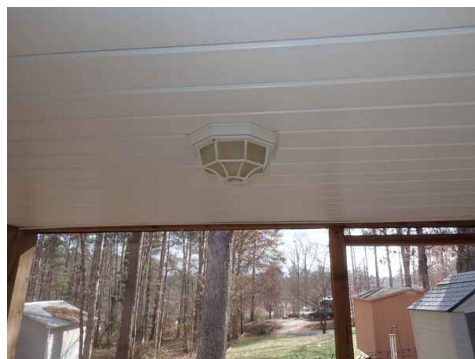
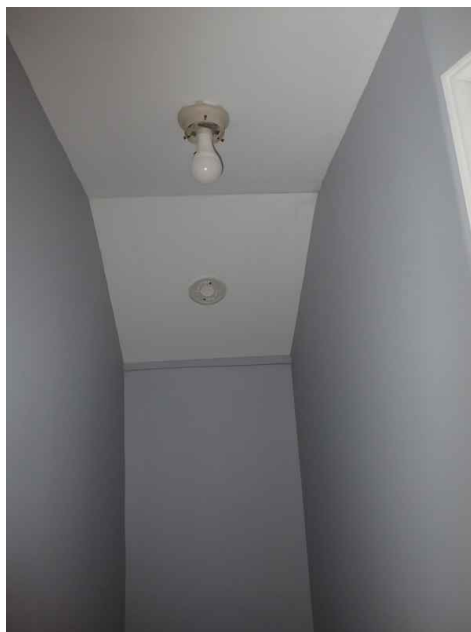
6.4.1 Connected Devices and Fixtures

Inspected lights throughout the home. One or more lights are not operating at the interior/exterior of the home. The non functioning lights can be a electrical issue. Contact a qualified contractor to repair.

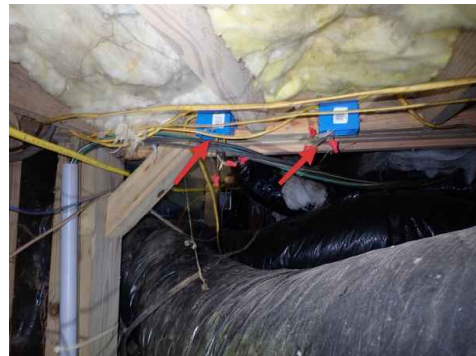
6.4.2 Connected Devices and Fixtures

Inspected electrical devices and connections. There are exposed wires outside of a junction box/receptacle. Exposed wires can cause a shock hazard. Contact a qualified contractor to repair.

Contact a qualified electrical contractor.

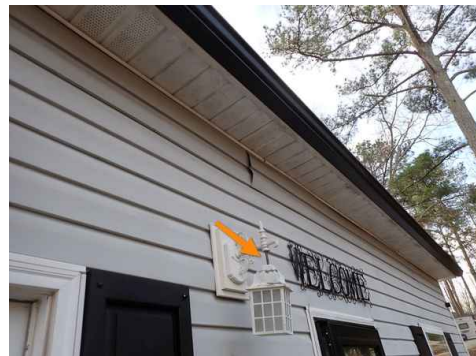
#### 6.4.3 Connected Devices and Fixtures

Inspected light fixtures. There are one or more fixtures that are not fully attached. The loose fixtures can detach completely and/or damage fixtures. Contact a qualified contractor to repair.

Contact a qualified electrical contractor.

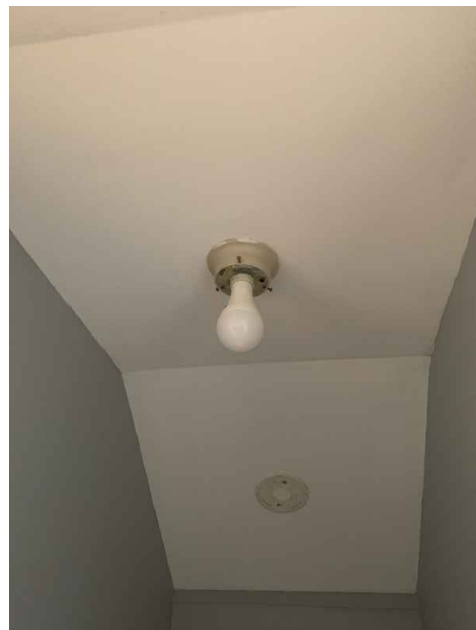
#### 6.4.4 Connected Devices and Fixtures

Inspected light fixtures. There is one or more fixtures missing light covers. This can decrease protection of light bulbs. Contact qualified electrical contractor to repair.

Contact a qualified electrical contractor.

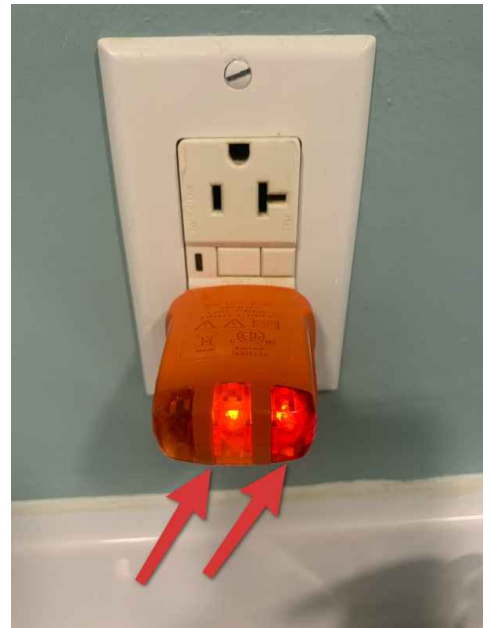
### 6.5.2 Polarity and Grounding of Receptacles

Light pattern indicates hot and neutral reversed at bathroom GFCI receptacle.

Contact a qualified electrical contractor.

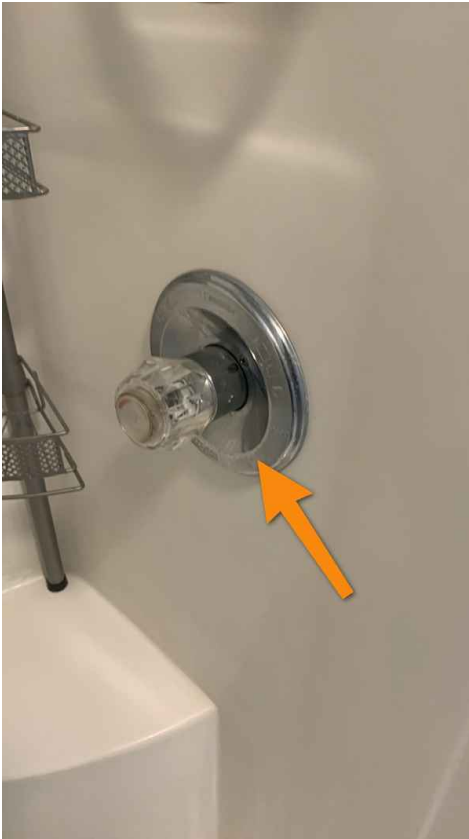
Shower faucet loose.

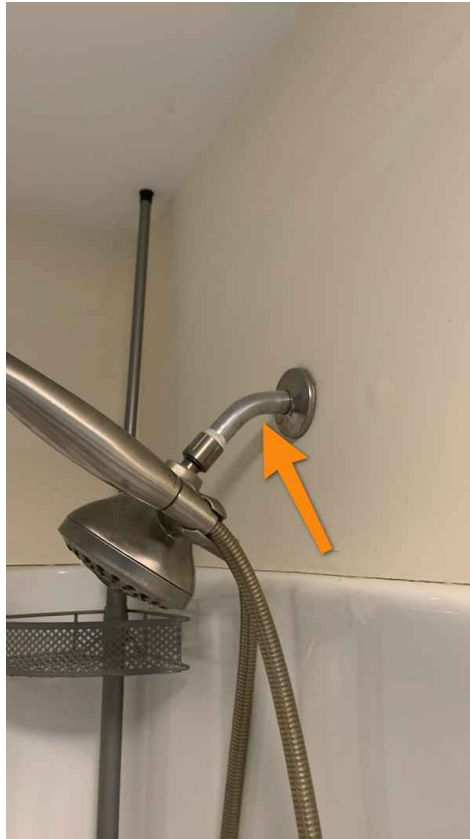
Shower arm post loose.

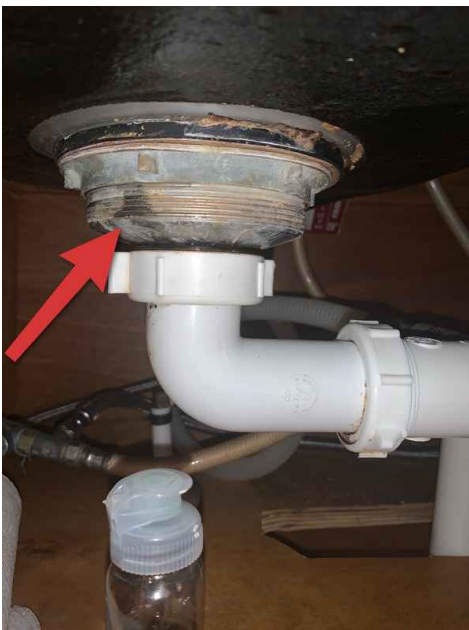
## 9.1.2 Fixtures / Faucets

Left sink drain leaking under kitchen sink.

Contact a qualified plumbing contractor.

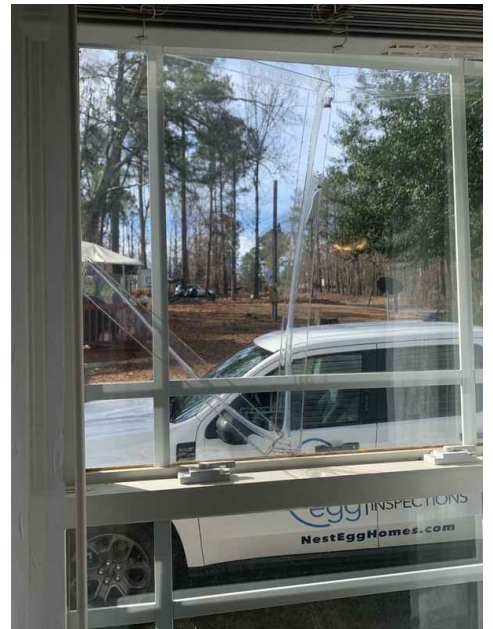
Living Room

**BROKEN GLASS WINDOW**

Inspected windows. There are one or more windows that are cracked or broken. The broken glass is a safety hazard to the occupants. Contact a qualified contractor to repair.

Contact a qualified general contractor.

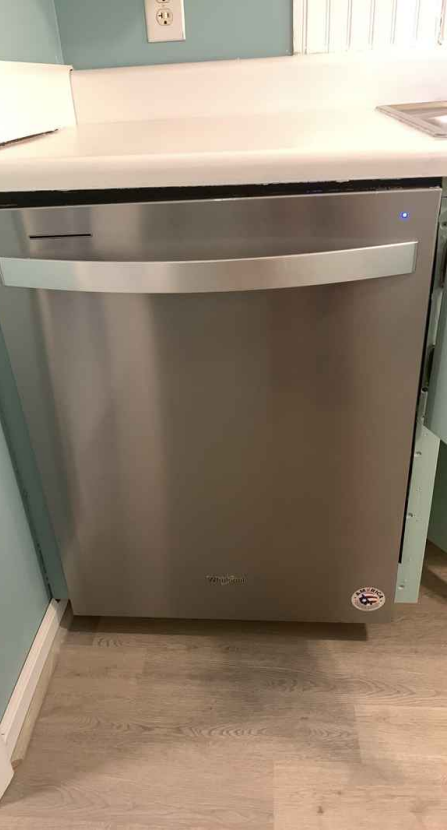
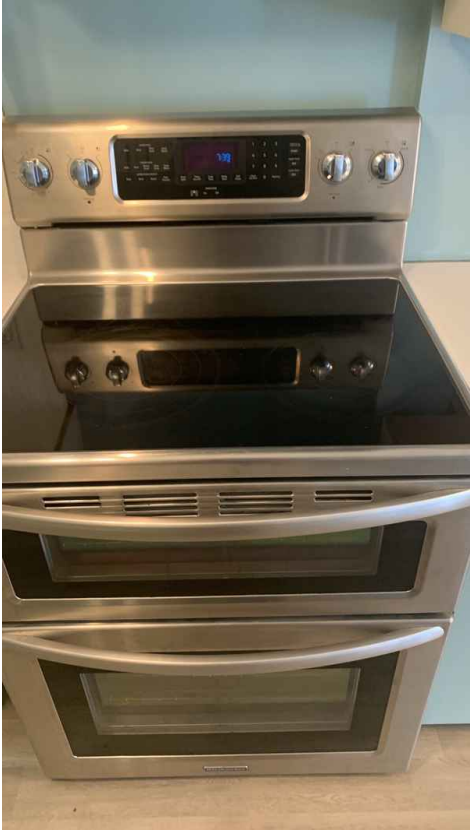
**Range/Oven/Cooktop:**  
**Range/Oven Brand**  
Kitchenaid

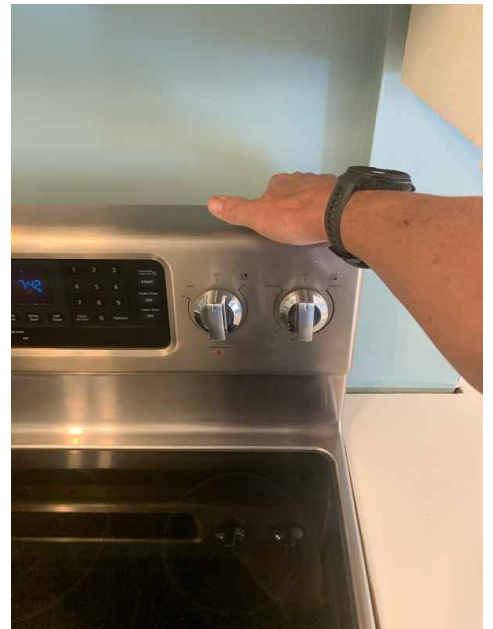
## 11.2.1 Range/Oven/Cooktop

**ANTI-TIP DEVICE MISSING**

Inspected range. Anti-tip device is missing. This can cause a safety concern if range is tipped forward. Contact a qualified contractor to repair.

Contact a qualified general contractor.

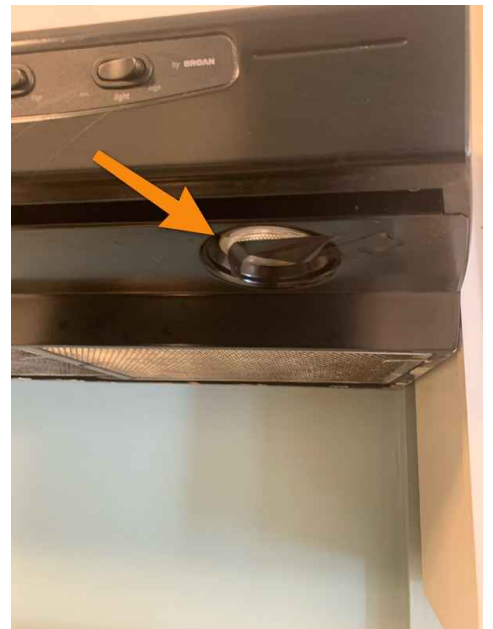
## 11.2.2 Range/Oven/Cooktop

Inspected exhaust hood above range. The light is not functioning. This can prevent visibility during cooking. Contact a qualified contractor to repair.

Contact a qualified electrical contractor.

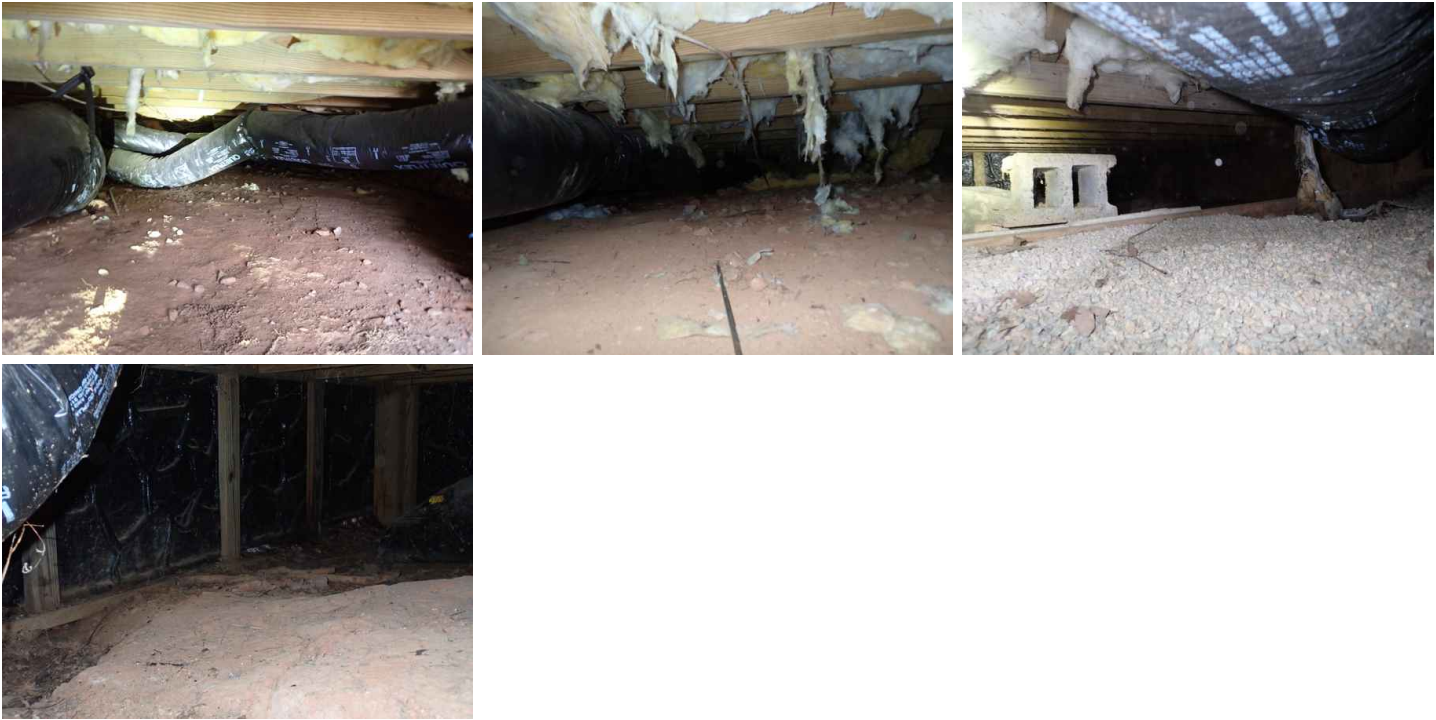
#### **MISSING VAPOR BARRIER**

Inspected vapor barrier. There is no vapor barrier in the crawlspace. This can allow moisture to buildup and damage flooring structure. Contact a qualified contractor to repair.

Contact a qualified insulation contractor.

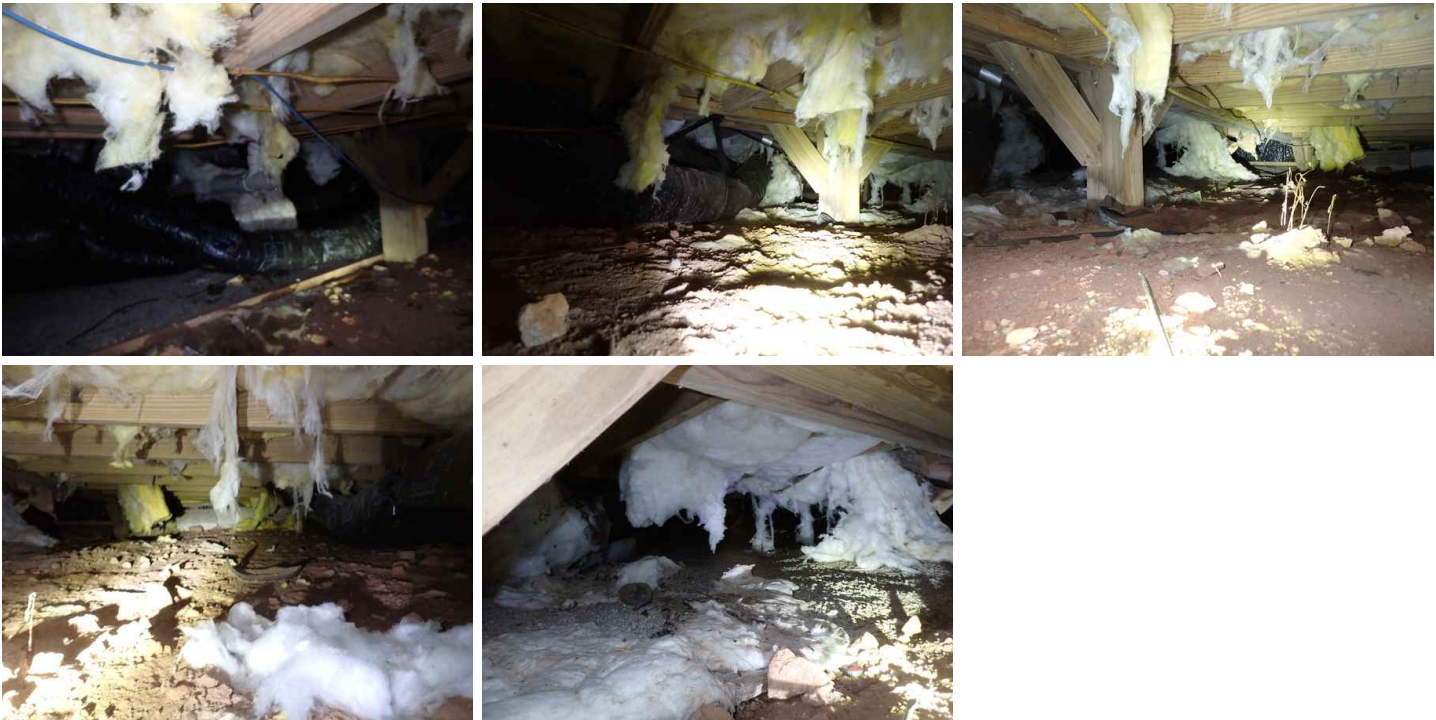
12.3.1 Flooring Insulation

**DAMAGED INSULATION**

Inspected flooring insulation. There are one or more areas of damaged/missing insulation. This can decrease energy efficiency and promote organic growth. Contact a qualified contractor to repair.

Contact a qualified insulation contractor.
