RE: Underground Storage Tank (UST) Closure Assessment Report  
300 Forest Road, Oxford, North Carolina  
Cedar Rock Project Number 425422590

**UNDERGROUND STORAGE TANK  
CLOSURE ASSESSMENT REPORT FOR  
300 FOREST ROAD  
OXFORD, NORTH CAROLINA**

**CR #425422590**

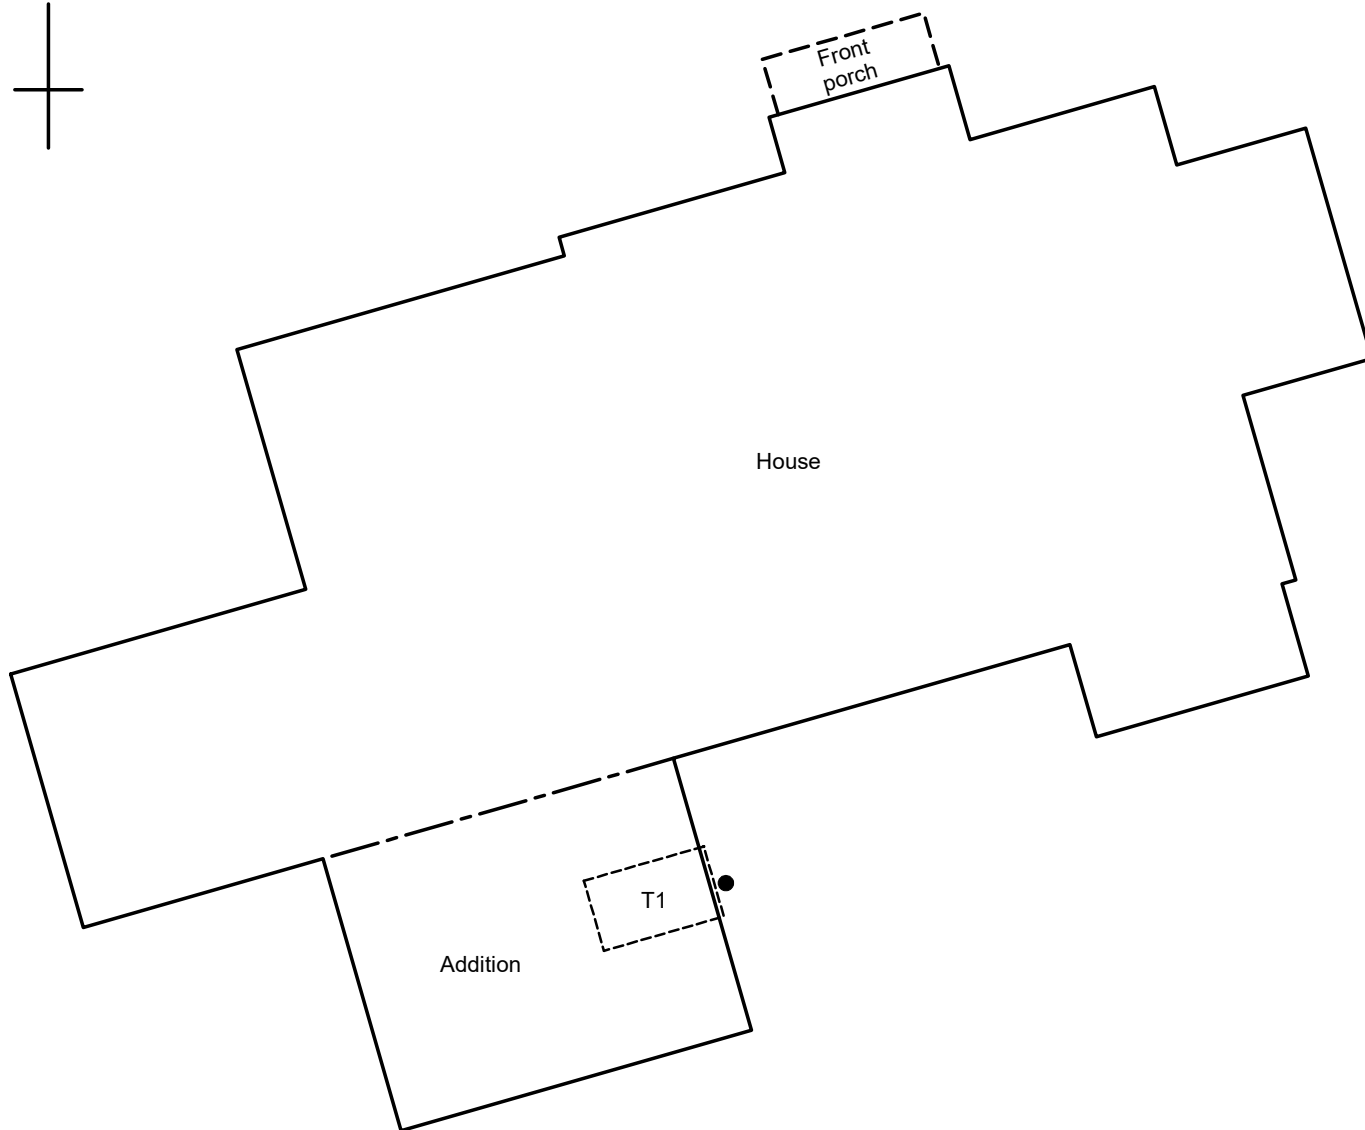
**FIGURE 1**

● : Soil boring location

□ : T1 = 550-Gallon UST

Once the orientation of the UST was determined, a soil boring was performed at the location marked on the Site Map using a ¾-inch diameter drill auger. The boring was advanced to a depth of approximately 5.7 feet bls, about 1.5 feet below the bottom of the UST. A strong petroleum odor and discoloration was observed in the soil from the base of the boring suggesting significant leakage from the UST had occurred. The soil underlying the tank consists of a gray sandy silt.

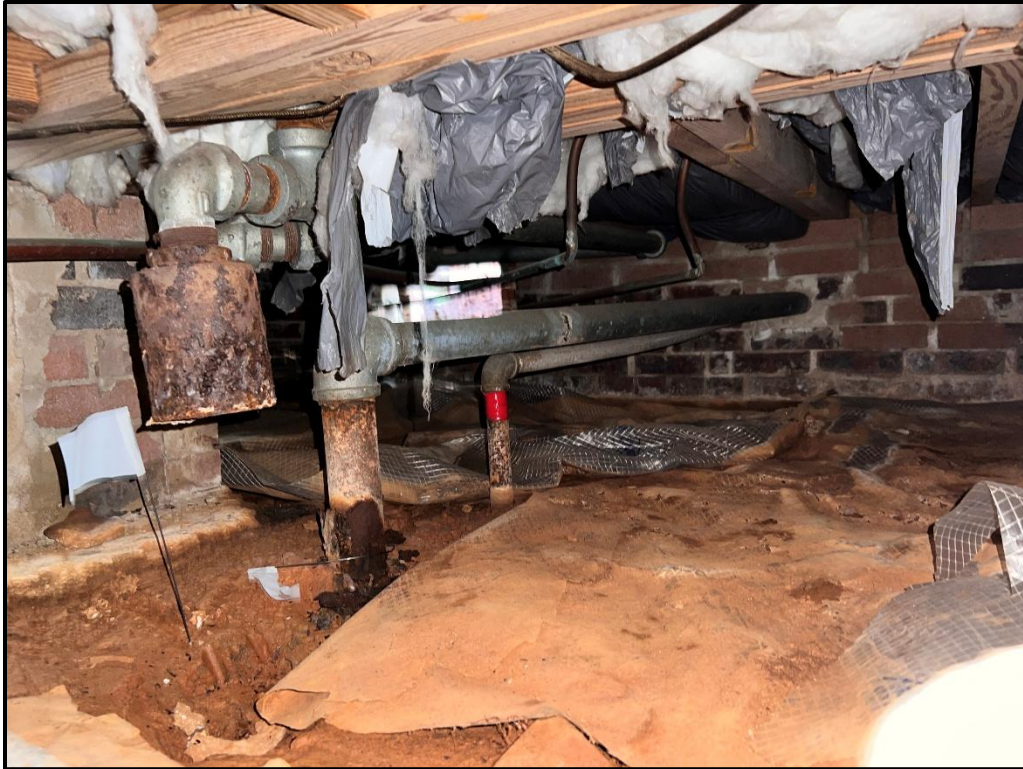
**Photo 1.** View of the UST site prior to abandonment activities.

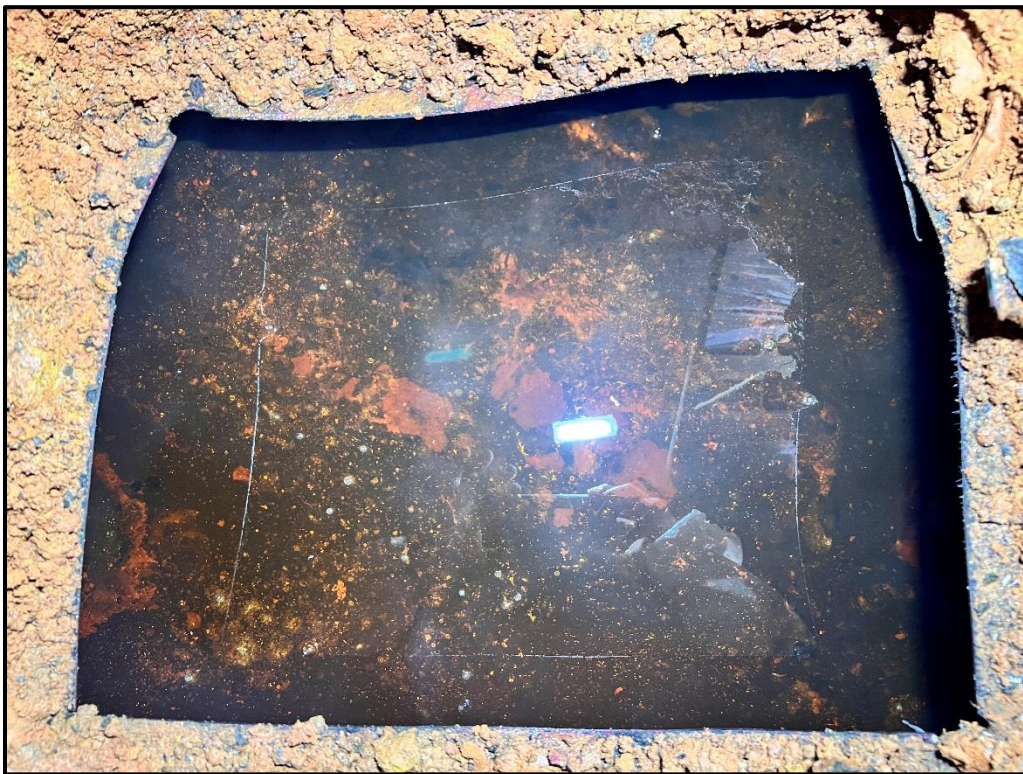
**Photo 2.** View of the UST interior prior to the removal of tank contents.

The in-place abandonment of the UST was performed on April 2, 2026. The abandonment consisted of the hand excavation of the soil overlying the western end of the UST to expose the top side of the tank. A hole approximately 2.0 feet in diameter was then cut on the top of the UST to allow for removal of the tank contents, cleaning and visual inspection of the UST interior, and subsequent filling. The tank was pressure washed to remove all residual petroleum sludge. Several large corrosion holes were observed in the bottom of the tank. Residual oil in the fuel lines was also removed by vacuum. The fuel lines were removed from the crawlspace. Approximately 556 gallons of fluid and sludge (including rinsate) were removed from the UST. The fluid disposal manifest for the tank contents is included in Appendix A.

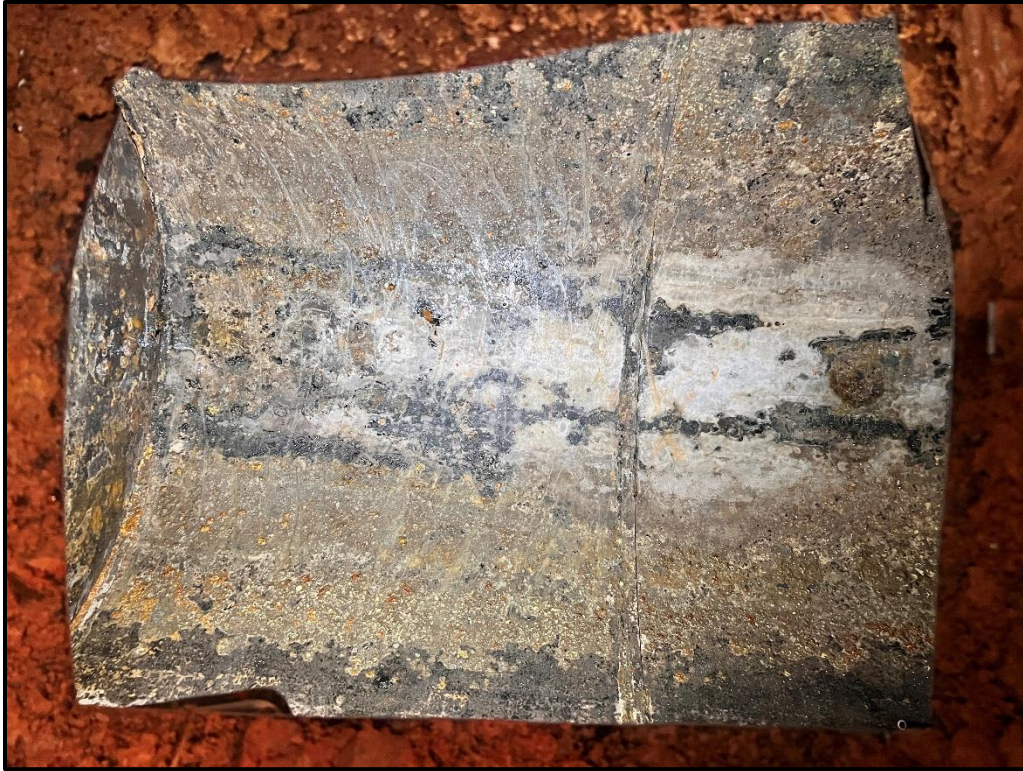
**Photo 3.** View of the UST interior after the removal of UST contents and pressure wash cleaning of the tank interior.

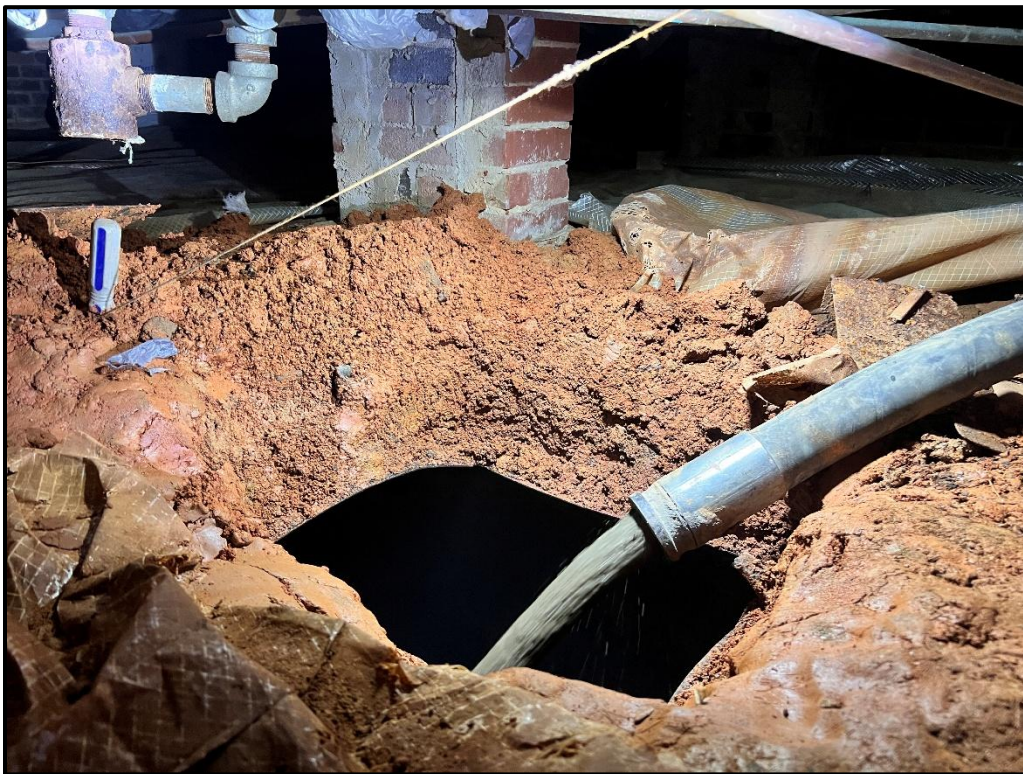
**Photo 4.** View of the UST being filled with flowable fill cement slurry.

After the interior of the UST was cleaned, the tank was then entirely filled with an excavatable flowable fill cement slurry. Once filled, the exposed portion of the UST was then covered with site soil (see Appendix B - Photographic Documentation).

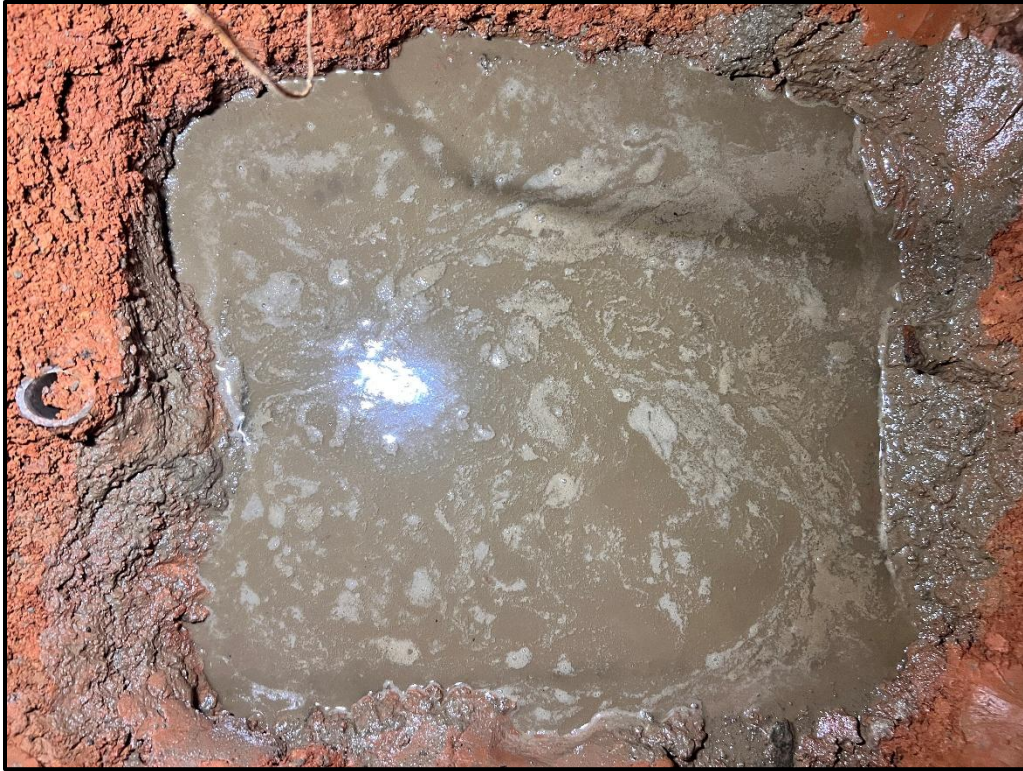
**Photo 5.** View of the UST after filling with flowable fill cement slurry.

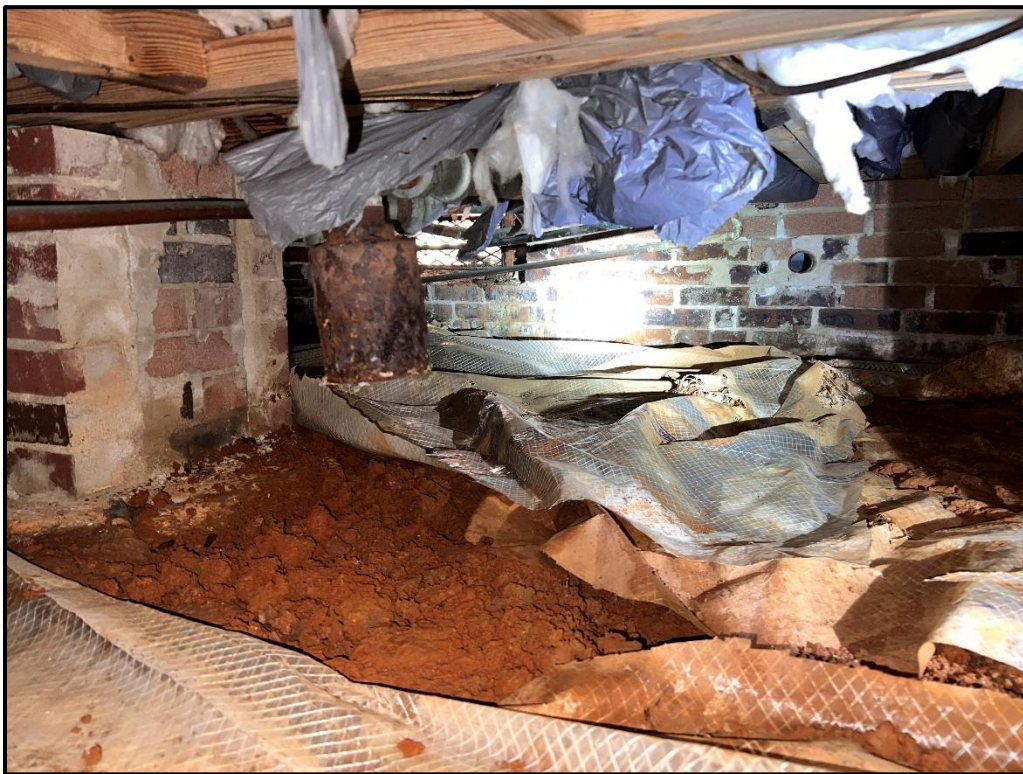
**Photo 6.** View of the UST site after the completion of abandonment activities.
