# Inspection Report

**Property Address:**  
4218 Tommie Sneed Road  
Oxford NC 27565

**Cornerstone Residential Inspections, LLC.**

| <b>Date:</b> 5/15/2026 | <b>Time:</b> 10:30 AM | <b>Report ID:</b> 0515265486N |

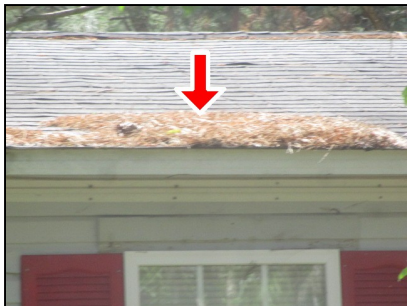
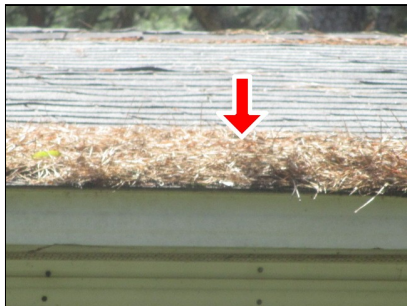
(1) There are leaves and debris covering the roof and/or the roof valleys. Accumulating leaves and debris may allow moisture to penetrate the shingles and flashing and damage the sheathing material. Have the leaves and debris removed by a qualified person.

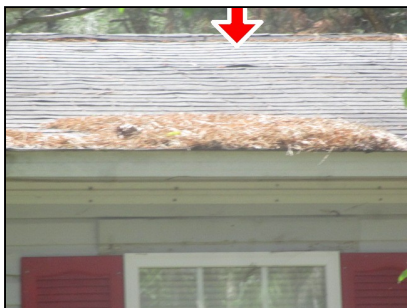
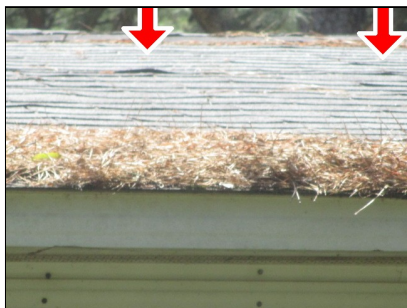
(2) The roof shingles are raised/lifted at the front and rear of home. The shingles should be properly sealed to eliminate possible moisture intrusion.. A qualified contractor should inspect and repair as needed.

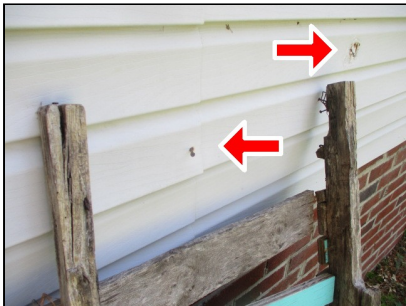
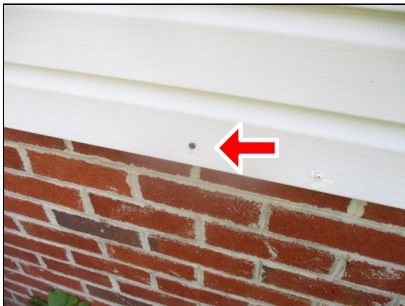
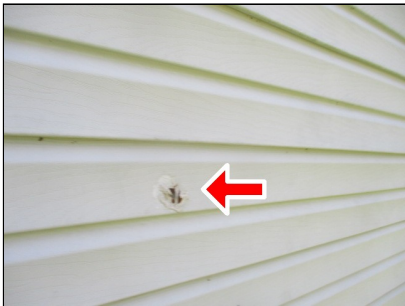
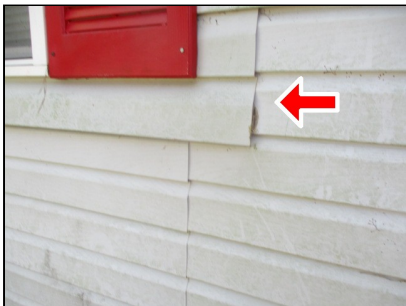
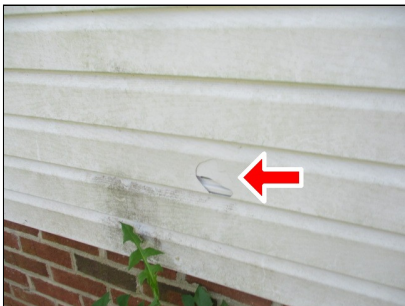
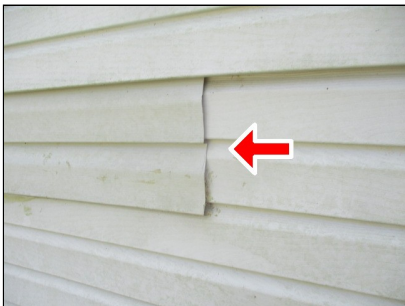
(1) There is numerous areas of loose siding, holes and damage to the vinyl siding and trim. Have a qualified person inspect all the siding and trim and repair or replace as needed to eliminate possible moisture intrusion.

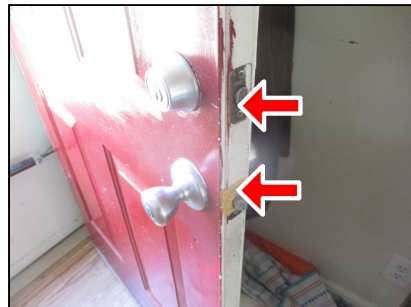
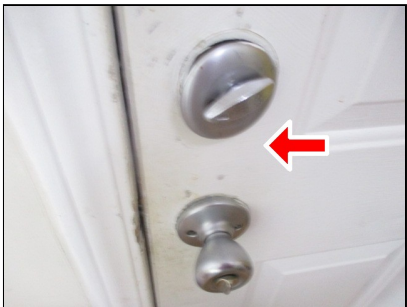
(1) The front door hardware is loose and needs to be properly secured to safety secure the door. Have a qualified contractor repair or replace as needed to correct.

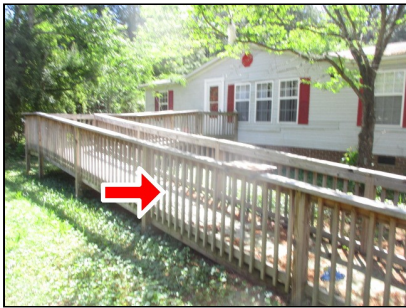
(3) There is a ramp at the front of the house, would recommend removing the ramp. The porch area of the structure appears to be structurally sound, recommend removing the ramp at this area and install steps and a set of handrails. Have a qualified contractor perform the work.

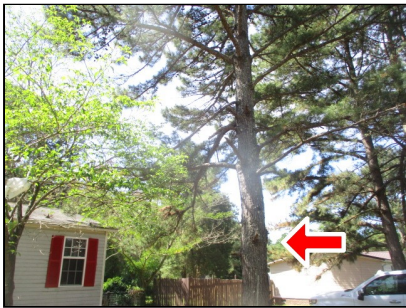
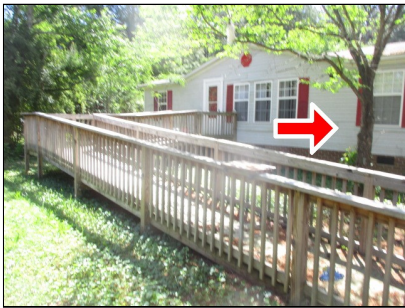
(1) The current industry standards is to maintain an area of 15 to 20 feet of clearance of trees from the home. This is to eliminate falling debris to the roof as well as preventing possible root damage to the foundation. This is for your information.

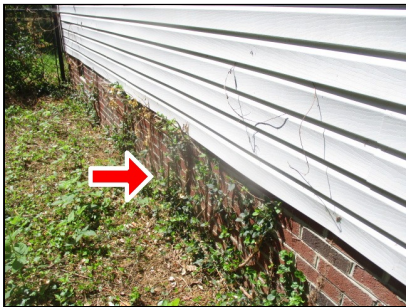
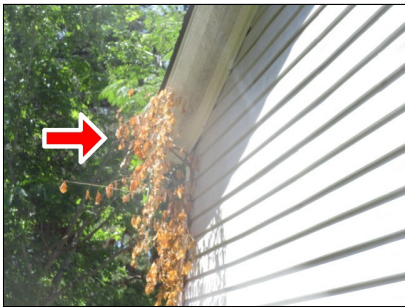
(2) Shrubbery is too close or is in contact with the siding. Have the shrubbery cut back to eliminate possible water intrusion or damage.

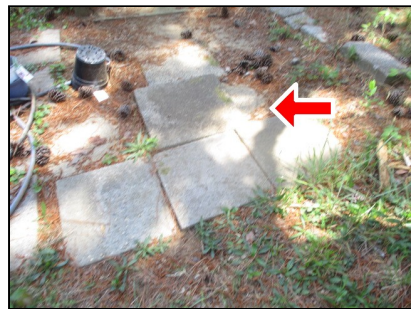
2.4 Item 5(Picture)

(3) There are pavers at the front yard that are designed to be a walkway. The pavers are loose and some are above grade. This can create a safety issue and possible trip and/or fall hazard. Have a qualified person correct or remove the pavers for safety.

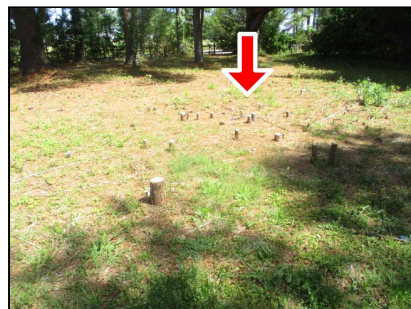
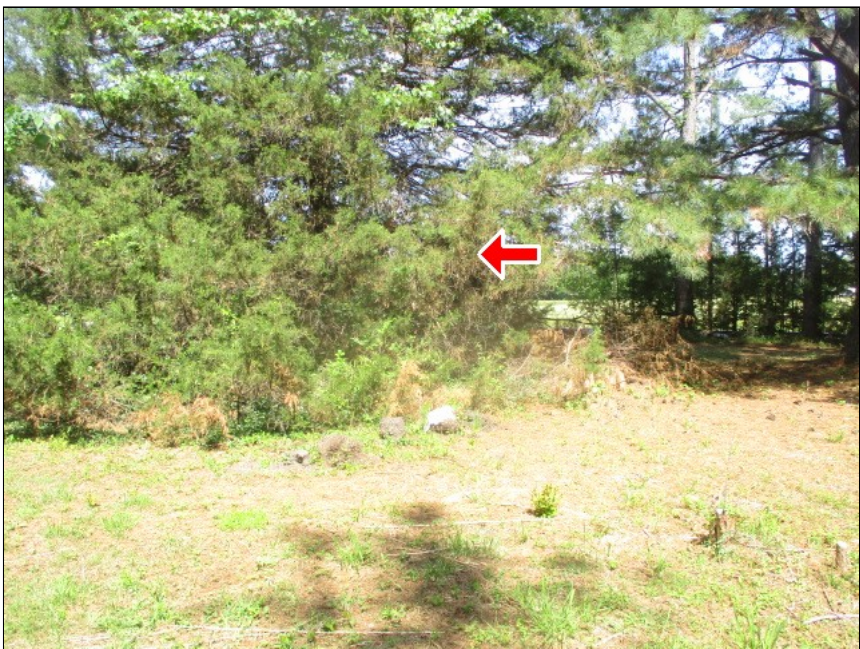
(4) The yard is overgrown in areas and a number of small pines have been cut down but there are small stumps left in the yard. Have a qualified landscape contractor evaluate the yard and remove the stumps, cut back the over growth as well clean up the debris in the yard.

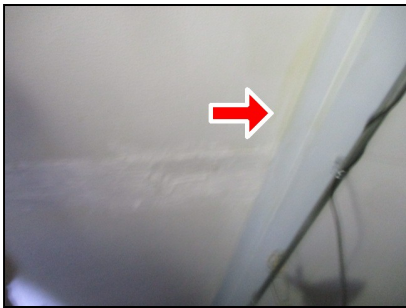
3.0 Item 1(Picture)

**Comments:** Repair or Replace  
There are numerous areas where the crown moulding/trim has been install but is pulling loose and overall is amateur in appearance. Recommend having a qualified contractor evaluate and repair or replace as needed to obtain a professional appearance.

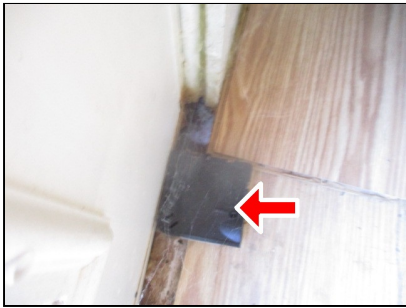
3.3 Item 1(Picture)

The laminate flooring that is installed is of poor quality and amateur in appearance. There are holes in the flooring that extends to the crawlspace. The planks are improperly installed at the seams in numerous areas and the floor trim is missing or loose in areas. Have a qualified contractor evaluate, more than likely will end up removing and replacing most if not all of the flooring.

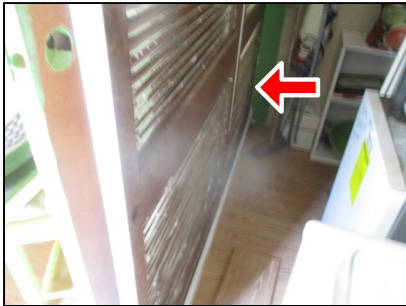
3.4 Item 1(Picture)

The sliding bi-pass doors that are installed for the utility/laundry area are improperly installed. There are no rollers installed on the doors and the doors are hard to slide. Have a qualified contractor install proper doors to function properly.

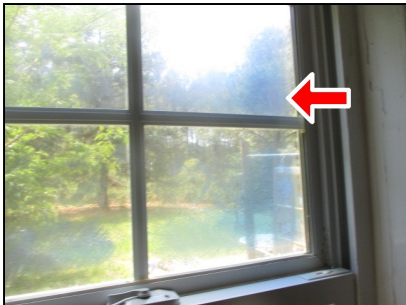
3.5 Item 1(Picture)

There are several windows that appear to have lost the thermoseal which has left evidence of condensation or fogged glass. Have a qualified person inspect the windows and repair or replace as needed.

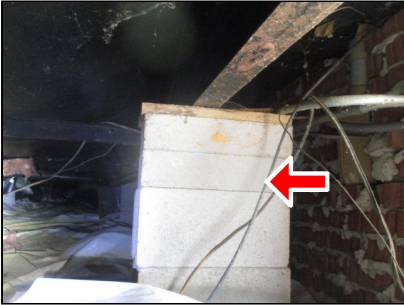
4.2 Item 1(Picture)
- 4.3 FLOORS (Structural)**

The stacked masonry block piers in the crawlspace have not been coated with the fiber mastic sealer. The fiber mastic is a sealing binder for the piers that is a FHA industry standard that is usually required. Recommend further evaluation to assure that the FHA standards are done if required for this structure.

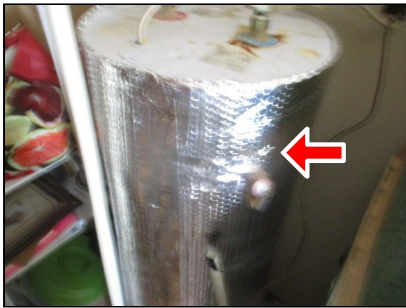
5.2 Item 3(Picture)

(3) The hot water heater was covered in the closet and could not be fully inspected. This is for your information.

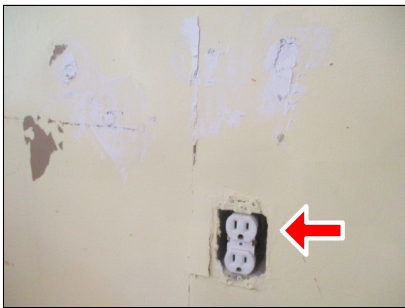
(1) There are numerous missing outlet and/or switch covers in the home. This is a safety issue that needs to be corrected. Have a qualified person install the proper covers.

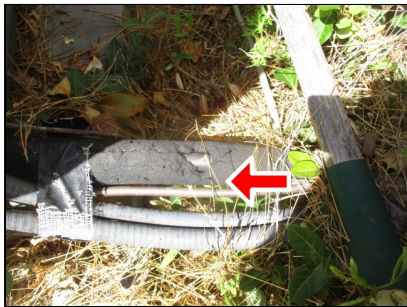
7.6 Item 1(Picture)

(1) The foam sleeve on suction line is missing foam sleeve in area(s) at outside unit. Missing foam on suction line can cause energy loss and condensation. I recommend service or repair as needed.

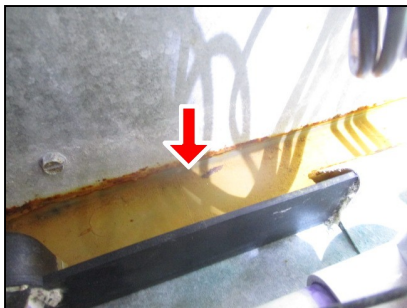
7.6 Item 2(Picture)

(2) There is rust in the condensate pan for the air handler in the attic. This may indicate that the unit has or did have a clogged drain line. Have a licensed HVAC contractor inspect and repair or replace as needed.

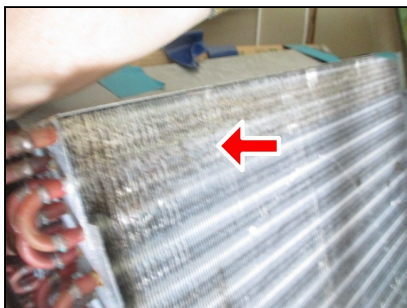
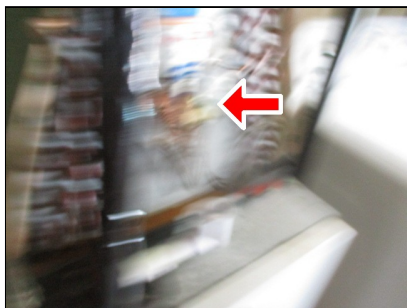
(3) The evaporator coils are dirty and have evidence of rust. This can reduce the efficiency of the unit. Have a licensed HVAC contractor evaluate and repair or replace as needed to correct.

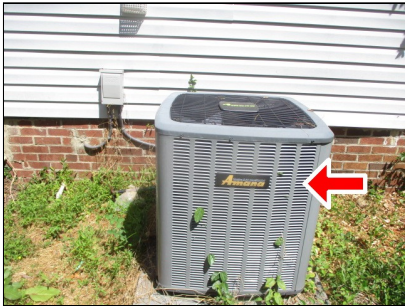
7.6 Item 6(Picture)

(4) HVAC manufacturers label - Amana - 2020. This is a older unit. The unit was functioning at the time of the inspection. Most HVAC manufacturers recommend servicing the units every 6 months, if the unit has not been serviced in the past 6 months. Due to the age recommend having a licensed HVAC contractor evaluate and service if needed. If the unit has been serviced in the past 6 month, have the seller provide a copy of the receipt showing the scope of work that was performed.

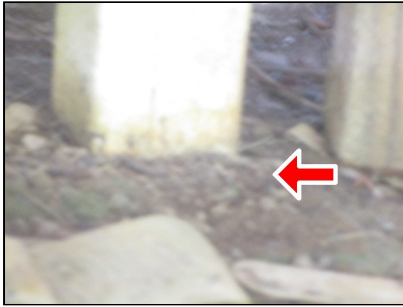
8.2 Item 1(Picture)

The vapor barrier (plastic) on the crawlspace ground is missing in areas. A vapor barrier provides added protection to the floor system from moisture or dampness that can enter from ground. Recommend having a qualified person install a vapor barrier to cover exposed ground.

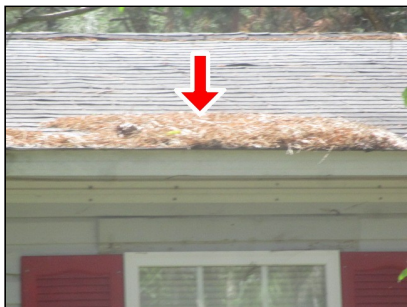
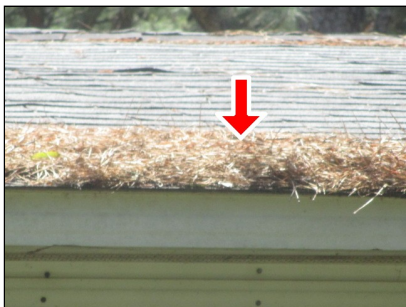
- 1
- (1) There are leaves and debris covering the roof and/or the roof valleys. Accumulating leaves and debris may allow moisture to penetrate the shingles and flashing and damage the sheathing material. Have the leaves and debris removed by a qualified person.

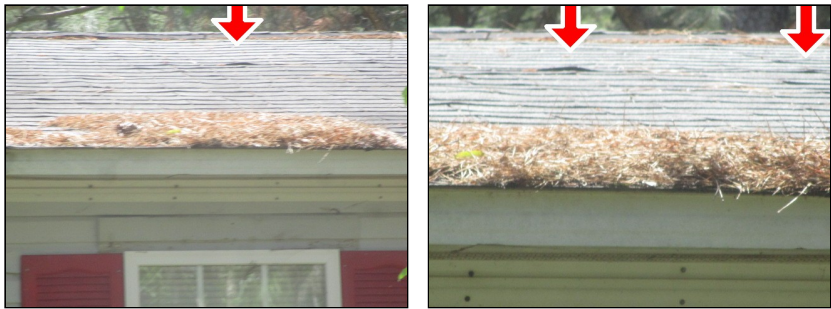
- 2
- (2) The roof shingles are raised/lifted at the front and rear of home. The shingles should be properly sealed to eliminate possible moisture intrusion.. A qualified contractor should inspect and repair as needed.

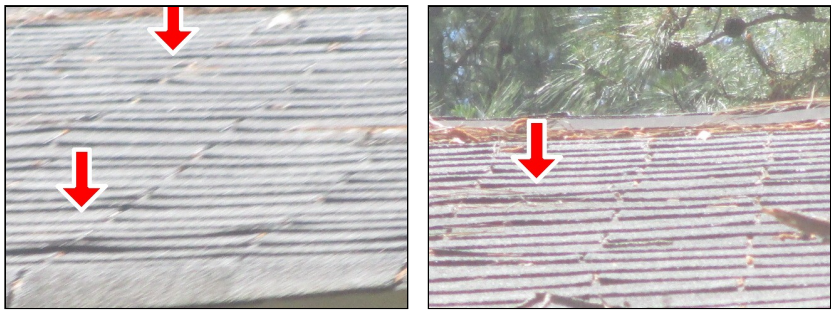
- 3
- (3) The roof shingles are showing evidence of minor curling, mildew and wear and tear. There was no evidence of moisture leaks on the ceiling at the time of the inspection. Recommend monitoring of the roof periodically as the roof ages to maintain the life of the shingles. Recommend further evaluation by a qualified roofer. There is limited ventilation to the roof area and the roof appears to have premature aging. Anticipate replacement within the next several years.

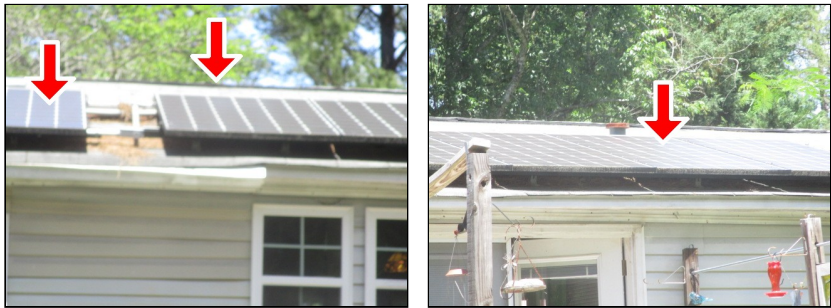
- 4
- (4) There are solar panels on the rear roof. The panels have been disconnected and did not function at the time of the inspection. If the panels are removed, shingles will need to be repaired or replaced.

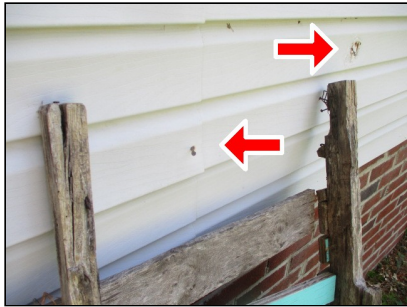
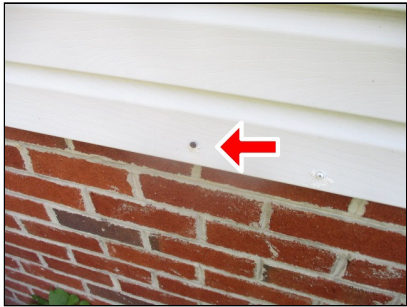
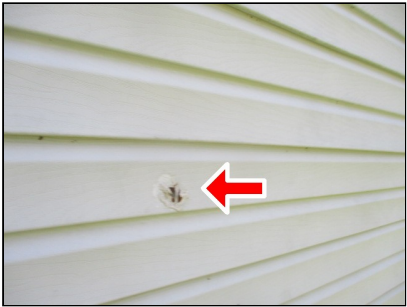
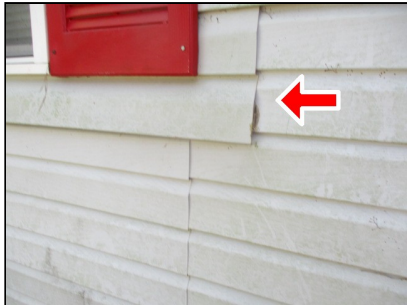
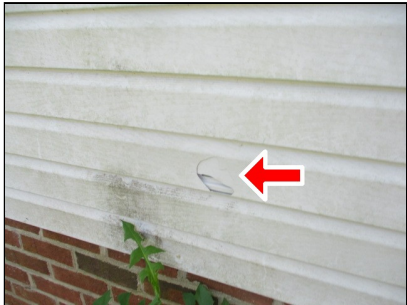
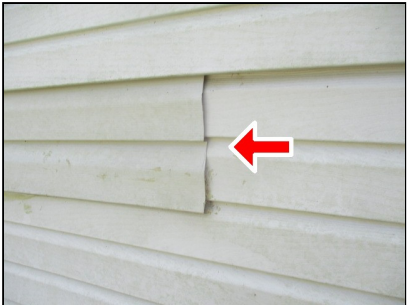
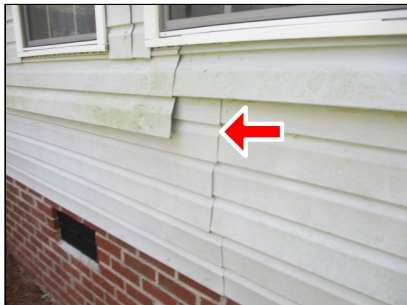
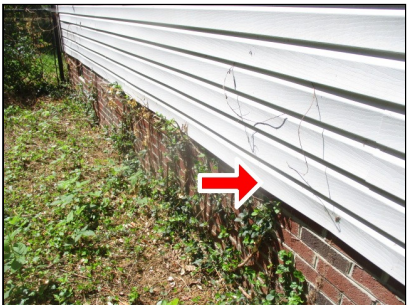
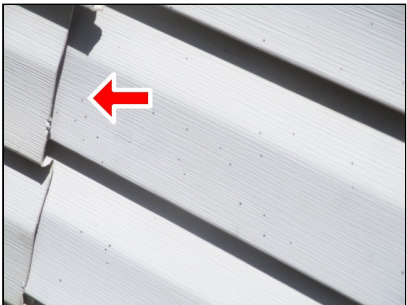
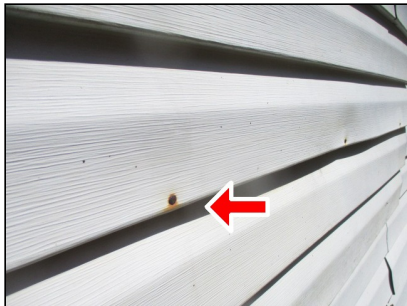
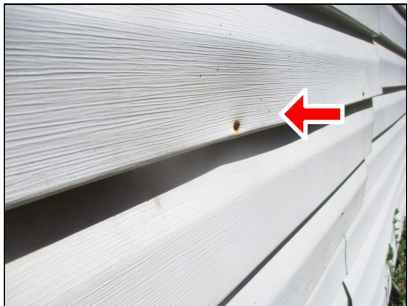
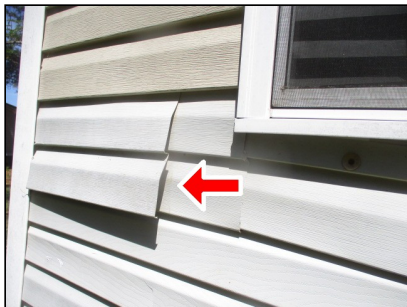
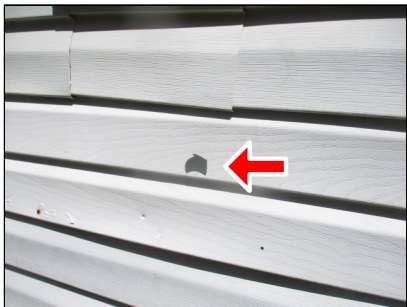
- 5
- (1) There is numerous areas of loose siding, holes and damage to the vinyl siding and trim. Have a qualified person inspect all the siding and trim and repair or replace as needed to eliminate possible moisture intrusion.

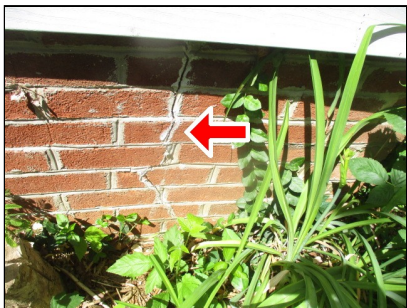
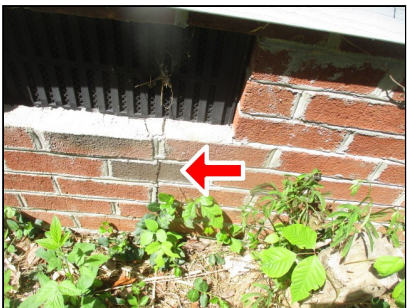
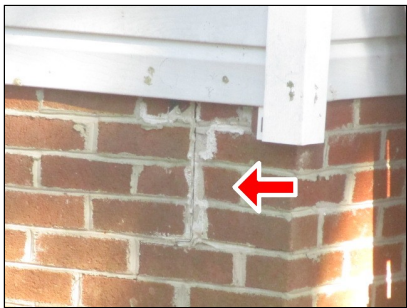
- 6 (2) There are several areas of cracking at the brick veneer at the exterior of the home. There did not appear to be evidence of structural issues in the crawlspace or the interior walls of the home. Further evaluation may be required if concerned, but sealing of the cracks need to be addressed to eliminate possible moisture intrusion. This is a curtain wall construction and the crack is usually not a structural concern as the structure is supported by the piers. If concerned, recommend further evaluation by a structural contractor or engineer.

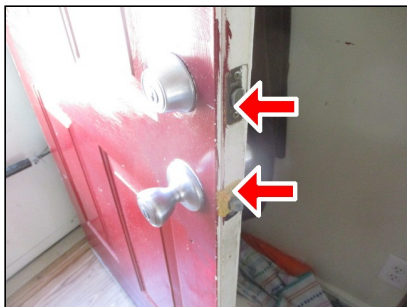
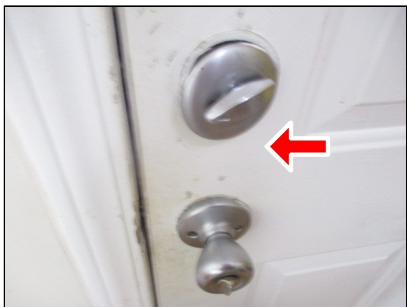
- 7 (1) The front door hardware is loose and needs to be properly secured to safety secure the door. Have a qualified contractor repair or replace as needed to correct.

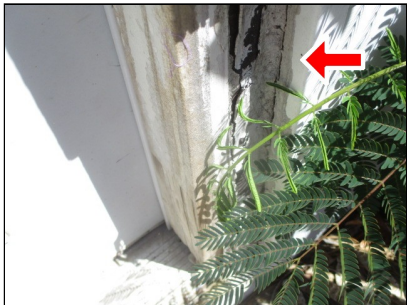
Item 8 - Item 2(Picture)

- 8
- (2) There is evidence of moisture damage at the rear deck door frame and/or trim. There is daylight at the door when closed. Energy loss is occurring as well as the door does not closed securely. Further deterioration will occur if not corrected. Have a qualified person inspect and repair or replace as needed.

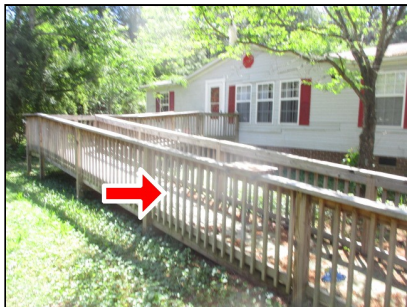
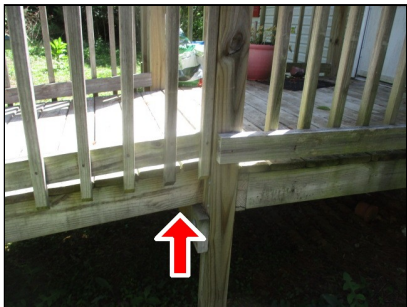
- 10
- (2)
- 11
- (3) There is a ramp at the front of the house, would recommend removing the ramp. The porch area of the structure appears to be structurally sound, recommend removing the ramp at this area and install steps and a set of handrails. Have a qualified contractor perform the work.

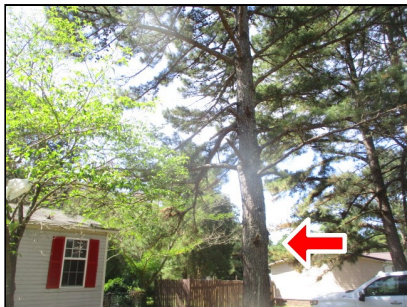
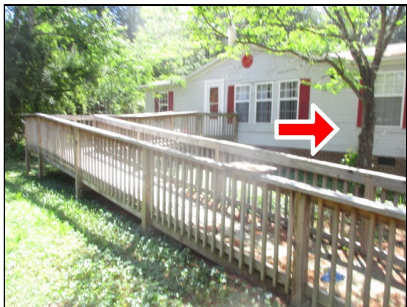
- 12
- (1) The current industry standards is to maintain an area of 15 to 20 feet of clearance of trees from the home. This is to eliminate falling debris to the roof as well as preventing possible root damage to the foundation. This is for your information.

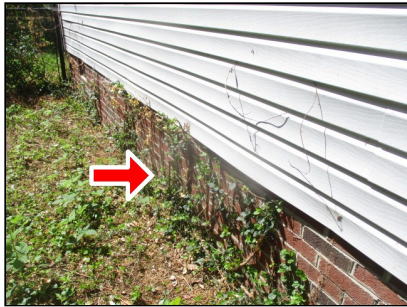
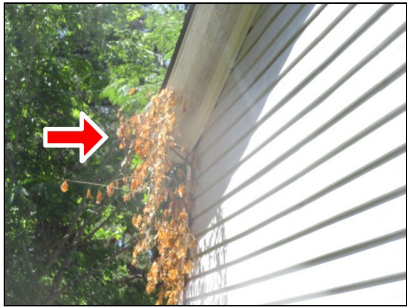
- 13
- (2) Shrubbery is too close or is in contact with the siding. Have the shrubbery cut back to eliminate possible water intrusion or damage.

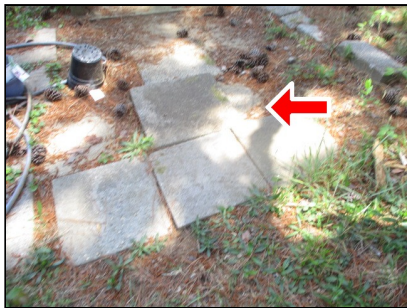
Item 14 - Item 1(Picture)

- 14
- (3) There are pavers at the front yard that are designed to be a walkway. The pavers are loose and some are above grade. This can create a safety issue and possible trip and/or fall hazard. Have a qualified person correct or remove the pavers for safety.

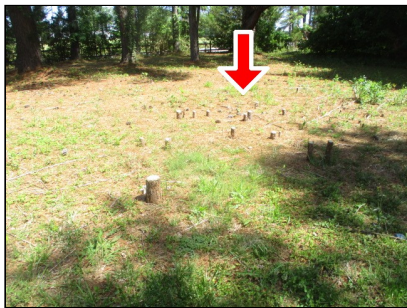
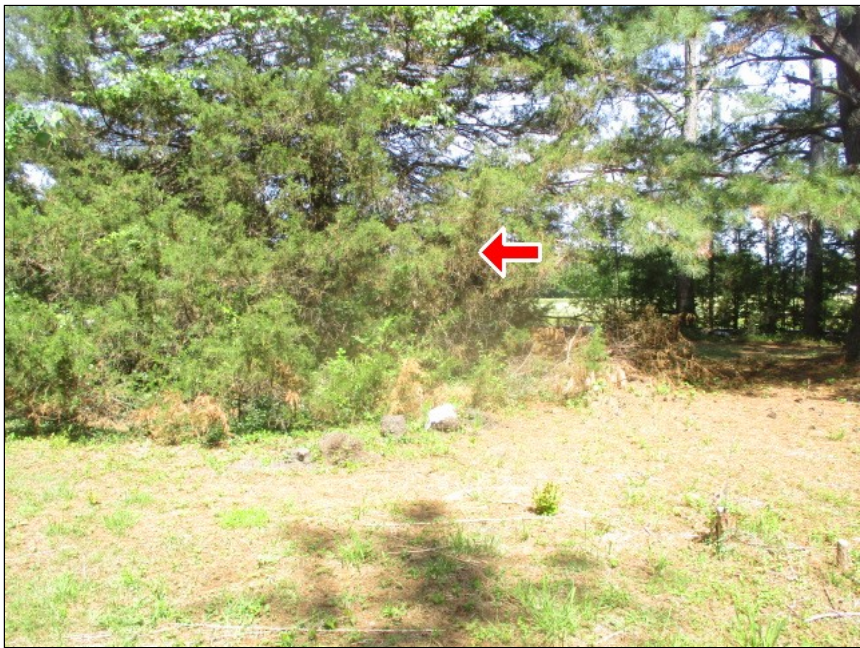
- 15
- (4) The yard is overgrown in areas and a number of small pines have been cut down but there are small stumps left in the yard. Have a qualified landscape contractor evaluate the yard and remove the stumps, cut back the over growth as well clean up the debris in the yard.

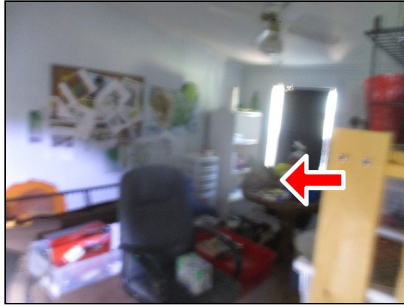
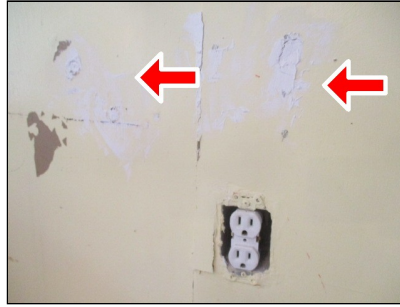
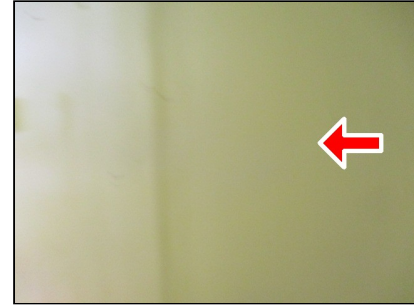
- 18 There is a lot of homeowners personal items still in the house, several of the rooms are totally full. Cleaning is needed and painting is needed throughout the house . Have a qualified person remove the personal items, repair the walls as needed and paint.

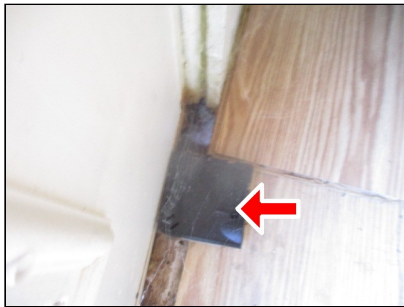
Item 20 - Item 1(Picture)

- 20 The laminate flooring that is installed is of poor quality and amateur in appearance. There are holes in the flooring that extends to the crawlspace. The planks are improperly installed at the seams in numerous areas and the floor trim is missing or loose in areas. Have a qualified contractor evaluate, more than likely will end up removing and replacing most if not all of the flooring.

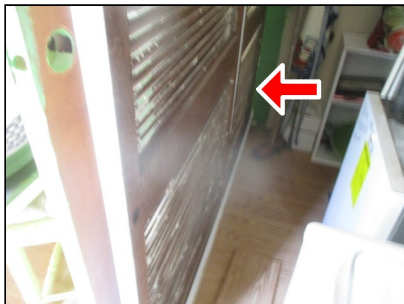
Item 21 - Item 1(Picture)

- 21 The sliding bi-pass doors that are installed for the utility/laundry area are improperly installed. There are no rollers installed on the doors and the doors are hard to slide. Have a qualified contractor install proper doors to function properly.

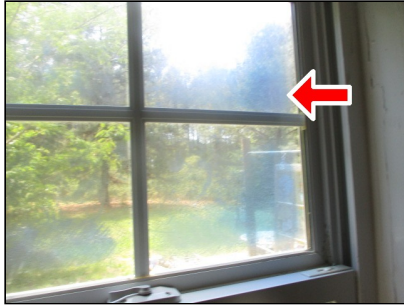
Item 22 - Item 1(Picture)

- 22 There are several windows that appear to have lost the thermoseal which has left evidence of condensation or fogged glass. Have a qualified person inspect the windows and repair or replace as needed.

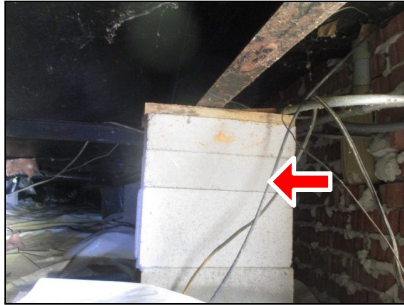
Item 23 - Item 1(Picture)

- 23 The stacked masonry block piers in the crawlspace have not been coated with the fiber mastic sealer. The fiber mastic is a sealing binder for the piers that is a FHA industry standard that is usually required. Recommend further evaluation to assure that the FHA standards are done if required for this structure.

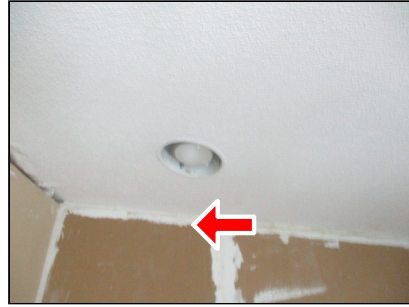
Item 25 - Item 3(Picture)

- 25 (2) The master bathroom shower has been taken out apparently to remodel. The work is incomplete and major work is still required to finish. Since plumbing is being changed, recommend checking to see if any permits were obtained for the changes. Have a licensed plumber and contractor perform the work.

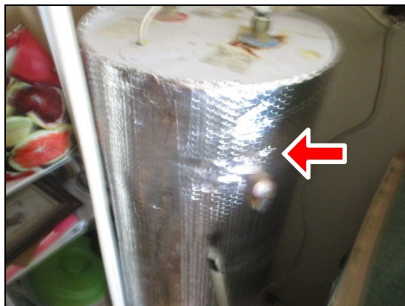
Item 28 - Item 1(Picture)

- 28** (3) The hot water heater was covered in the closet and could not be fully inspected. This is for your information.

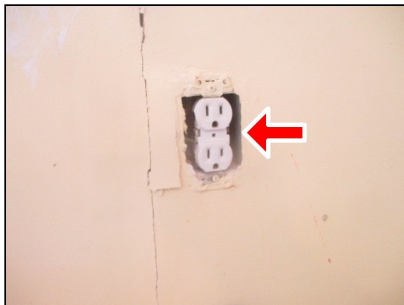
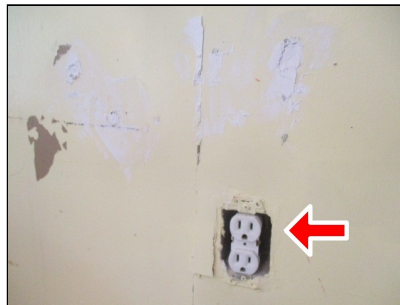
- 30 (1) There are numerous missing outlet and/or switch covers in the home. This is a safety issue that needs to be corrected. Have a qualified person install the proper covers.

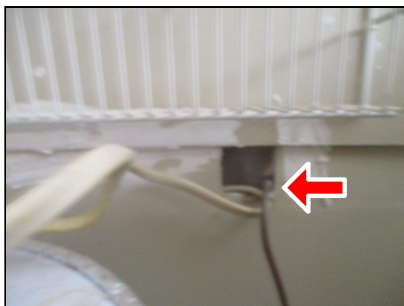
Item 31 - Item 1(Picture)

- 31 (2) There is an exposed wire under the water heater that is not protected. The wiring can easily be damaged, snagged or cut. This is a safety issue that needs to be corrected. Have a licensed electrician properly install the wire in conduit.

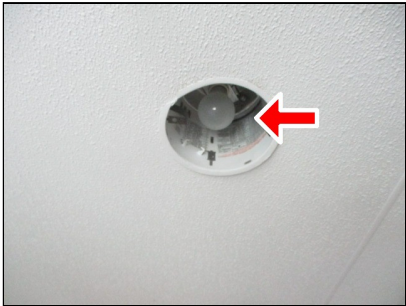
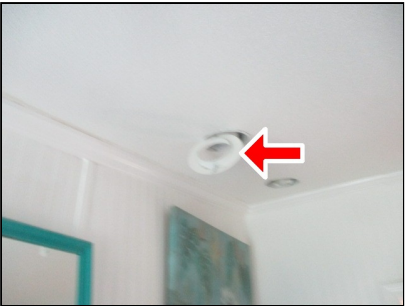
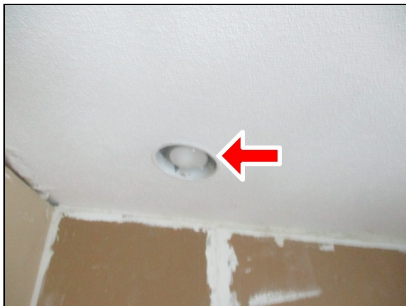
33 (4) There are numerous light fixtures in the home that are missing bulbs or the bulbs are burned out, the fixtures are loose are missing covers. These are safety issues that need to be corrected. Have a qualified contractor repair or replace as needed to correct.

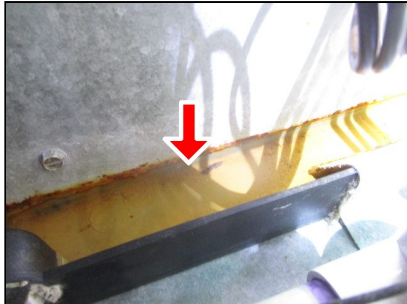
Item 39 - Item 1(Picture)

- 39 (2) There is rust in the condensate pan for the air handler in the attic. This may indicate that the unit has or did have a clogged drain line. Have a licensed HVAC contractor inspect and repair or replace as needed.

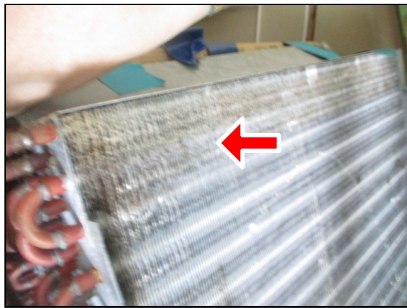
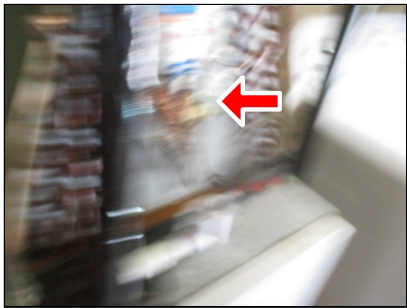
- 40 (3) The evaporator coils are dirty and have evidence of rust. This can reduce the efficiency of the unit. Have a licensed HVAC contractor evaluate and repair or replace as needed to correct.

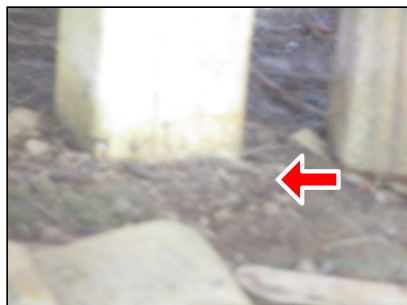
Item 43 - Item 1(Picture)

- 43 The vapor barrier (plastic) on the crawlspace ground is missing in areas. A vapor barrier provides added protection to the floor system from moisture or dampness that can enter from ground. Recommend having a qualified person install a vapor barrier to cover exposed ground.
