HERO HOME INSPECTORS

## RESIDENTIAL REPORT

939 cheves rd  
Zebulon, Nc 27597

02/10/2026

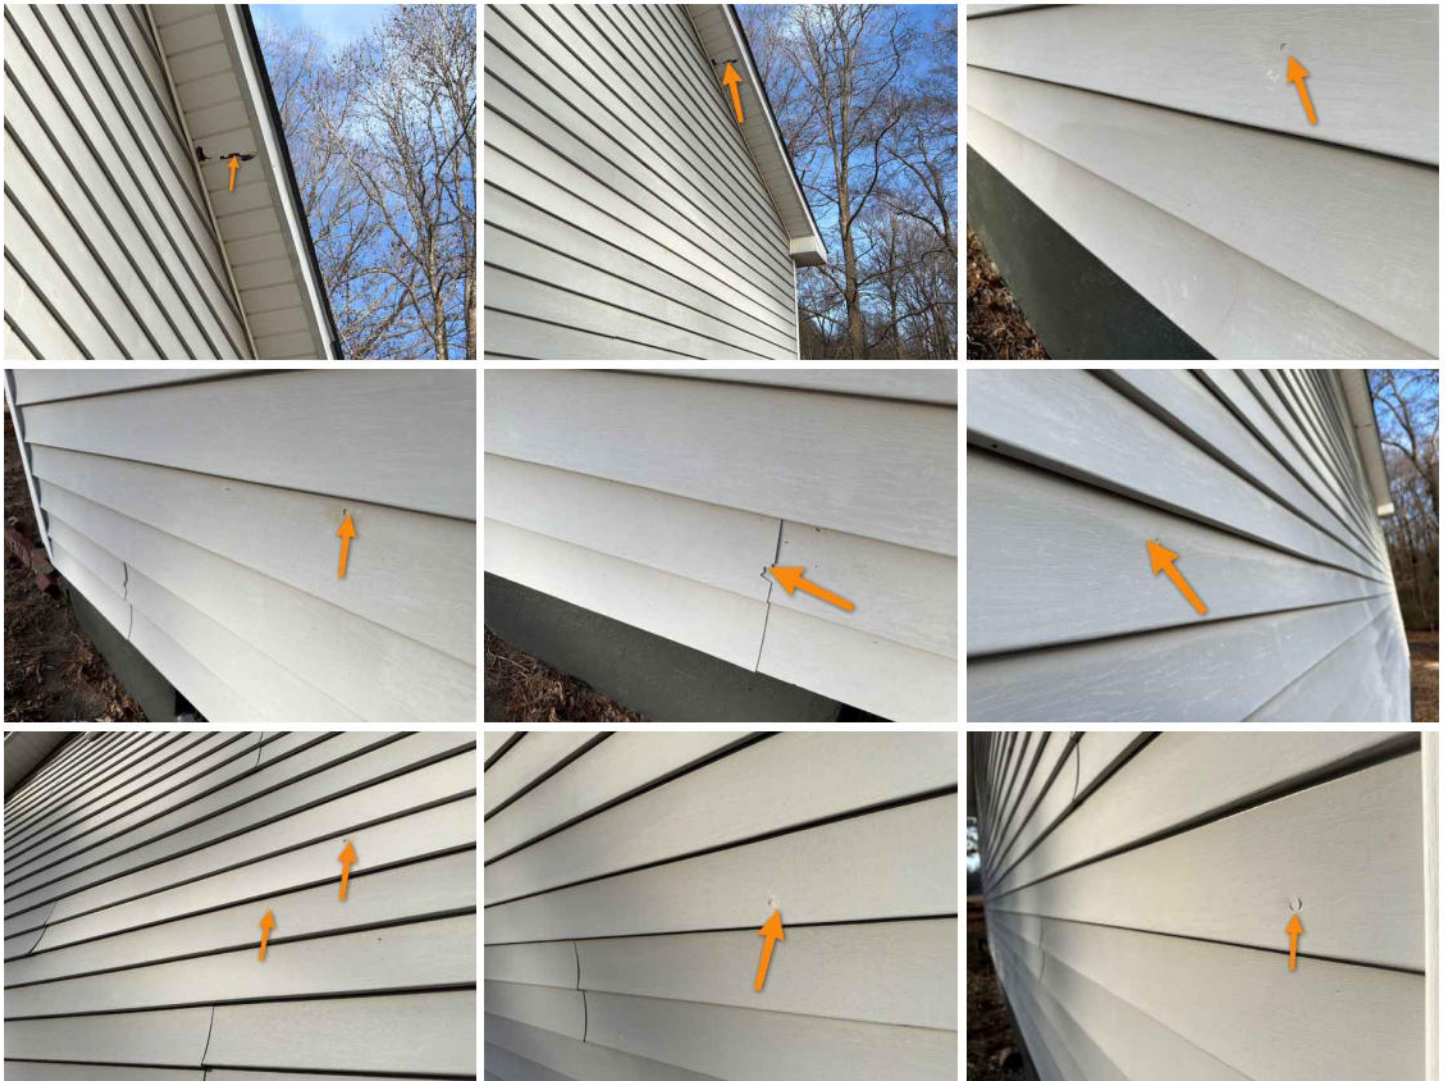
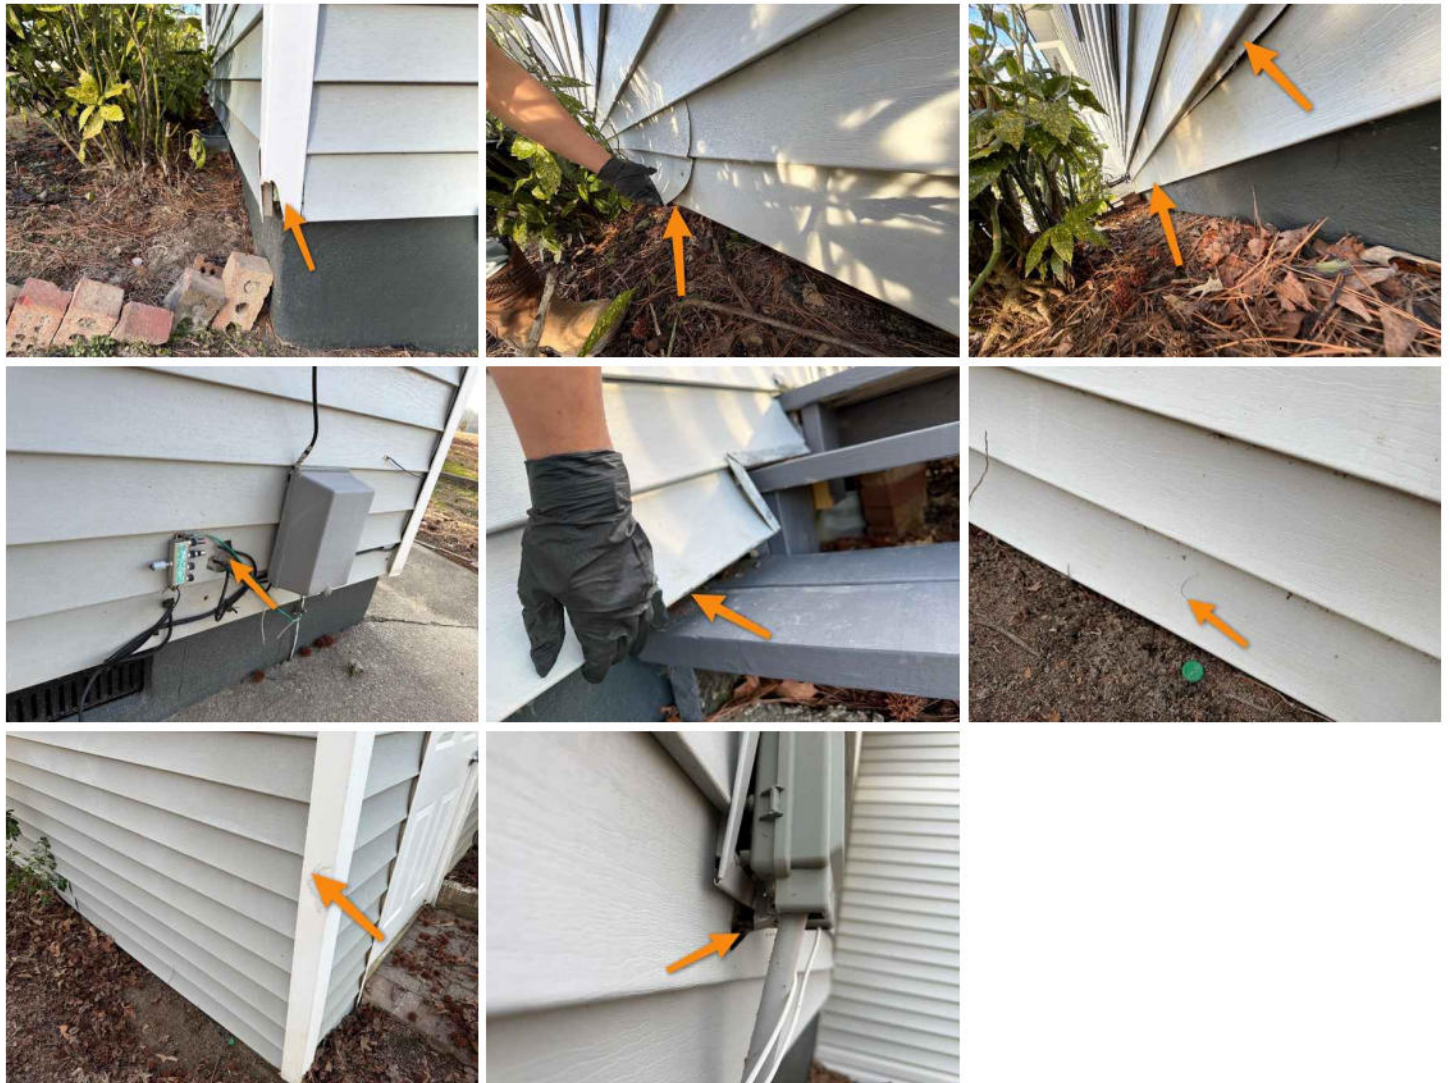
##### **VINYL SIDING: CRACKED**

Cracked pieces of vinyl siding and trim were noted on the around the home. The pieces should be replaced to prevent any possible water penetration underneath the siding. A licensed general contractor should be consulted for evaluation and repair.

**Seller has repaired most of this**

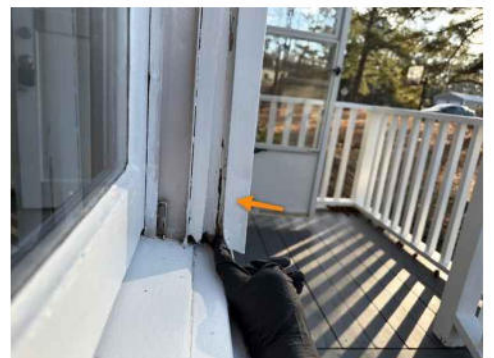
### 2.2.2 Siding, Flashing & Trim

#### ALUMINUM TRIM: LOOSE

The aluminum pieces on the left side of the home were loose, exposing the wood behind to potential water intrusion. A licensed contractor should evaluate and repair it to prevent decay and water damage to the trim and wall components.

**Seller was repairing this**

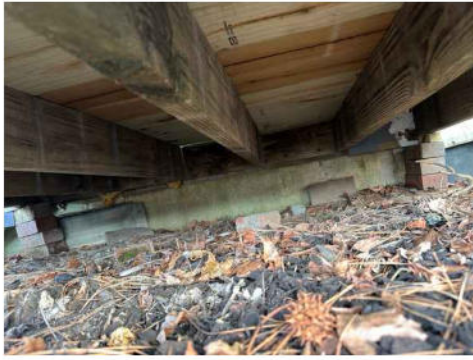
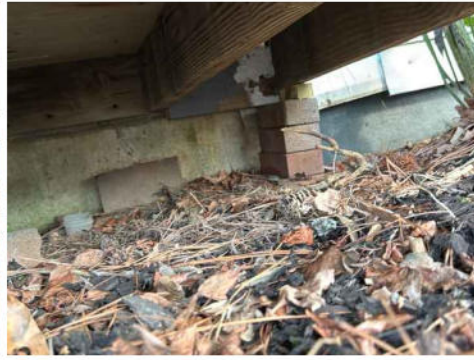
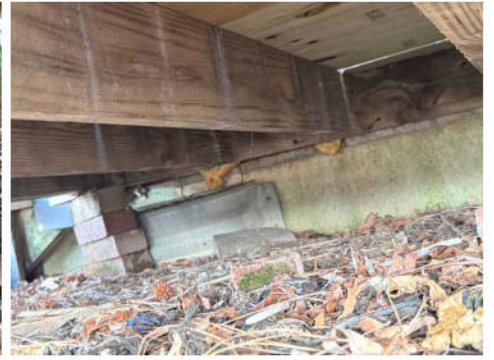
### 2.4.1 Decks, Balconies, Porches & Steps

#### DECK - UNSTABLE SUPPORT

One of more areas of the deck support appears unstable. This could cause a safety hazard and further deterioration of the deck. Recommend qualified deck contractor evaluate and repair.

**This has been repaired**

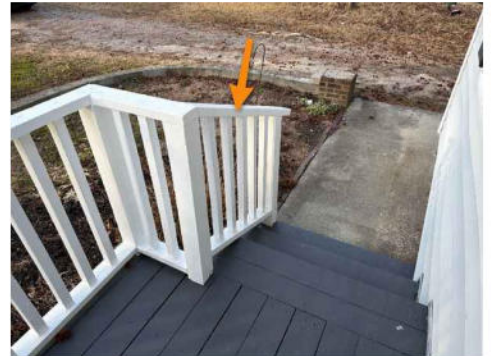
#### 2.4.2 Decks, Balconies, Porches & Steps

##### **STEPS: HANDRAIL: LOOSE**

The handrails to the front steps are loose and or present a safety/fall hazard. A licensed general contractor should be consulted for evaluation of the deck/steps handrail system and to make necessary repairs.

**This has been repaired**

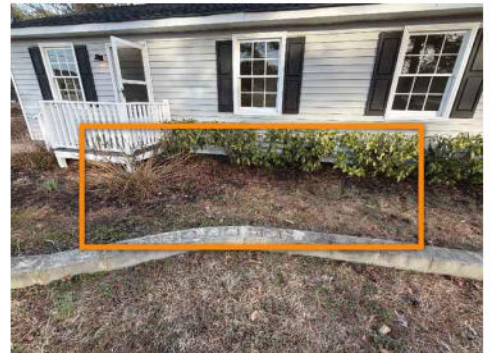
#### 2.6.1 Vegetation, Grading, Drainage & Retaining Walls

##### **NEGATIVE GRADING**

Sections of grading on the front yard is too high and sloping towards the home. This could lead to water intrusion and foundation issues. Recommend qualified landscaper or foundation contractor regrade so water flows away from home.

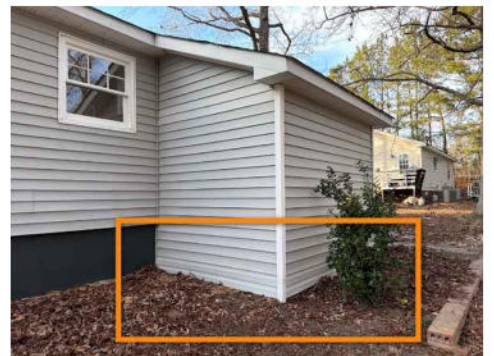
#### 2.6.2 Vegetation, Grading, Drainage & Retaining Walls

##### **GRADING: HIGH: VENTS/SIDING**

The grading on the front side of the home is too high and too close to a foundation vent. If not corrected, this condition could result in water penetration in the foundation area and interior walls and electrical hazard. It's recommended to engage a licensed contractor to adjust the grading for proper drainage and clearance to prevent further water from entering the crawl space, insect/rodents problems, and decay.

**Should be repaired. See Ferguson invoice**

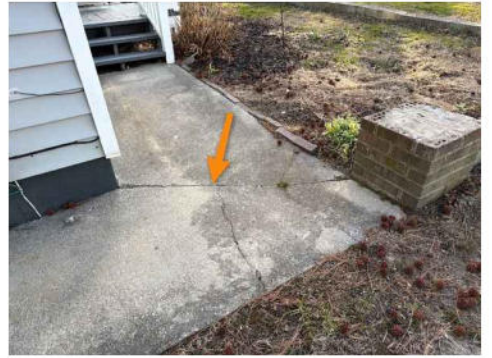
## 2.7.1 Walkways, Patios &amp; Driveways

**WALKWAY CRACKING - MINOR**

Minor cosmetic cracks observed. Recommend monitor and/or patch/seal.

**This was not addressed**

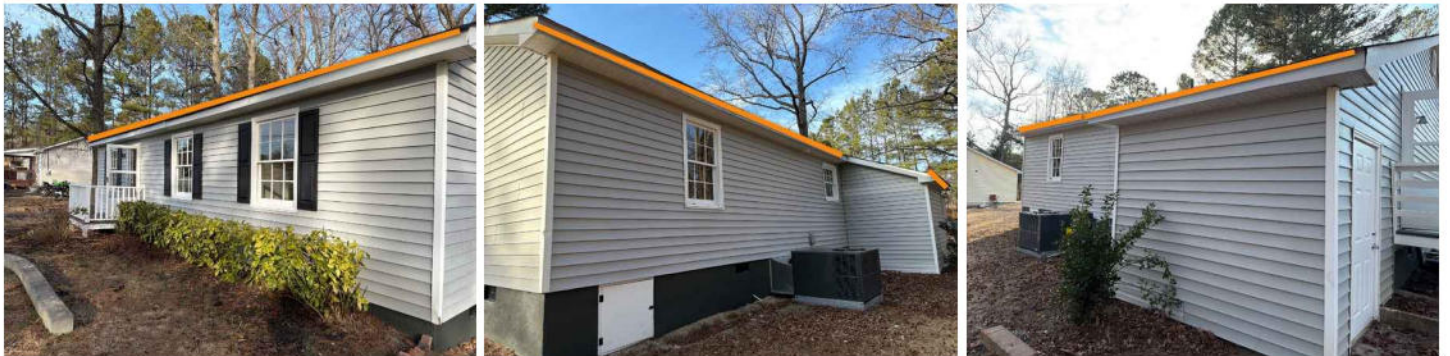
##### **GUTTERS: MISSING**

There are no gutters present on the home, and the grading does not have the proper slope to direct drainage away from the structure. Gutters are recommended to collect rainwater from the roof and direct it away from the building, helping to prevent moisture buildup around foundation that could damage the structure, flooring, insulation, and other components. The builder should be consulted for evaluation and installation of a gutter system.

**New gutters, downspouts and drainage improvements have been installed  
See the Ferguson estimate**

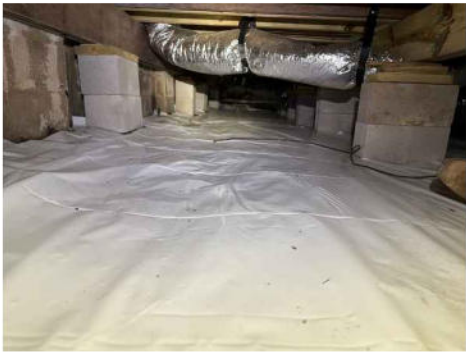
**Floor Structure:**  
**Basement/Crawlspace Floor**  
Vapor Barrier

**Floor Structure: Sub-floor**  
Floor Joist System, Plywood

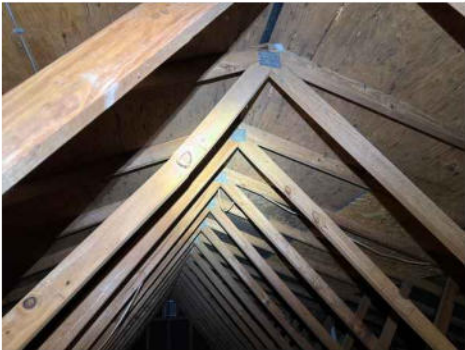
**Roof Structure & Attic: Material**  
Plywood

**Roof Structure & Attic: Type**  
Gable

**Roof Structure & Attic: Roof System**  
Truss System

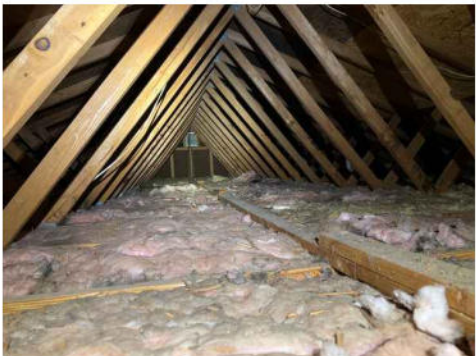
**ATTIC AREA: LIMITED OR NO ACCESS DURING INSPECTION**

For personal information: the inspection of the attic area was significantly limited due to the absence of walking boards and accessibility. The examination was conducted using the existing walking boards. It is highly recommended that a comprehensive inspection of the attic area be carried out before the closing, ensuring proper access and installation of walking boards.

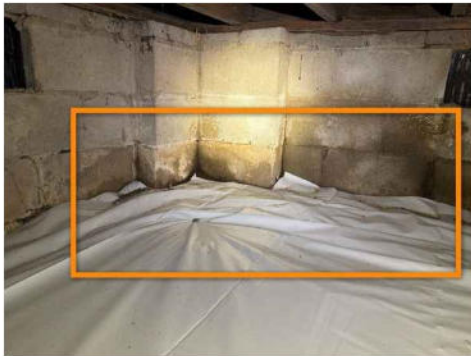
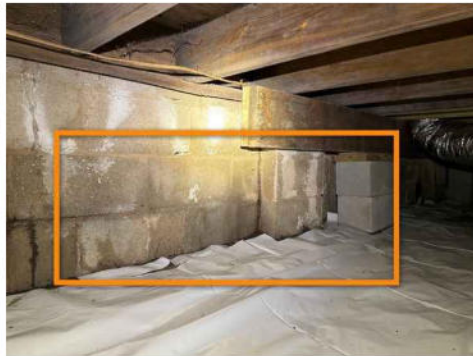
## 4.1.1 Foundation

Muddy areas were observed in the crawl space and around the foundation perimeter. This has resulted in high moisture level due to direct water penetration. This condition can harm the foundation, wooden structure, and foster undesirable conditions for insects and mold. Water presence suggests issues with waterproofing and foundation drainage. Repairs are necessary to prevent water entry. Seek a licensed contractor for further assessment and repairs to address moisture sources. Refer to roofing section of the report for related information.

Contact a qualified general contractor.

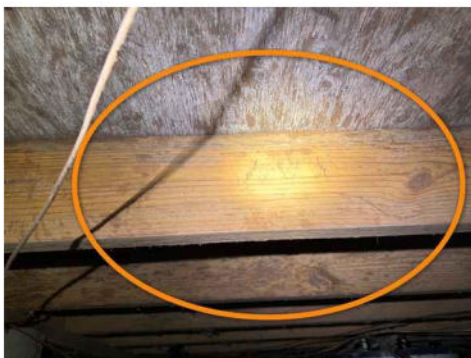
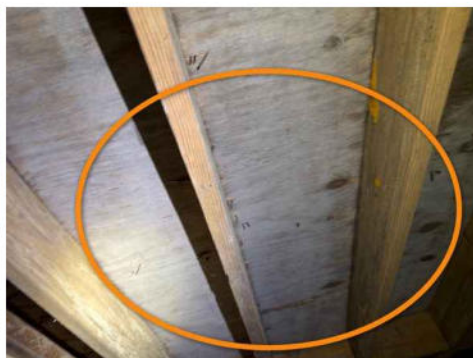
## 4.3.1 Floor Structure

**DAMAGED: DECAY: FUNGI**

The wood framing in the crawl space shows signs of light fungal growth from moisture and/or water penetration. This suggests an active or history of leaks and/or wet conditions. Consult a licensed general contractor to assess the damage, fix the floor framing, and improve the crawl space to maintain the home's stability and prevent more harm.

Contact a qualified general contractor.

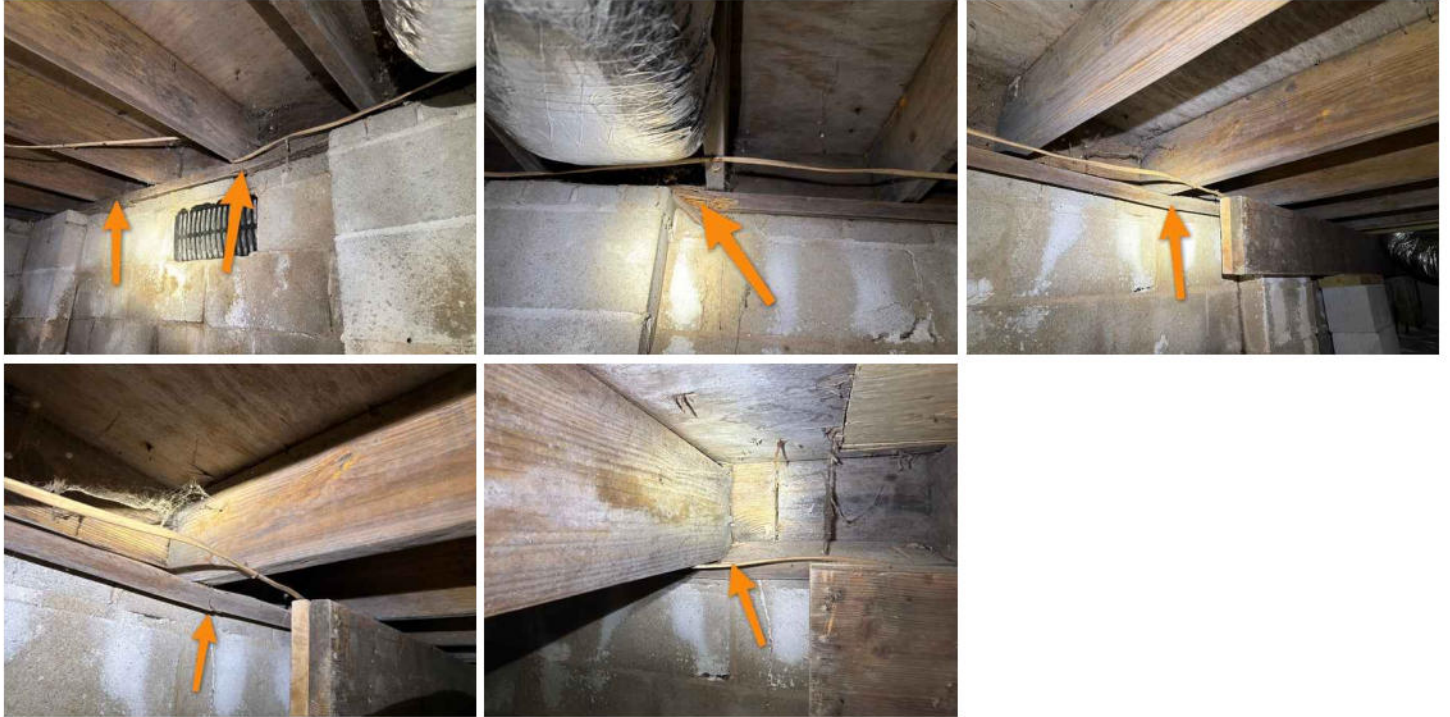
## 4.3.2 Floor Structure

**SUB -FLOOR: WATER STAINS: PERIMETER**

Sections of the framing at the front perimeter of the foundation shows signs of decay, which indicates a water entry points or source of moisture. To prevent further damage to TV structure components of the floor and water penetration, it's crucial to locate and address these issues promptly. It is recommended to consult a licensed general contractor for a thorough evaluation and repair of the floor system to uphold the integrity of the structure. Refer to roofing section of the report.

**Should be corrected, see the Ferguson estimate**

Contact a qualified general contractor.

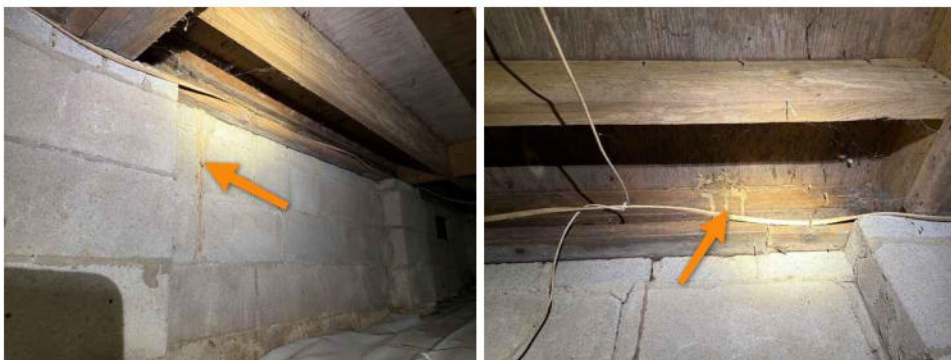
#### 4.3.3 Floor Structure

##### **MUD TUBES: POSSIBLE TERMITE ACTIVITY**

Mud tubes were noted on several piers within the crawl space, which may indicate the presence of subterranean termites. This condition should be further evaluated by a licensed pest control inspector and a licensed general contractor to determine the extent of any hidden damage and to recommend proper treatment if necessary.

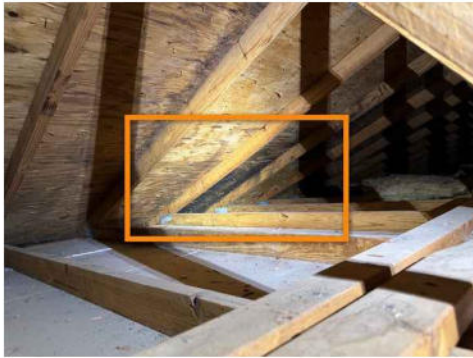
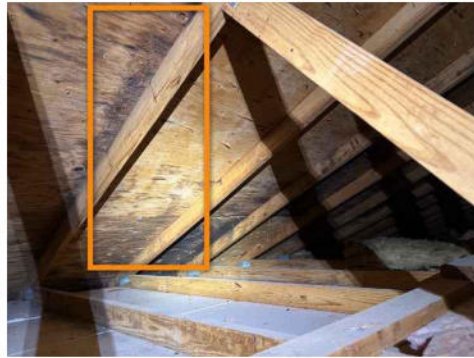
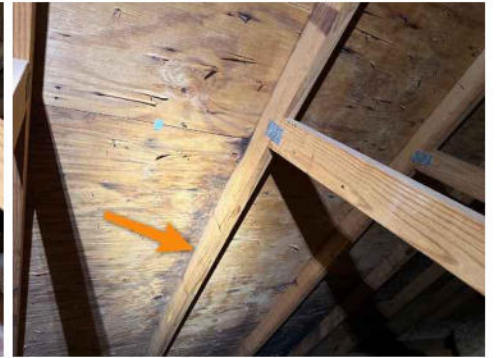
## 4.6.1 Roof Structure &amp; Attic

**ATTIC: STAINS**

From the attic, water marks were noticed in the framing components above the hall area around the chimney. A comprehensive inspection of the area is needed to uncover any potential concealed damage. Consulting a licensed general contractor is recommended to evaluate the extent of the decay, identify the underlying causes, and carry out the required repairs.

Contact a qualified general contractor.

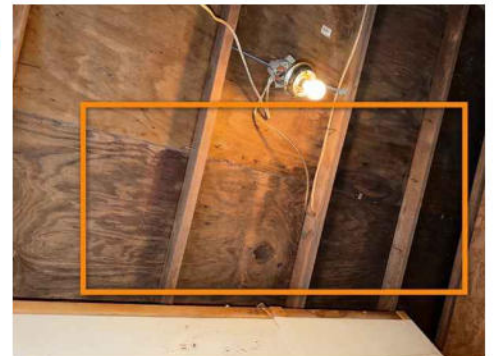
## 4.6.2 Roof Structure &amp; Attic

**ATTIC: STAINS**

Water marks were noticed in the framing components above the utility room area. A comprehensive inspection of the area is needed to uncover any potential concealed damage. Consulting a licensed general contractor is recommended to evaluate the extent of the decay, identify the underlying causes, and carry out the required repairs.

Contact a qualified general contractor.

**Not addressed**

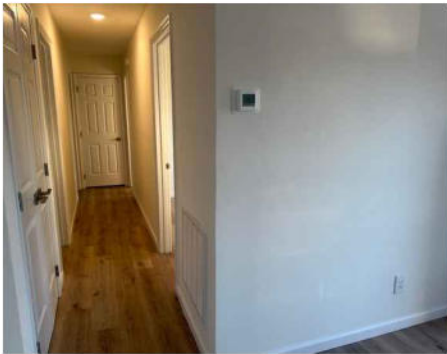
#### **Normal Operating Controls: Thermostat**

This home has a thermostat for the heating and cooling system. The thermostat located the hall.

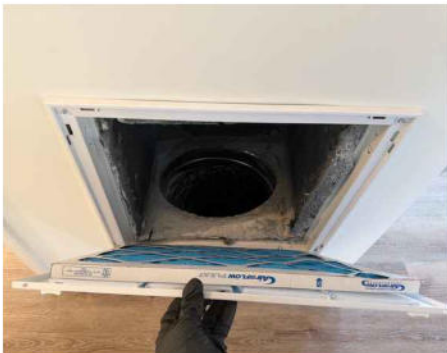
#### **Distribution Systems: Metal Box & Metal Ducts**

The HVAC filter is located in the hall. According to the manufacturer's recommendation, it should be replaced every 6 to 12 months. For further questions or maintenance concerns regarding the filter, it's advisable to consult an HVAC contractor should be consulted.

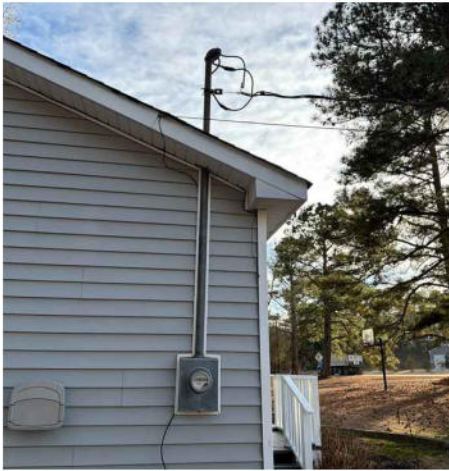
#### **Service Entrance Conductors: Electrical Meter**

For personal information, the electrical meter is located on the left side of the home.

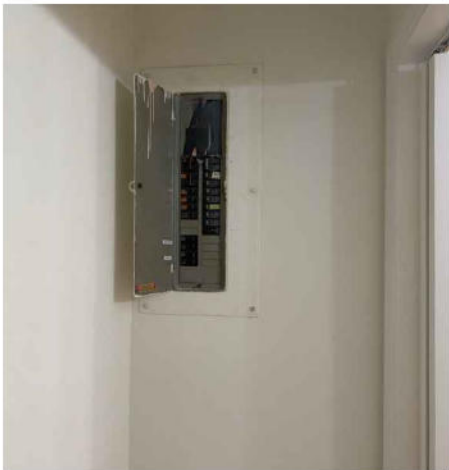
#### **Main & Subpanels, Service & Grounding, Main Overcurrent Device: Main Panel #1**

For personal information, the main electrical panel is located in rear side of the home.

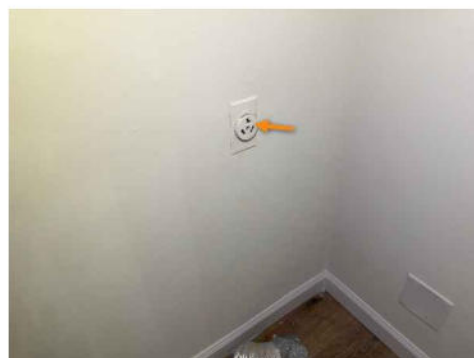
### DRYER: 3 PRONGS

For personal information, the dryer was noted to be 3 prongs type, newer units used 4 prongs outlets. A licensed electrical contractor should be consulted for evaluation and repair.

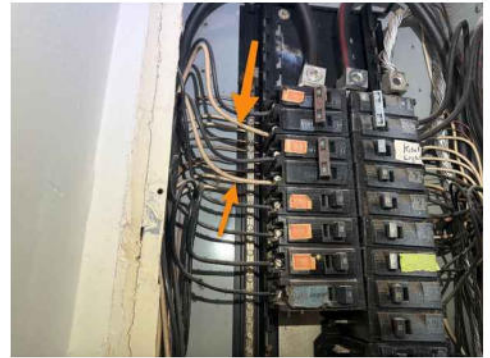
### 8.2.1 Main & Subpanels, Service & Grounding, Main Overcurrent Device

Two white wires in the distribution electrical pane were not appropriately marked with red or black tape. It is crucial to mark these wires to ensure proper identification of hot and neutral wires for electricians and repair personnel. This marking is essential for safety and effective troubleshooting. It is recommended to label the white wires with the appropriate color tape to adhere to standard electrical practices.

Contact a qualified electrical contractor.

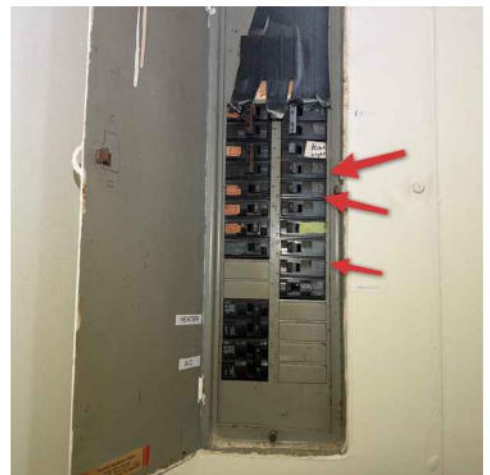
### 8.2.2 Main & Subpanels, Service & Grounding, Main Overcurrent Device

During the home inspection, it was observed that the main panel located in the laundry is not adequately properly labeled to identify all the breakers present. Proper labeling of breakers is essential for easy identification and safety purposes. It is recommended to have a licensed electrician evaluate the electrical panel and provide clear and comprehensive labeling for each breaker. This will help ensure that occupants can easily identify and isolate specific circuits when necessary, promoting electrical safety within the property.

Contact a qualified electrical contractor.

not addressed

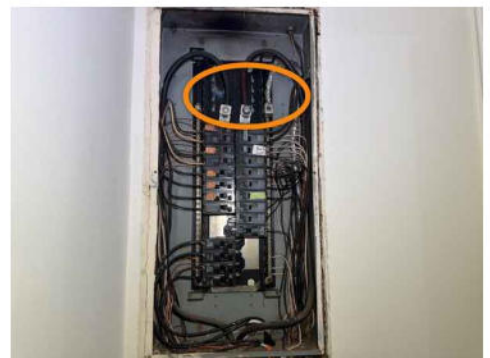
### 8.2.3 Main & Subpanels, Service & Grounding, Main Overcurrent Device

The electrical system in this home lacks a safe and efficient means to swiftly cut off power during emergencies. Typically, any system requiring more than six manual actions to shut down is deemed unsafe. It's advisable to engage a licensed electrical contractor for a thorough assessment. This includes labeling all electrical panels, subpanels, and service breakers, and confirming the compatibility of the configuration with the main service disconnect.

Contact a qualified electrical contractor.

not addressed

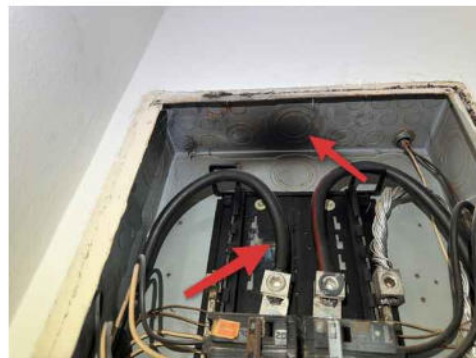
### 8.2.4 Main & Subpanels, Service & Grounding, Main Overcurrent Device

Soot and heat damage were observed inside the electrical panel, including a burned/discolored section along the interior section of the panel and near the bus area. This condition is consistent with a previous arcing or overheating event, which can result from loose connections, improper installation, or failing components. Such conditions pose a potential fire and safety hazard. It is recommended that a licensed electrical contractor further evaluate the panel to determine the cause and perform any necessary repairs or replacement.

**not addressed**

Contact a qualified professional.

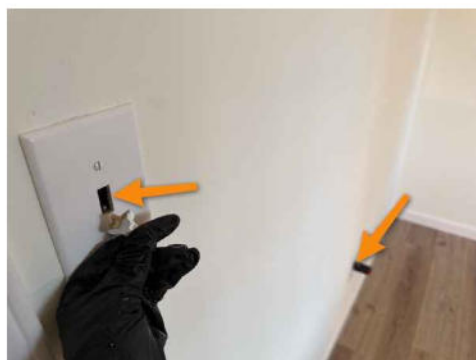
#### 8.4.1 Lighting Fixtures, Switches & Receptacles

### DEFECTIVE WALL SWITCH

The wall switch controlling the receptacle in the front left bedroom was observed to be broken at the time of inspection. Due to its damaged condition, the switch could not be properly tested and was not functional. This condition may affect the operation of the associated outlet and could present a safety concern. It is recommended that a licensed electrical contractor evaluate the switch and perform the necessary repair or replacement.

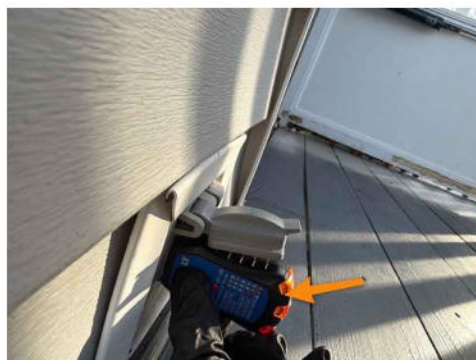
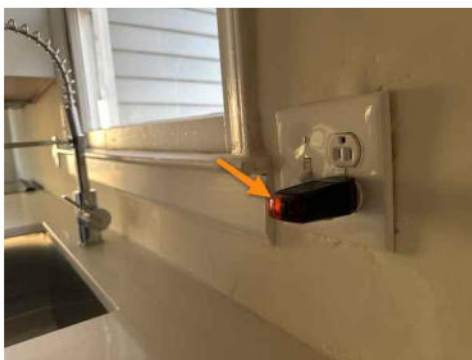
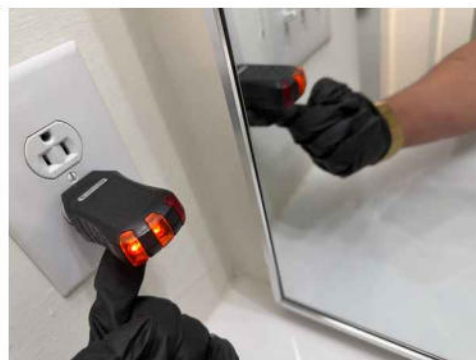
#### 8.5.1 GFCI & AFCI

### NO GFCI PROTECTION INSTALLED

No GFCI protection present in the exterior, bathrooms and kitchen. Recommend licensed electrician upgrade by installing ground fault receptacles in all locations.

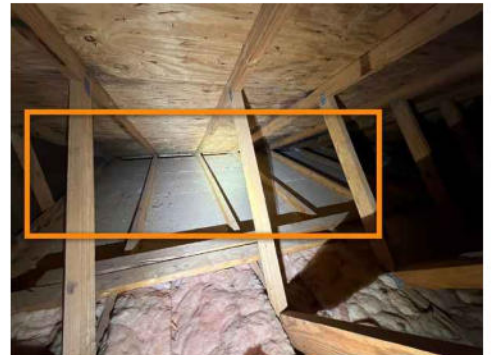
#### ATTIC INSULATION: MISSING SECTIONS

In the attic section above front hall and master bedroom perimeter, it was noted that a few sections of insulation are missing. This could lead to condensation issues and energy loss. It is recommended to install insulation in this area. A licensed contractor should be consulted for proper evaluation and installation.

**Not addressed**

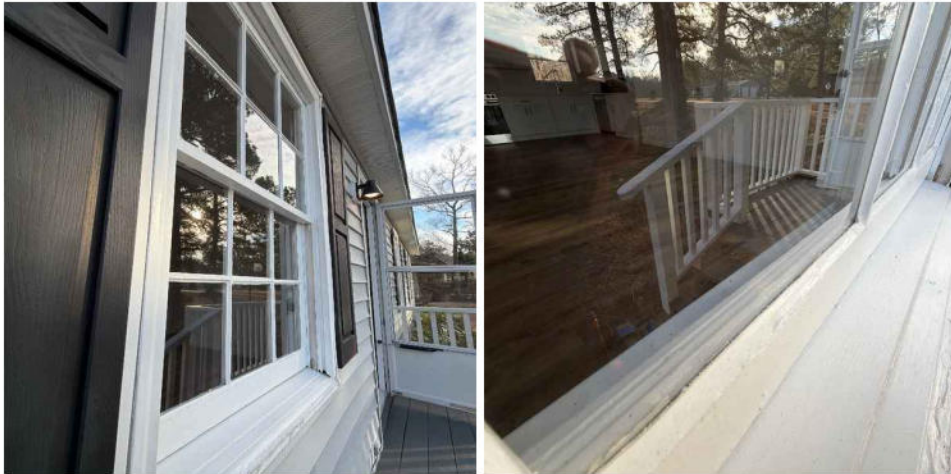
#### SINGLE PANE

The windows in the home were noted to be single pane, typical for the age of a home. It is recommended to replace all single pane windows to prevent personal injuries and weather intrusion.

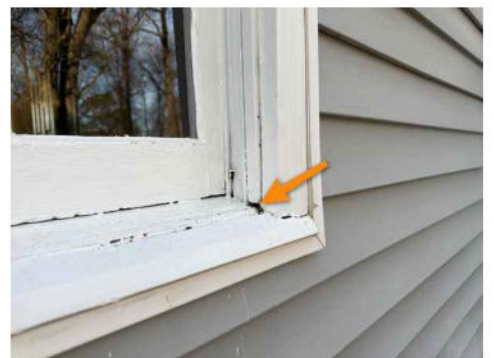
### 11.2.1 Windows

#### WINDOW-DOOR: DECAY FRAME

The window located on the rear-right side of the home was noted to have areas of decaying. Further evaluation and repair are needed. At the time of the evaluation, the general contractor should assess every window and repair as needed to ensure their functionality.

**This should be repaired**

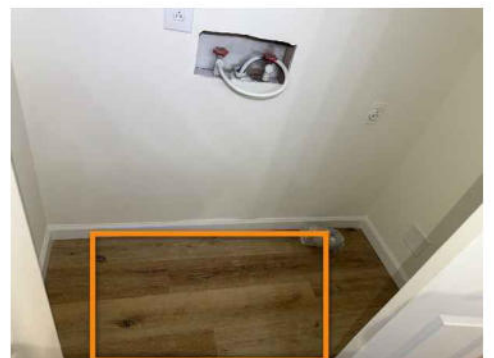
### 11.3.1 Floors

#### WASHER: MISSING PAN

The dryer in the laundry is missing the tray/pan underneath, which could lead to water damage if there's a leak or overflow from the washer. It's recommended to consult a licensed plumbing contractor for evaluation and repair.

**Will not be provided by seller**

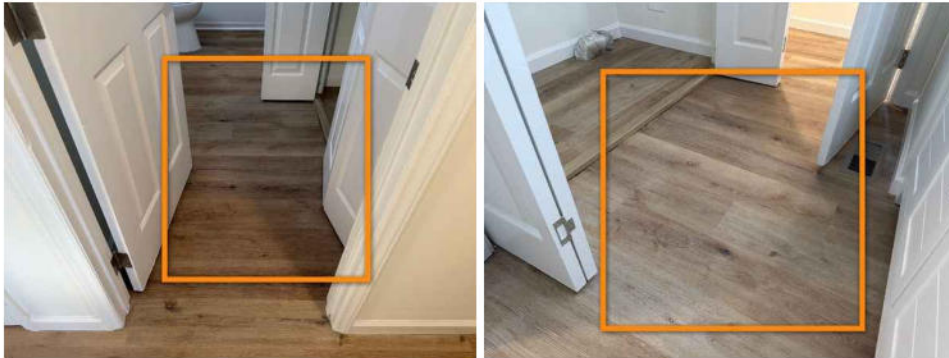
## 11.3.2 Floors

**FLOOR: RAISED**

Contact a qualified general contractor.

**There was a repair for this. See Ferguson estimate**

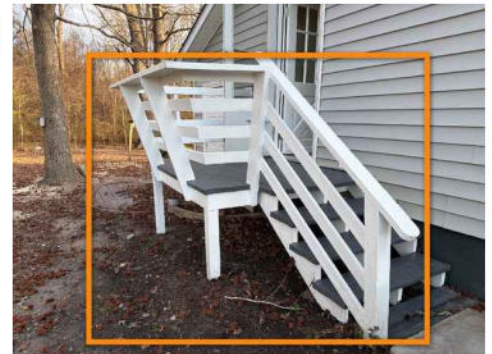
## 11.6.1 Steps, Stairways &amp; Railings

**RAILINGS: HORIZONTAL WIRE RAILINGS**

The railings for the stairway with horizontal balusters instead of vertical pose a safety concern for children, as they could climb the wires and potentially fall. Additionally, there may be concerns about the wires loosening over time or being less robust than traditional balusters. This is just a precautionary note to ensure the safety of all users.

**This was not changed**

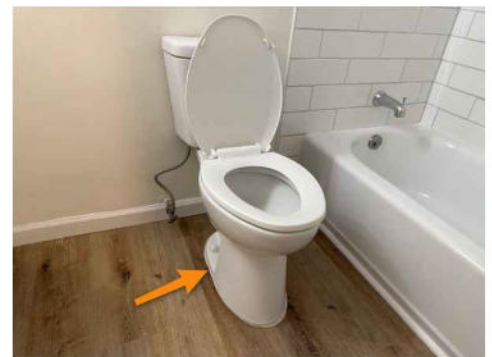
## 11.11.1 Bathroom

**LOOSE TOILET**

The toilet for the hall bathroom was noted to be loose. Further evaluation and repair is needed to prevent property damaged and/or leaks. A licensed plumbing contractor should be consulted.

Contact a qualified plumbing contractor.

**Should be repaired**

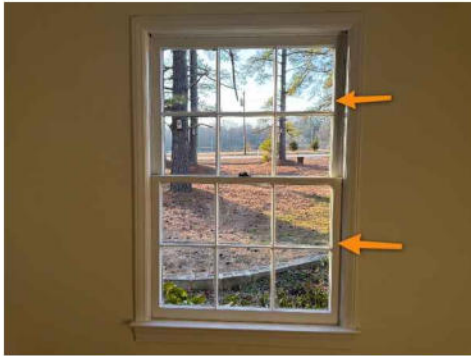
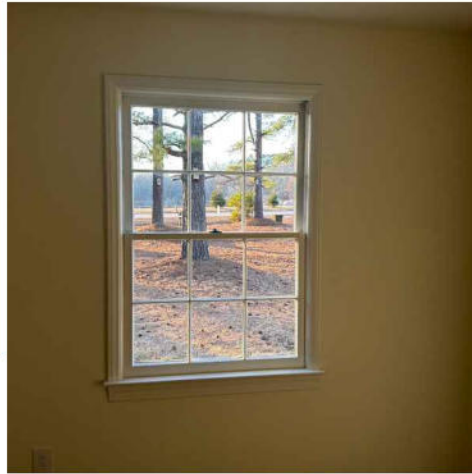
## 11.13.1 Kitchen

**WINDOW: STUCK**

Contact a qualified general contractor.

**This should have been addressed**

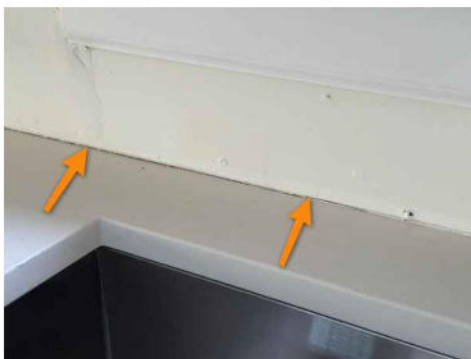
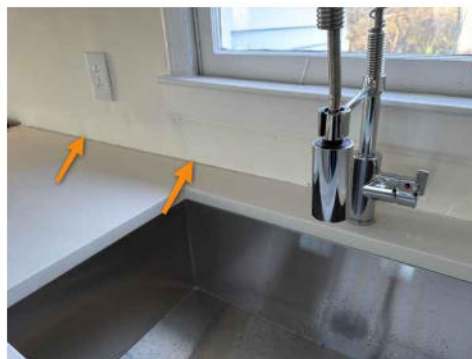
11.13.2 Kitchen

**COUNTER TOP: OPEN SEAM**

**This was repaired**

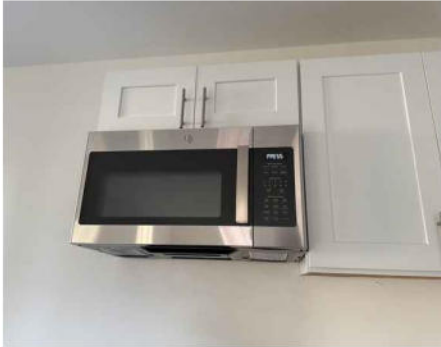
**Range/Oven/Cooktop:**  
**Range/Oven**  
Re-circulate

**Range/Oven/Cooktop: Range**  
GE

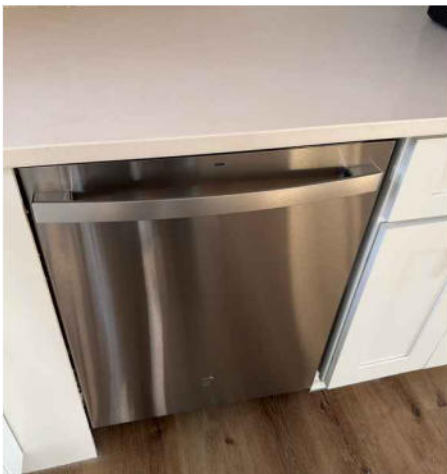
**Dishwasher: Brand**  
GE

The dishwasher was operated through the "Normal Cycle". The unit was inspected to function and complete the cycle, but the effectiveness of the cleaning was not determined.

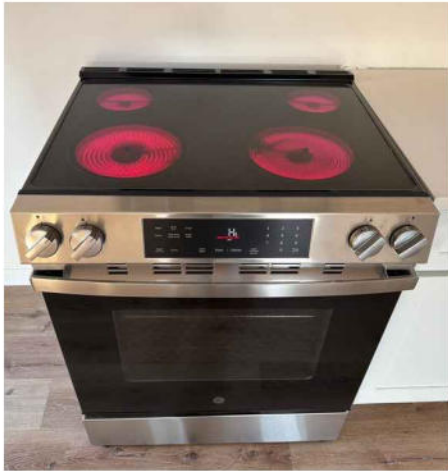
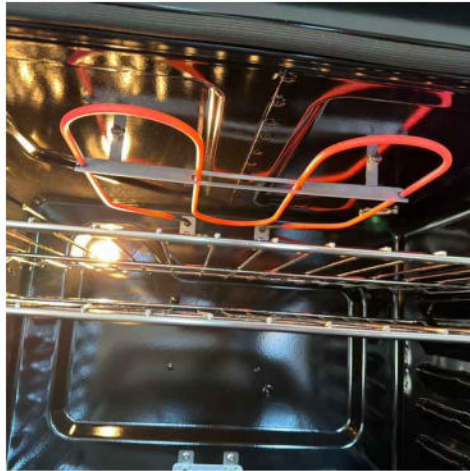
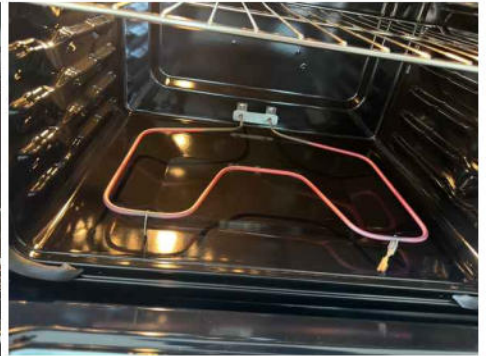
## Range/Oven/Cooktop: Range/Oven Energy Source

Electric

The range/oven elements were operated with indicator set to HIGH until the element was noted to be functional or until a defect was noted. The unit calibration was not verified. If the client would like to verify temperature calibration, an appliance specialist should be consulted.

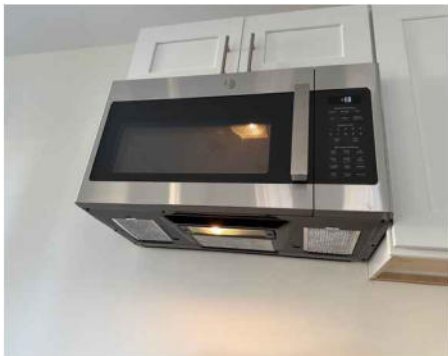
## Built-in Microwave: Microwave

We tested the microwave by running it on HIGH for 1 minute, or until steam appeared from a wet paper towel, or until we detected any defects. However, we didn't verify its cooking effectiveness or wattage.

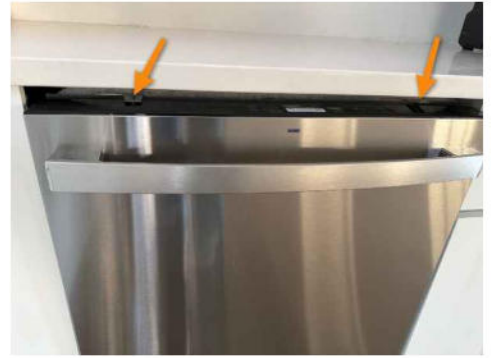
### 12.1.2 Dishwasher

#### DISHWASHER: NOT ATTACHED

Contact a qualified appliance repair professional.
