## Home Inspection Report

PROPERTY INSPECTED:  
**120 Carolina Ave**  
**Oxford, NC 27565**

Date of Inspection: 09/08/2026

Inspection No. 341431-2057

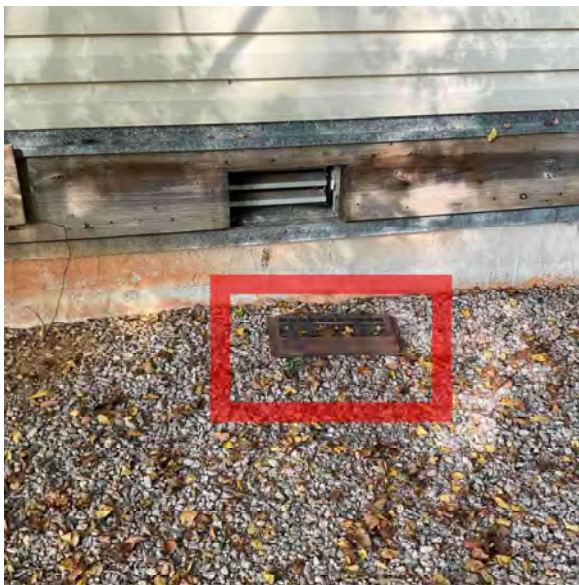
2.2.1 Crawl space vent has a loose cover. Have a qualified contractor repair/correct to prevent rodent and pest intrusion. **(Exterior Rear)**

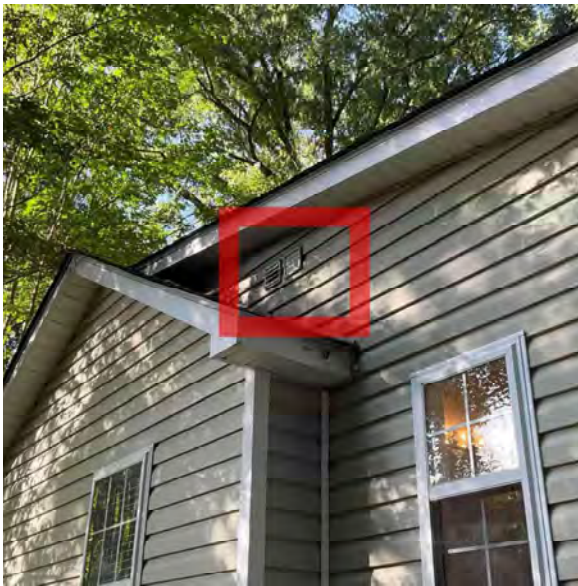
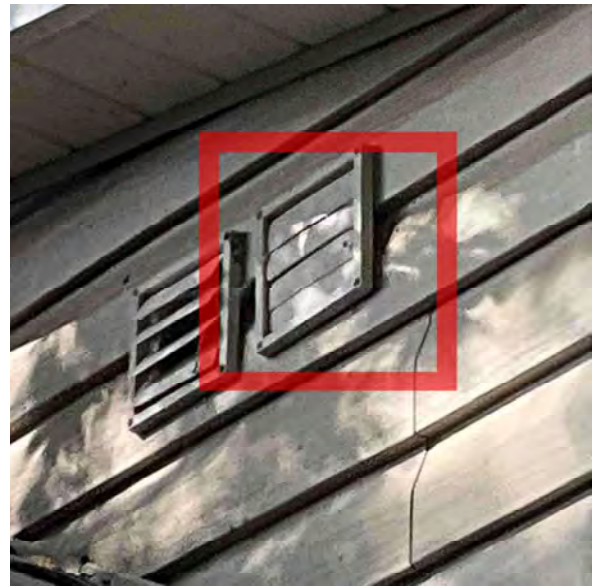
2.3.1 Exterior exhaust vent is not opening when in use and may be obstructed or clogged. A non-functioning vent could prevent moist air from exiting the bathroom and lead to undesirable living conditions. Have a qualified contractor correct to ensure proper functionality. **(Exterior Rear)**

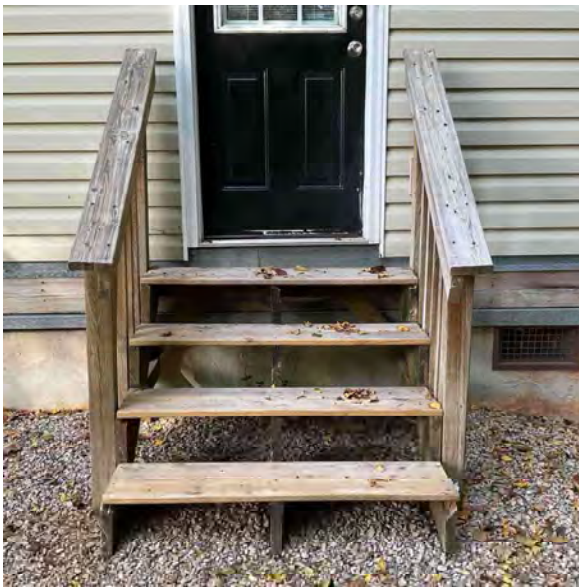
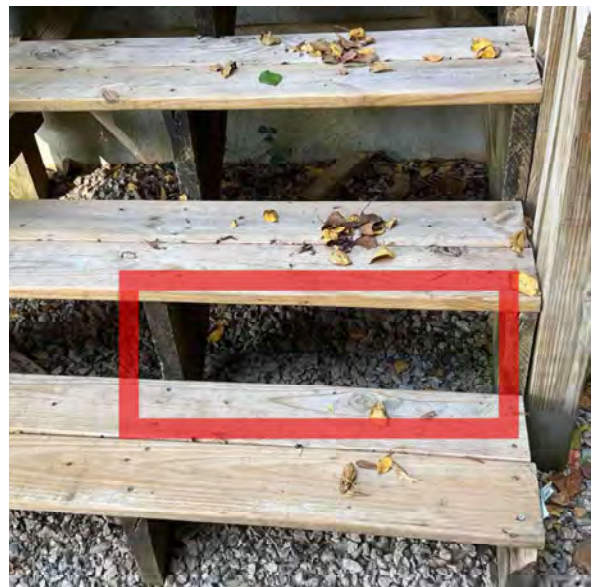
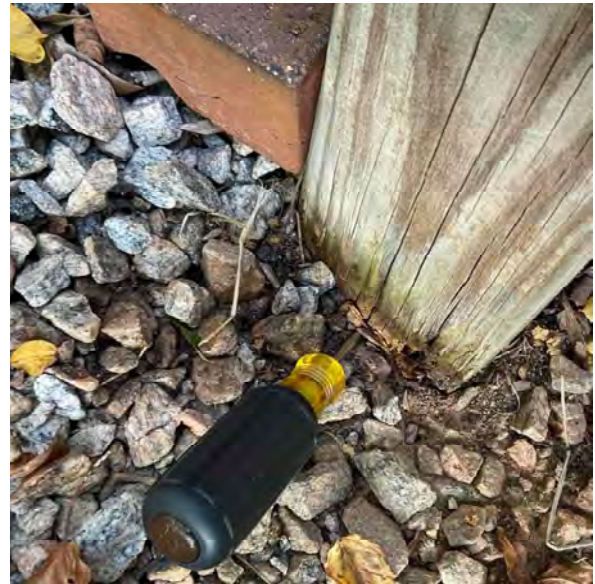
2.5.1 The wood entry stairs have some noted safety and/or structural concerns that could lead to personal injury. Further evaluation by a licensed general contractor is required to assess the deck and to determine appropriate corrective actions to provide adequate functionality and safety.

- The handrails and posts on the staircase to the porch are loose/wobbly and present a safety hazard
- Open risers present trap hazard
- Damage was noted at the bottom of a post **(Exterior Rear)**

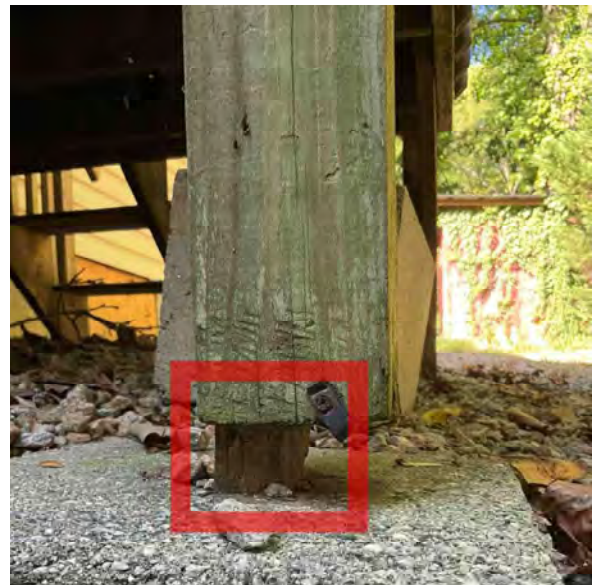
2.5.2 The side wood porch has some noted safety and/or structural concerns that could lead to personal injury. Further evaluation by a licensed general contractor is required to assess the deck and to determine appropriate corrective actions to provide adequate functionality and safety.

- The footings are above grade, and the posts are not properly secured
- The joist are supported by nails alone. Typically hangers or ledger are required for proper support and strength.
- Support posts were not attached using bolts or bearing directly under girder which is needed for intended support
- There are open risers in the staircase, which presents a trap hazard, and the handrail is too wide and not graspable.
- Damaged boards were noted on the stairs and platform **(Exterior Left)**

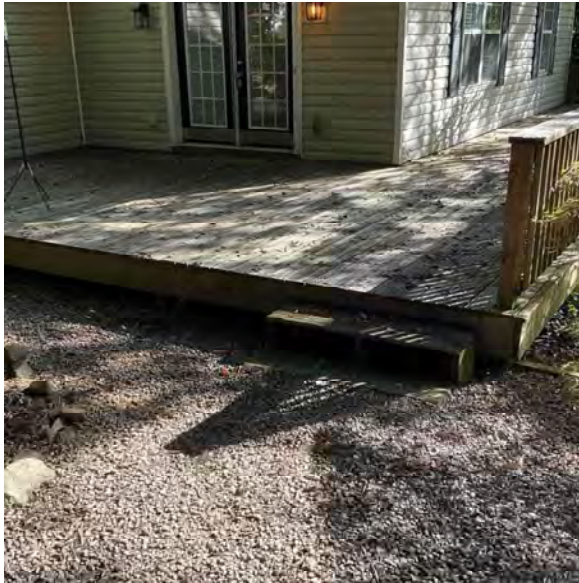
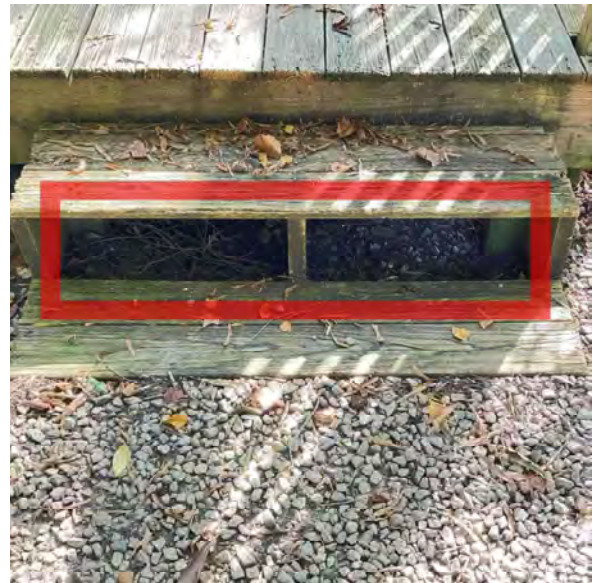
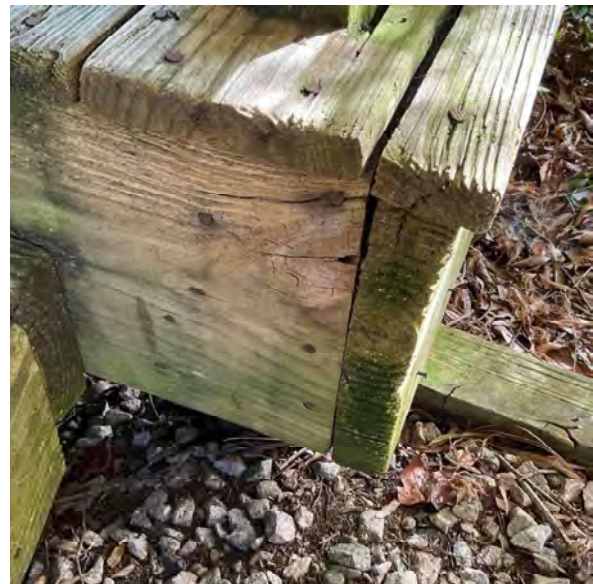
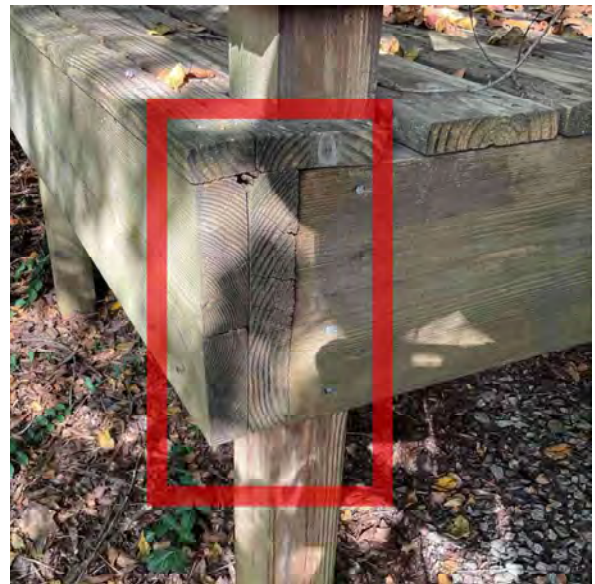
2.6.1 The wood deck has multiple noted safety and/or structural concerns that could lead to personal injury. Further evaluation by a licensed general contractor is required to assess the deck and to determine appropriate corrective actions to provide adequate functionality and safety.

- There were "open risers" present between the stair treads creating a potential trip/fall hazard.
- Support posts were not attached using bolts or bearing directly under girder which is needed for intended support
- There were damaged boards noted on the deck floor
- Underneath the deck, there were multiple stacks of blocks and bricks suggesting there is overspend joists, damaged wood, and or deflection.
- Rust and corrosion was noted on and around several bolts / fasteners that can lead to weakening and failure
- Exterior Front
- Exterior Right

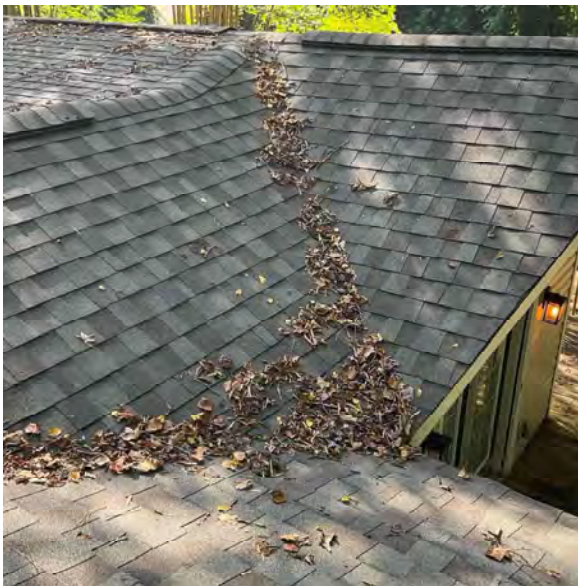
3.3.1 There is tree debris in the roof valleys. Have a qualified contractor remove tree debris off roof to prevent accelerated shingle deterioration and damage.

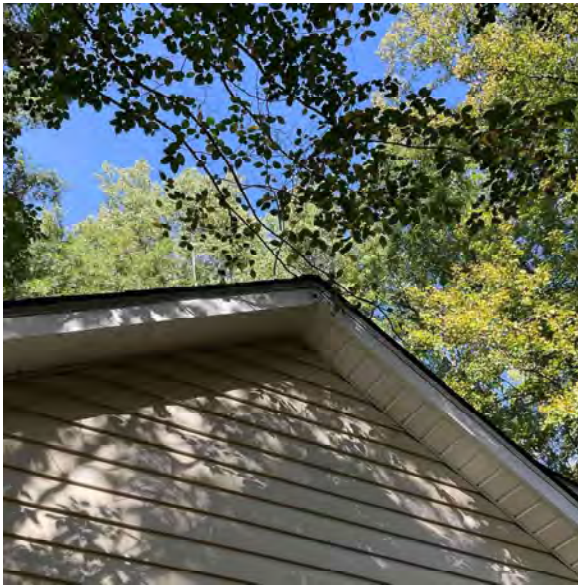
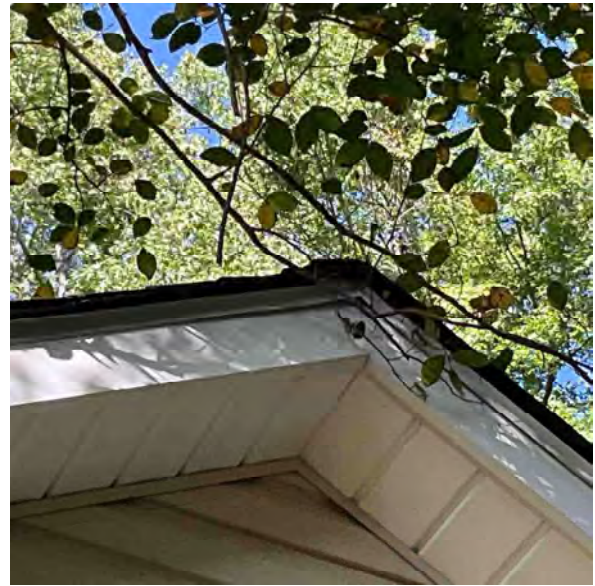
3.3.2 There are tree limbs in contact or hanging over the roofing surface. This can lead to accelerated deterioration and promote animal / pest activity. Have a qualified contractor assess and trim back the tree limbs that are touching the rear slope of the house to reduce damage to the roof covering and accessories. **(Exterior Rear)**

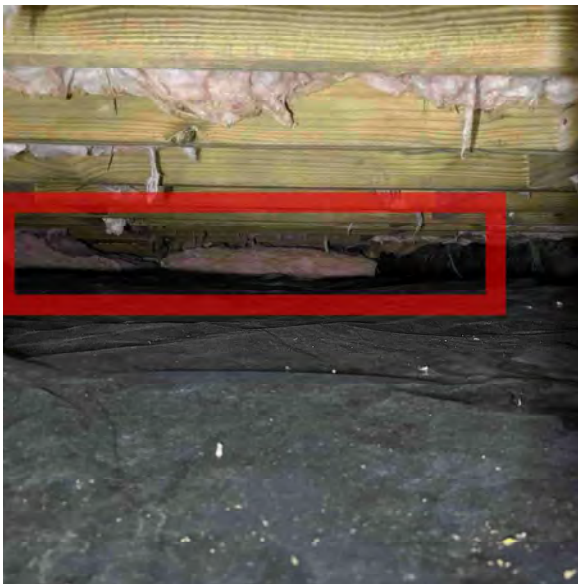
6.3.1 Have a qualified contractor resecure fallen/missing insulation batts between joists and replace any that are damaged to improve heating and cooling efficiency. **(Crawlspace)**

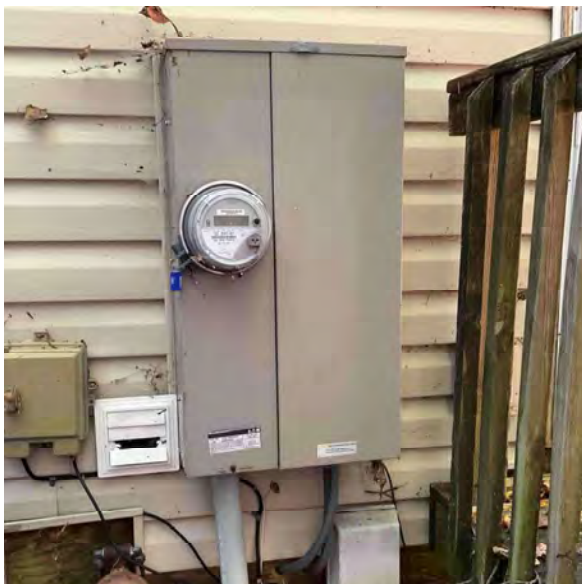
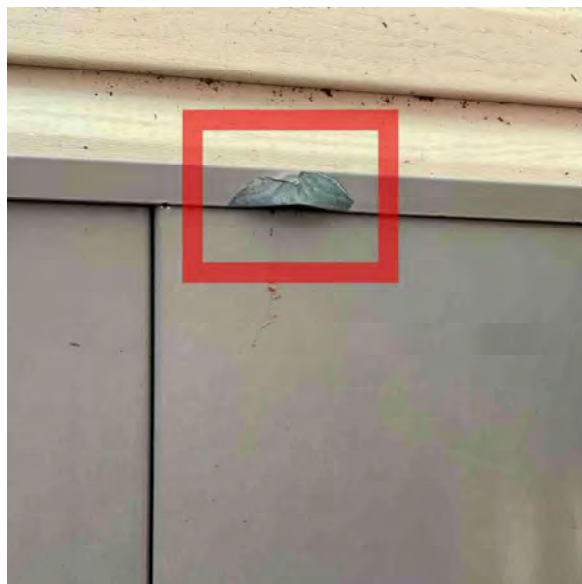
7.5.1 The door to the electrical panel was unable to be opened during the inspection. Signs of forced entry were noted at the top of the distribution panel. Through a slight opening, it was noted that there was no cover plate protecting the exposed wires behind the panel door. Have a licensed electrician gain access and fully evaluate the electrical panel. Any deficiencies found should be corrected by a licensed electrician.

Limitation: due to the lack of access to the distribution panel, determining the service size, conduction material, and observations of potential deficiencies were unable to be completed. These exclusions are not limited to examples provided. **(Exterior Left)**

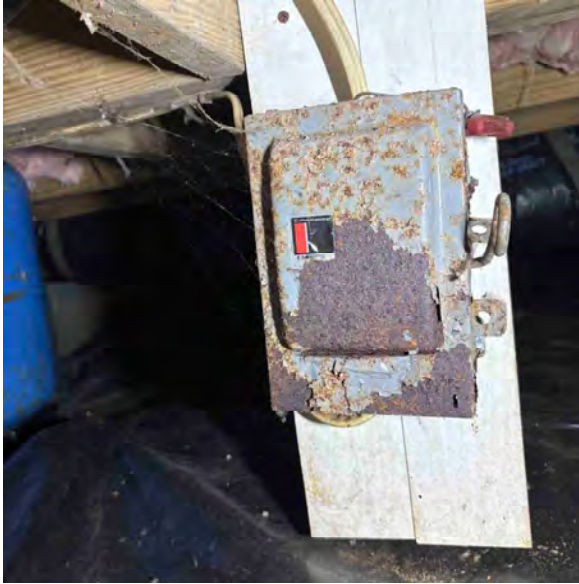
7.6.1 The disconnect box for the well water storage tank is rusted and there are exposed wires. Have a licensed electrician replace as needed for proper condition. **(Crawlspace)**

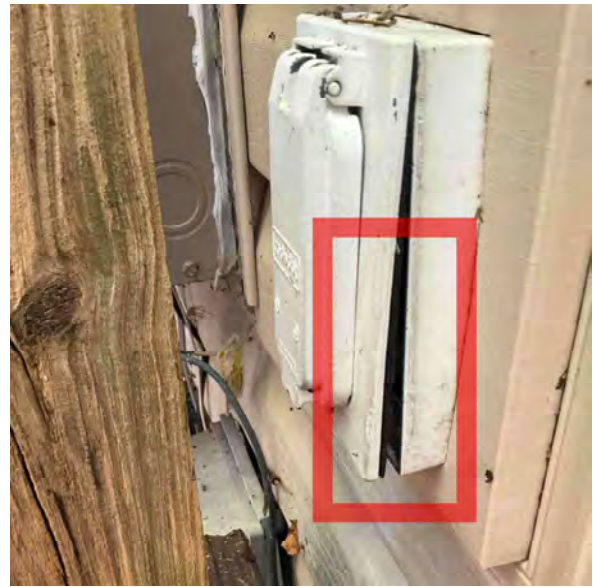
7.7.2 The receptacle has an open gap that can allow moisture penetration and subsequent damages. A licensed electrician should correct receptacle as required for electrical safety. **(Exterior Left)**

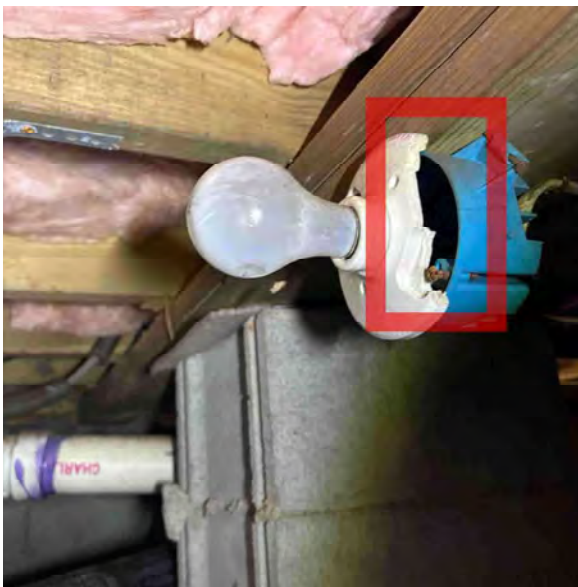
7.8.3 The junction box for the light in the crawlspace is damaged and electrical components are exposed. Have a licensed electrician correct as needed for electrical safety.

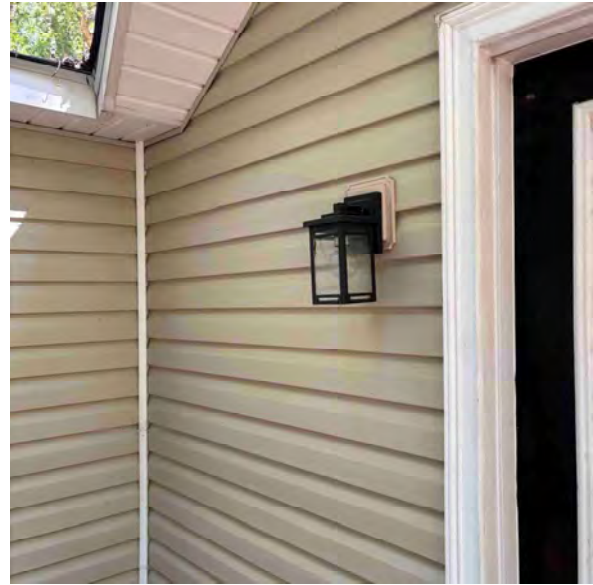
7.8.4 Light did not responding to the switch. Check/install bulb first prior to evaluating the fixture. Have a licensed electrician evaluate and repair as needed to allow safe and proper operation. **(Exterior Front)**

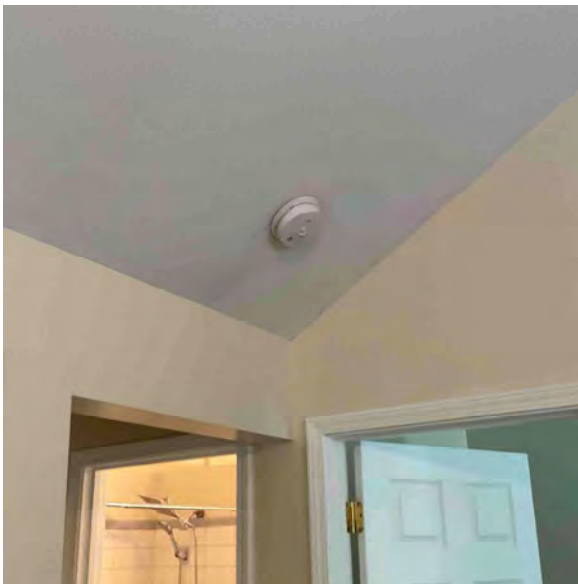
7.11.1 Smoke detector were not operating properly at the time of inspection. Check battery first. If problem persists, have a licensed electrician repair to improve safety. The National Fire Protection Association recommends replacing all smoke detectors when they are 10 years old. Confirm age of detectors and of CO monitors when replacing batteries, replace if detectors are out of date to provide intended protection. CO monitors should be in service on every floor. **(Family Room)**

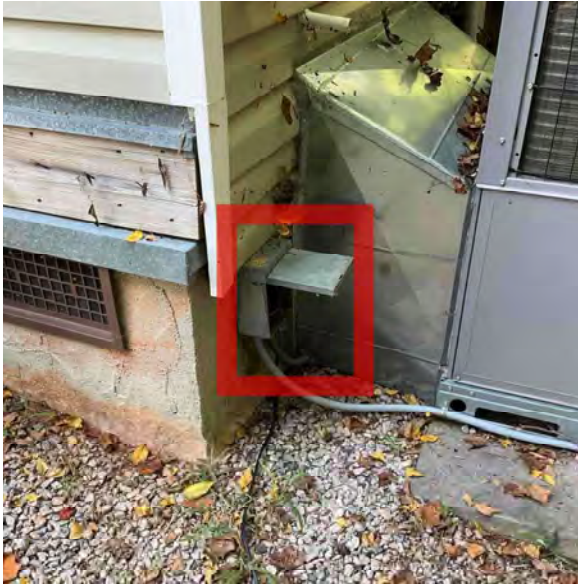
8.3.1 The air conditioners electrical disconnect has a missing panel cover. The exposed wiring presents a shock hazard. A licensed HVAC technician or licensed electrician should further assess and correct as required for safety. Additionally, this disconnect is directly below two water faucets. Although these boxes are designed for exterior exposure, direct running water is not recommended. Have a licensed electrician assess to determine if relocation is necessary and make any needed corrections. **(Exterior Left)**

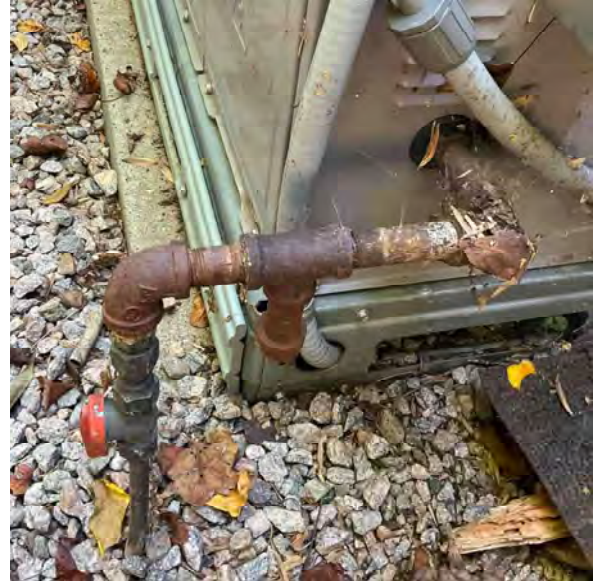
8.6.1 The metal gas line is rusted. Rust can cause damage to gas line leading to leaks and subsequent hazards. Have a licensed plumber or licensed HVAC technician to evaluate to determine what repairs are needed an correct. **(Exterior Left)**

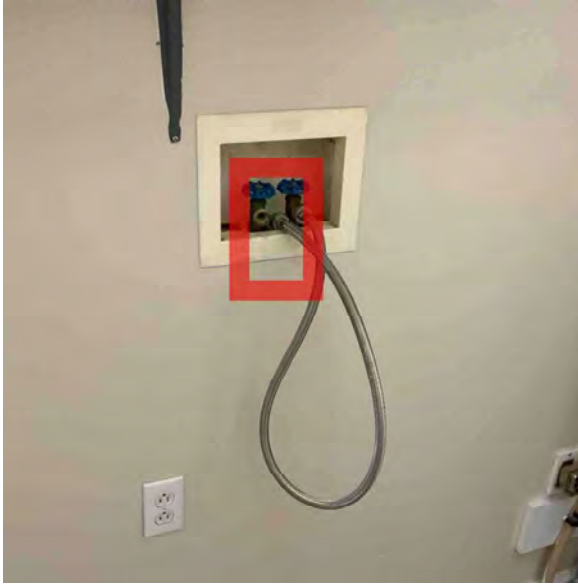
9.4.1 The distribution piping valve for the washer connection is leaking. A licensed plumber should repair as required to prevent water damage. **(Laundry area)**

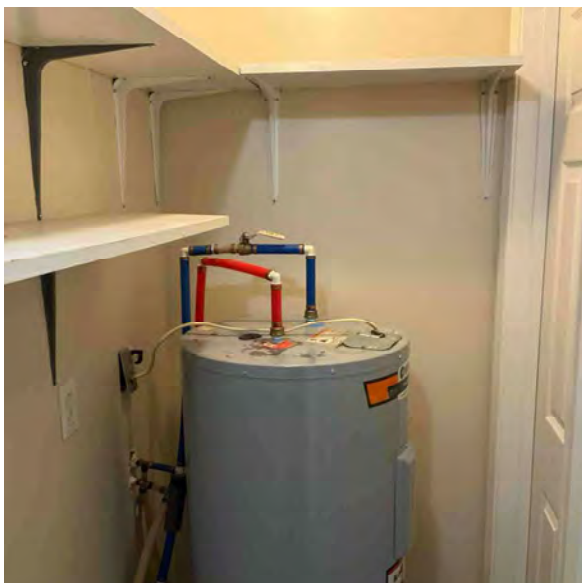
9.6.2 There was no expansion tank present for the water heater. An expansion tank is designed to handle the thermal expansion of water as it heats up in the water heater, preventing excessive water pressure and prolonging the life of the unit. If water pressure gets too high they can damage valves and plumbing fixtures, joints and supply pipes and the water heater itself. Recommend having a licensed plumber install as needed. **(Laundry area)**

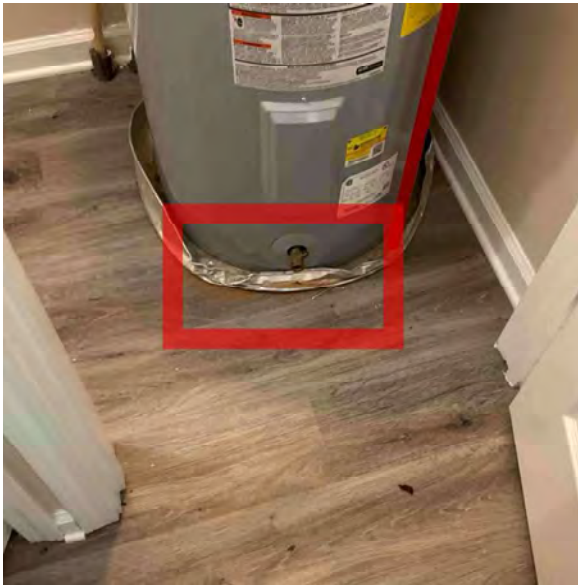
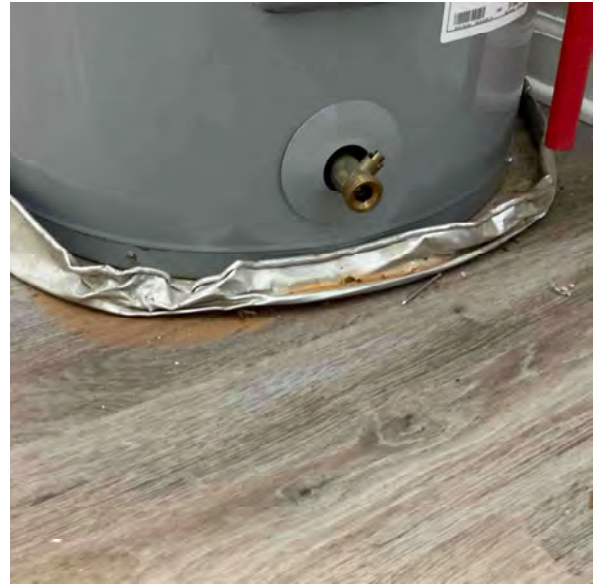
9.6.4 The pan below the water heater is damaged and may not contain water as intended. Have a qualified contractor correct as needed. **(Laundry area)**

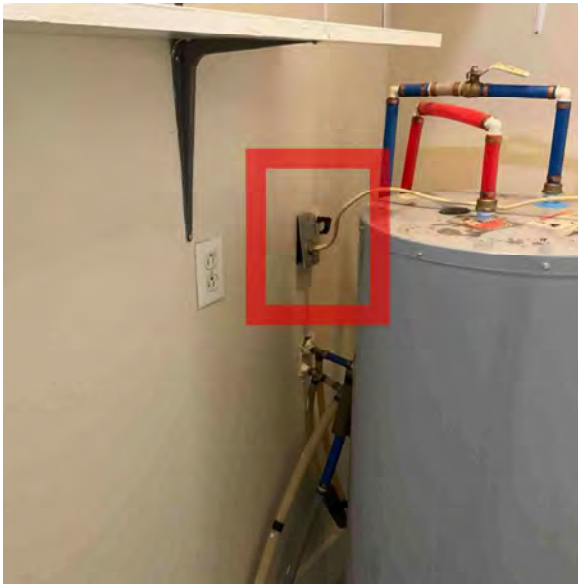
9.6.6 The wall cover for the electrical to the water heater has an open gap. This presents an electrical hazard. Have a licensed plumber or a licensed electrician, correct as needed for safety. **(Laundry area)**

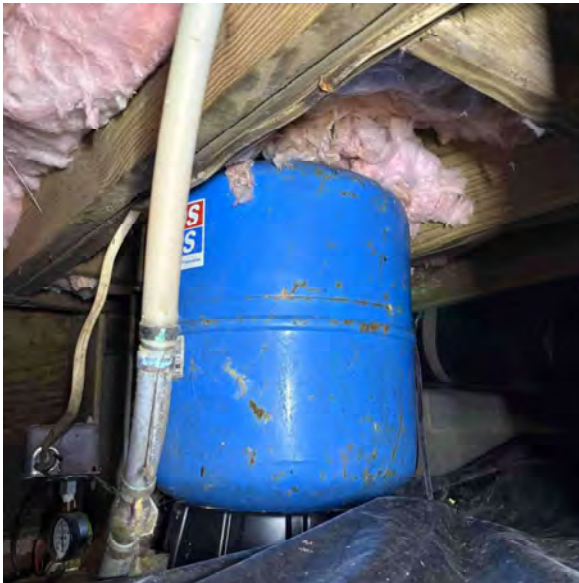
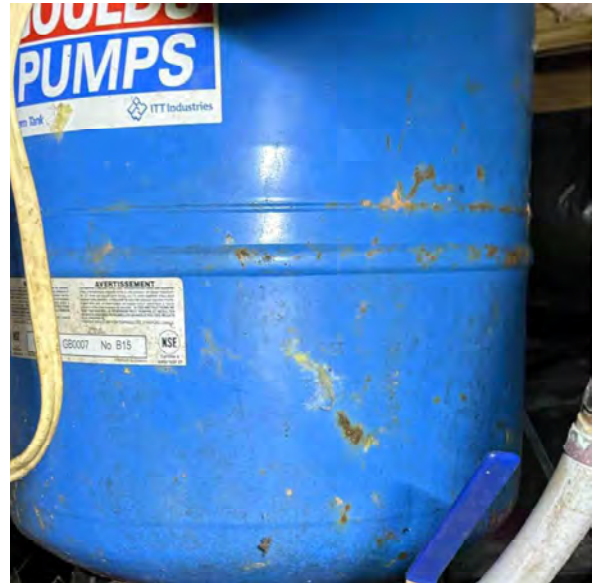
9.10.1 The storage tank is rusted. A qualified plumber should repair or replace as required to ensure proper function. **(Crawlspace)**

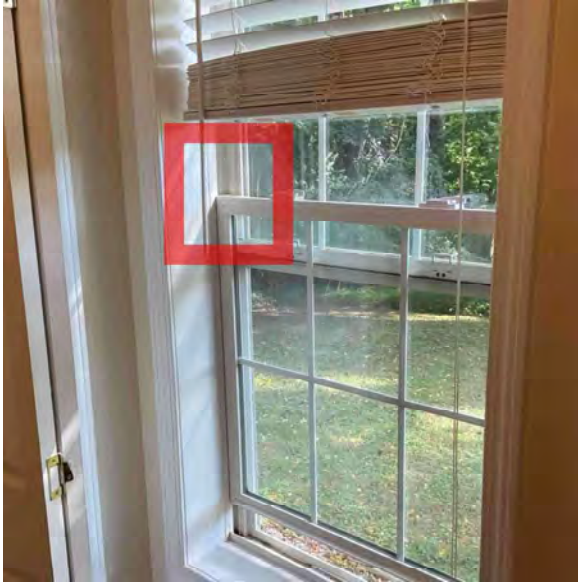
10.3.1 The window jamb latch hardware is damaged. Have a window specialist adjust/repair as needed to ensure proper functionality and security. **(Rear Bedroom)**

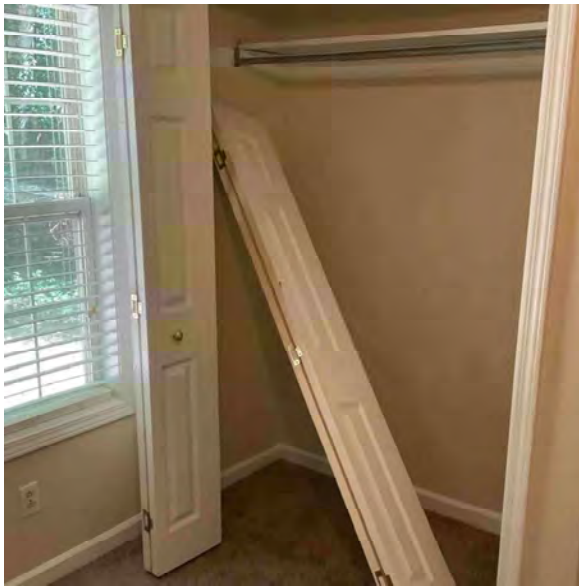
10.4.2 The closet door is not properly hung on the track. Have a qualified contractor correct as needed for proper functionality and condition. **(Front Bedroom)**

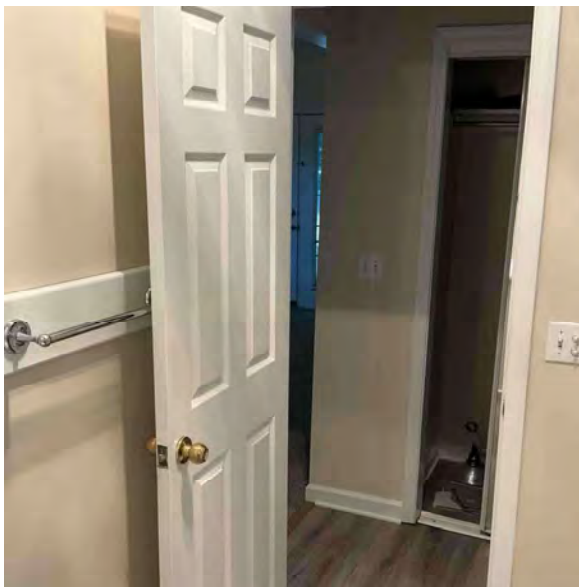
10.4.3 The door is not properly balanced. It will not stay in the shut position and opens automatically. Have a qualified contractor correct/adjust the door to provide proper balance. **(Hall Bath)**

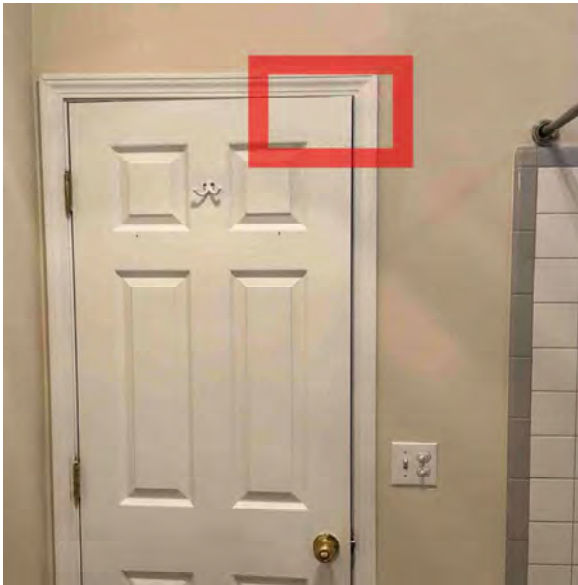
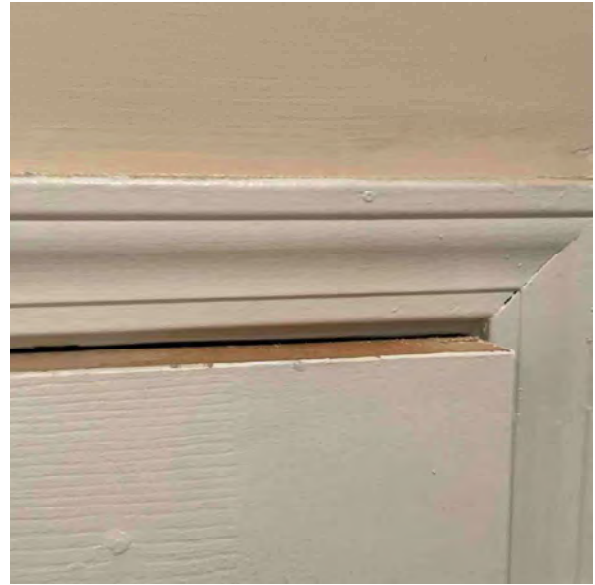
10.4.4 The door binds and will not close. Have a qualified contractor repair/adjust for improved functionality and prevent damage to door frame. **(Hall Bath)**

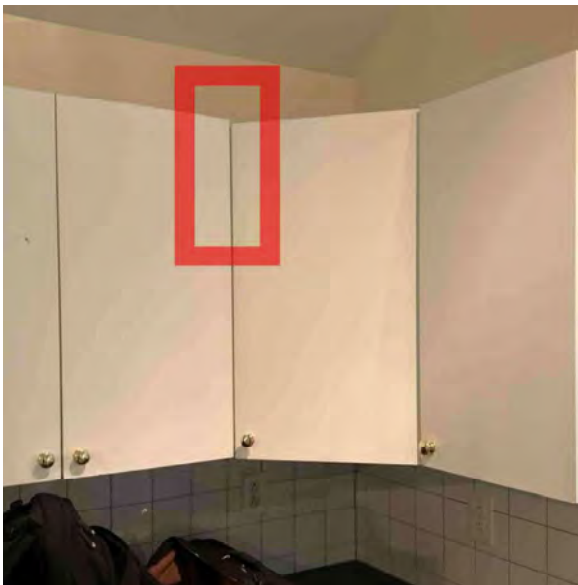
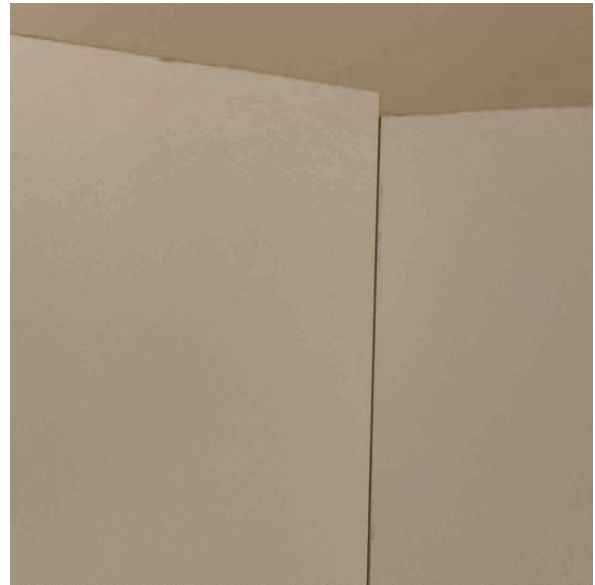
10.5.1 Corner cabinet door rubs against adjacent door when opening and closing. This could cause damage to the door. Have a qualified contractor correct as needed. **(Kitchen)**

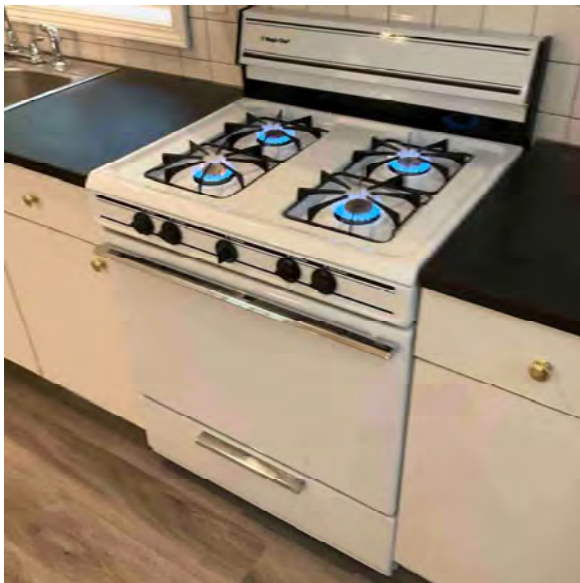
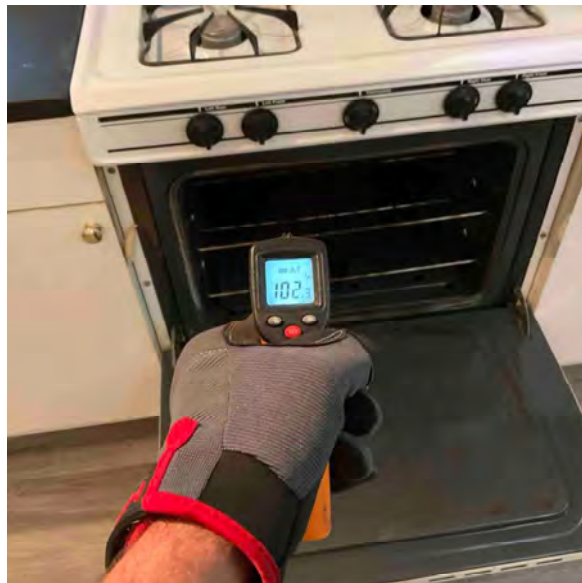
11.2.1 There was some heat coming from the stove prior to operation. This suggests that the gas stove may have a standing pilot light. Appliances don't typically have standing pilot lights anymore because it presents a waste of fuel in a higher gas leak or fire risk. This unit should be evaluated by an appliance technician to determine if it is functioning properly and if replacement is needed. **(Kitchen)**

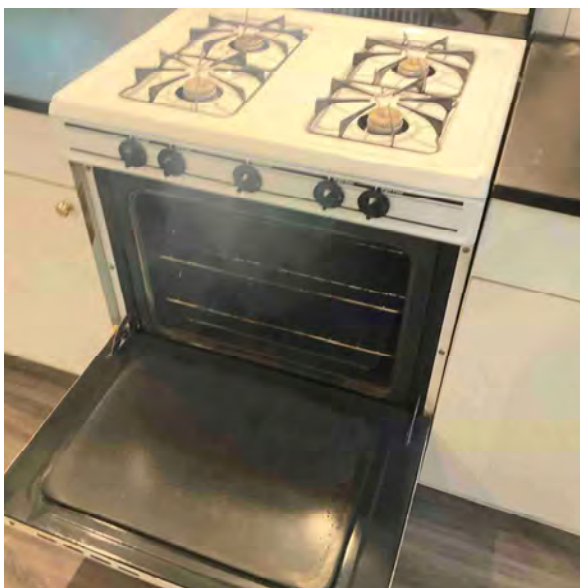
11.2.2 During operation, the oven smoked heavily. This could indicate improper function or a cleaning as needed. Have an appliance technician assess and correct as needed. **(Kitchen)**
