# Inspection Report

05.18.26

7636 Birchmoor Way  
Raleigh, NC 27616

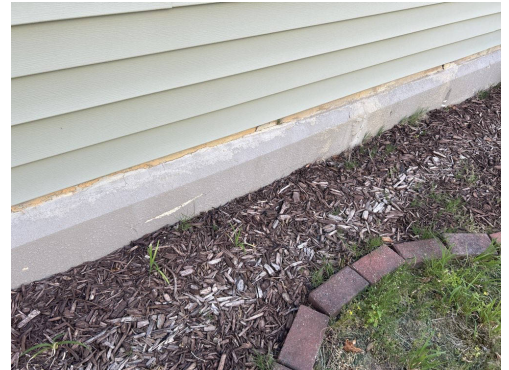
1. Needs Repair: Slab Foundation - Insulation Damaged - This house has a concrete slab foundation. Some areas of the applied insulation have been damaged, likely due to assumed landscape maintenance. This will reduce the insulation rating provided to the slab. Have a professional contractor evaluate the slab insulation and make the necessary repairs to restore the R-value.

>>> Note: Caution is advised when providing exterior maintenance in the yard in order to prevent any further damage from occurring.

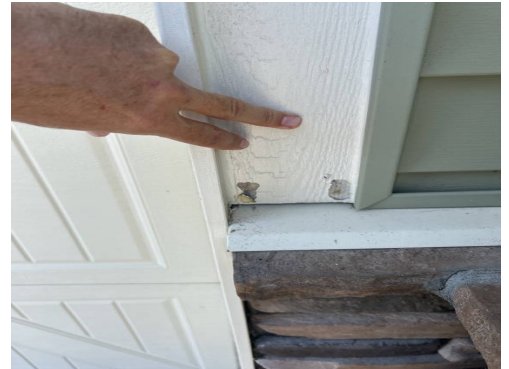
2. A) Needs Repair: Exterior Trim Needs Painting - Observed areas of peeling paint/minor surface damage the exterior trim at multiple locations. Exposed improperly sealed materials will absorb moisture over time (even some of the composite type) and swelling/deterioration will occur as a result. Have a professional contractor properly prepare, and paint/seal all exterior trim at this time.

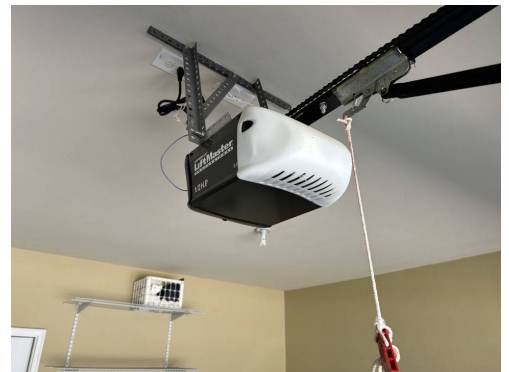
3. Needs Repair: Garage - Garage Door Operator Light Not Working - The light did not turn on in the garage door opener when the door was activated. The door opener appliance provides a temporary source of light when accessing the garage at night which is a necessary safety feature. Replace the assumed burned out bulb in order to verify that the fixture and timer operation are working properly.

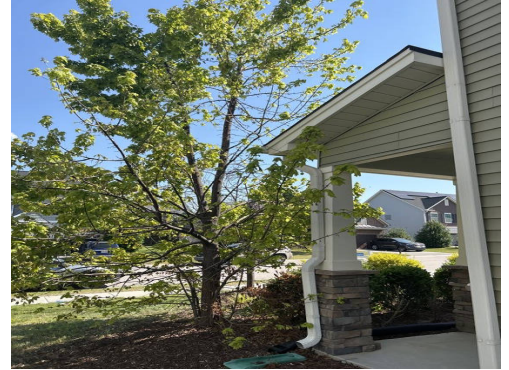
5. A) Needs Repair: Tree/Shrub Limbs - Limbs In Contact With The House - Observed tree/shrub limbs that are in contact/near contact with the home. Branches in contact with the house can cause damage to the shingled roof covering and water shedding off the trees can divert water toward the house. The canopy under large trees will hold higher moisture levels in them that will over time cause wood to deteriorate. Maintain large vegetation away from the house in order to prevent damage to the house and reduce higher moisture levels that can cause rot on wood surfaces.

B) Further Evaluation Recommended: Trees - Possible Dead Tree - There is a tree in the front yard that appears to not have any live growth. Home inspector is not qualified to determine the condition of the tree. Recommend that a professional arborist evaluate the tree to determine if the tree needs further attention/removal. >>> Note: The trees around the yard are not inspected as part of the home inspection, and the comment/concern noted in the report is based on an observation made while working around the home.

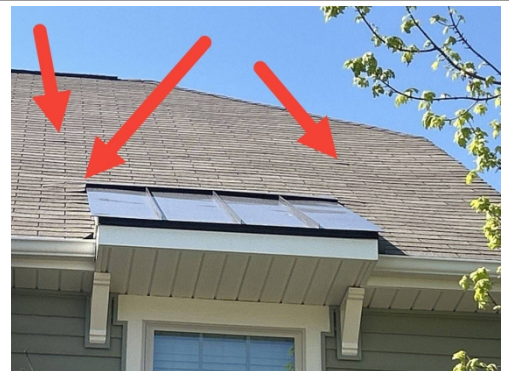
6. Needs Repair: Roof Covering - Raised Shingles - Observed raised shingles on the front roof elevation. Raised shingles can allow moisture to penetrate under the roof covering that can result in damage, as well as exposing the shingle to further damage during high wind conditions. Have a professional roofing contractor evaluate the entire roof and make the necessary repairs for proper installation and long term serviceability.

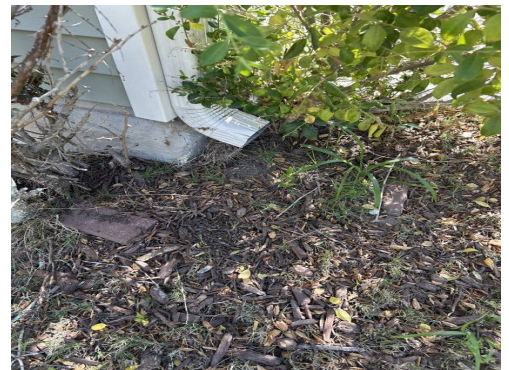
7. Needs Repair: Gutter System - Splash Block Not Installed - Splash block is not installed at the right rear corner gutter downspout turnout. Recommend installing splash blocks or buried plastic pipes at the end of the downspouts from the gutters to divert water further away from the foundation and prevent possible dirt grade washout.

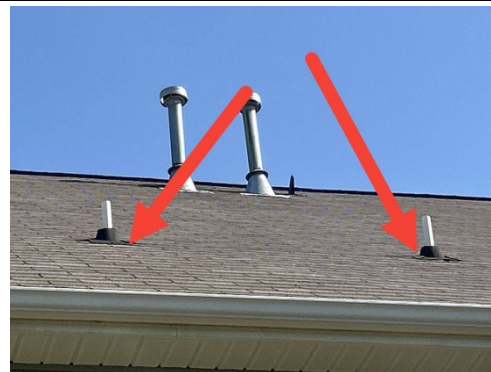
8. Needs Repair: Roof Covering - Raised Flashings - Observed raised flashings at the rear roof elevation. Raised flashings can allow moisture to penetrate under the roof covering that can result in damage. Have a professional roofing contractor evaluate the entire roof and make the necessary repairs for proper installation and long term serviceability.

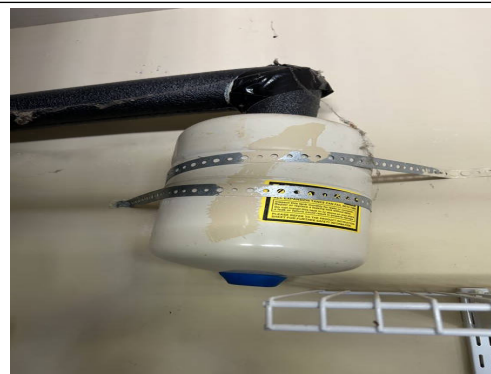
9. Needs Repair: Water Heater Safety - Compromised Thermal Expansion Tank Bladder - The thermal expansion tank (TET) on the water supply plumbing system was observed to be full of water. This tank compensates for increased water pressure resulting from the stored heated water in the water heater. Tank being full of water indicates that the bladder inside the tank is compromised and the tank needs replacement. Have a professional plumbing contractor service this device and make any repairs necessary in order to provide proper installation.

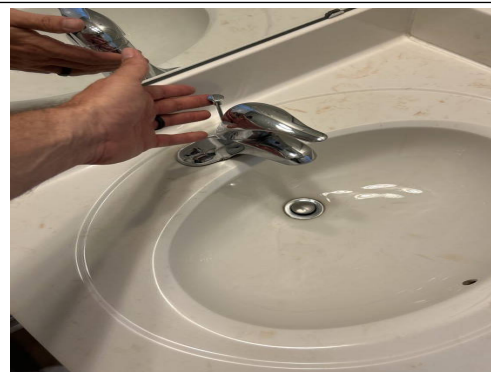
10. Needs Repair: Bathroom Sink Drain Stop Not Operating Properly - The 1st floor hall bathroom vanity sink drain stop is not installed/not operating properly in the waste drain opening and the sink basin cannot hold water. Have a professional plumbing contractor evaluate the stopper mechanism and make the necessary repairs so that proper operation is provided.

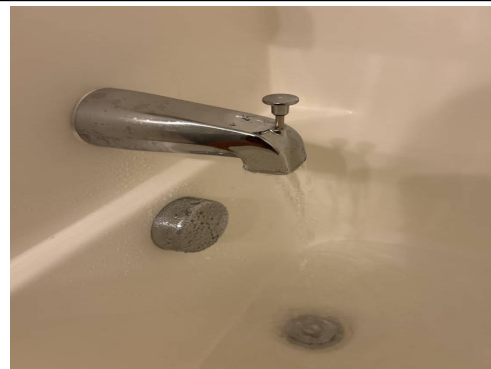
11. Needs Repair: Bathroom Tub/Shower Diverter Not Working Properly - The 1st floor hall bathroom tub/shower valve does not fully divert water to the shower head. This can limit use and is inefficient. Have a professional plumbing contractor evaluate the fixture and make the necessary repairs for proper operation.

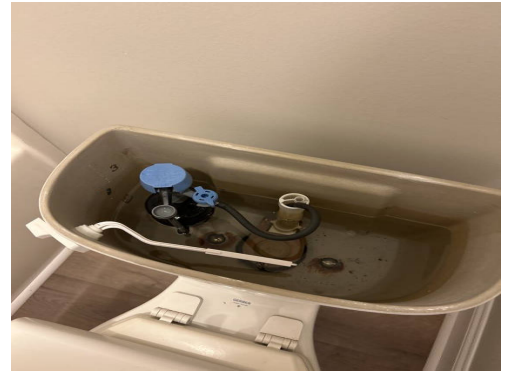
**12. Needs Repair: Toilet Not Flushing Properly** - The 2nd floor hall bathroom toilet does not flush properly. The toilet handle is required to be held in the down position to complete the flush cycle. Recommend a professional plumbing contractor further evaluate the toilet and repairs/adjustments be made to ensure the toilet is flushing properly.

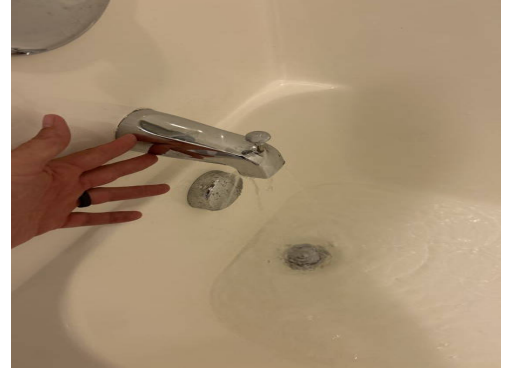
**13. A) Needs Repair: Bathroom Tub/Shower Diverter Not Working Properly** - The 2nd floor hall bathroom tub/shower valve does not fully divert water to the shower head. This can limit use and is inefficient. Have a professional plumbing contractor evaluate the fixture and make the necessary repairs for proper operation.

**B) Needs Repair: Shower/Tub Water Spout Loose/Not Sealed To The Shower Wall** - The shower/tub water spout in the 2nd floor hall bathroom is loose in the wall. Have a plumbing contractor make any necessary repairs to secure and seal this plumbing fixture. At a minimum, this water supply manifold and water supply spout need to be sealed/caulked to the wall of the tub/shower. This will secure the fixture in place and prevent water from intruding into the wall cavity behind the fixture.

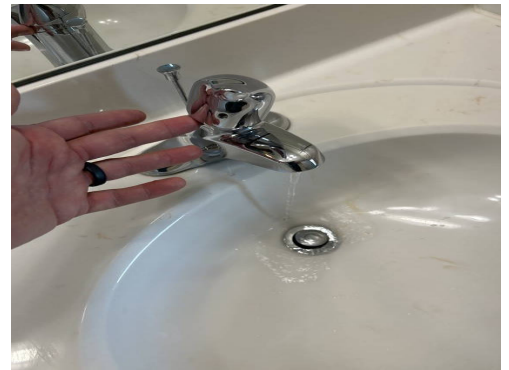
**14. A) Needs Repair: Bathroom Sink Low Water Pressure/Volume** - Low hot water pressure/volume was observed at the Jack & Jill, right side sink faucet. This can limit use. Have a professional plumbing contractor evaluate sink faucet/supply plumbing and make the necessary repairs to allow for proper operation.

**B) Needs Repair: Bathroom Sink Drain Stop Not Operating Properly** - The Jack & Jill bathroom, right side vanity sink drain stop is not installed/not operating properly in the waste drain opening and the sink basin cannot hold water. Have a professional plumbing contractor evaluate the stopper mechanism and make the necessary repairs so that proper operation is provided.

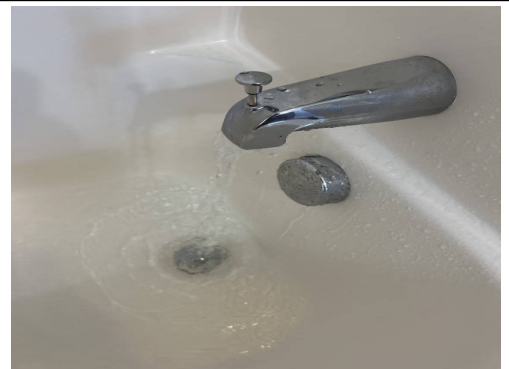
**15. Needs Repair: Bathroom Tub/Shower Diverter Not Working Properly** - The Jack & Jill bathroom tub/shower valve does not fully divert water to the shower head. This can limit use and is inefficient. Have a professional plumbing contractor evaluate the fixture and make the necessary repairs for proper operation.

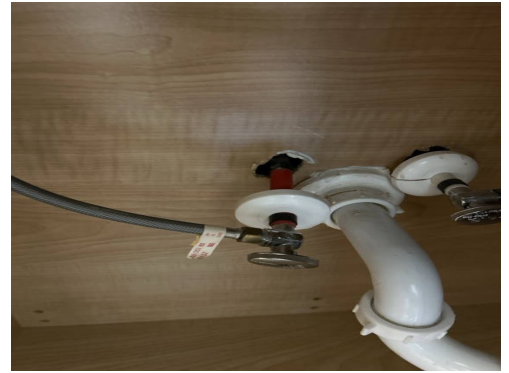
**16. Needs Repair: Water Lines Loosely Installed in the Bathroom Sink Base** - The water supply lines are loosely installed inside the primary bathroom sink base cabinet. Loose plumbing lines are vulnerable to damage/leaking particularly in storage areas. Have a professional plumbing contractor evaluate the water supply plumbing under the sink and make the necessary repairs to secure the lines to avoid possible damage.

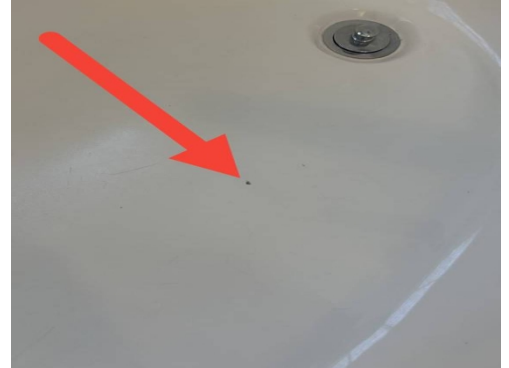
**17. Needs Repair: Bathroom Bathtub Surface Damaged** - There is an area of surface damage on the primary bathroom bathtub. Damaged tub surfaces can result in increased damage and/or leaking. Have an professional contractor further evaluate and repairs be made to prevent further damage from occuing and long serviceability is provided.

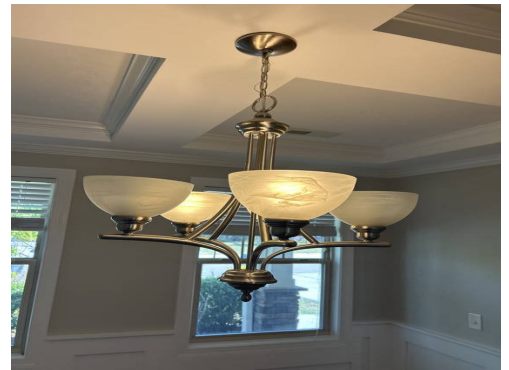
**18. Needs Repair: Lights Not Operating** - Light bulbs in the dining room light fixture did not all turn one when tested. This will prevent proper lighting when needed. Have a professional electrical contractor evaluate the light fixtures throughout the home and make the necessary repairs to ensure proper operation.

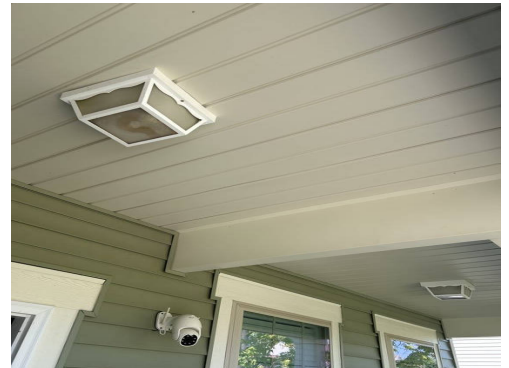
**19. Needs Repair: Lights Not Operating** - Some of the light fixtures on the exterior of the house were not operating when tested. This will prevent proper lighting when needed. Have a professional electrical contractor evaluate the light fixtures on the home and make the necessary repairs to ensure proper operation.

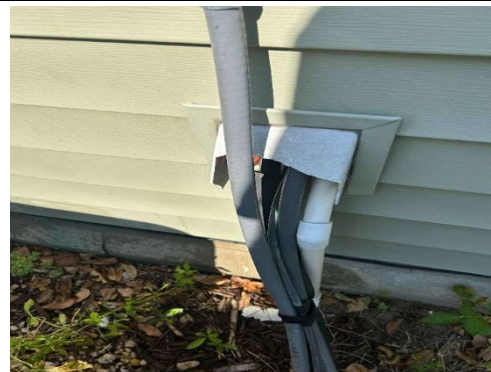
20. Needs Repair: Rain Cap Damaged - The rain cap on the 1st floor A/C unit pressure line wall penetration is damaged. Damage is currently not allowing any adverse conditions such as water intrusion to occur, but due to the concern for personal injury due to the sharp edges present at the break, it is recommended that a professional contractor replace the damage rain cap to prevent personal injury from occurring.

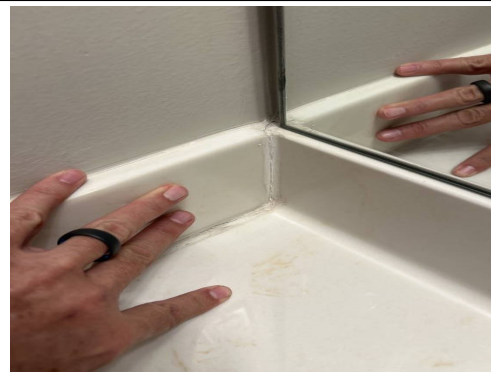
21. Needs Repair: Open Joints in Countertop Backsplash - The 2nd floor hall bathroom countertop backsplash is not sealed at the union to the wall and/or countertop. Opening allows for unsanitary conditions to be present. Water can get behind the backsplash and damage can occur over time if repairs are not made. Have a professional contractor evaluate all countertop areas and apply a sealant where needed.

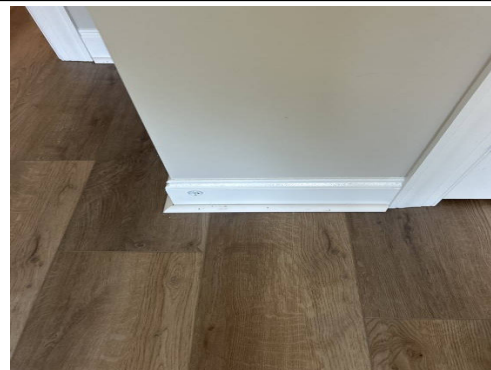
22. Needs Repair: Door Stop Not Installed - The door stop is not provided at the 1st floor bedroom closet door. Door stop helps prevent damage from occurring to the door and or interior wall if excessive force is used to open the door. Recommend a professional contractor install missing door stops where needed at the this time.

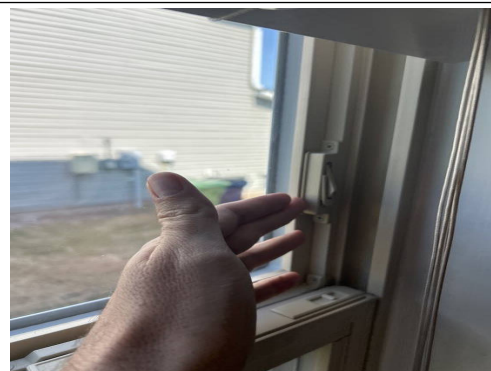
23. A) Needs Repair: Windows - Broken Child Safety Latches - Observed windows throughout the home that have damaged child safety latches. These devices are not part of a security system, and cannot prevent an adult from opening the window, but will prevent a small child from being able to open the window wide enough to get out. When broken in the engaged position they limit operation of the window which can prevent swift egress in an emergency. Have a professional window contractor replace the damaged safety features where necessary. >>> Note: Adults should properly disengage the device prior to opening the windows to prevent damage to the safety latches.

B) Needs Repair: Windows - Window Seal Compromised - Window seal was observed to be compromised in the primary bathroom window. Compromised glass seals may not necessarily be limited to just the glass units noted. Signs of compromised glass seals can be masked by weather conditions, lighting, and cleanliness of glass at the time of the inspection. Have a professional window pane replacement company evaluate all of the glass units in the home and make the necessary repairs/replacement to restore the insulation integrity of any units determined to have bad seals.

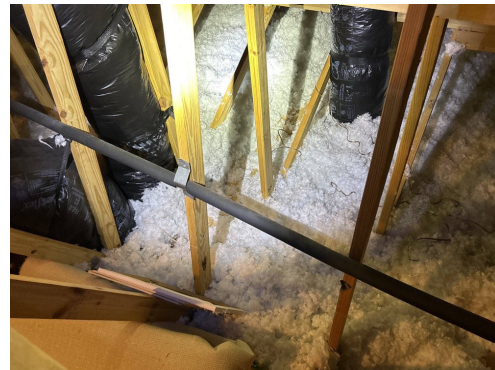
**24. Needs Repair: Attic Insulation - Compressed/Displaced Insulation Present -** Insulation was packed down and/or displaced in several places in the attic. This is reducing the thermal efficiency in the attic at these locations. Recommend that the proper depth of insulation be replenished in order to provide a continuous "R" rating of insulation that was installed at the time of the installation.

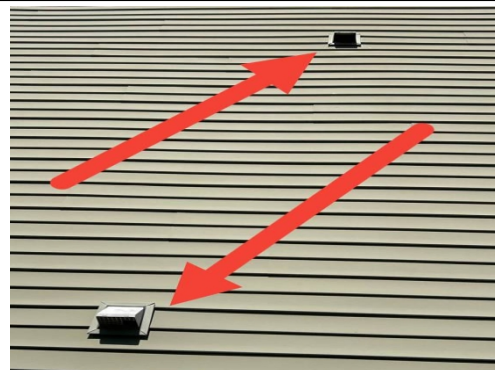
**25. A) Needs Repair: Bathroom Exhaust Vent - Baffle Not Closing Fully -** There are bathroom exhaust vent rain cap on the exterior of the home that have their baffle stuck in a partially open position. The open flap can allow access of outside air into the house and/or birds have been known to nest in the opening. Have a professional contractor evaluate the bathroom vent exhaust system and make the necessary repairs/replacement to allow for proper operation.

**B) Needs Repair: Bathroom Exhaust Vent - Missing Baffle -** A rain cap installed on the right and left side of the have their baffles removed at the end of the duct run. Open ended duct allows access of outside air into the house and or birds that have been known to nest in the opening. Have a professional contractor make repairs or replace this duct end cap shroud so that proper operation is provided.

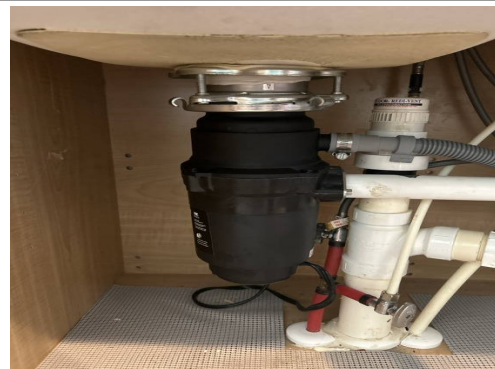
**26. Needs Repair: Disposal - Dead/Frozen Disposal -** Disposal was dead when tested at the time of the inspection. The mini breaker at the bottom of the appliance was reset and operation was still not available. Disposal was frozen in place. The wrench supplied by the manufacturer used to release frozen disposal was not located at time of inspection. The disposal is not operational when dead/frozen. Have a professional contractor service the appliance to allow for proper operation.
