## RESIDENTIAL INSPECTION REPORT J.B. SIMPSON HOME INSPECTION

4245 The Oaks Dr  
Raleigh, NC 27606

Crys Rivers  
06/04/2026

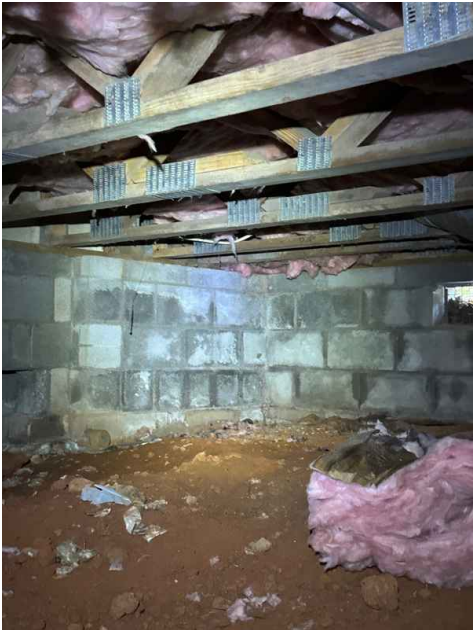
2.2.1 Foundation  
**MOISTURE STAINING**  
FRONT WALL

Moisture staining along the foundation wall was observed. This condition often occurs from moisture exposure. Prolonged exposure and moisture infiltration can potentially cause damage to the foundation. Recommend further evaluation and recommendations from a licensed general contractor.

Recommendation  
Contact a qualified general contractor.

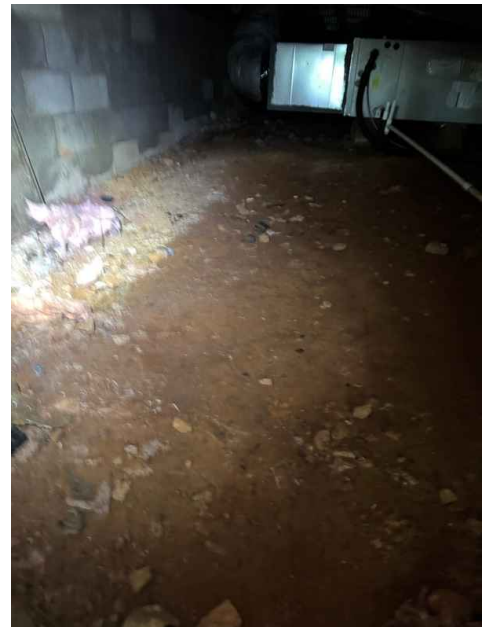
### 2.3.2 Crawl Space

The crawlspace lacks a vapor barrier. This can leave the crawlspace susceptible to moisture elevations. Recommend installation from a qualified contractor.

Contact a qualified professional.

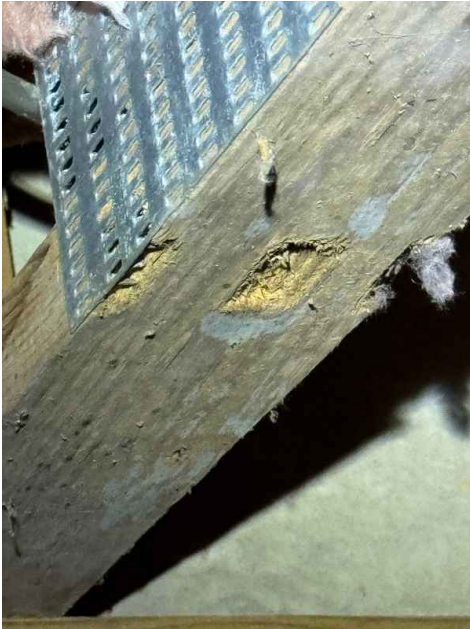
#### **EVIDENCE OF DEGRADATION**

Evidence of degradation was observed to portions of the floor structure. This condition can potentially worsen and spread. Further evaluation of the affected areas should be made from a licensed general contractor. If repairs are needed to be made, the repairs should be approved by a structural engineer.

Recommendation

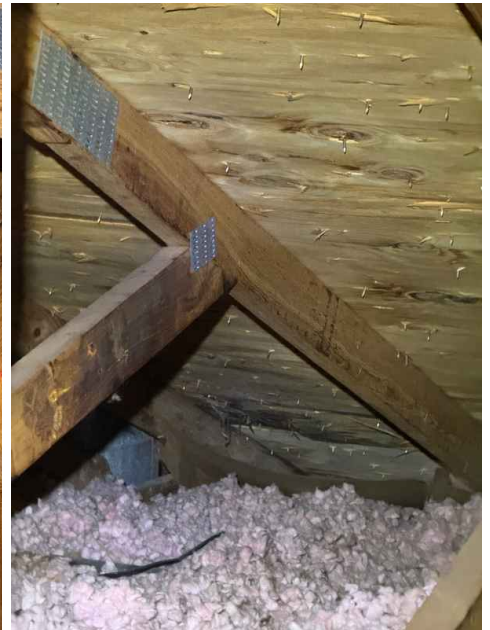
## 2.7.1 Roof Structure and Attic

Moisture damage was found at this location. This can result in premature decay of building materials. This should be repaired or replaced as deemed necessary by a qualified contractor.

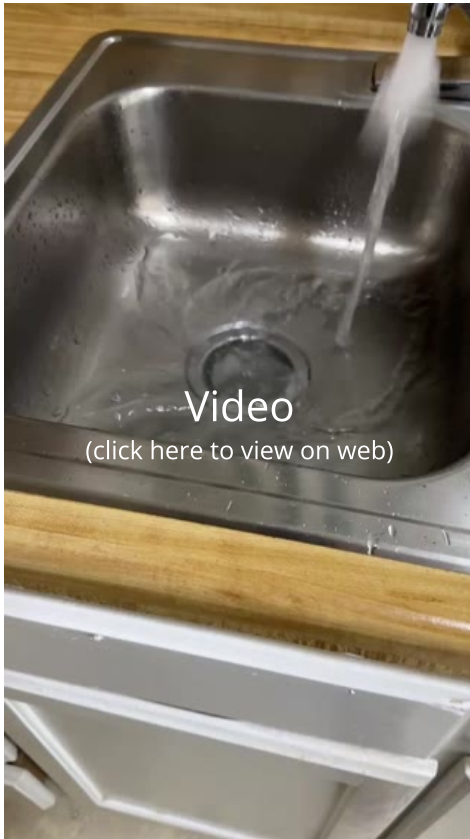
Slow drainage to the sink was observed. This condition can potentially indicate blockages or restrictions. Further evaluation and recommendations should be made from a plumbing contractor.

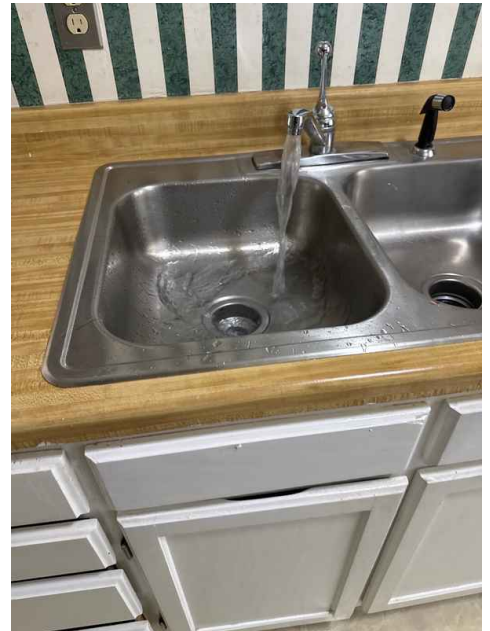
### 3.3.2 Water Distribution Systems

Water hammer was observed to the noted fixture. This causes sporadic spraying. Recommend corrections/ repair from a plumbing professional.

Contact a qualified plumbing contractor.

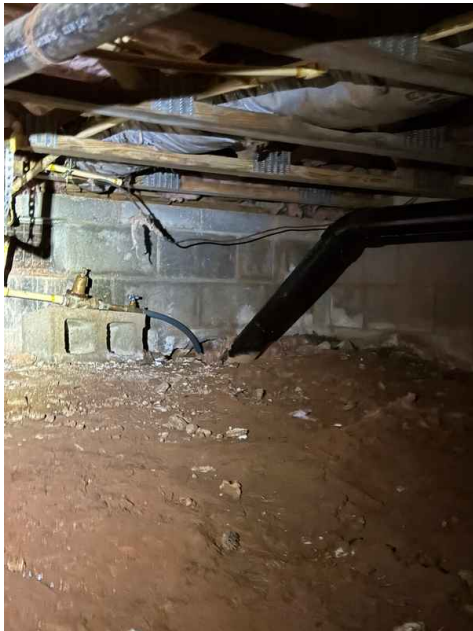
Portions of polybutylene was observed at areas of the crawlspace, and at fixture connections. Polybutylene is a material that is susceptible to failure and leak development. Recommend further evaluation and recommendations for repairs from a plumbing professional.

Contact a qualified plumbing contractor.

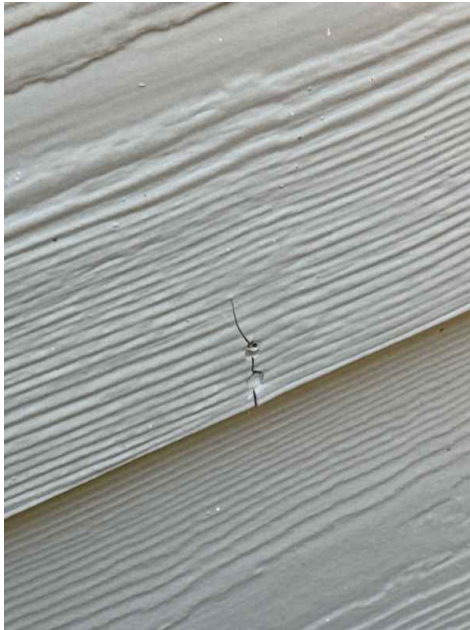
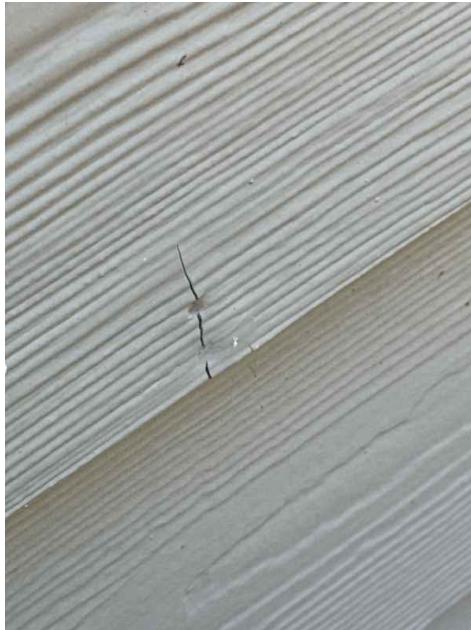
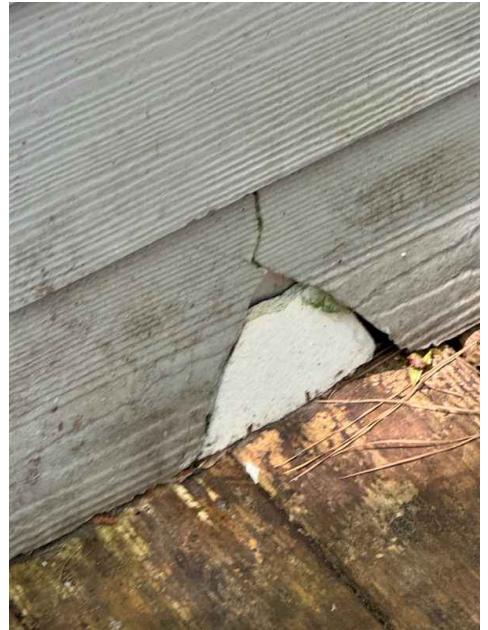
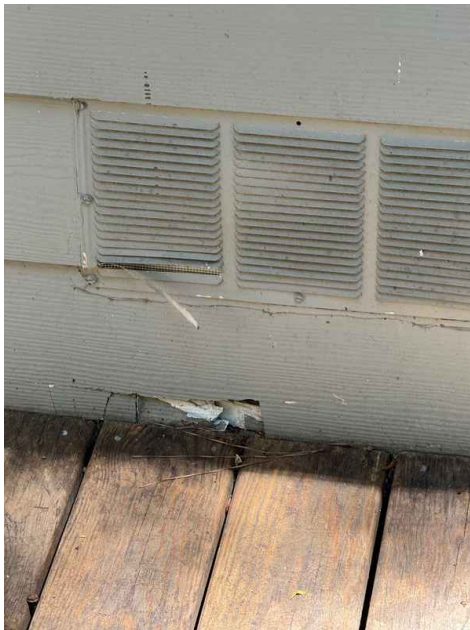
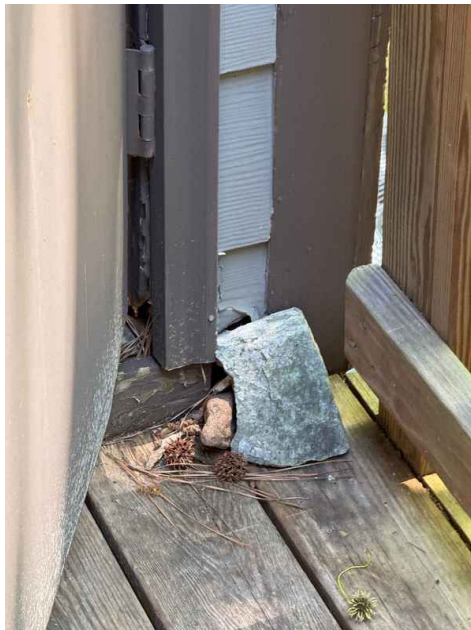
Physical damage to the siding was observed. This form of damage can leave the affected area susceptible to water entry and further damage. Recommend evaluation and repairs as needed.

Contact a qualified siding specialist.

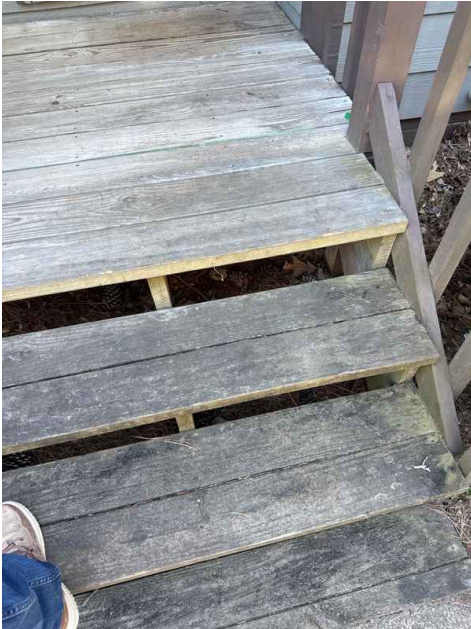
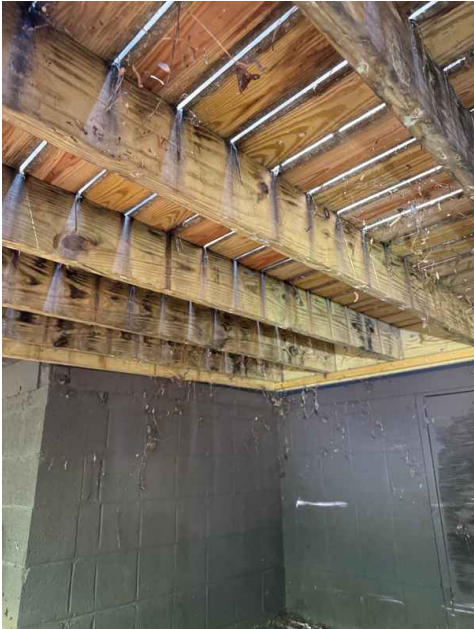
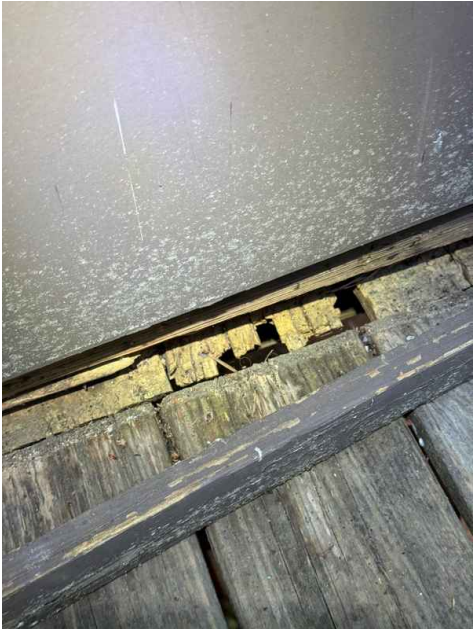
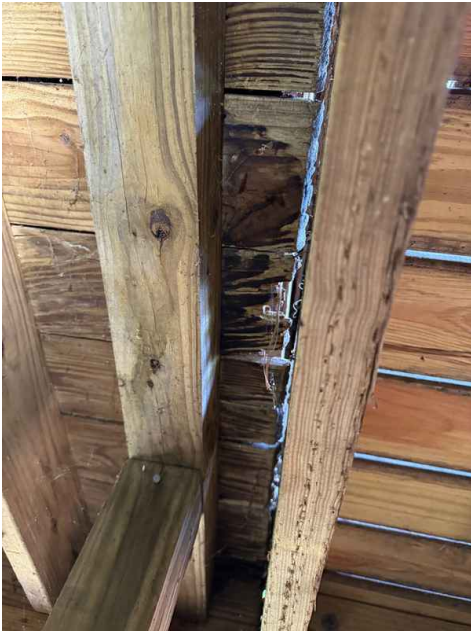
## 4.7.1 Decks, Balconies and Appurtenances

Evidence of weathering and decay to the decking was observed at various locations. This condition can worsen and spread if left unattended. Recommend further evaluation and recommendations for repairs as needed.

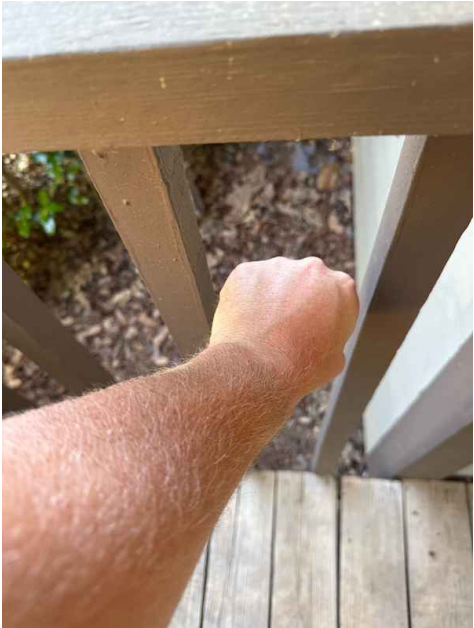
4.7.3 Decks, Balconies and Appurtenances

Railing infill was observed to be spread apart. This condition poses a safety risk to children. Recommend further evaluation and recommendations for corrections as needed.

Contact a qualified professional.

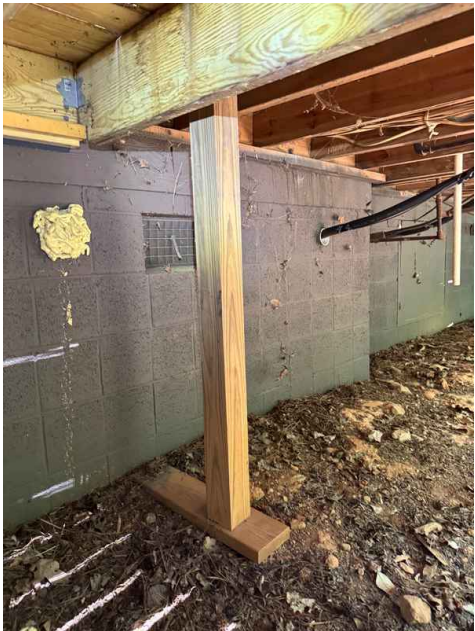
4.7.4 Decks, Balconies and Appurtenances

Atypical bracing practices were observed under the deck. This appears to be a temporary brace/ repair. Recommend further evaluation and recommendations from a deck professional.

Recommendation  
Contact a qualified deck contractor.

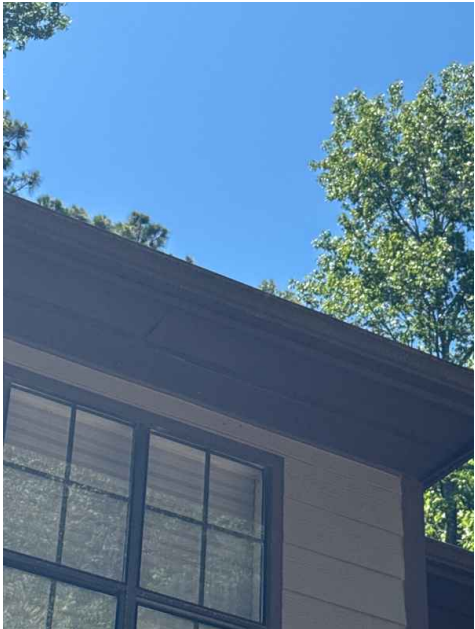
4.8.1 Eavs, Soffits and Fascia

Damage to eaves was observed. This condition can potentially leave the affected area susceptible to water entry. Recommend evaluation and repair as needed.

Recommendation  
Contact a qualified professional.

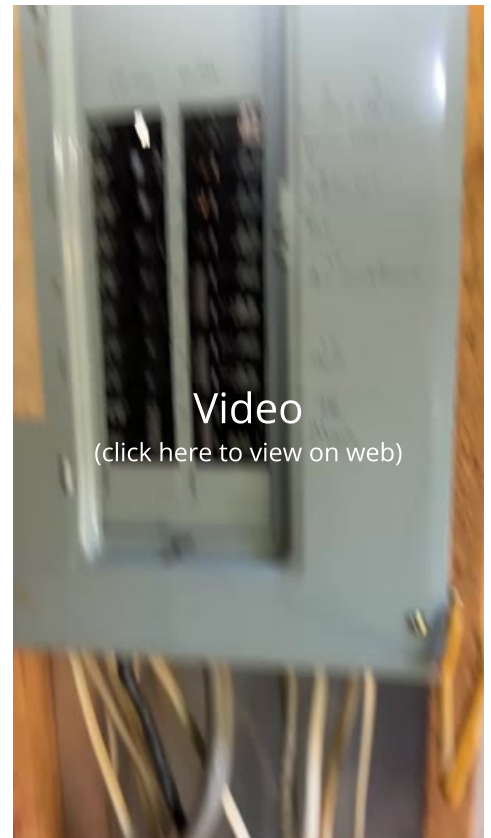
### 6.2.3 Service Panel

The panel cover is not seating over the breakers properly. This condition causes pressure to be exerted against the breakers. Recommend further evaluation and recommendations from a licensed electrical contractor.

Contact a qualified electrical contractor.

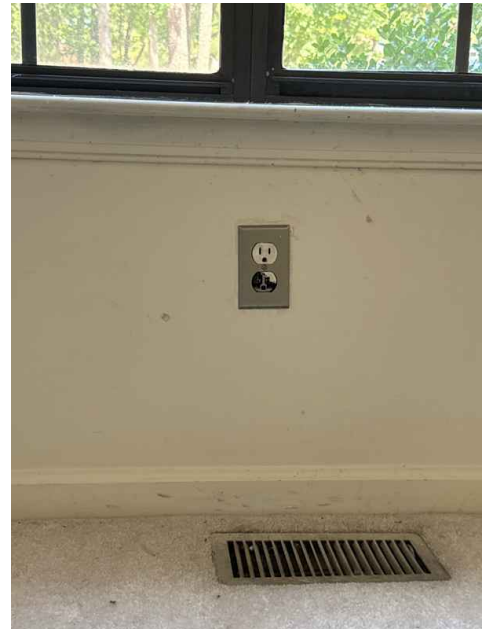
6.5.2 Lighting Fixtures,  
Switches, and Receptacles

Physical damage to receptacles was observed. This condition poses a safety risk for use. Recommend evaluation and recommendations for repair as needed.

Contact a qualified electrical contractor.

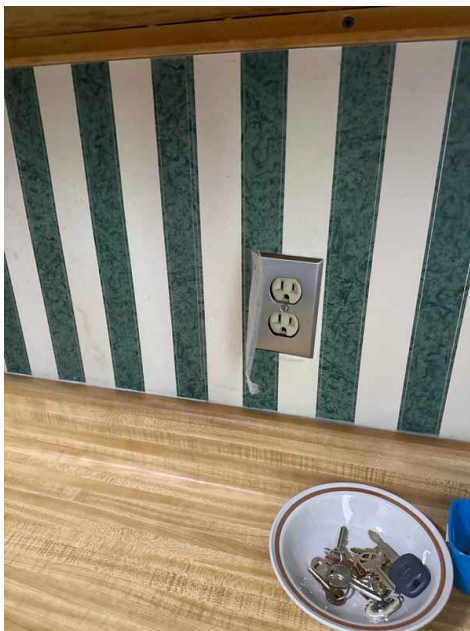
## 6.5.3 Lighting Fixtures, Switches, and Receptacles

Noted receptacles were found to be taped over. This condition may indicate damage or deficiency to the receptacle. Recommend further evaluation and recommendations for repair or replacement as needed.

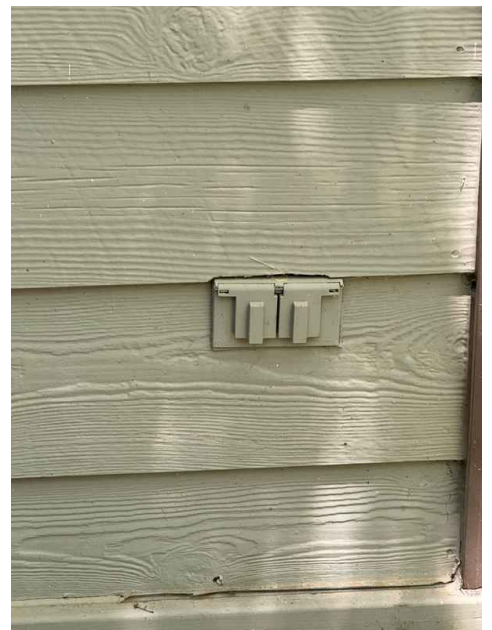
#### 6.5.6 Lighting Fixtures, Switches, and Receptacles

Exterior weather covers were found to be outdated. This can leave the receptacles potentially susceptible to moisture exposure. Recommend evaluation and repair/ correction as needed.

Contact a qualified electrical contractor.

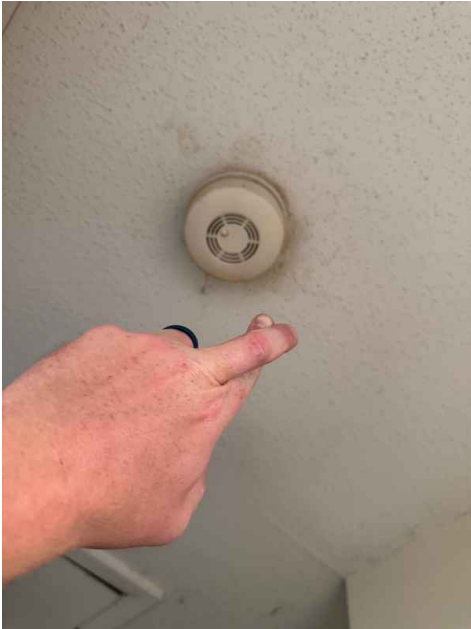
#### 6.8.1 Smoke Detectors

The smoke detector at this location did not function at the time of inspection. This prevents adequately alarming of a fire. Have evaluated and repaired or replaced as deemed necessary by a qualified contractor.

Contact a qualified professional.

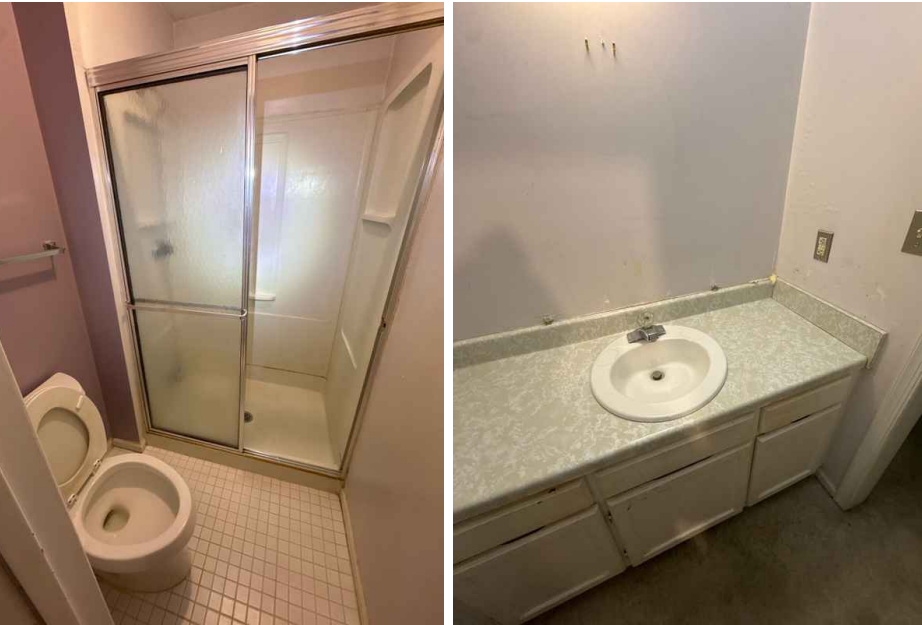
**Bathrooms: Master Bathroom**

- Electrical Receptacle Present (Y/N): Y
- Ventilation Fan Present (Y/N): Y
- Window Present (Y/N):N
- GFCI Reset Location (Y/N):N

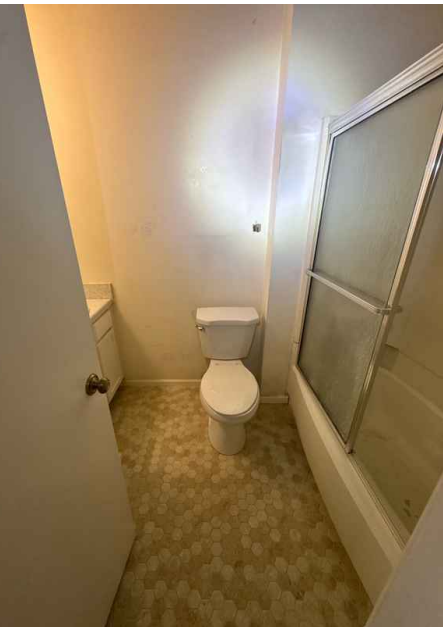
**Bathrooms: Full Bathroom 2nd Floor**

- Electrical Receptacle Present (Y/N): Y
- Ventilation Fan Present (Y/N): Y
- Window Present (Y/N):N
- GFCI Reset Location (Y/N):Y

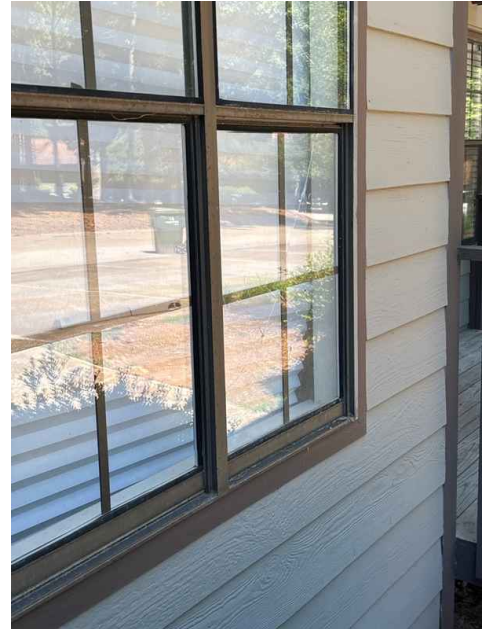
## 7.3.3 Windows

Noted windows were observed to have broken glazing. This condition can allow water and air infiltration. Recommend further evaluation and recommendations for repair as needed.

Contact a qualified window repair/installation contractor.

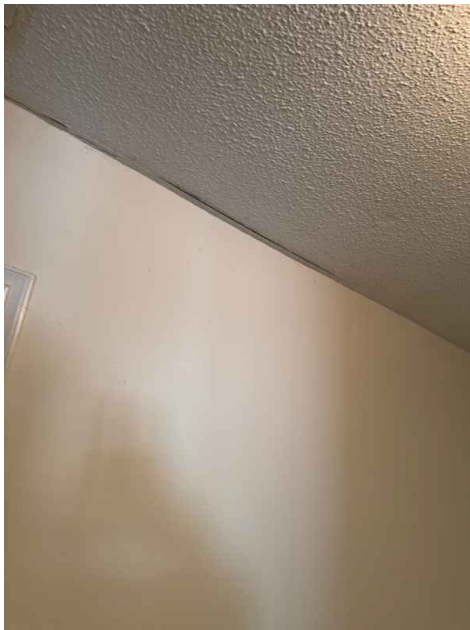
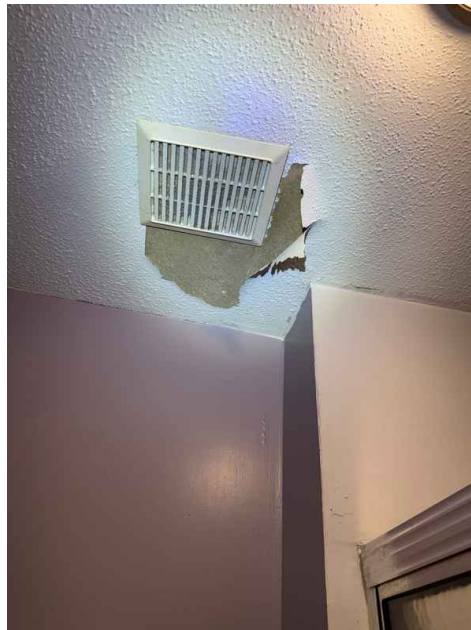
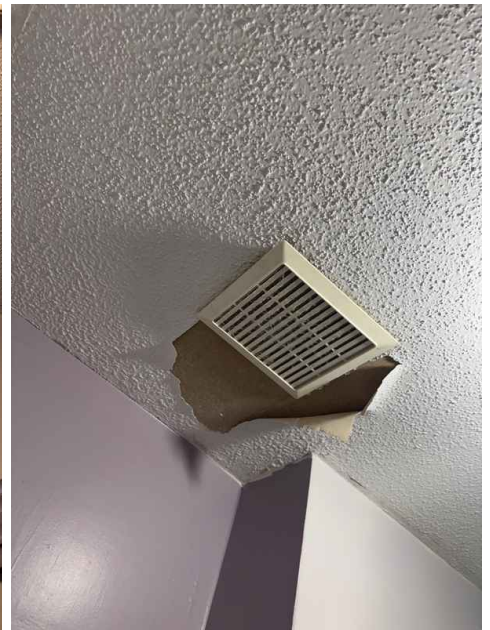
## 7.4.1 Ceilings

**DELAMINATION**

Often occurs from moisture/ humidity exposure. Recommend evaluation and repair as needed.

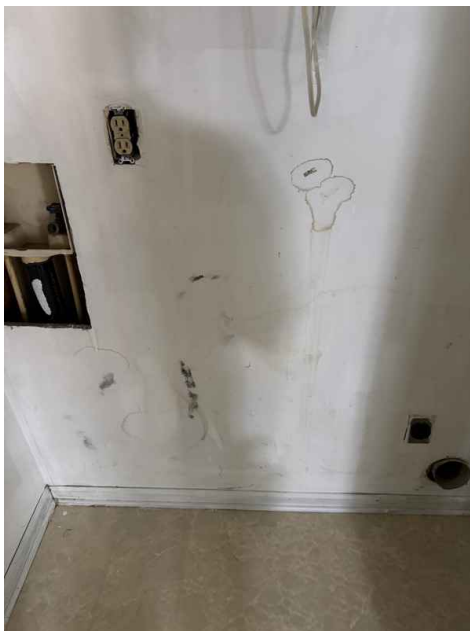
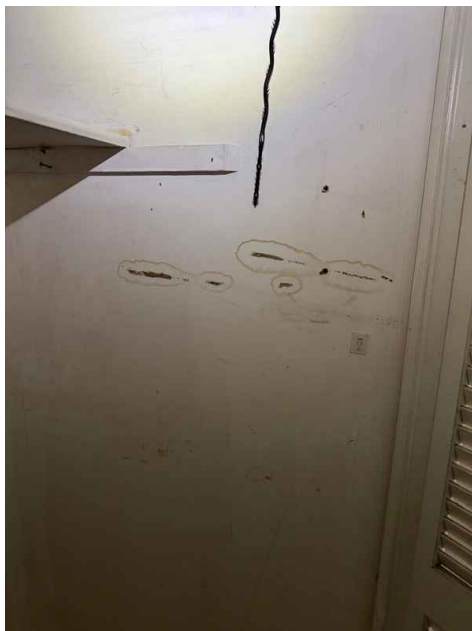
## 7.5.1 Walls

Staining to the wall was observed at various locations. This condition may indicate moisture exposure. Recommend evaluation and repair as needed.

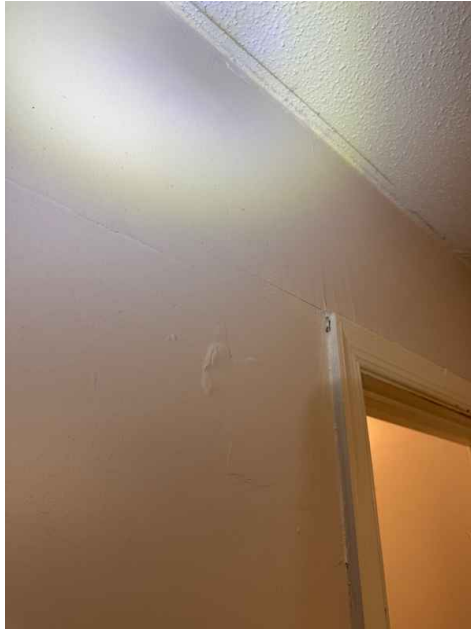
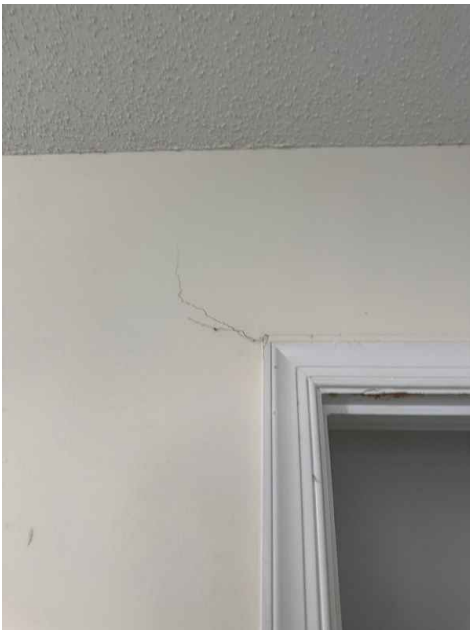
## 7.5.3 Walls

Cracking to drywall was observed at various locations around the home. Cracking to drywall can potentially signify structural movement/ settlement. Recommend evaluation and repair and monitoring.

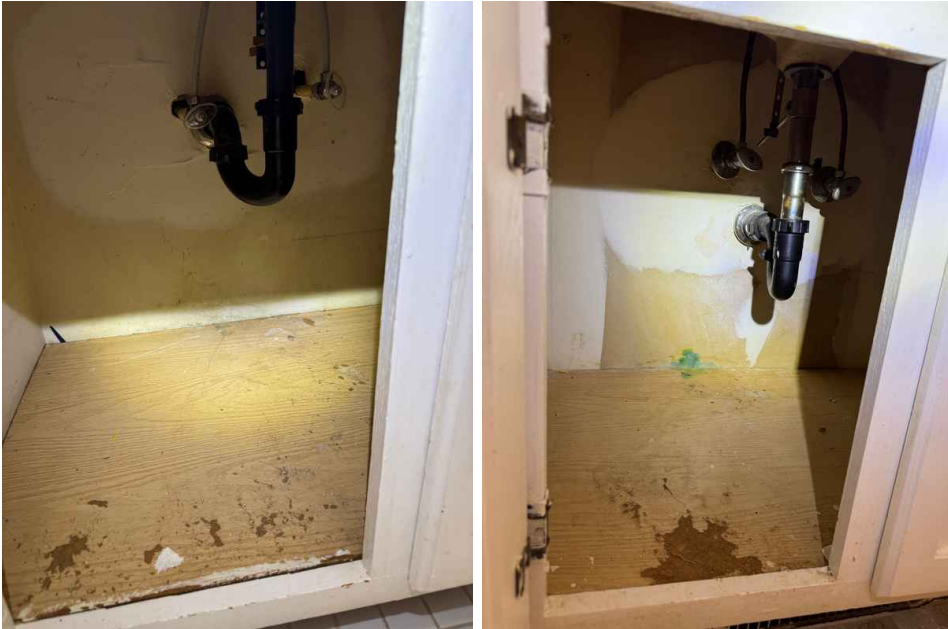
#### 7.9.1 Bathrooms

### **WARPING TO CABINETRY**

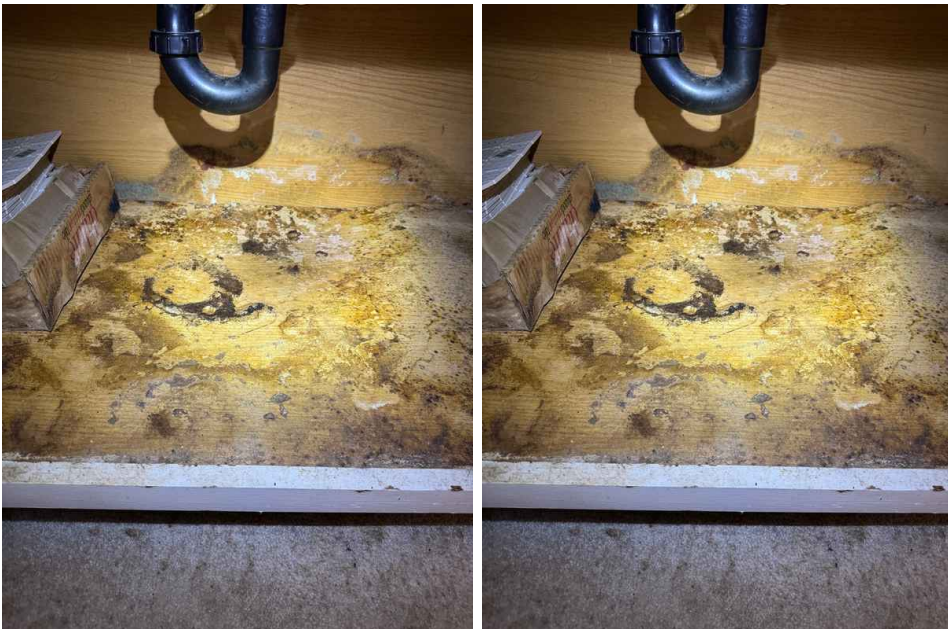
### 7.9.2 Bathrooms

#### **MOISTURE DAMAGE AND DECAY**

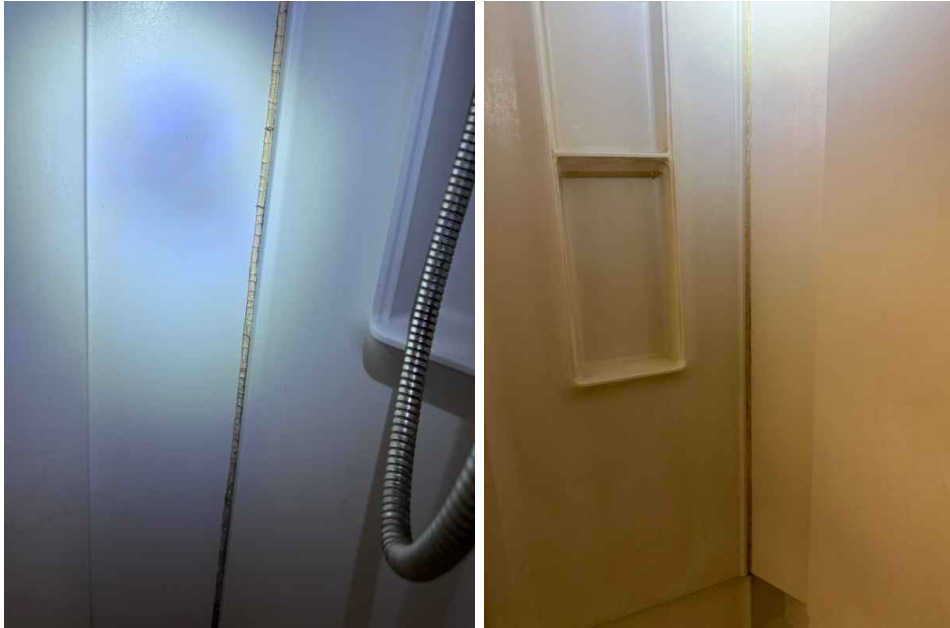
### 7.9.3 Bathrooms

#### **GAPS AROUND ENCLOSURE**

Contact a qualified professional.

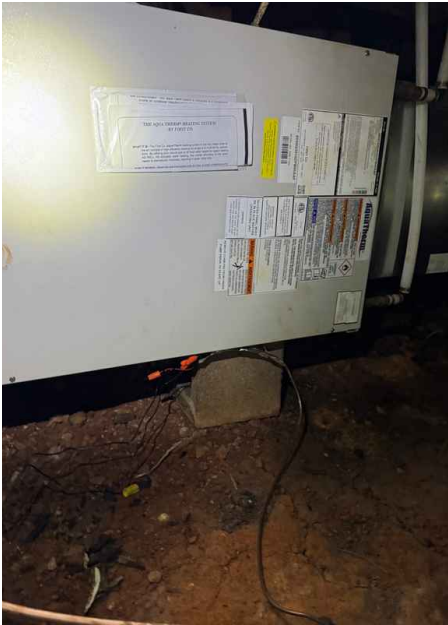
Heating Equipment: Air Handler

Location: crawlspace  
Manufacturer: Aqua Therm  
Model#: MODELE0CXQ3010ZB00AAF  
Serial#: 2508-11323  
Est Year Manufactured: 2025  
Fuel Source: Electric / hot water  
Were Panels Removed (Y/N):N

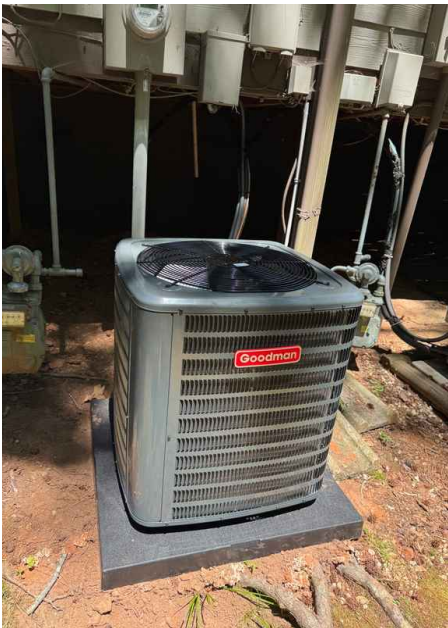
Cooling Equipment: Condenser Unit:

Location: Exterior  
Manufacturer:  
Model#:  
Serial#:  
Est Year Manufactured:  
Fuel Source: Electric  
Were Panels Removed (Y/N):N

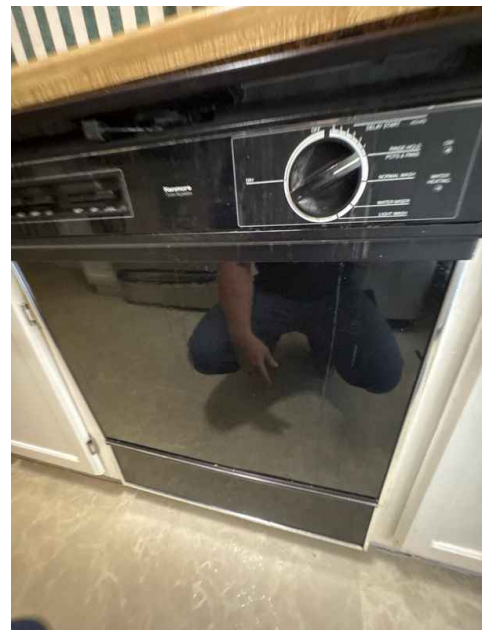
Dishwasher

**OLDER APPLIANCE**

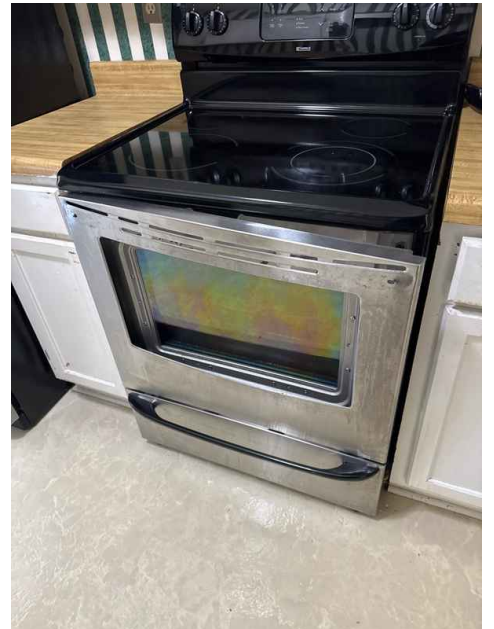
10.3.1 Range

### **FUNCTIONALLY DAMAGED DOOR**

The range oven door was found to be damaged to a point that inhibits functional use of the appliance. Recommend evaluation and repair or replacement.

Contact a qualified appliance repair professional.
