A-1 HOUSE INSPECTORS, INC.

## A-1 RESIDENTIAL REPORT

106 Allison Way  
Cary, NC 27511

07/14/2026

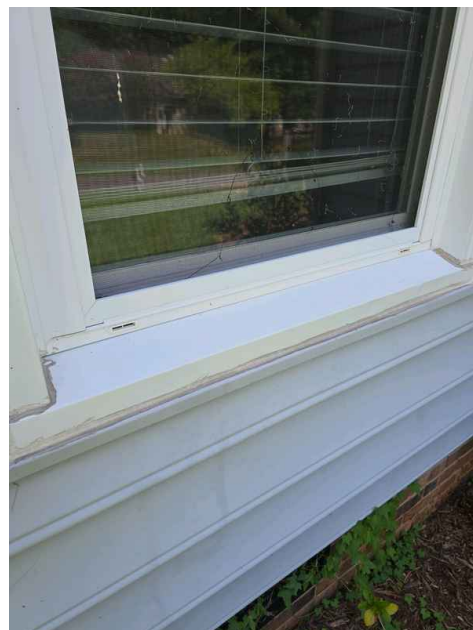
Original Siding Replaced/Concealed, Window Frames Cladded

The siding/Trim/Window frames exhibit the following obstructions which can conceal damages. A more invasive inspection by a qualified professional is recommend to fully ascertain concealed conditions.

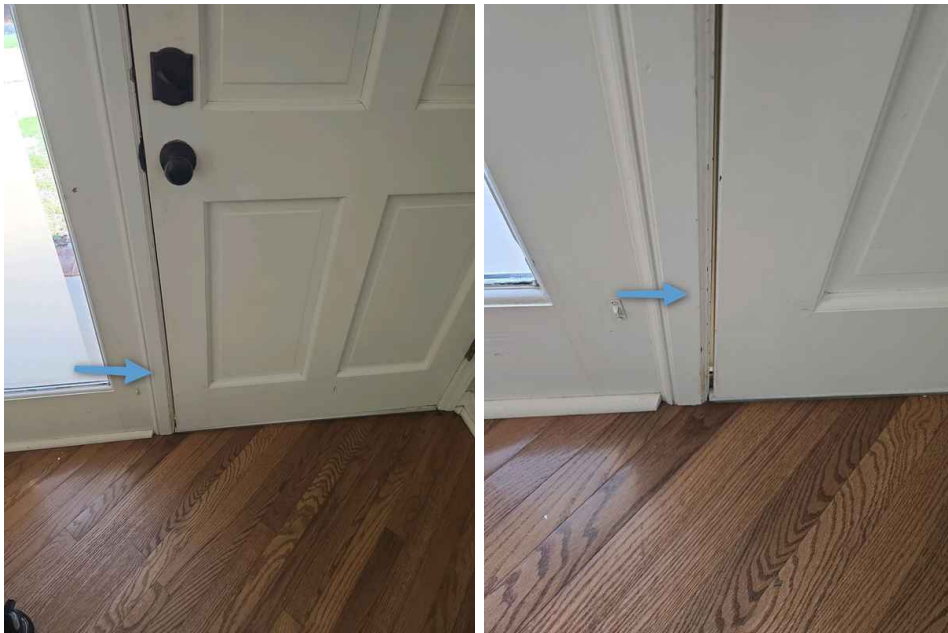
The referenced exterior entrance doors exhibit weatherstrip gaps to the outside. This will allow the loss of conditioned air and a pathway for insect or wind driven rain intrusion. Repair.

Contact a qualified professional.

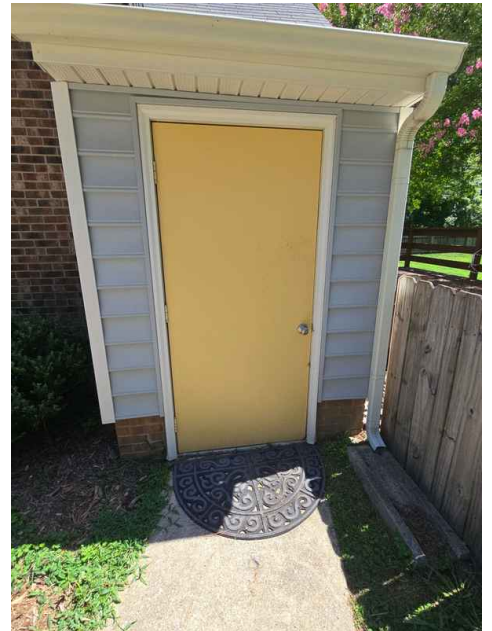
### 2.3.2 Exterior Doors

#### **EXTERIOR DOOR BIND**

The referenced exterior entrance doors bind on the frame, floor, or threshold during operation. Repair as needed.

Contact a qualified professional.

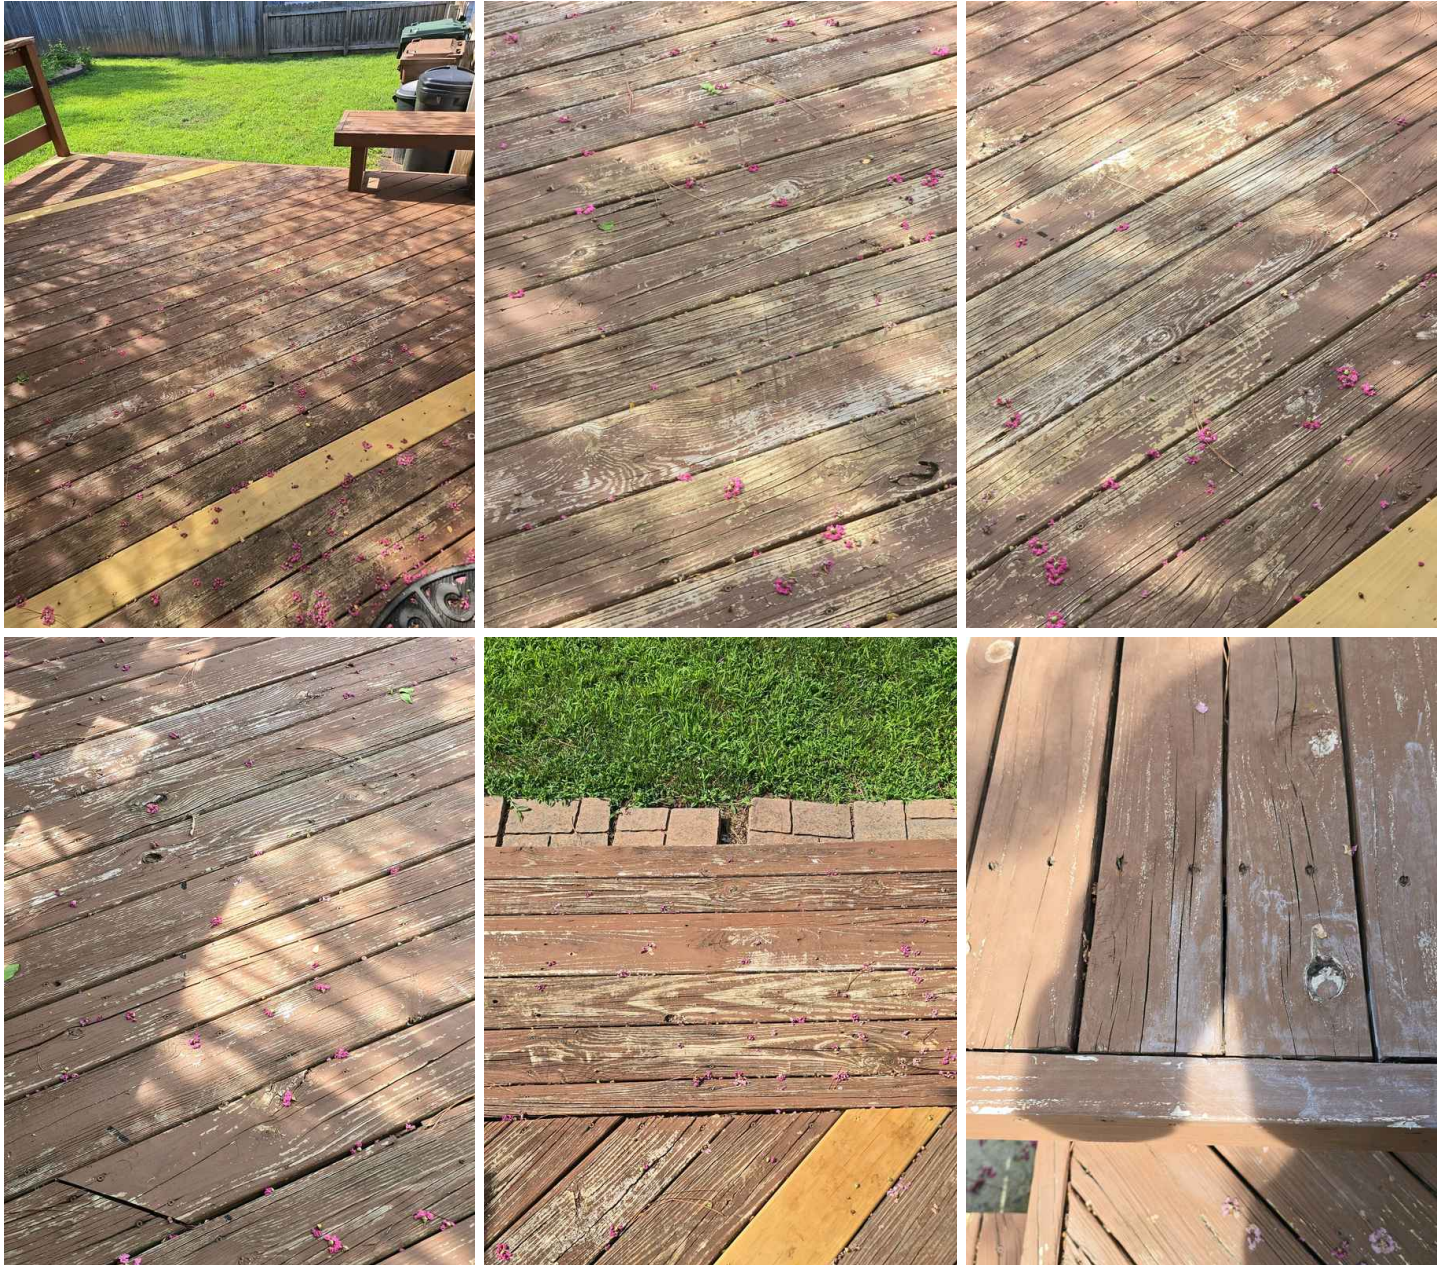
## 2.4.1 Decks, Balconies, Porches & Steps

### DECK/PORCH/BALCONY/WALKWAY ISSUES

Deteriorated Wood, Cracked/Weathered Boards, Deck is generally aged, Paint/Stain Worn, Support Posts Deteriorated At/Under Ground Level, Excessive Baluster Spacing, Missing railing

The deck exhibits the referenced issues which compromise the integrity and/or safety of the structure. Recommend a full evaluation by a Licensed General Contractor to determine the entire scope of repairs needed, and perform them as necessary.

Contact a qualified licensed general contractor

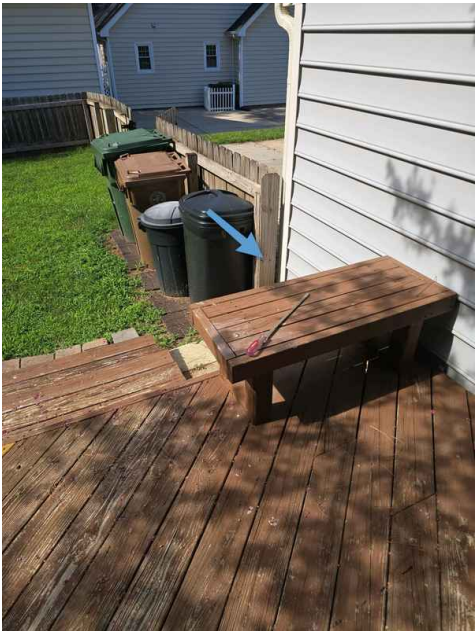
No railing behind bench

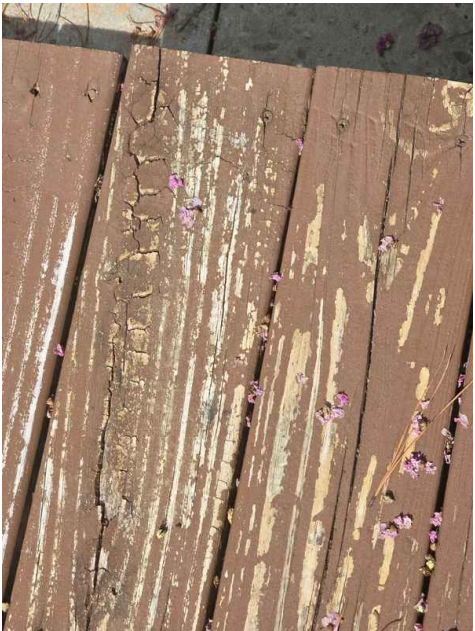
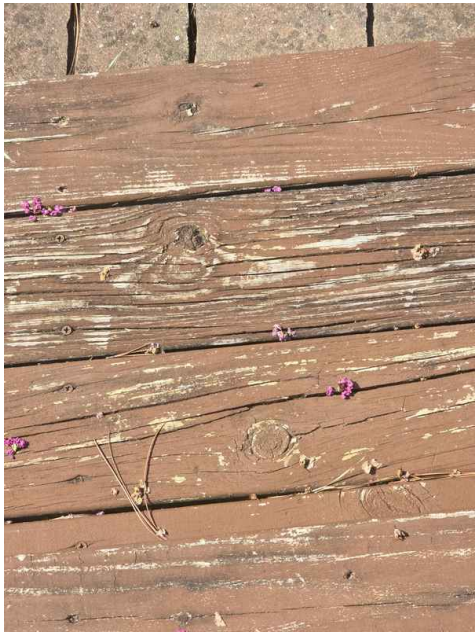
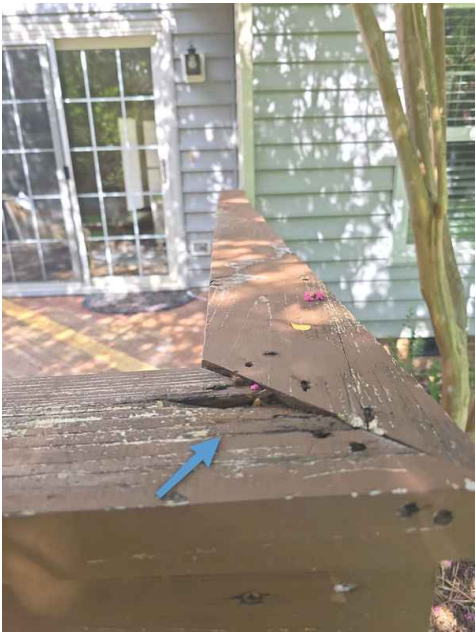
Allowed at time of construction, but not currently

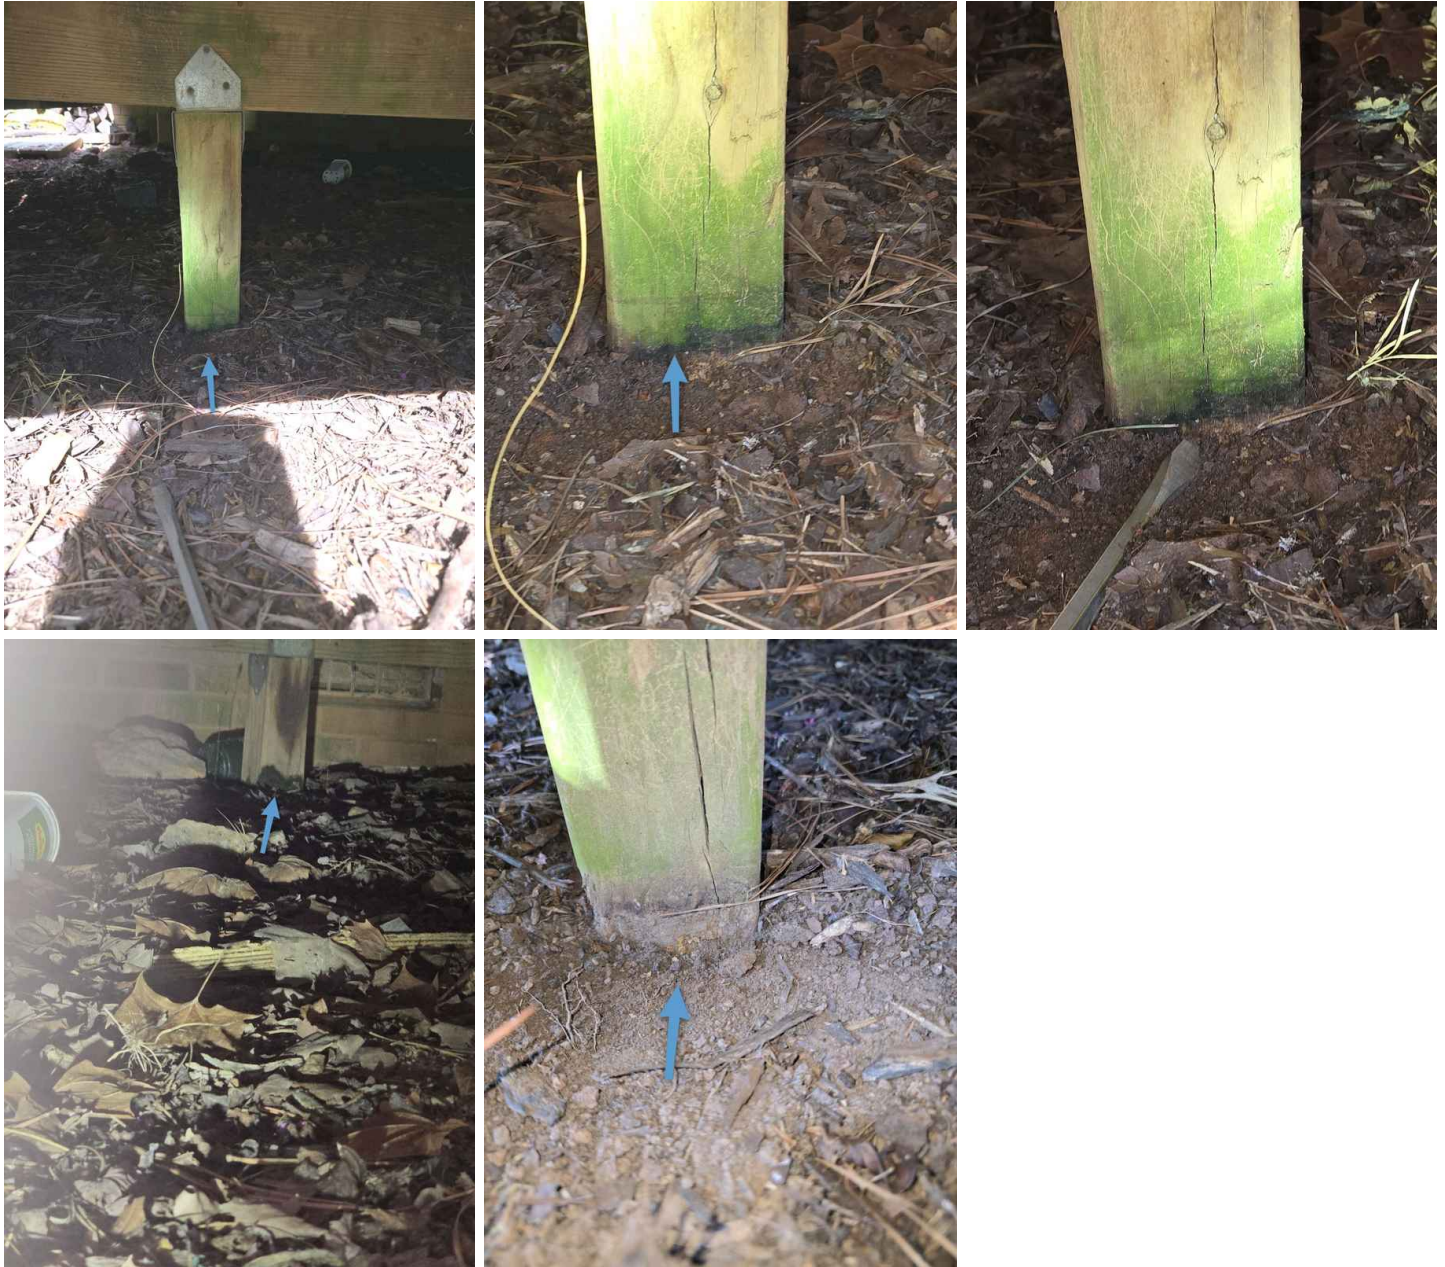
## 2.4.2 Decks, Balconies, Porches & Steps

### DECK SUPPORT DETERIORATION

The deck supports exhibit some deterioration at ground level. There may be additional damage underground. This affects support of the structure and can lead to failure over time. Have a qualified contractor dig away and evaluate all, then make all needed repairs.

Contact a qualified licensed general contractor

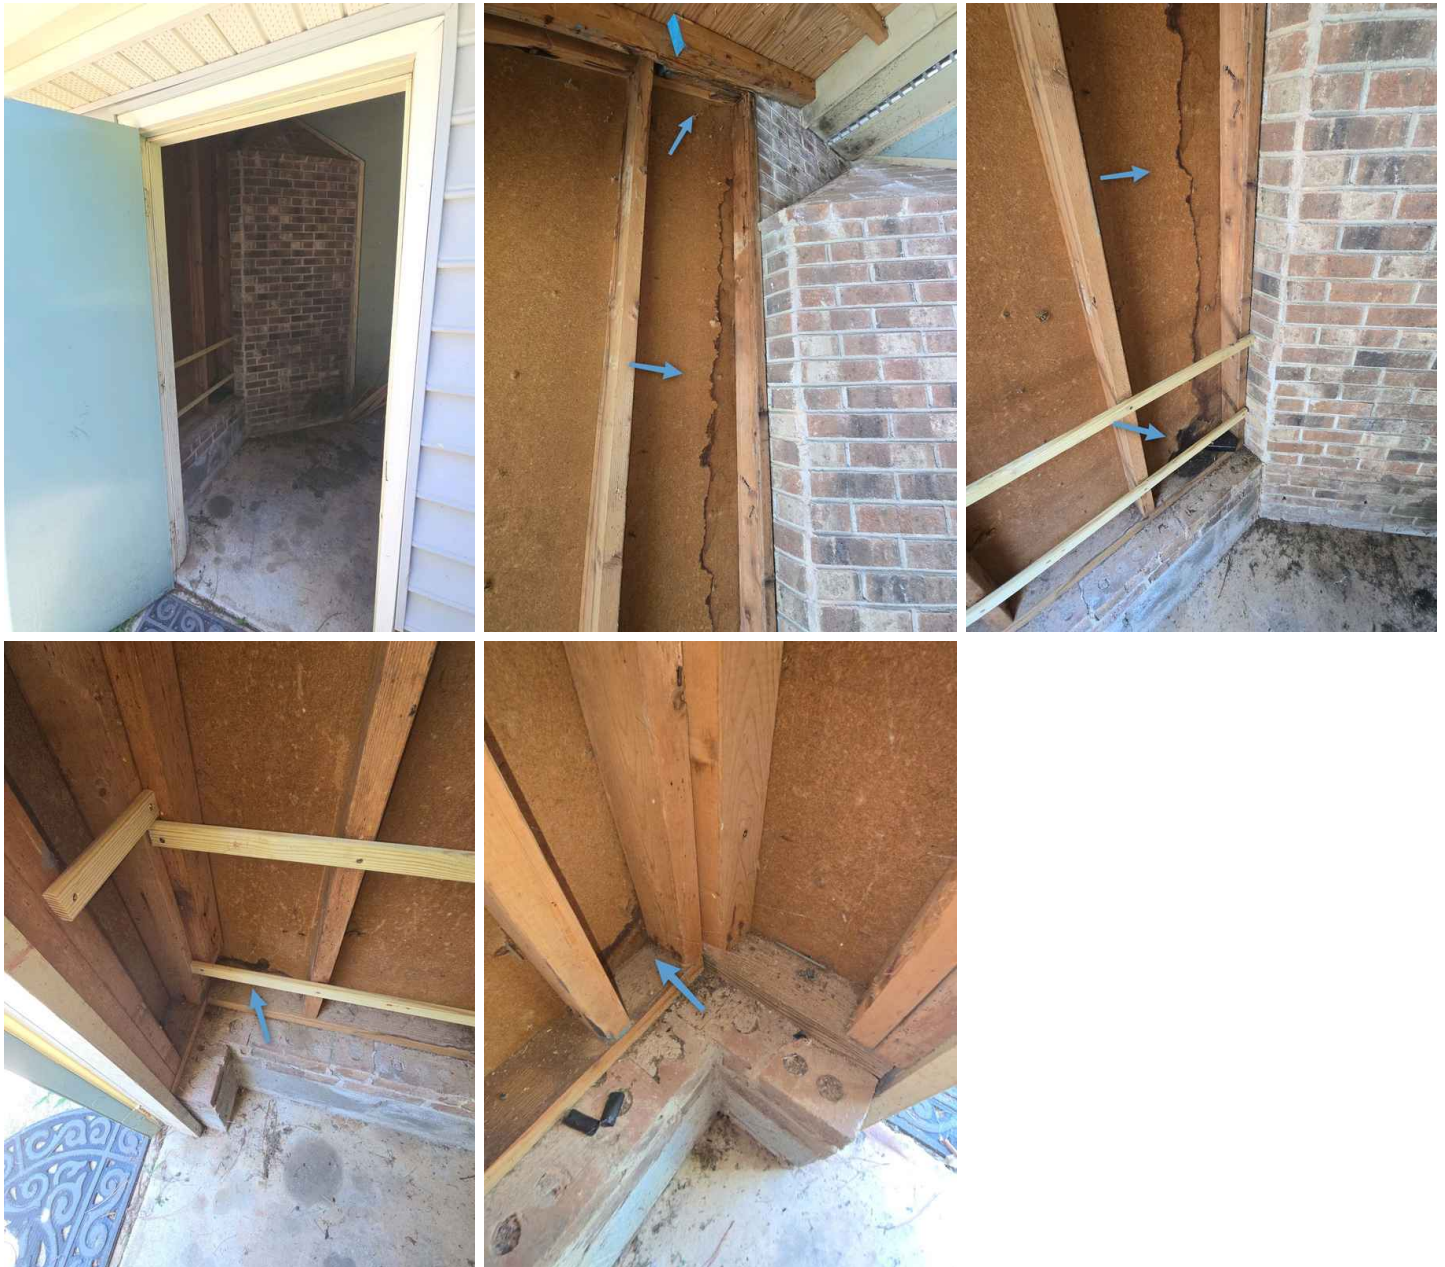
### 2.4.3 Decks, Balconies, Porches & Steps

#### STORAGE ROOM WATER INTRUSION

Evidence suggests water is entering the exterior storage room at one or more areas. Recommend evaluation by a qualified contractor to determine the source and check for any concealed damages, then make all needed repairs.

**Note:** The stains may pre-date the exterior cladding replacement.

Contact a qualified professional.

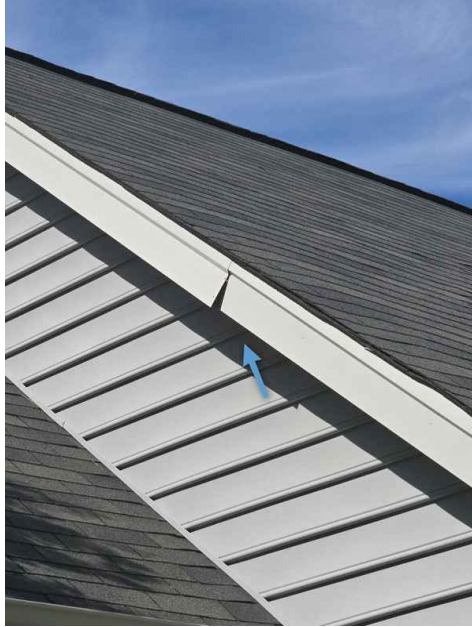
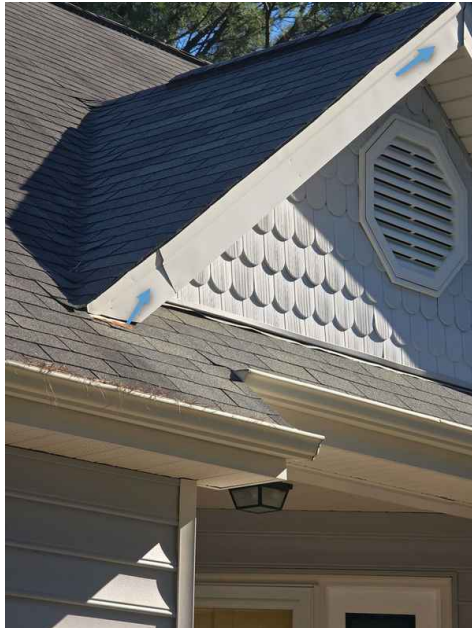
## 2.5.1 Eaves, Soffits &amp; Fascia

**LOOSE FASCIA**

The fascia is loose at the referenced location. This can allow water intrusion behind the fascia/eave. Secure or repair as required.

Contact a qualified professional.

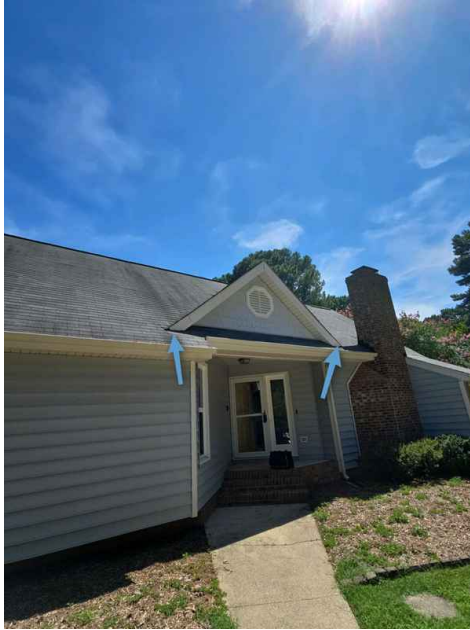
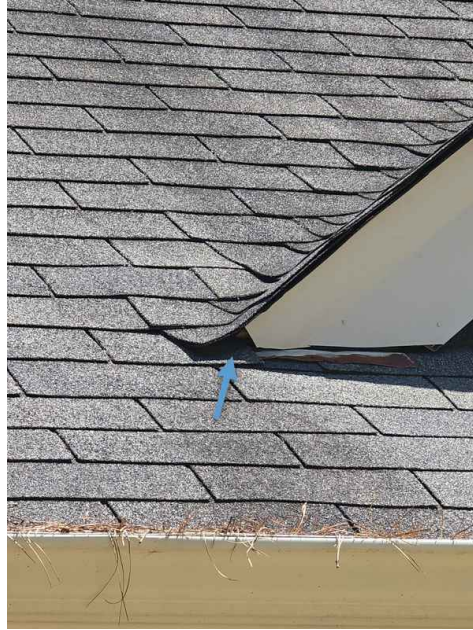
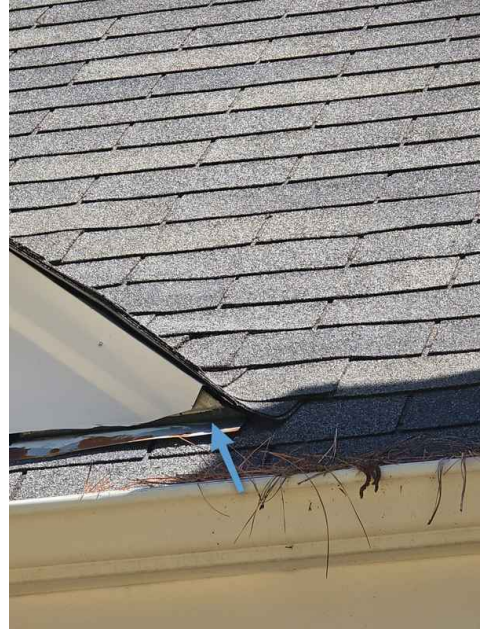
### 2.5.2 Eaves, Soffits & Fascia

#### **FASCIA GAPS**

Gaps are present at lower fascia edges. This can allow an entry point for water intrusion. The house has been re-cladded and the original trim may present to help stop this from occurring, but visibility is limited without invasive measures. Recommend evaluation to determine if any damage is present and to seal the edges if deemed necessary by a qualified professional.

Contact a qualified professional.

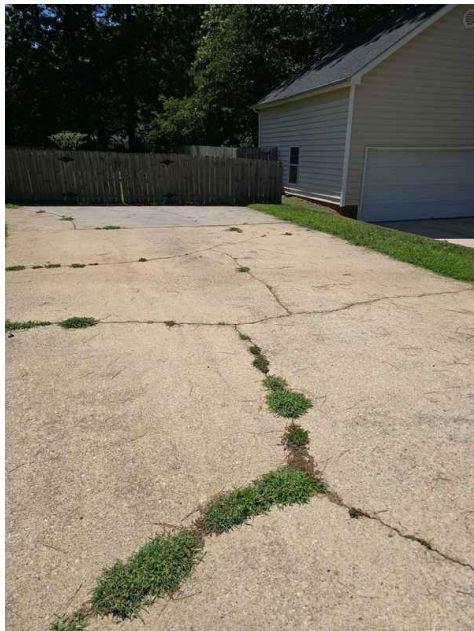
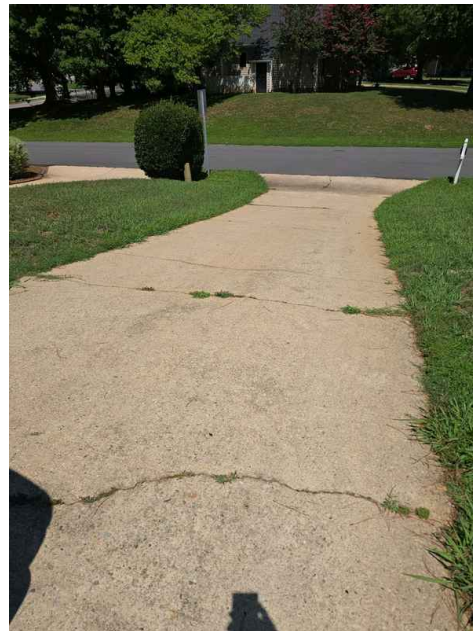
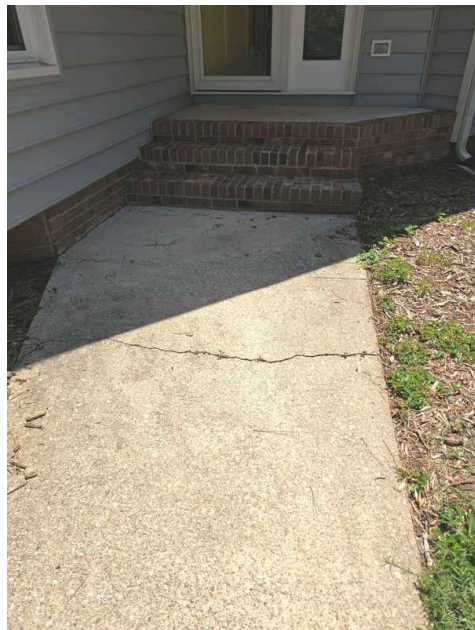
### 2.7.1 Walkways, Driveways, Patio/Porch Floors

## CONCRETE CRACKS WITH DISPLACEMENT

The referenced concrete surfaces exhibit cracking with vertical/lateral displacement. This is often due to tree roots or settling, and can pose a trip hazard. Have a qualified contractor repair.

Contact a qualified professional.

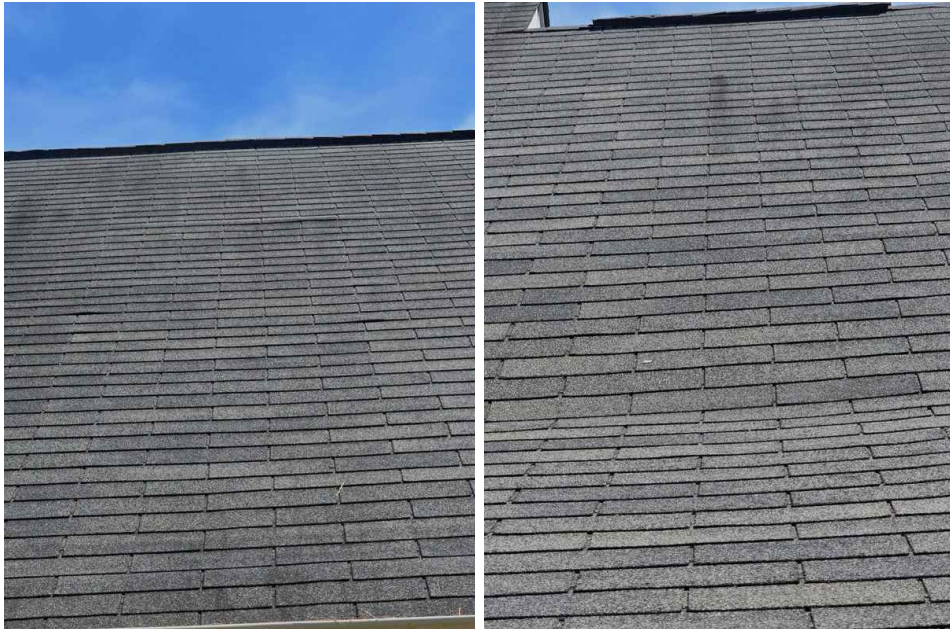
The shingles are showing signs of age. Aggregate loss is evident. Have a roofer evaluate to determine life span remaining before replacement is necessary as well as make any immediately needed repairs to prevent leaking.

Contact a qualified roofing professional.

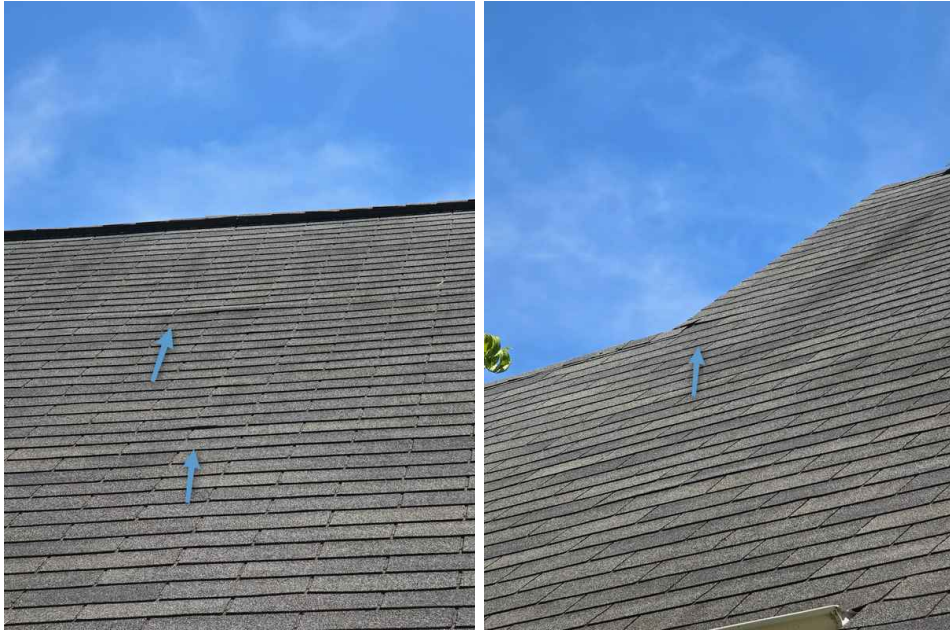
### 3.1.2 Coverings

#### **LIFTED SHINGLES**

Lifted shingles are noted at one or more areas on the roof. These are susceptible to being pulled from the roof during periods of wind, as well as more likely to leak in wind-driven rains. All shingles should be secured flat to the roof decking.

Contact a qualified roofing professional.

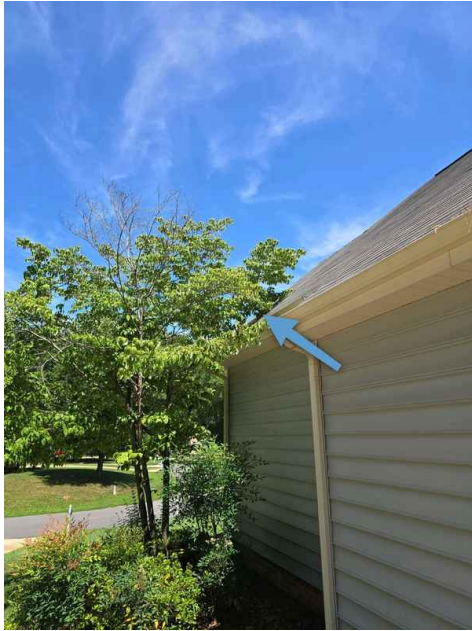
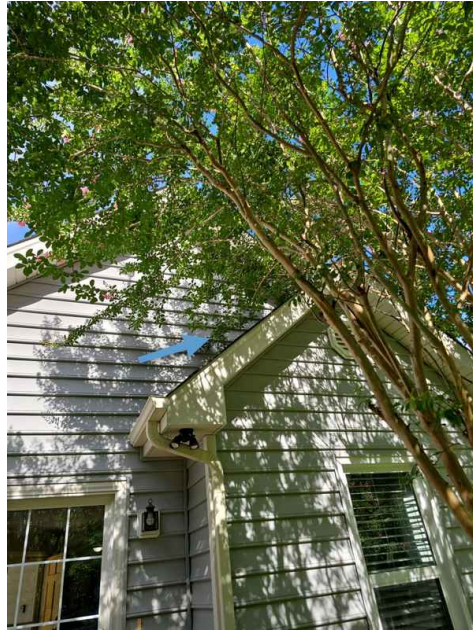
### 3.1.3 Coverings

#### **VEGETATION ROOF CONTACT**

Vegetation is in/near contact with the shingles. This can damage the roof system during periods of wind and allow a pathway for animal/insect intrusion. The vegetation should be trimmed away and shingles evaluated by a roofer for damage.

Contact a qualified roofing professional.

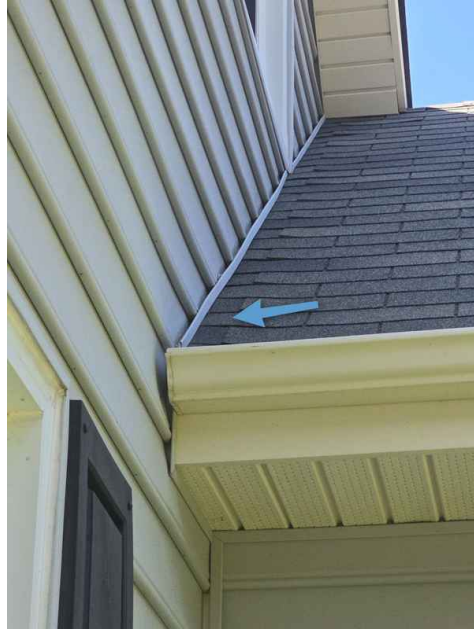
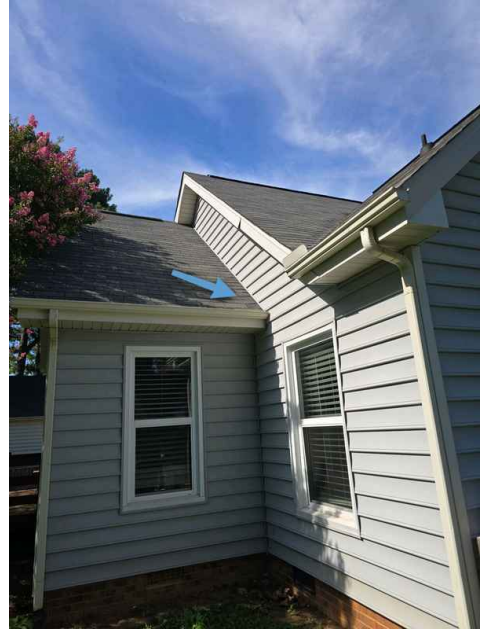
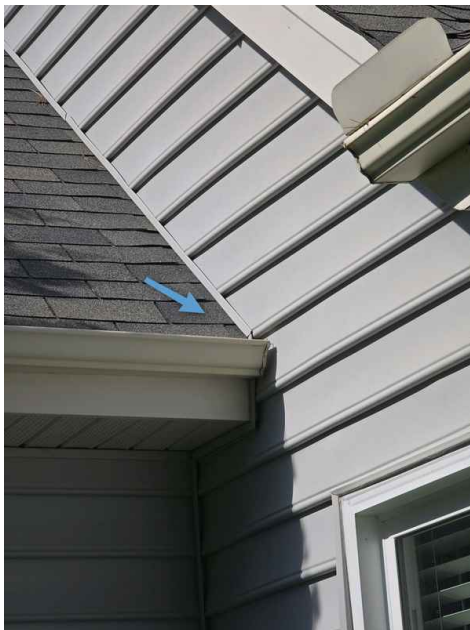
### 3.2.1 Flashings

#### **KICKOUT FLASHINGS MISSING**

Kickout flashings are missing at one or more areas on the roof. These flashings are curved and are typically installed where the roof terminates at the siding to shunt water away from the house. Have a roofer evaluate all required locations as the flashings can be concealed from view, then repair as needed.

Contact a qualified roofing professional.

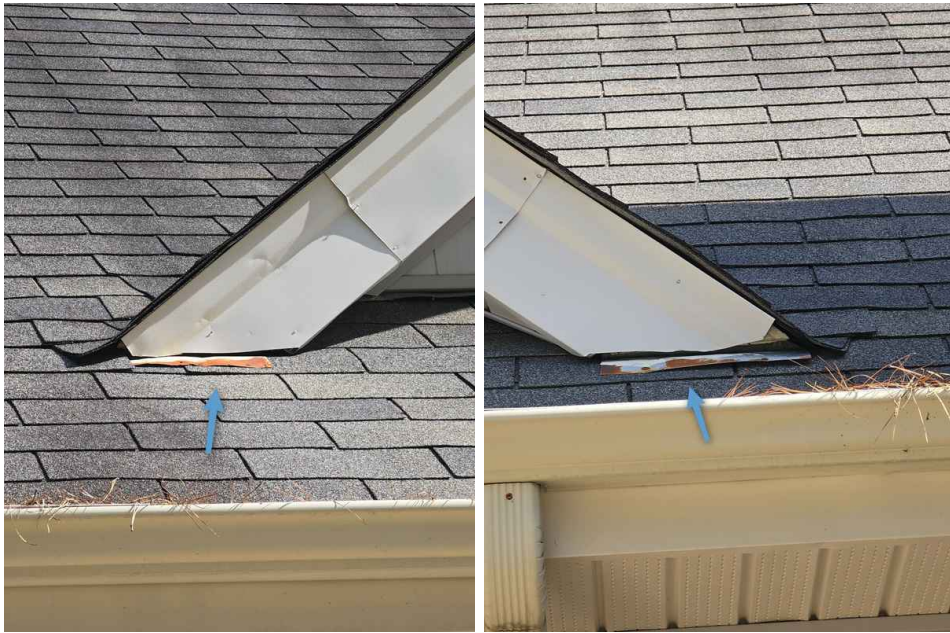
### 3.2.2 Flashings

#### **FLASHINGS RUSTED**

Flashings at one or more areas are rusting. This is susceptible to leaking. Repair or replace.

Contact a qualified roofing professional.

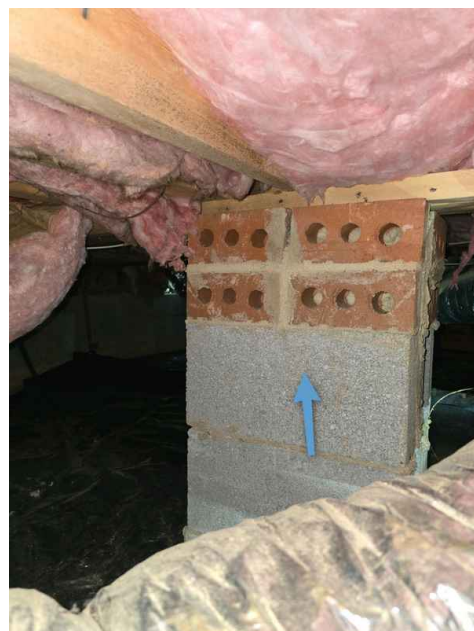
### 6.2.1 Piers and Columns

#### FOUNDATION PIER ISSUES

Contact a qualified professional engineer

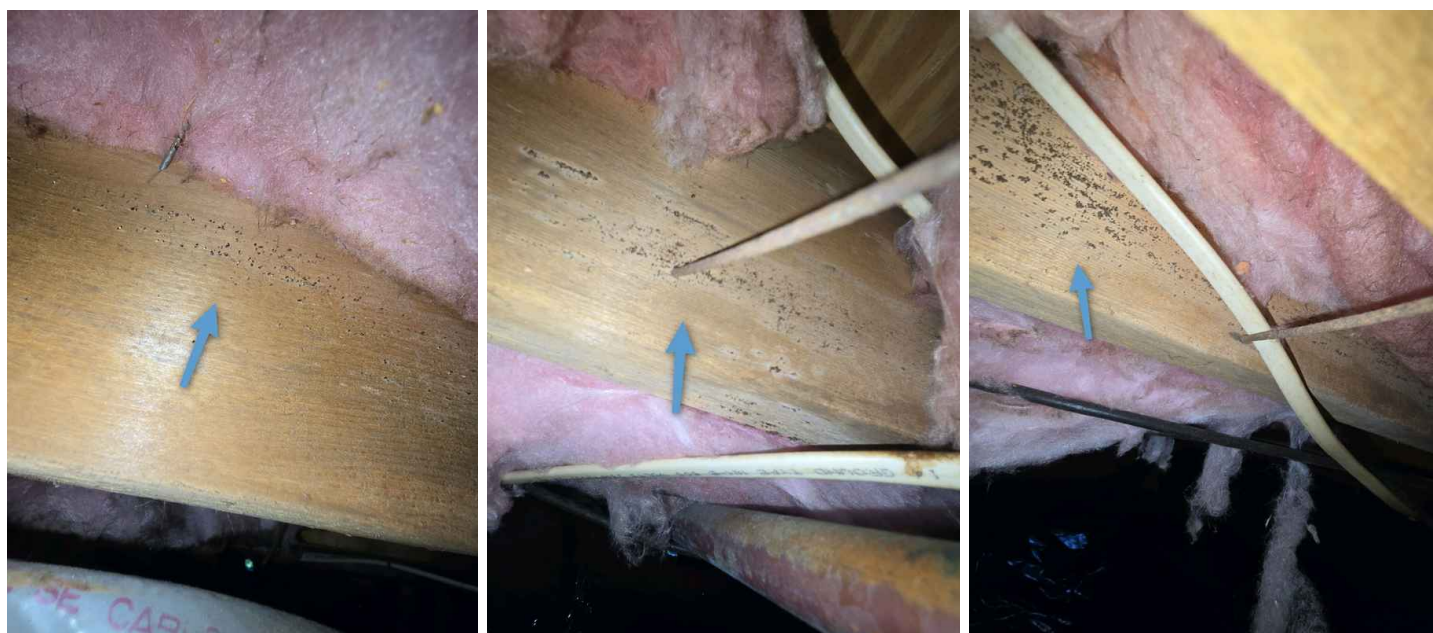
### 6.3.1 Basements & Crawlspaces

#### ORGANIC GROWTH

Contact a qualified environmental remediation contractor

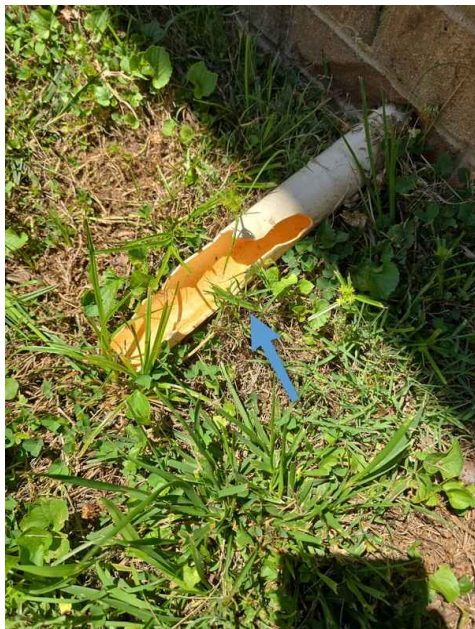
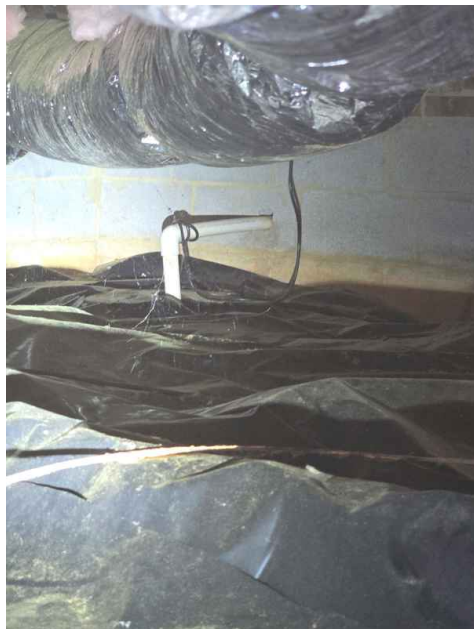
### 6.3.2 Basements & Crawlspaces

#### **SUMP PUMP DISCHARGE LINE DAMAGED**

Contact a qualified professional.

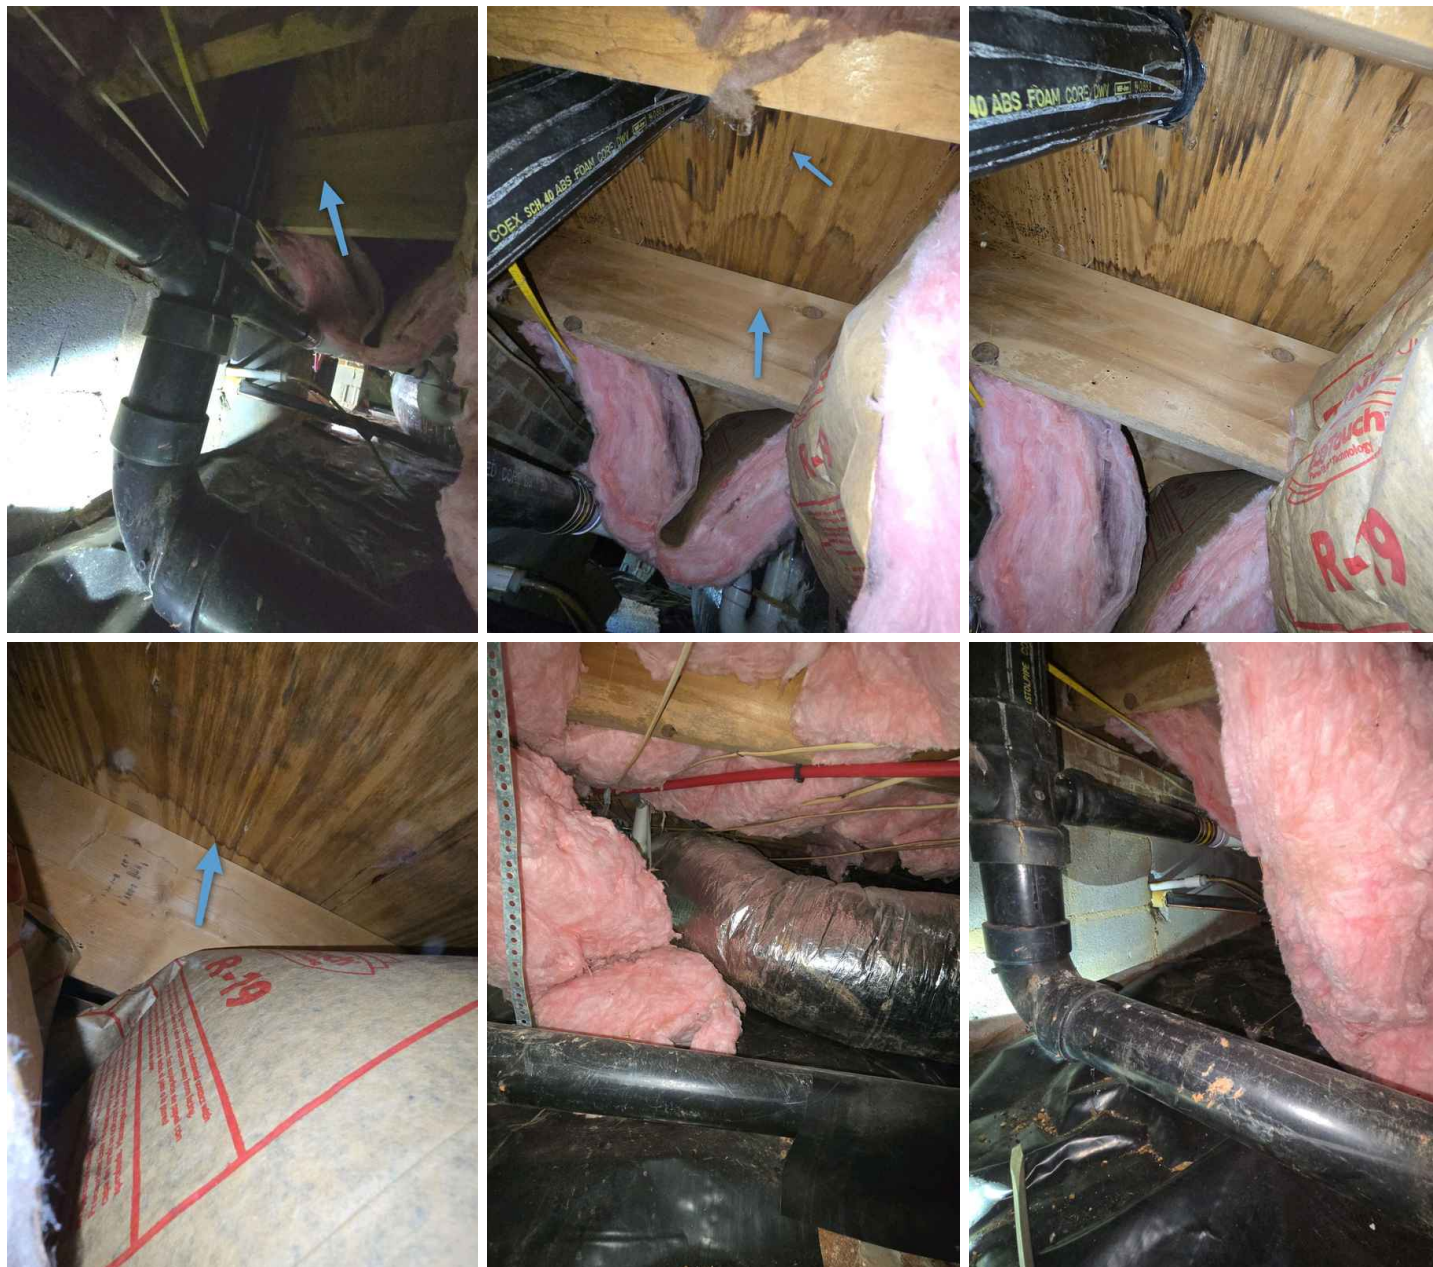
## 6.4.1 Floor Structure

**DETERIORATED/STAINED SUBFLOOR**

Contact a qualified licensed general contractor

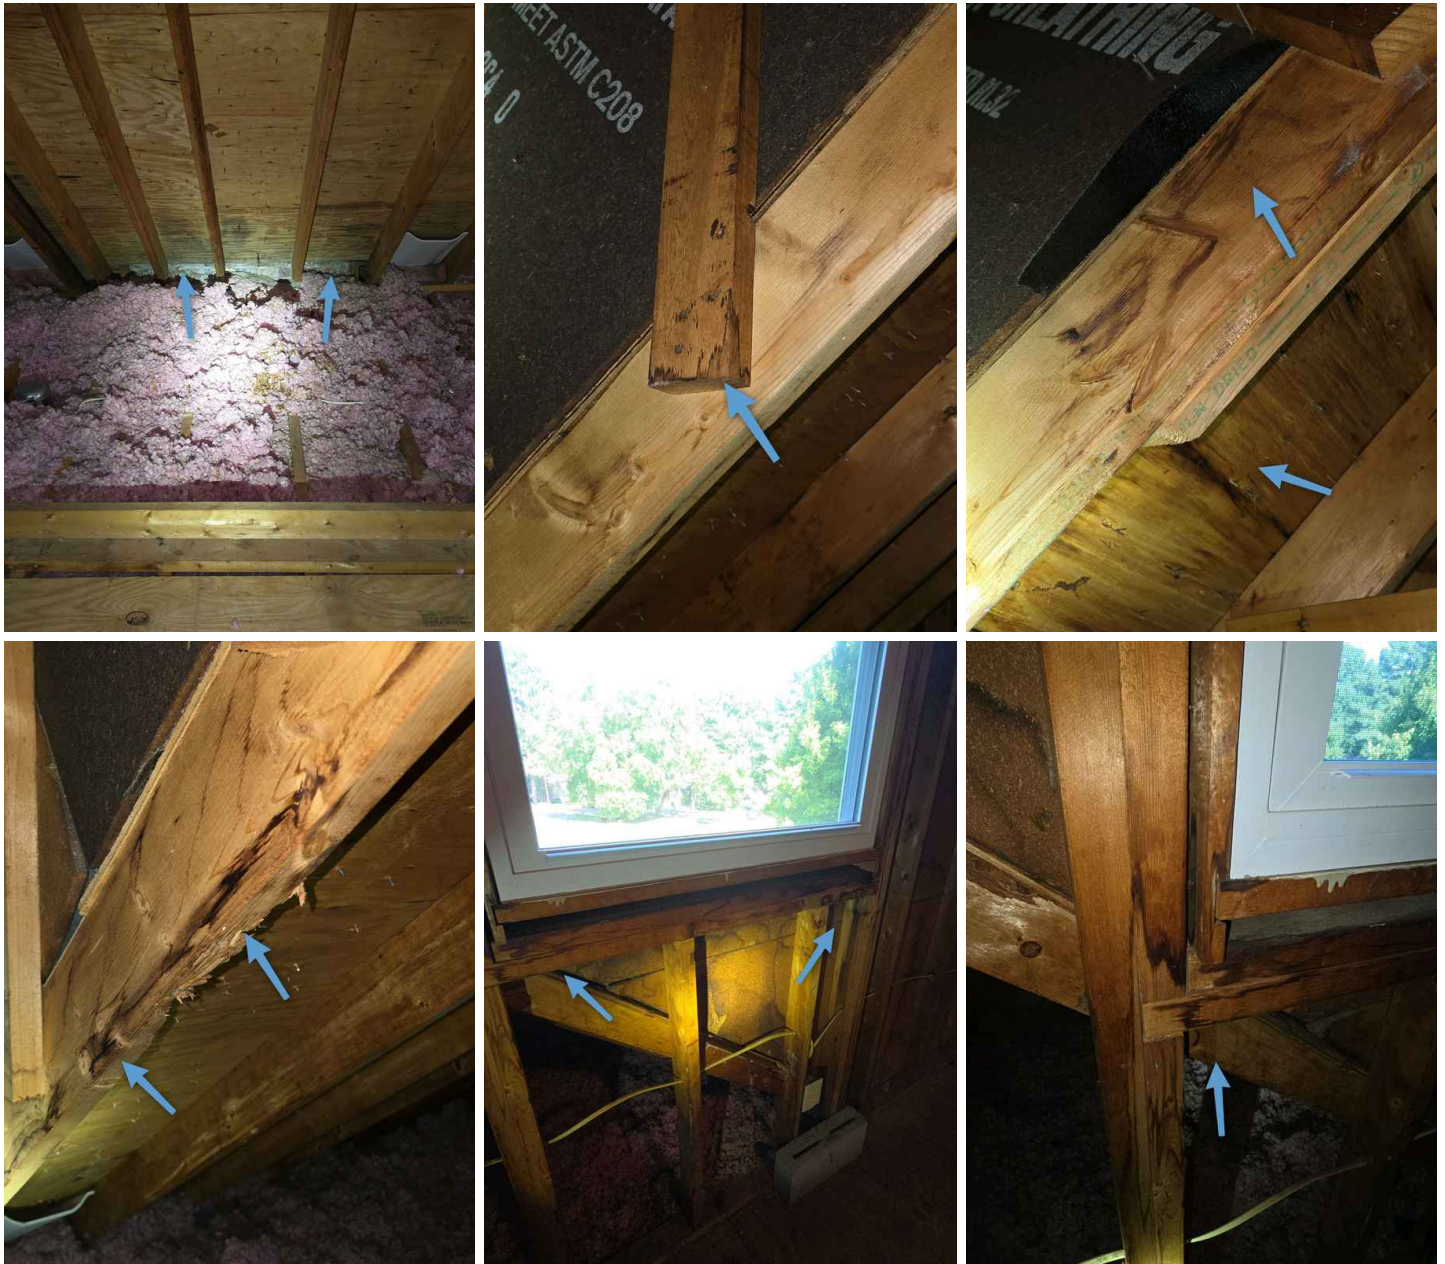
## 6.6.1 Roof Structure &amp; Attic

**ATTIC WATER STAINS**

Contact a qualified professional.

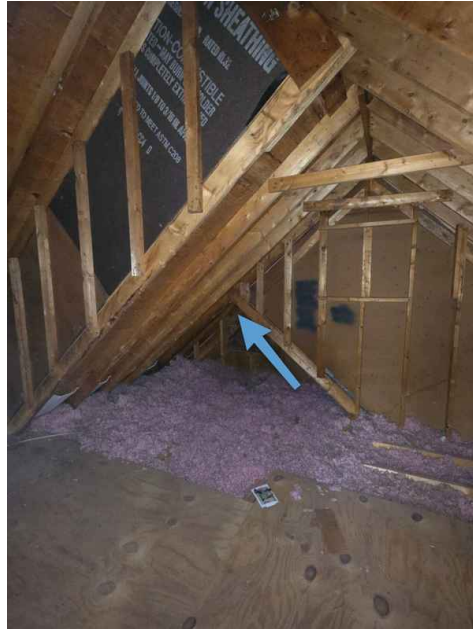
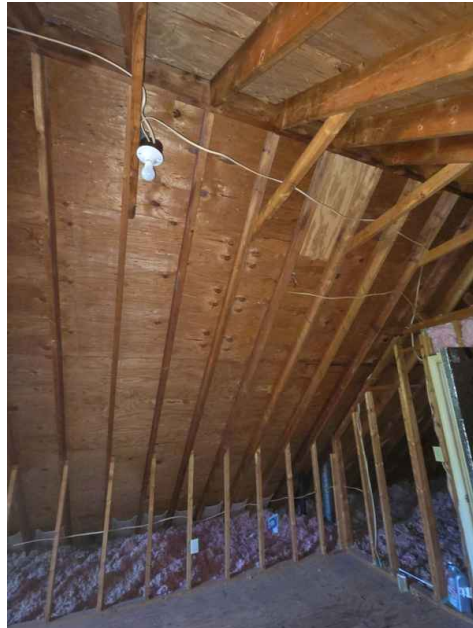
## 6.6.3 Roof Structure &amp; Attic

**ROOF SHEATHING DAMAGE**

Contact a qualified professional.

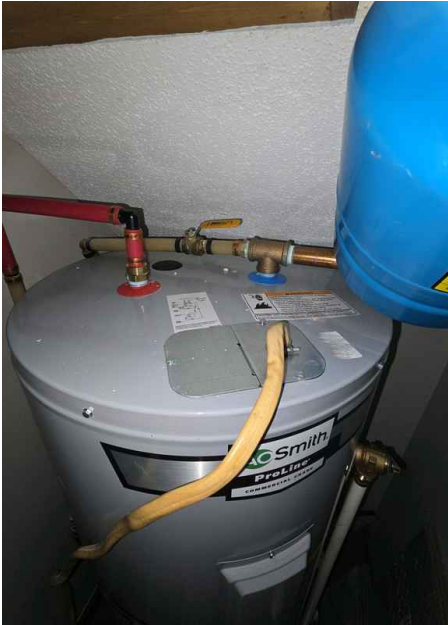
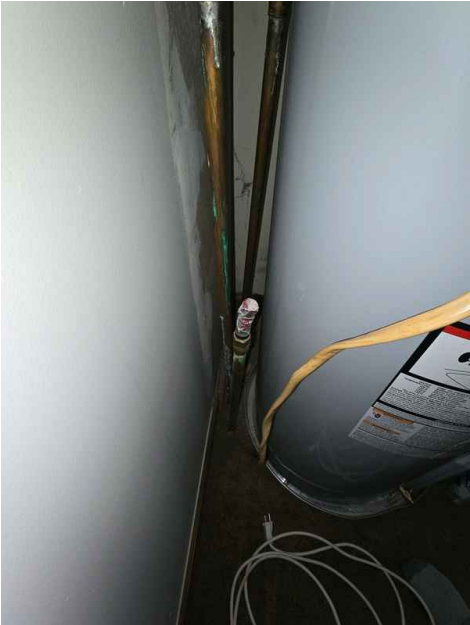
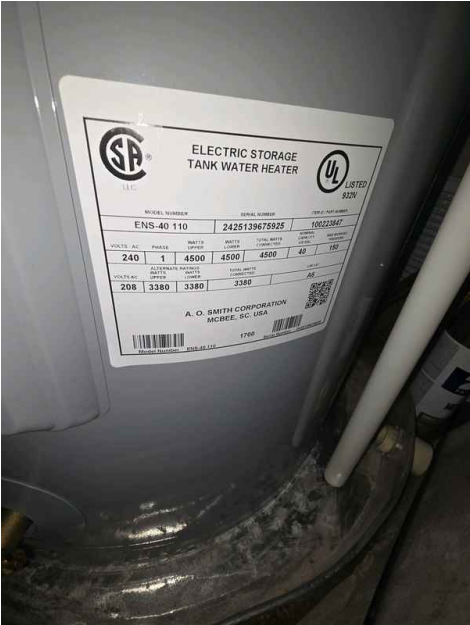
**Hot Water Systems, Controls, Flues & Vents: Water Heater Pictures**

**Hot Water Systems, Controls, Flues & Vents: Location**  
Closet, Expansion Tank Present, Overflow Pipe Present

**Hot Water Systems, Controls, Flues & Vents: Power Source/Type**  
Electric

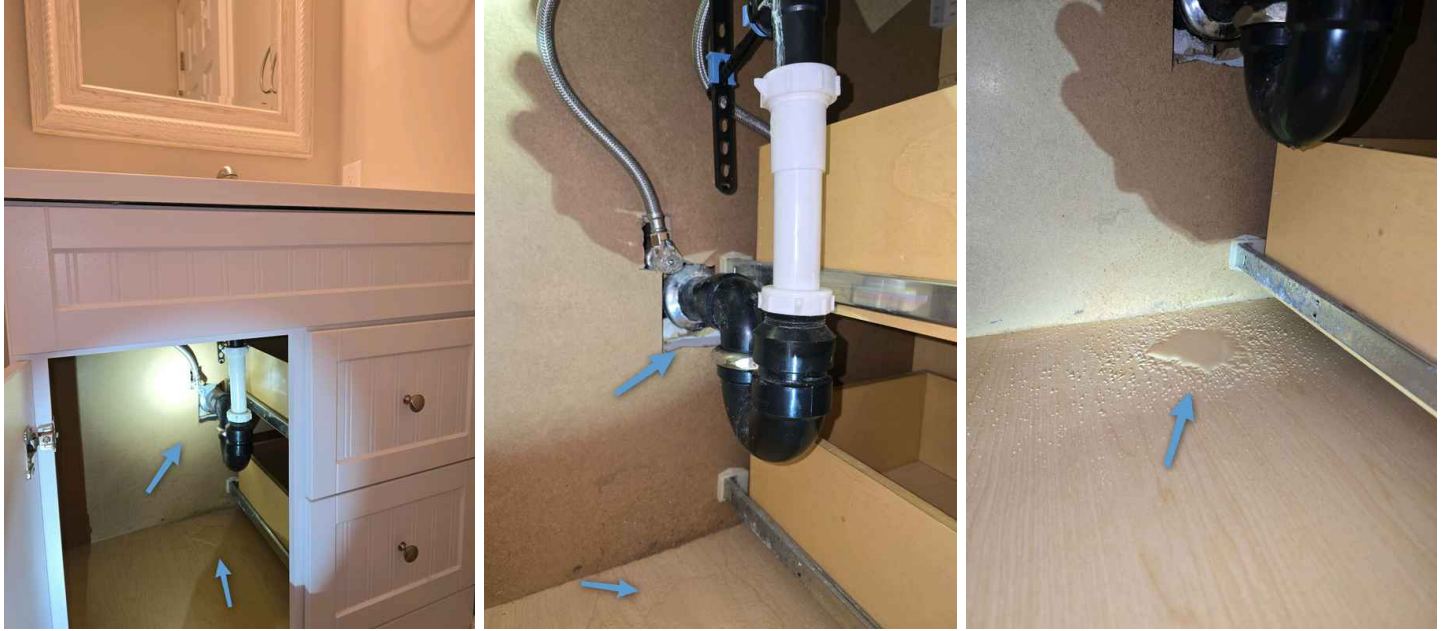
**BASIN DRAIN LEAKING**

The referenced area basins leak at the underside drain assembly during operation. This can allow moisture damage at adjacent areas. Have a Plumber repair as needed.

Contact a qualified professional.
