A-1 HOUSE INSPECTORS, INC.

## A-1 RESIDENTIAL REPORT

106 Allison Way  
Cary, NC 27511

07/14/2026

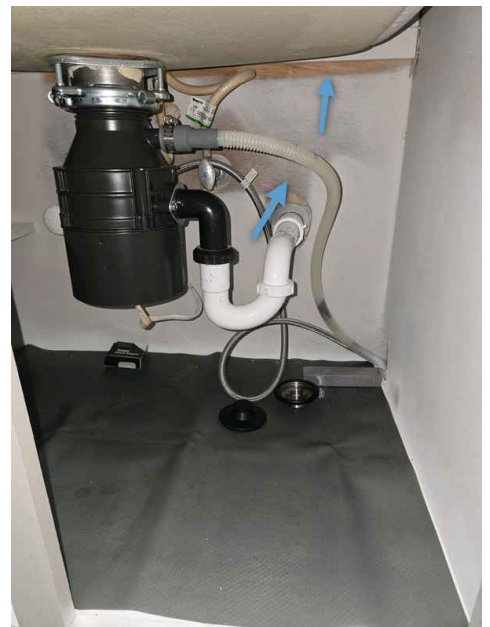
## 10.2.2 Drain, Waste, &amp; Vent Systems

**DISHWASHER DRAIN ROUTING**

Contact a qualified professional.

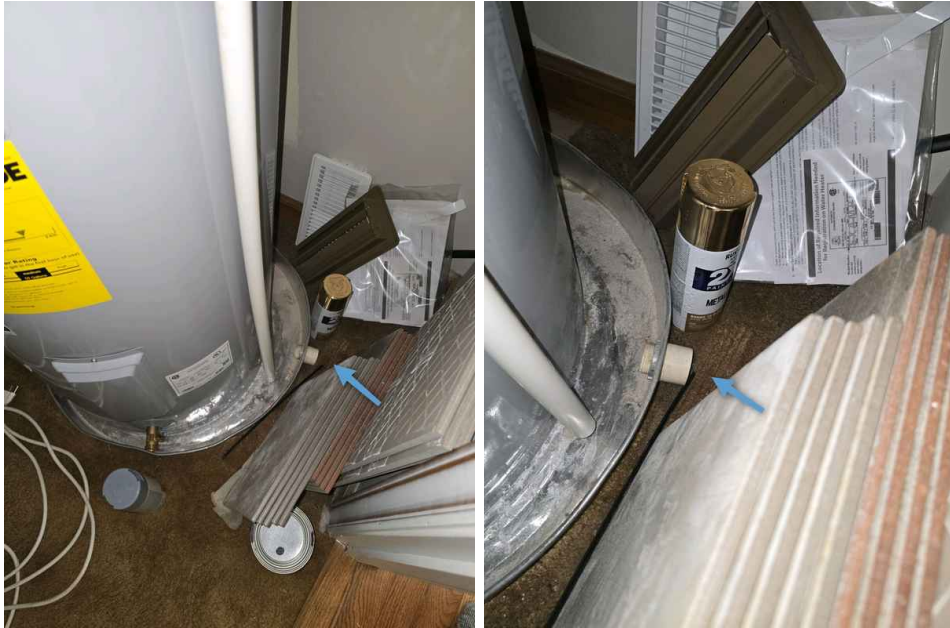
## 10.6.1 Hot Water Systems, Controls, Flues &amp; Vents

**OVERFLOW PIPE EXTEND TO EXTERIOR**

Contact a qualified plumbing contractor.

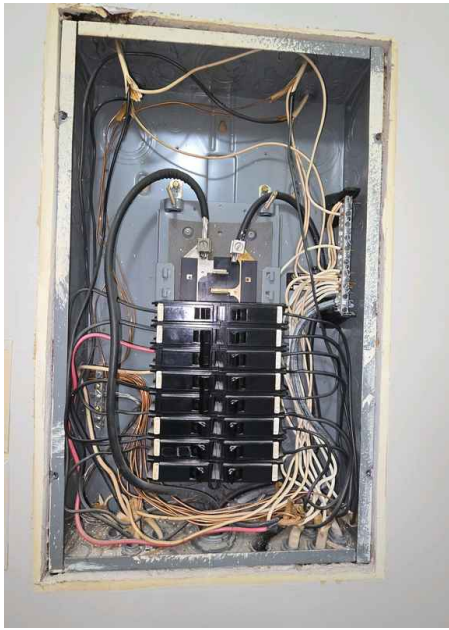
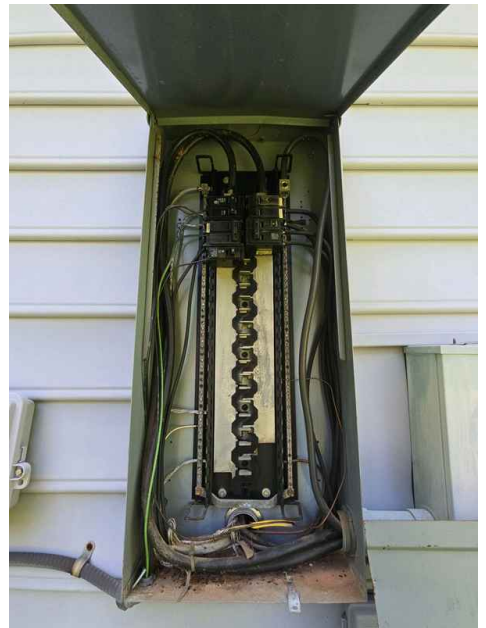
**Main & Subpanels, Service & Grounding, Main Overcurrent Device: Electric Panel Pictures**

**Main & Subpanels, Service & Grounding, Main Overcurrent Device: Electric Main Shutoff Location**  
Left Exterior

**Main & Subpanels, Service & Grounding, Main Overcurrent Device: Electric Panel Locations**  
Laundry Room, Left Exterior

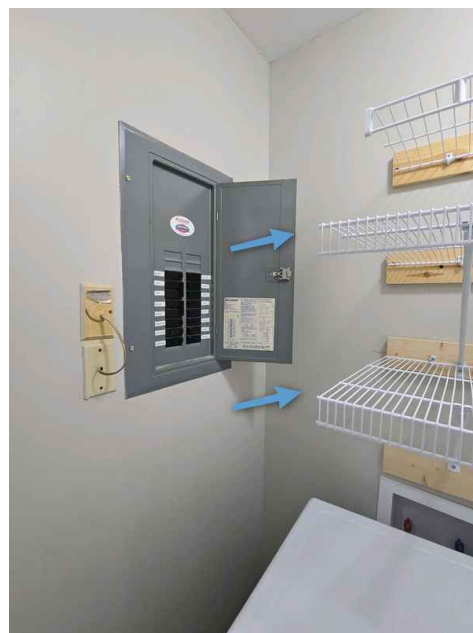
## 11.2.2 Main &amp; Subpanels, Service &amp; Grounding, Main Overcurrent Device

**INADEQUATE SPACING AROUND PANEL**

Contact a qualified electrical contractor.

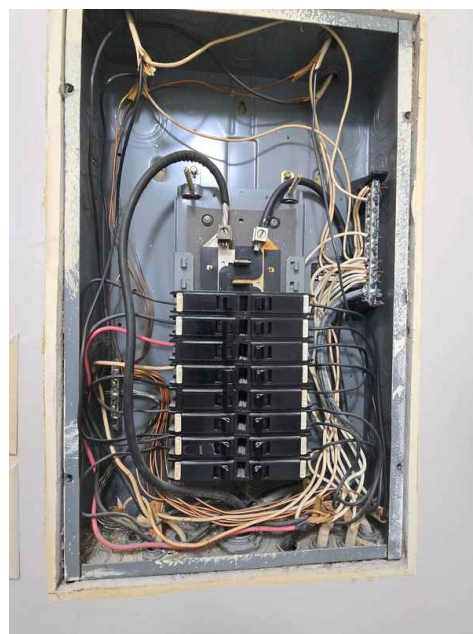
### 11.2.4 Main & Subpanels, Service & Grounding, Main Overcurrent Device

#### **ELECTRICAL SYSTEM AGED**

Contact a qualified electrical contractor.

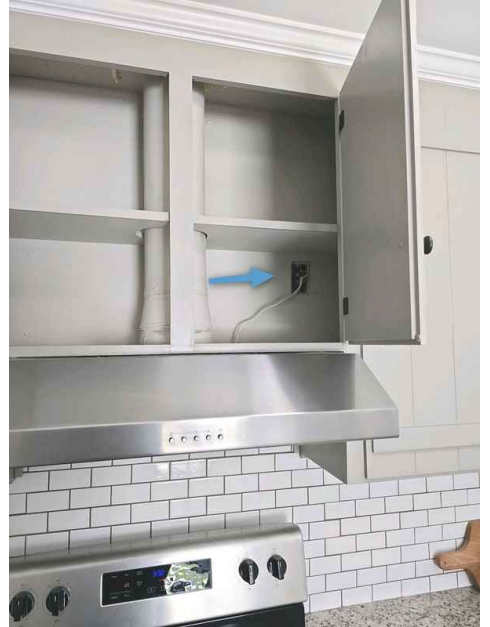
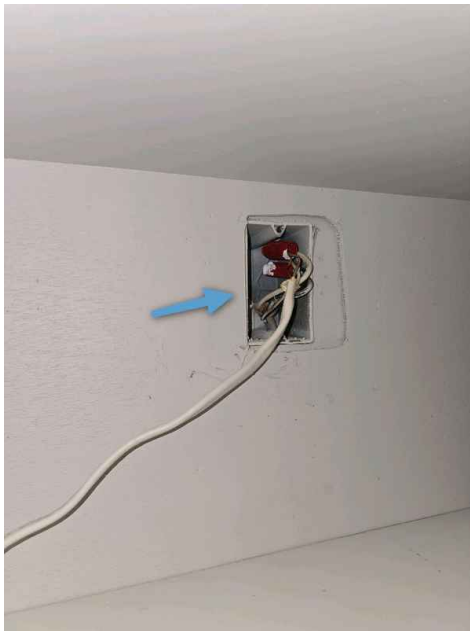
### 11.3.1 Branch Wiring Circuits, Breakers & Fuses

## WIRES OUTSIDE JUNCTION BOX

Contact a qualified professional.

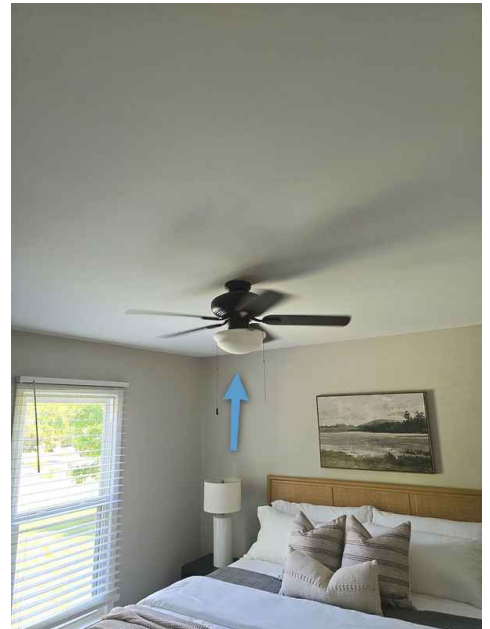
#### 11.4.1 Lighting Fixtures, Switches & Receptacles

### LIGHT BULBS OUT

Contact a qualified professional.

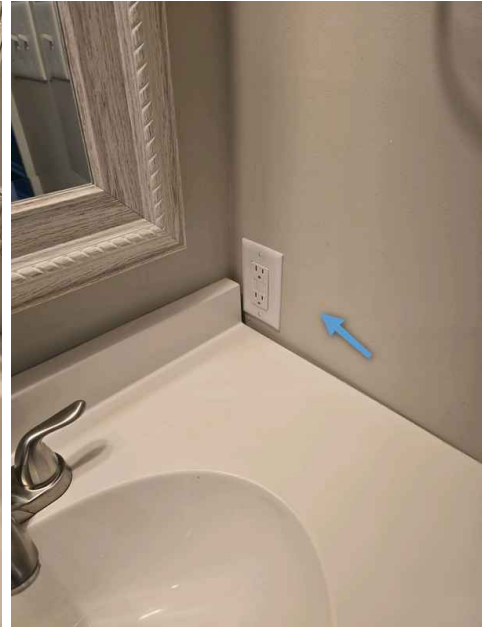
## 11.5.1 GFCI &amp; AFCI

**GFCI MULTIPLE RESETS**

Same Circuit

Contact a qualified electrical contractor.

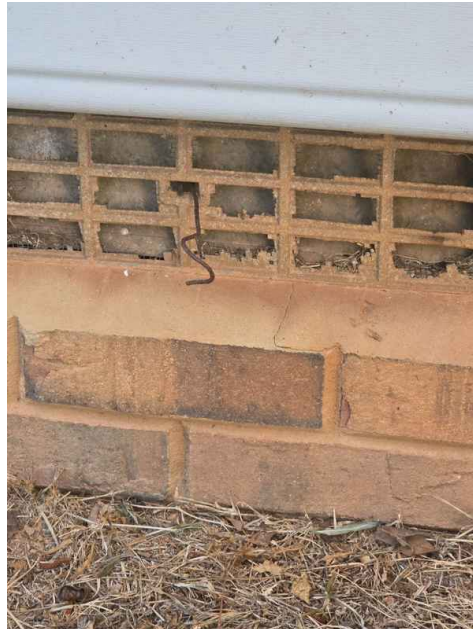
## 12.5.1 Ventilation Crawlspace

**FOUNDATION VENT SCREENS**

Contact a qualified professional.

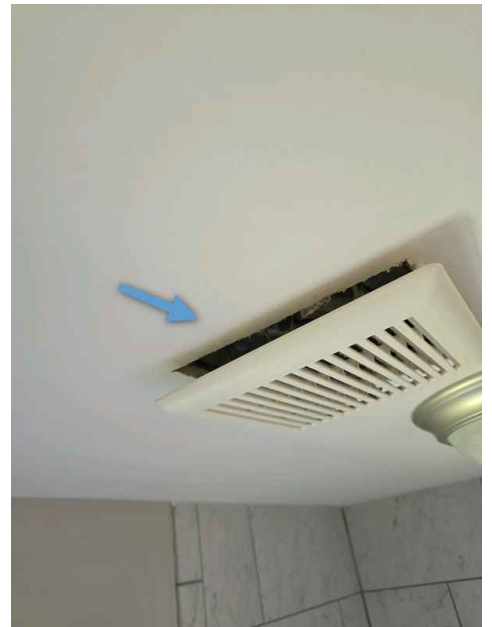
## 12.7.3 Exhaust Systems

**EXHAUST FAN LOOSE**

Contact a qualified professional.

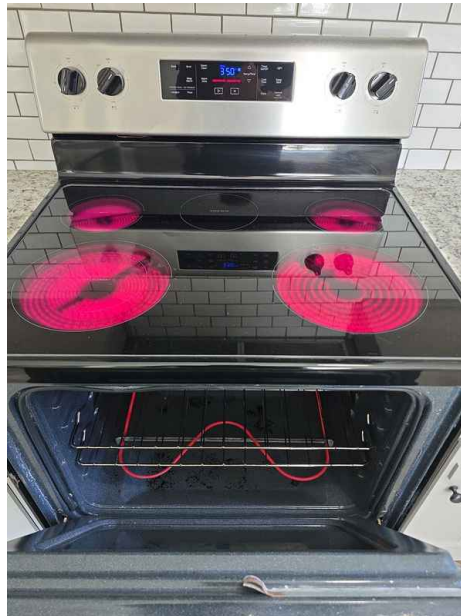
**Range/Oven/Cooktop/Vent:**  
**Range Type/Energy Source**  
Electric Range
