## HOME INSPECTION REPORT

262 Bally Shannon Way  
Apex, NC 27539

MAY 8, 2026

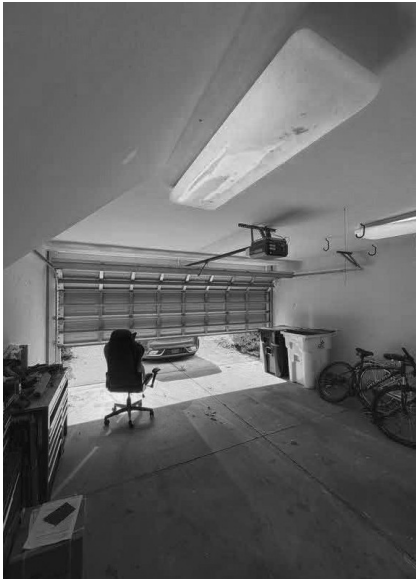
Safety Reverse Operational, Photo  
Lenses Operational

Safety features tested

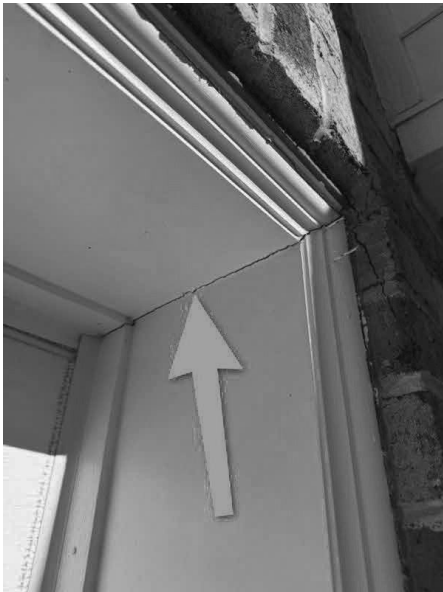
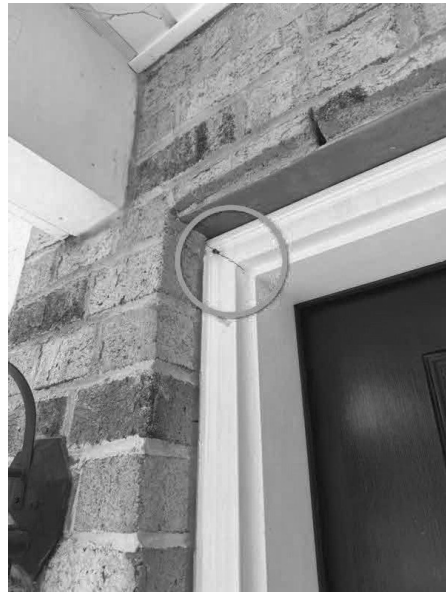
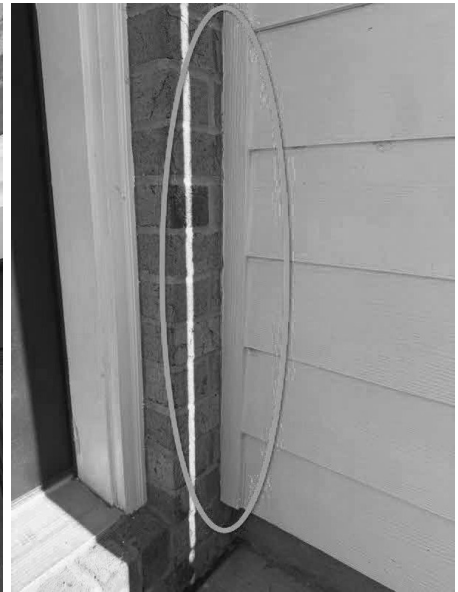
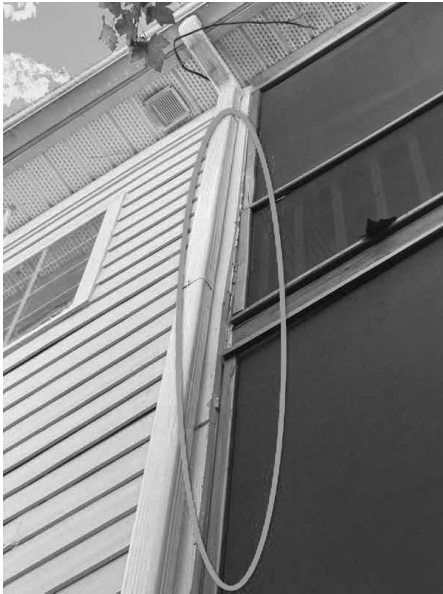
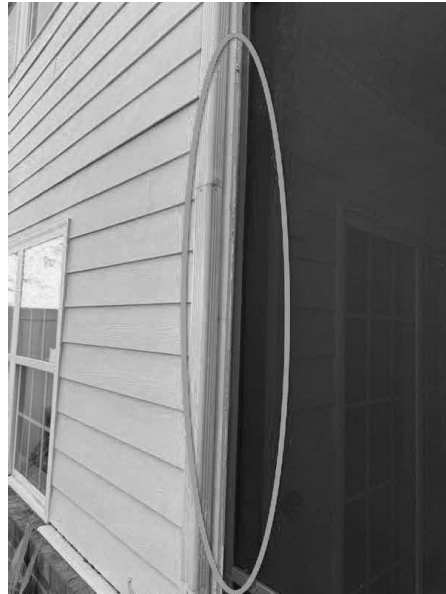
3.1.1 Siding

### SEALANT MISSING

One or more areas of the exterior is missing caulk or sealant has deteriorated. This can allow moisture or pests to enter the structure and may damage surrounding components. Recommend a siding contractor evaluate entire exterior (trim, soffits, fascia, windows, doors, etc.) and repair / replace as needed.

Garage door surround trim

Front door surround trim

Front porch area

Rear deck corner trim

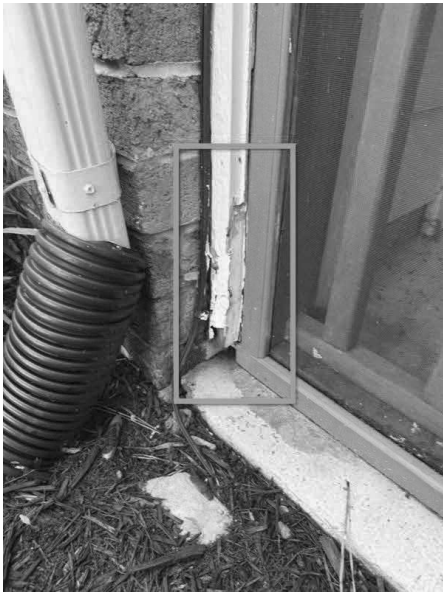
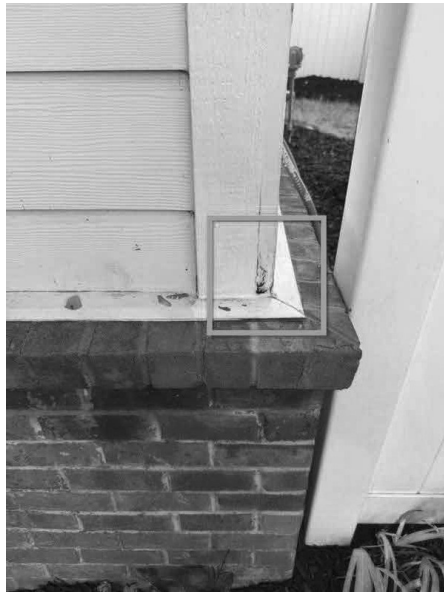
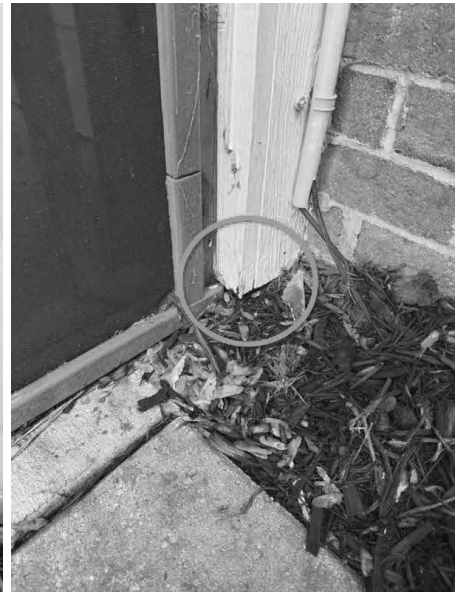
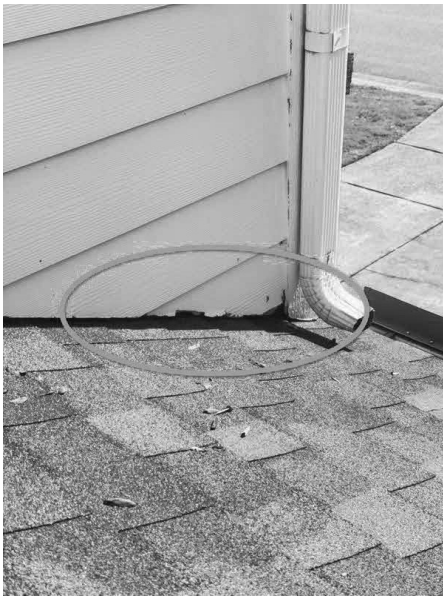
### 3.1.2 Siding

#### **DAMAGE**

A component of the exterior was damaged. Anywhere water is able to come in contact with the sheathing of the home, accelerated deterioration is possible. Recommend evaluation of all exterior siding and possible repairs or remedies to prevent further damage by a qualified contractor.

Rear patio area trim corner

Rear left exterior corner

Rear patio patio corner trim

Front porch roof

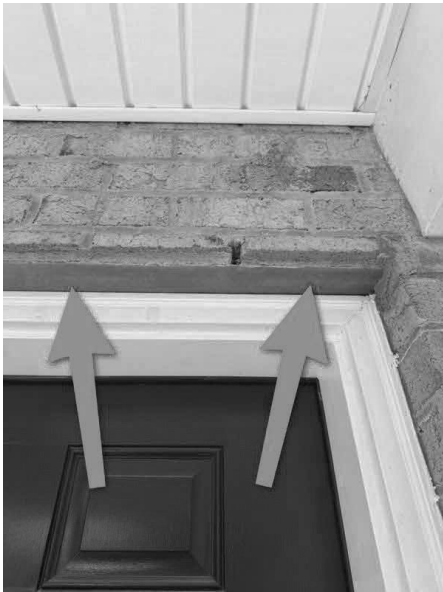
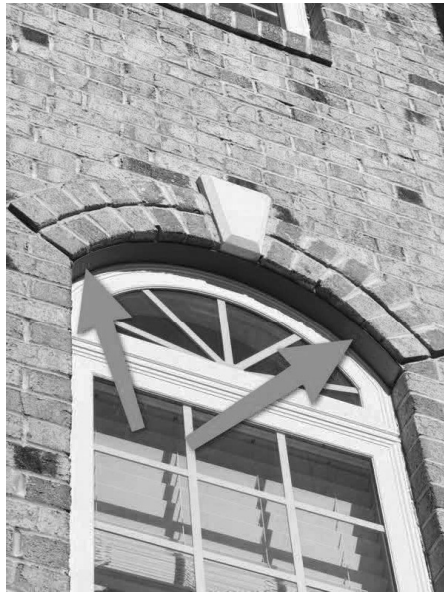
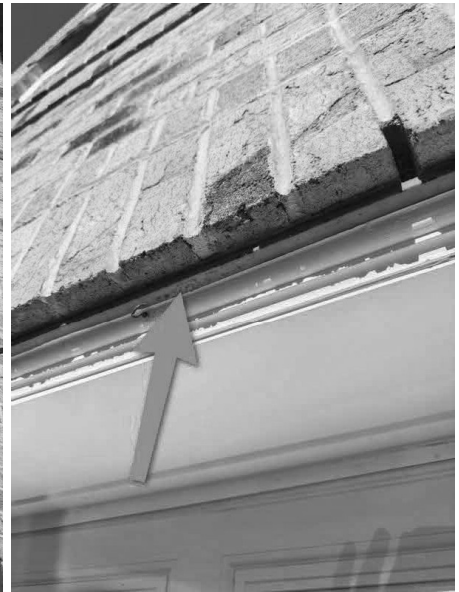
### 3.1.3 Siding

#### LINTEL

The lintel (metal support) above an exterior opening is showing signs of aging. Rusting of the lintel can lead to weakening support. Recommend qualified contractor further evaluate and repair / paint as necessary.

Front exterior

Front exterior window lintels

Garage door lintel

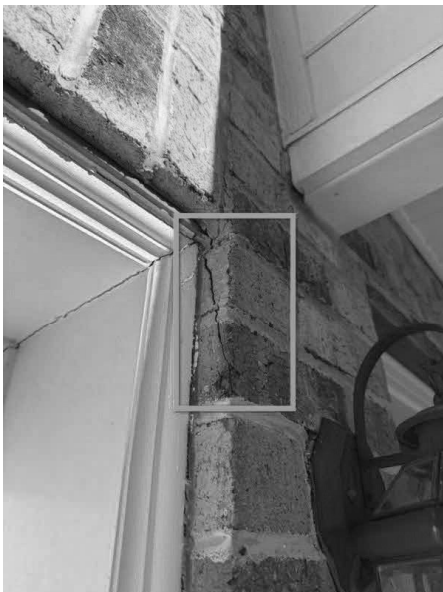
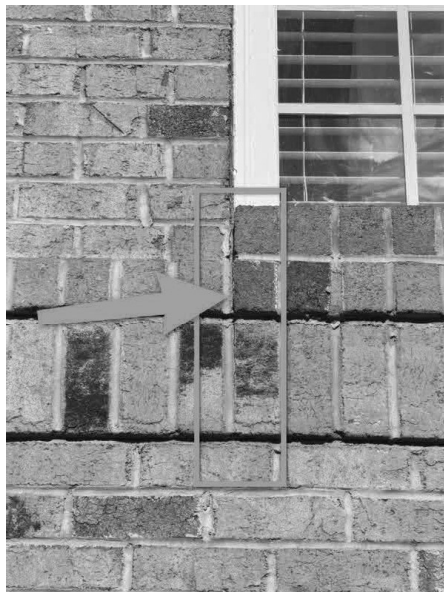
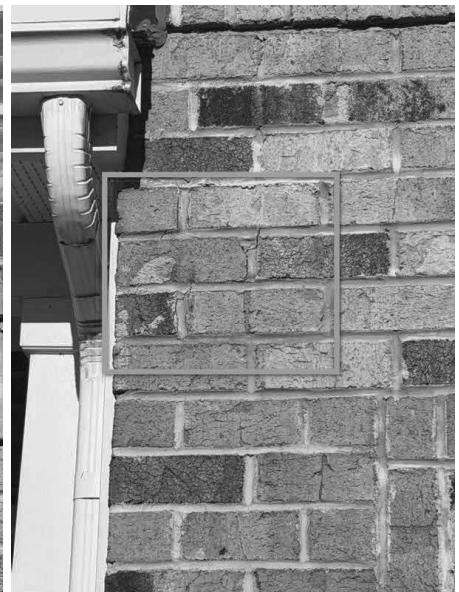
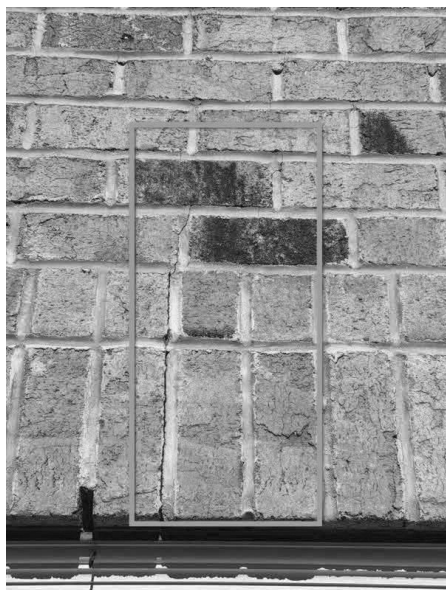
### 3.1.4 Siding

#### CRACKING

Siding showed cracking in one or more places. This could allow moisture intrusion in some scenarios or indicate settlement. Recommend monitoring for further movement and contacting a qualified contractor to seal areas or a structural engineer for further evaluation if so desired.

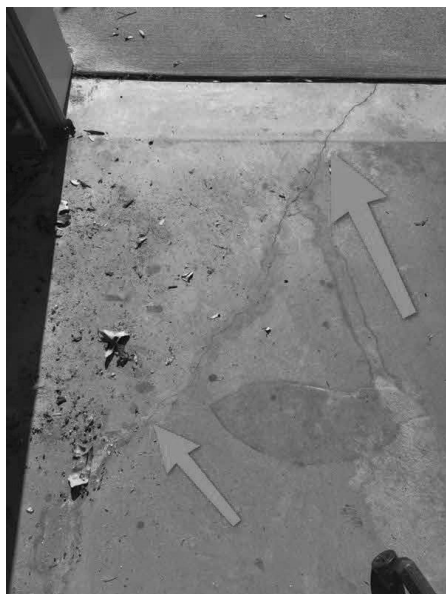
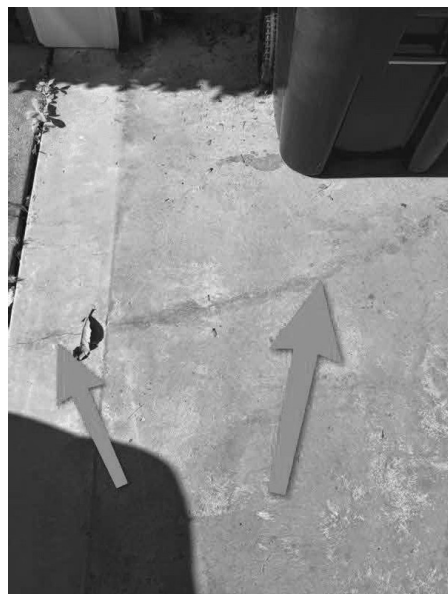
### 3.2.1 Walkways, Patios & Driveways

#### **SLAB CRACKS**

There were cracks or settlement areas in the poured slab. These cracks are common and normally are only an aesthetic concern. In some scenarios, this may pose a tripping hazard. It is important to prevent water from entering the crevices, as with freezing this contributes to expansion. We recommend repair/sealing by qualified professional, monitoring these areas for further movement, and consulting a qualified contractor for a second opinion if so desired.

Garage slab

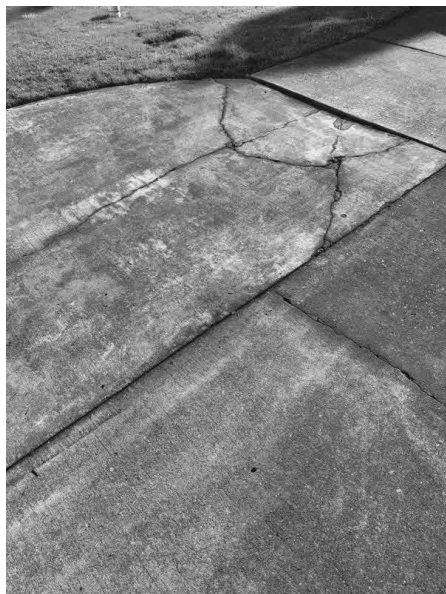
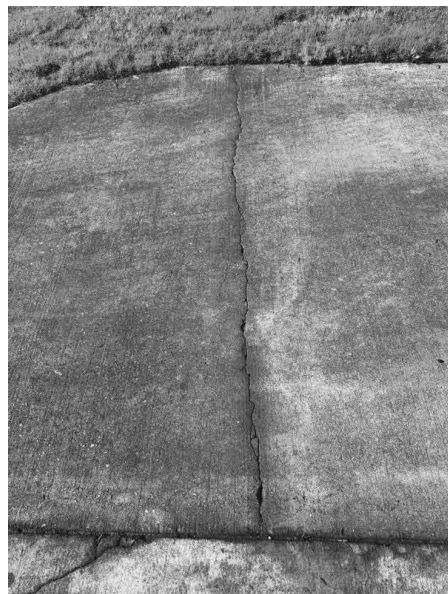
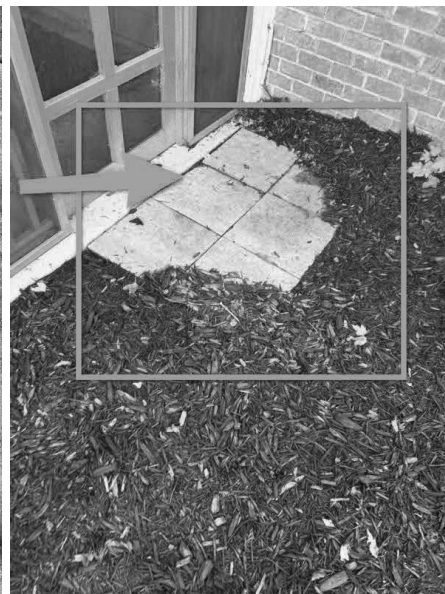
### 3.2.2 Walkways, Patios & Driveways

#### **CRACKS / SETTLEMENT**

There was cracks / settlement in areas of the poured driveway or walkway slab. This can prevent proper drainage, or indicate other underlying issues such as tree roots, incorrect soil compacting, ect. This is fairly common in older structures. A qualified contractor should be consulted for possible repairs, keeping crevices sealed and keeping moisture out is important.

Driveway

Rear patio pavers. Settlement noted

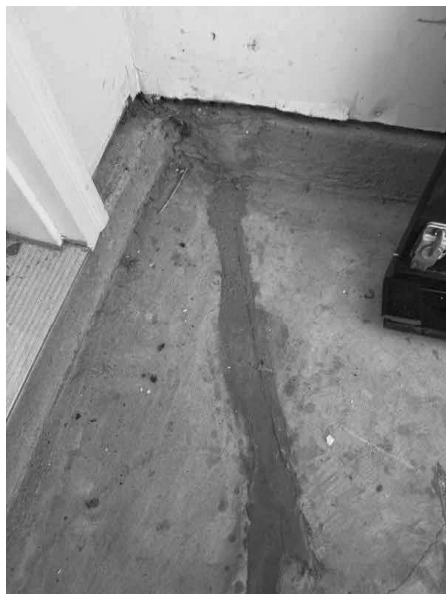
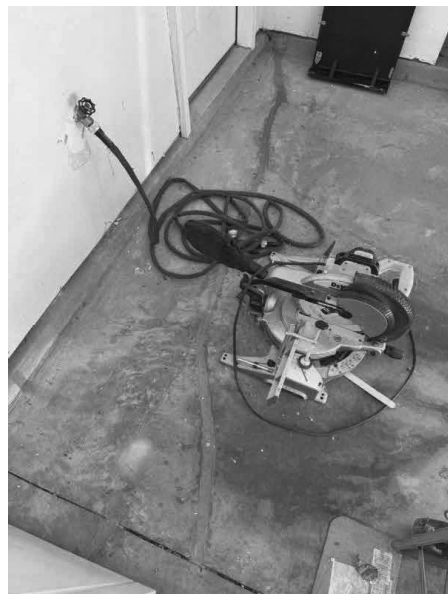
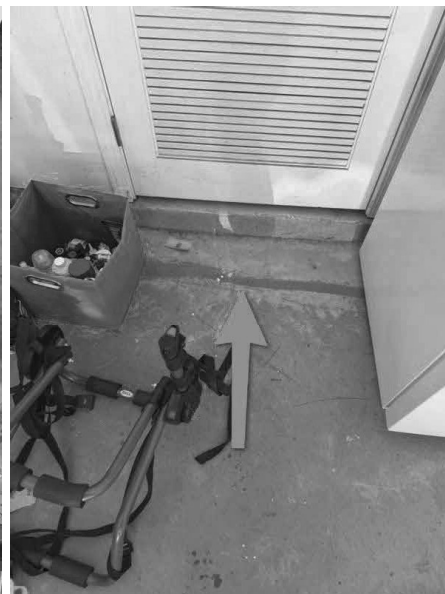
### 3.2.3 Walkways, Patios & Driveways

#### REPAIRS

There have been repairs made. This can indicate a current or past problem with the area, or may not perform as intended aesthetically. Recommend inquiring with seller as to nature of repairs, and if needed a qualified contractor for further evaluation, replacement.

Garage slab

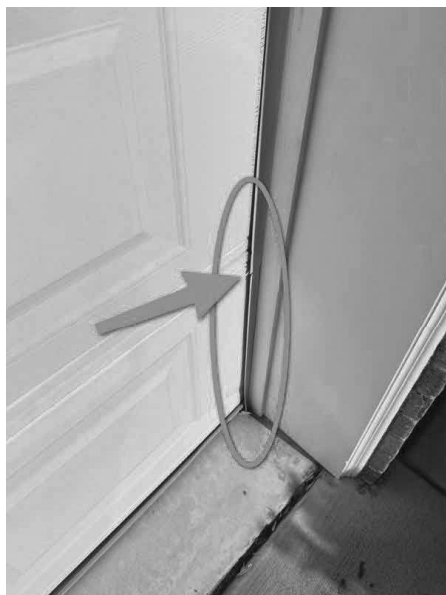
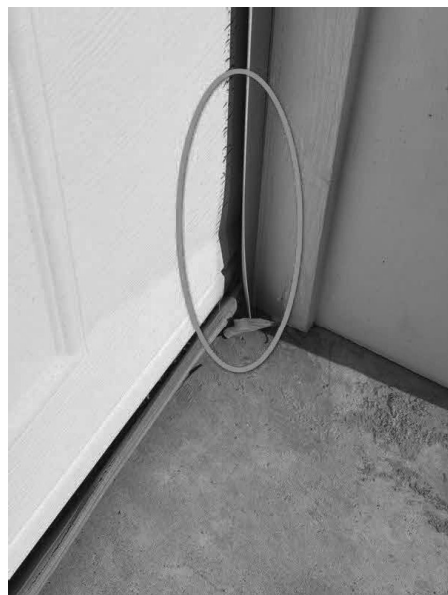
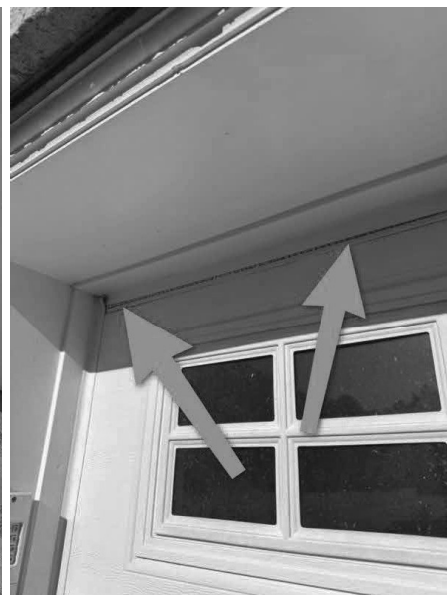
## 3.3.1 Overhead Doors

**TRIM**

The overhead door trim or weather stripping is incorrect in some way. This can contribute to moisture intrusion, or impede proper operation. Recommend repair or replacement by qualified personnel.

Garage door trim

Garage door surround trim

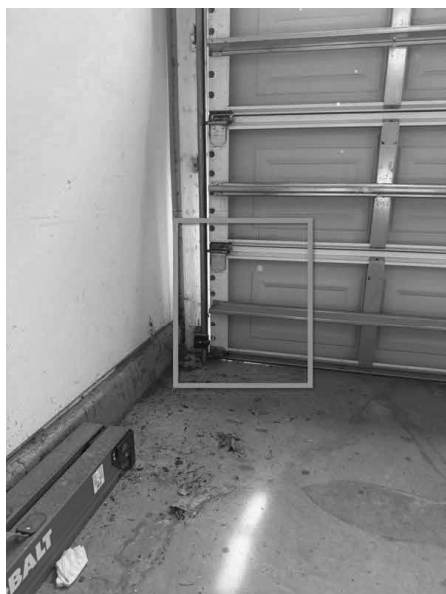
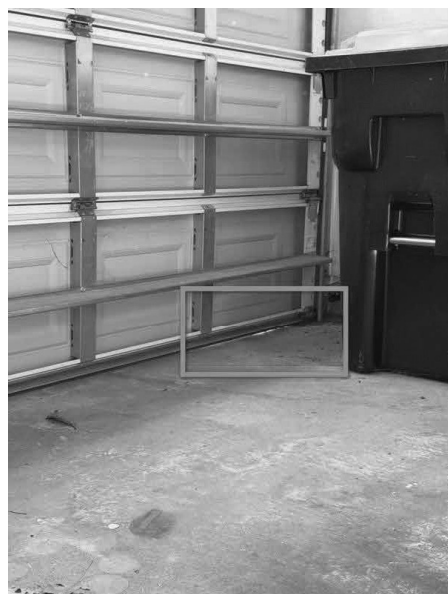
## 3.3.2 Overhead Doors

**DAYLIGHT**

There was daylight visible at one or more areas around the garage door. This can contribute to insect and moisture intrusion. We recommend a qualified contractor evaluate and make appropriate adjustments if needed.

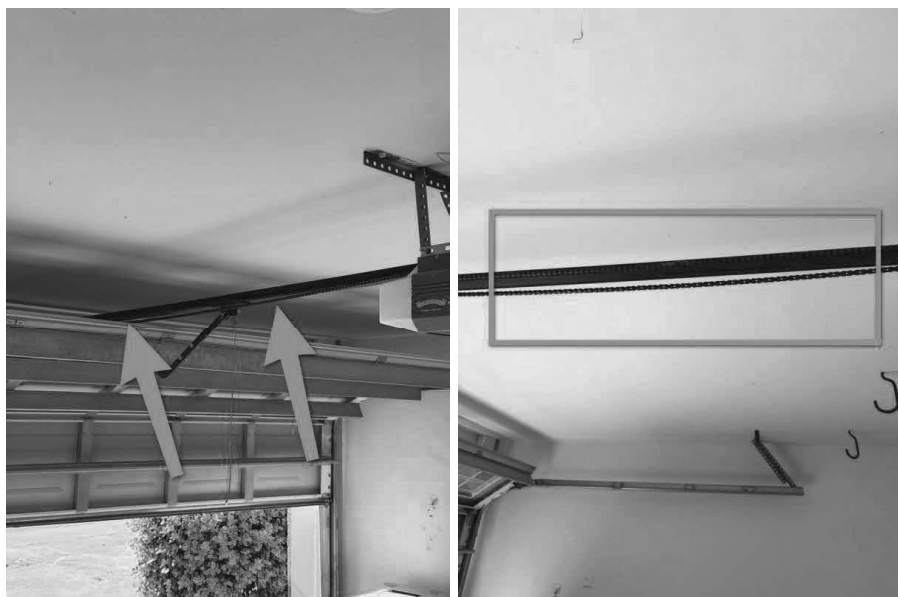
## 3.3.3 Overhead Doors

**LOOSE COMPONENT**

A component of the overhead door was loose. This can worsen over time and not perform as intended either functionally or aesthetically. Recommend qualified contractor further evaluate and repair or replace as needed.

Garage door drive chain had excessive slack and movement

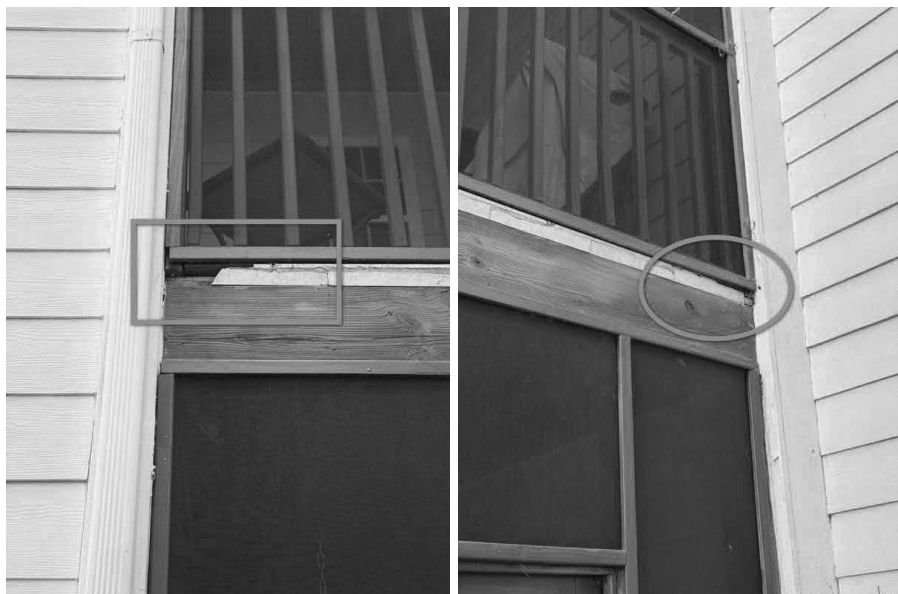
## 3.4.1 Decks, Balconies, Porches &amp; Steps

**DAMAGED / SPLITTING**

A component appears to be damaged or splitting. This can sometimes pose a safety concern, compromise the integrity of the system, or not perform as intended aesthetically. Recommend further evaluation and recommendations by a licensed contractor if so desired.

2nd floor deck tile, damaged/missing

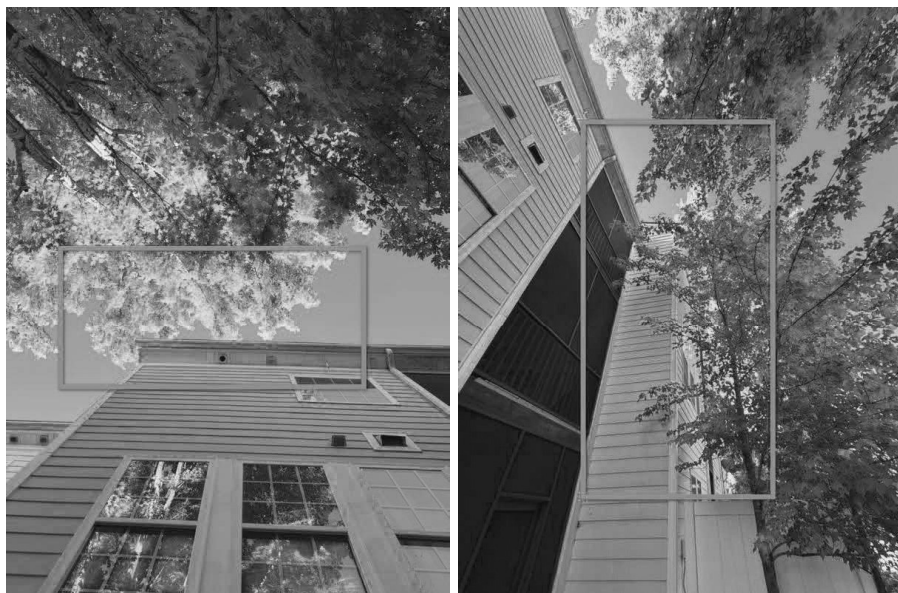
### 3.5.1 Vegetation, Grading, Drainage & Retaining Walls

#### VEGETATION

Vegetation was touching the structure or overhanging in a way that could damage components during inclement weather. This can cause damage to siding or roofing material and could allow water intrusion with subsequent structural damage. This also limits visibility for the inspector. We recommend all vegetation is cleared from structure, or monitored closely.

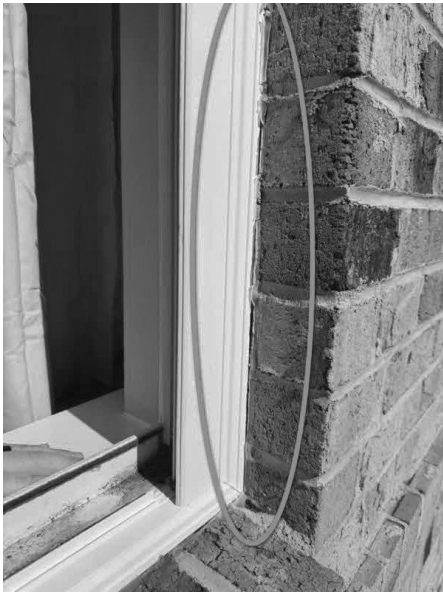
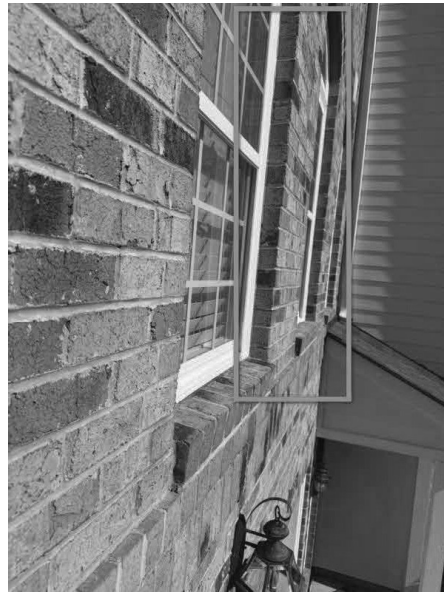
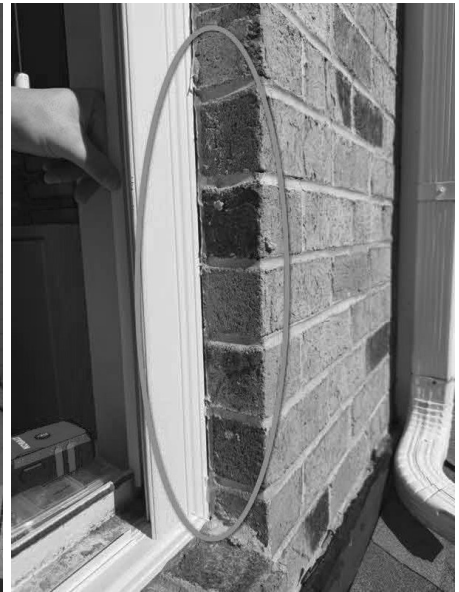
### 3.6.1 Windows

#### SEALANT

Sealant was missing around windows. This can allow moisture intrusion and sometimes damage surrounding components. Recommend contractor further evaluate and repair as necessary.

Multiple windows at front exterior

Multiple window perimeters at front exterior
