# Inspection Report

8724 Owl Roost Pl  
Raleigh NC 27617

**Capital City Home Inspections, LLC**

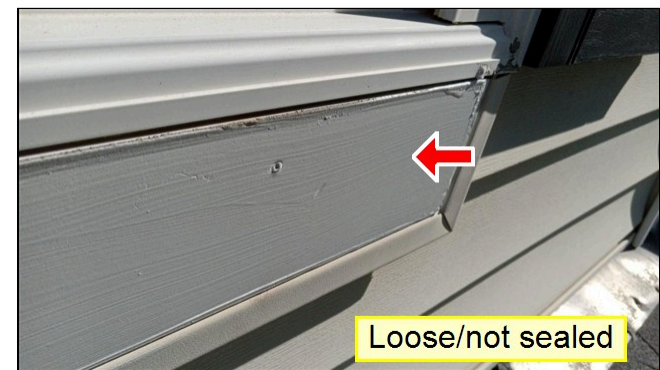
2.0 Item 1(Picture)

**2.0 Repair Item** The trim beneath the windows above the garage was loose and the J-channel next to the rear door was disconnected. Siding components in this condition can allow water to enter behind the cladding, causing damage over time. Recommend contacting a qualified contractor to secure the siding and seal where needed.

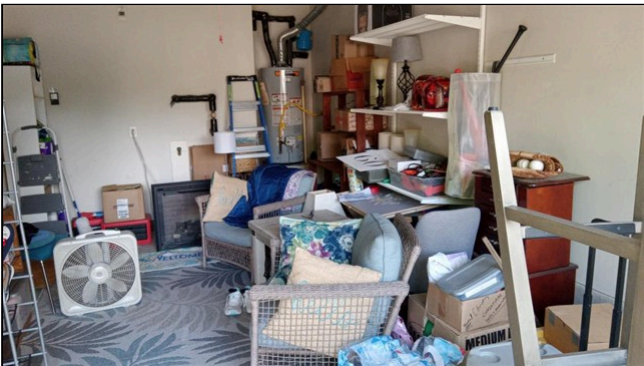
3.1 Item 1(Picture)

**3.1 Comment** Limited inspection of the walls and floor was performed in the garage due to storage. Statements made concerning the garage walls and floor refer to the visible portion only and may not reflect the areas which were inaccessible or visually obstructed.

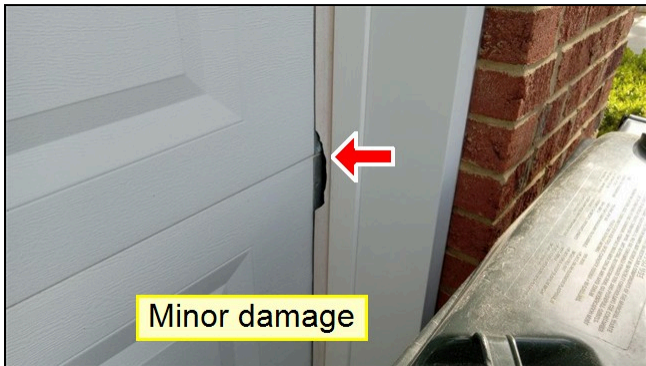
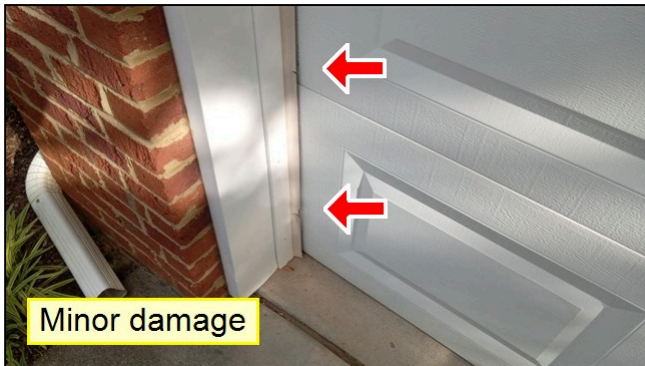
3.3 Item 1(Picture)

**3.3 Repair Item** Minor damage was observed to the weather stripping around the garage door. Weather stripping helps reduce water and pests from entering the garage when the door is closed. Recommend contacting a qualified contractor to replace the weather stripping to ensure proper function.

**Repair Item** Minor damage was observed to the weather stripping around the garage door. Weather stripping helps reduce water and pests from entering the garage when the door is closed. Recommend contacting a qualified contractor to replace the weather stripping to ensure proper function.

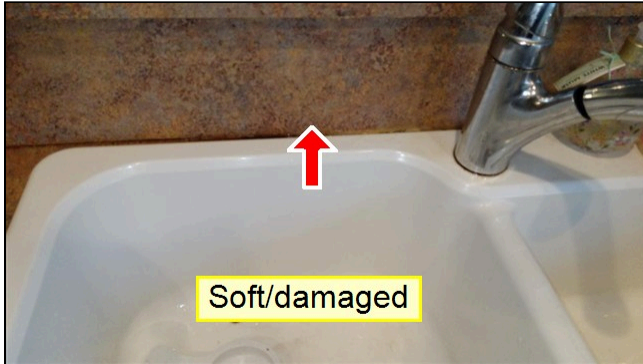
4.4 Item 3(Picture)

**4.4 (2) Repair Item** The countertop behind the kitchen sink was wet and soft, indicating active water intrusion and damage. Without repair, further damage will likely occur over time. Recommend contacting a qualified contractor for repair. **NOTE:** Areas of hidden damage will most likely be found during the repair. The contractor should repair all damage as needed.

(2) **Repair Item** The countertop behind the kitchen sink was wet and soft, indicating active water intrusion and damage. Without repair, further damage will likely occur over time. Recommend contacting a qualified contractor for repair. **NOTE:** Areas of hidden damage will most likely be found during the repair. The contractor should repair all damage as needed.

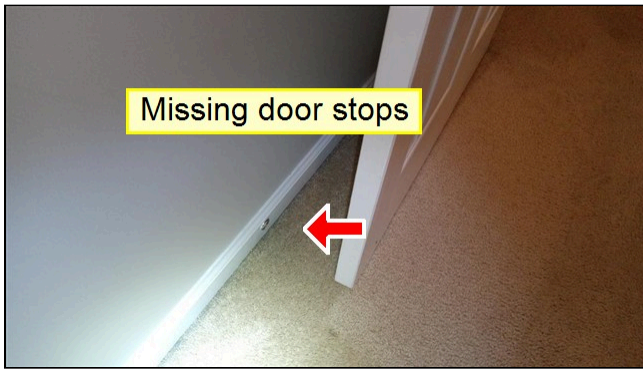
4.5 Item 1(Picture)

**4.5 Repair Item** Many doors in the home are missing door stops. Door stops help prevent damage by preventing contact with other building components when opened. Door stops can be purchased at many home and hardware stores and installed by a qualified person.

**Repair Item** Many doors in the home are missing door stops. Door stops help prevent damage by preventing contact with other building components when opened. Door stops can be purchased at many home and hardware stores and installed by a qualified person.

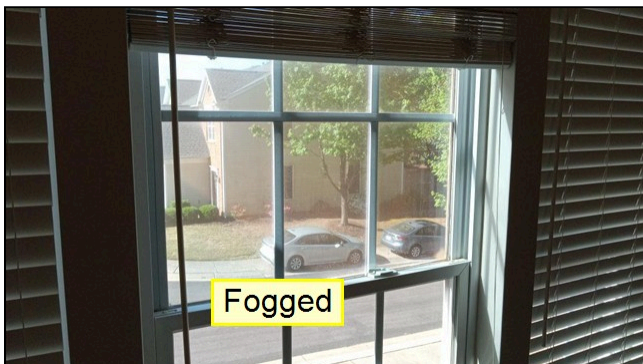
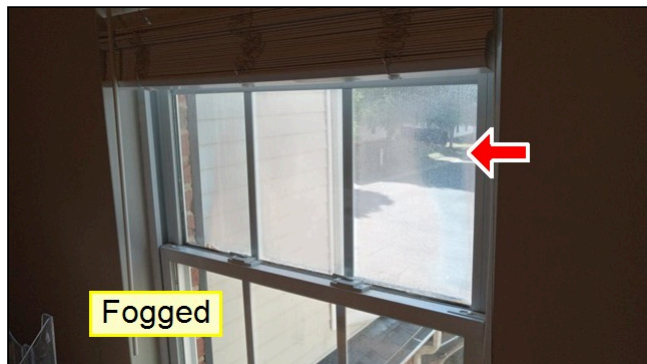
4.6 Item 1(Picture)

**4.6 (1) Repair Item** Two windows including one above the garage and one in the bedroom above the front door appear to have moisture/buildup between the panes indicating a broken seal. A broken or weakened seal on an insulated window does more than just limit your view. The loss of the inert gas, such as argon, between the panes removes the windows ability to insulate properly allowing heat to pass through the glass more easily potentially raising heating and cooling costs. Recommend contacting a qualified contractor to evaluate all the windows in the home to determine if other failed seals are present and repair/replace as needed. **NOTE:** We do not guarantee that all failed seals are identified; some are very difficult to detect and may be more apparent only under certain weather or lighting conditions.

(1) **Repair Item** Two windows including one above the garage and one in the bedroom above the front door appear to have moisture/buildup between the panes indicating a broken seal. A broken or weakened seal on an insulated window does more than just limit your view. The loss of the inert gas, such as argon, between the panes removes the windows ability to insulate properly allowing heat to pass through the glass more easily potentially raising heating and cooling costs. Recommend contacting a qualified contractor to evaluate all the windows in the home to determine if other failed seals are present and repair/replace as needed. **NOTE:** We do not guarantee that all failed seals are identified; some are very difficult to detect and may be more apparent only under certain weather or lighting conditions.

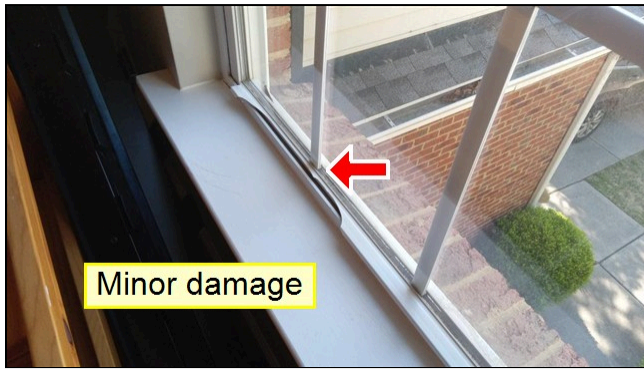
4.6 Item 3(Picture)

**4.6 (2) Comment** The trim at the bottom of the lower sash for the upstairs bedroom window on the front of the home was observed broken. This does not affect proper function or use of the window. No immediate repair is needed at this time. A qualified contractor can be contacted as needed.

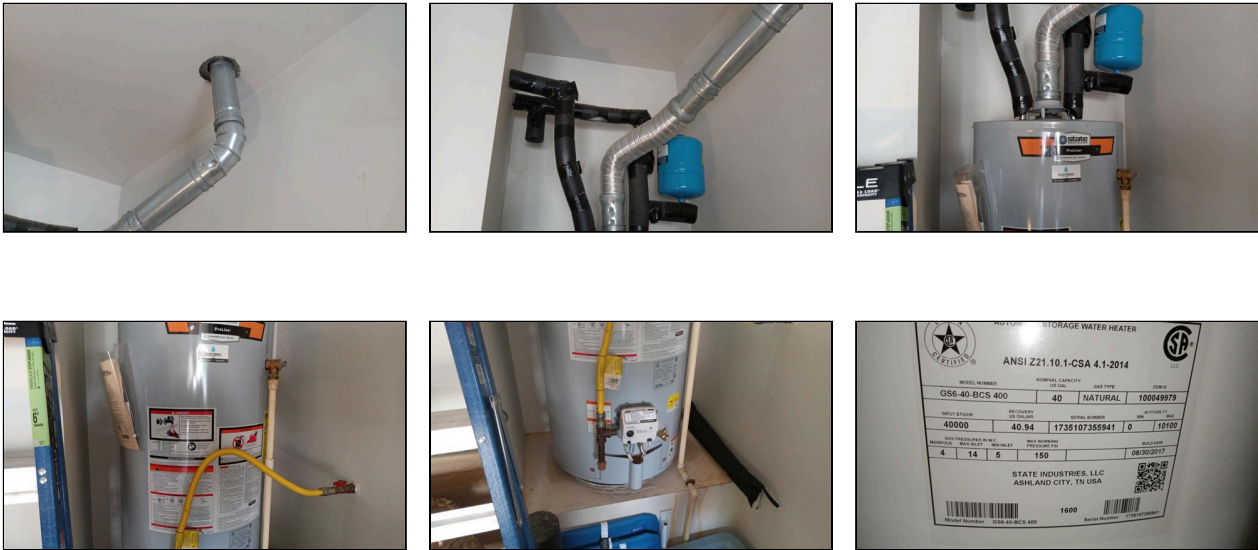
Unit was manufactured in 2017

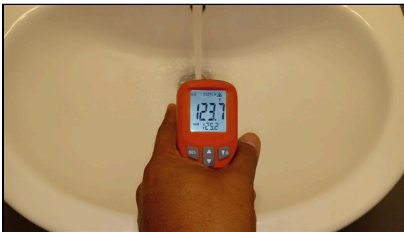
Approx hot water temperature

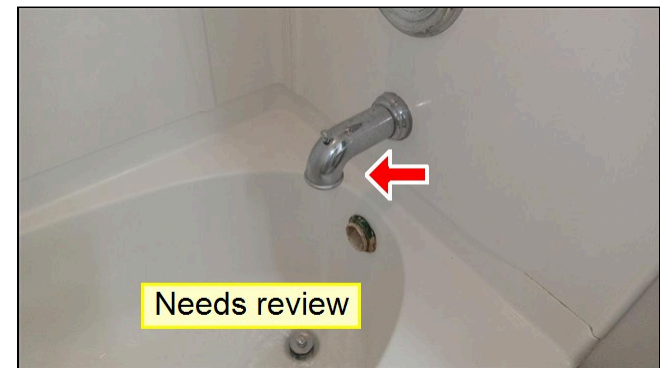
6.1 Item 3(Picture)

**6.1 (2) Repair Item** The shower diverter in the upstairs hallway bathroom did not completely seal and made a loud noise. This most commonly occurs as a result of worn components. Without repair, the shower may be loud when in use and an incomplete seal can reduce pressure at the shower head. Recommend contacting a qualified plumber for repair.

(2) **Repair Item** The shower diverter in the upstairs hallway bathroom did not completely seal and made a loud noise. This most commonly occurs as a result of worn components. Without repair, the shower may be loud when in use and an incomplete seal can reduce pressure at the shower head. Recommend contacting a qualified plumber for repair.

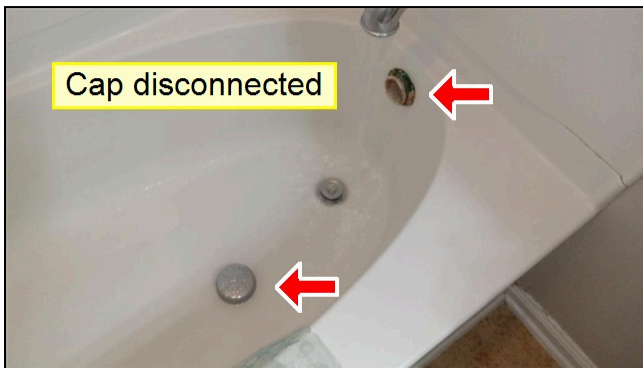
6.1 Item 4(Picture)

**6.1 (3) Repair Item** The cap has disconnected from the overflow drain in the upstairs hallway bathroom tub. The cover is designed to prevent larger objects from entering the drain, which would cause slow drainage and clogs. Recommend reattaching the cover by a qualified person.

(3) **Repair Item** The cap has disconnected from the overflow drain in the upstairs hallway bathroom tub. The cover is designed to prevent larger objects from entering the drain, which would cause slow drainage and clogs. Recommend reattaching the cover by a qualified person.

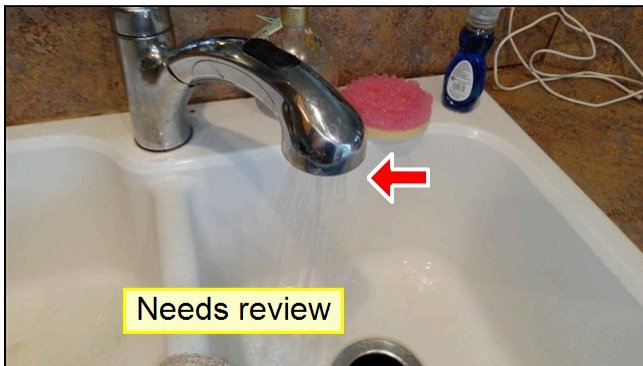
6.1 Item 5(Picture)

**6.1 (4) Repair Item** The kitchen sink fixture could not be changed from spray to stream. This commonly occurs as a result of age and use. A qualified plumber can be contacted as needed to replace the fixture.

(4) **Repair Item** The kitchen sink fixture could not be changed from spray to stream. This commonly

occurs as a result of age and use. A qualified plumber can be contacted as needed to replace the fixture.

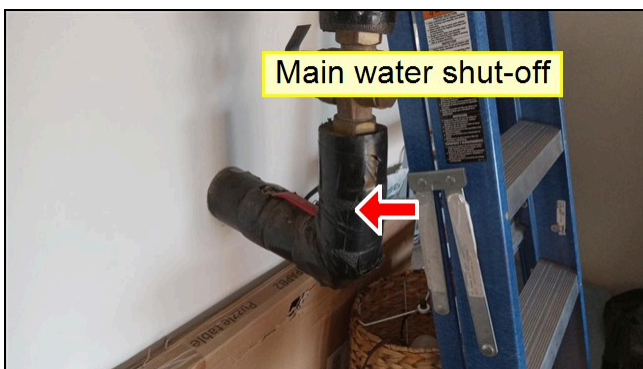
6.3 Item 1(Picture)

**6.3 Comment** Main water shut-off is located in the garage.

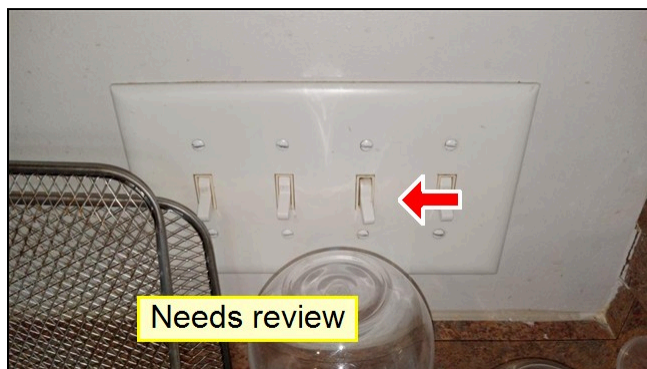
7.4 Item 1(Picture)

**7.4 (1) Repair Item** The third light switch from the left in the kitchen next to the range is slightly askew and did not operate any known fixture. During the inspection, the only fixture which a switch could not be located for was the flood lights on the rear of the home. This switch may control the flood lights. A damaged or worn switch may not function as intended and should be replaced. A qualified electrician should be contacted to replace the switch and ensure proper function of the flood lights.

(1) **Repair Item** The third light switch from the left in the kitchen next to the range is slightly askew and did not operate any known fixture. During the inspection, the only fixture which a switch could not be located for was the flood lights on the rear of the home. This switch may control the flood lights. A damaged or worn switch may not function as intended and should be replaced. A qualified electrician should be contacted to replace the switch and ensure proper function of the flood lights.

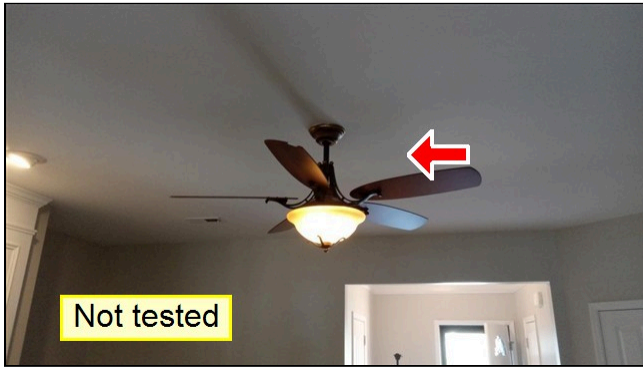
7.4 Item 2(Picture)

**7.4 (2) Comment** The batteries for the remote control to operate the ceiling fan in the living room did not have power. The fan was not tested. Recommend buyer receive confirmation of proper function.

(2) **Comment** The batteries for the remote control to operate the ceiling fan in the living room did not have power. The fan was not tested. Recommend buyer receive confirmation of proper function.

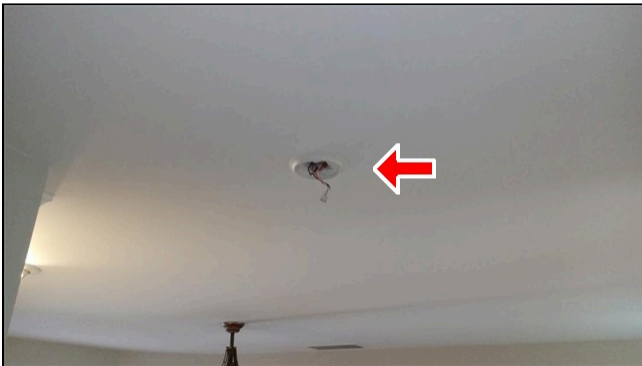
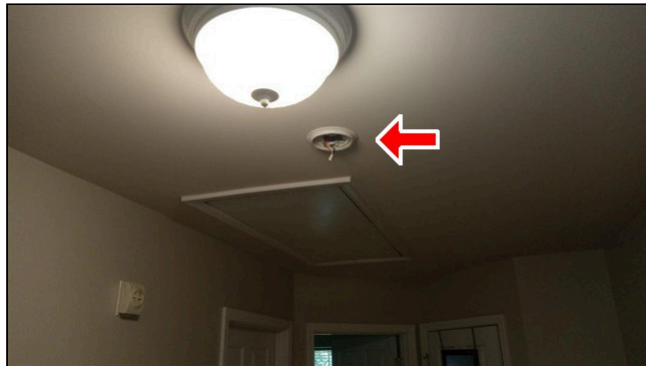
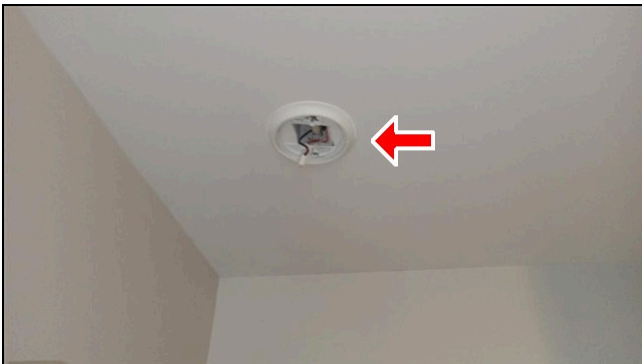
7.8 Item 1(Picture)

**7.8 (2) Repair Item** Several smoke detectors in the home have been removed. The lack of functional or adequate smoke and carbon monoxide detectors is considered a safety hazard and should be addressed. They can be purchased at many home and hardware stores and installed by a qualified person. **NOTE:** The smoke detectors at the base of the stairs and in the upstairs hallway are commonly a combination smoke and carbon monoxide detector. As a result, no carbon monoxide detectors were observed in the home. These two should be replaced with combination smoke and CO detectors.

(2) **Repair Item** Several smoke detectors in the home have been removed. The lack of functional or adequate smoke and carbon monoxide detectors is considered a safety hazard and should be addressed. They can be purchased at many home and hardware stores and installed by a qualified person. **NOTE:** The smoke detectors at the base of the stairs and in the upstairs hallway are commonly a combination smoke and carbon monoxide detector. As a result, no carbon monoxide detectors were observed in the home. These two should be replaced with combination smoke and CO detectors.

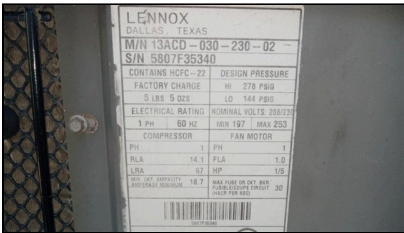
Unit was manufactured in 2007

**8.0 Investigate Further** The heating and air conditioning unit appears to have been manufactured in 2007 and is approximately 19 years old. Although it produced AC when tested, concerns could be present which were not visible during the home inspection. A licensed HVAC technician should be contacted for a full evaluation of the internal components including the heat exchanger and freon levels to reduce the potential for costly repairs upon move-in. **NOTE:** A cracked heat exchanger can release carbon monoxide into the home creating unsafe conditions. **NOTE:** Service records can also be provided if a recent evaluation or repair

**Investigate Further** The heating and air conditioning unit appears to have been manufactured in 2007 and is approximately 19 years old. Although it produced AC when tested, concerns could be present which were not visible during the home inspection. A licensed HVAC technician should be contacted for a full evaluation of the internal components including the heat exchanger and freon levels to reduce the potential for costly repairs upon move-in. **NOTE:** A cracked heat exchanger can release carbon monoxide into the home creating unsafe conditions. **NOTE:** Service records can also be provided if a recent evaluation or repair has been performed.

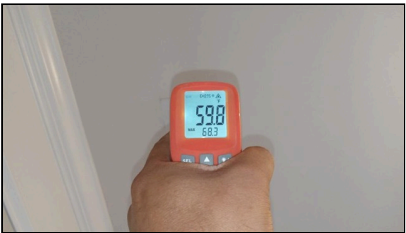
Approx AC temperature

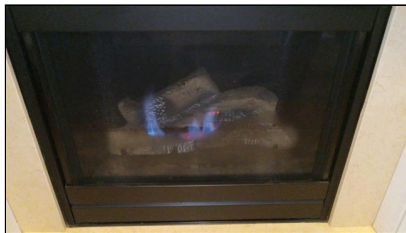
Gas logs operated properly

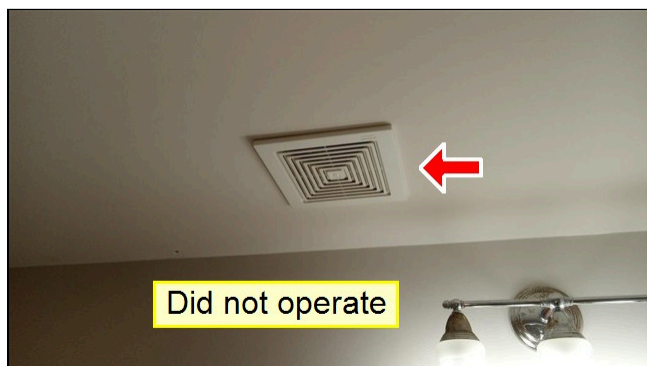
9.4 Item 1(Picture)

**9.4 (2) Repair Item** The exhaust vents in both upstairs bathrooms were inoperable on the day of inspection. An exhaust fan removes undesired moisture from the home produced by the shower to the exterior. Without a properly working fan, moisture stains on the walls and ceiling are possible. Recommend contacting a qualified contractor to repair or replace as needed to ensure proper function.

(2) **Repair Item** The exhaust vents in both upstairs bathrooms were inoperable on the day of inspection. An exhaust fan removes undesired moisture from the home produced by the shower to the exterior. Without a properly working fan, moisture stains on the walls and ceiling are possible. Recommend contacting a qualified contractor to repair or replace as needed to ensure proper function.

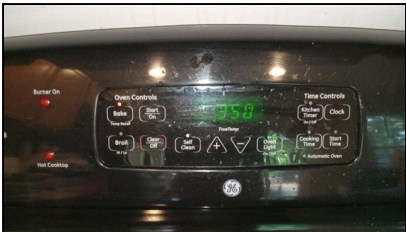
Oven heated to 350°
