A-1 HOUSE INSPECTORS, INC.

## A-1 RESIDENTIAL REPORT

945 Mere Oak Dr  
Raleigh, NC 27615

06/01/2026

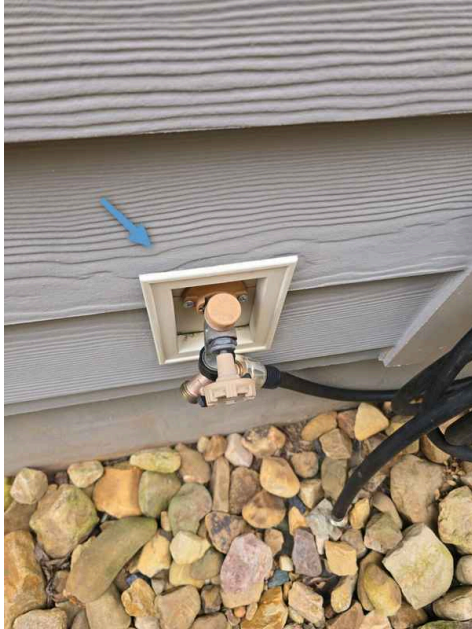
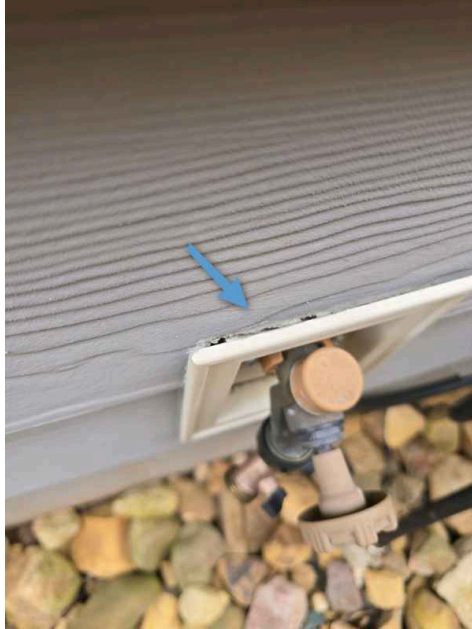
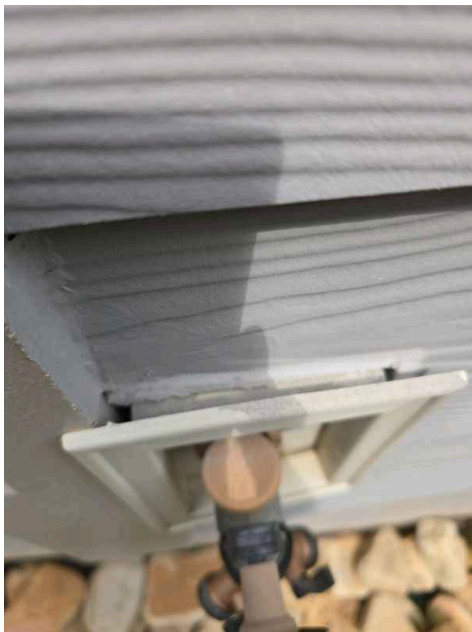
**Note:** Voids around the decorative escutcheons. There is typically flashing and flange that helps deter water intrusion behind the siding, but recommend sealing around the escutcheons as well.

Contact a qualified professional.

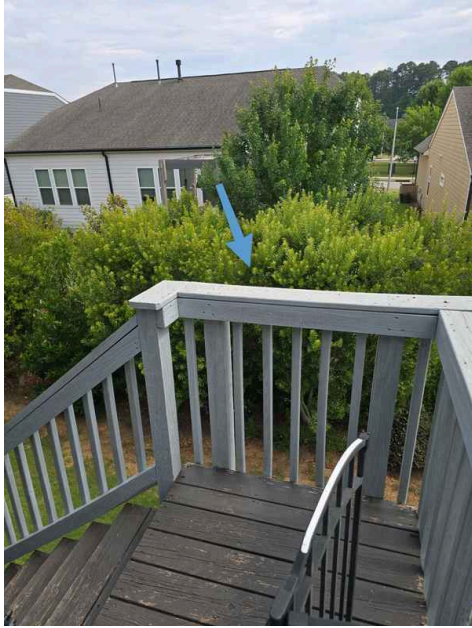
Deteriorated Wood, Cracked/Weathered Boards, Paint/Stain Worn, Loose Railings, Separations, Lifted Nails, Boards cut short

The deck/Porch/Pergola/Railings exhibits the referenced issues which compromise the integrity and/or safety of the structure. Recommend a full evaluation by a Licensed General Contractor to determine the full scope of repairs needed, and perform them as necessary.

Contact a qualified licensed general contractor

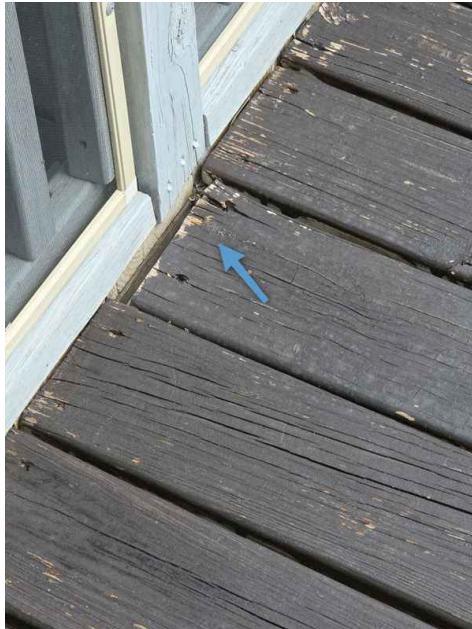
Worn paint/stain

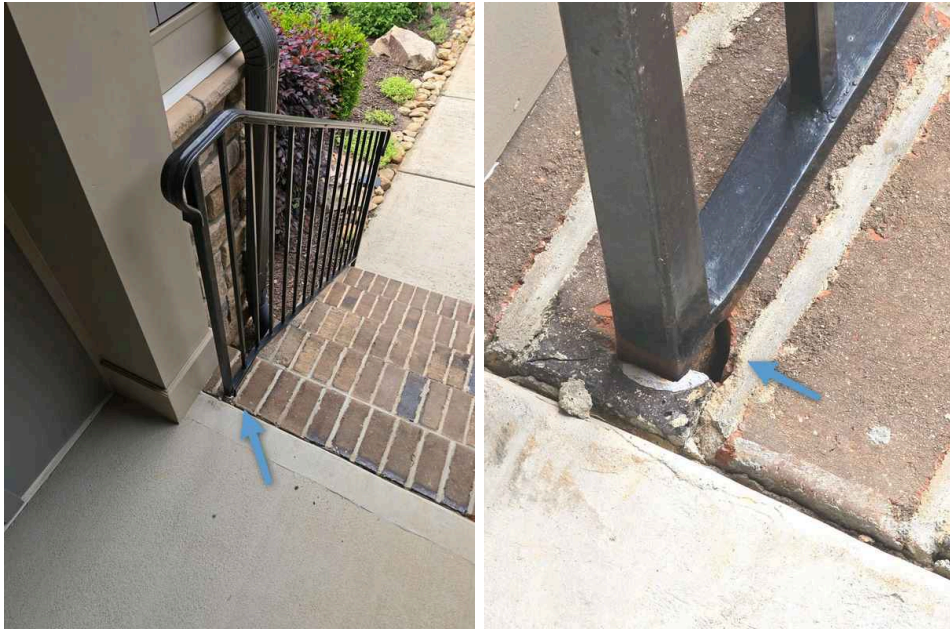
#### Moderately Loose

The railings and/or balusters at the referenced locations exhibit the listed issues. This can affect the integrity of the railing system leading to failure and/or injury. Recommend repair by a Licensed Contractor.

**Note:** Mortar is missing where the vertical support meets the brick. The mortar helps hold the post in place. Currently the post is slightly loose.

Contact a qualified licensed general contractor

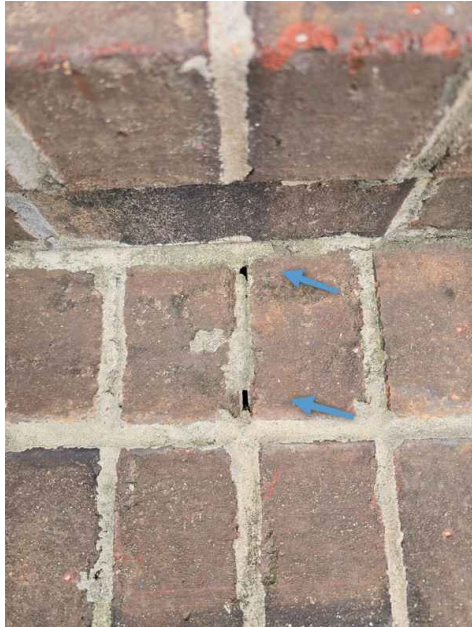
Voids in the mortar are present on the brick stairs at the front entrance door. Re-point mortar to prevent water penetration which will worsen cracking.

Contact a qualified professional.

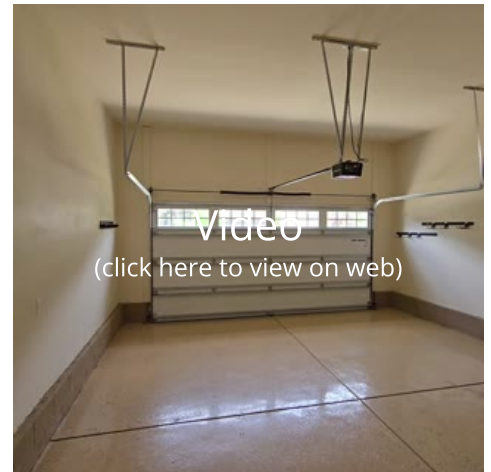
The garage door exhibits moderate binding/squeaking in the tracks during operation. This can indicate the need for adjustment/lubrication. Have a garage door tech evaluate and repair as needed.

Contact a qualified professional.

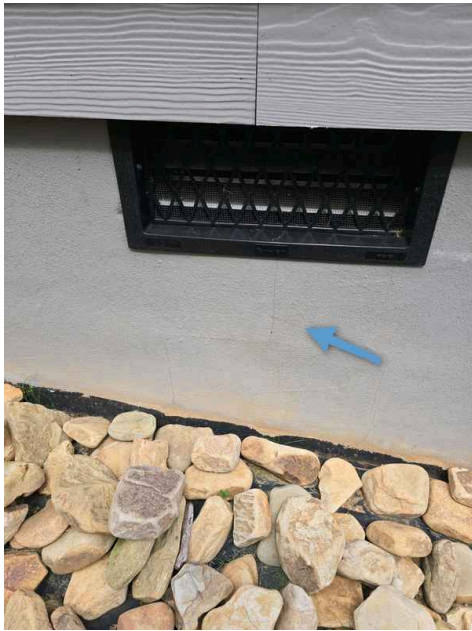
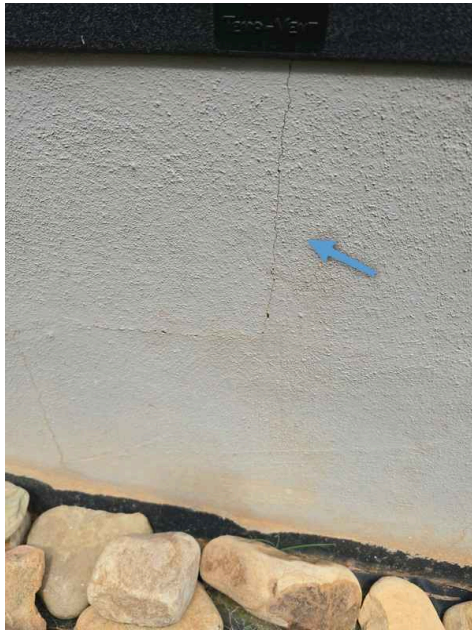
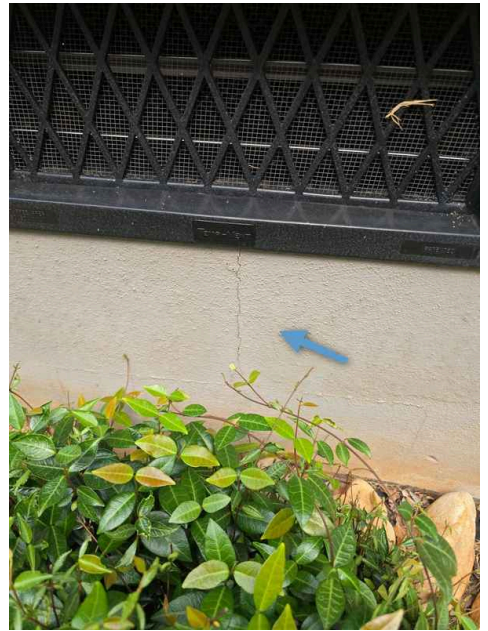
**PARGING CRACKS**

MAINLY UNDER RANDOM FOUNDATION VENTS

Minor to moderate cracks are present in the decorative parging layer of the foundation blocks at random areas. No signs of cracking visible in the actual foundation. This is common as the parging layer shrinks as it cures, and typically only cosmetic in nature. Recommend sealing and subsequent observation for changes in displacement.

Contact a qualified professional.

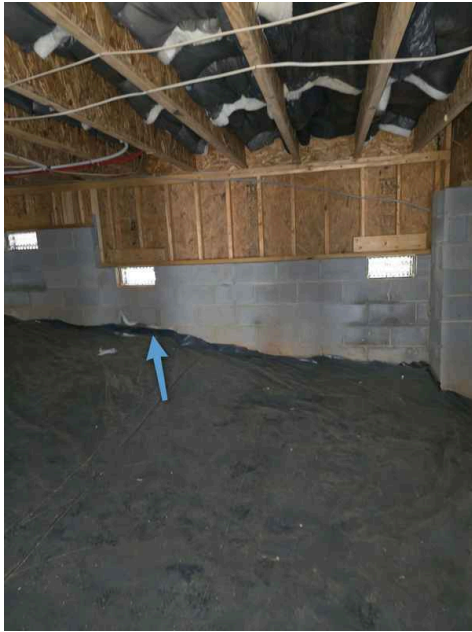
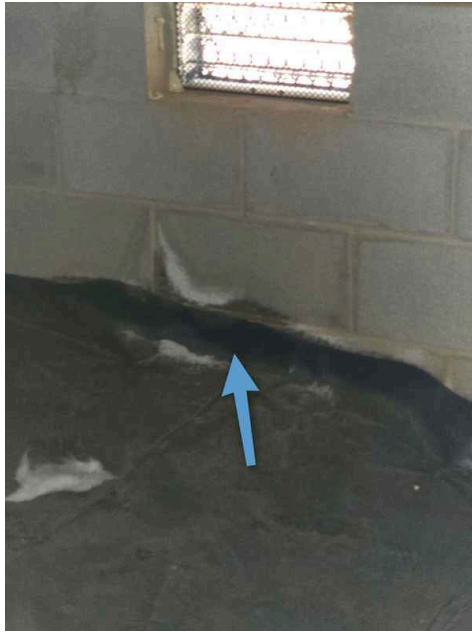
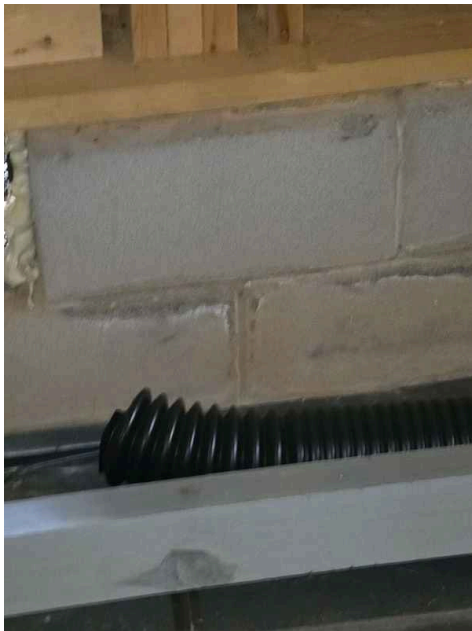
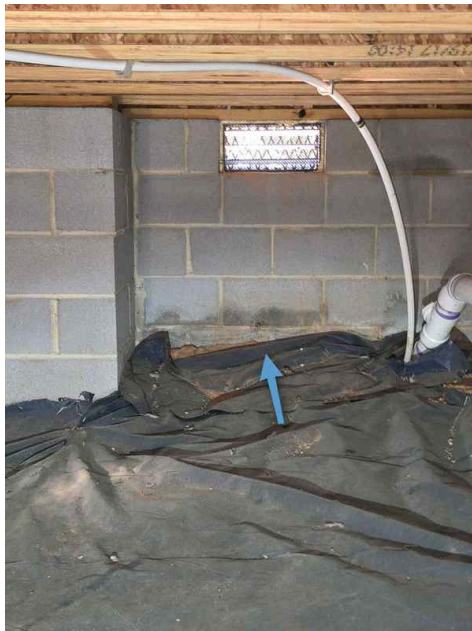
**EFFLORESCENCE FOUNDATION WALLS**

Efflorescence is present at one or more areas around the foundation perimeter. This is indicative of water intrusion as the efflorescence is mineral deposits pulled from the water as it passes through the masonry/concrete. Excessive moisture can lead to conditions favorable to fungal growth and wood destroying insects as well as potentially damage foundation components over time. Have a waterproofing contractor repair intrusion as needed.

Contact a qualified waterproofing contractor

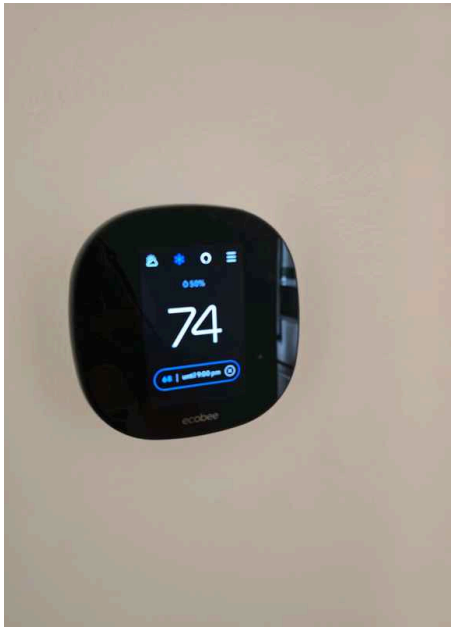
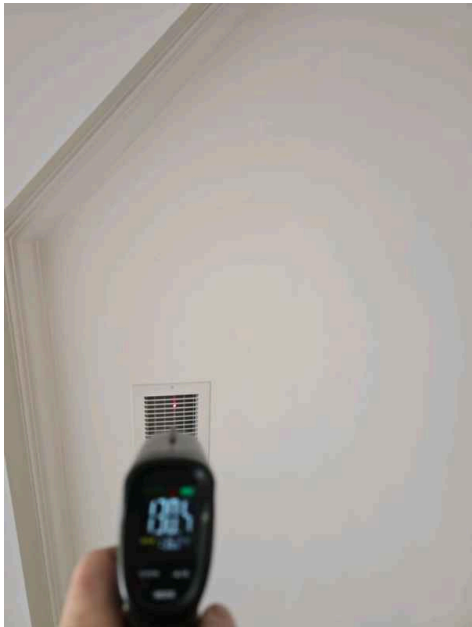
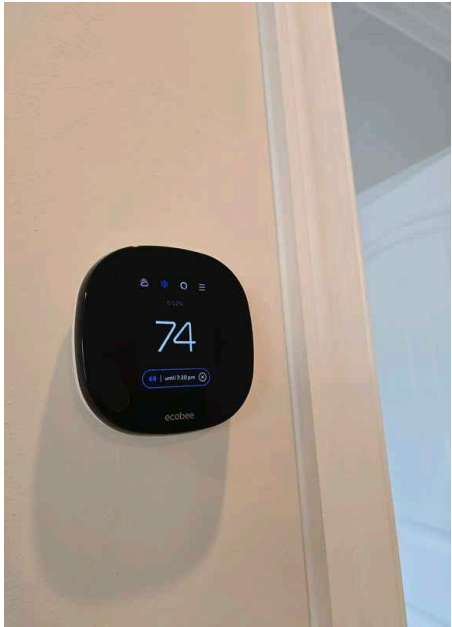
### Equipment: Temperature Differentials

1st Floor

2nd Floor

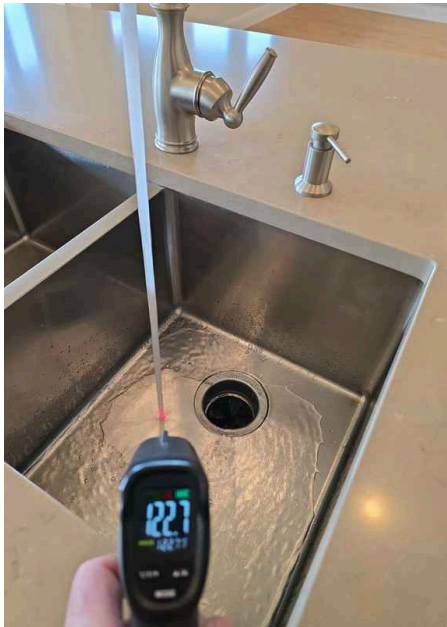
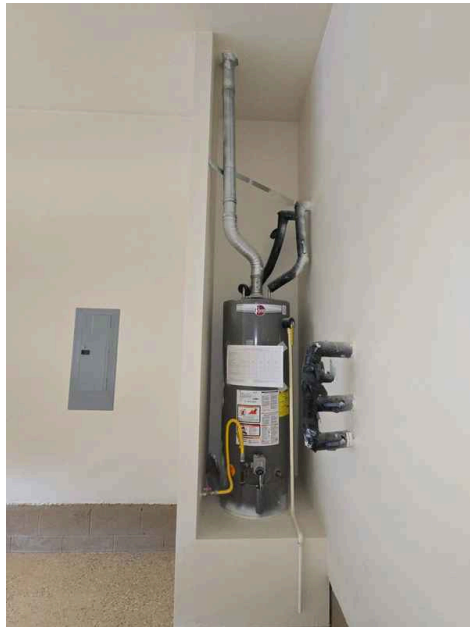
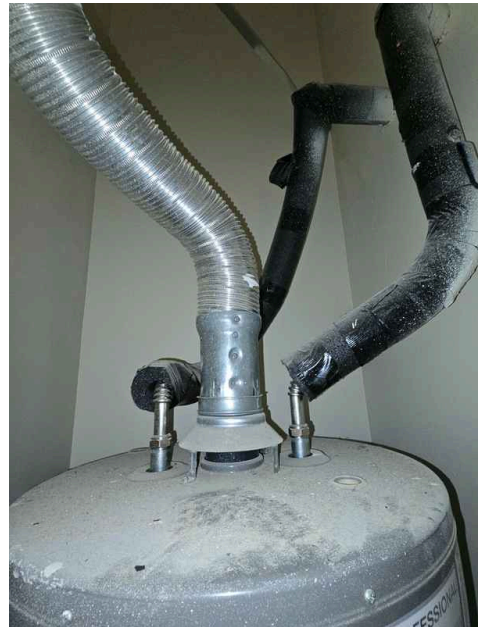
### Hot Water Systems, Controls, Flues & Vents: Water Heater Pictures

Garage, Expansion Tank Present, Overflow Pipe Present

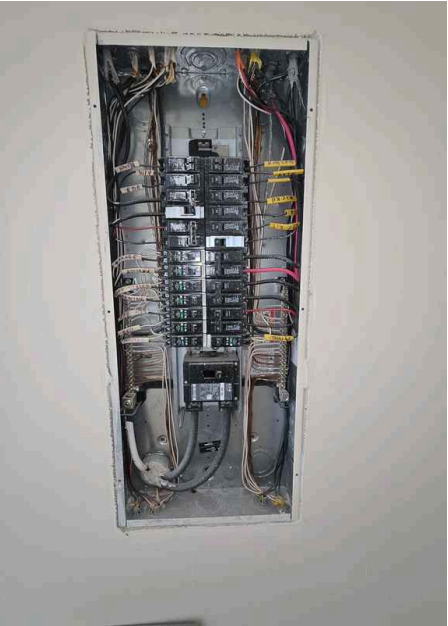
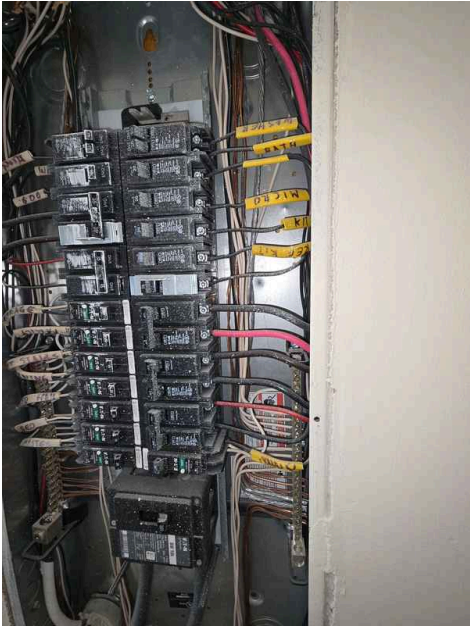
**Main & Subpanels, Service & Grounding, Main Overcurrent Device: Electric Panel Pictures**

**Main & Subpanels, Service & Grounding, Main Overcurrent Device: Electric Main Shutoff Location**  
Garage

**Main & Subpanels, Service & Grounding, Main Overcurrent Device: Electric Panel Locations**  
Garage

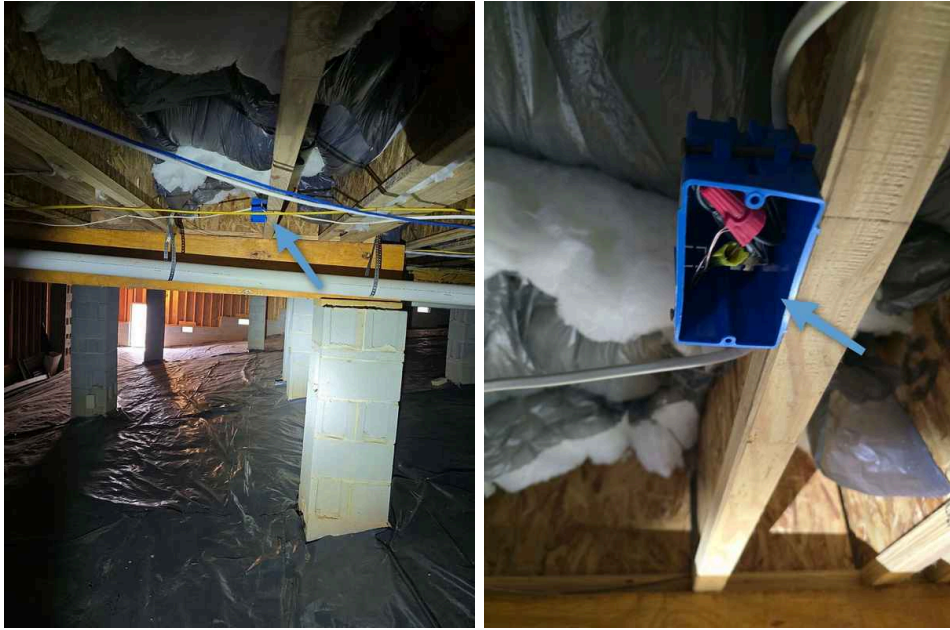
**JUNCTION BOX COVER PLATE MISSING**

Electrical cover plates are missing at unused locations in the noted rooms. This is a safety/shock/fire hazard. Install covers.

Contact a qualified professional.
