## HOME INSPECTION REPORT

307 Wax Myrtle Ct  
Cary, NC 27513

Angel Grace Mitchem  
05/12/2026

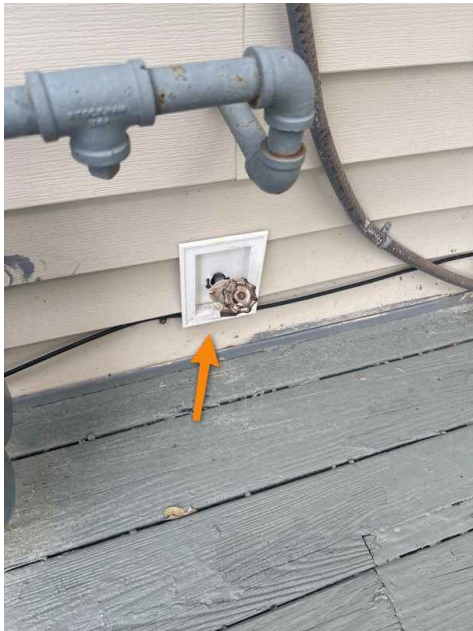
Rear Exterior

The faucet is loose which could result in moisture damage. Recommend securing the faucet by a qualified contractor.

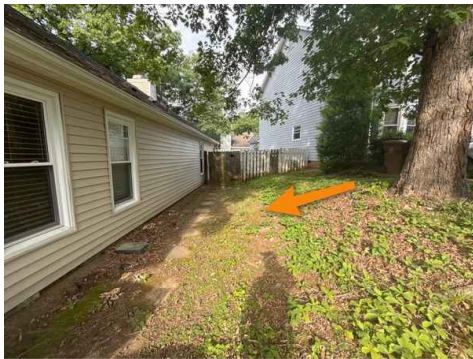
Bathroom Right Exterior

Grading slopes towards the structure and could result in moisture issues. Recommend repair of the grading so water is properly diverted away from the structure. The grade should slope at least 6 inches for the first 10 feet away from the structure.

Contact a qualified professional.

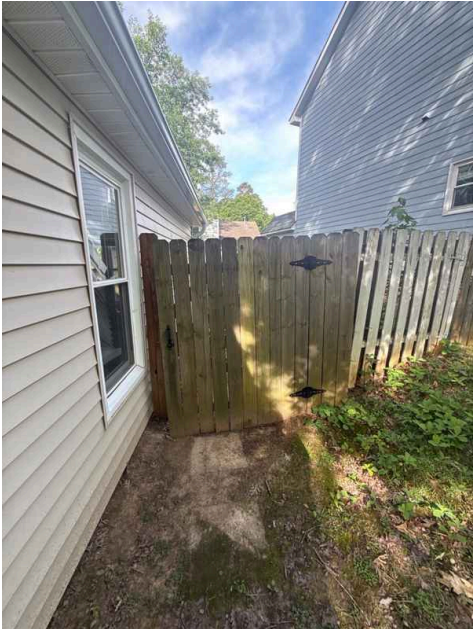
Rear Right

The gate does not close properly during inspection. This may prevent secure closure of the fence and could affect property security and safety. Have a fence contractor evaluate the gate mechanism, hinges, and latch system to determine the cause and necessary repairs.

Contact a qualified professional.

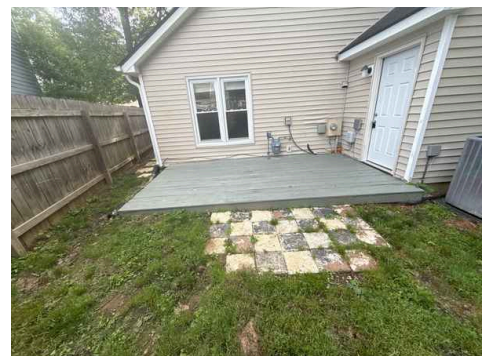
**Decks****LIMITED ACCESSIBILITY - DECK HEIGHT**

The deck access was not readily accessible and limited to viewing from the perimeter due to the height being too low. It is recommended that the deck be inspected when access is permissible.

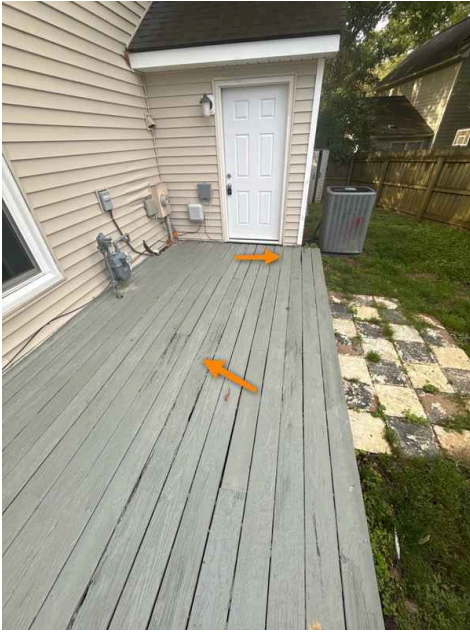
Rear Exterior

**4.1.1 Decks****DAMAGED DECKING**

Recommend repair of the damaged decking boards by a qualified contractor to help prevent a trip hazard. Any hidden damage to the stringers/joists should also be evaluated and repaired.

Contact a qualified professional.

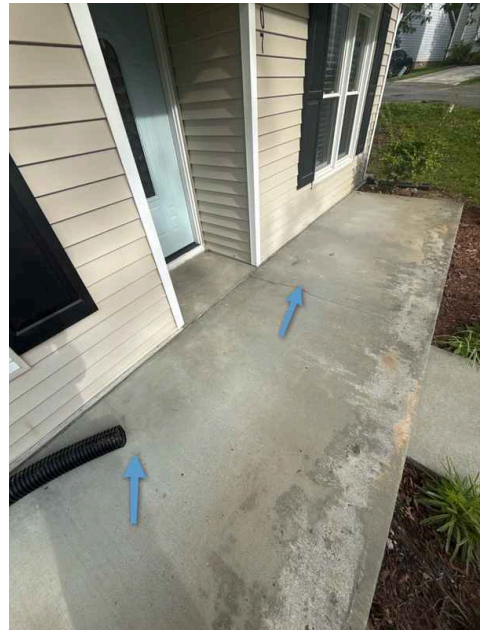
Living Room Front Exterior

**PORCH - CRACKS**

Cracks observed and should be sealed with an appropriate sealant to help prevent further damage.

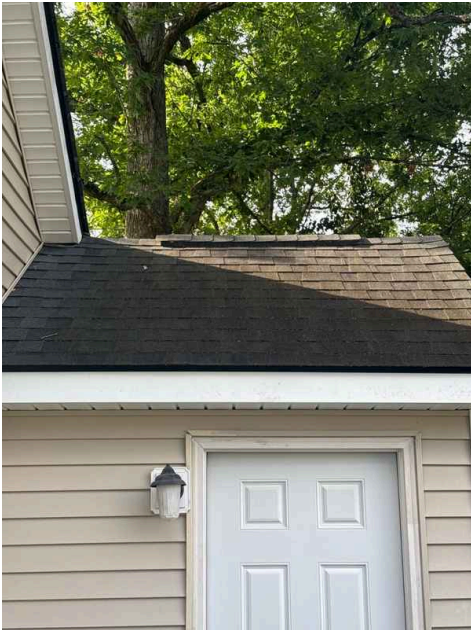
Rear Roof (moss)

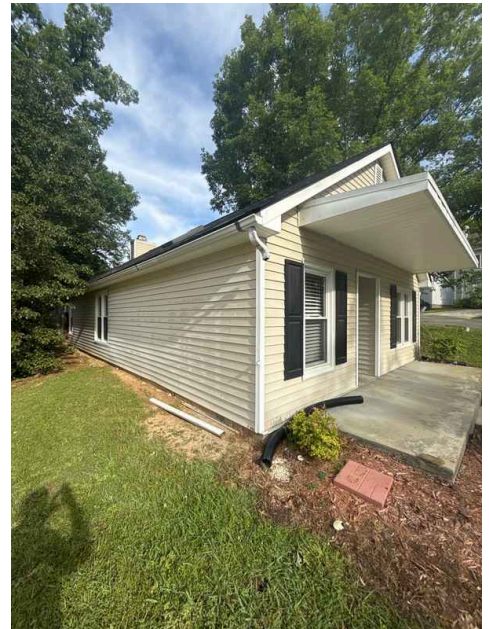
Front Left

**DOWNSPOUT/GUTTER - DAMAGED**

Gutter/downspouts were damaged. Recommend a qualified contractor repair to prevent moisture damage.

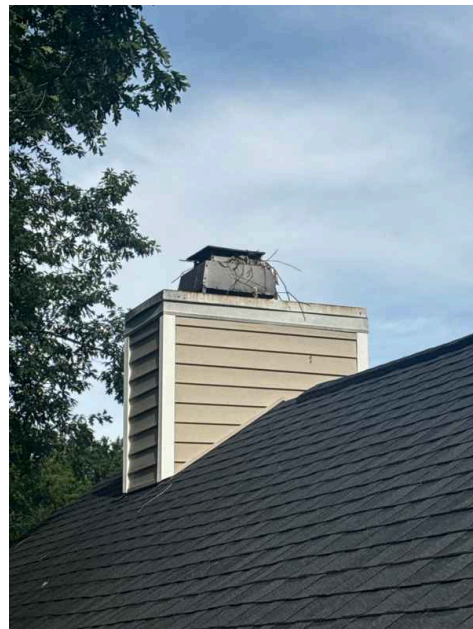
Debris was observed accumulating in the chimney cap during inspection. This can restrict proper ventilation and airflow, potentially causing draft issues or allowing water and animals to enter the chimney system. The chimney cap should be cleaned and inspected by a chimney professional to ensure it functions properly.

Contact a qualified professional.

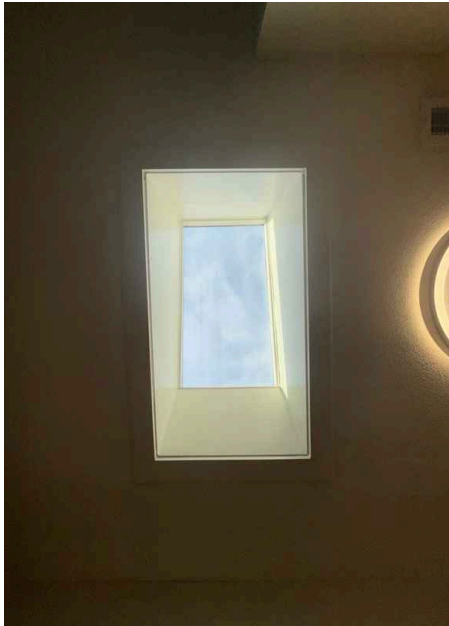
### Skylight

Skylights, especially older ones, are prone to leaking, especially in heavy rain/snow storms. Although leaks not observed on the day of inspection, recommend routine monitoring of skylights for leaks and/or stains and consulting with a qualified contractor if a leak is observed or if the client would like more information.

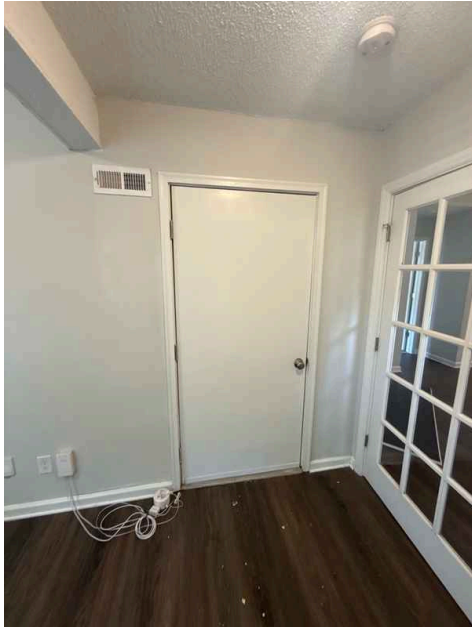
Utility Room

Door sticks and can be difficult to open and close or may cause damage. Recommend repair by a general repair specialist.

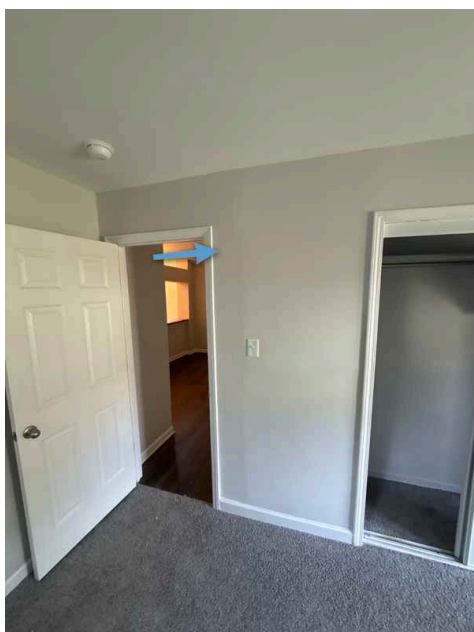
Master Bedroom

**CRACKS - MONITOR**

Cracks noted in walls/ceiling. Some movement is not unusual in a home of this age. Recommend monitoring the cracks and consult with a qualified contractor for further evaluation if the cracks continue to grow or if the client would like more information about this condition.

Recommend monitoring.

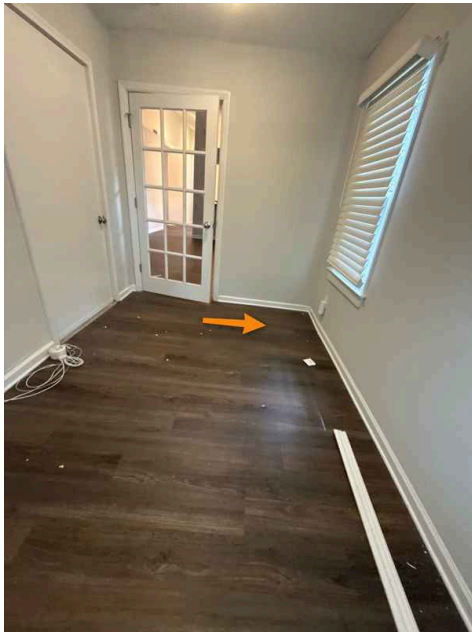
Office

The floor has uneven areas. The cause of this condition is sometimes a result of home settlement, moisture, construction methods, etc; however, the cause of this specific condition could not be determined at the time of inspection. It is recommended that a licensed general contractor or structural engineer should be consulted for a complete evaluation of the entire area and repair as needed to correct or reduce progression of uneven areas. See floor structure and foundation sections for related comments and concerns.

Contact a qualified structural engineer.

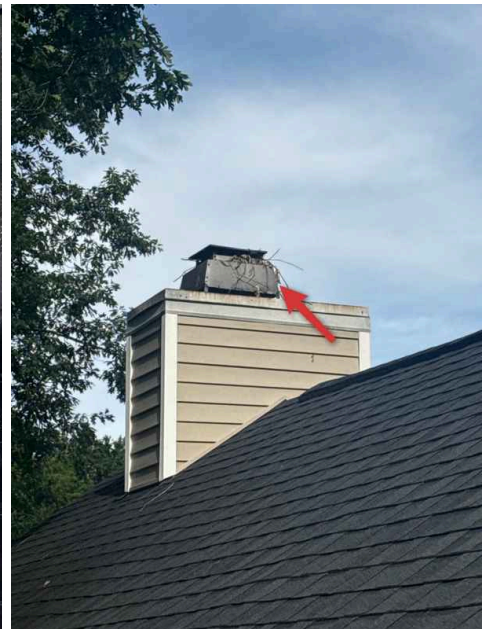
Front Bedroom

**DEBRIS AND ANIMAL INTRUSION IN FIREPLACE**

Debris and evidence of animal intrusion were observed in the fireplace during inspection. This indicates the chimney or fireplace opening may lack proper screening or closure, allowing wildlife access. Animal nesting materials and droppings can create fire hazards, block airflow, and pose health risks. A chimney professional should inspect the entire system, remove debris and nesting materials, and install or repair chimney caps and screens to prevent future intrusion.

Contact a qualified professional.

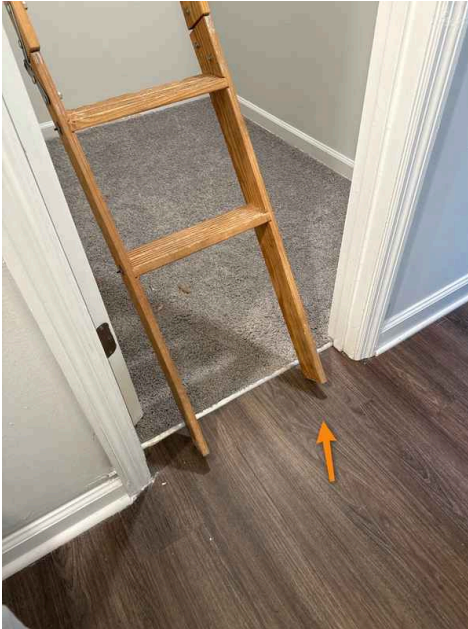
Master Closet

The stair legs are not flush on the floor. Recommend that the stairs be properly installed per the manufacturers instructions by a qualified contractor to reduce the risk of a fall.

Contact a qualified professional.

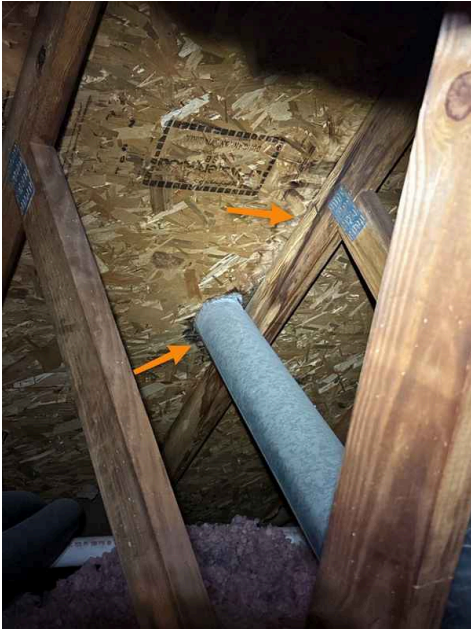
Right Attic

#### **STAINS-NOT TESTED**

Stains were observed at areas of the attic framing that were inaccessible and were not tested at the time of inspection. Therefore the inspector could not determine if the stains were currently active. This is a water penetration and damage concern. Recommend having stains tested and evaluated by a qualified contractor and repairs made as necessary.

Contact a qualified professional.

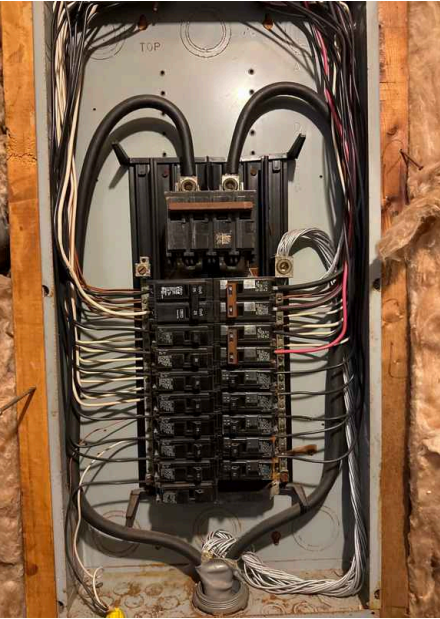
Main Panel: Photo  
Interior of Main Panel

Main Panel: Electrical Service  
Conductors Material  
Aluminum, Bus Bar

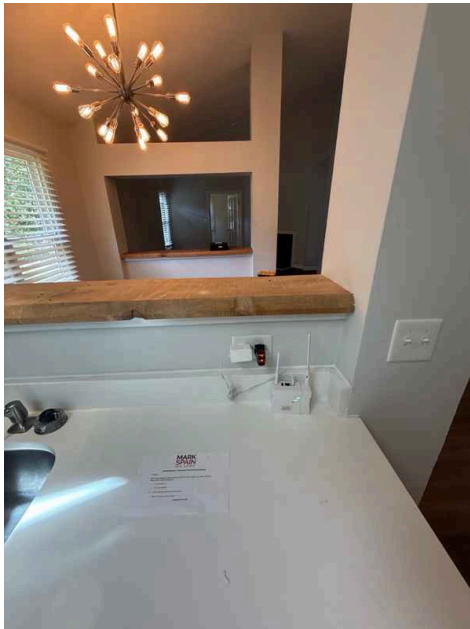
Kitchen

**LOOSE RECEPTACLE**

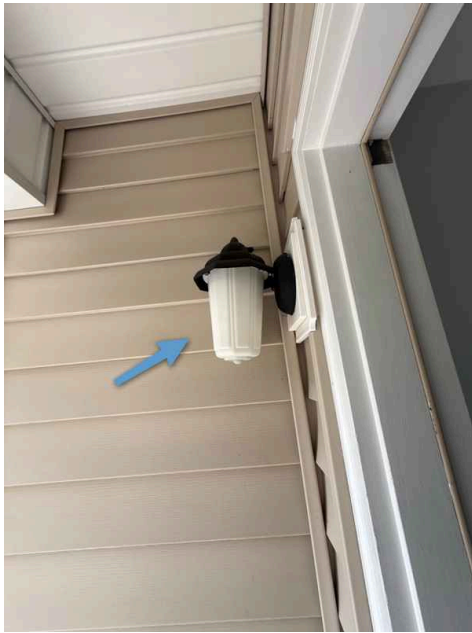
Front Exterior

Light bulb did not work. Recommend replacing the non working bulbs to verify the fixture functions as intended. If the issue is not resolved then recommend further evaluation by a qualified contractor.

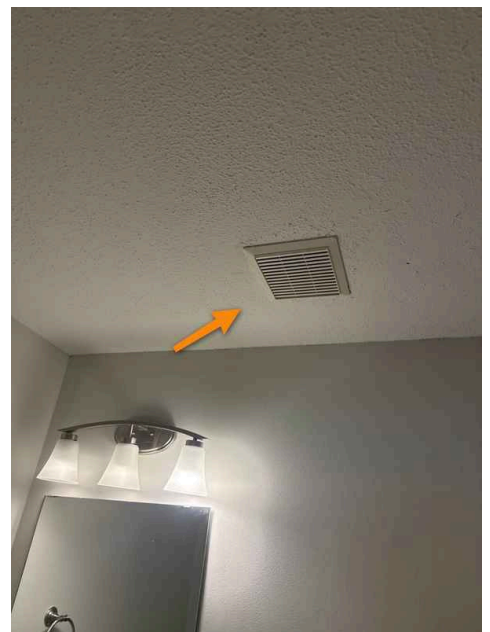
Hallway Bathroom

The exhaust fan did not work and recommend repair by a qualified contractor. Inadequate ventilation can lead to moisture issues.

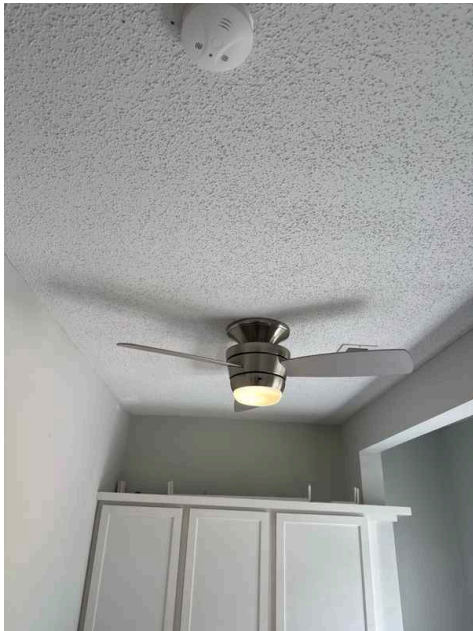
Front Bedroom

**CEILING FAN REMOTE CONTROL MISSING**

The remote control for the ceiling fan was not located during inspection. Obtain a replacement remote from the manufacturer or a compatible universal remote to restore full functionality of the fan's speed and lighting controls.

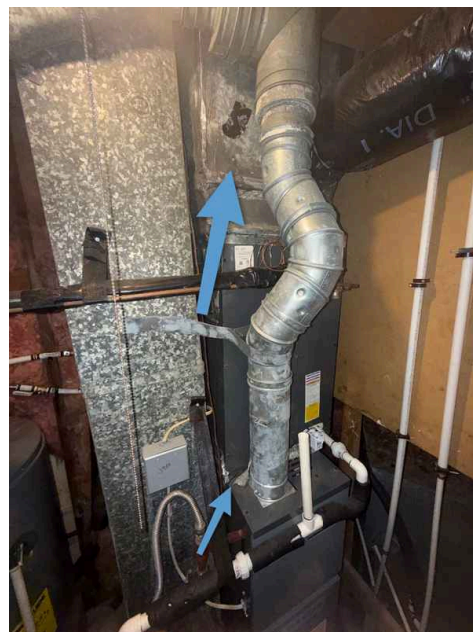
Utility Room

#### CONDITIONED AIR LEAK

Air leak observed in the air handler. Recommend properly sealing the systems and ducts by a qualified contractor to help prevent the loss of efficiency.

Contact a qualified heating and cooling contractor

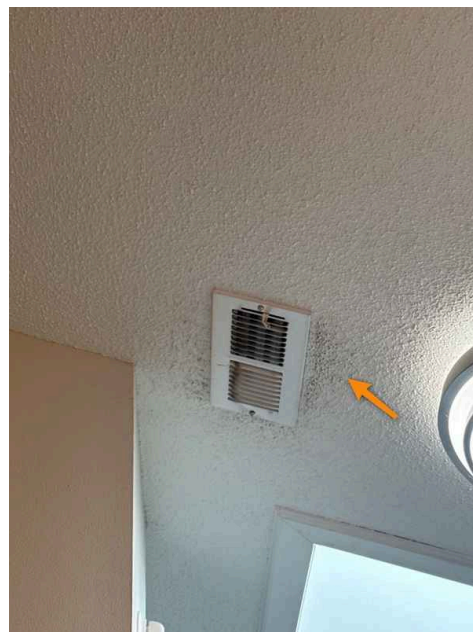
Kitchen

Fungal growth observed at the registers. Although the interior of the ducts are not inspected, there could be fungal growth inside the ducts. Recommend further evaluation of the ducts by a qualified contractor. If the client has any health related concerns, then consult with an industrial hygienist.

Contact a qualified professional.

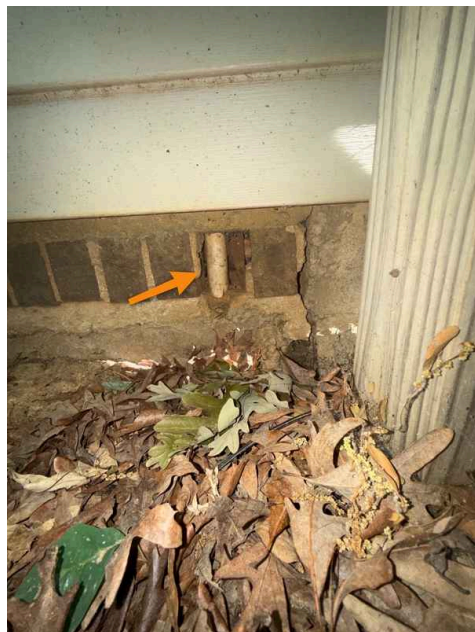
Rear Left

13.3.2 Foundation

Contact a qualified structural engineer.
