# Inspection Report

**Property Address:**  
208 Highlands Lake Drive  
Cary NC 27518

**Steve Smallman Property Inspections  
2213 Myron Drive  
Raleigh, NC 27607  
(919) 602-2390**

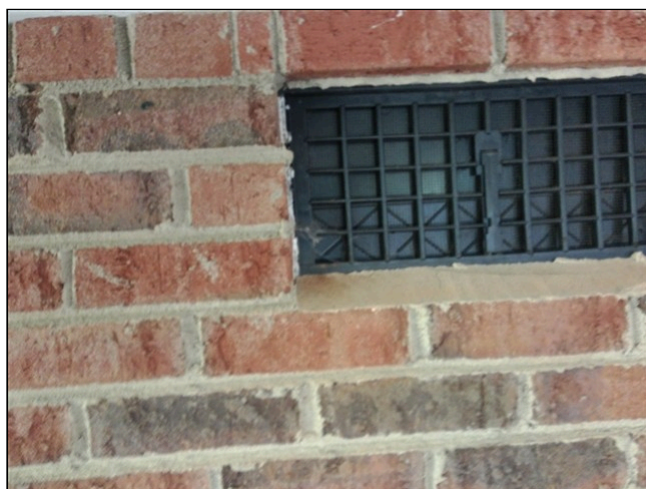
Item 2 - 1

**2 Repair Item** The screening material is torn or missing at several of the foundation vents. Screening should be replaced to prevent rodents, reptiles, and other small animals from entering the crawl space. Work should be performed by a qualified technician.

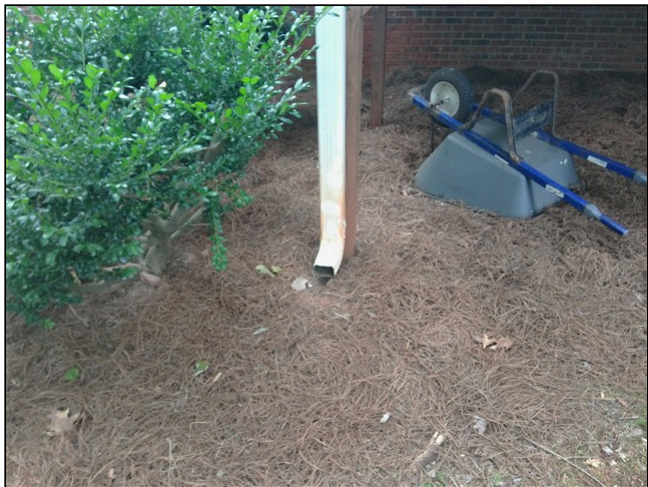
Item 3 - 1

**3 Repair Item** One or more downspouts deposit runoff directly outside the foundation. This is conducive to water penetration and erosion. Location(s): rear right corner of the sunroom. Extend downspouts as needed (short lengths of drain pipe are typical method). Repairs should be made by a qualified technician.

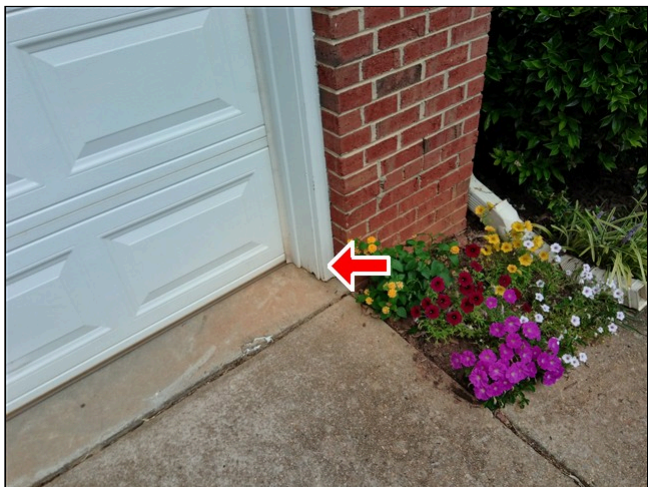
Item 4 - 1

**Repair Item** One or more pieces of siding and/or trim are damaged or deteriorated to the degree that repair or replacement is needed. Damaged cladding materials should be repaired to prevent further damage and possible water penetration to the wall assembly behind the cladding. Repairs should be performed by a qualified contractor. Location(s): garage door jamb / trim at the lower corners of the garage door and trim / exterior cladding at the front right box bay windows.

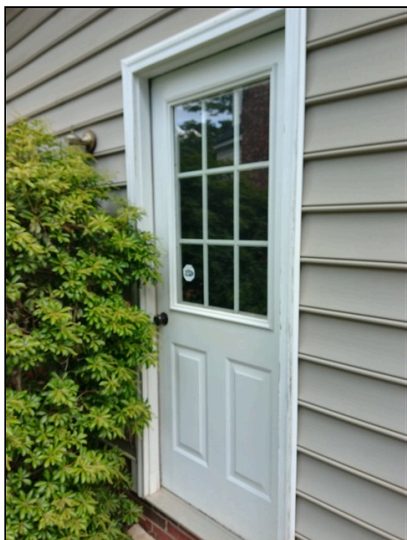
Item 5 - 1

**5 Repair item** Paint has peeled to the extent that bare wood or composition cladding materials are exposed to potential water damage. Exposed surfaces must be kept painted and caulked to prevent water penetration and damage. Qualified painter should renew paint/caulk as needed. Locations: garage pedestrian exterior door, first floor window at the center of the right exterior, and rear exterior window above the deck floor.

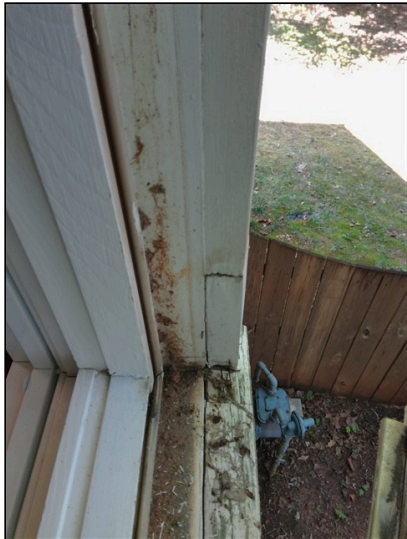
Item 6 - 1

**6 Repair Item** One or more exterior wood components (jambs, casings, sash, etc.) are deteriorated at the following window(s): front right window in the primary bedroom. Damaged window components should be replaced to prevent further damage and possible water penetration to the wall assembly around the windows. Repairs should be performed by a qualified contractor.

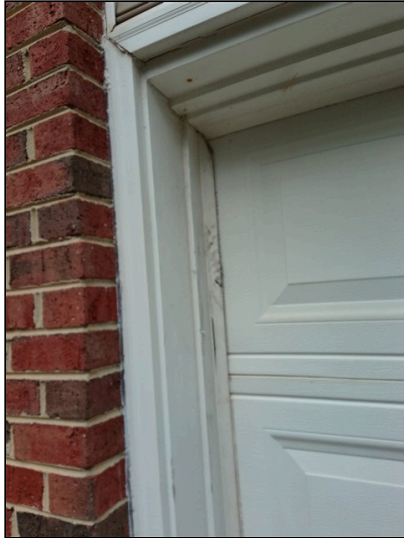
Item 7 - 1

**7 Repair Item** A portion of the weather stripping at the garage door is deteriorated. Repairs should be performed to prevent water penetration into the garage. Repairs should be performed by a qualified contractor.

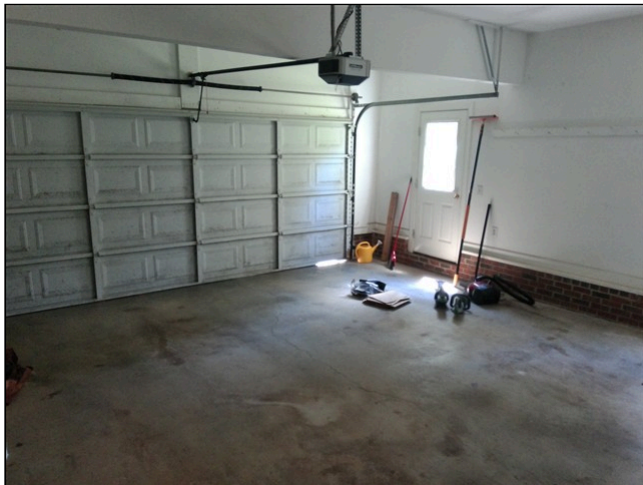
Item 8 - 1

- 8 Repair item** There is a gap between lower corner of the garage door and the concrete floor in the garage. We recommend weather stripping is added to eliminate this gap. Repairs are recommended by a qualified overhead door contractor.

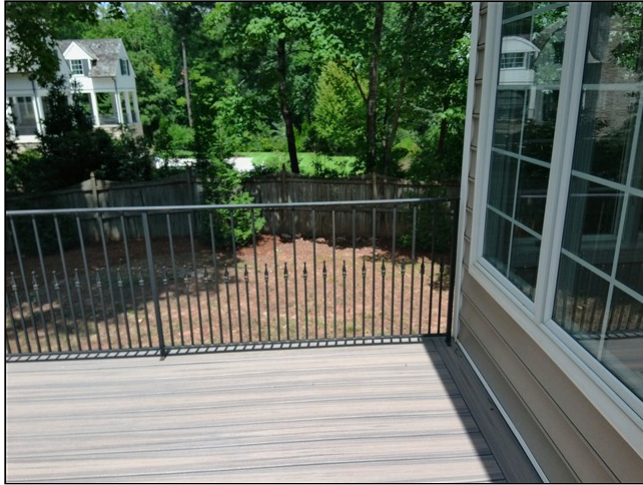
Item 9 - 1

- 9 Repair item** The deck safety railing is loose where it meets the rear left corner of the sunroom. Loose railings do not provide intended level of fall protection, a safety hazard. Repairs should be performed by a qualified contractor.

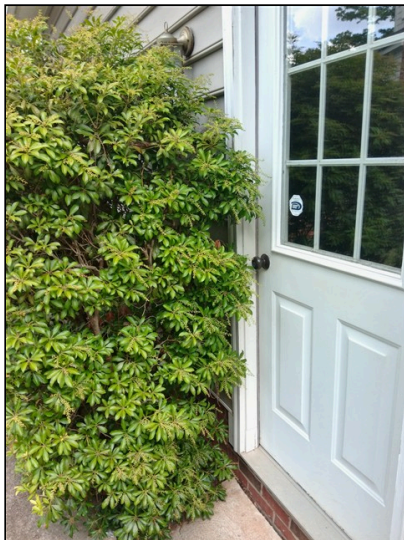
Item 10 - 1

**10 Repair Item** Vegetation (bushes, etc.) is in contact with the exterior of the house. This condition is conducive to decay and termite infestation, and limits inspection. Vegetation needs to be trimmed back away from the house.

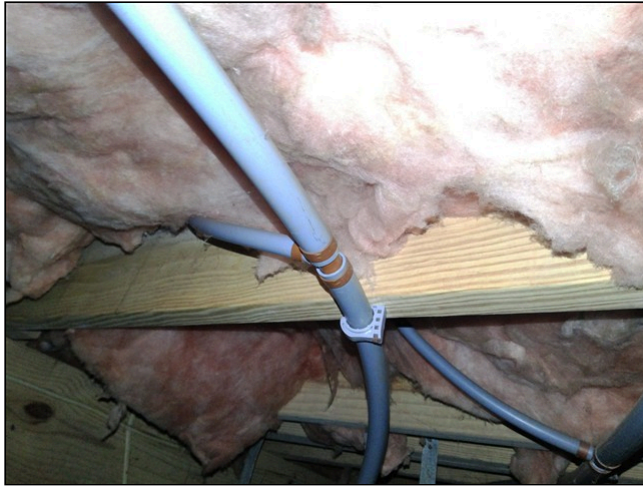
Item 11 - 1

**11 Investigate further** Polybutylene plastic water supply pipes are installed in this house. A higher rate of failure resulting in leakage has been reported with this type of pipe than with most other types of water supply pipe, but no active leaks were noted at the time of inspection. There has been no recall of this type of pipe, and it is found in thousands of houses built in this area in the 1980's and early 1990's. Many of the failures resulted from plastic pipe fittings used in earlier generations of this type of pipe. Later use of metal fittings significantly reduced the incidence of failures, but the pipe itself is thought to be more susceptible to failure than other types of water supply pipe. We cannot inspect every fitting but the fittings we observed in this installation are metal. Note that class action settlements have been reached in regard to failure of this type of pipe, but they have expired and no funds remain to reimburse homeowners. For additional information about this type of pipe visit the

website(s) listed below, and/or contact a licensed plumbing contractor. <http://www.polybutylene.com>

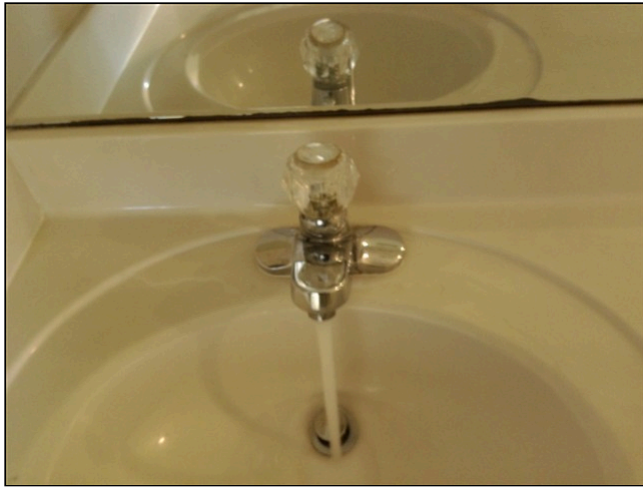
Item 12 - 1

**12 Repair Item** Repair is needed to a plumbing valve that leaks around its handle when the water is turned on (this is known as a faucet stem leak). Location(s): left sink in the second floor bathroom and left sink in the primary bathroom. All leaks require prompt repair to prevent damage and wasted water. Repairs should be performed by a qualified plumbing contractor.

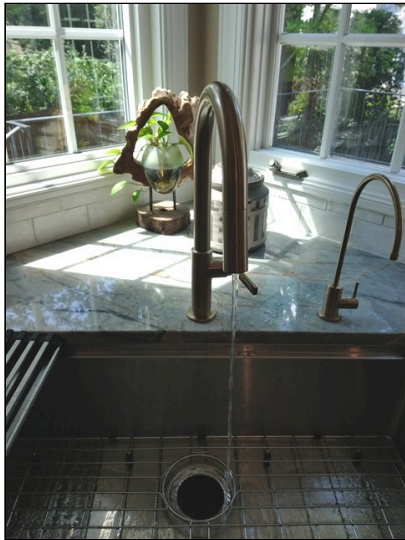
Item 13 - 1

**13 Repair item** The kitchen sink faucet is loose where it mounts to the sink or countertop. It must be secure to prevent leakage. Repairs should be performed by a qualified contractor.

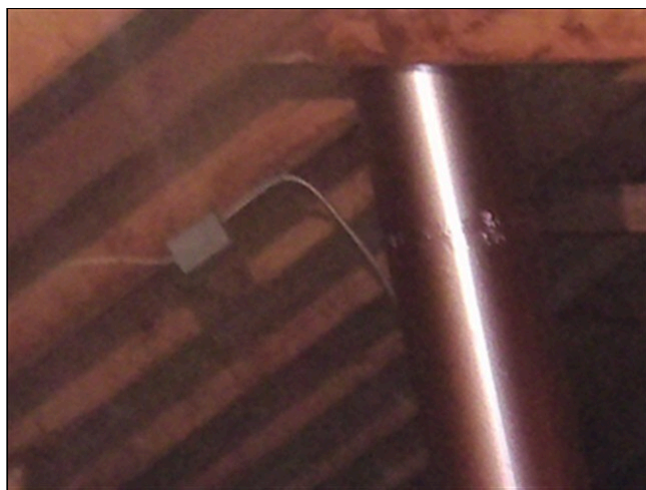
Item 15 - 1

**15 Repair Item** Apparently abandoned or unused high-voltage electrical cables are not properly terminated with wire nuts and enclosed in covered junction boxes, a potential shock hazard. As a general rule, unless both ends of abandoned cables can be seen in the same space (to assure that they are disconnected from the electrical system) they should be terminated or removed. Simply testing them for voltage cannot determine with certainty that they are disconnected, as there could be a switch or breaker that is turned off and could later be turned on and energize the cable. Electrical system defects are safety hazards and should be promptly repaired by a licensed electrician. Locations: upper attic (where an attic fan was removed).

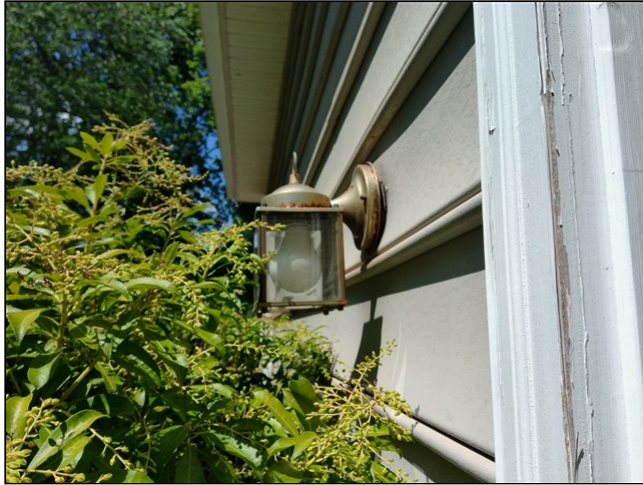
Item 16 - 1

**16 Investigate Further** The following devices would not respond to switches, or switches could not be located to turn them on: exterior light by the garage pedestrian exterior door. Check fixtures with known working bulbs, or check with the current owner. If new bulbs do not correct the problem, an electrician should be contacted for evaluation and to complete any needed repairs.

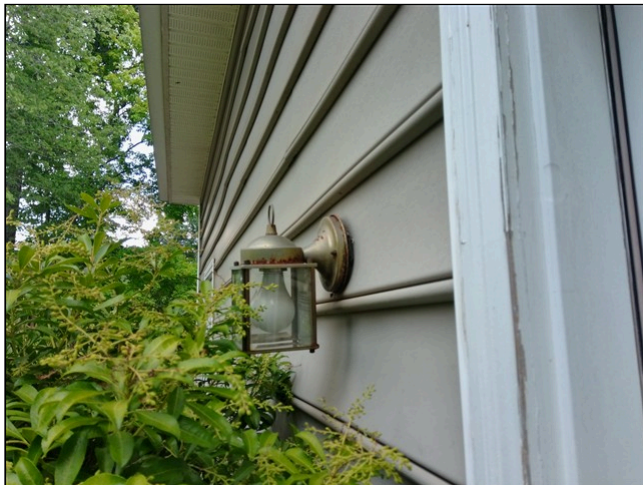
Item 17 - 1

- 17 Repair Item** A light fixture mounted to the exterior wall is loose or are not sealed where the fixture meets the wall; this can allow water to enter and reach wiring behind the fixture, a safety hazard. Secure and caulk fixture to wall to prevent water entry. Location: light outside the garage pedestrian exterior door.

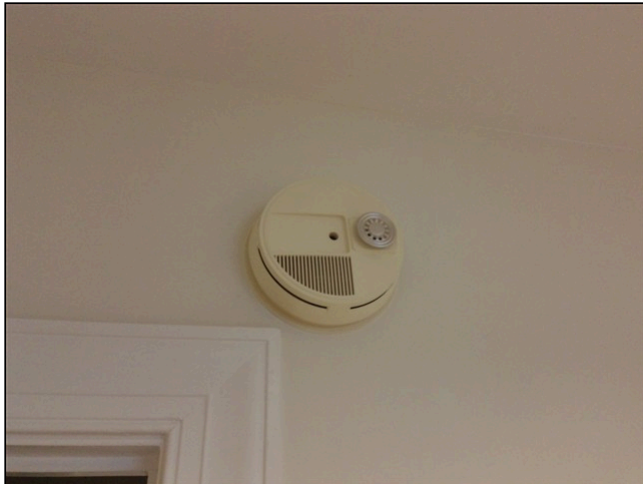
Item 19 - 1

- 19 Repair item** One or more smoke alarms appear to be more than ten years old. The National Association of State Fire Marshals recommends replacing alarms after ten years as they are typically not designed to operate longer than that. Working smoke alarms are an essential fire safety component of the home.

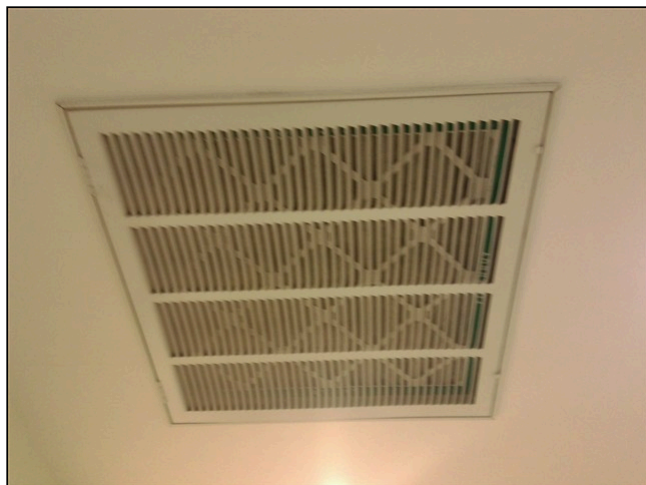
Item 20 - 1

- 20 Maintenance** The HVAC system filter on the second floor is overdue for changing. Clean filters are needed for proper and efficient system function and indoor air quality.

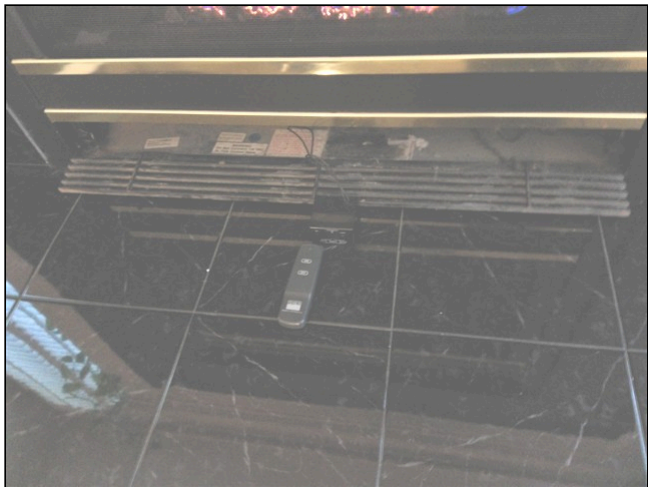
Item 22 - 1

- 22 Investigate Further** The gas log fireplace was operational at the time of the inspection. However, the remote control provided did not operate the gas logs. We recommend check the batteries in the remote control and the remote control module and replace as needed. If the remote control does not function with known functional batteries, contact a qualified gas fireplace technician for further investigation and repairs.

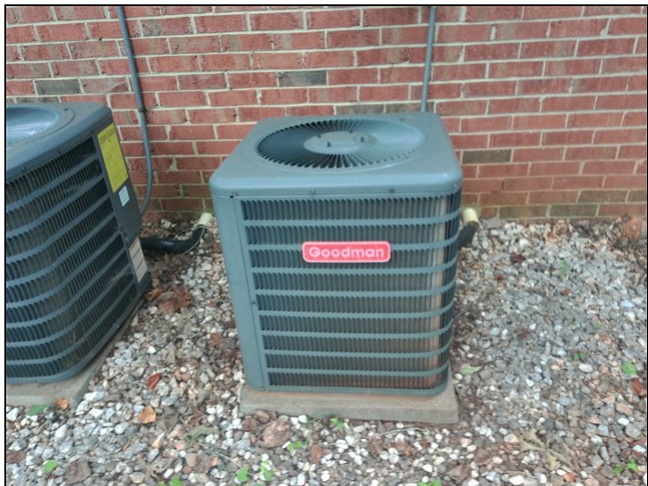
Item 23 - 1

**23 Investigate** Both of the heating and air conditioning equipment systems are approximately 13-14 years old. Typical service life for this type of equipment is 12-15 years, though some fail sooner and some lasts longer. With equipment of this age, you should have it further inspected by a licensed heating contractor, and budget for its replacement at any time.

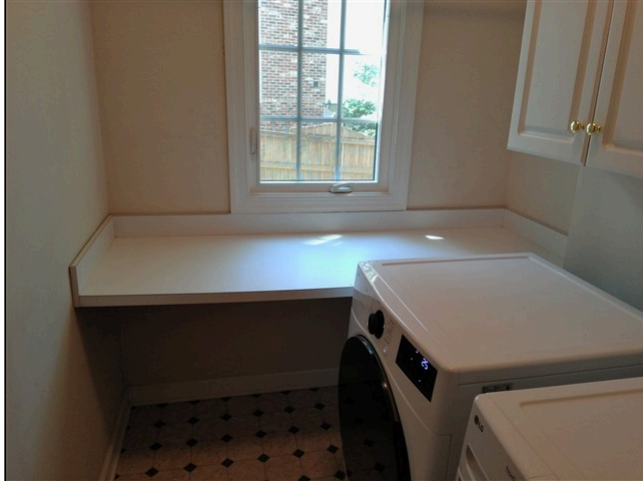
Item 24 - 1

**24 Repair item** The countertop in the laundry room is loose. We recommend it is secured in place by a qualified technician.

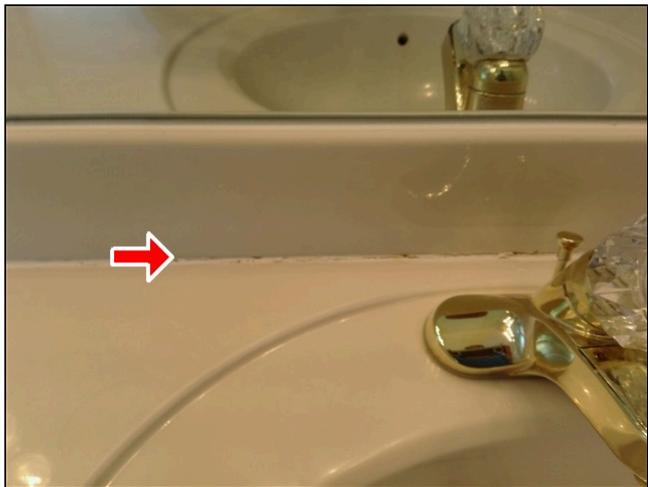
Item 26 - 1

**26 Repair Item** The joint between the countertop and the backsplash at the primary bathroom is open and subject to damage from water penetration. Renew caulk joint as needed to prevent water from entering behind the cabinet.

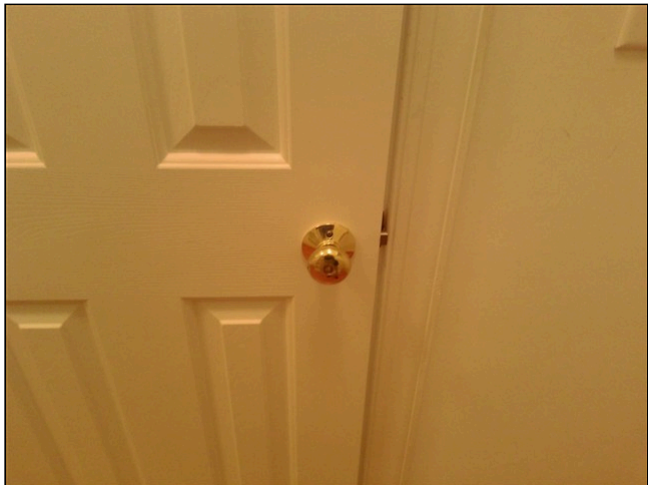
Item 27 - 1

**27 Repair Item** The following interior door(s) do not open/close and/or latch properly: second floor recreation room door, dining room door, and larger closet door in the primary bedroom. Qualified technician should repair/adjust as needed for proper operation.

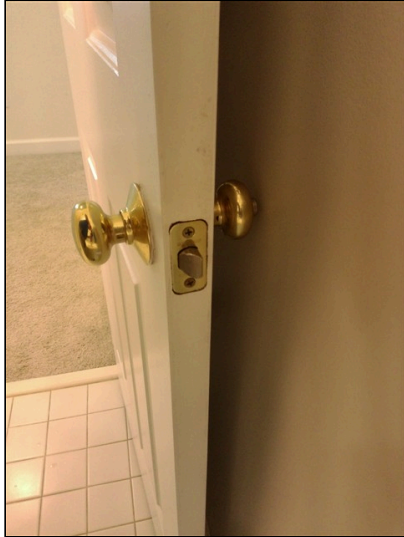
Item 28 - 1

- 28 Repair item** Missing or defective doorstops were noted. This condition could allow damage to adjoining wall covering or to door. Recommend repair or install doorstops to prevent damage. Any repairs should be performed by a qualified technician.

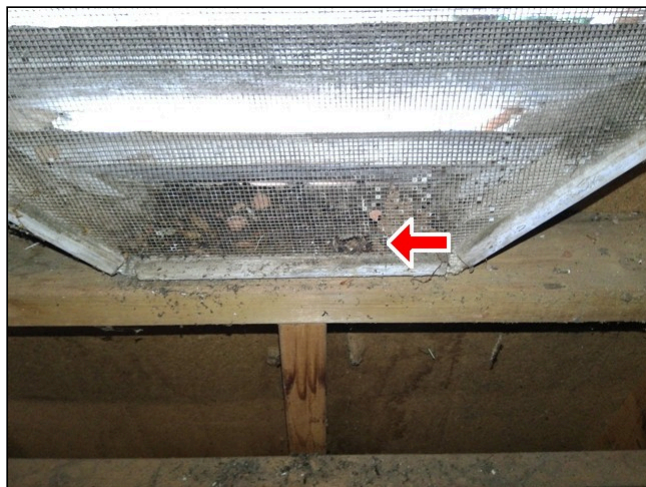
Item 30 - 1

- 30 Repair item** One or more screens is torn at an attic vent. Location: front gable end vent. This can allow small animals and insects to enter the attic. Replace damaged/missing screening. Repairs should be performed by a qualified contractor.

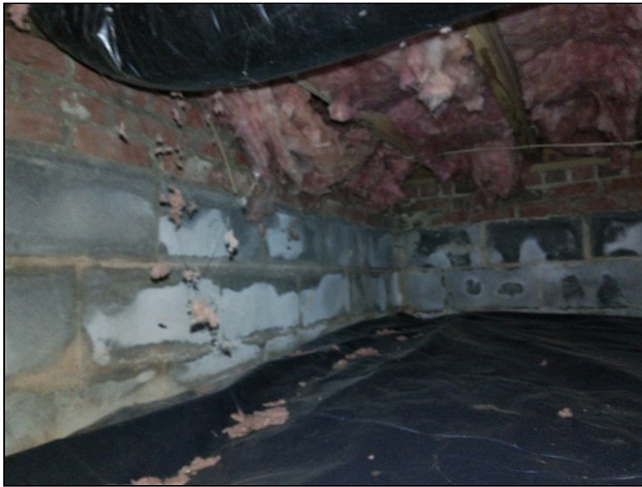
1.4 1

**Comment** There is evidence of some previous crawl space moisture, in the form of water stains on the interior of the foundation walls. This is typical for houses of this age. At the time of inspection there was no standing water, the soil was not unusually wet, and wood members in the crawl space were reasonably dry. Bear in mind that most crawl spaces tend to be damp, and that if it rains hard enough some water may enter. Also, the moisture level in crawl spaces may vary with the seasons. All crawl spaces should be checked occasionally for unusual moisture. If you ever observe what you consider unusual moisture, contact us for advice before contracting with any waterproofing or repair company.

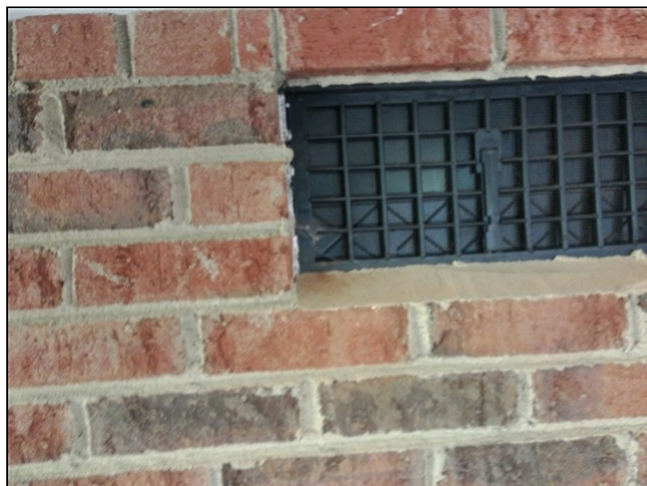
2.3 1

**Repair Item** The screening material is torn or missing at several of the foundation vents. Screening should be replaced to prevent rodents, reptiles, and other small animals from entering the crawl space. Work should be performed by a qualified technician.

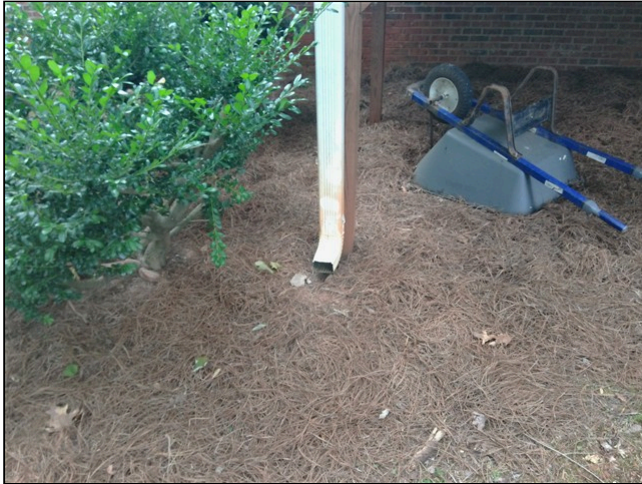
3.2 1

**Repair Item** One or more downspouts deposit runoff directly outside the foundation. This is conducive to water penetration and erosion. Location(s): rear right corner of the sunroom. Extend downspouts as needed (short lengths of drain pipe are typical method). Repairs should be made by a qualified technician.

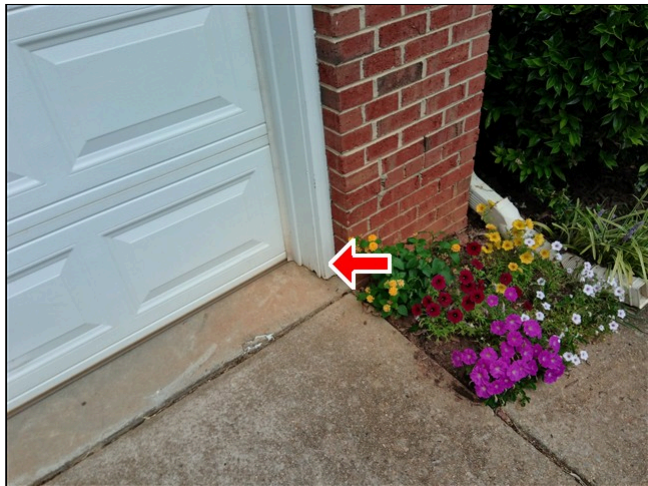
4.0 1

**Repair Item** One or more pieces of siding and/or trim are damaged or deteriorated to the degree that repair or replacement is needed. Damaged cladding materials should be repaired to prevent further damage and possible water penetration to the wall assembly behind the cladding. Repairs should be performed by a qualified contractor. Location(s): garage door jamb / trim at the lower corners of the garage door and trim / exterior cladding at the front right box bay windows.

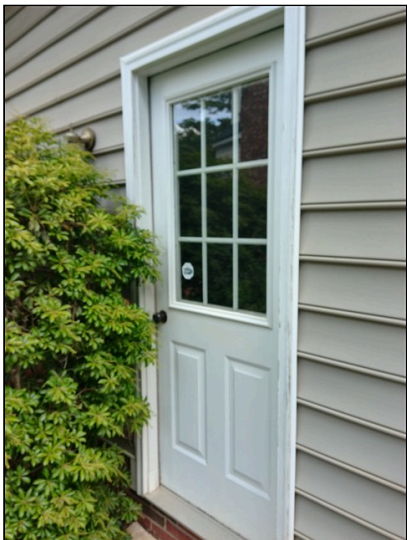
4.0 6

**Repair item** Paint has peeled to the extent that bare wood or composition cladding materials are exposed to potential water damage. Exposed surfaces must be kept painted and caulked to prevent water penetration and damage. Qualified painter should renew paint/caulk as needed. Locations: garage pedestrian exterior door, first floor window at the center of the right exterior, and rear exterior window above the deck floor.

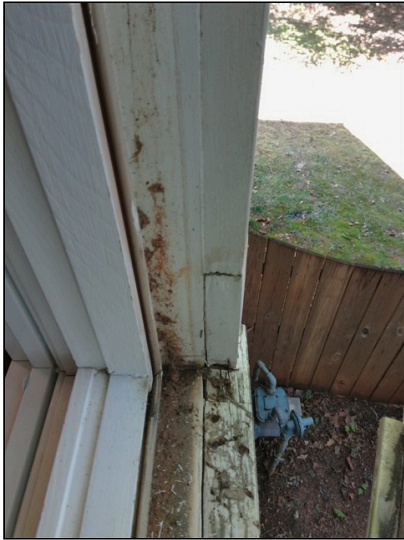
4.4 1

**Repair Item** One or more exterior wood components (jambs, casings, sash, etc.) are deteriorated at the following window(s): front right window in the primary bedroom. Damaged window components should be replaced to prevent further damage and possible water penetration to the wall assembly around the windows. Repairs should be performed by a qualified contractor.

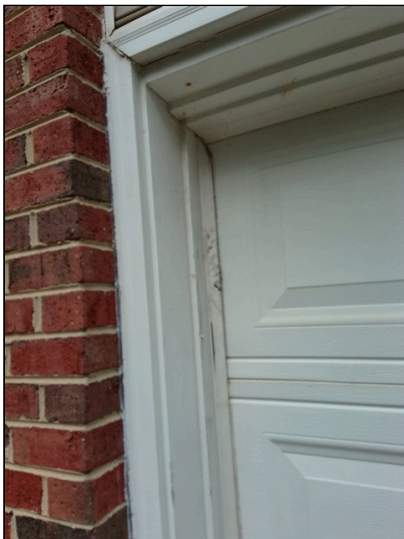
4.5 1

**Repair item** A portion of the weather stripping at the garage door is deteriorated. Repairs should be performed to prevent water penetration into the garage. Repairs should be performed by a qualified contractor.

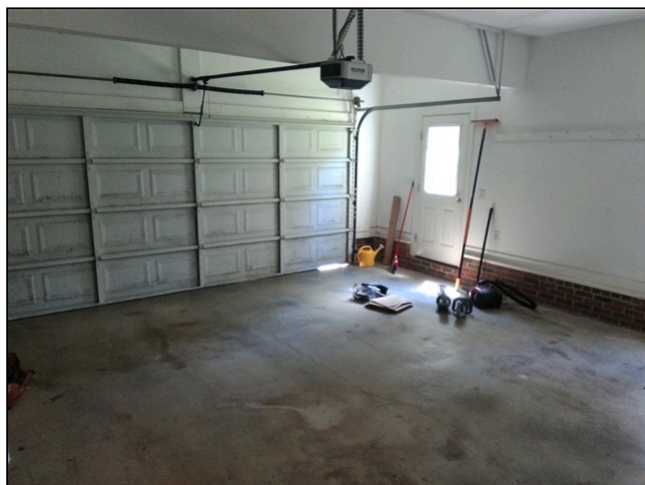
4.5 2

**Repair item** There is a gap between lower corner of the garage door and the concrete floor in the

garage. We recommend weather stripping is added to eliminate this gap. Repairs are recommended by a qualified overhead door contractor.

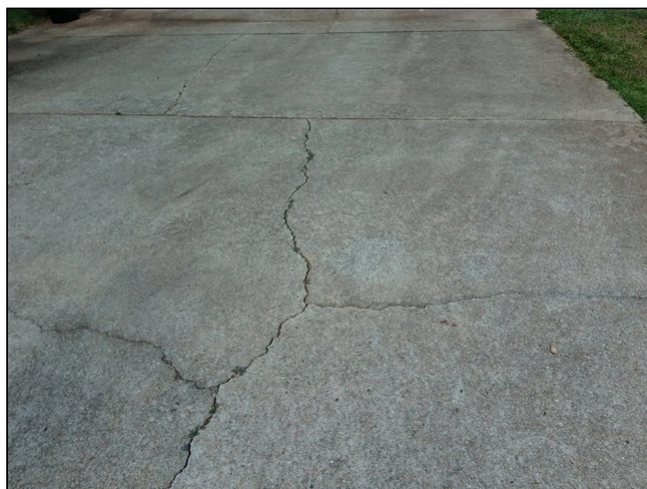
4.9 1

Typical cracks were observed in the driveway.

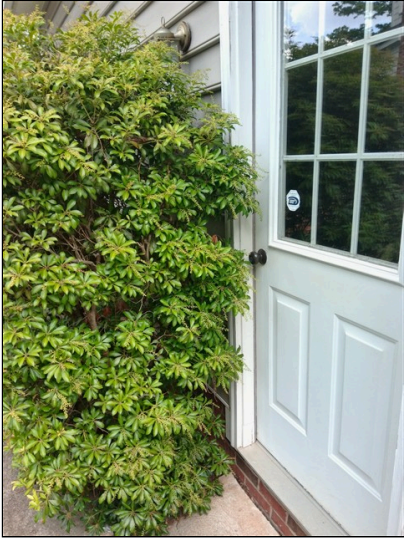
4.10 1

**Repair Item** Vegetation (bushes, etc.) is in contact with the exterior of the house. This condition is conducive to decay and termite infestation, and limits inspection. Vegetation needs to be trimmed back away from the house.

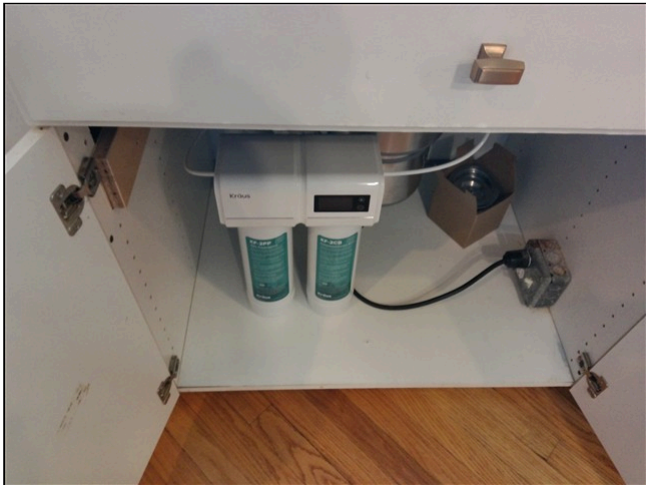
5.0 1

**Comments:** Inspected  
**Comment** Water filtration systems are outside the scope of a home inspection.

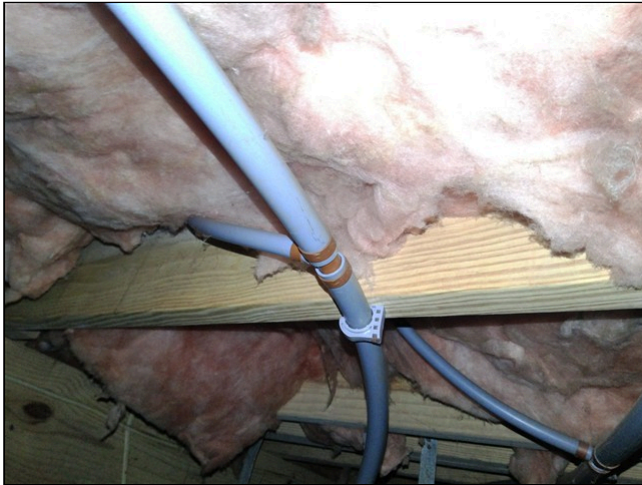
5.0 2

**Investigate further** Polybutylene plastic water supply pipes are installed in this house. A higher rate of failure resulting in leakage has been reported with this type of pipe than with most other types of water supply pipe, but no active leaks were noted at the time of inspection. There has been no recall of this type of pipe, and it is found in thousands of houses built in this area in the 1980's and early 1990's. Many of the failures resulted from plastic pipe fittings used in earlier generations of this type of pipe. Later use of metal fittings significantly reduced the incidence of failures, but the pipe itself is thought to be more susceptible to failure than other types of water supply pipe. We cannot inspect every fitting but the fittings we observed in this installation are metal. Note that class action settlements have been reached in regard to failure of this type of pipe, but they have expired and no funds remain to reimburse homeowners. For additional information about this type of pipe visit the website(s) listed below, and/or contact a licensed plumbing contractor. <http://www.polybutylene.com>

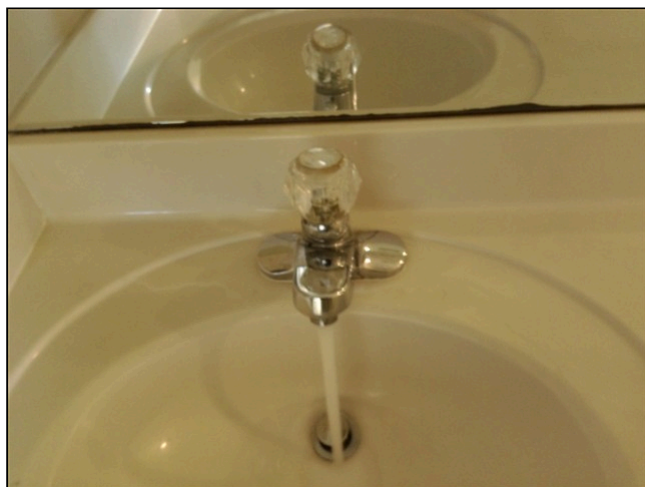
5.1 1

**Repair Item** Repair is needed to a plumbing valve that leaks around its handle when the water is turned on (this is known as a faucet stem leak). Location(s): left sink in the second floor bathroom and left sink in the primary bathroom. All leaks require prompt repair to prevent damage and wasted water. Repairs should be performed by a qualified plumbing contractor.

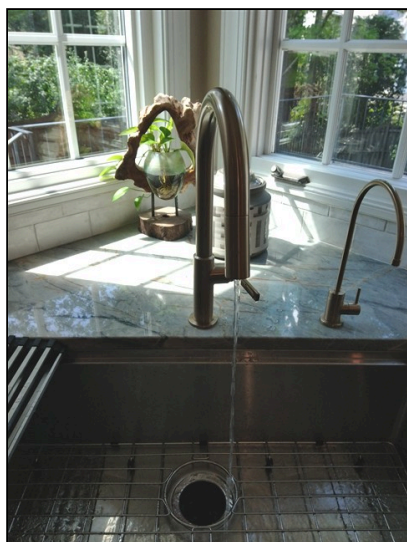
5.1 3

**Repair item** The kitchen sink faucet is loose where it mounts to the sink or countertop. It must be secure to prevent leakage. Repairs should be performed by a qualified contractor.

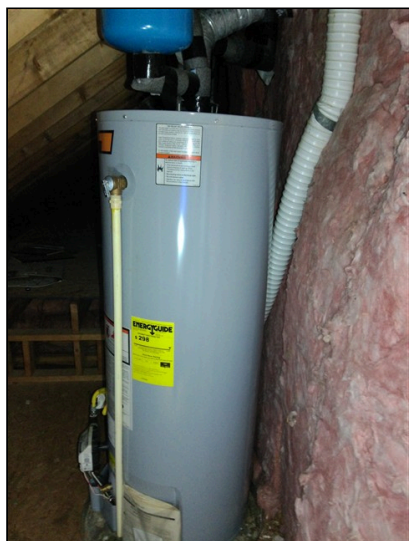
5.7 1

**Comment** The water heater is approximately 6 years old. It was functional and showed no signs of active leakage at time of inspection. However, all water heaters eventually leak, and some plumbing

professionals recommend replacing water heaters once they reach ten years, especially when they are installed in a location where leakage could cause significant damage. There is an overflow pan under this water heater, but be aware that overflow pans do not always prevent damage when leakage occurs. Recommend replacing water heater when it reaches 10 years old

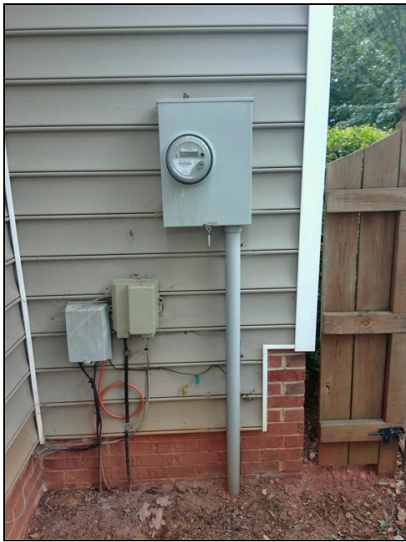
6.0 1

**Comments:** Inspected  
**Comment** There is an underground service with a ground rod.

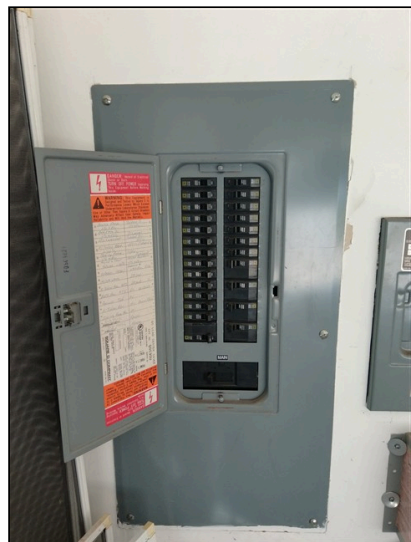
6.1 1

**Comment** The main panel is located in the garage. There is also a sub-panel in the garage.

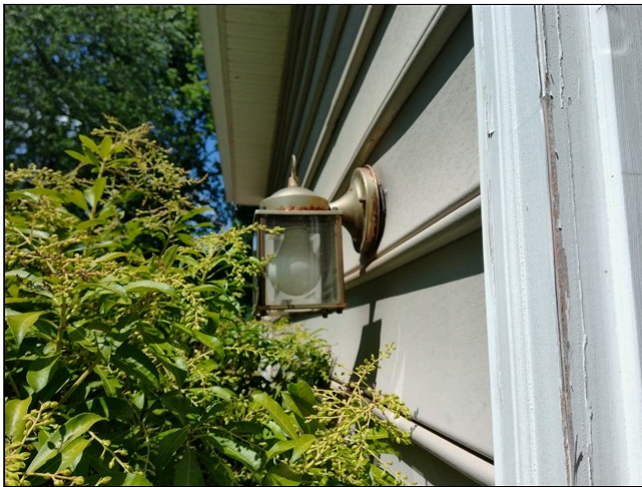
6.3 1

**Investigate Further** The following devices would not respond to switches, or switches could not be located to turn them on: exterior light by the garage pedestrian exterior door. Check fixtures with known working bulbs, or check with the current owner. If new bulbs do not correct the problem, an electrician should be contacted for evaluation and to complete any needed repairs.

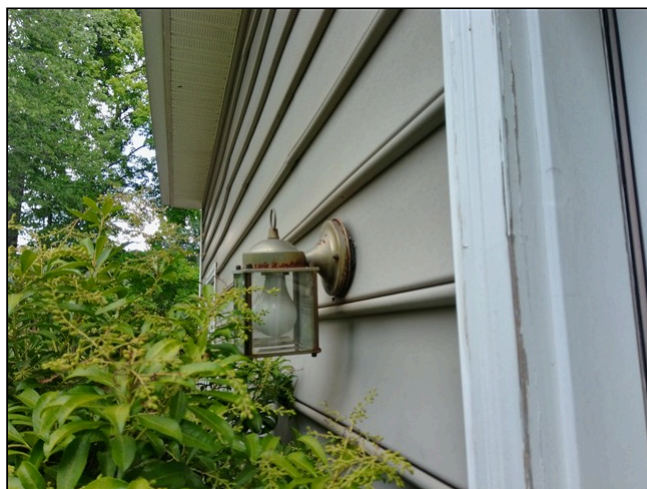
6.3 2

**Repair Item** A light fixture mounted to the exterior wall is loose or are not sealed where the fixture meets the wall; this can allow water to enter and reach wiring behind the fixture, a safety hazard. Secure and caulk fixture to wall to prevent water entry. Location: light outside the garage pedestrian exterior door.

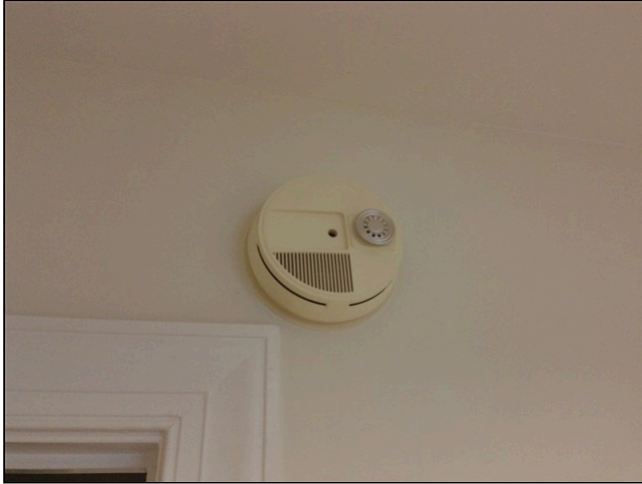
6.6 1

**Repair item** One or more smoke alarms appear to be more than ten years old. The National Association of State Fire Marshals recommends replacing alarms after ten years as they are typically not designed to operate longer than that. Working smoke alarms are an essential fire safety component of the home.

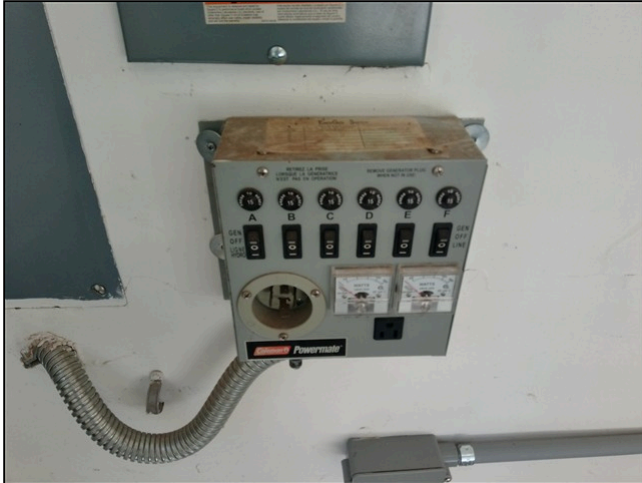
6.8 1

**Comment** A generator panel and wiring are installed. Generators and related wiring are speciality equipment that is outside the scope of the home inspection service, and accordingly these components were not inspected and not tested. Recommendation: consider having this equipment checked by a licensed electrician who has experience with generator systems.

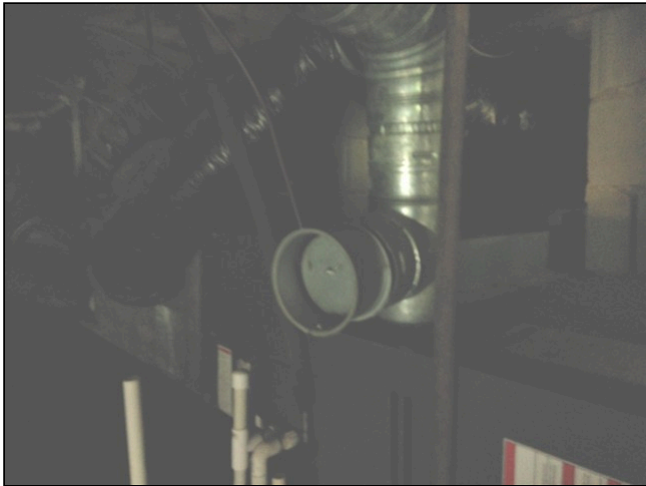
7.0 1

**Comment:** The furnace in the crawl space has an older type of ventilation system. We recommend this is checked by the heating contactor at each of the normal bi-annual service appointments.

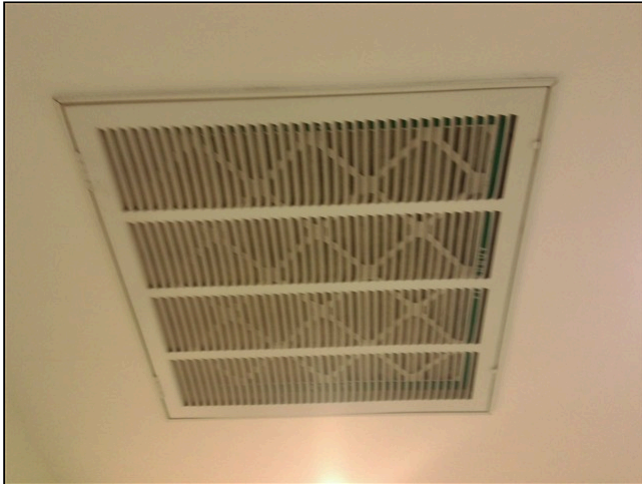
7.2 1

**Maintenance** The HVAC system filter on the second floor is overdue for changing. Clean filters are needed for proper and efficient system function and indoor air quality.

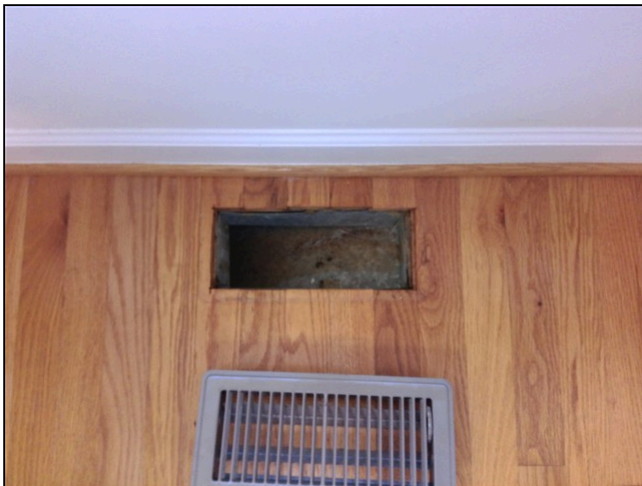
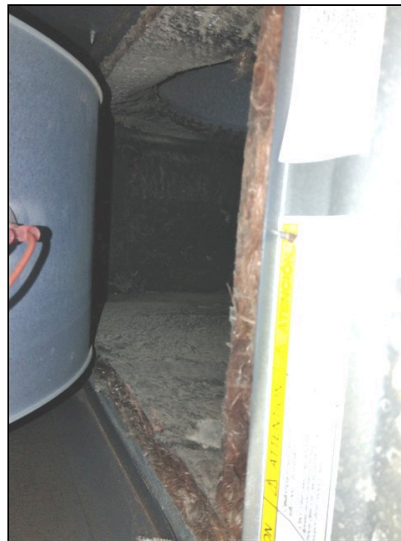
7.2 2

**Maintenance** Most of the interior of the duct system is not visible for inspection. Limited areas that are visible are dirty to the degree that duct cleaning is recommended. Dirty ducts can decrease operating efficiency and can pose a health hazard. Duct cleaning is typically performed by duct cleaning specialist or licensed heating contractors.

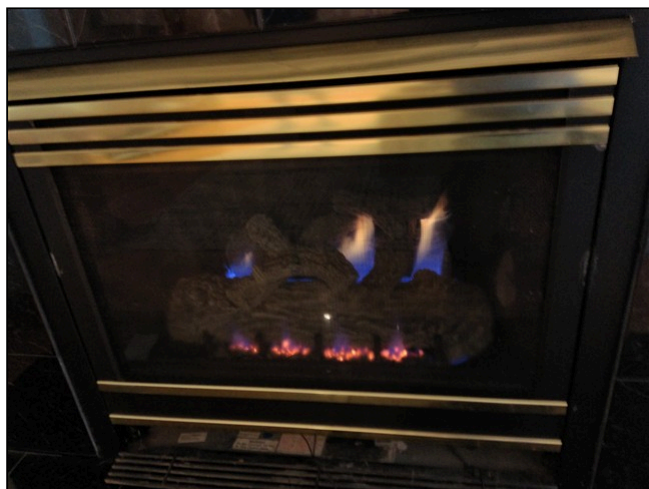
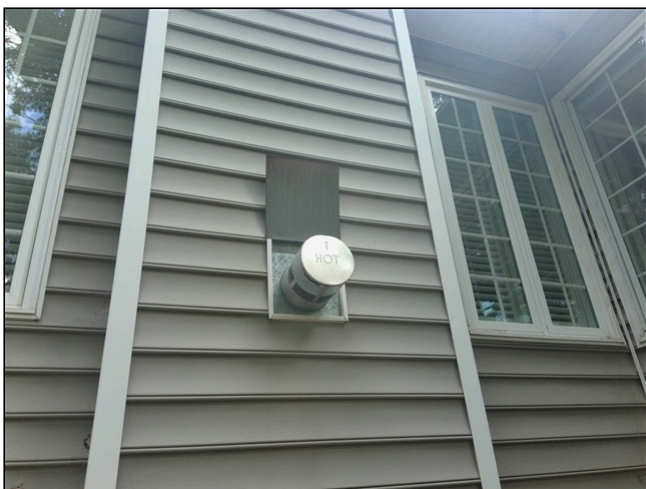
7.4 1

**Comment:** The gas logs were operated and found to be functional. Be sure to follow the manufacturer's instructions for proper operation.

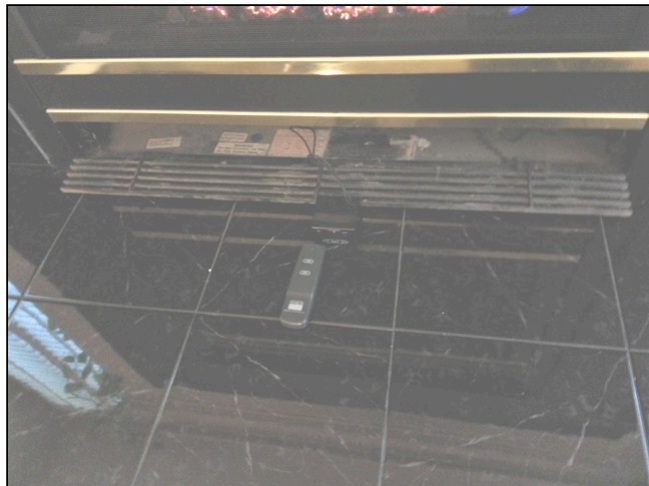
7.4 3

**Investigate Further** The gas log fireplace was operational at the time of the inspection. However, the remote control provided did not operate the gas logs. We recommend check the batteries in the remote control and the remote control module and replace as needed. If the remote control does not function with known functional batteries, contact a qualified gas fireplace technician for further investigation and repairs.

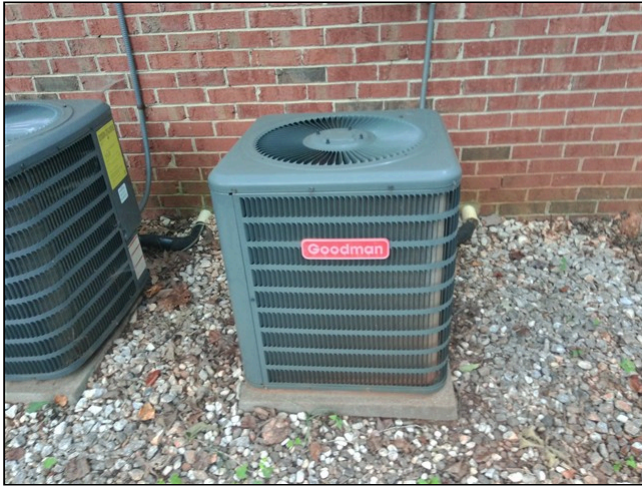
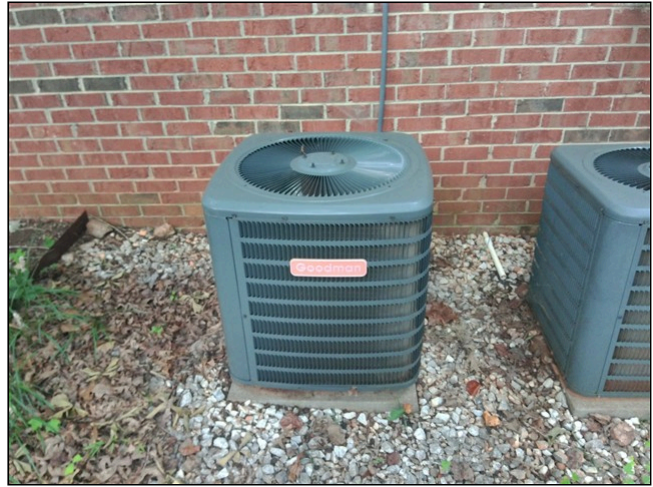
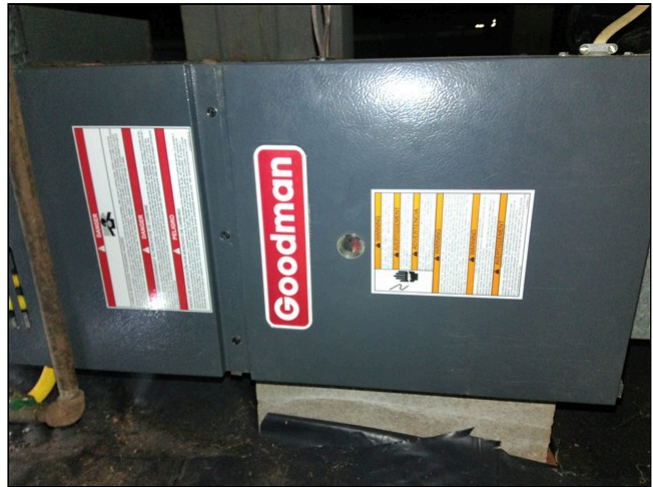
7.5 1

**Investigate** Both of the heating and air conditioning equipment systems are approximately 13-14 years old. Typical service life for this type of equipment is 12-15 years, though some fail sooner and some lasts longer. With equipment of this age, you should have it further inspected by a licensed heating contractor, and budget for its replacement at any time.

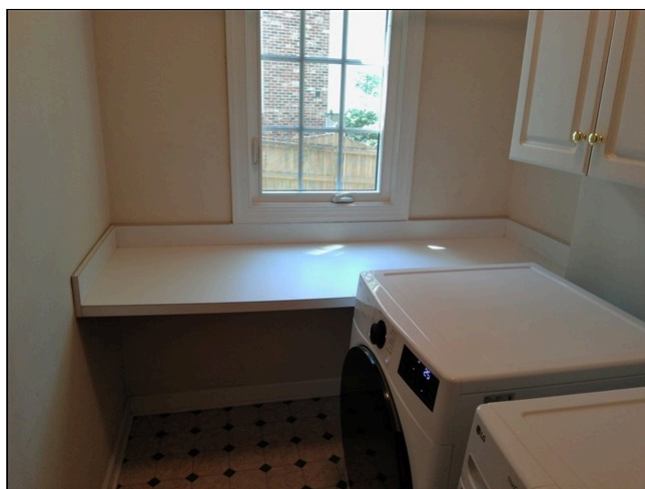
8.3 1

**Repair item** The countertop in the laundry room is loose. We recommend it is secured in place by a qualified technician.

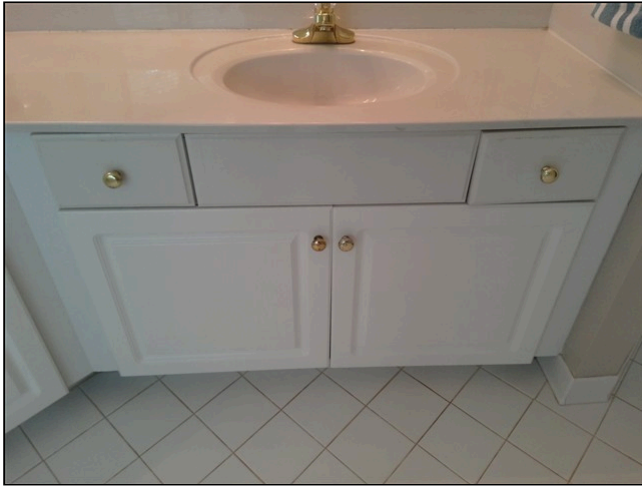
8.3 2

**Repair item** The sink base cabinet door at the right sink in the primary bathroom rub together. This can deteriorate the finish of the cabinet doors. Also, the doors should be adjusted to open and close with ease as intended. Repairs are recommended by a qualified contractor.

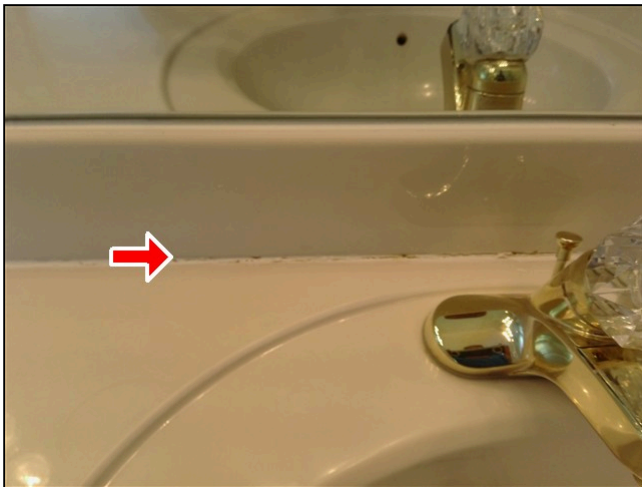
8.3 3

**Repair Item** The joint between the countertop and the backsplash at the primary bathroom is open and subject to damage from water penetration. Renew caulk joint as needed to prevent water from entering behind the cabinet.

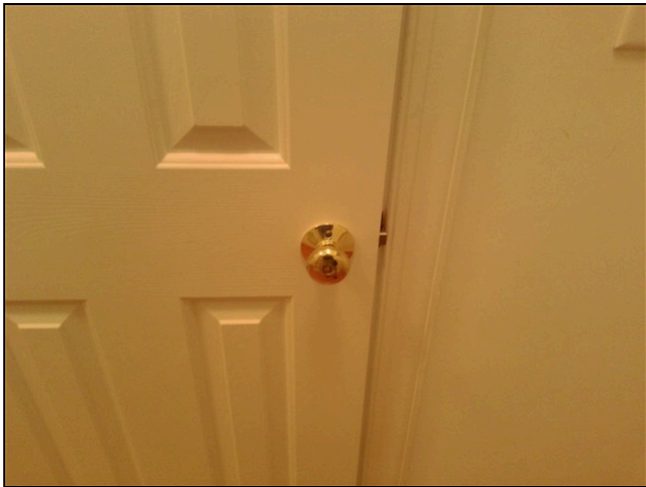
8.4 3

**Repair Item** The following interior door(s) do not open/close and/or latch properly: second floor recreation room door, dining room door, and larger closet door in the primary bedroom. Qualified technician should repair/adjust as needed for proper operation.

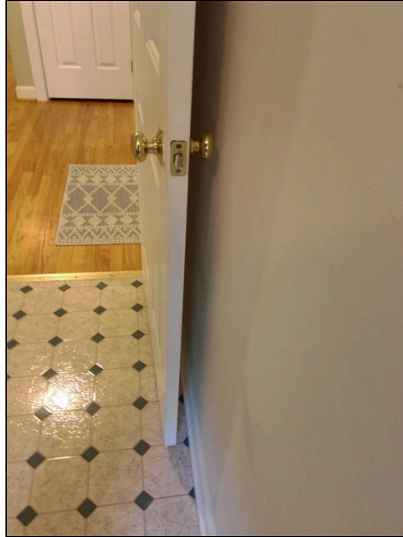
8.4 5

**Repair item** Missing or defective doorstops were noted. This condition could allow damage to adjoining wall covering or to door. Recommend repair or install doorstops to prevent damage. Any repairs should be performed by a qualified technician.
