# Inspection Report

**Property Address:**  
208 Highlands Lake Drive  
Cary NC 27518

**Steve Smallman Property Inspections  
2213 Myron Drive  
Raleigh, NC 27607  
(919) 602-2390**

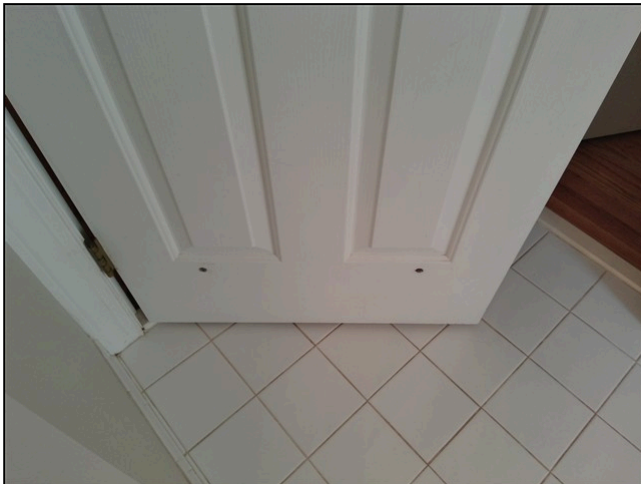
8.4 6

**Repair item** There are holes in the back side of the primary bathroom door. We recommend repairs are performed to restore the door. Repairs are recommended by a qualified contractor.

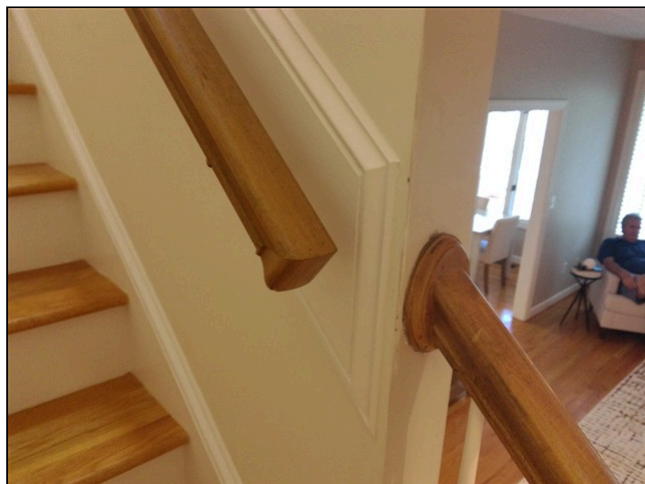
8.5 1

**Improvement** The interior stair and safety railing components are typical for the age of the home, but do not meet all current safety standards. There is no requirement for repair, but as a recommended safety improvement you should consider modifying the railings to meet current standards.

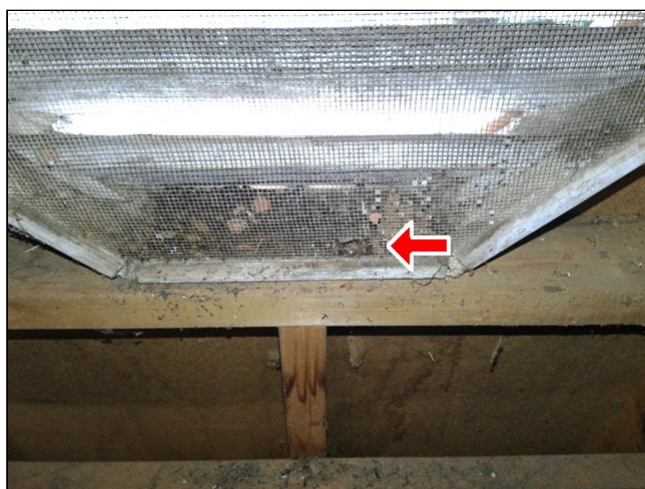
8.6 1

**Repair item** One or more screens is torn at an attic vent. Location: front gable end vent. This can allow small animals and insects to enter the attic. Replace damaged/missing screening. Repairs should be performed by a qualified contractor.

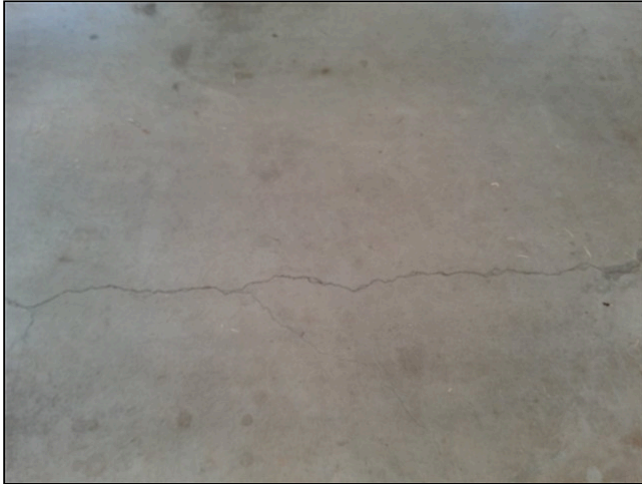
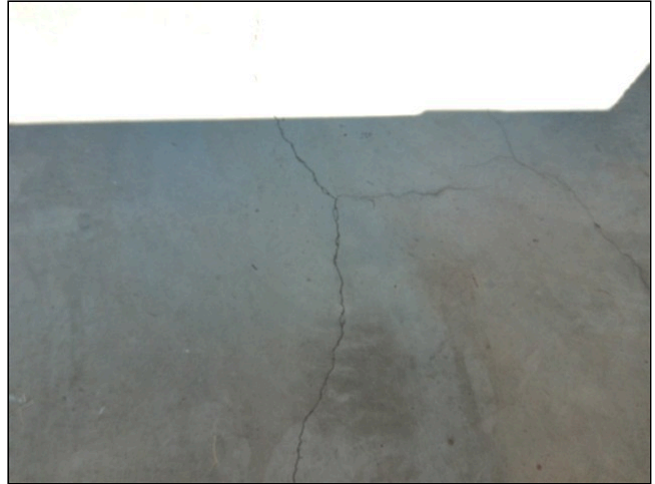
8.7 1

**Comment:** Cracks were noted in garage slab. Recommend monitoring cracks over time for evidence of movement.
