<https://jbsimpsonhomeinspection.com/>

TABLE OF CONTENTS

Thank you for choosing J.B. Simpson Home Inspection as your trusted home inspector.

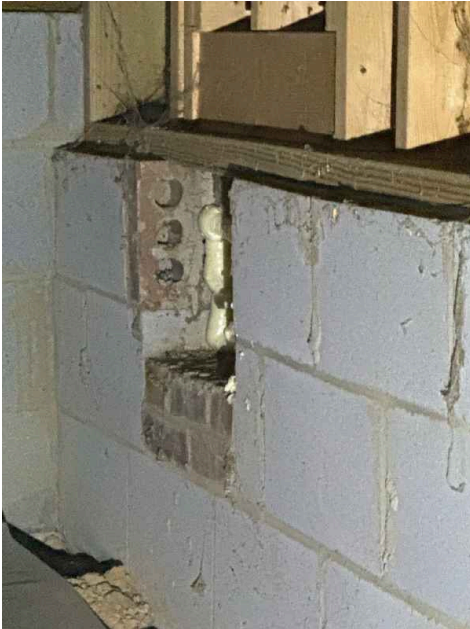
Crawlspace

2.2.1 Foundation

With bricks/ blocks oriented in this manner they may not provide the intended structural support. This should be further evaluated and repaired or replaced as deemed necessary by a qualified contractor.

Contact a qualified masonry professional.

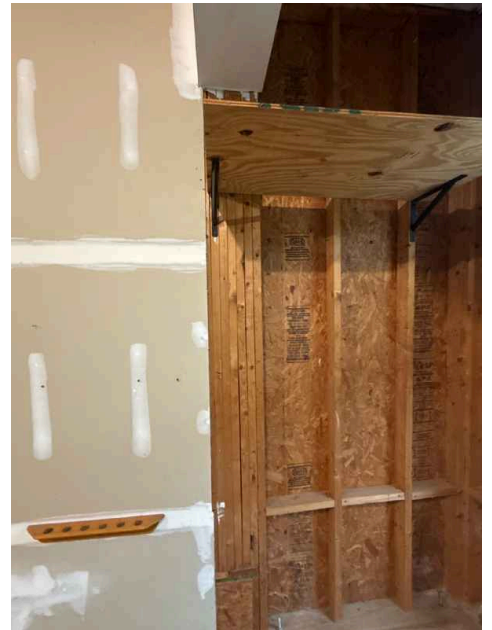
Garage

## 2.5.1 Wall Structure

**FRAMING STRAP  
MISSING**

Without the framing strap installed movement of building materials can occur. This should be further evaluated and repaired or replaced as deemed necessary by a qualified contractor.

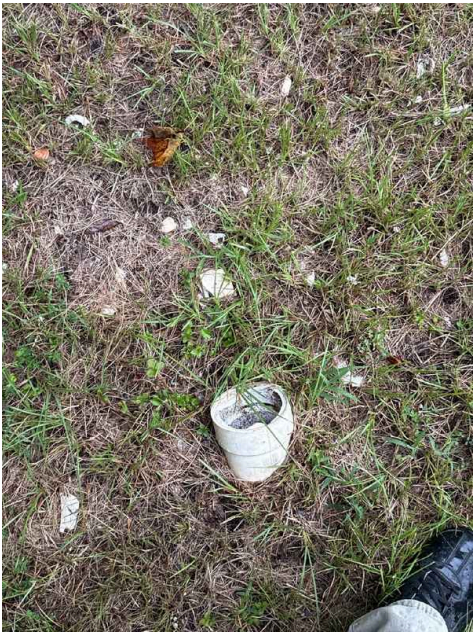
Left

CLEANOUT CAP MISSING

Contact a qualified plumbing contractor.

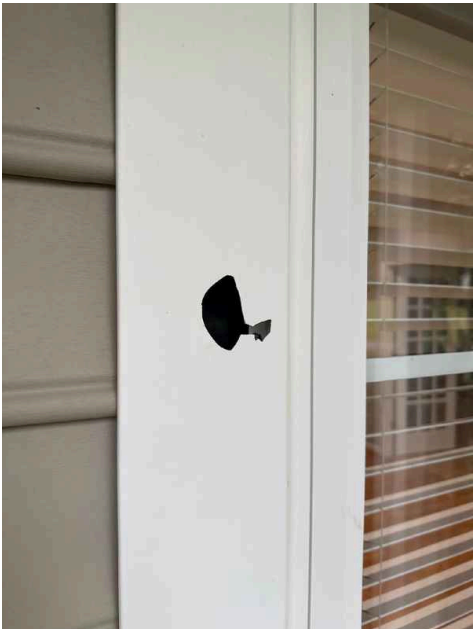
Front

| 4.1.1 Cladding Flashing and Trim | Recommendation/ Does not Function |
| <b>DAMAGED SIDING/ TRIM</b> | |

The siding/ trim at this location was found damaged at the time of inspection. This can allow moisture to damage building materials. Have evaluated and repaired or replaced as deemed necessary by a qualified contractor.

Recommendation  
Contact a qualified siding specialist.

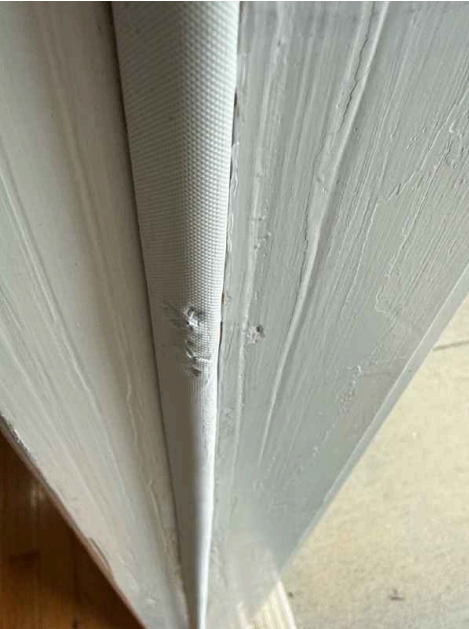
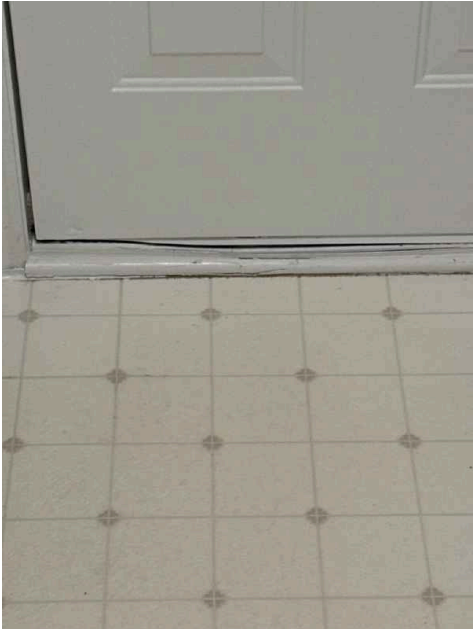
4.2.1 Exterior Doors

**DAMAGED WEATHER STRIPPING**

Weather stripping at this location was missing at the time of inspection. This can allow for energy loss. Have weather stripping evaluated and repaired or replaced as deemed necessary by a qualified contractor.

Recommendation  
Contact a qualified handyman.

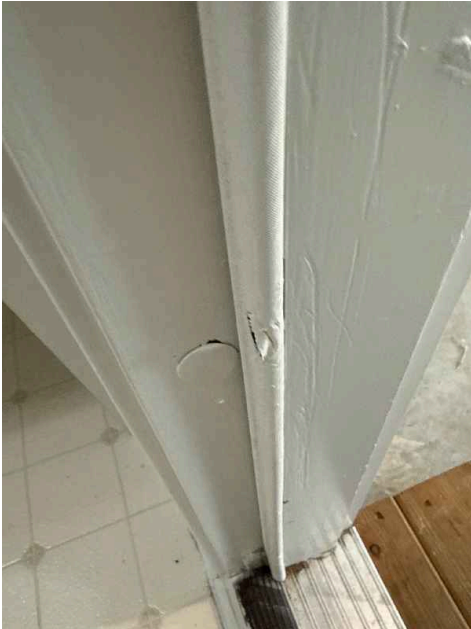
Garage

**DAMAGED DOOR FRAME**

The door frame at this location was damaged at the time of inspection. This can allow moisture to damage building materials. Have evaluated and repaired or replaced as deemed necessary by a qualified contractor.

Recommendation  
Contact a qualified handyman.

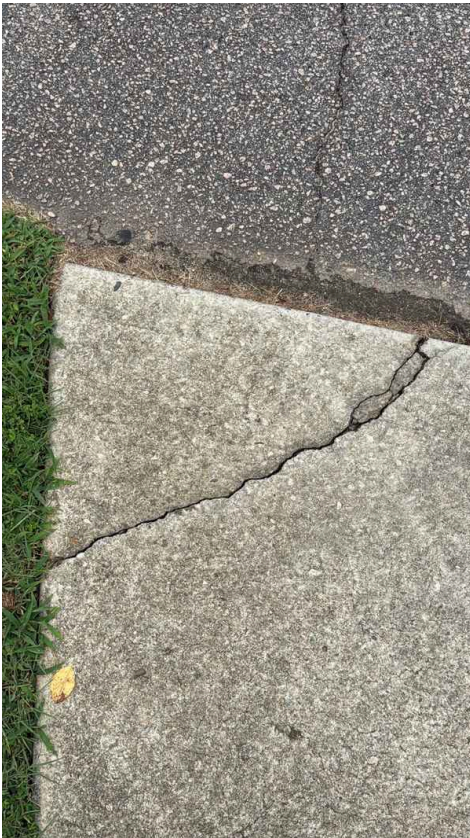
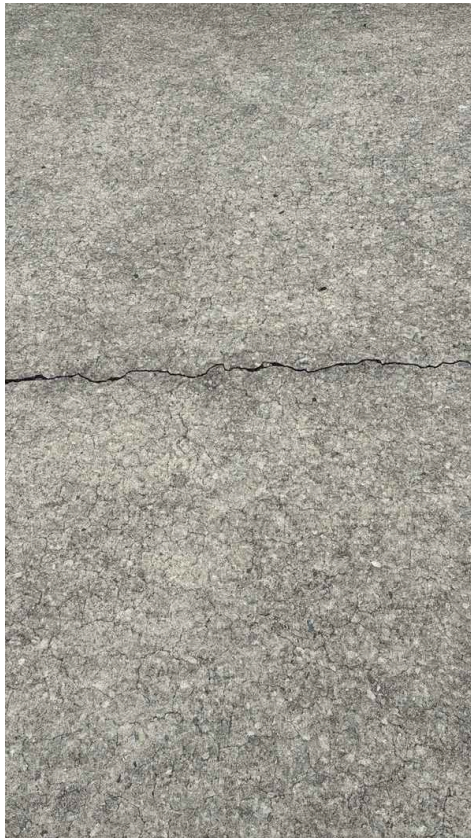
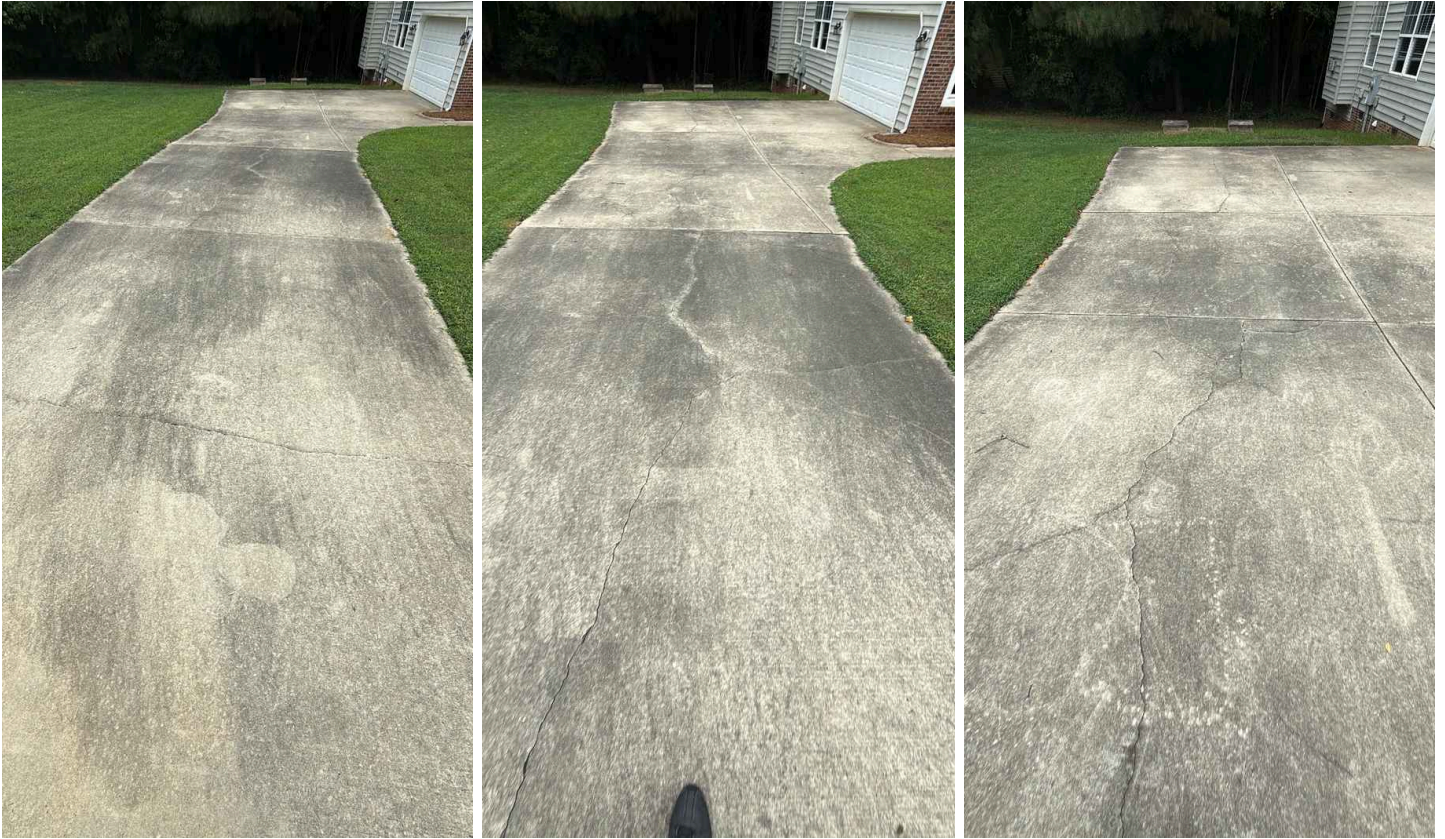
## DRIVEWAY CRACKS

Cracks were found in the driveway. These cracks can expand over time by collecting water if not sealed. Have the driveway sealed or replaced as/if deemed necessary by a qualified contractor.

Contact a qualified driveway contractor.

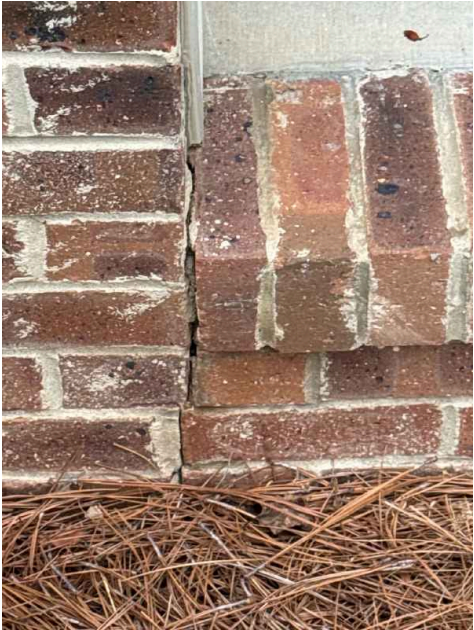
Front

4.6.1 Patios and Porches

**MORTAR  
DETERIORATION**

Mortar was deteriorated at this location. This can allow the bricks to loosen. Have evaluated and repaired or replaced as deemed necessary by a qualified contractor.

Recommendation  
Contact a qualified masonry professional.

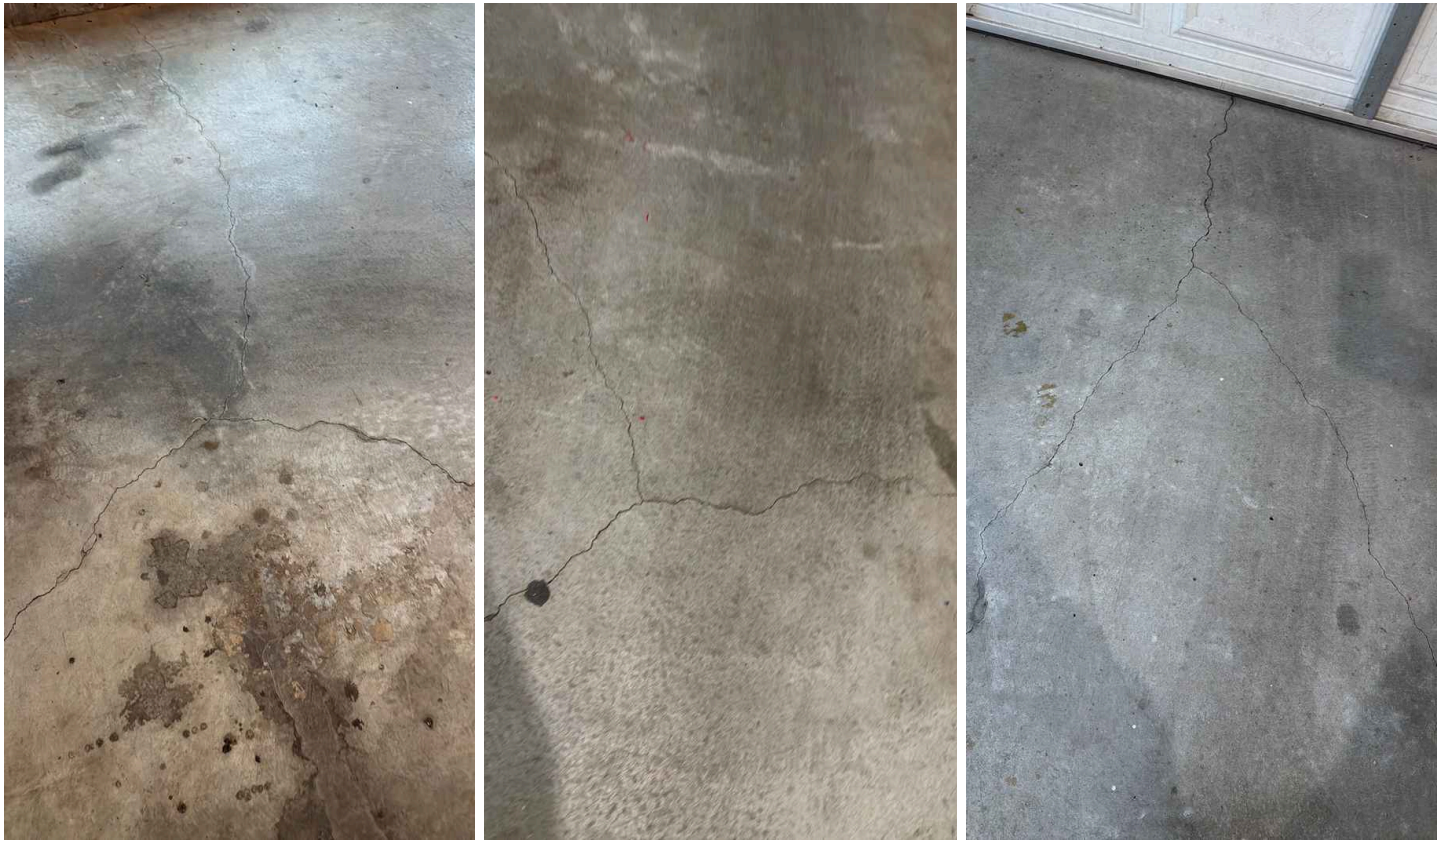
5.1.1 Floor  
**CRACK OBSERVED**  
GARAGE

Cracks were found in the concrete garage floor. These cracks can expand over time by collecting water if not sealed. Have the cracks sealed as/if deemed necessary by a qualified contractor.

Recommendation  
Contact a qualified concrete contractor.

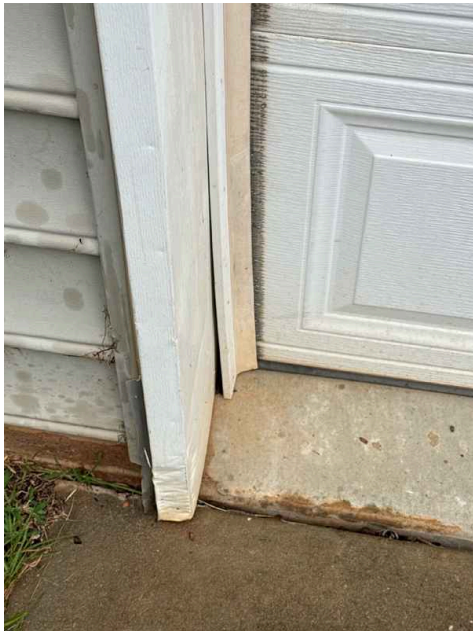
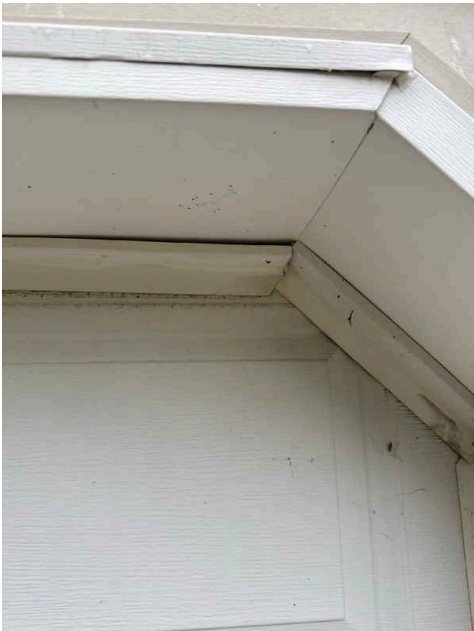
5.2.1 Garage Door

**WEATHER SEAL LOOSE/MISSING**

The weather seals are not installed or are loose at the garage door. This can allow moisture and insects to enter the garage. Have weather seals installed by a qualified contractor.

Contact a qualified garage door contractor.

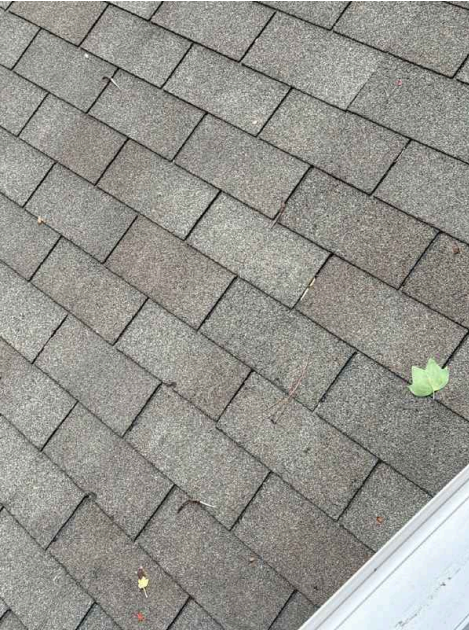
Right

**DAMAGED SHINGLE(S)**

One or more shingles were damaged at the time of inspection. Damage shingles generally do not wear at the same rate as others and may increase the likelihood of roof leakage. Have evaluated and repaired or replaced as deemed necessary by a qualified contractor.

Contact a qualified roofing professional.

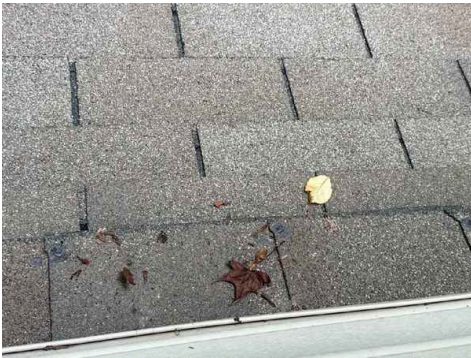
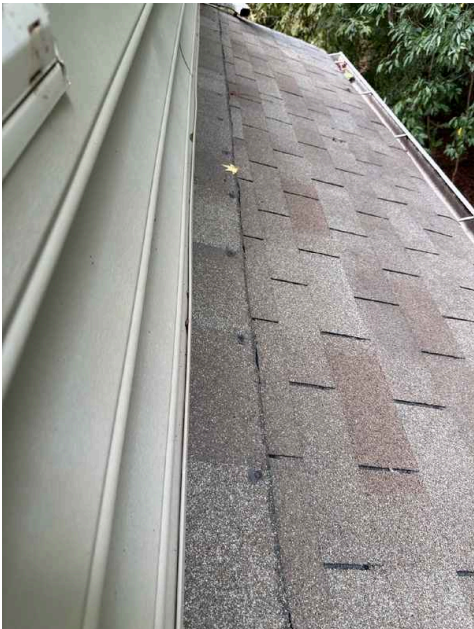
6.1.3 Coverings

Exposed roofing nails are conducive to leakage. This should be further evaluated and repaired or replaced as deemed necessary by a qualified contractor.

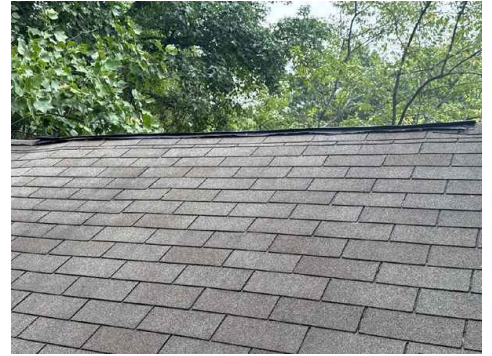
Right

6.1.4 Coverings

RIDGE CAP MISSING/  
DAMAGED

With the ridge cap damaged and/ or missing leakage can occur. This should be further evaluated and repaired or replaced as deemed necessary by a qualified contractor.

Contact a qualified roofing professional.

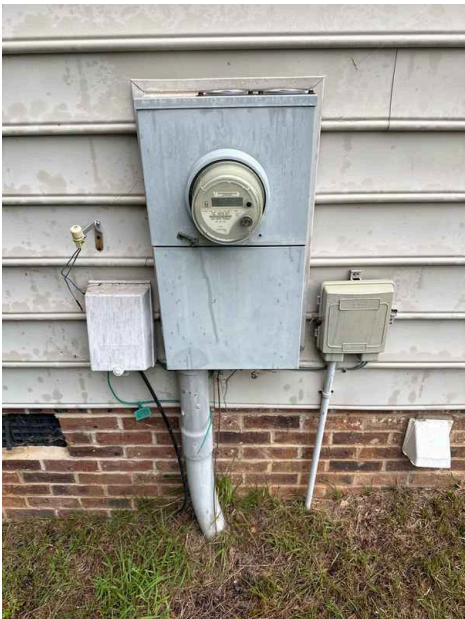
**Main Service: Electrical Service Photo**

**Main Service: Grounding Method**  
In ground (hidden)

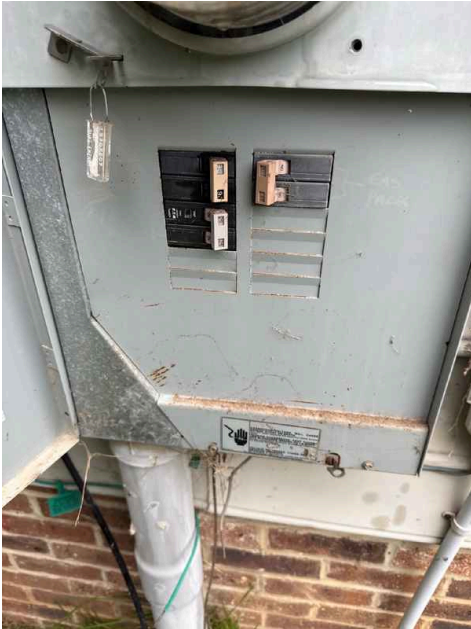
Service panel

LABEL MISSING

The labels at the panel are no longer legible or are missing. Labels are required to identify circuits and may create a hazard if there were to be an emergency and the proper circuit could not be turned off. Have the panel completely and properly labeled by a qualified contractor.

Contact a qualified electrical contractor.

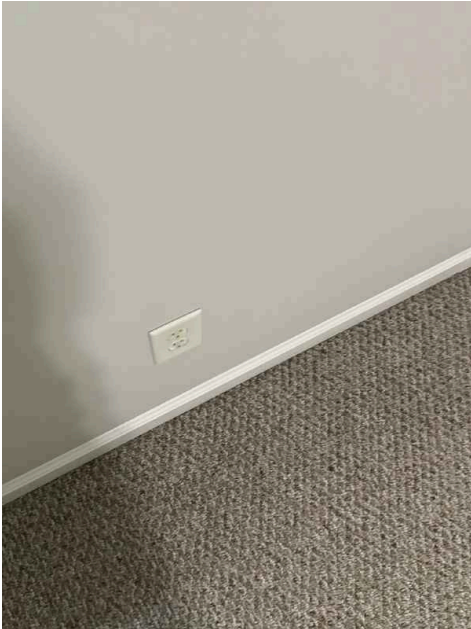
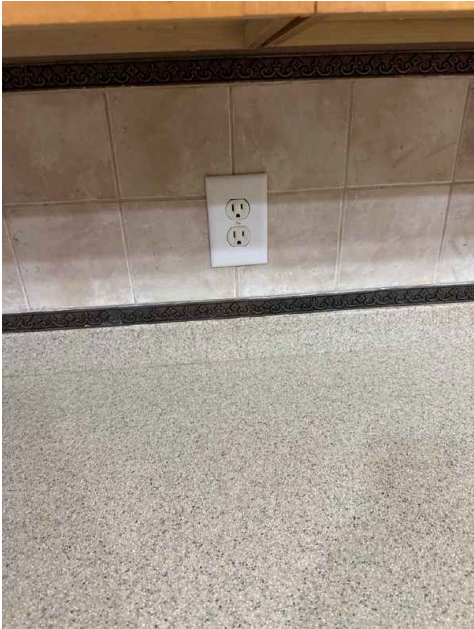
7.5.1 Lighting Fixtures, Switches, and Receptacles

**LOOSE OUTLET/ SWITCH**

One or more receptacles/ switches are loose in their mounting box. Receptacles/ switches should be tight to prevent wiring from becoming loose. Have evaluated and repaired or replaced as deemed necessary by a qualified contractor.

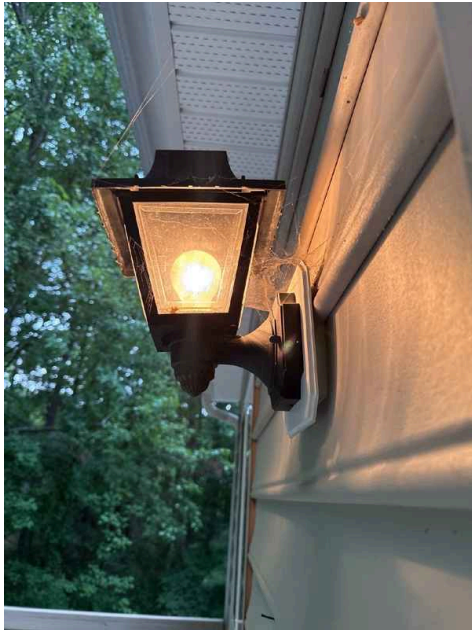
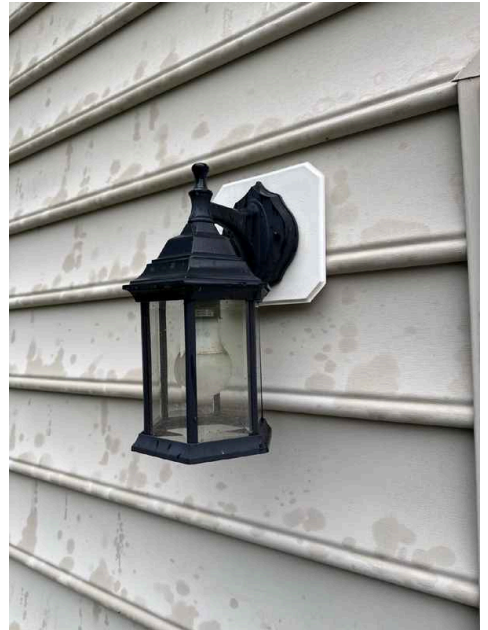
7.5.2 Lighting Fixtures, Switches, and Receptacles

**LOOSE EXTERIOR FIXTURE**

An exterior light fixture is loose. This can allow moisture and insects to reach wiring behind the fixture. Have light evaluated and repaired or replaced as deemed necessary by a qualified contractor.

Contact a qualified handyman.

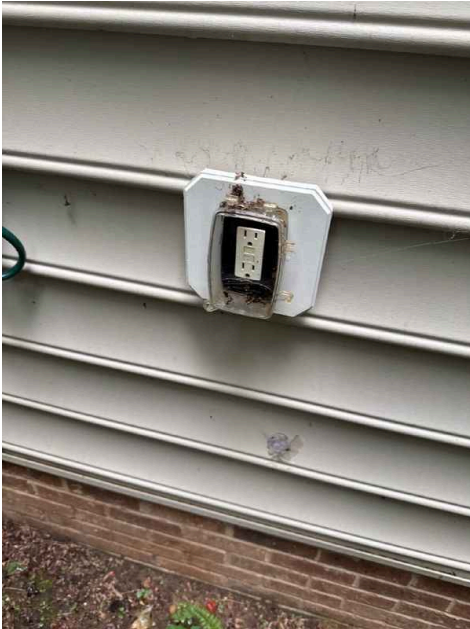
Right

#### **MISSING/ DAMAGED WEATHER COVER**

The weather cover at this exterior receptacle was found to be damaged/missing at the time of inspection. Weather covers should be installed by a qualified contractor to prevent damage to the receptacle.

Contact a qualified electrical contractor.

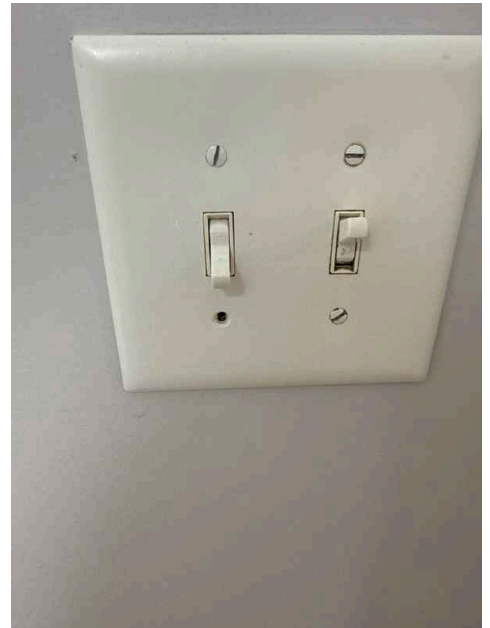
Partial bathroom

#### 7.5.4 Lighting Fixtures, Switches, and Receptacles

##### **COVER PLATE SCREW MISSING**

Contact a qualified handyman.

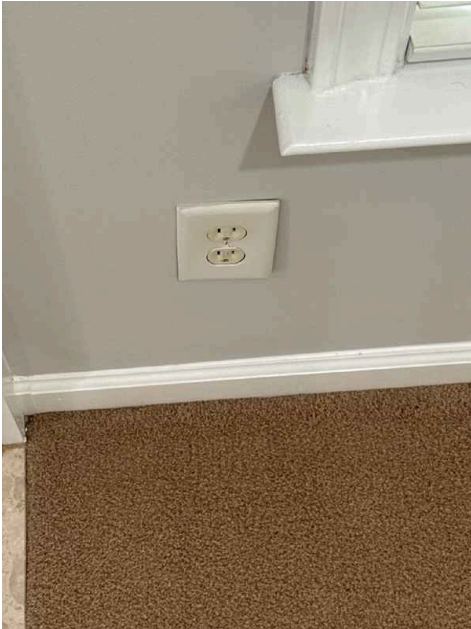
Living Room

#### 7.5.5 Lighting Fixtures, Switches, and Receptacles

##### **WORN OUTLET**

With the receptacle(s) worn inconsistent voltage to items may occur. This should be further evaluated in repaired or replaced as the necessary by a qualified contractor.

Contact a qualified electrical contractor.

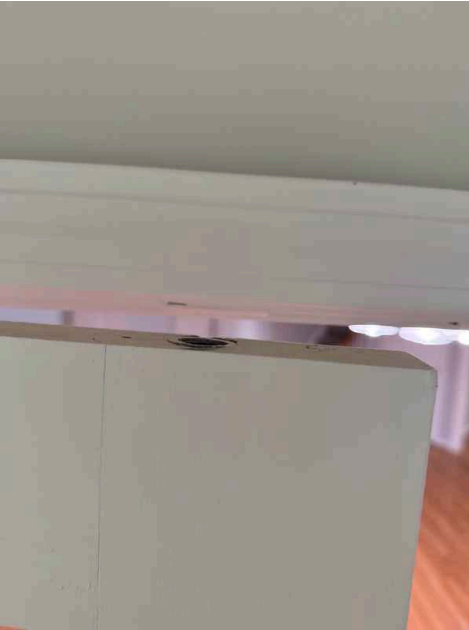
Nook

8.2.1 Doors

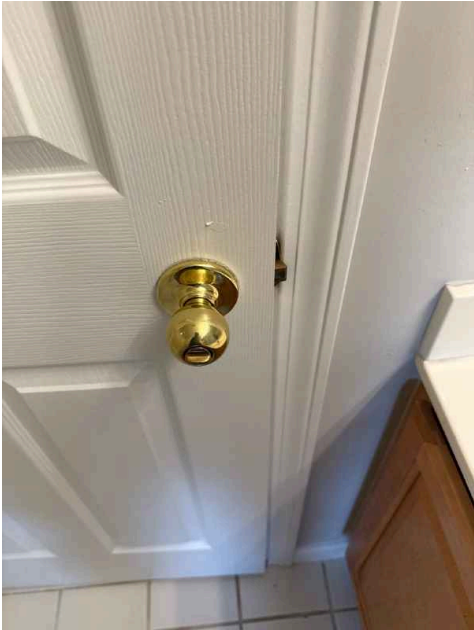
Front Right Bathroom

Without properly latching the door does not function as designed and can just be pushed open or in some situations just open on its own. Have evaluated and repaired as deemed necessary by a qualified contractor.

Recommendation  
Contact a qualified door repair/installation contractor.

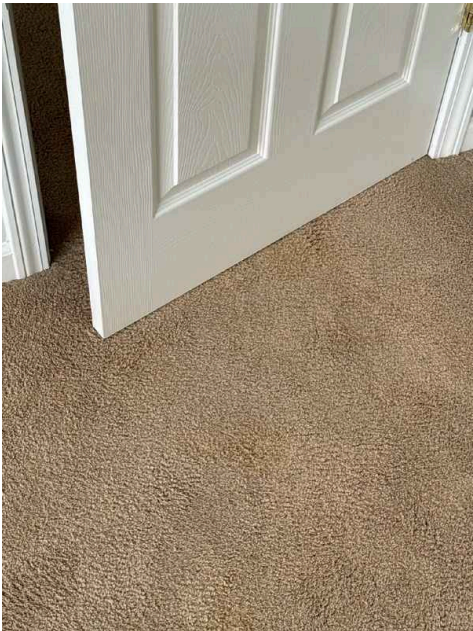
1st Floor Office

The door at this location rubs the floor. This can cause damage to the flooring and the door. Have further evaluated and repaired or replaced as deemed necessary by a qualified contractor.

Contact a qualified door repair/installation contractor.

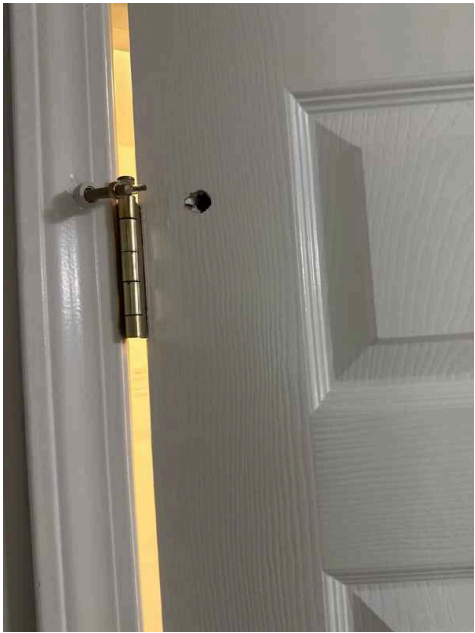
Right Middle Bedroom

8.2.4 Doors

**DOOR DAMAGED**

The door at this location was damaged at the time of inspection. Damaged doors may not function as intended. Have evaluated and repaired or replaced as deemed necessary by a qualified contractor.

Contact a qualified door repair/installation contractor.

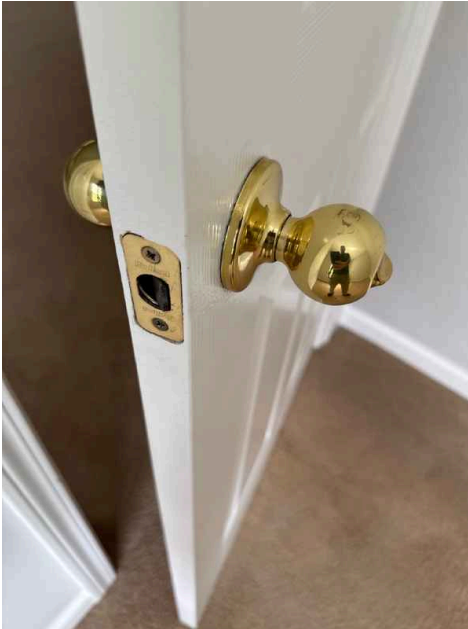
1st Floor Office

8.2.5 Doors

The door does not operate as designed and is difficult to open and close. Have evaluated and repaired as deemed necessary by a qualified contractor.

Contact a qualified handyman.

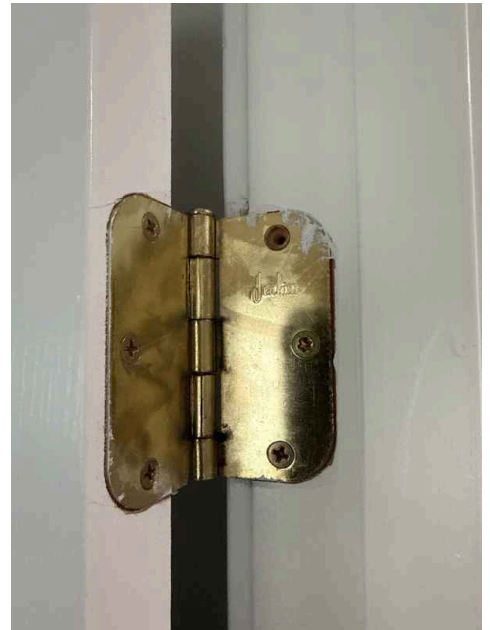
Master Bedroom

## 8.2.6 Doors

**HINGE SCREW MISSING**

With the hinge screw missing movement of the hinge can occur resulting in damage to the door. Have screws installed by a qualified contractor.

Contact a qualified handyman.

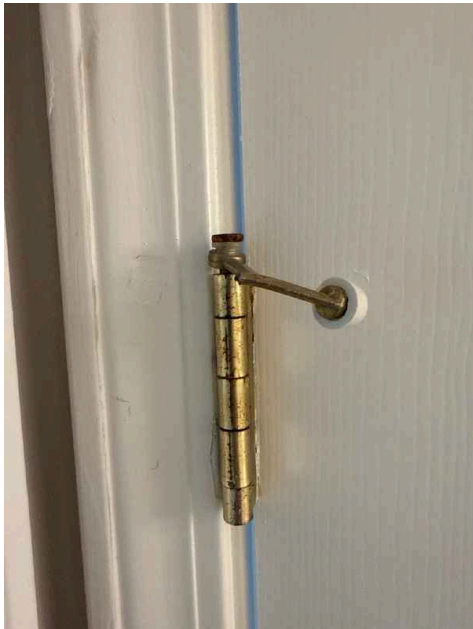
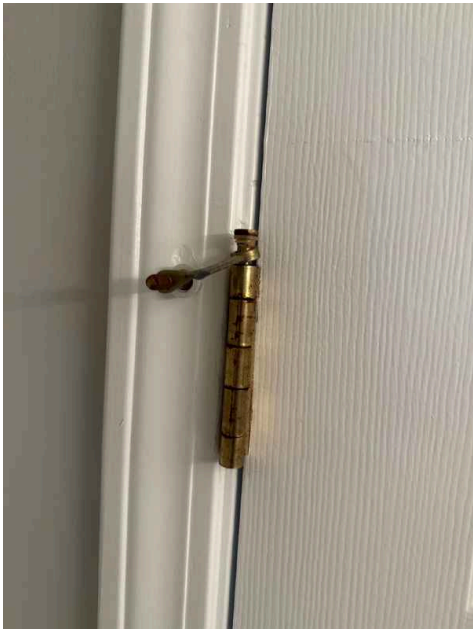
## 8.2.7 Doors

**DOOR STOP DAMAGED**

The damaged door stop did not effectively stop the door from striking the wall. This should be further evaluated and repaired or replaced as deemed necessary by a qualified contractor.

Contact a qualified handyman.

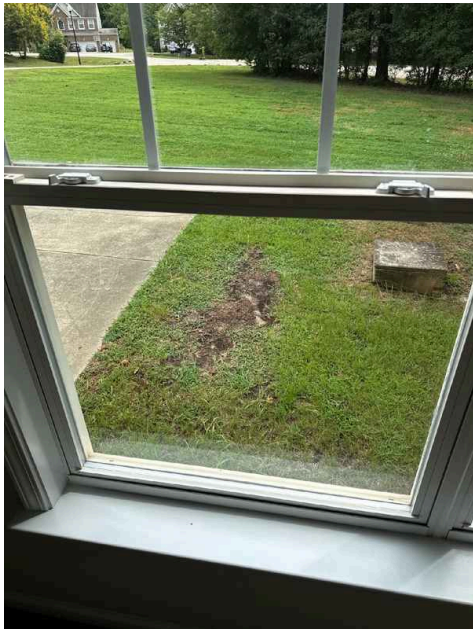
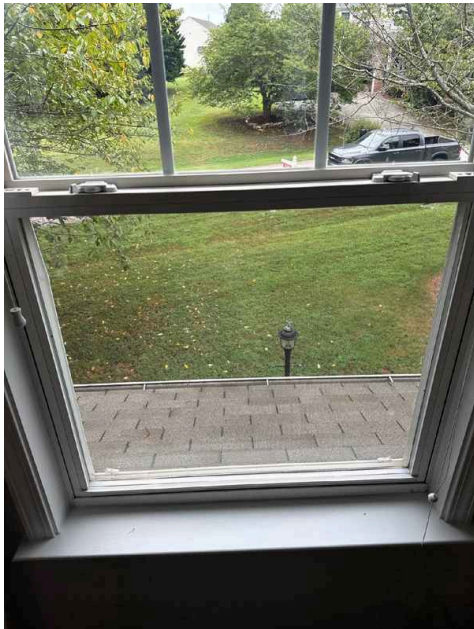
8.3.1 Windows

The window at this location will not stay raised on its own. This is allowing the window to close suddenly, possibly resulting in damage to the window or personal injury. Have the window(s) evaluated and repaired or replaced as deemed necessary by a qualified contractor.

Contact a qualified window repair/installation contractor.

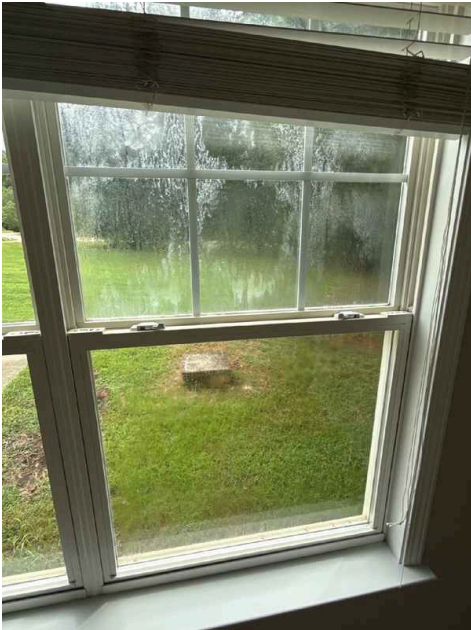
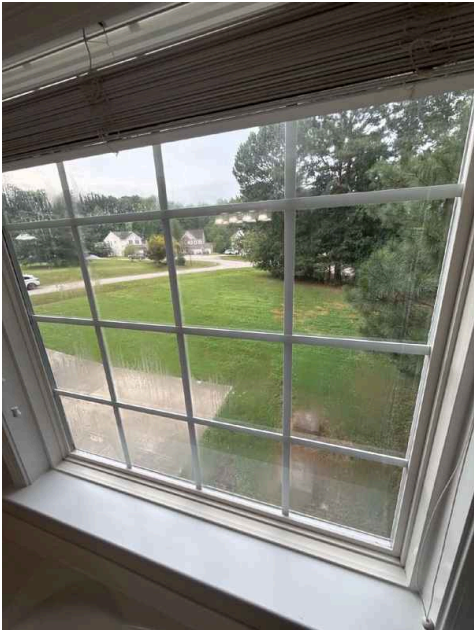
8.3.2 Windows

With the thermal seal compromised energy efficiency is reduced. Have evaluated and repaired or replaced as deemed necessary by a qualified contractor.

Recommendation  
Contact a qualified window repair/installation contractor.

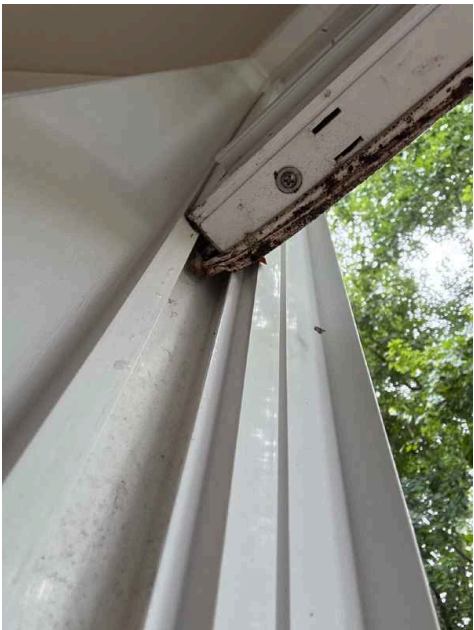
Nook

8.3.3 Windows

The window at this location was not secured in the track at the time of inspection. This can allow the window to become detached when opening. Have evaluated and repaired or replaced as deemed necessary by a qualified contractor.

Recommendation  
Contact a qualified window repair/installation contractor.

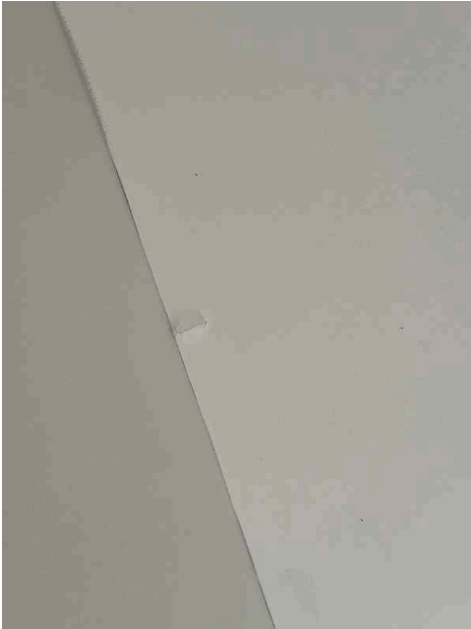
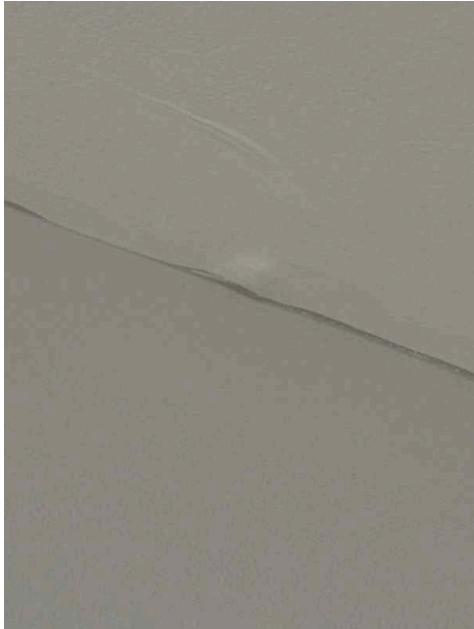
Without repair these nail pops can result in loose building materials. Have evaluated and repaired or replaced as deemed necessary by a qualified contractor.

**Nail pop pictures are representative and not all nail pops observed may be documented.**

Contact a qualified drywall contractor.

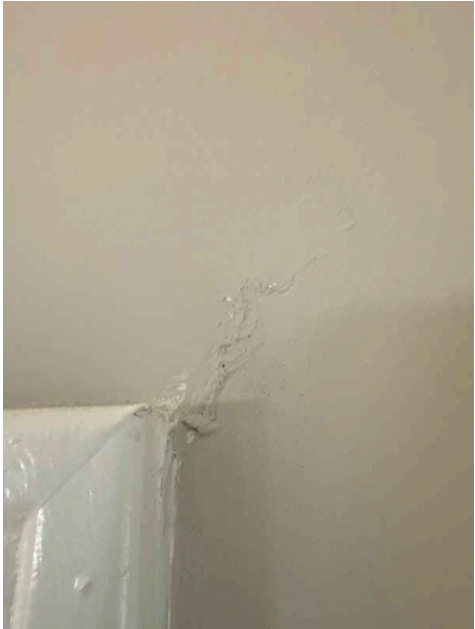
8.5.1 Walls

**HAIRLINE CRACK**

Hairline cracks were found at this location. These cracks are typical and often only require only cosmetic measure to correct. However in rare circumstances this may be a sign of movement. Monitor cracks for any evidence of further separation or growth and/or have evaluated and repaired as/if deemed necessary by a qualified contractor.

Contact a qualified drywall contractor.

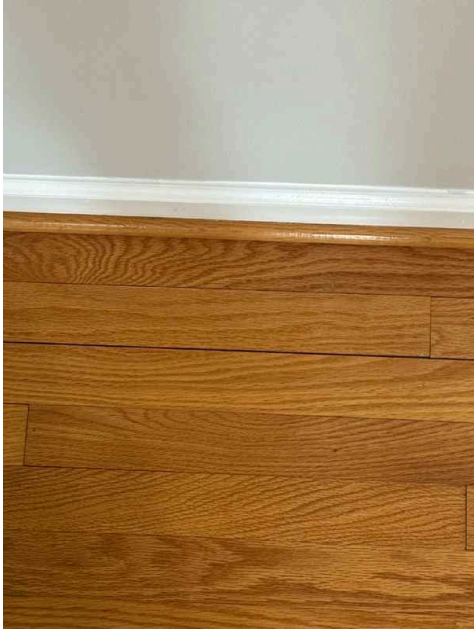
Dining Room

8.6.1 Floors

Gaps were found in the flooring at this location. This can reduce energy efficiency. Have evaluated and repaired or replaced as deemed necessary by a qualified contractor.

Contact a qualified flooring contractor

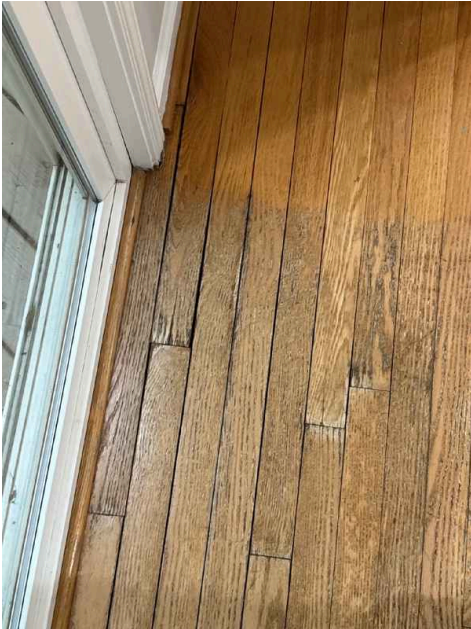
Kitchen

8.6.2 Floors

**DAMAGED FLOORING**

Contact a qualified flooring contractor

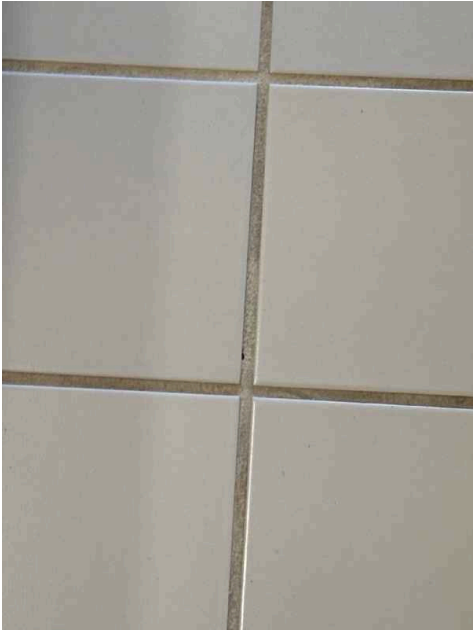
Front Right Bathroom

8.6.3 Floors

Contact a qualified tile contractor

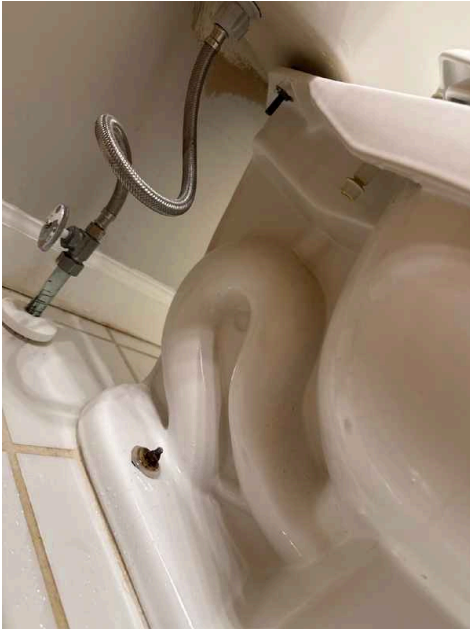
Rear Right Bathroom

8.9.1 Bathrooms

LEAK

Contact a qualified plumbing contractor.

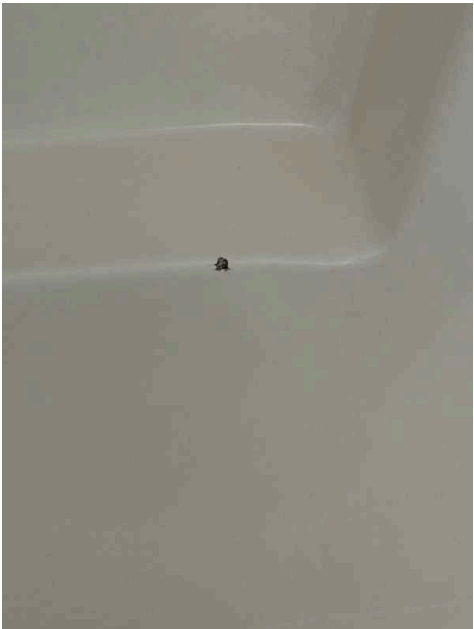
Front Right Bathroom

A chip was observed in the tub/shower. Without repair further damage is likely. Have evaluated and repaired as deemed necessary by a qualified contractor.

Recommendation  
Contact a qualified professional.

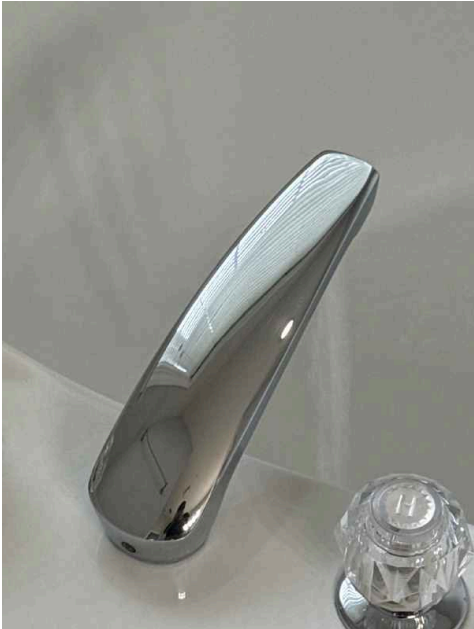
8.9.6 Bathrooms

Loose plumbing parts can result in leaks. Have evaluated and repaired or replaced as deemed necessary by a qualified contractor.

Recommendation  
Contact a qualified plumbing contractor.

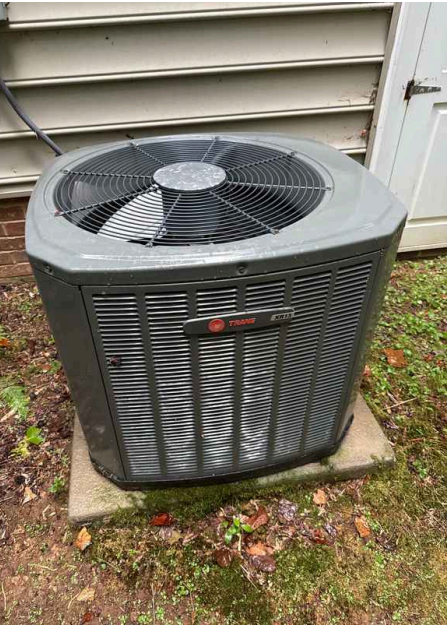
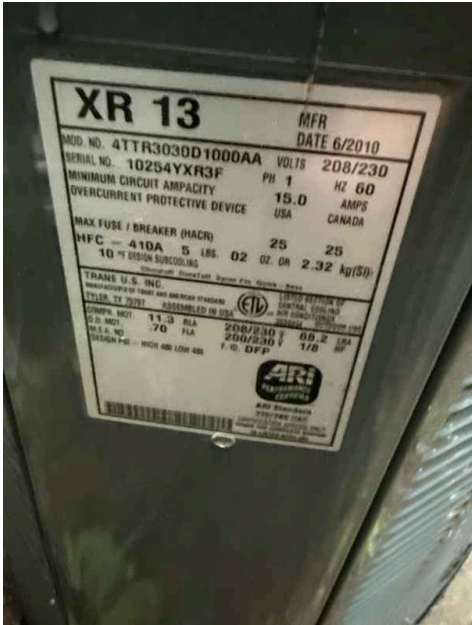
Cooling Equipment: Condenser Unit:

Location: Exterior  
Manufacturer: Trane  
Model#: 4TTR3030D1000AA  
Serial#: 10254YXR3F  
Est Year Manufactured: 2010  
Fuel Source: Electric  
Were Panels Removed (Y/N):N

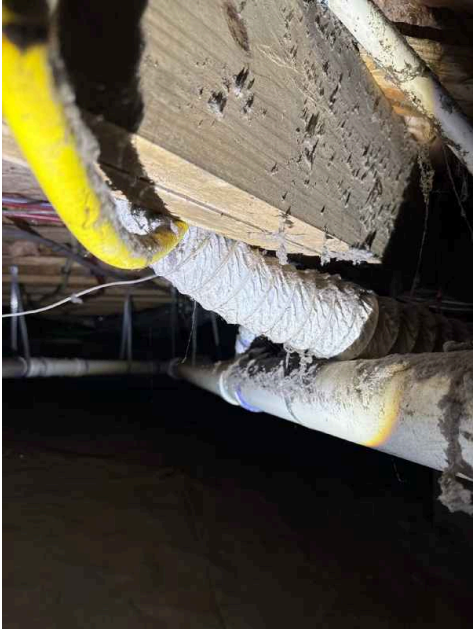
Crawlspace

Flexible dryer vent piping was observed in the crawlspace. Flexible piping has a higher chance of becoming clogged than smooth metal piping creating restricted air flow and in extreme cases a fire hazard. Have a flexible vent replaced with a dryer exhaust product with a smooth interior by a qualified contractor.

Recommendation  
Contact a qualified appliance repair professional.

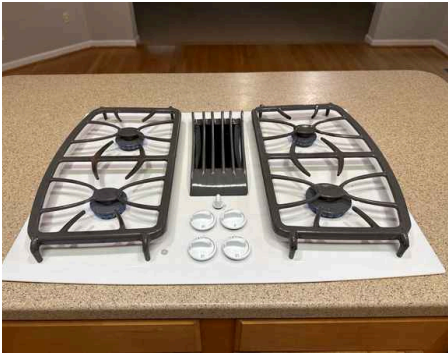
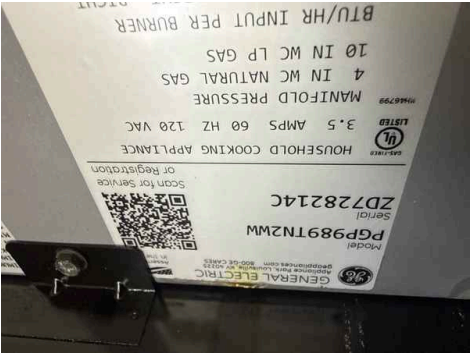
Cooktop: Information

- Brand: GE
- Model: PGP989TN2WW
- Serial: ZD728214C
- Est Year Manufactured: 2014
- Fuel: Natural gas

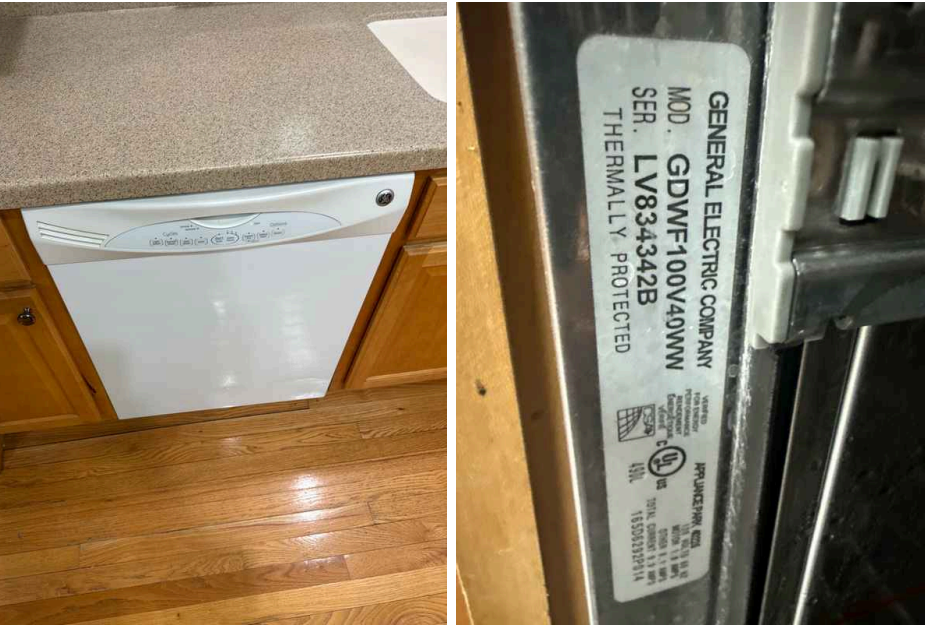
Dishwasher: Information

Brand: GE  
Model: GDWF100V40WW  
Serial: LV834342B  
Est Year Manufactured: 2023

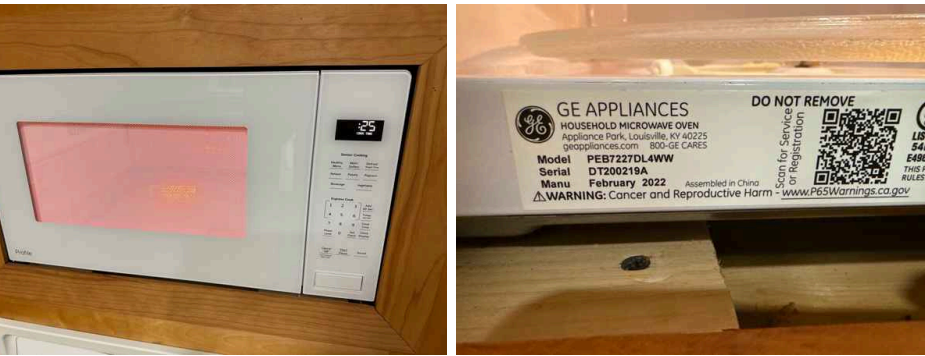
Installed Microwave: Information

Brand: GE  
Model: PEB7227DL4WW  
Serial: DT200219A  
Est Year Manufactured: 2022

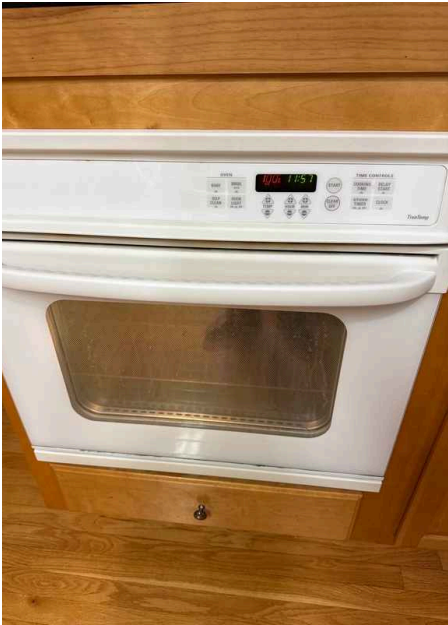
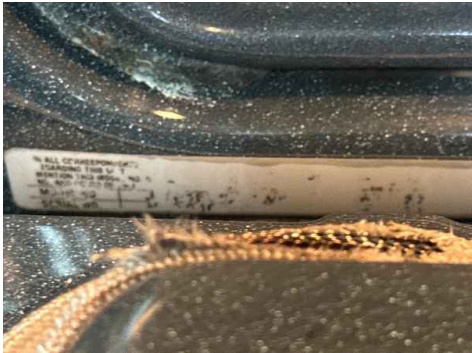
Wall Oven: Information

Brand: GE  
Model:unknown  
Serial: unknown  
Est Year Manufactured: unknown

Wall Oven  
**COULD NOT READ SERIAL NUMBER**
