GUARDIAN INSPECTIONS

## RESIDENTIAL INSPECTION

534 Siltstone Pl  
Cary, NC 27519

05/28/2025

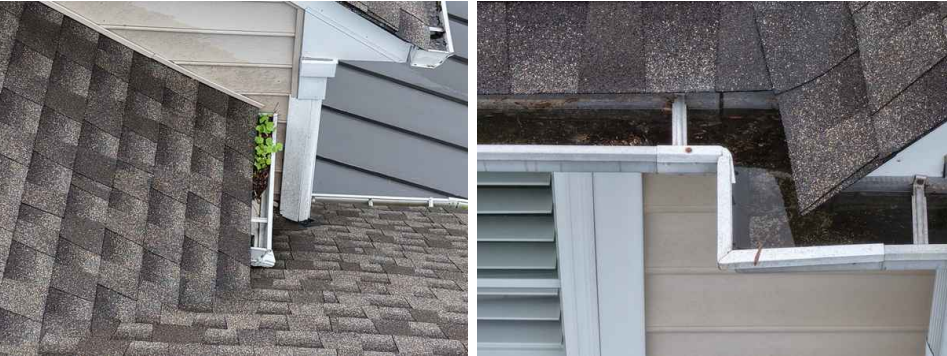
Plant debris was accumulated in the gutters. Water could be unable to properly divert away from the roof structure leading to moisture damage around the fascia and soffit. Recommend cleaning by a qualified contractor.

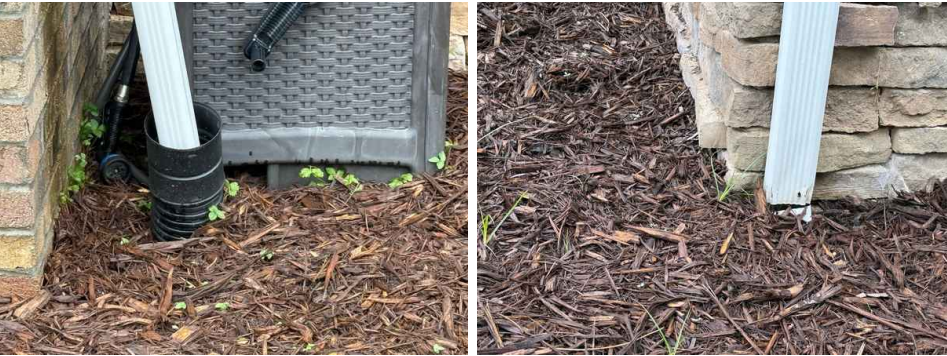
2.2.2 Roof Drainage Systems

**UNDERGROUND DRAINAGE**

Underground drains were present. Drains can collapse or become clogged. Recommend verification of termination points and checking for clear drainage.

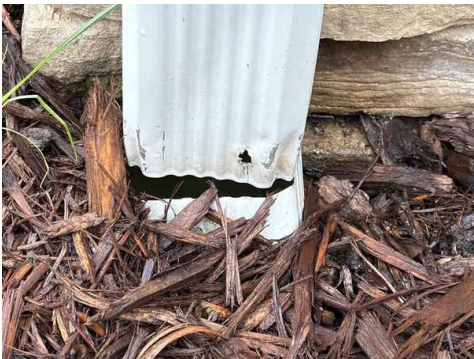
2.2.3 Roof Drainage Systems

**DOWNSPOUT DISCONNECTED**

The downspout was disconnected. This can allow water to drain near the foundation. Recommend repair by a qualified contractor.

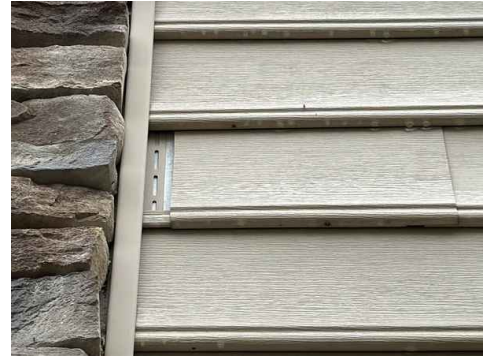
#### LOOSE/SEPARATED SIDING

One piece of siding was observed to be loose. This could cause the siding to further separate or fall off. Recommend repair by a siding contractor.

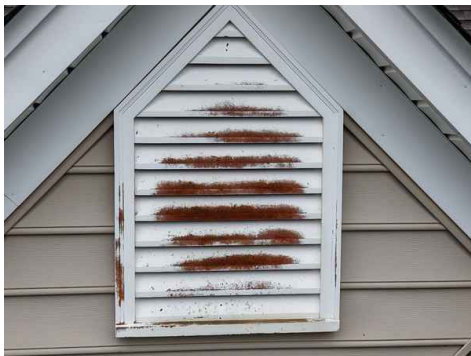
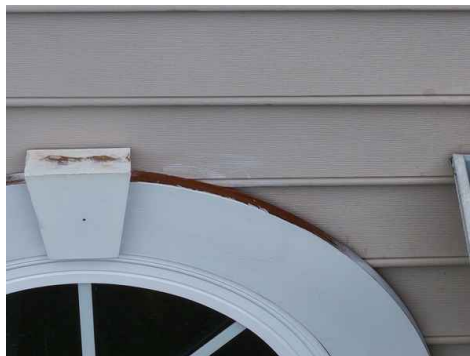
### 3.2.2 Siding, Flashing & Trim

#### PAINT MAINTENANCE NEEDED

Areas of exterior trim were showing signs of normal wear such as fading and chipping. Unprotected surfaces are subject to accelerated wear. Recommend a qualified painter or siding contractor repair.

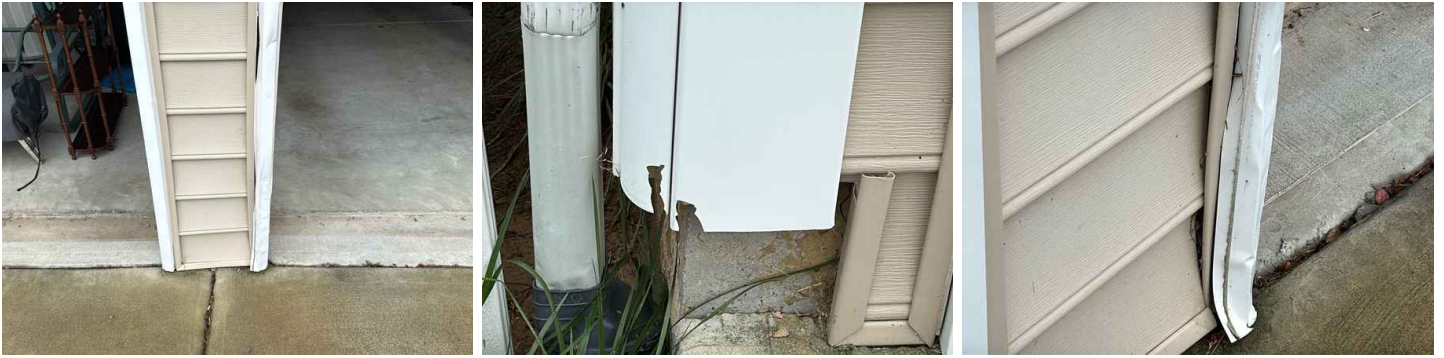
#### DAMAGED SIDING

Areas of the siding were damaged. This could allow moisture behind the siding leading to sheathing or wall damage. Recommend repair by a qualified siding contractor.

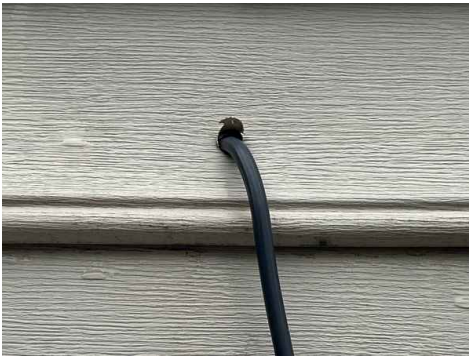
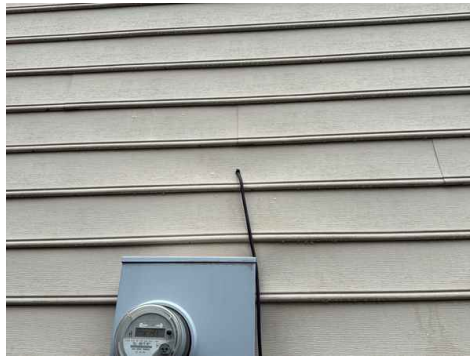
## 3.2.4 Siding, Flashing &amp; Trim

**HOLE IN SIDING**

Cable passing through wall was not sealed. This can allow moisture behind the siding. Recommend sealing by a qualified contractor.

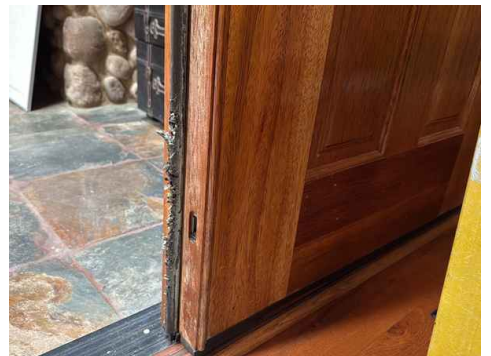
## 3.4.1 Exterior Doors

**DAMAGED WEATHERSTRIPPING**

Weatherstripping at door was damaged. This can allow conditioned air to escape the home. Recommend replacement with new weatherstripping by a qualified contractor.

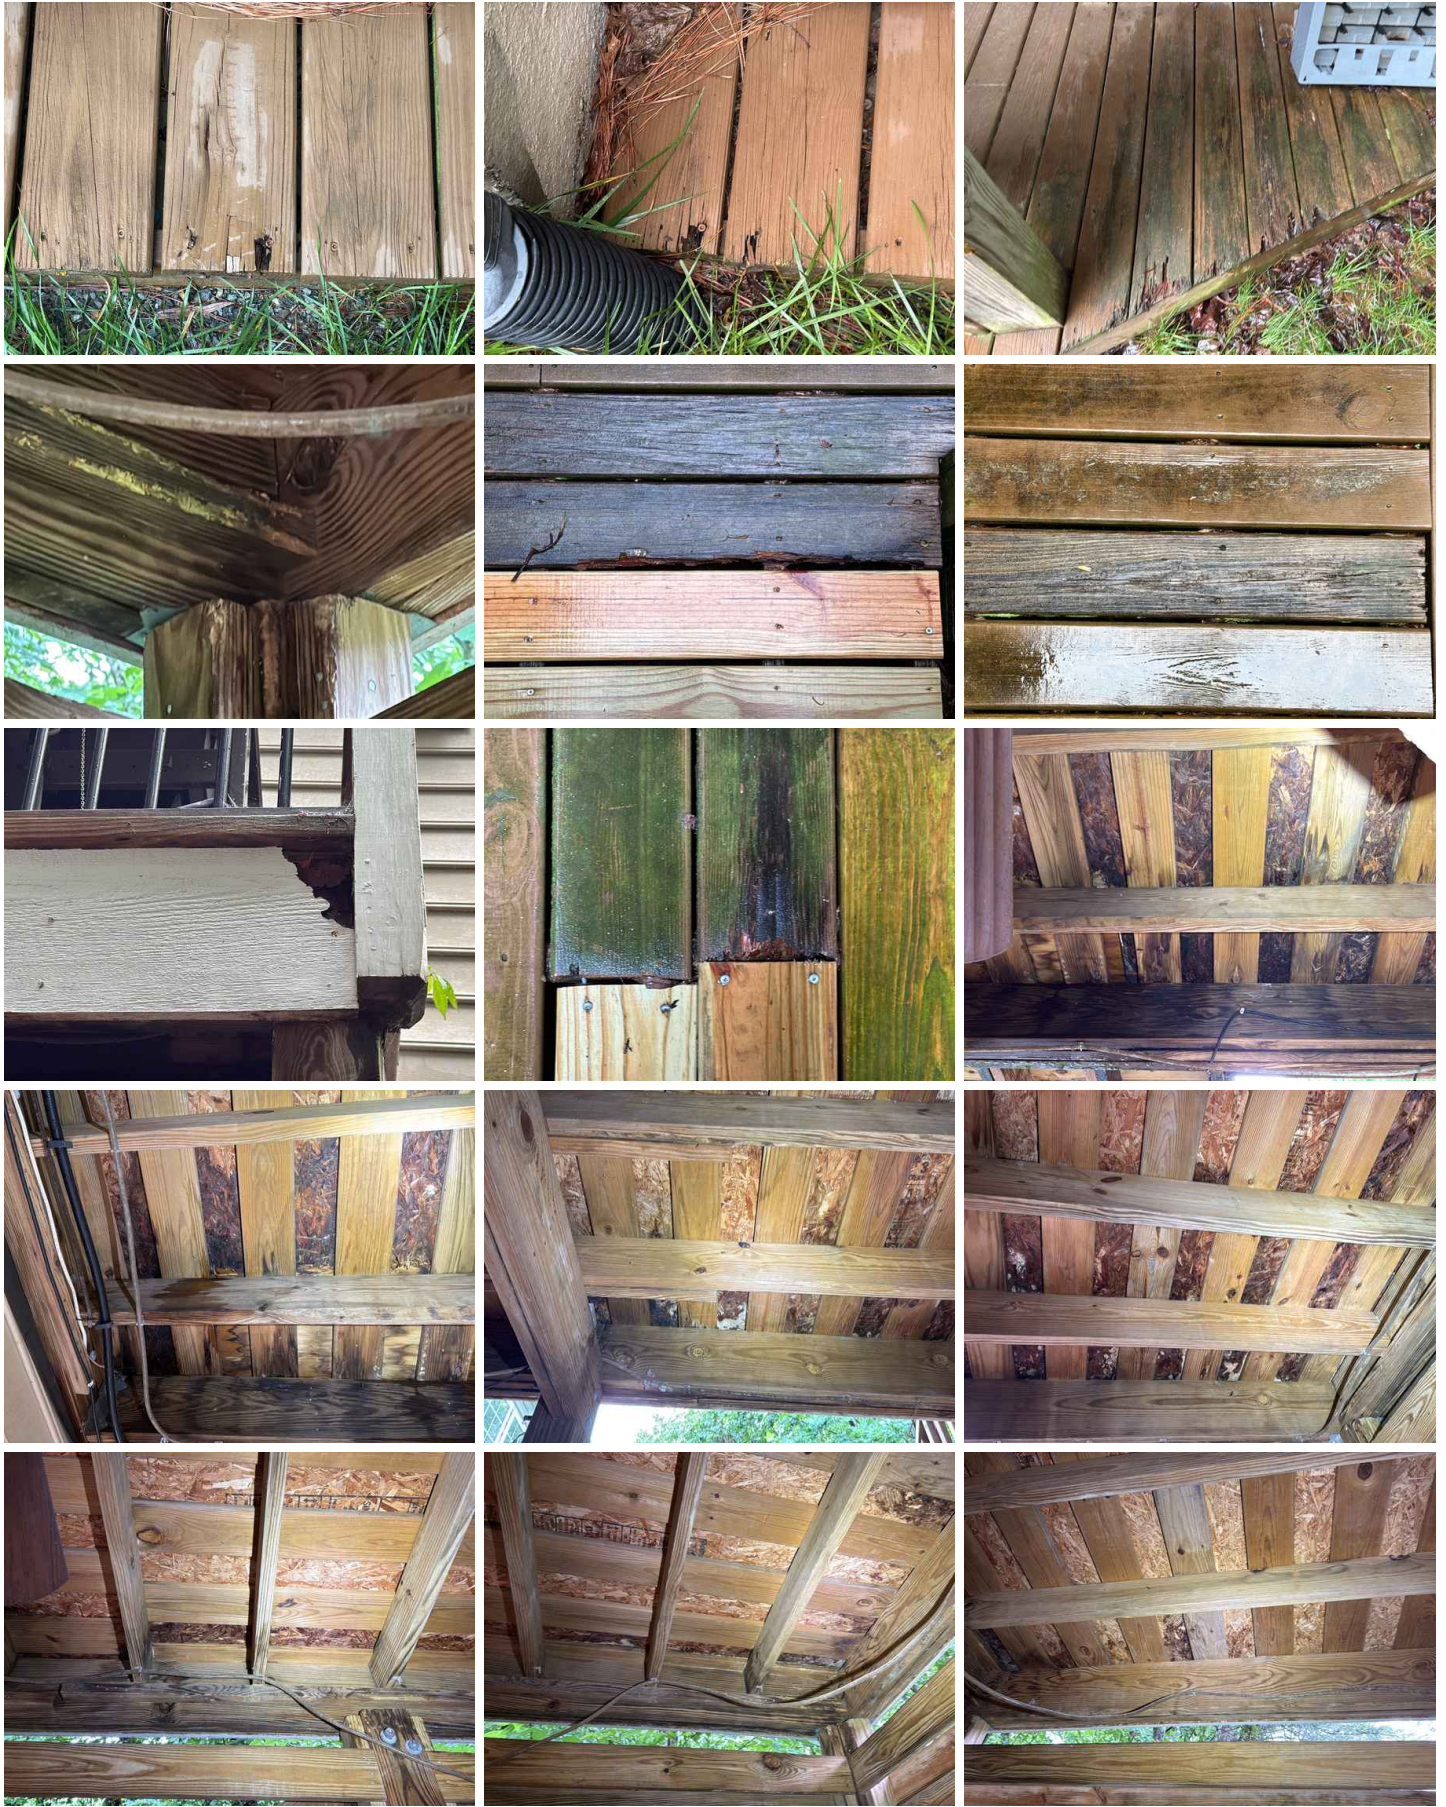
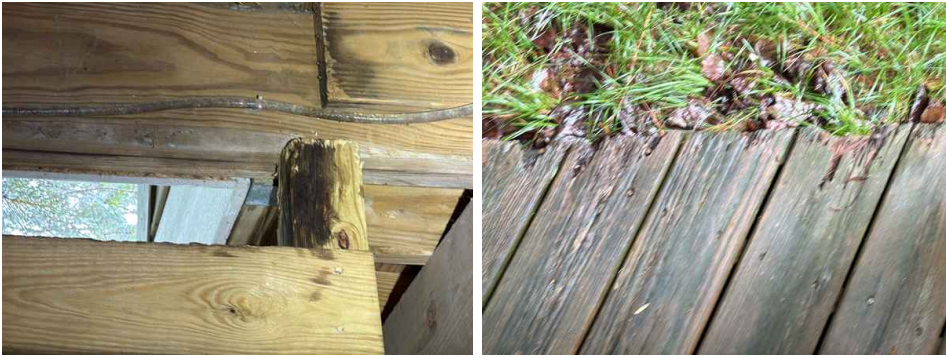
## 3.5.1 Decks, Balconies, Porches &amp; Steps

**DECK - ROTTED BOARDS**

One or more deck boards are showing signs of rot. Boards can fail under weight. Recommend a qualified deck contractor replace all compromised deck boards

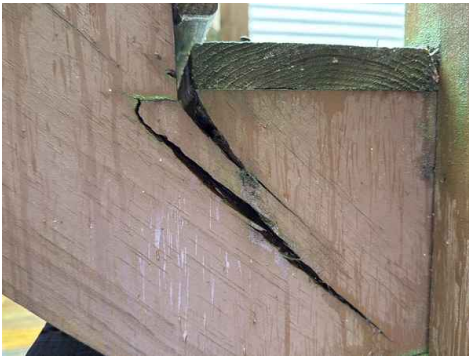
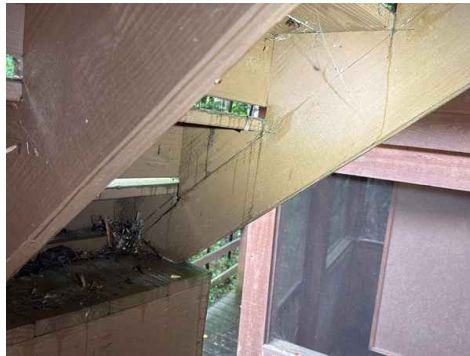
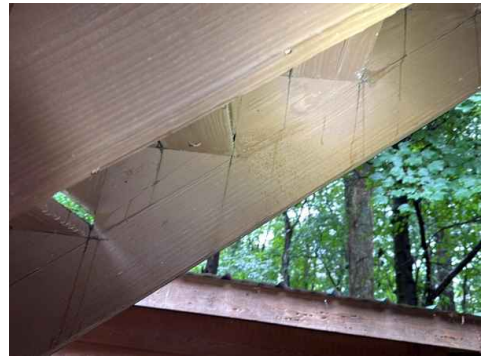
### 3.5.2 Decks, Balconies, Porches & Steps

#### **STRINGER CRACKED**

Stringer on rear porch staircase was cracked. This can lower the ability of the stairs to support weight. Recommend repair by a qualified contractor.

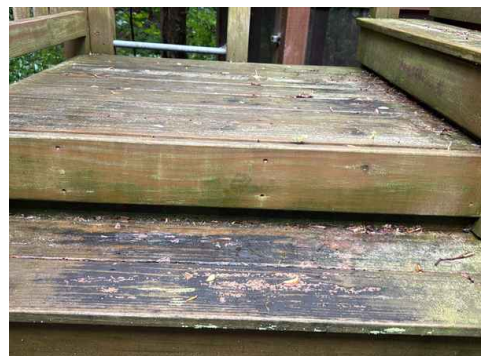
### 3.5.3 Decks, Balconies, Porches & Steps

#### **ALGAE ON STEPS**

Algae was present on the stairs of the back deck and patio area. This can be a slip hazard. Recommend cleaning by a qualified contractor.

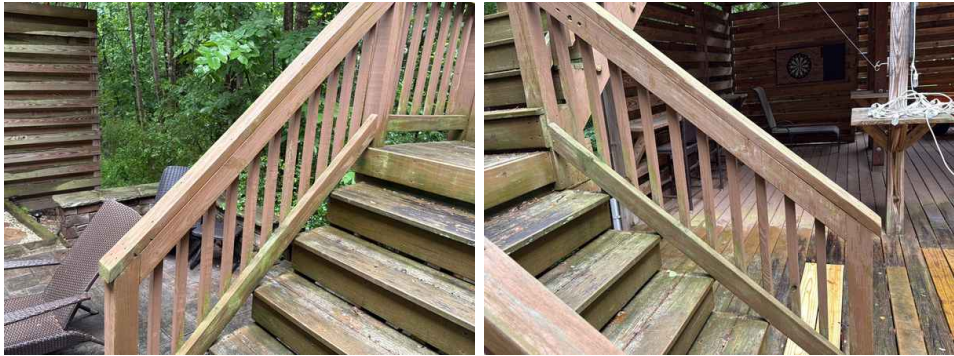
### 3.5.4 Decks, Balconies, Porches & Steps

#### **LOOSE HANDRAIL**

Handrails were loose. This could fail to support the designed load. Recommend repair by qualified contractor.

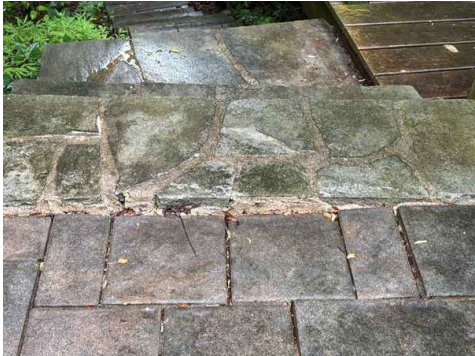
3.5.5 Decks, Balconies, Porches & Steps

**TRIP HAZARD**

Paver had sunk approximately 1 inch at stairs. This is a trip hazard. Recommend repair by a qualified contractor.

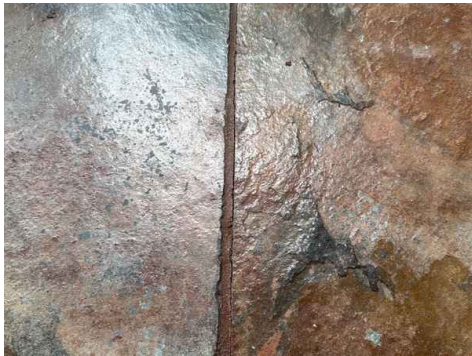
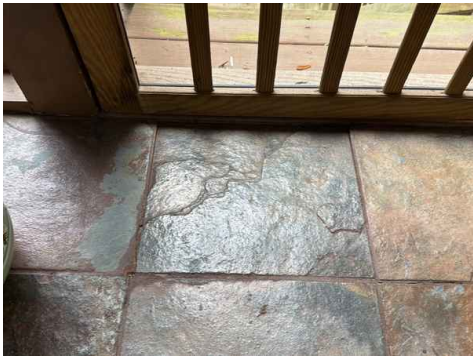
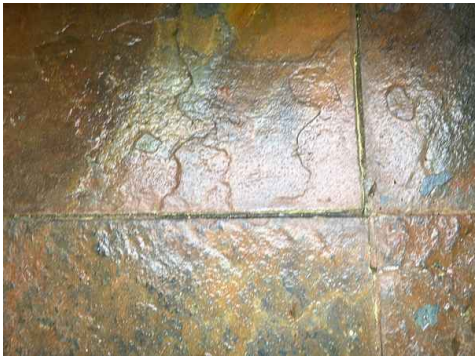
3.5.6 Decks, Balconies, Porches & Steps

**MORTAR CRACKED**

The mortar was cracked in several locations. This could continue to crack and deteriorate. Recommend repair by a qualified contractor.

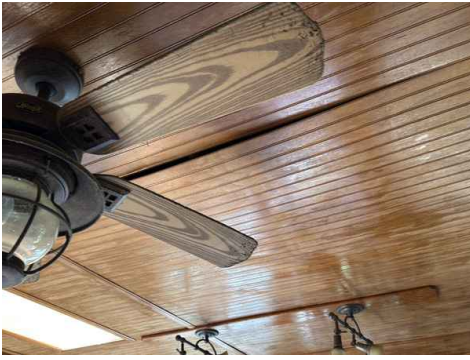
3.5.7 Decks, Balconies, Porches & Steps

**LOOSE CEILING PANEL**

Ceiling panel was loose. Panel can continue to loosen and become disconnected. Recommend repair by a qualified contractor.

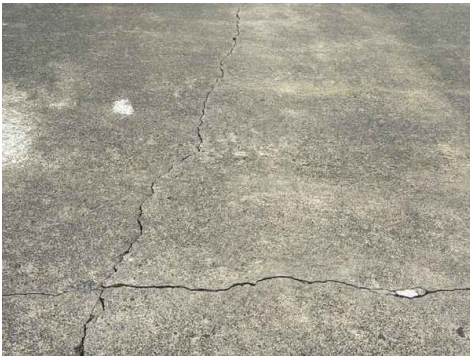
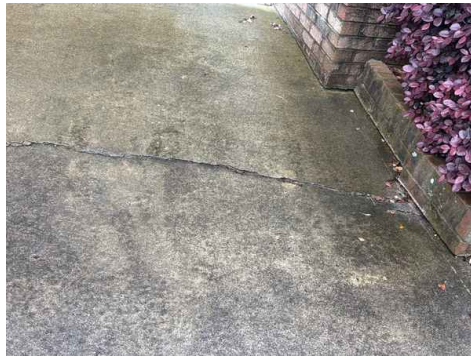
### 3.6.1 Walkways & Driveways

#### **DRIVEWAY CRACKING - MODERATE**

Moderate cracking was present in the driveway. This can be due to age related deterioration or settlement. Recommend repair by a qualified concrete contractor.

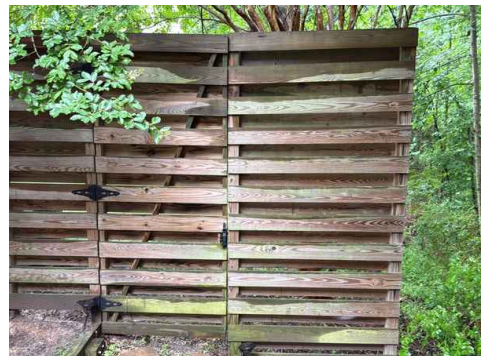
### 3.8.1 Fencing

#### **GATE MISALIGNED**

The gate leading to the left exterior was out of alignment. This can make operation difficult. Recommend repair by a qualified contractor.

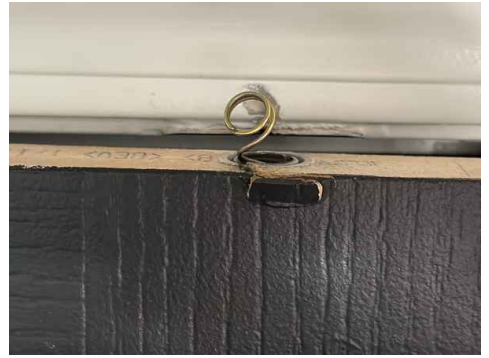
**DOOR DAMAGED**

Closet door were missing retaining balls on top. This can prevent operation and closing as intended. Recommend repair by a qualified carpentry contractor.

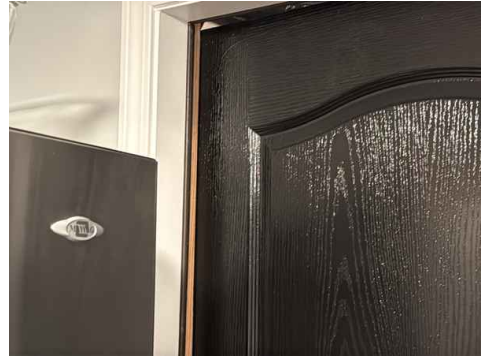
## 4.2.2 Doors

**DOOR WAS RUBBING FRAME**

Door was rubbing frame and difficult to close. This can wear on the door and worsen if not corrected. Recommend repair by a qualified contractor.

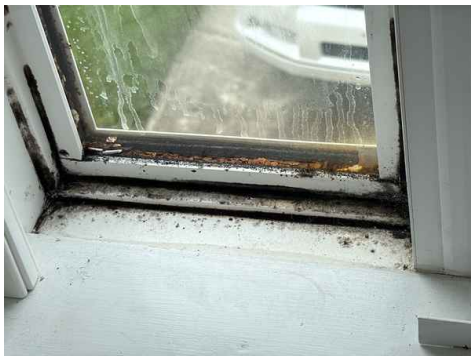
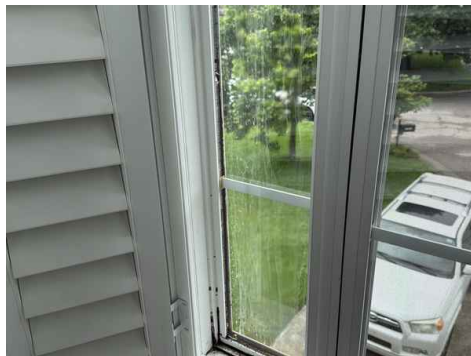
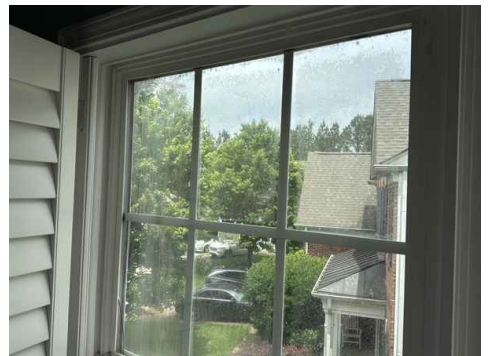
## 4.3.1 Windows

**FAILED WINDOW SEAL**

Observed evidence of condensation and discoloration between the window panes. This can indicate a failed seal which lowers the windows efficiency to insulate. Operation of the window was not affected. Recommend qualified window contractor repair or replace.

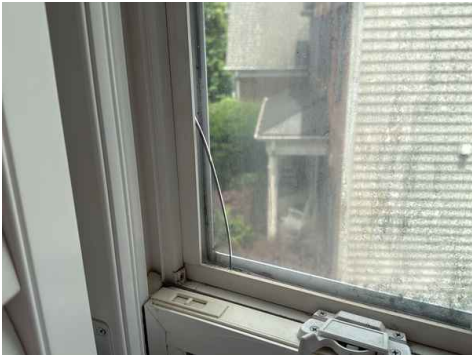
## 4.3.2 Windows

**BROKEN WINDOW GLASS**

Window pane was broken. Recommend replacement by a qualified window contractor.

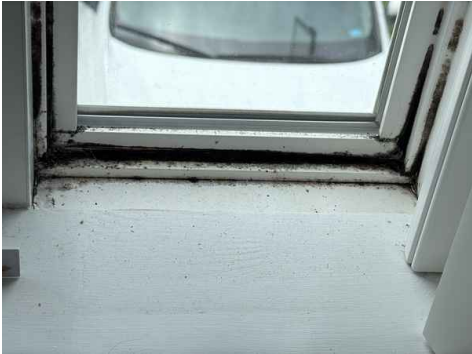
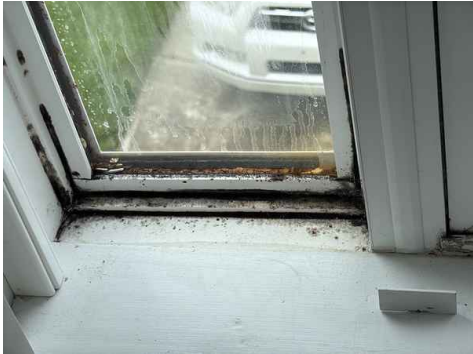
4.3.3 Windows

ORGANIC GROWTH

Possible organic growth was observed in the window seal. This was not identified and any hazard is unknown. Recommend cleaning by a qualified contractor.

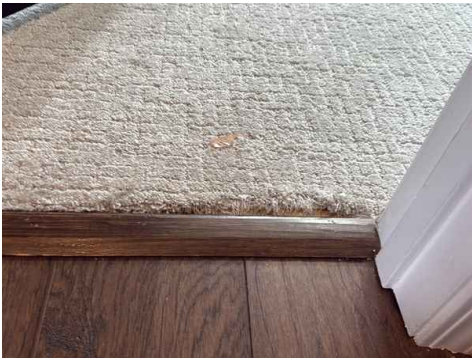
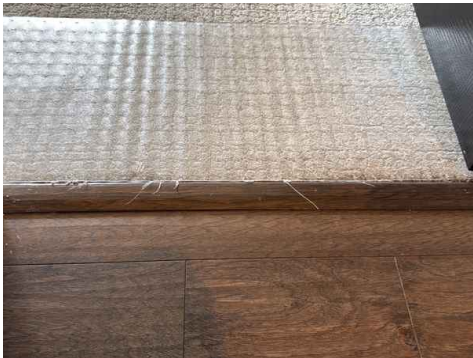
4.4.1 Floors

DAMAGED CARPET

Carpet was damaged in several areas on the upstairs level. Carpet can continue to peel leading to further damage recommend repair by a qualified flooring contractor.

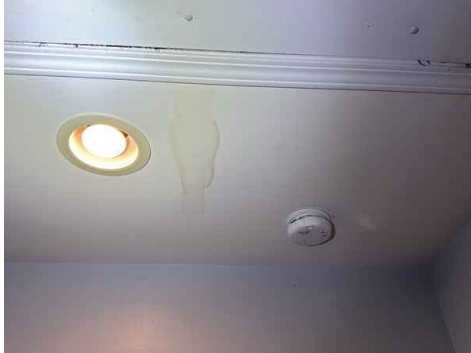
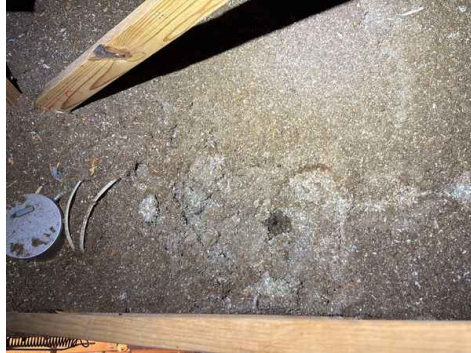
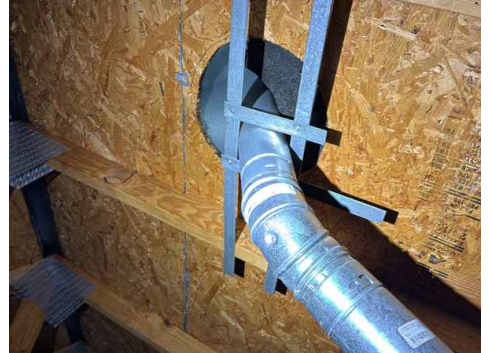
## 4.6.1 Ceilings

**ACTIVE LEAK**

Water staining was present in the upstairs hallway. Moisture reading was dry at the time of the inspection. However the attic insulation directly above was slightly wet. Recommend repair by a qualified contractor.

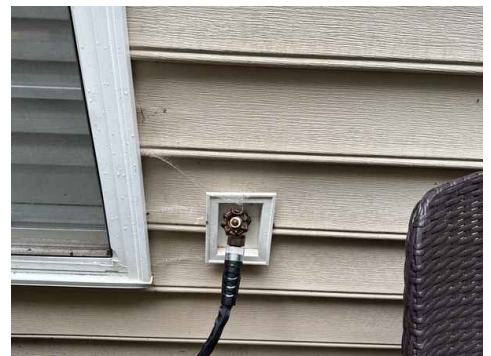
### HOSE BIB LOOSE

Hose bib was not secured to home adequately. This could lead to a water leak due to excessive movement. Recommend repair by a licensed plumbing contractor.

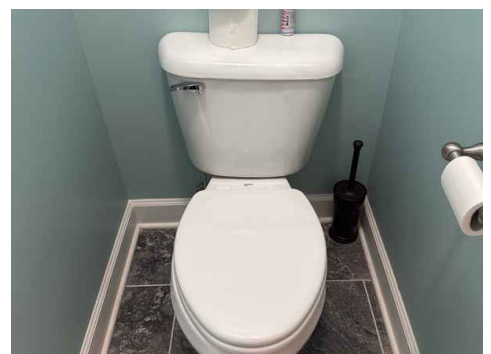
### 10.4.2 Water Supply, Distribution Systems & Fixtures

### TOILET MOUNT LOOSE

Toilet was not tightly mounted and could be moved. This can cause leaking and floor damage. Recommend repair by a qualified plumbing contractor.

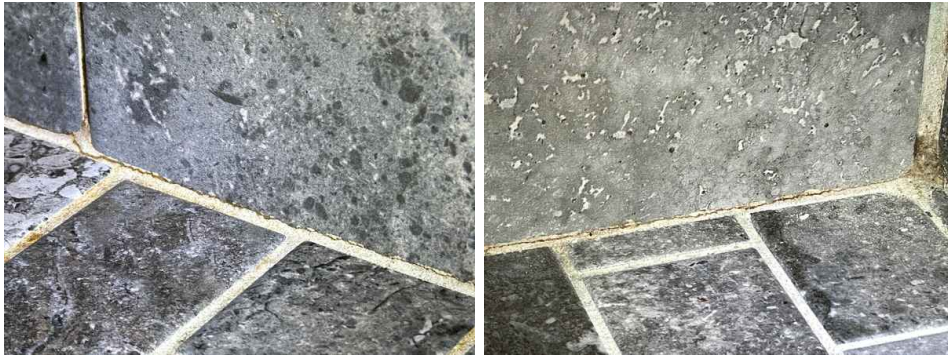
## 10.4.3 Water Supply, Distribution Systems &amp; Fixtures

**RECOMMEND CAULKING INSIDE CORNERS**

Cracks were observed on the inside corner of the shower. This can allow water behind the tile leading to further damage. Recommend caulking of all inside corners by a qualified contractor.

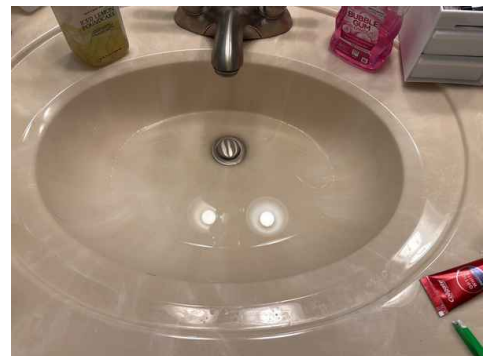
## 10.5.1 Drain, Waste, &amp; Vent Systems

**BATHROOM SINKS SLOW DRAINING**

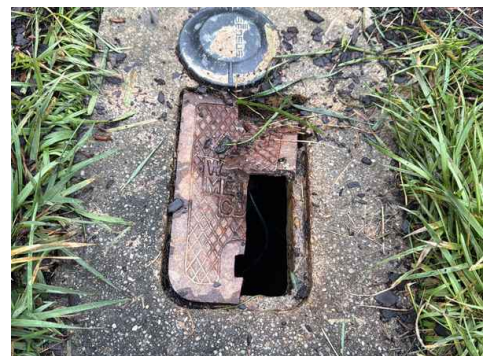
## 10.8.1 Sprinkler System

**METER COVER DAMAGED**

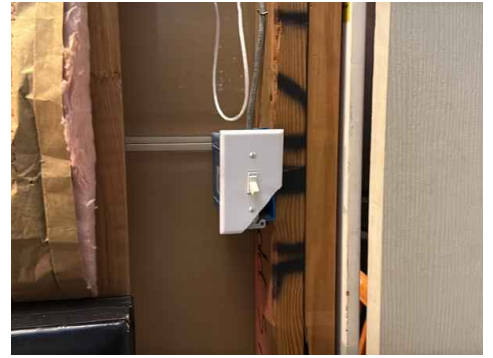
**COVER PLATES DAMAGED**

One or more receptacles have a damaged cover plate. Recommend replacement.

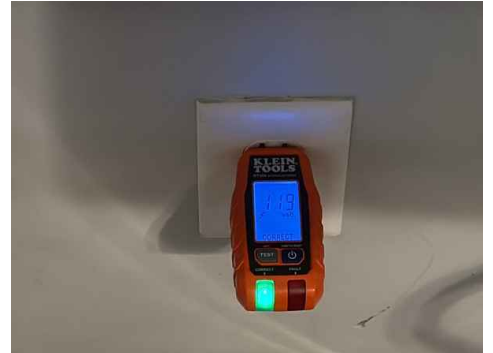
## 11.5.2 Lighting Fixtures, Switches &amp; Receptacles

**LOOSE WALL RECEPTACLE**

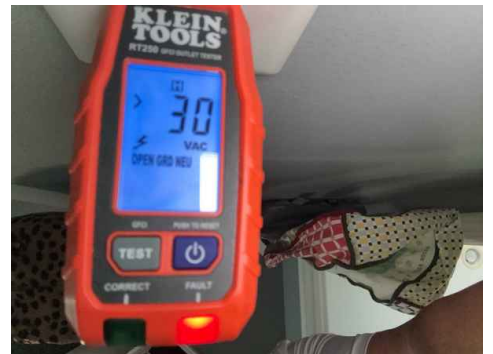
## 11.5.3 Lighting Fixtures, Switches &amp; Receptacles

**OUTLET ERROR OPEN GROUND**

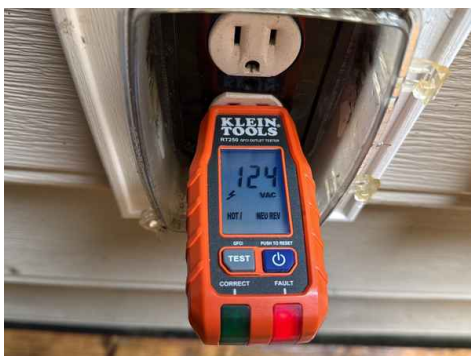
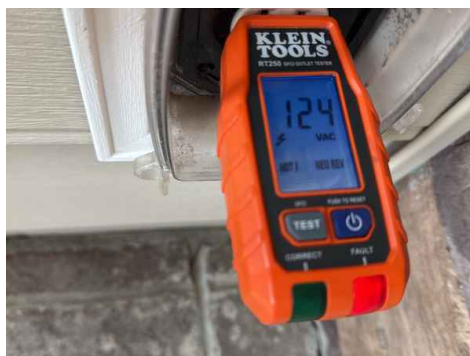
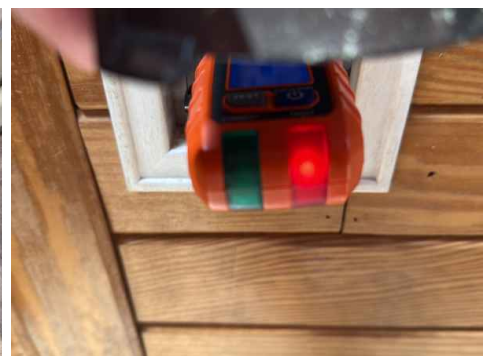
## 11.5.4 Lighting Fixtures, Switches &amp; Receptacles

**HOT AND NEUTRAL REVERSED**

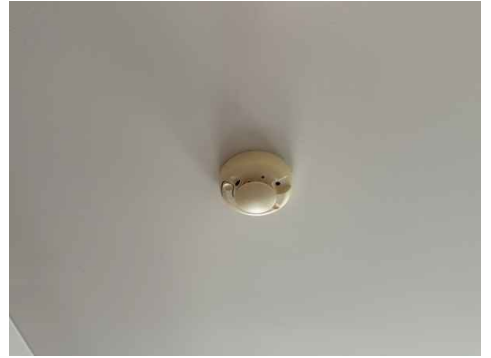
## 11.7.1 Smoke Detectors

**OLD SMOKE DETECTOR**

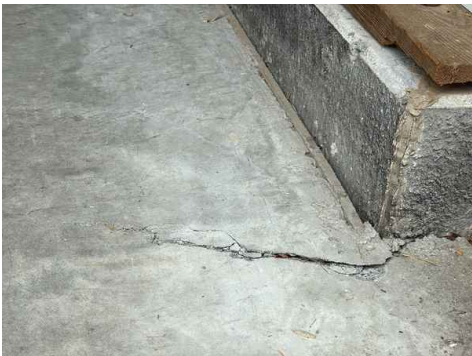
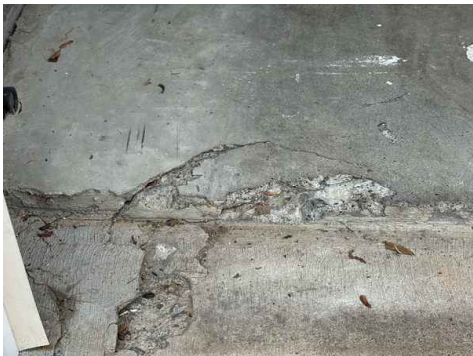
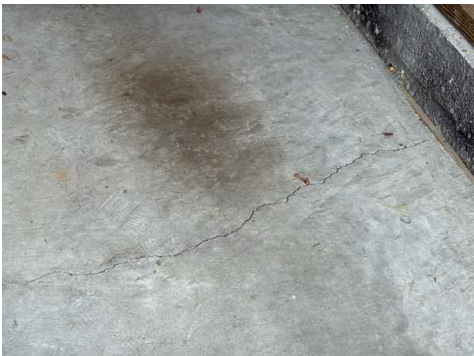
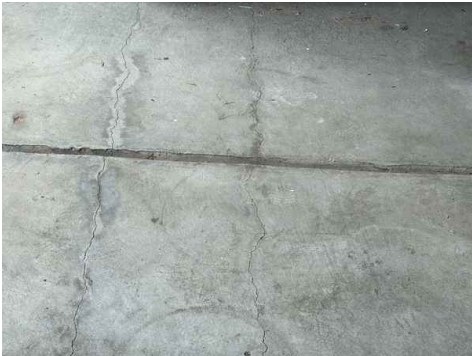
16.4.1 Floor

CRACKING - MAJOR

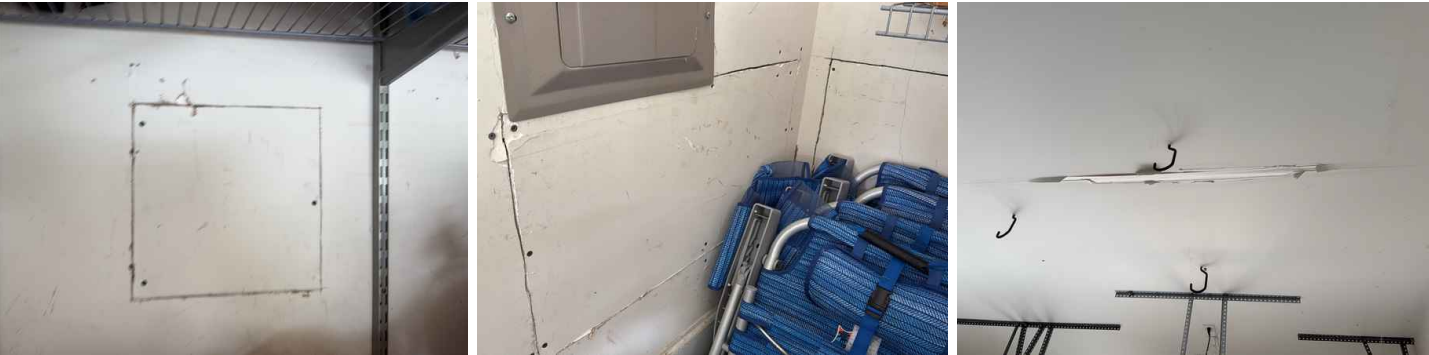
16.5.1 Walls & Firewalls

DAMAGED DRYWALL

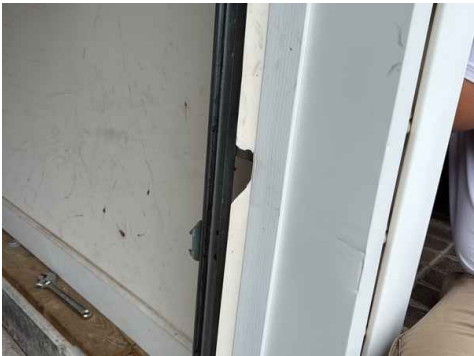
16.6.1 Garage Door

DAMAGED WEATHER SEAL
