# START TO FINISH HOME INSPECTIONS LLC

## **General Information**

**BUILDING ADDRESS:** 1414 E Lenoir Street  
**CITY:** Raleigh  
**STATE / PROVINCE:** NC  
**POSTAL CODE:** 27610  
**INSPECTION DESCRIPTION:** Single family home/vacant  
**SQUARE FOOTAGE:** 1152  
**Picture:**

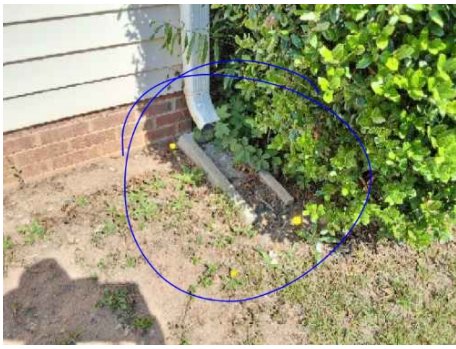
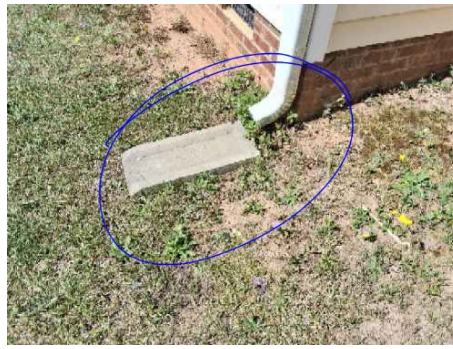
Gutter System

Fair

Recommend downspout extension pipe to discharge water away from the foundation structure

**Recommend downspout extension pipe to discharge water away from the foundation structure**

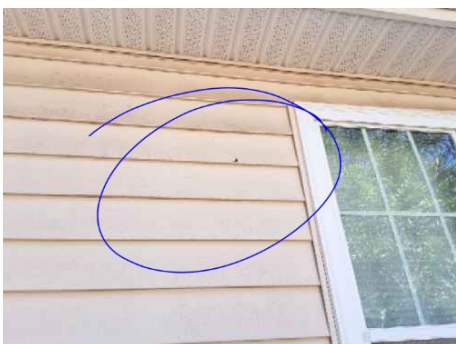
Vinyl siding

Damaged section of vinyl

Recommend repair to prevent water penetration from entering causing deterioration to exterior walls

Recommend professional contractor to evaluate

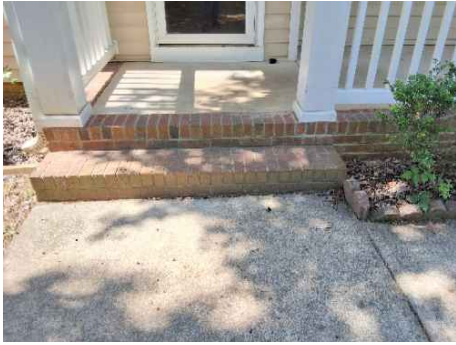
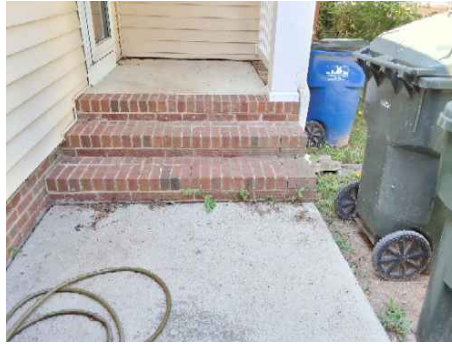
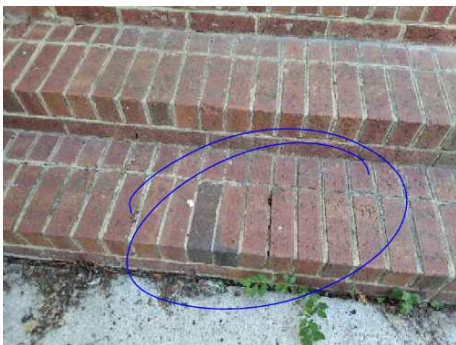
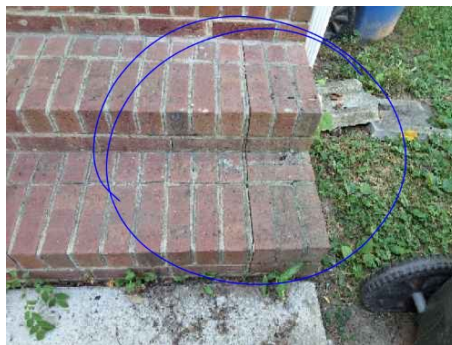
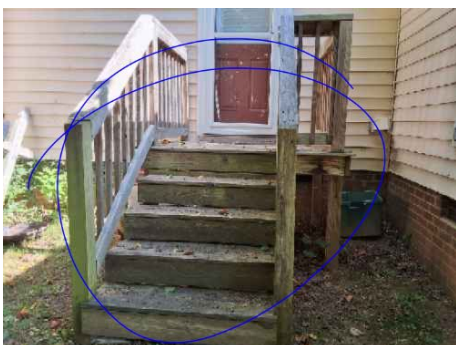
Brick steps and wood steps

Missing mortar in brick joints

Wood steps

Recommend cleaning and sealing all exposed wood members from the elements

Recommend professional contactor to evaluate further

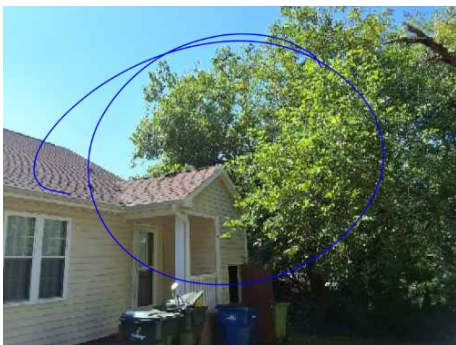
Trees are on the roof structure

Recommend trimming back to prevent damage to roof structure

Recommend professional contractor to evaluate further

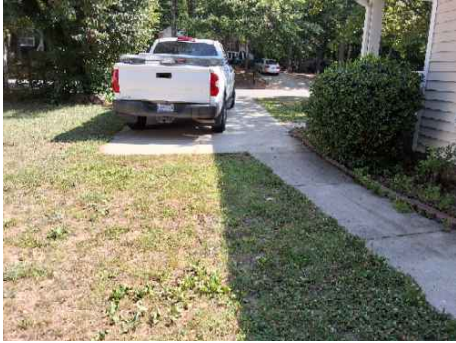
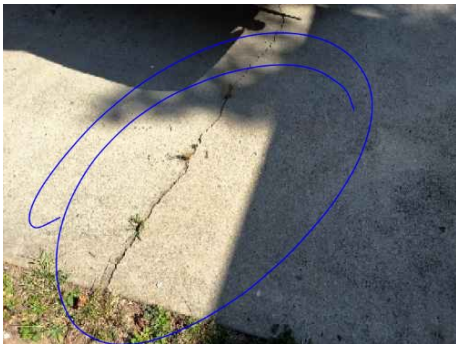
Settling cracks in driveway

Multiple areas of Settling cracks

Recommend repair to prevent water penetration from entering causing deterioration and expansion further

Recommend professional contactor to evaluate

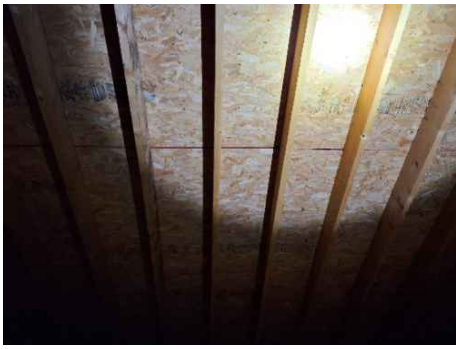
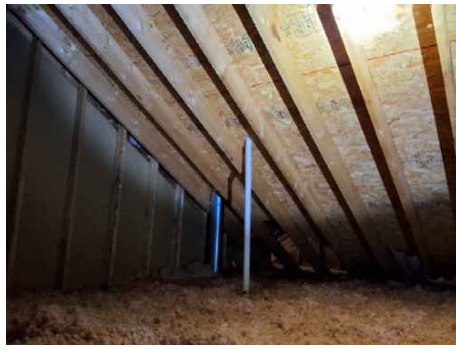
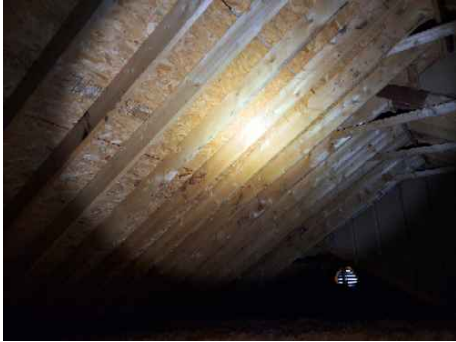
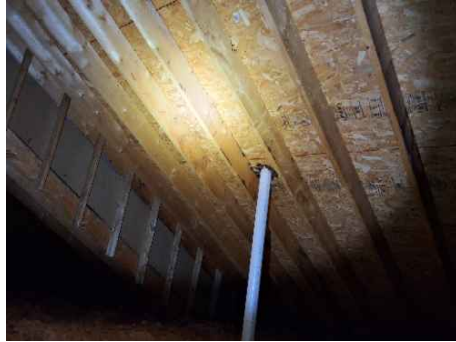
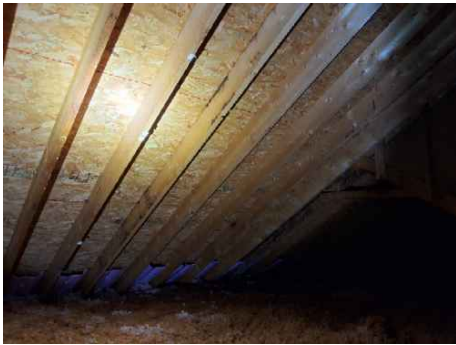
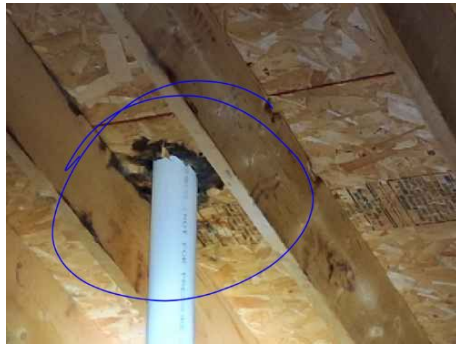
Water stains around pvc vent pipe

Osb plywood roof sheathing

Recommend professional contactor to evaluate further

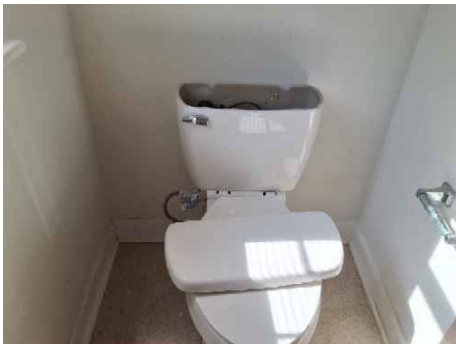
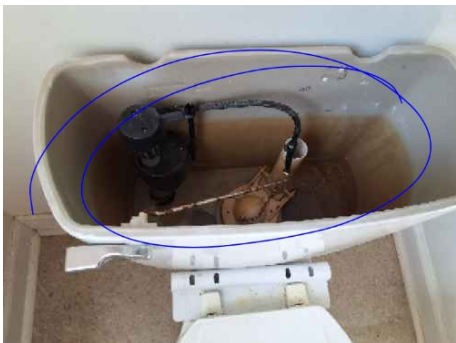
Toilet

No water supply to toilet tank, possible broken shut off value

Recommend licensed plumber to evaluate further

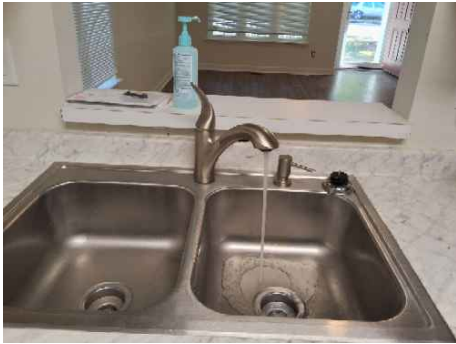
Leaking water supply and drainage lines

Recommend repair to prevent cabinet damage

Recommend licensed plumber to evaluate further

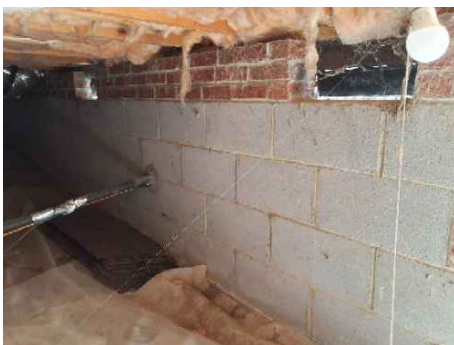
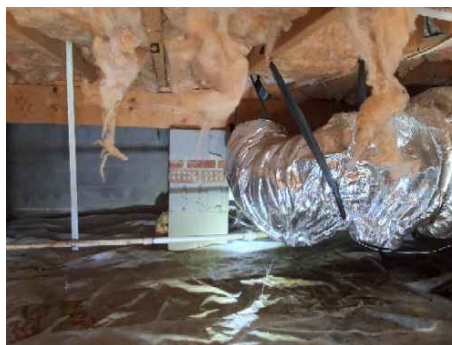
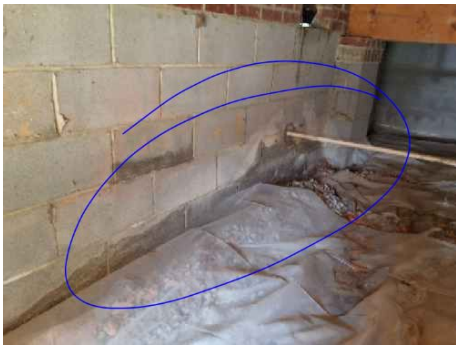
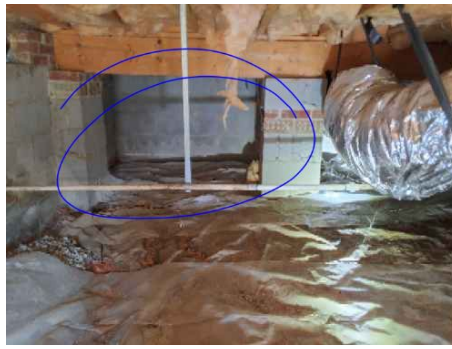
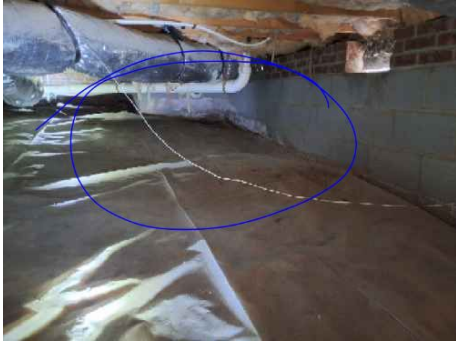
Brick veneer and brick and block foundation walls and piers

White efflorescence on foundation walls appears water penetration has occurred

Recommend professional foundation service to evaluate further

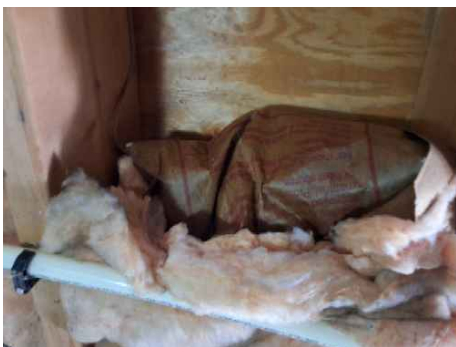
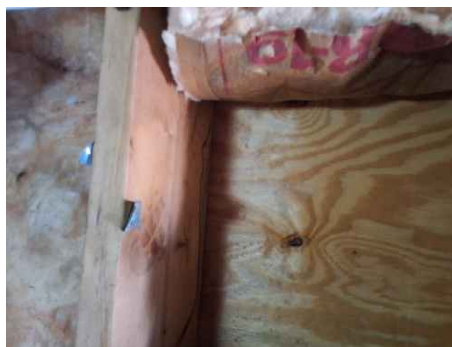
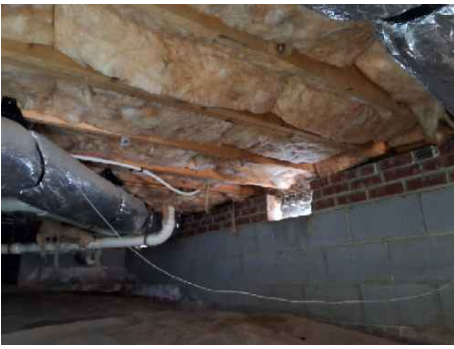
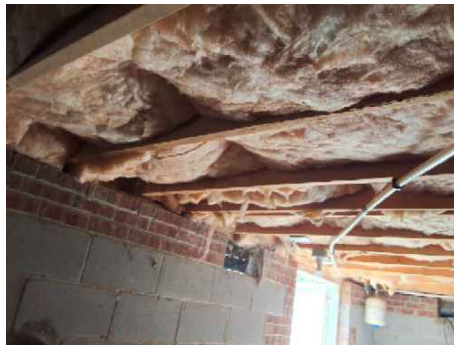
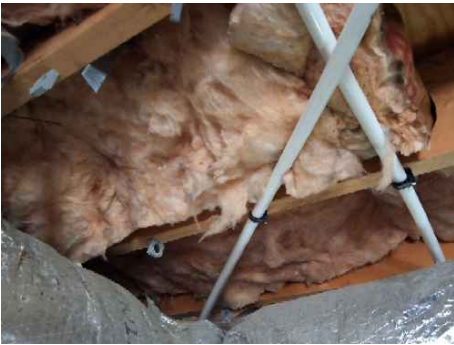
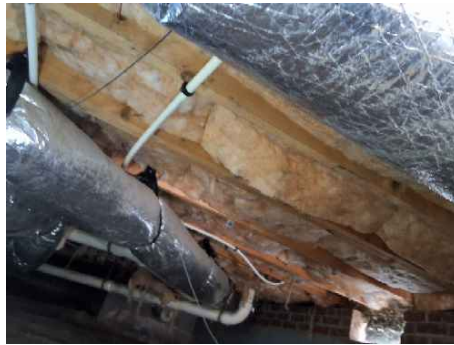
Wood girders/ wood joist/ plywood wood sub floor/ insulation between joist/ vapor barrier present

20% moisture levels reading to all wood structural components

Micro growth on all wood structural components

Micro growth on all insulation

Recommend professional foundation service and licensed General contractor to evaluate Further

To prevent future damage

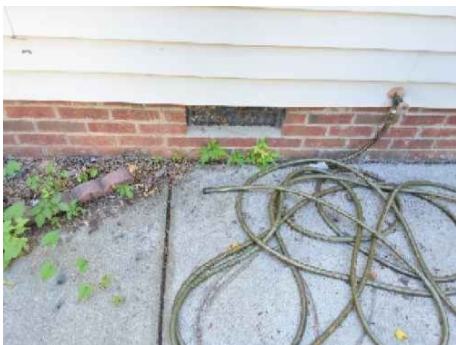
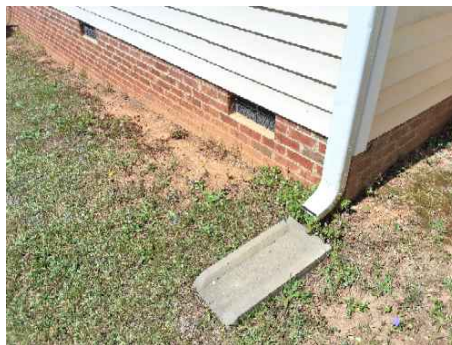
Foundation wall vents

Low foundation vents require foundation vent wells To prevent water penetration from entering crawl space

Recommend professional contractor to evaluate further

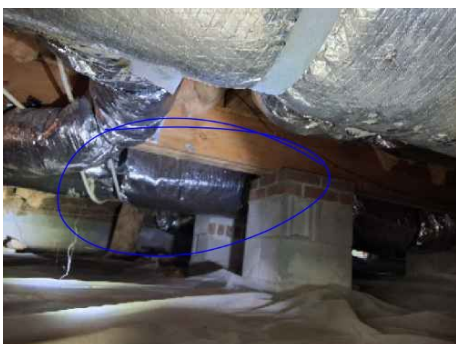
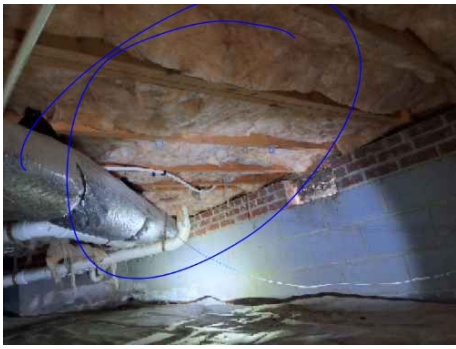
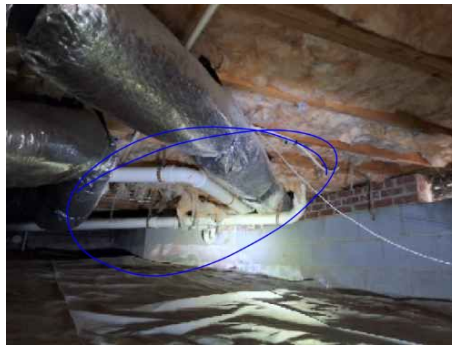
20 % moisture levels reading to all wood structural components

Micro growth on all wood structural components

Micro growth on all insulation/ wet insulation

Recommend professional foundation service and licensed General contractor to evaluate Further

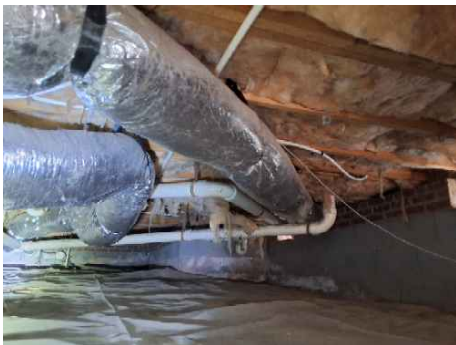
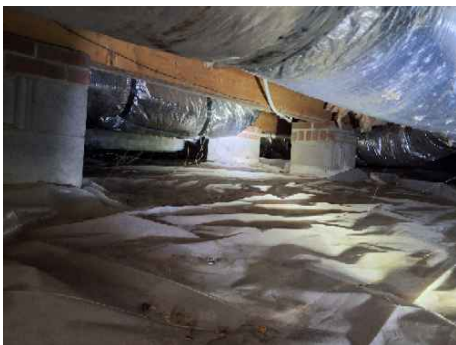
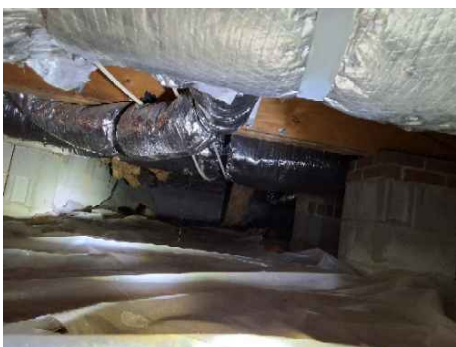
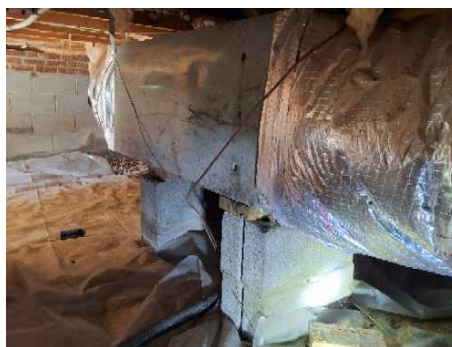
Damaged return air supply line not able to pull air

Recommend cleaning hvac duct lines very dirty

Recommend repair

Recommend licensed HVAC technician to evaluate further

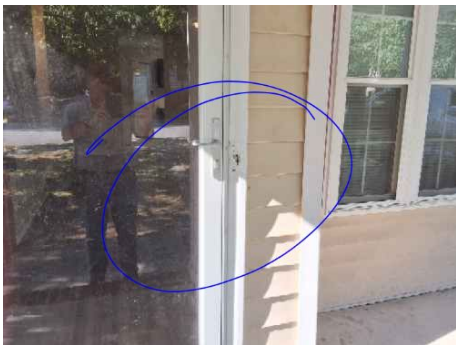
Front door bell

Damaged door bell

Not operating

Recommend licensed electrician to evaluate further
