## INSPECTION REPORT BY ADVANCED QUALITY INSPECTIONS

1240 Grenshaw Dr  
Morrisville, NC 27560

06/15/2026

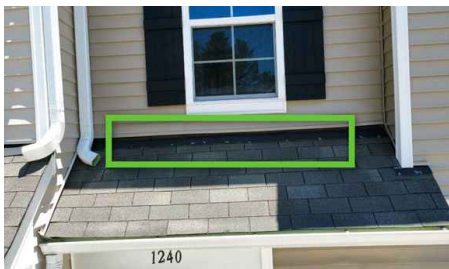
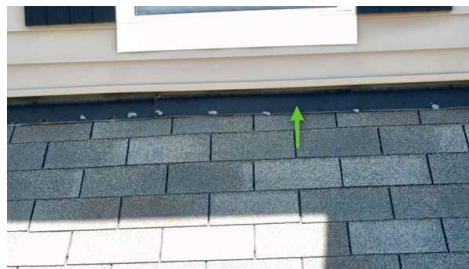
## Flashing: Material

Aluminum, Rubber, Various

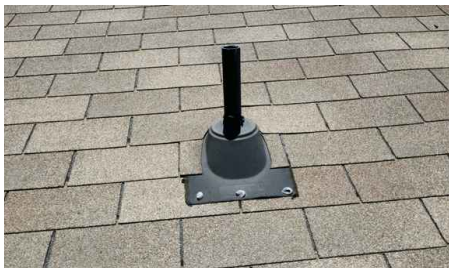
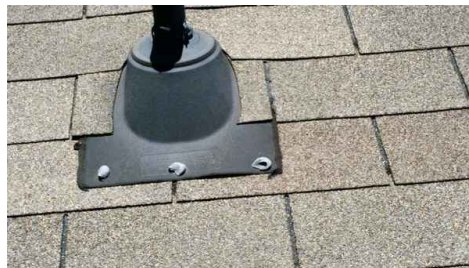
## Plumbing Vent Pipes: Plumbing Vent Pipes Inspected

I looked at DWV (drain, waste and vent) pipes that pass through the roof covering. There should be watertight flashing (often black rubber material) installed around the vent pipes. These plumbing vent pipes should extend far enough above the roof surface.

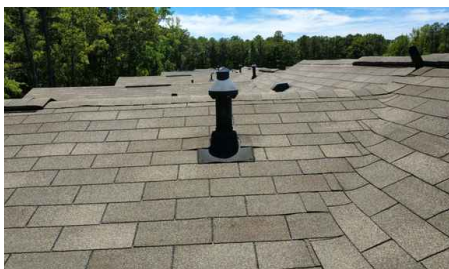
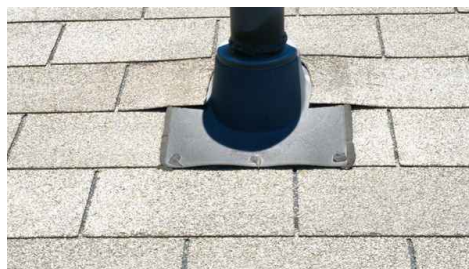
## Flue Gas Vent Pipes: Flue Gas Vent Pipe Inspected

I looked at flue gas vent pipes that pass through the roof covering.

All gas-fired appliances must be connected to venting systems. There should be watertight metal flashing installed around the flue gas vent pipes. The vent pipes should extend far enough above the roof surface.

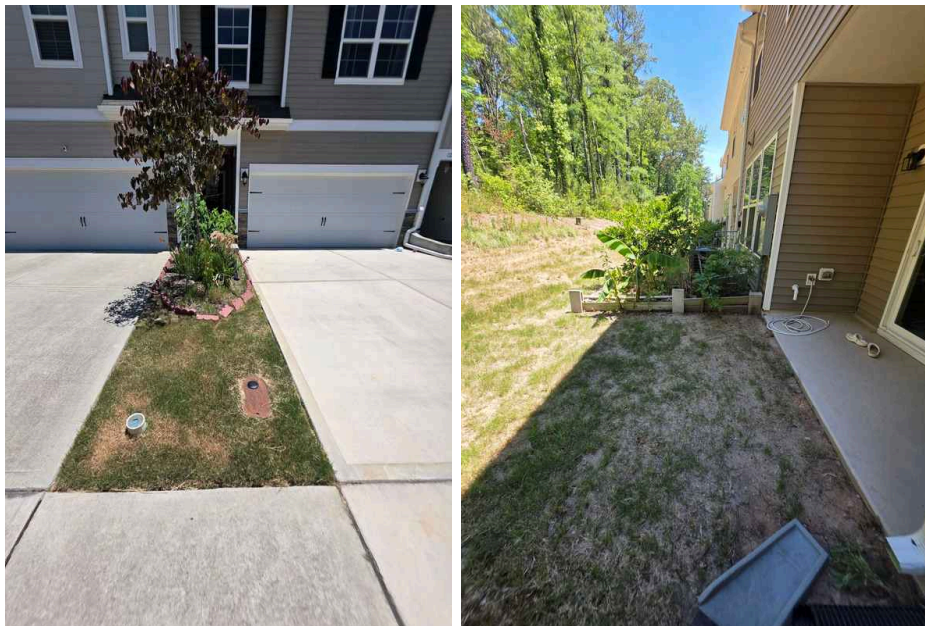
## Vegetation, Surface Drainage, Retaining Walls & Grading: Vegetation, Drainage, Walls & Grading Were Inspected

I inspected the vegetation, surface drainage, retaining walls and grading of the property, where they may adversely affect the structure due to moisture intrusion.

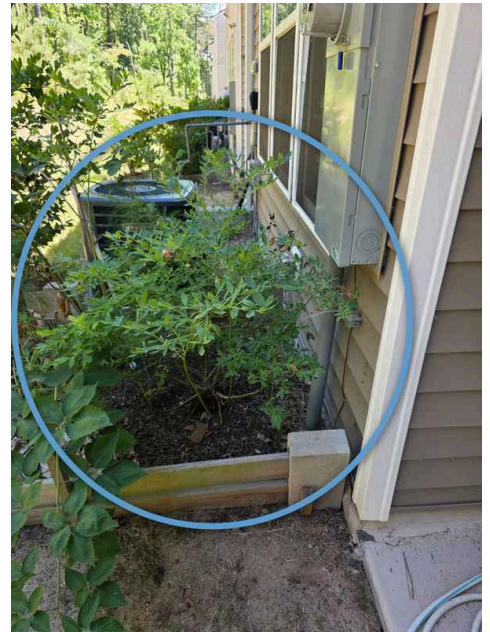
I observed dense vegetation in areas. This condition limited and restricted my visual inspection. Dense vegetation and landscaping up against or near the foundation and exterior walls may be prone to water penetration and insect infestation.

Trimming, pruning and some landscaping is recommended.

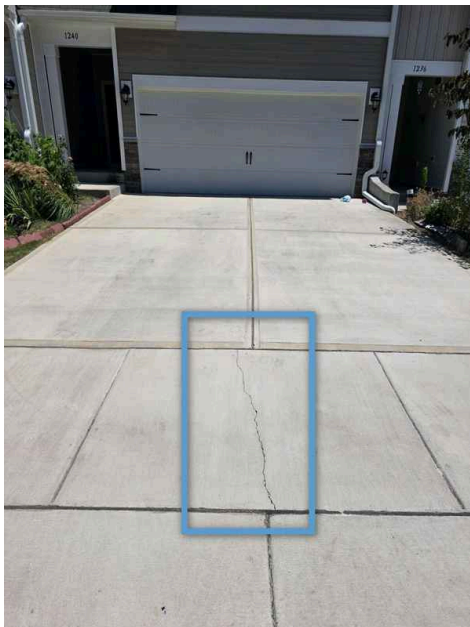
### 3.3.1 Walkways, Patios & Driveways

#### DRIVEWAY CRACKING - MINOR

Minor, typical cracks observed in driveway. Recommend sealing cracks to prevent further deterioration of material.

Recommend monitoring.

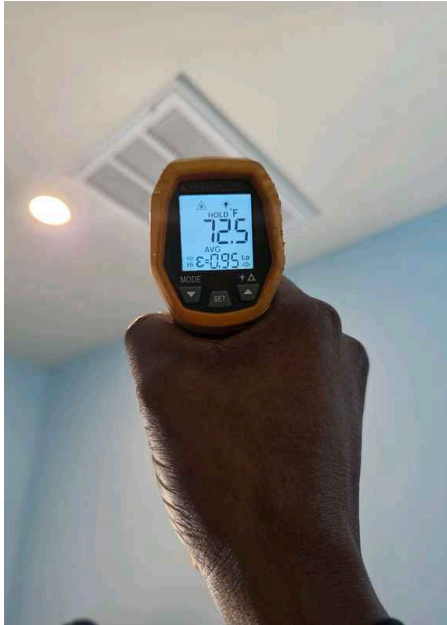
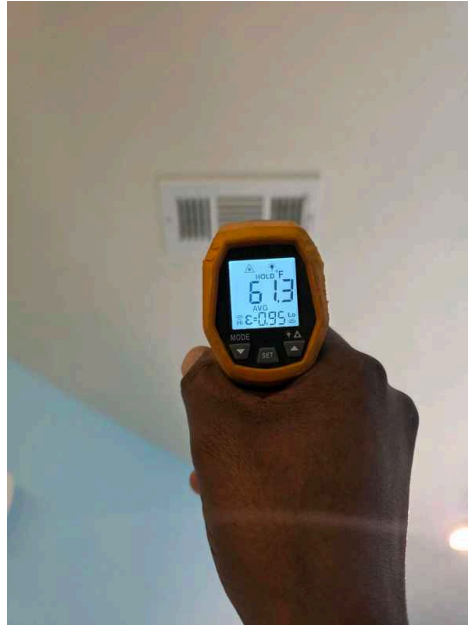
## Cooling System Information: Delta T

Less Than 16°F

The return and supply air temperature was measured.

While there isn't any perfect temperature you should set your HVAC system to, there is an ideal temperature difference between the supply and return air, which should be between 16 and 22 degrees Fahrenheit. This difference in temperature is the evaporator Delta T.

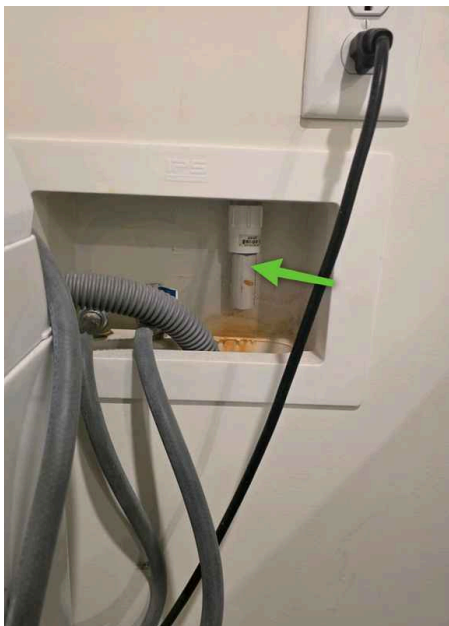
## Condensate: Condensate Discharge Confirmed

I observed a discharge pipe apparently connected to the condensate pump installed at the cooling system.

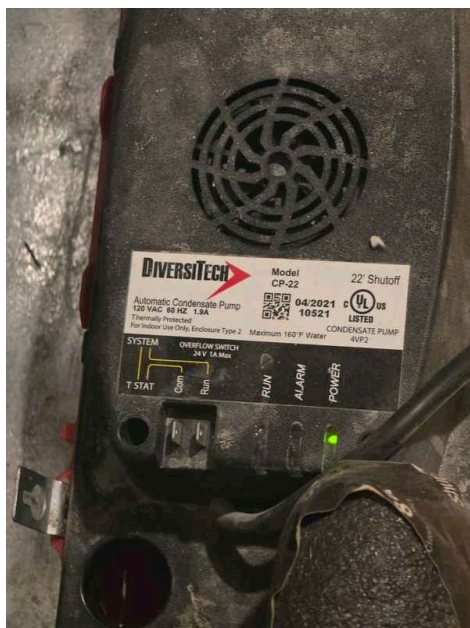
## Condensate: Condensate Pump

I observed a condensate pump installed at the cooling system. This component collects condensate water that is created when the cooling system is operating. The condensate pump should collect and discharge the water properly.

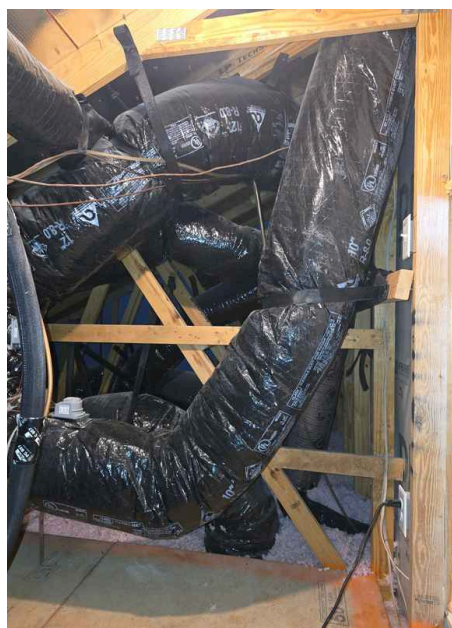
I observed ductwork in the house. Air conditioning (cooling) systems, including heat pump systems, use ductwork to distribute the cooled, conditioned air throughout the house. I will attempt to determine if the each room has a cooling source or conditioned-air supply, but I may not be able to find every duct register.

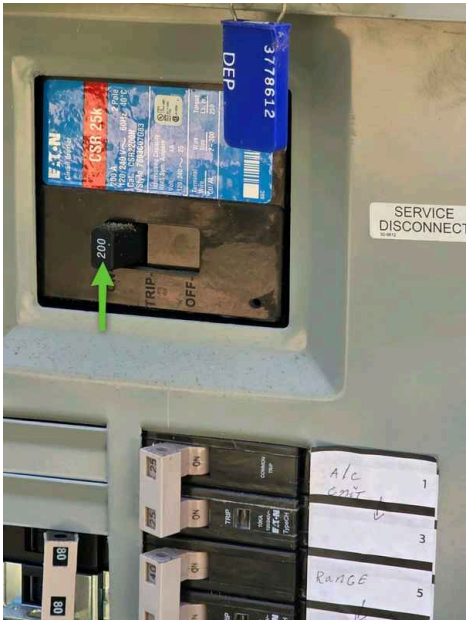
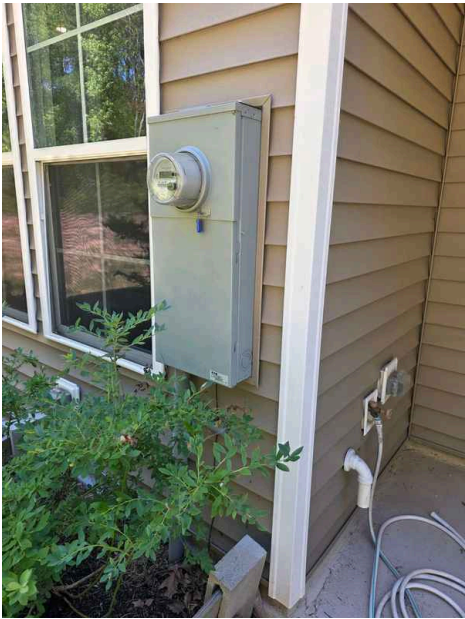
**Main Service Disconnect:**  
**Inspected Main Service Disconnect**  
I inspected the electrical main service disconnect.

**Electric Meter & Base:** Inspected the Electric Meter & Base  
I inspected the electrical electric meter and base.

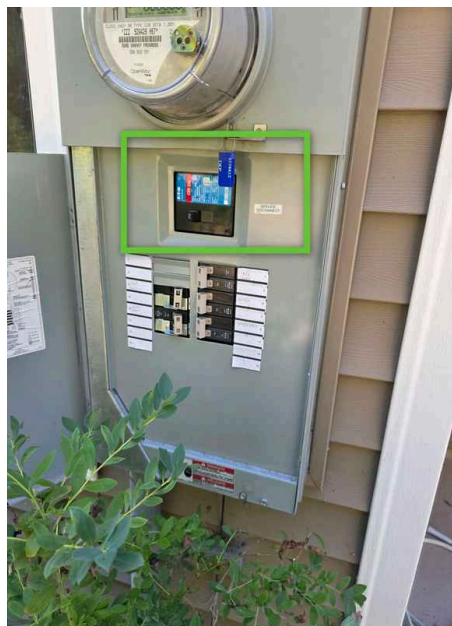
## Main Service Disconnect: Main Disconnect Rating, If Labeled

200

I observed indications of the main service disconnect's amperage rating. It was labeled.

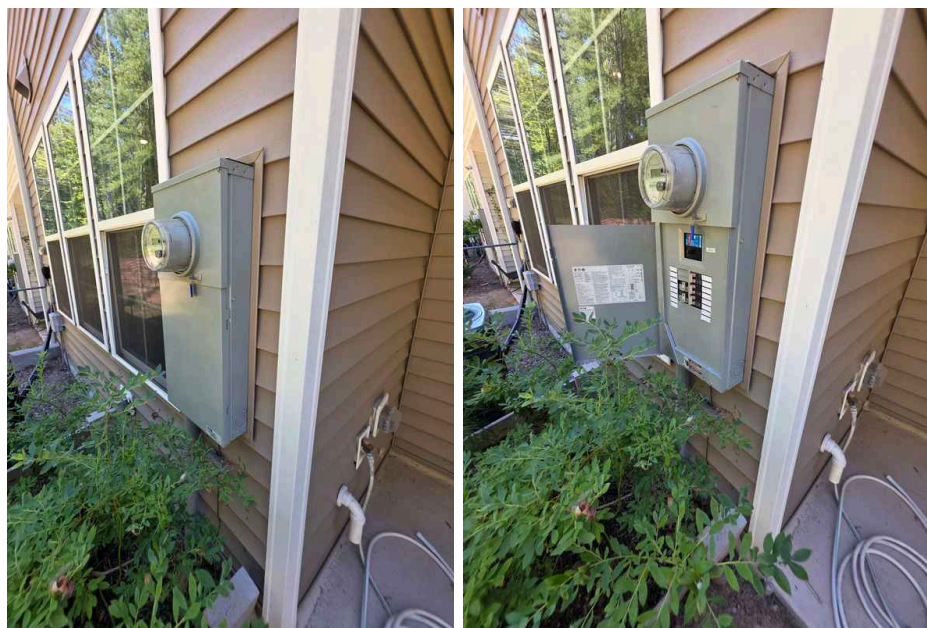
## Panelboards & Breakers: Main Panel Location

Back, Exterior

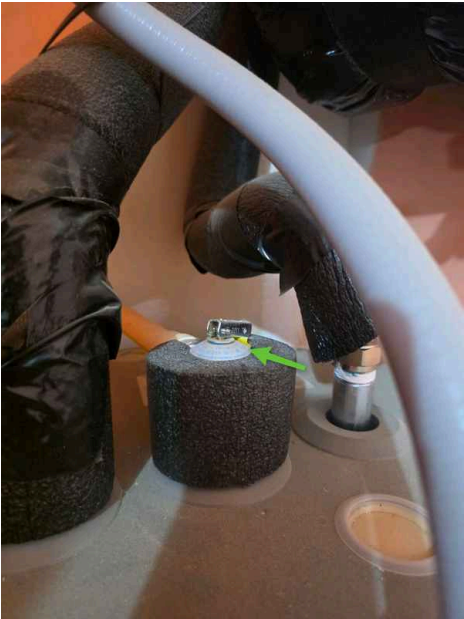
Hot Water Source: Inspected TPR  
Valve

I inspected the temperature and pressure relief valve.

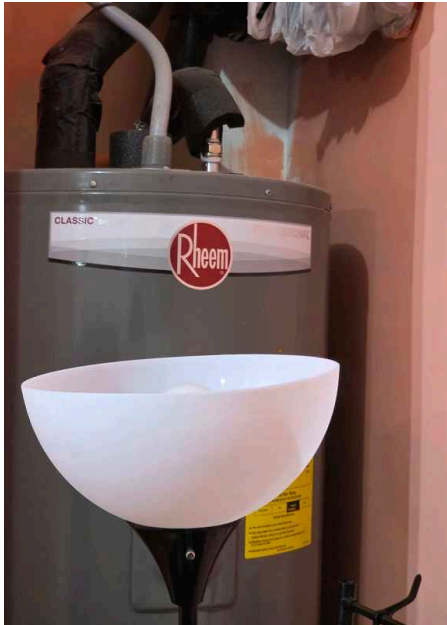
## Hot Water Source: Type of Hot Water Source

Electric Hot Water Tank

I inspected for the main source of the distributed hot water to the plumbing fixtures (sinks, tubs, showers). I recommend asking the owner for details about the hot water equipment and past performance.

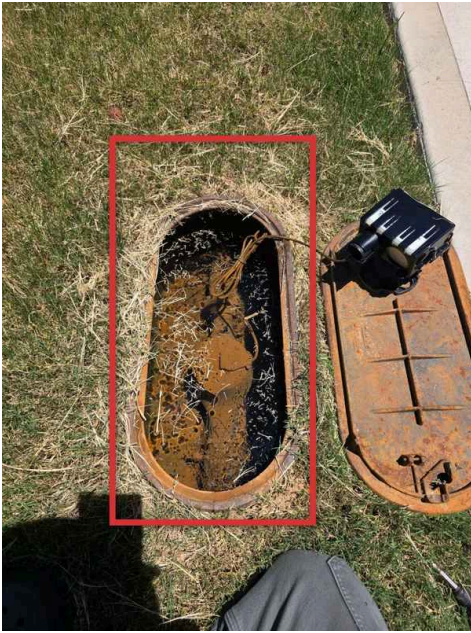
I observed standing water in the meter box. This can be an indication of a nearby leak at a plumbing fitting or poor drainage at the meter box. Since I cannot confirm that this is not a leak, I recommend further evaluation to ensure the leak is not present.

Recommendation  
Contact a qualified plumbing contractor.

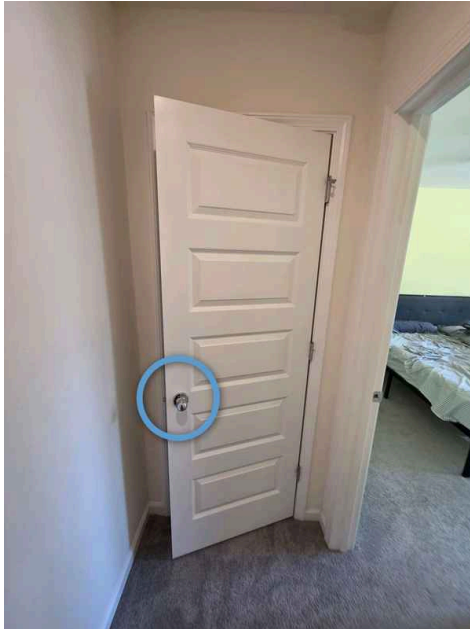
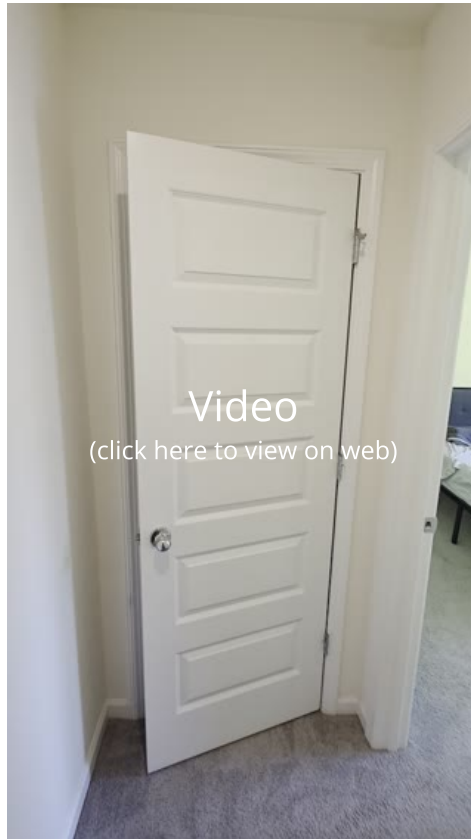
### 10.1.1 Doors

I observed that a door does not latch and close properly. Recommend adjustment and further evaluation of all doors to ensure proper functionality.

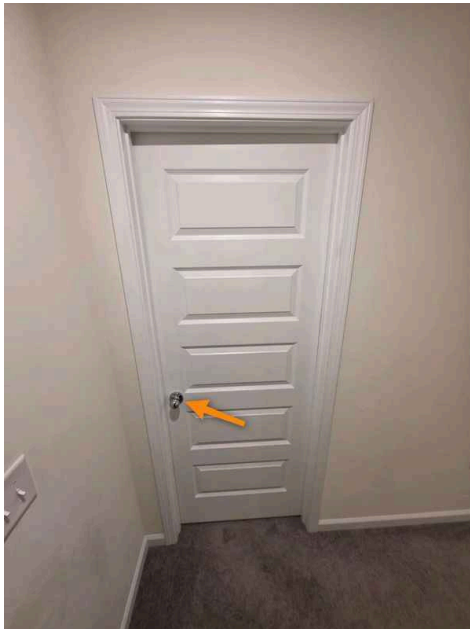
Door hardware is loose at one or more doors. Recommend tightening to ensure proper functionality.

Contact a qualified handyman.

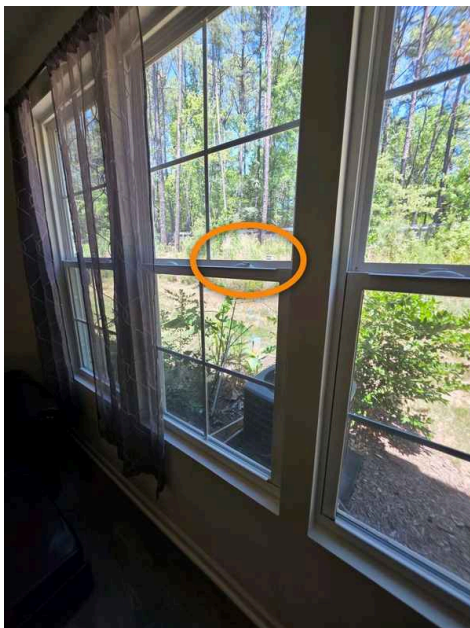
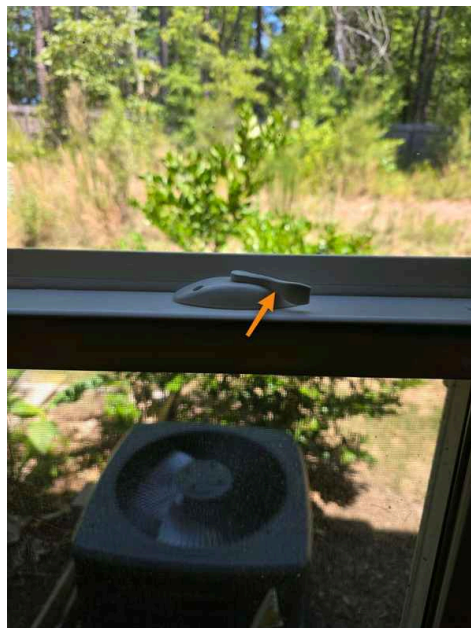
Some windows in the home are difficult to latch or the locking mechanism does not engage properly. Recommend replacement or adjustment by window contractor.

Contact a qualified window repair/installation contractor.

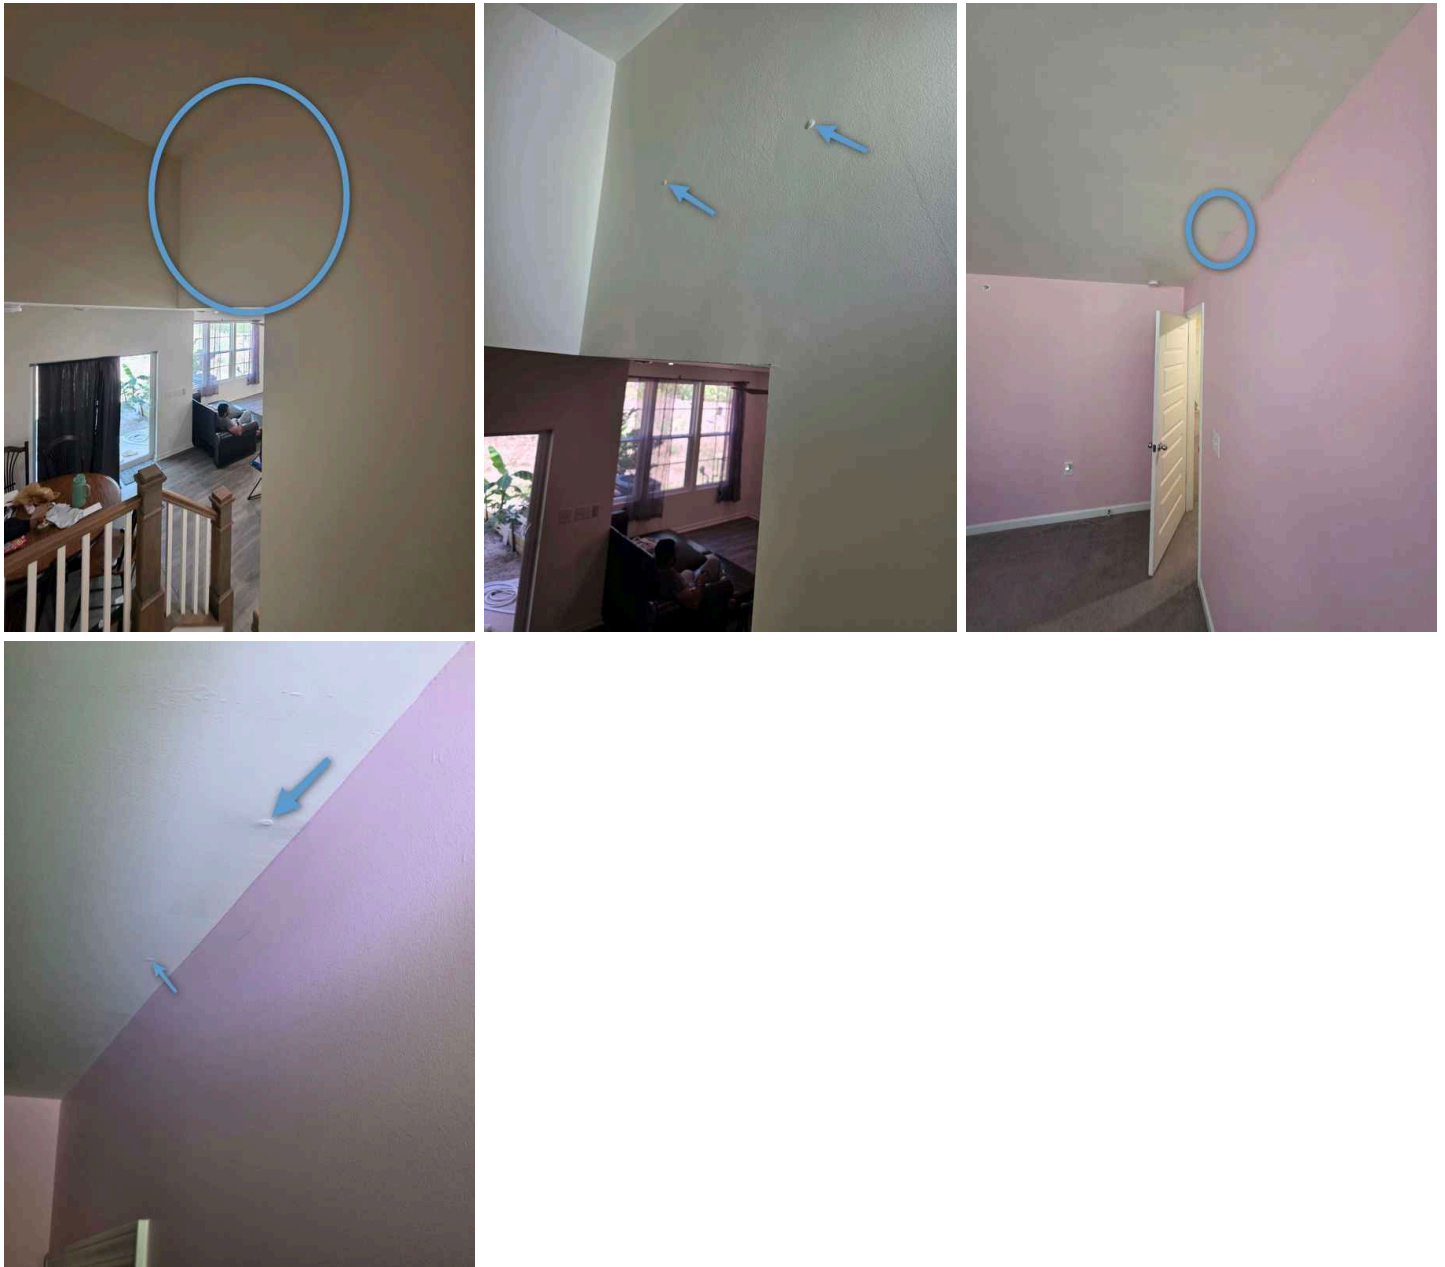
## 10.3.2 Floors, Walls, Ceilings

**NAIL POPS**

Protruding nail heads were visible at the time of the inspection. Recommend further evaluation of all surfaces and repair by a qualified contractor as needed. Nail pops are largely due to wood or drywall movement and often appear within a year of construction. The result is a tiny bulge on the wall surface or, in some cases, a visible nail head if the drywall compound comes loose and falls away. This is the most common cause of nail pops and it's completely cosmetic. Another reason for nail pops to show themselves is due to the introduction of moisture. Moisture can swell or expand the building material and force the nail to pop out. Because of this possibility, I recommend to ensure that the contractor looks for signs of moisture when repairing.

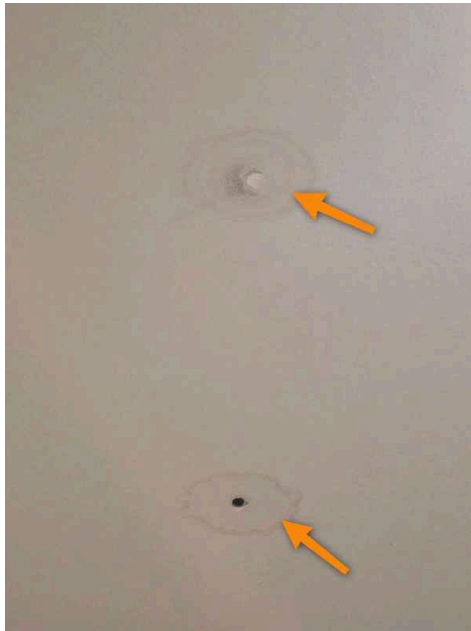
There is a stain on ceiling/wall that requires repair and paint. Source of staining should be determined.

Contact a qualified professional.

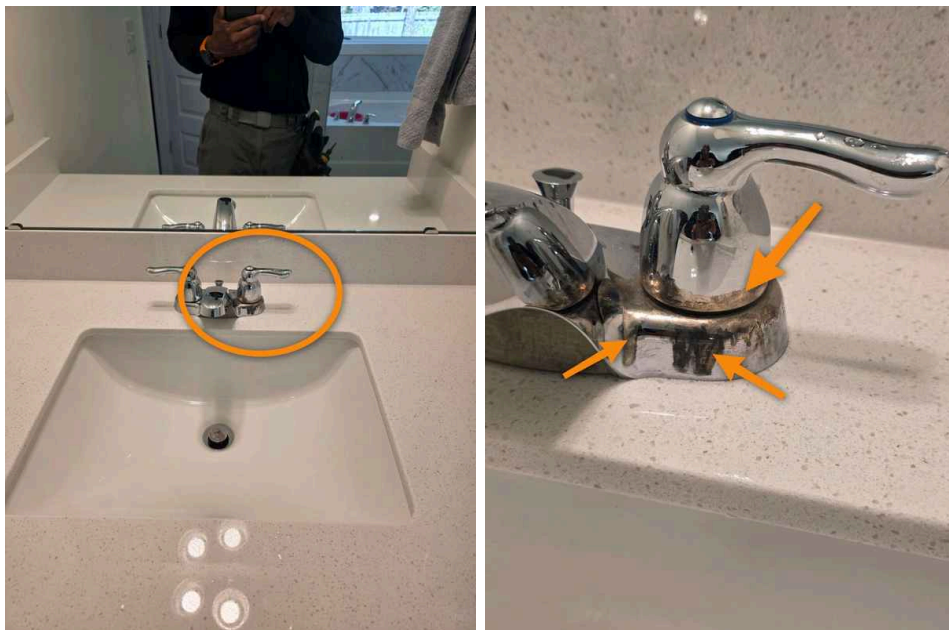
#### **DAMAGE AT FIXTURE**

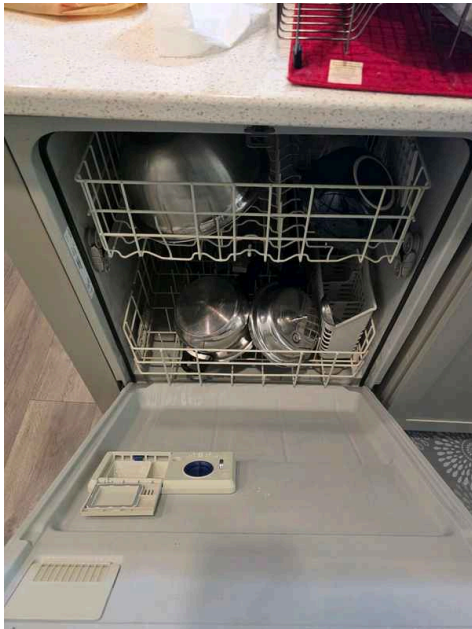
### **DISHWASHER WAS NOT OPERATED**

I did not operate the dishwasher due to occupant belongings.

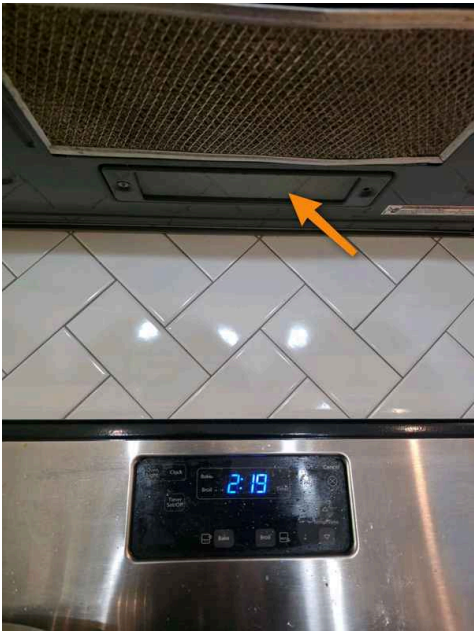
### 12.9.1 Exhaust Fan

#### **LIGHT DID NOT TURN ON**

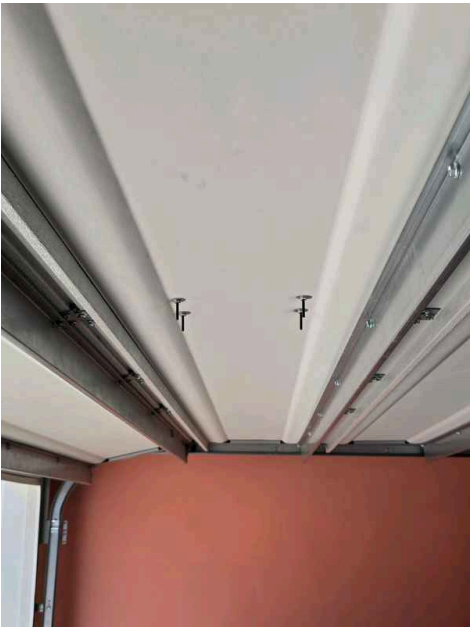
### Garage Door: Material Metal, Insulated

### Garage Door Opener: Manual Release

I checked for a manual release handle--a means of manually detaching the door from the door opener.

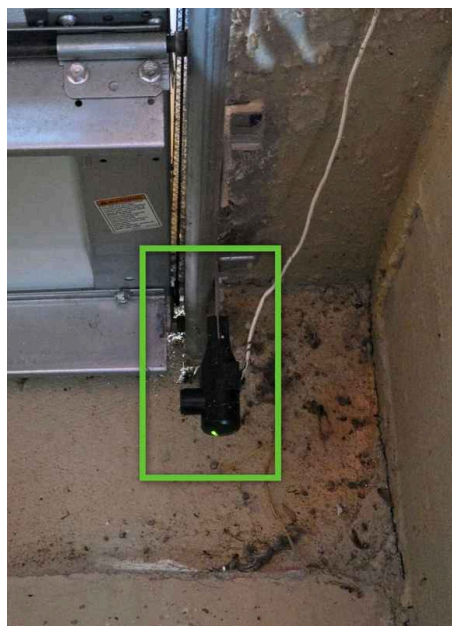
Federal law states that residential garage door openers manufactured after 1992 must be equipped with photo-electric eyes or some other safety-reverse feature that meets UL 325 standards.

I checked to see if photo-electric eyes are installed. The vertical distance between the photo-eye beam and the floor should be no more than 6 inches.

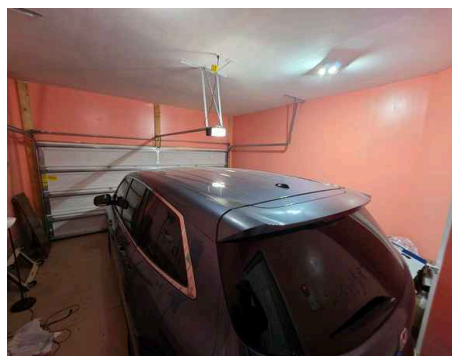
## Ceiling, Walls & Firewalls in Garage: Garage Ceiling & Walls Were Inspected

I inspected the ceiling and walls of the garage according to the Home Inspection Standards of Practice.

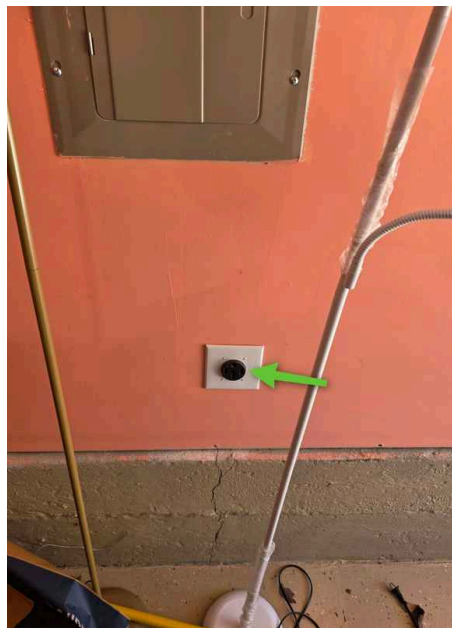
## Electric in Garage: Car Charger

I observed what appears to be a receptacle for a car charger. I did not test this, only observed.

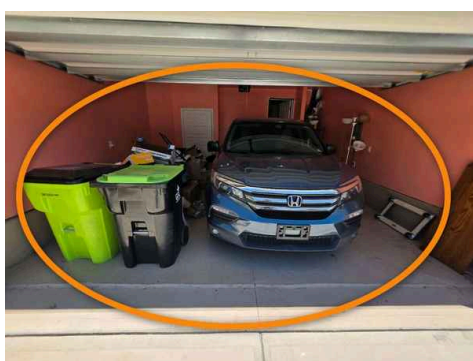
## CAN'T SEE EVERYTHING

I can not observe everything due to occupant belongings. Inspection restrictions. My inspection was limited.
