# TABLE OF CONTENTS

This summary page is not the entire report. The complete report may include additional information of interest or concern to you. It is strongly recommended that you promptly read the complete report. For information regarding the negotiability of any item in this report under the real estate purchase contract, contact your North Carolina real estate agent or an attorney.

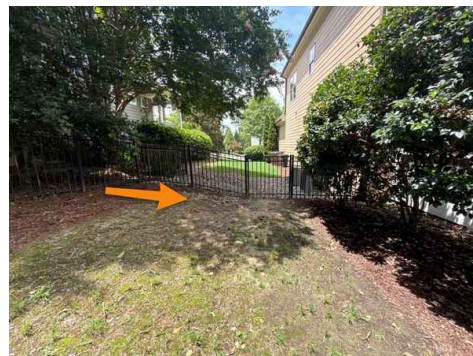
Right Exterior

The grade does not appear to be properly sloped away from the structure. The grade should slope at least 6 inches for the first 10 feet away from the structure. Recommend monitoring this and repair if necessary so water is properly diverted away from the foundation.

Recommend monitoring.

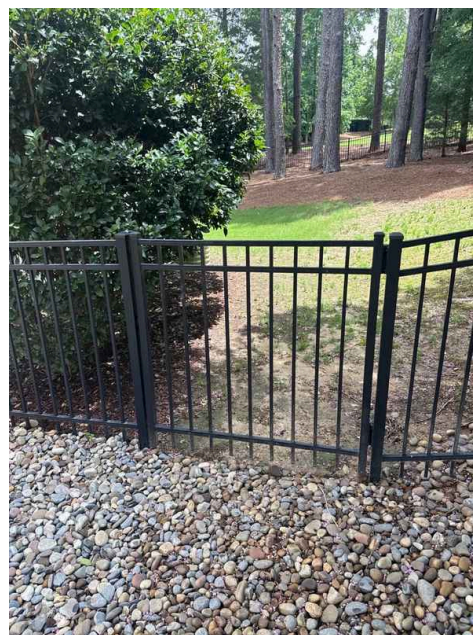
Right Exterior

The gate does not latch properly. This prevents secure closure and may allow unauthorized entry or escape of pets or children. The latch mechanism should be inspected and repaired or replaced by a fence contractor.

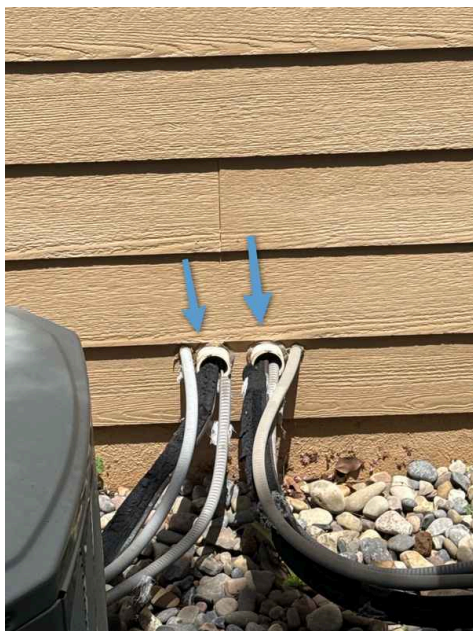
Right Exterior

Recommend that the gaps/openings be properly sealed to help prevent moisture or pests from entering.

Contact a qualified professional.

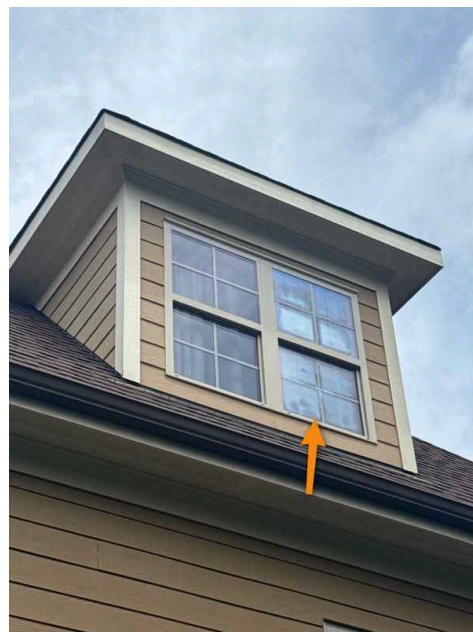
Attic, Right Exterior

The seal appeared to be damaged in windows. Condensation between the window panes can lead to fogged windows and elevated moisture.

Due to weather conditions, a failed seal is not necessarily always visible. Recommend a qualified contractor evaluate all windows/doors & and repair.

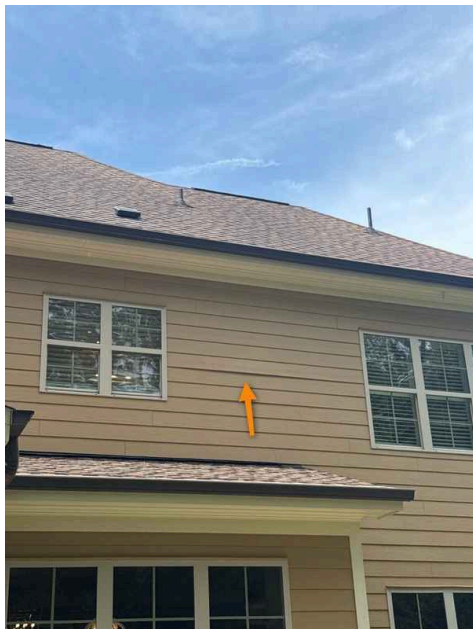
Laundry Rear Left 2nd Floor

One or more pieces of siding were loose, which could result in moisture intrusion. Recommend properly securing the siding by a qualified contractor.

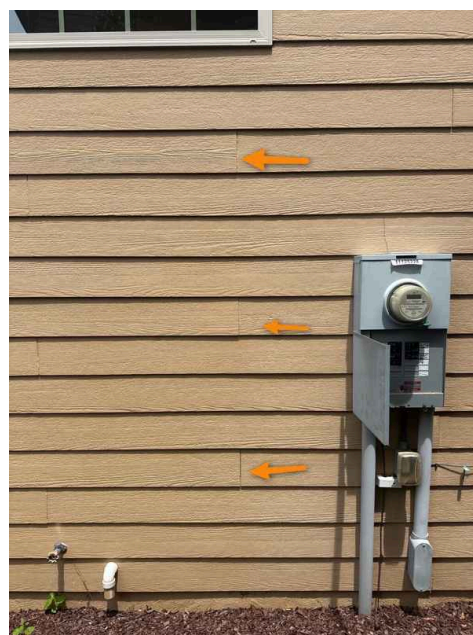
All siding

When viewing the siding, there are open gaps between the siding butt joints. This condition could allow for air passage, pest entry and moisture damage. Repair is needed to ensure proper function of the exterior cladding. Although not the standard when the home was constructed, current building practices require non-metal flashing to be applied at the siding butt joints. This eliminates the need for sealing and painting of these joints. A general repair specialist or licensed general contractor should be consulted for evaluation and repair.

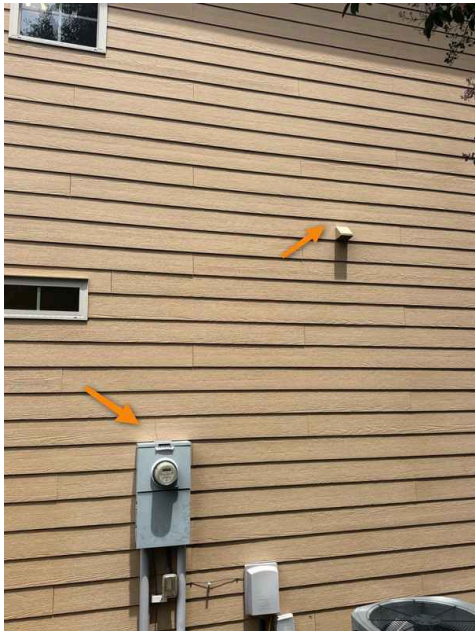
Right Exterior

There were areas where the siding was found to be cracked. This condition could allow for excessive air passage, pest entry and hidden moisture damage to structural components. It is recommended that a licensed general contractor repair as needed. Photos are limited examples and do not depict all areas of damage.

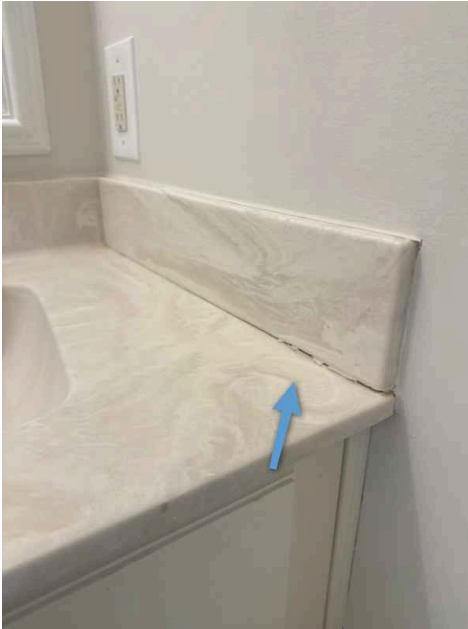
2nd Floor Shared Bathroom

Countertop was missing sufficient caulk/sealant. This can lead to water damage. Recommend adding sealant at sides and corners where counters touch walls or sinks.

Contact a qualified professional.

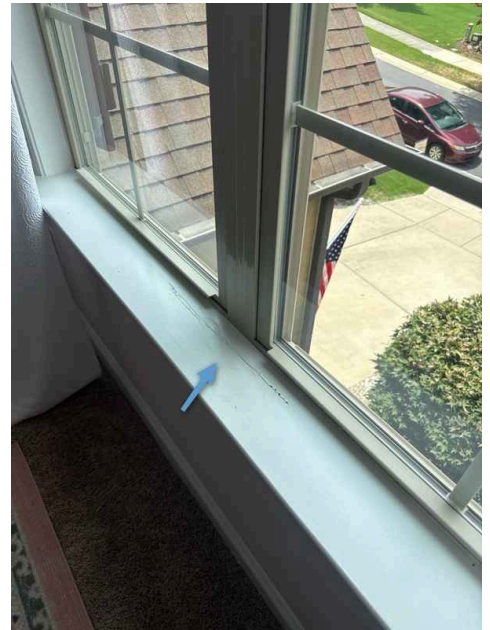
2nd Floor Front Left Bedroom

Stains noted around windows. Tested dry during inspection. Recommend monitoring and consult with a qualified contractor if a leak is noted or if the client would like more information.

Recommend monitoring.

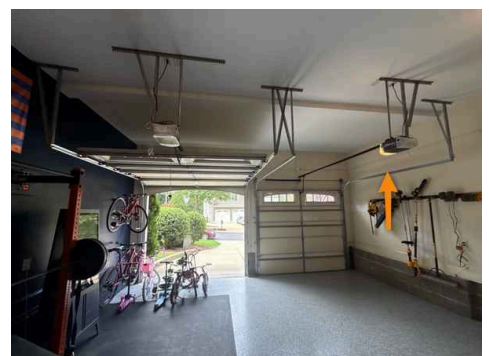
Garage Left

Garage door did not reverse when resistance was applied to the door. This is a potential hazard and could prevent the door from reversing when something is blocking the door. Recommend that the garage door be evaluated and adjusted for improved safety.

Contact a qualified professional.

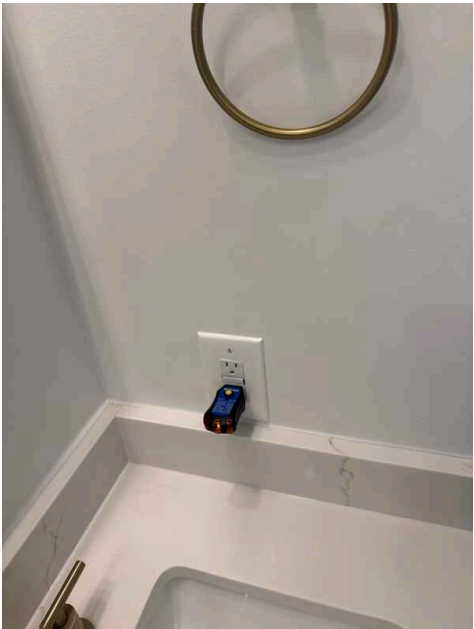
Master Bathroom

This is an older home and original wiring did not have outlets with an equipment ground but they would have been connected to outlets with only two prongs. Some outlet receptacles have been upgraded to three prong outlets but do not have an equipment ground. This could result in an unsafe condition and risk of electrical shock. Recommend further evaluation of the all the outlets by a licensed electrical contractor.

Recommendation  
Contact a qualified electrical contractor.

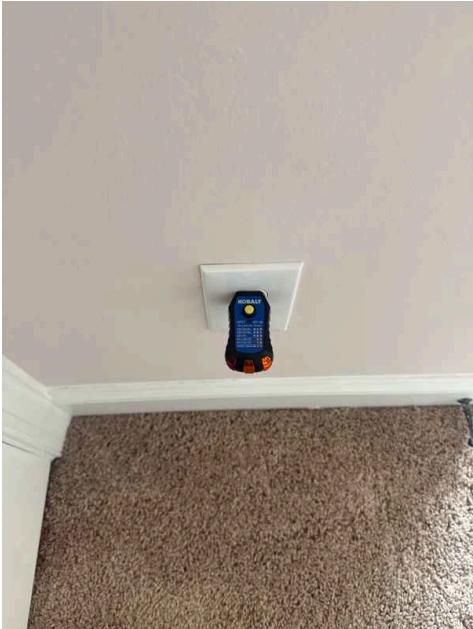
Front Left Bedroom 2nd Floor

A receptacle was tested and found to have an open neutral. This condition presents a safety hazard that could result in personal injury and or property damage. A licensed electrical contractor should be consulted for repair and a complete evaluation of the electrical system.

Recommendation  
Contact a qualified electrical contractor.
