RE: Underground Storage Tank (UST) Closure Assessment Report  
1307 Wake Forest Road, Raleigh, North Carolina  
Cedar Rock Project Number 414122590

**UNDERGROUND STORAGE TANK  
CLOSURE ASSESSMENT REPORT FOR  
1307 WAKE FOREST ROAD  
RALEIGH, NORTH CAROLINA**

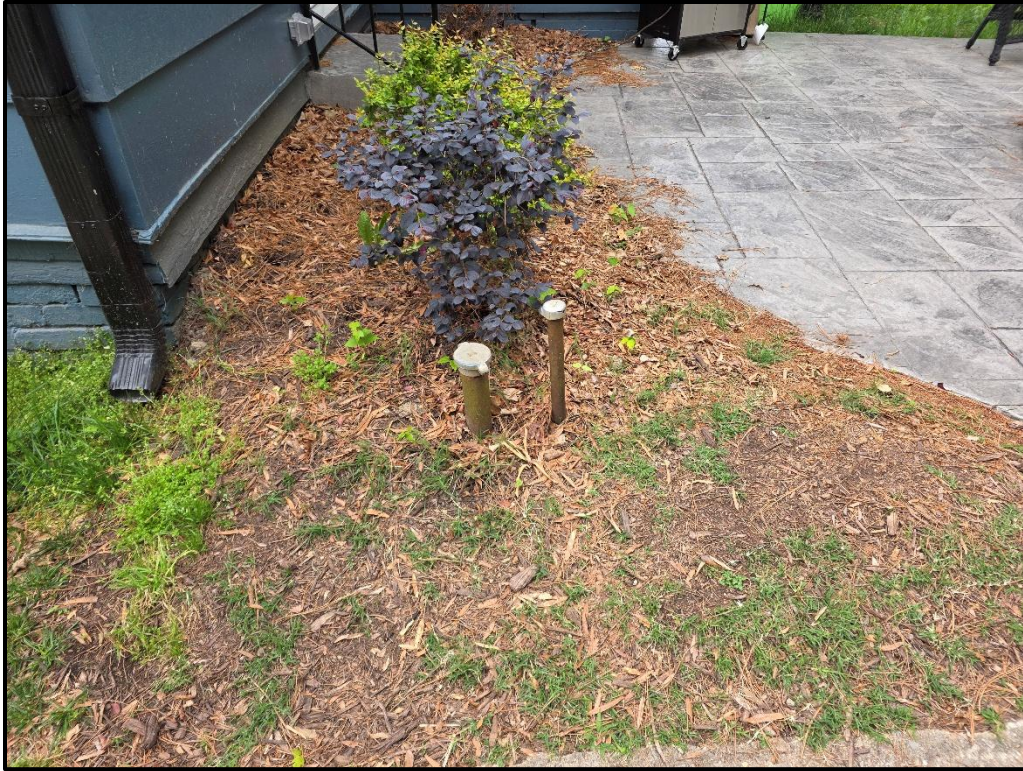
**Photo 1.** View of the UST site prior to abandonment activities.

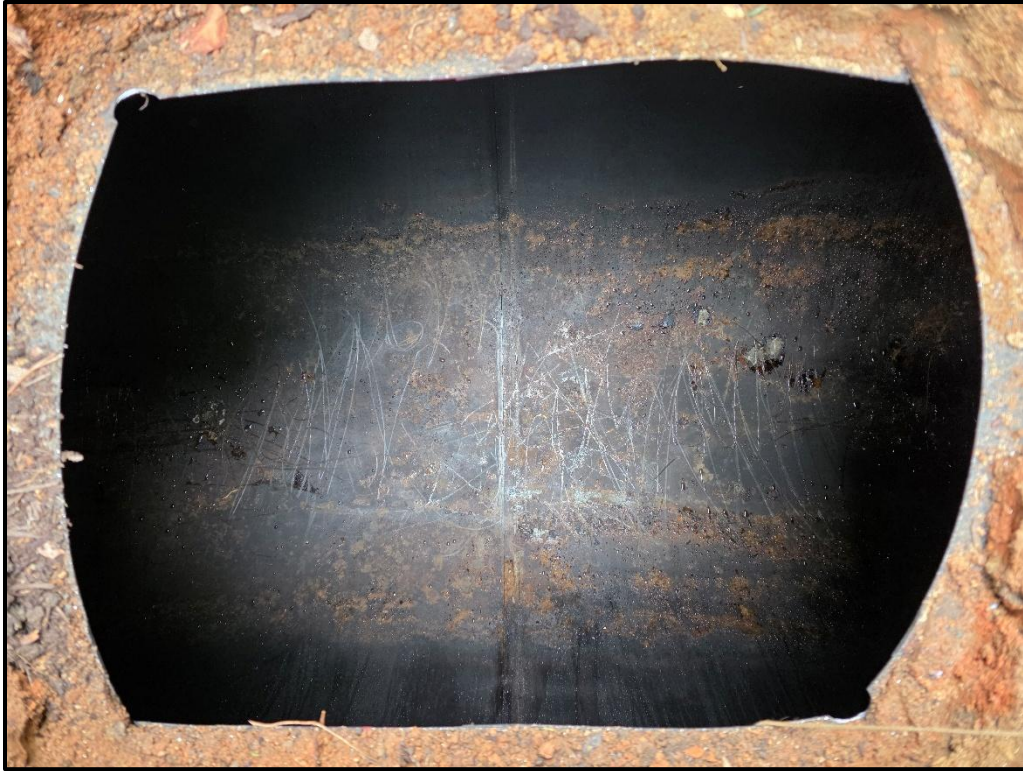
**Photo 3.** View of the UST interior after the removal of UST contents and pressure wash cleaning of the tank interior.

After the contents of the tank had been removed and the tank properly cleaned, a soil boring (#3) was performed through the bottom of the tank at the location marked on the Site Map using a 1/2-inch diameter drill auger. The boring was advanced to a depth of approximately seven inches beneath the tank. No petroleum odor was noted in the soil from this boring confirming the tank had not leaked and contaminated the underlying soil.

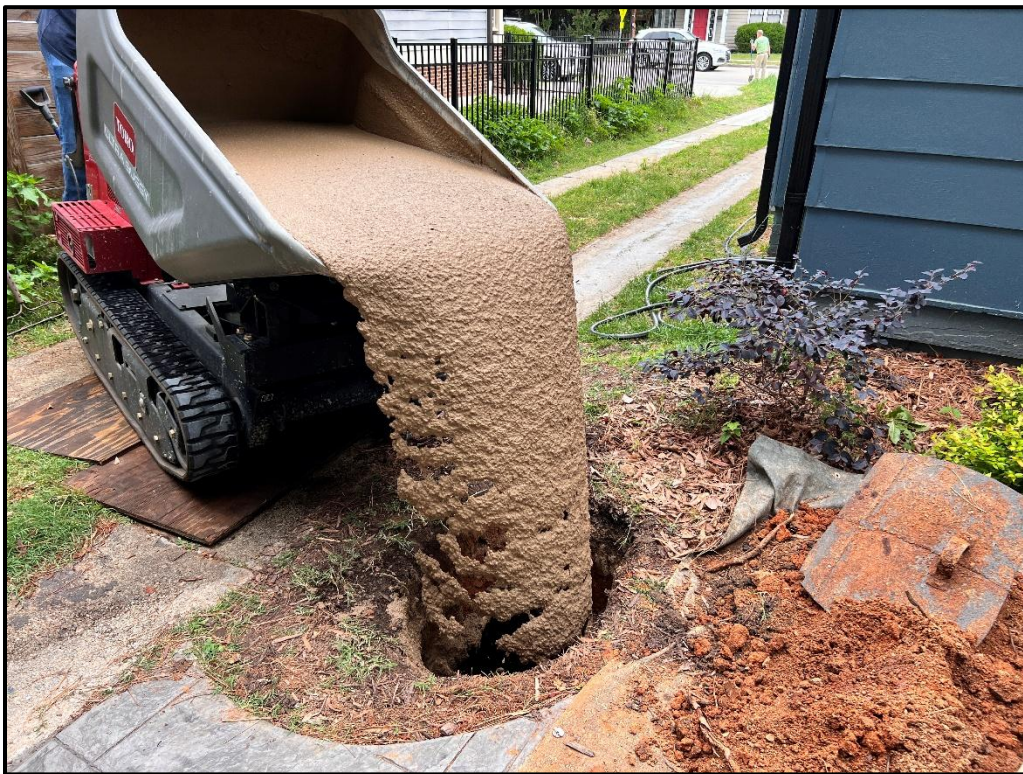
**Photo 4.** View of the UST being filled with flowable fill cement slurry.

After the interior of the UST was cleaned, the tank was then entirely filled with an excavatable flowable fill cement slurry. Once filled, the exposed portion of the UST was then covered with site soil (see Appendix B - Photographic Documentation).

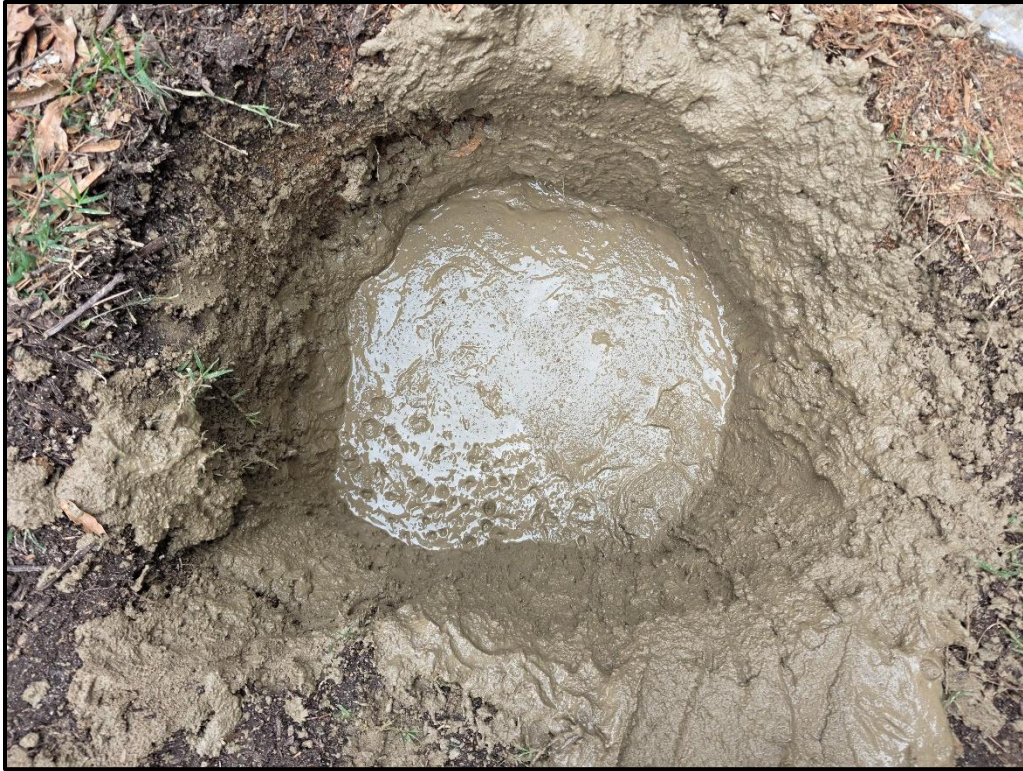
**Photo 5.** View of the UST after filling with flowable fill cement slurry.

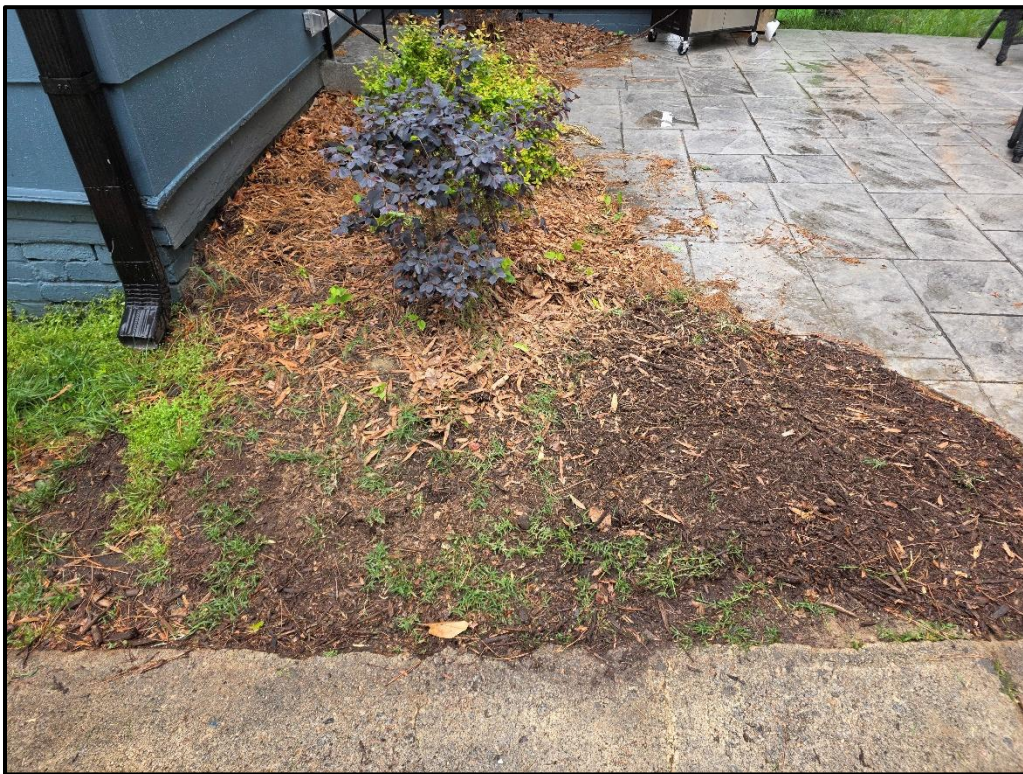
**Photo 6.** View of the UST site after the completion of abandonment activities.
