# TABLE OF CONTENTS

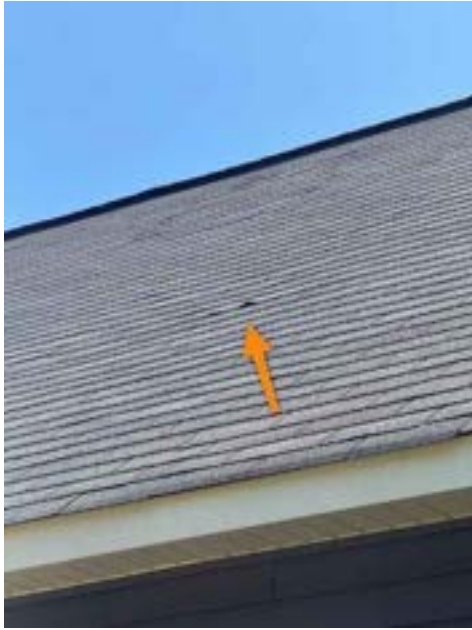
Observed raised shingles at the time of inspection. Likely due to under-driven fasteners. Prone to wind damage and moisture intrusion. Recommend repair.

Contact a qualified roofing professional.

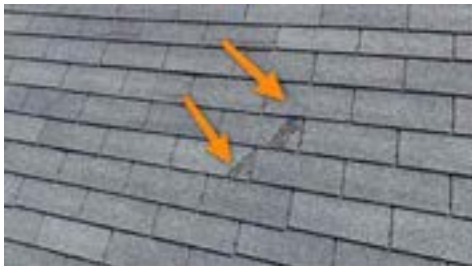
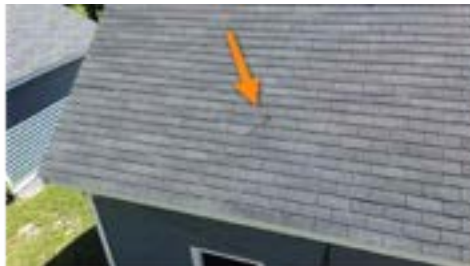
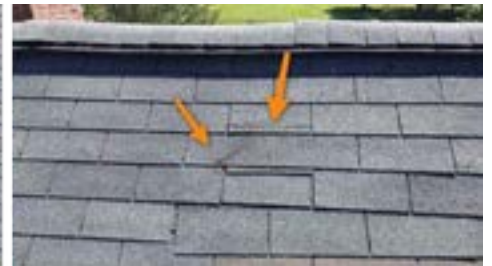
### 2.1.2 Roof Covering CRACKED AND DAMAGED SHINGLES

Cracked and damaged shingles were observed during the roof covering inspection. Damaged shingles compromise the roof's ability to shed water effectively, potentially allowing moisture to penetrate the underlying structure. Have a roofing professional evaluate the extent of the damage and recommend repair or replacement of affected shingles to prevent water intrusion and structural damage.

Recommendation

Contact a qualified roofing professional.

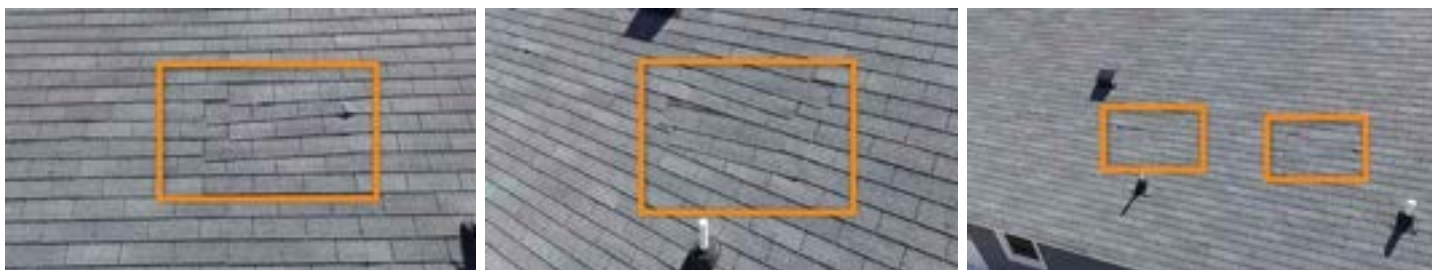
#### LOOSE ROOF SHINGLES

Loose shingles were observed during the roof inspection. This condition allows water infiltration beneath the shingle layer, potentially leading to leaks, wood rot, and structural damage. A roofing professional should evaluate the extent of the looseness and secure or replace affected shingles as needed.

Contact a qualified roofing professional.

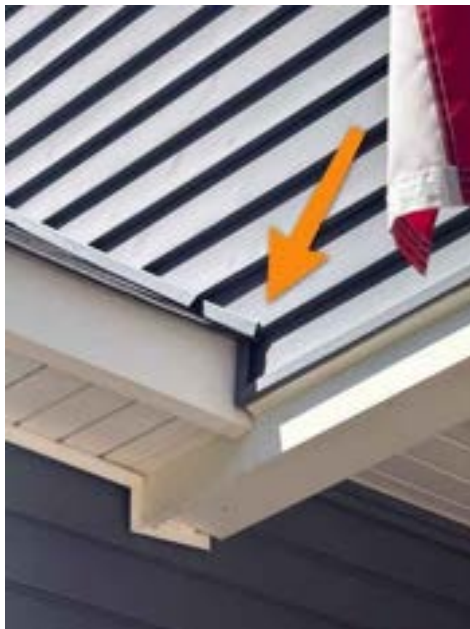
#### MISSING KICKOUT FLASHING

I observed a defect at the flashing area called a "kickout." It's missing. Not installed. A kickout flashing "kicks" the roof water away from the house structure and diverts it into a gutter. This missing flashing could lead to hidden moisture intrusion and water damage issues that I would not be able to observe during a visual-only home inspection. A roofing professional is needed to further evaluate and make necessary corrections.

##### Recommendation

Contact a qualified roofing professional.

Owner is actively working with the company that installed the roof in attempt to remediate issues

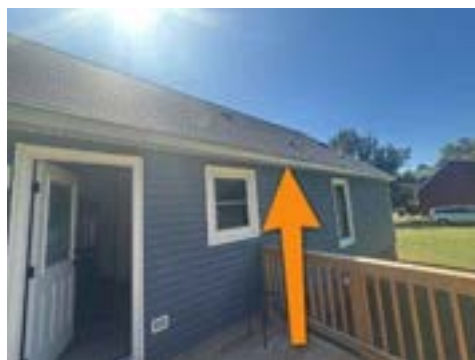
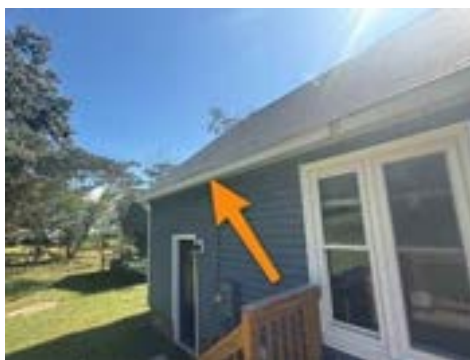
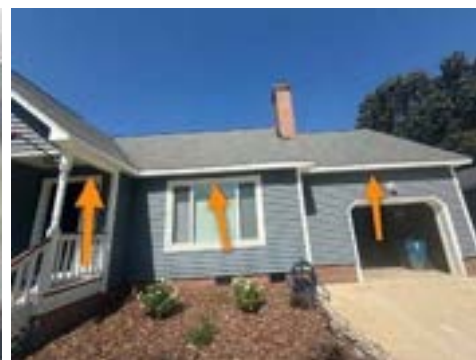
#### 2.4.1 Gutters & Downspouts

Gutters are necessary to properly collect rain water from the roof, control it, divert it, and discharge that water away from the house and its foundation. A missing gutter is a defect. This is a defect that should be corrected by a professional contractor.

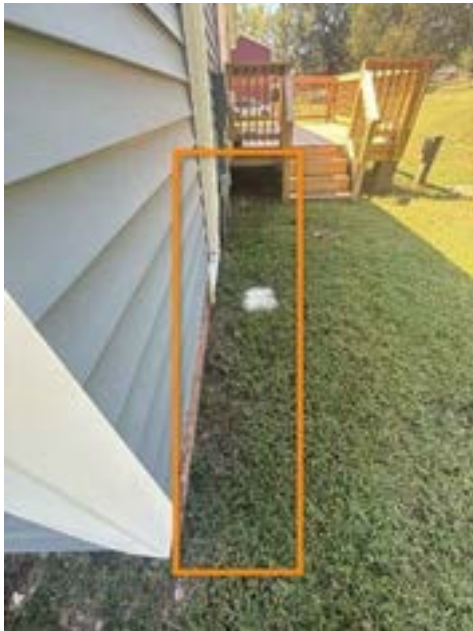
Grading is sloping towards the home in some areas. This could lead to water intrusion and foundation issues. Recommend qualified landscaper or foundation contractor regrade so water flows away from home.

Contact a qualified landscaping contractor

Owner had grading evaluated by professional landscaping company and grading was deemed acceptable

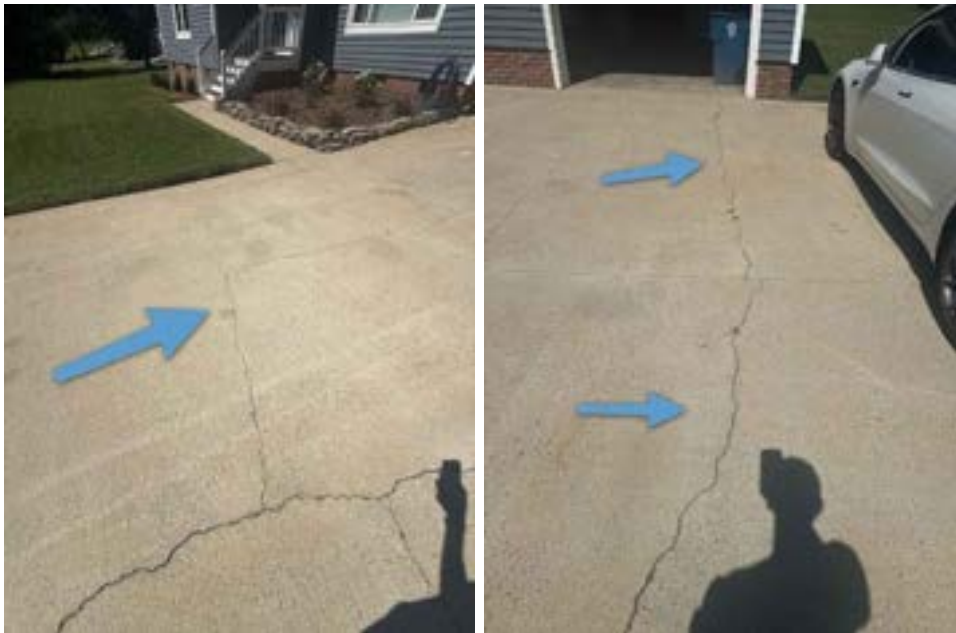
3.3.1 Walkways, Patios & Driveways  
**DRIVEWAY CRACKING - MINOR**

Minor, typical cracks observed in driveway. Recommend monitoring and/or have concrete contractor patch/seal if the cracks widen.  
Recommendation

Recommend monitoring.

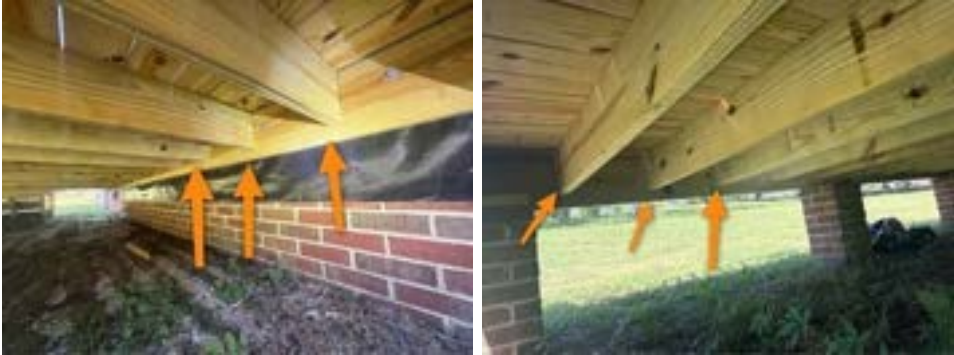
3.4.1 Decks, Balconies, Porches  
**JOIST HANGERS**

Joist hanger(s) are missing or improperly installed. This could cause the deck structure to be unstable.  
Recommend that joist hangers be properly installed by qualified contractor.

Recommendation  
Contact a qualified deck contractor.

Owner had deckers install joist hangers on deck, picture on page one

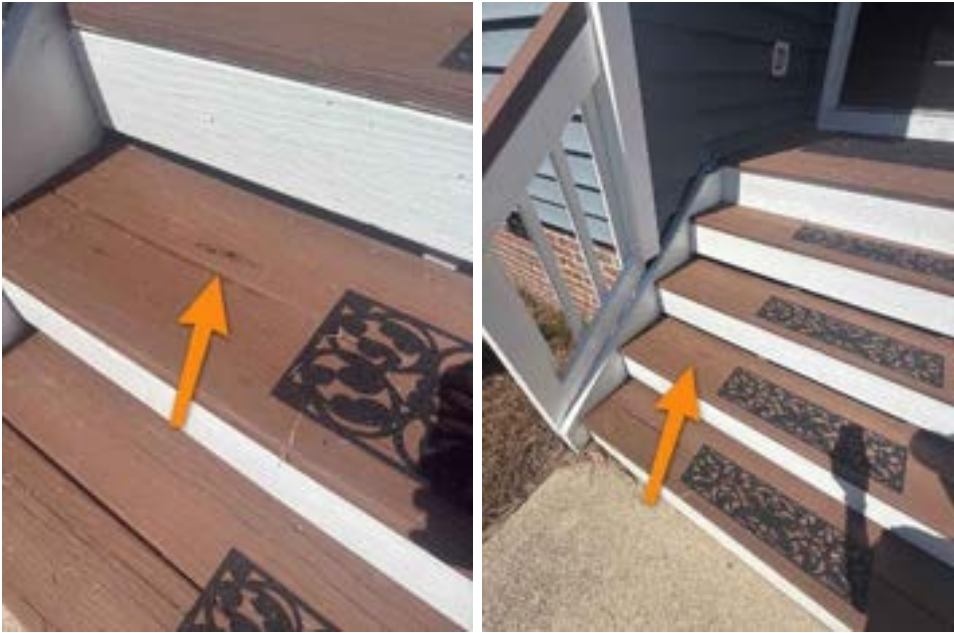
3.5.1 Stairs, Steps, Stoops, Stairways & Ramps  
**DAMAGED TREAD BOARD**

A tread board on the stairs shows visible damage. This deterioration can create a tripping hazard and compromise the structural integrity of the stairway. The damaged board should be inspected by a carpentry contractor and replaced or repaired to restore safe passage.  
Recommendation  
Contact a qualified deck contractor.

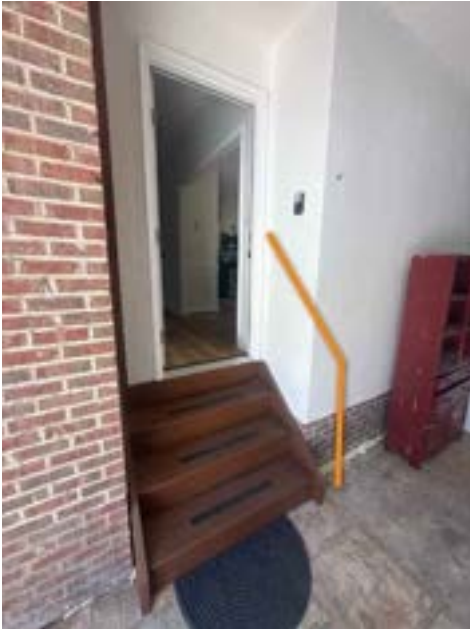
3.6.1 Railings, Guards & Handrails  
**MISSING HANDRAIL**

I observed indications of a missing handrail. While this may not be required by local code, since there is more than one step here, I recommend installing a handrail for enhanced safety.  
Recommendation

Recommendation  
Contact a qualified deck contractor.

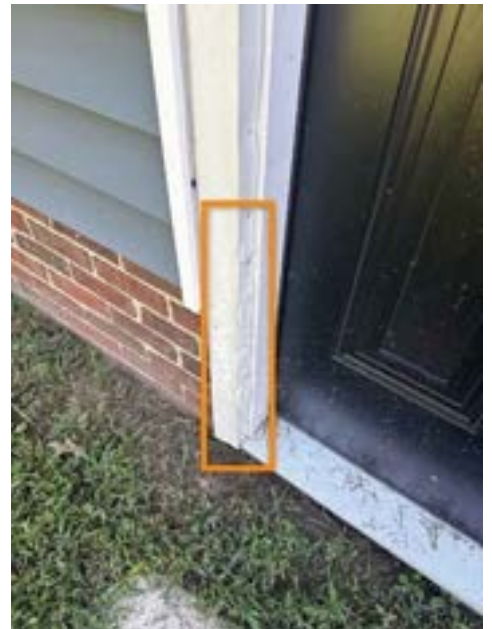
#### DAMAGED WALL-COVERING MATERIAL

I observed indications of a defect at the exterior wall-covering material.

Recommend repair to prevent water intrusion.

Contact a qualified siding specialist.

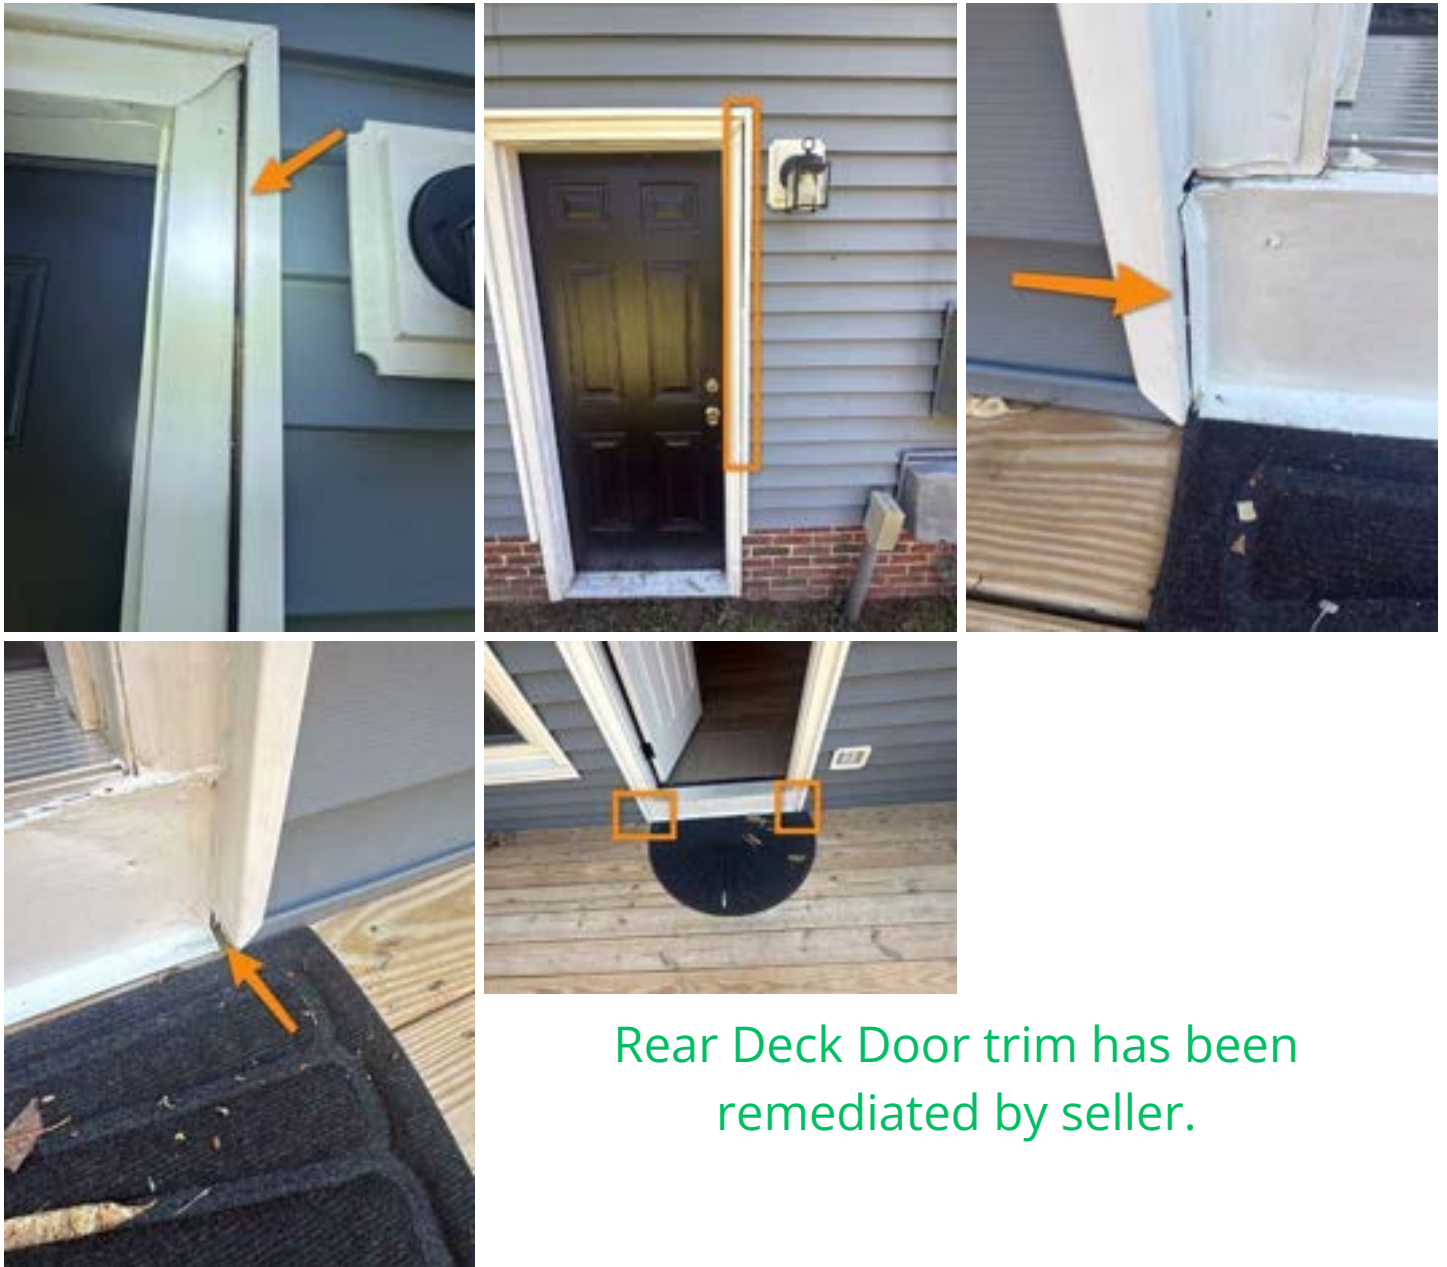
### 3.7.2 Siding, Flashing & Trim

**GAP** Gaps noted in some areas of the siding. Recommend siding contractor evaluate the areas and install correctly to prevent water intrusion.

Contact a qualified siding specialist.

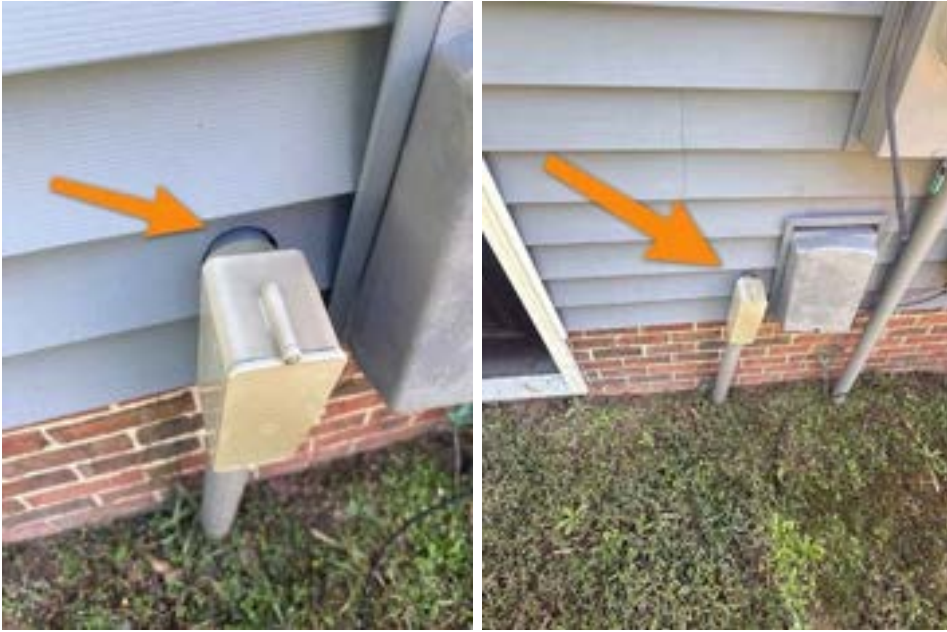
### 3.7.3 Siding, Flashing & Trim

Unsealed exterior penetrations were located. Recommend evaluation of all penetrations and sealing properly to prevent water and pest intrusion.

Contact a qualified handyman.

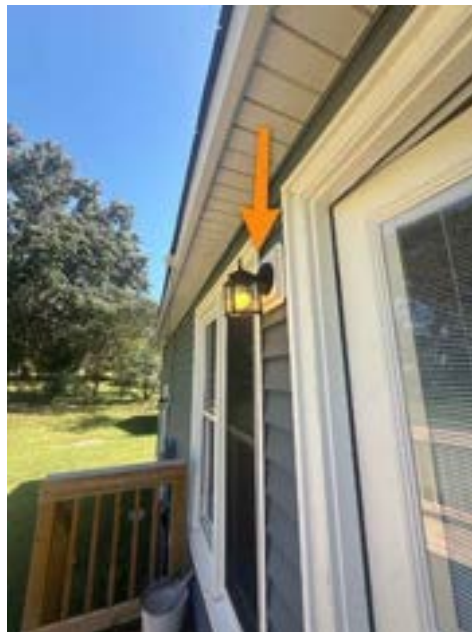
#### LOOSE LIGHT FIXTURE

Light fixture on exterior was loose and missing protective sealant at time of inspection. Recommend securing and adding sealant and further evaluation by qualified contractor to prevent damage to electrical components.

Contact a qualified handyman.

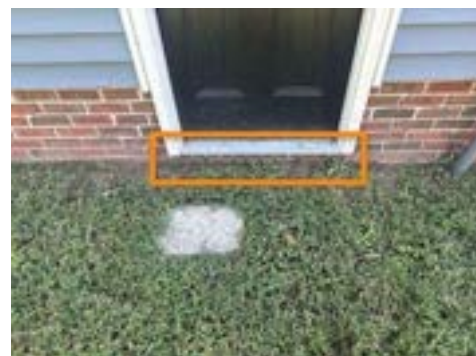
#### MISSING THRESHOLD SUPPORT MEMBER

Threshold support member was not installed at time of inspection. Recommend installation of threshold support member to prevent damage to threshold.

Recommendation

Contact a qualified carpenter.

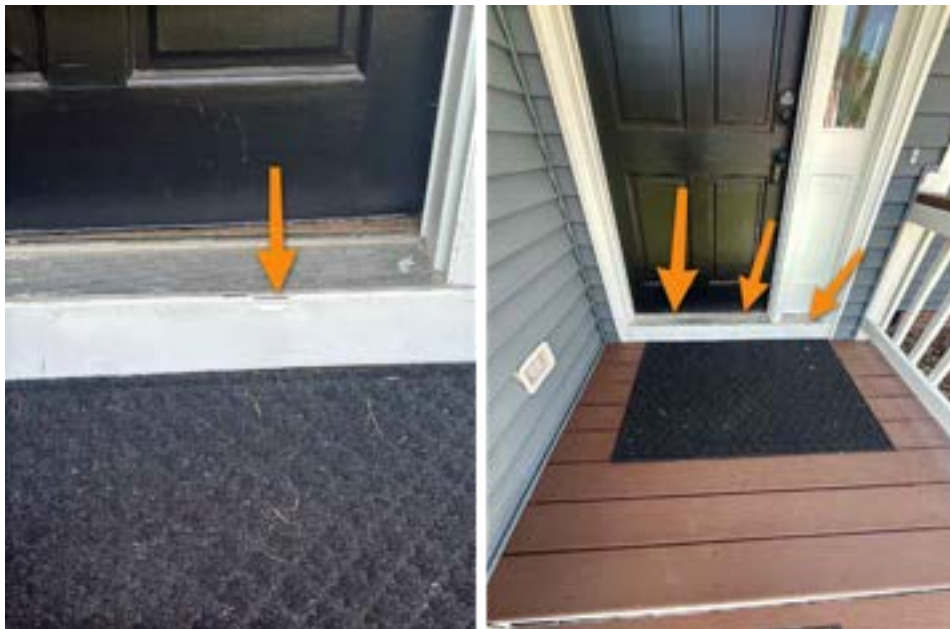
#### MISSING OR POORLY INSTALLED DOOR SEALANT

Missing or poorly installed sealant was observed around the exterior door during inspection. Inadequate sealant allows water infiltration, which can lead to wood rot, mold growth, and structural damage over time. The sealant should be removed, the area cleaned and dried, and new weatherproof caulk or sealant applied around the entire door frame perimeter.

Recommendation

Contact a qualified handyman.

Front door trim has been remediated by seller

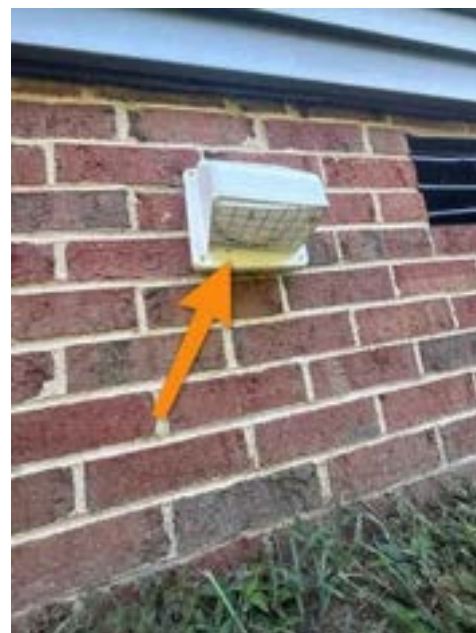
### 3.12.1 Exhaust Hoods

I observed that the clothes dryer exhaust hood has a screen. This will clog and create a re hazard.

Recommendation

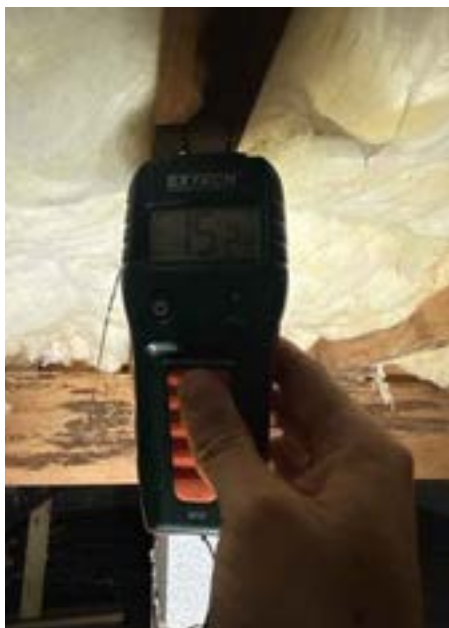
## Floor Structure: Crawlspace Moisture Reading

15

I measured the moisture at a surface in the crawlspace. This is for reference and does not indicate the entire crawlspace moisture content level.

Moisture is from a previous leak that has been repaired. Professional Crawl Space company is scheduled to make Crawl Space repairs in late October

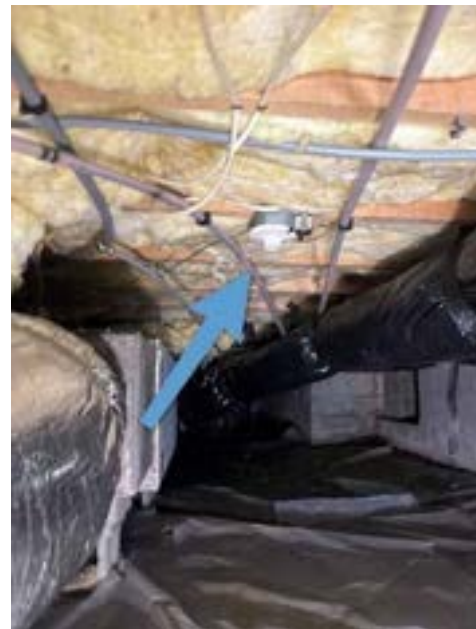
Lighting was inoperable in the crawlspace. Most likely a new bulb is needed.

Recommendation: Contact a qualified handyman.

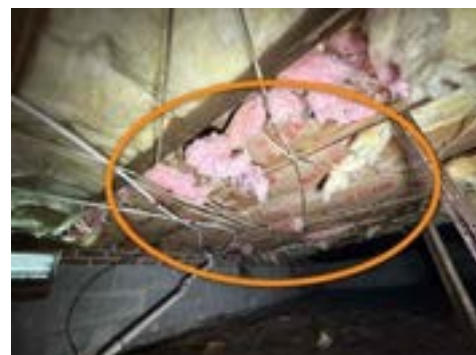
I observed that the insulation installed on the floor joists above the crawlspace is installed upside down. This can cause moisture and energy efficiency issues.

Recommendation: Contact a qualified insulation contractor.

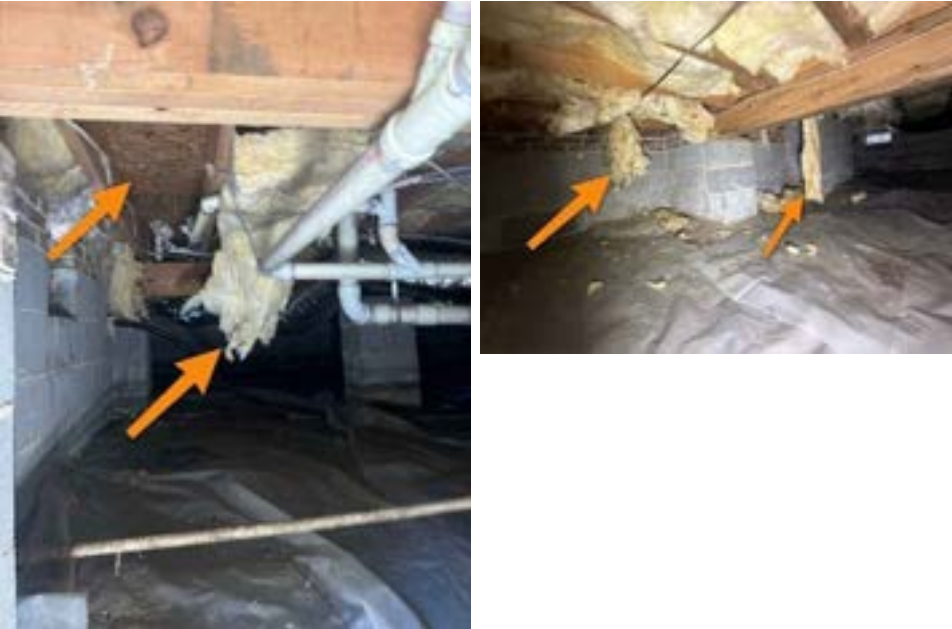
### 5.3.2 Insulation in Crawlspace

#### INSULATION HANGING LOOSELY / DETERIORATED

I observed that the insulation installed on the floor joists above the crawlspace is hanging loosely, falling off or appears to be deteriorated in areas. Recommend further evaluation of crawlspace insulation.

Contact a qualified insulation contractor.

Professional Crawl Space  
company is scheduled to make  
Crawl Space repairs in late  
October

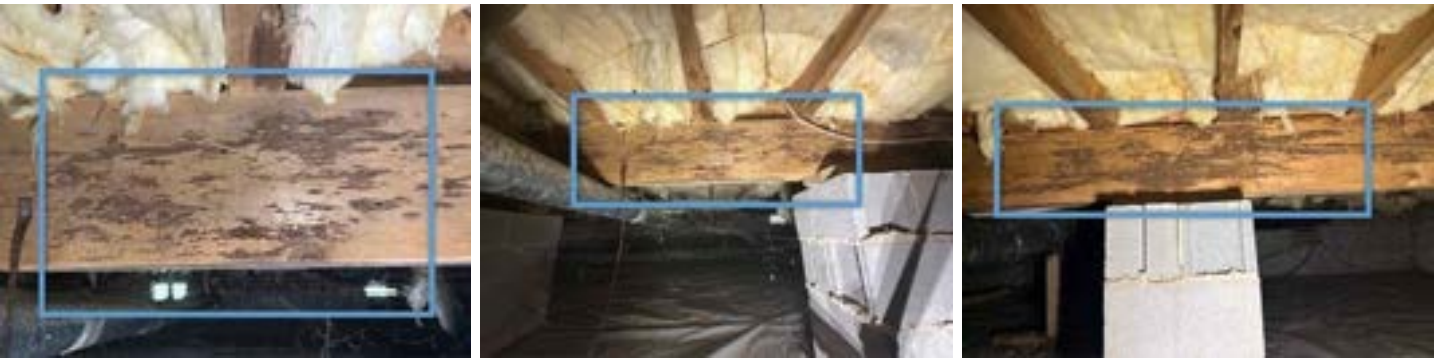
5.5.1 Floor Structure

SIGNS OF POSSIBLE BIOLOGICAL GROWTH

I observed signs of possible biological growth in some areas of the flooring structure. Recommend cleaning the areas and monitoring frequently. Maintaining a low moisture level in the crawlspace is important to prohibit the growth from reoccurring. In North Carolina, it is very typical for crawlspaces have moisture levels that are high enough to allow growths to begin.

Moisture is from a previous leak  
that has been repaired.  
Professional Crawl Space company  
is scheduled to make Crawl Space  
repairs in late October

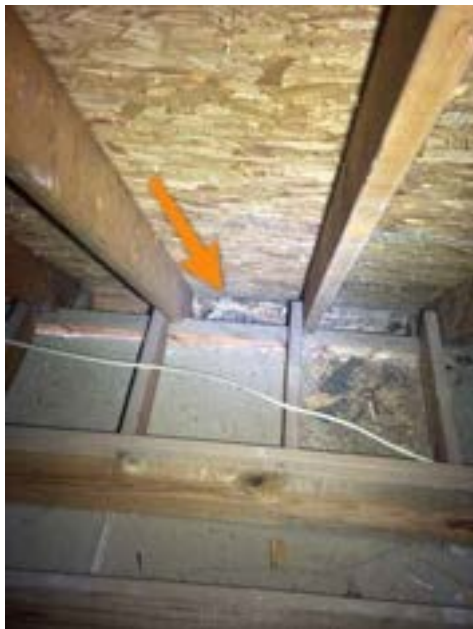
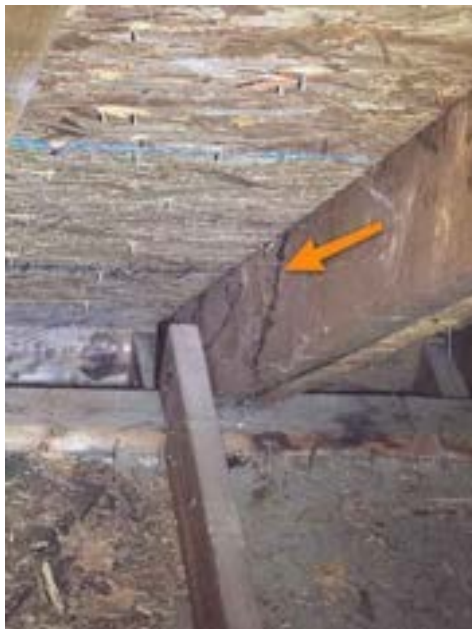
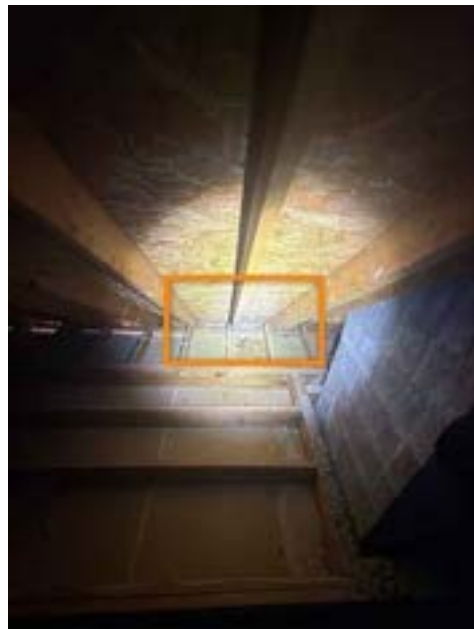
I observed indications that sometime in the past there was a minor water penetration or intrusion into the attic. Water marks were observed. For now, I recommend monitoring the area for continued water intrusion. After a heavy rainfall, check the area for dampness. If the area is wet, correction and further evaluation is recommended.  
Recommendation

Recommend monitoring.

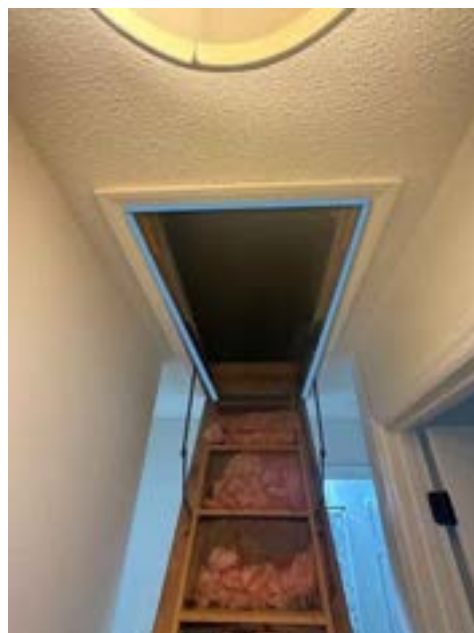
#### MISSING WEATHERSTRIPPING

Missing Weatherstripping around attic access door. Recommend adding weatherstripping for enhanced efficiency.

Contact a qualified handyman.

Owner has remediated  
improperly secured attic  
access

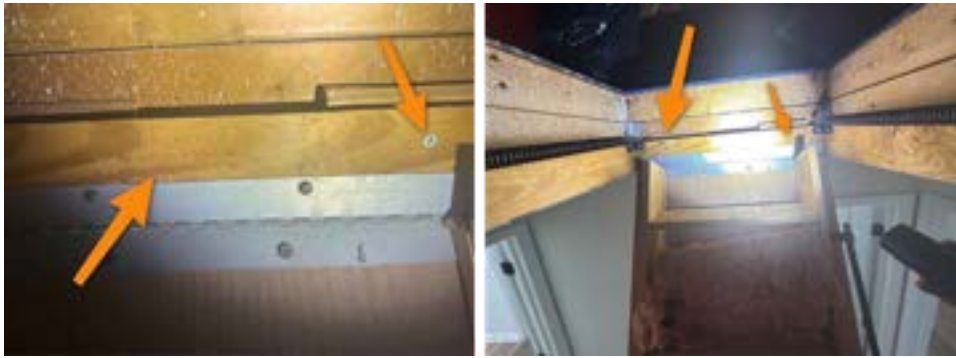
### 6.1.3 Structural Components & Observations in Attic

#### ATTIC ACCESS NOT PROPERLY SECURED

The attic access hatch is not secured with appropriate fasteners. Proper 16d nails should be used to ensure the access point remains safely closed and sealed. Without adequate fastening, the hatch may come loose, creating gaps that compromise insulation effectiveness and allow air infiltration.

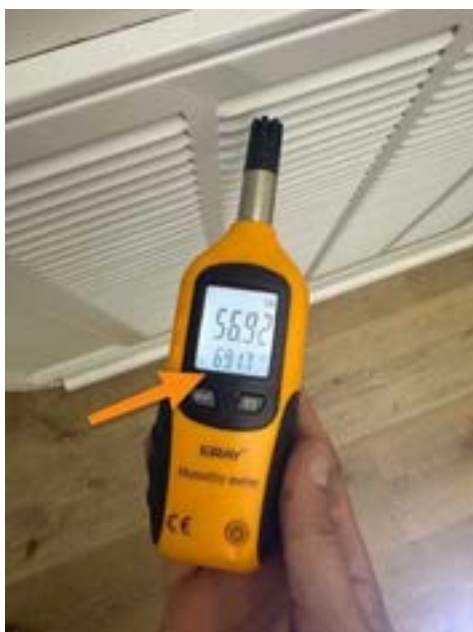
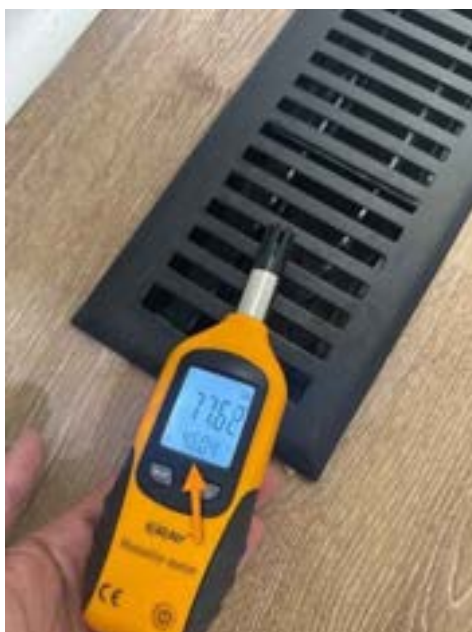
### 8.1.1 Cooling System Information

During the inspection, I noticed indications that the air conditioning system temperature difference may be higher than normal. 16-22 degrees is the normal range that we are looking for. If temperatures fall outside of that range, it means your AC may have some issues and needs to be further evaluated by a licensed HVAC technician to prevent damage to the system and prevent air quality issues.

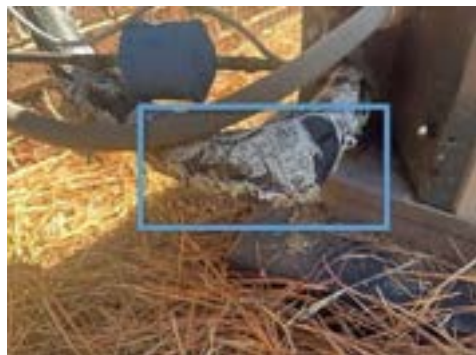
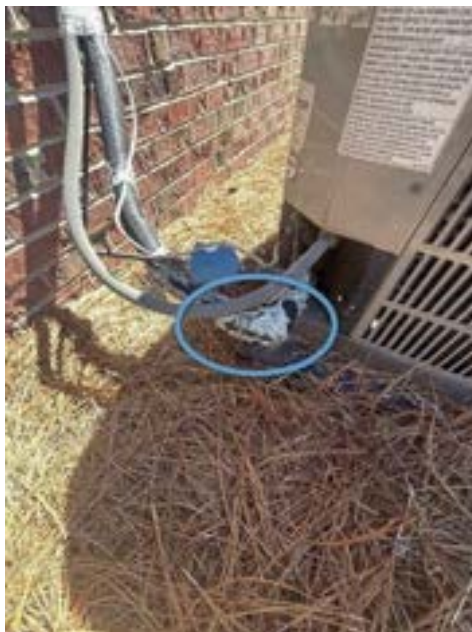
## 8.1.2 Cooling System Information

**REFRIGERANT LINE INSULATION MISSING OR DAMAGED**

I observed missing or damaged foam insulation at the cooling system's refrigerant line, which can cause energy loss and excess condensation.

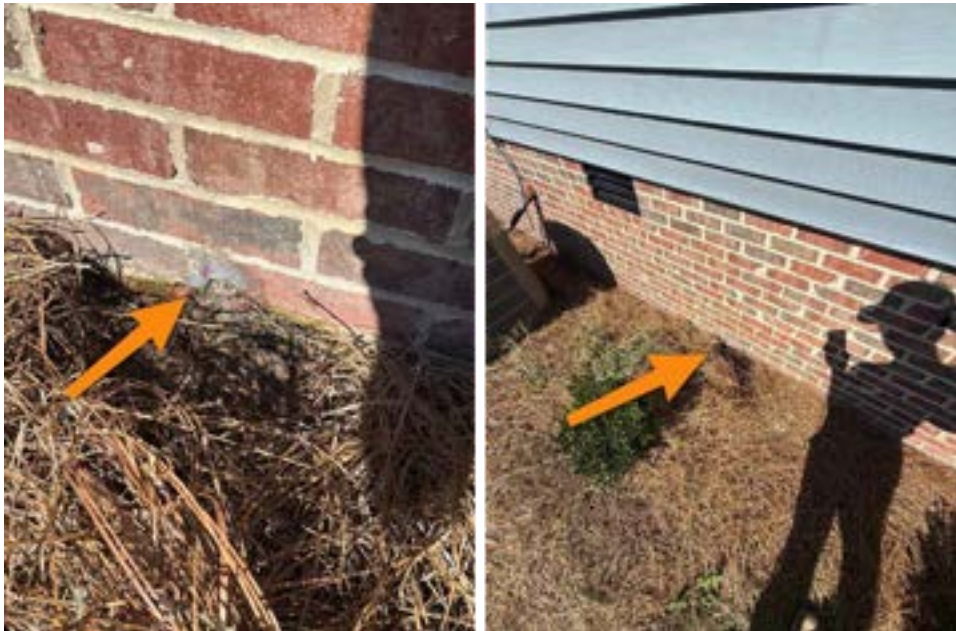
**CONDENSATE DISCHARGE SHOULD BE EXTENDED**

The condensate discharge pipe should be extended so that the water is diverted far enough away from the house foundation. The discharge could cause deterioration of the soil near the foundation.

Contact a qualified handyman.

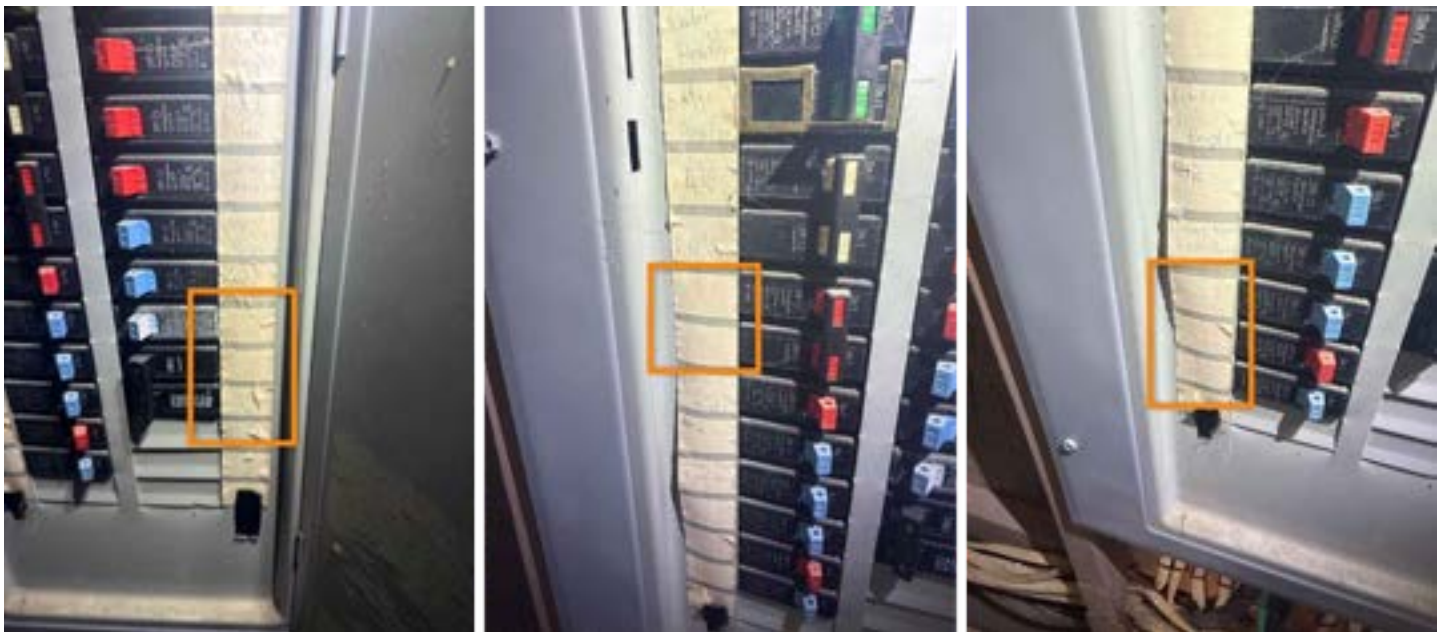
### MISSING LABELSONPANEL

At the time of inspection, panel was missing easily identifiable labeling. Recommend a qualified electrician or person identify, map out locations and clearly identify each circuit for safety.

Contact a qualified electrical contractor.

Electrical contractor confirmed  
electrical systems are consistent  
with building code at time of  
home's construction

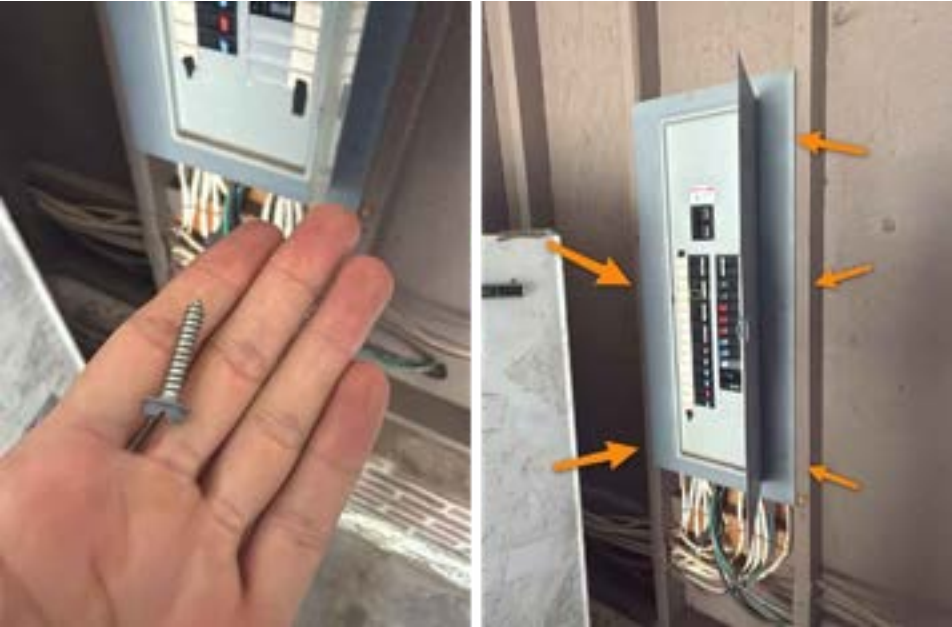
9.5.2 Panelboards & Breakers  
**INCORRECT TYPE OF SCREWS AT PANEL COVER**

I observed the use of incorrect types of screws / fasteners at the electrical panel cover. This could be potentially hazardous if the screws puncture a live electrical wire.  
Recommendation  
Contact a quali ed electrical contractor.

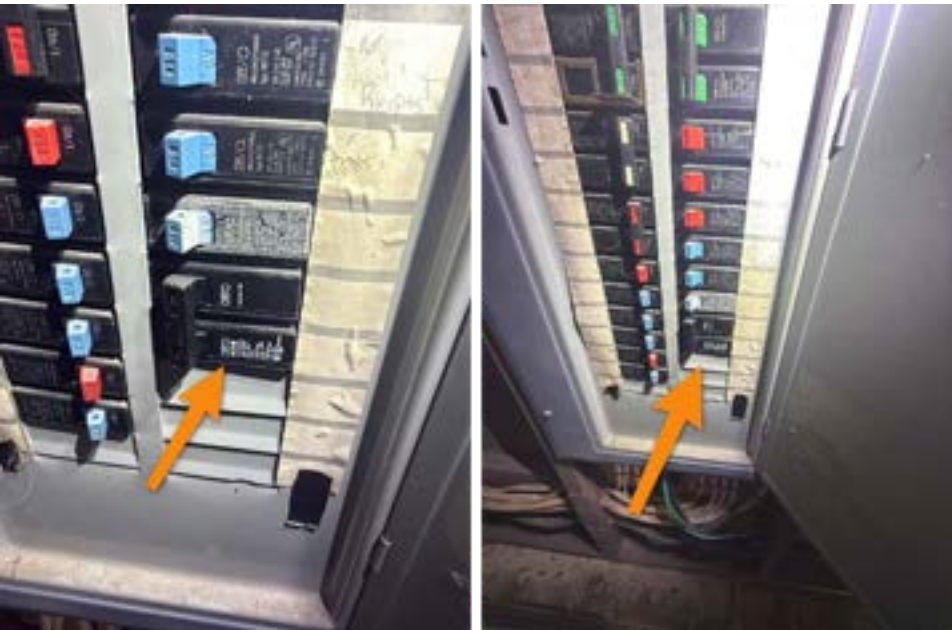
9.5.3 Panelboards & Breakers  
**BREAKER COMPATIBILITY**

Possible breaker compatibility issue. Some breaker brands are not safe to install in other brand panelboards due to tment issues. We recommend further evaluation by a licensed electrician for enhanced safety.  
Recommendation  
Contact a quali ed electrical contractor.

Electrical contractor confirmed electrical systems are consistent with building code at time of home's construction

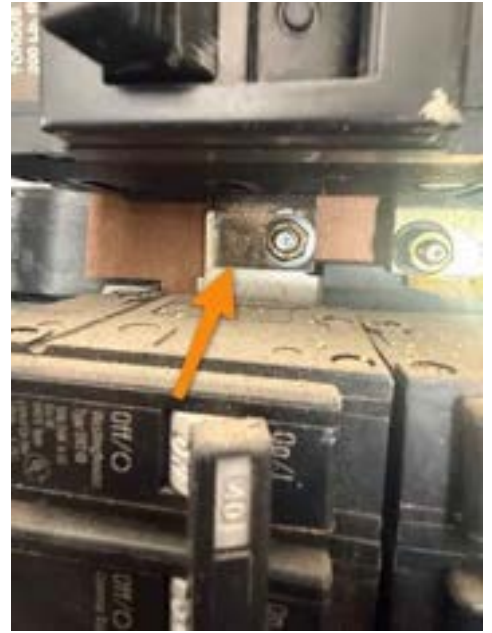
Signs of Possible scorching was observed inside the electrical panel during inspection. Scorching indicates heat damage and potential arcing or overheating within the panel, which creates a serious fire and electrical hazard. A licensed electrical contractor should evaluate the panel immediately to identify the cause and determine if repairs or replacement is necessary.

Contact a qualified electrical contractor.

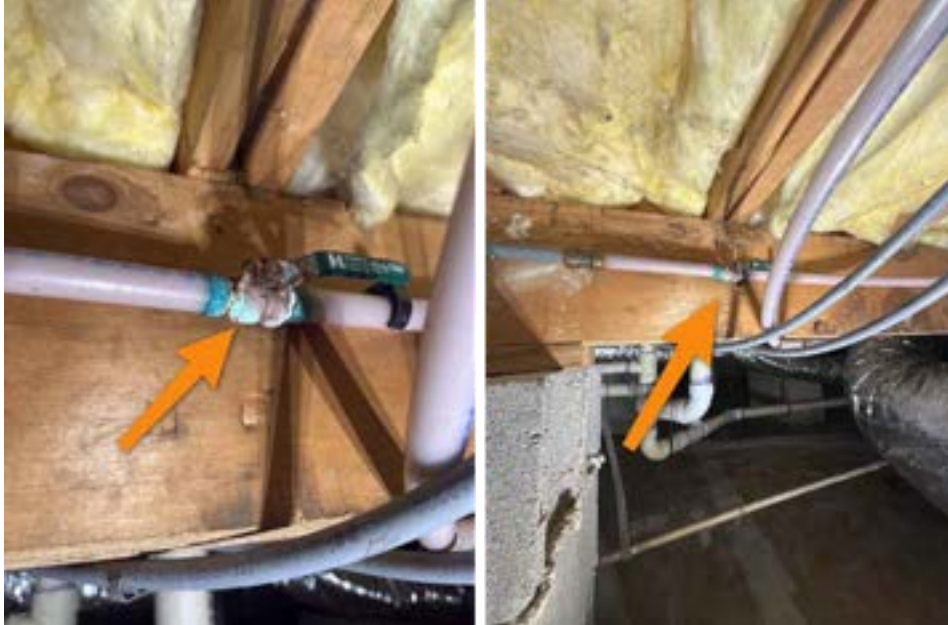
**WATER SUPPLY PIPE CORRODED**

Water supply pipe was corroded. This can lead to shortened lifespan of the pipe. Recommend a qualified plumber repair.

Contact a qualified plumbing contractor.

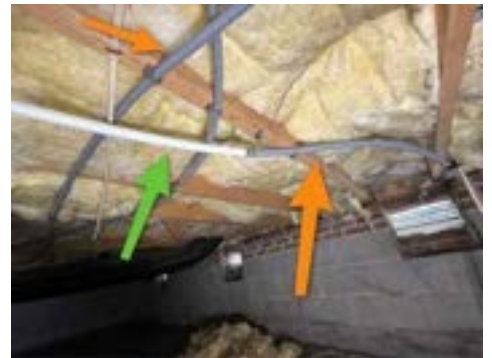
## 10.1.2 Water Supply &amp; Distribution Systems

I observed indications that the water supply pipes were made from polybutylene material. This material can be prone to fail without warning, causing damage to the property. Recommend a qualified plumber inspect the pipe further and consider replacing pipes and fittings with an approved material.

Contact a qualified plumbing contractor.

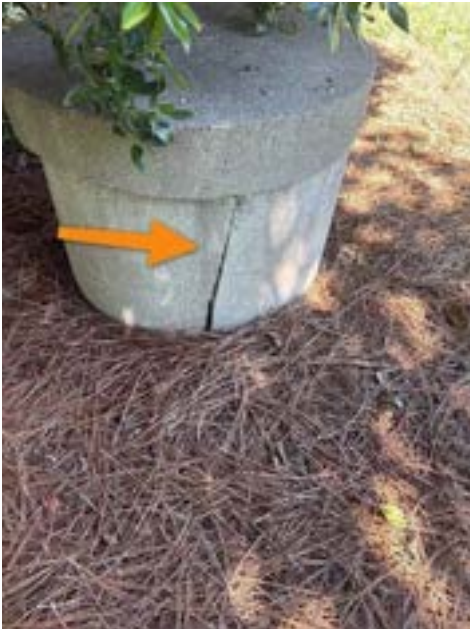
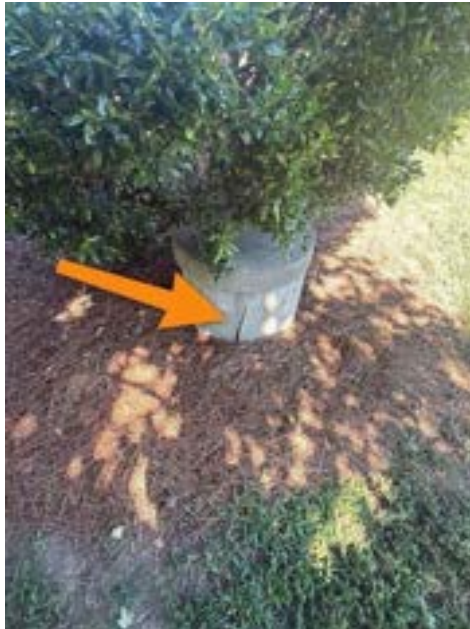
#### 10.1.4 Water Supply & Distribution Systems

##### CRACKED/DAMAGED WELLHEAD HOUSING

The concrete wellhead housing is cracked or damaged. This protective structure shields the well opening and can compromise water system integrity if not addressed. A qualified well service contractor should evaluate the damage and recommend repair or replacement to prevent contamination and ensure proper well function.

Contact a qualified well service contractor.

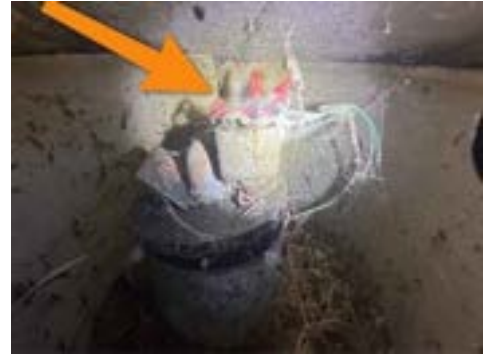
#### 10.1.5 Water Supply & Distribution Systems

##### EXPOSED WIRING AT WELLHEAD

An open electrical box with exposed wiring was observed at the wellhead during inspection. Exposed wiring creates a serious electrical hazard, including risk of shock, electrocution, and potential fire. The electrical box should be closed and secured, and all wiring should be properly protected and insulated by a qualified electrician.

Contact a qualified well service contractor.

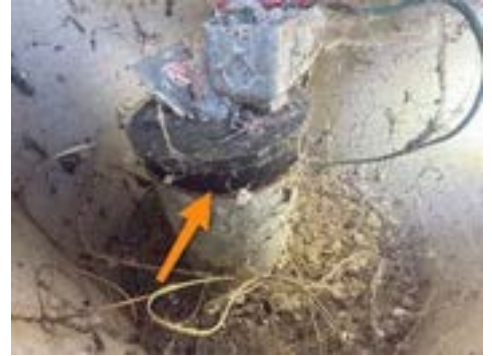
#### 10.1.6 Water Supply & Distribution Systems

##### WELLCAP LOOSE

A loose seal was observed on the wellhead container during inspection.

A compromised wellhead seal can allow contaminants to enter the water supply system, potentially affecting water quality and safety. The seal should be inspected by a well service contractor and tightened or replaced as needed to ensure proper protection of the water supply.

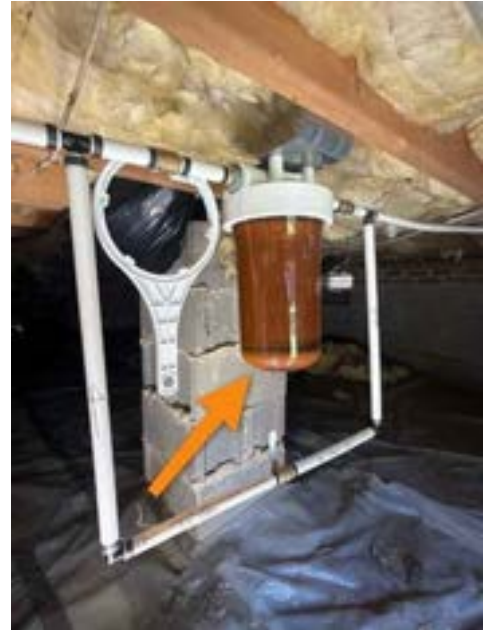
#### 10.1.7 Water Supply & Distribution Systems

##### DIRTY WATER FILTER

water flow throughout the home's plumbing system. A dirty filter reduces water pressure, increases strain on pipes and fixtures, and may allow contaminants to bypass filtration. The filter should be replaced promptly to restore proper water quality and system performance.

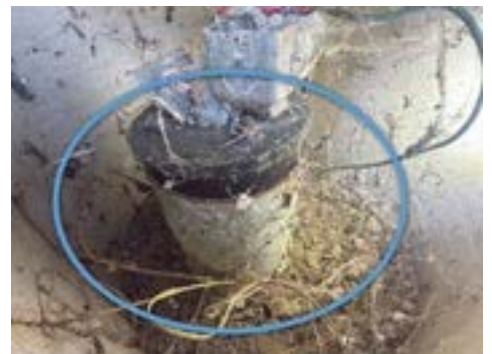
#### 10.1.8 Water Supply & Distribution Systems

##### MISSING WELL DATA PLATE

The data plate for the well system is missing. This plate typically

contains important information such as well depth, pump specifications, and system capacity. Without this documentation, it may be difficult to service the well or verify system specifications. Contact a well service contractor to document the system details and obtain replacement documentation.

Recommendation: Contact a qualified well service contractor.

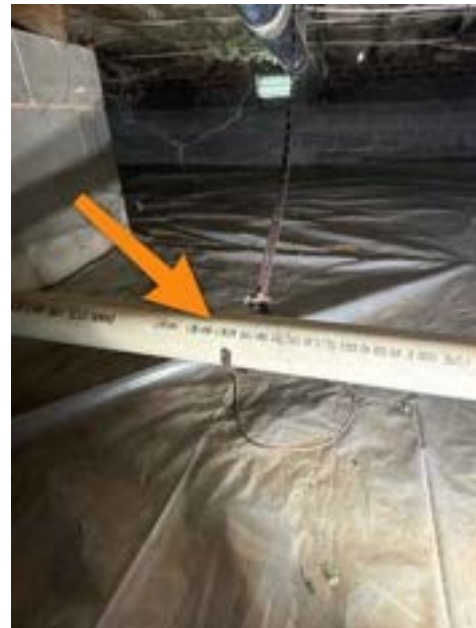
### 10.3.1 Drain, Waste, & Vent Systems

#### INADEQUATE PIPE SUPPORT

A section of plumbing pipe was observed with inadequate support. This can lead to sagging, joint stress, or leaks over time. Recommend securing the pipe properly in accordance with standard plumbing practices.

Recommendation: Contact a qualified plumbing contractor.

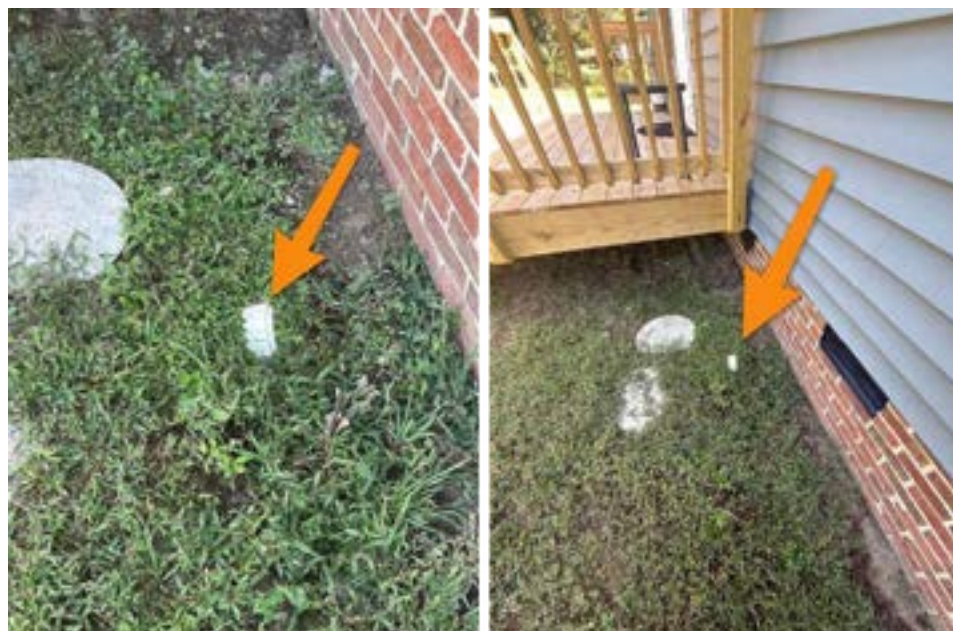
### 10.3.2 Drain, Waste, & Vent Systems

#### EXPOSED DRAIN PIPE

Drain pipe was exposed at the exterior during inspection. Recommend further evaluation to prevent damage to material and to prevent trip hazard.

Recommendation: Contact a qualified plumbing contractor.
