# TABLE OF CONTENTS

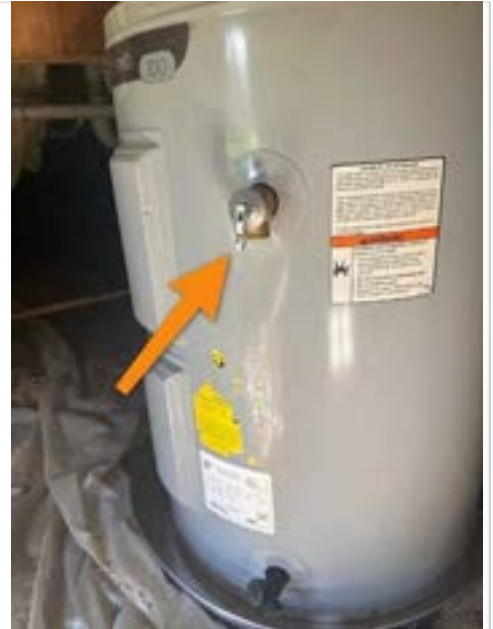
**DEFECT AT TPR VALVE DISCHARGE**

The discharge pipe that serves a temperature pressure relief valve must:

- Not be connected to the drainage system.
- Discharge through an air gap located in the same room as the water heater.
- Not be smaller than the diameter of the outlet of the valve.
- Serve a single relief device.
- Discharge to the floor.
- Discharge in a manner that does not cause personal injury or structural damage.
- Discharge to a termination point that is readily observable.
- Not be trapped.
- Be installed so as to flow by gravity.
- Terminate no more than 6 inches above the floor or flood level rim of the waste receptor. And not less than 2 times the discharge pipe diameter.
- Not have valves or fittings.
- Be constructed of materials listed or rated for such use.
- Be one nominal size larger than the size of the relief valve outlet, where the relief valve discharge piping is installed with insert fittings.

Contact a qualified plumbing contractor.

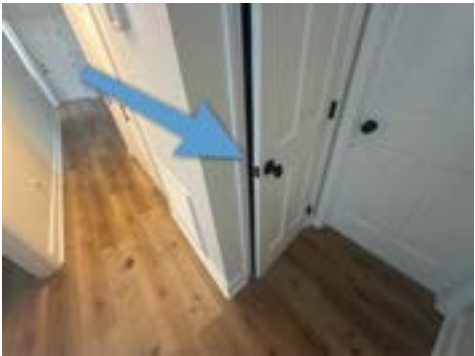
11.1.1 Doors

I observed that a door does not latch and close properly. Recommend adjustment and further evaluation of all doors to ensure proper functionality.  
Recommendation

Contact a qualified handyman.

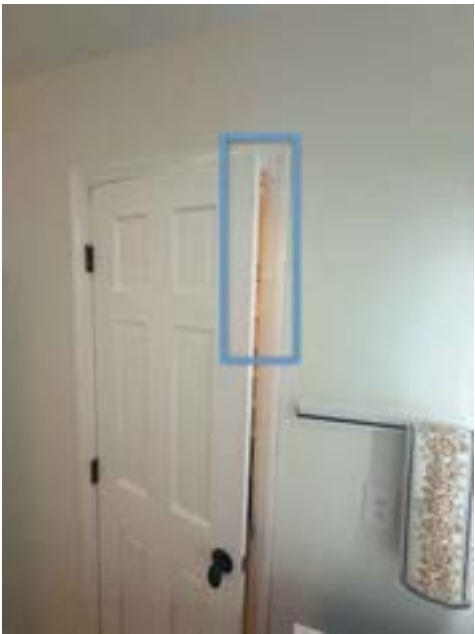
11.1.2 Doors

I observed that the door sticks. Recommend minor adjustment to ensure proper functionality and prevent wear on materials.  
Recommendation  
Contact a qualified handyman.

Improperly closing doors have been remediated by seller

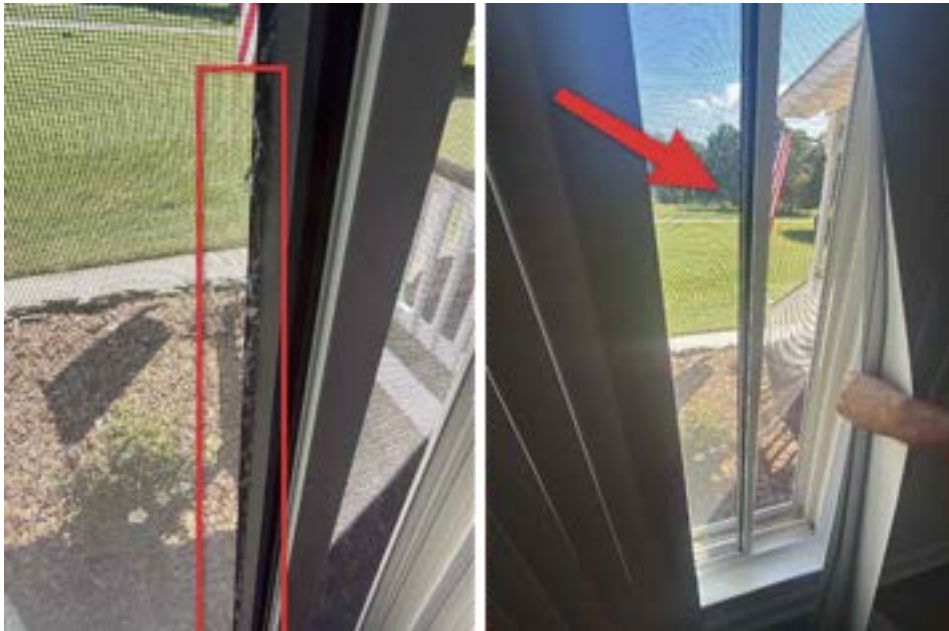
11.2.1 Windows

CRACKED GLASS

CRACKED GLASS - windowpane glass. Hazardous. Recommend replacement of damaged glass.  
Contact a qualified window repair/installation contractor.

Window is double-paned, one pane had cracked before current owner moved in, there has been no additional window cracking or damage since she has owned the home

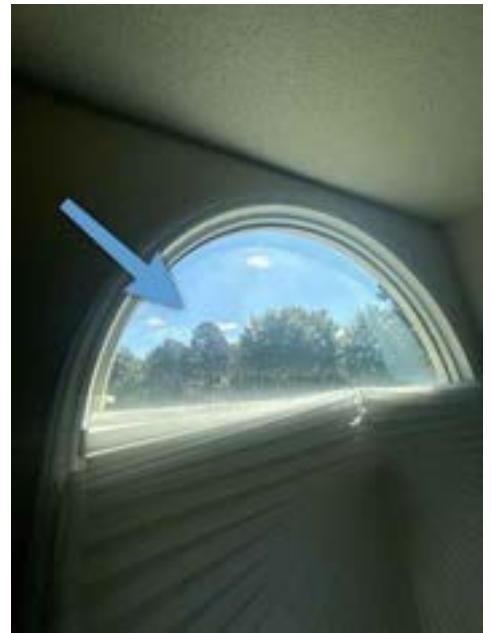
#### 11.2.2 Windows

##### FOGGED / BROKEN SEALS

I observed a fogged window which indicates a broken seal. Recommend monitoring windows for this symptom and obtaining an evaluation by a window contractor to replace as needed. Visible condensation is the most common sign of a broken window seal. When a window seal fails, humid air can seep between the panes and create the fog you're seeing. If you do nothing, the fog may lessen or worsen in conjunction with weather changes and fluctuating outdoor humidity levels. It is important to have window seals in place to ensure the effectiveness of the thermal insulation.

Contact a qualified window repair/installation contractor.

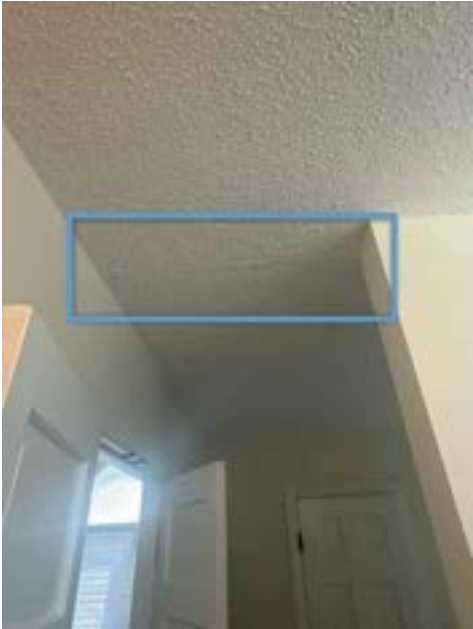
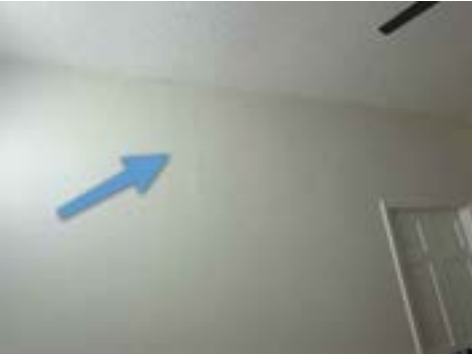
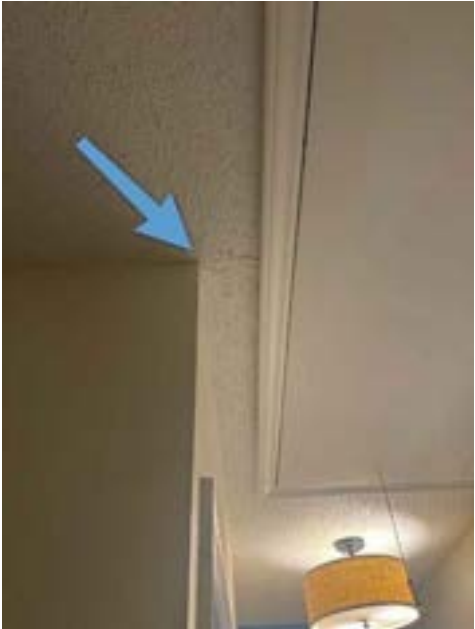
#### 11.3.1 Floors, Walls, Ceilings

##### MINOR CORNERCRACKS

Minor cracks at the corners of trim, doors, windows and walls. Appeared to be the result of settling. Some settling is not unusual in a home of this age. Recommend further evaluation of the interior walls and trim by a qualified contractor.

Contact a qualified drywall contractor.

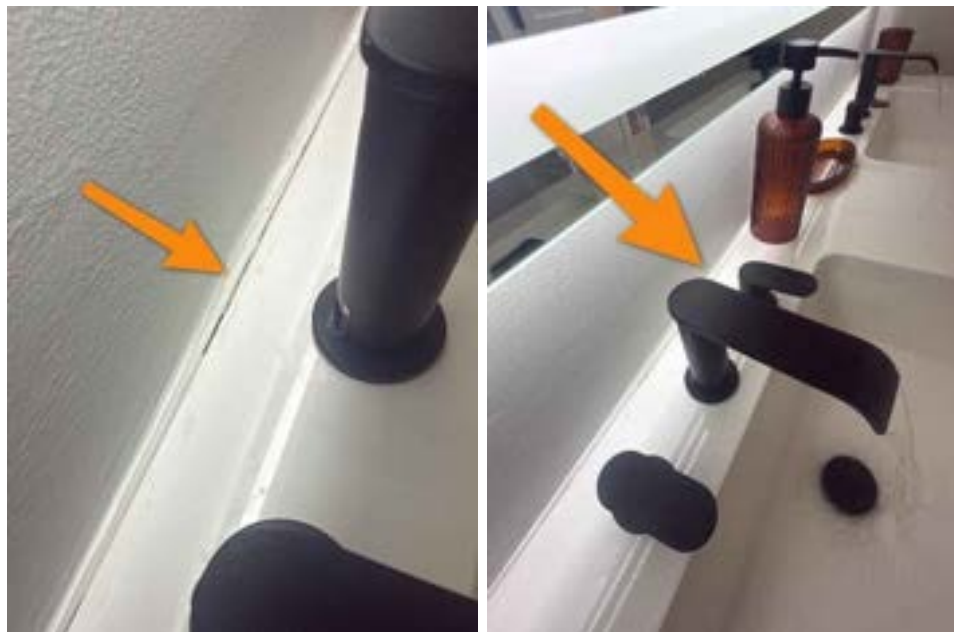
SEALANTS / TUBS & SHOWERS

Caulking / sealant was poor or missing in wet locations during inspection. Recommend properly installing sealant in all wet locations to prevent deterioration of material due to water intrusion.

Contact a qualified handyman.

Owner has remediated caulking in bathroom

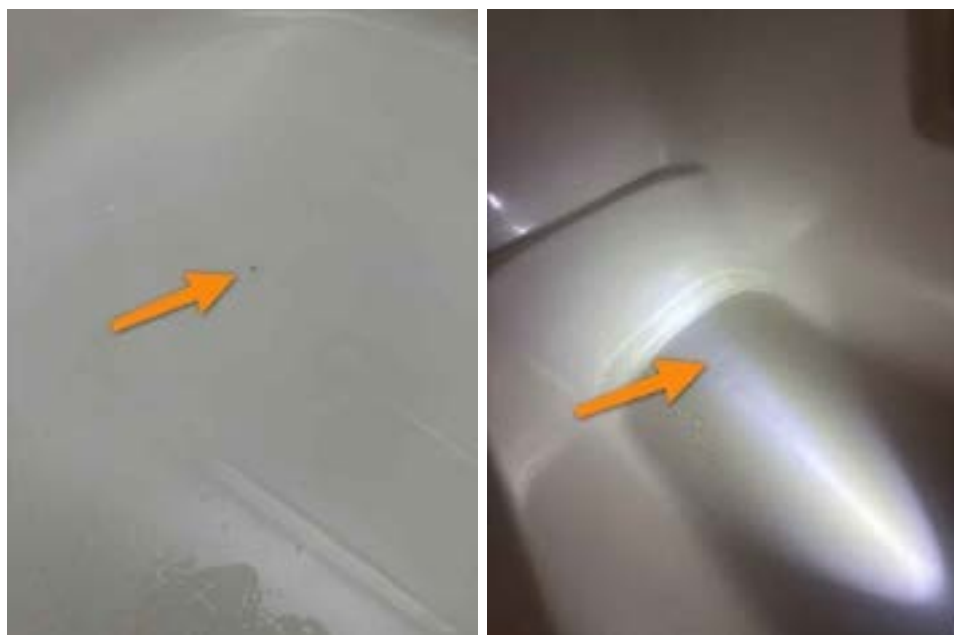
#### 12.2.2 Sinks, Tubs & Showers

##### DAMAGED TUB

The bathtub was damaged. Recommend replacement or repair prior to usage to prevent water intrusion and further damage.

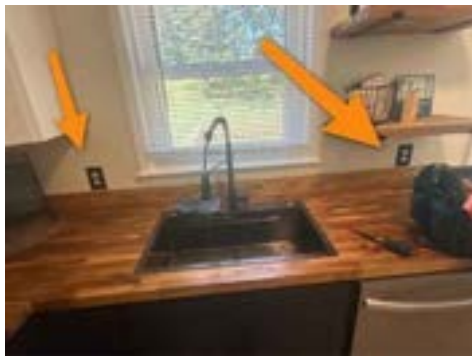
### 13.2.1 GFCI

#### MISSING GFCI PROTECTION

I observed indications of missing GFCI protection in the kitchen. All kitchen counter and island receptacles are required to be GFCI protected. Outlets on walls, behind wet areas (sinks, etc.) that have features such as countertop breakfast bars should also be GFCI protected.

Electrical contractor confirmed electrical systems are consistent with building code at time of home's construction

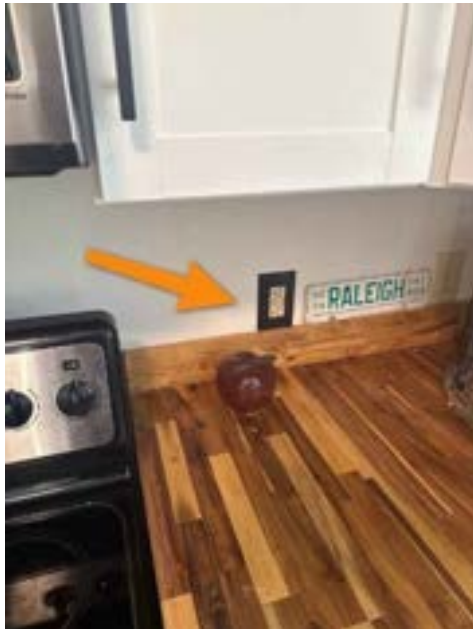
### 13-2-2-GFCI

The GFCI receptacle in the kitchen is not responding correctly to test button activation. GFCI outlets are critical safety devices designed to protect against electrical shock and ground faults. A non-functioning GFCI receptacle leaves the circuit unprotected and should be evaluated and repaired by a qualified electrician.

Electrical contractor confirmed electrical systems are consistent with building code at time of home's construction

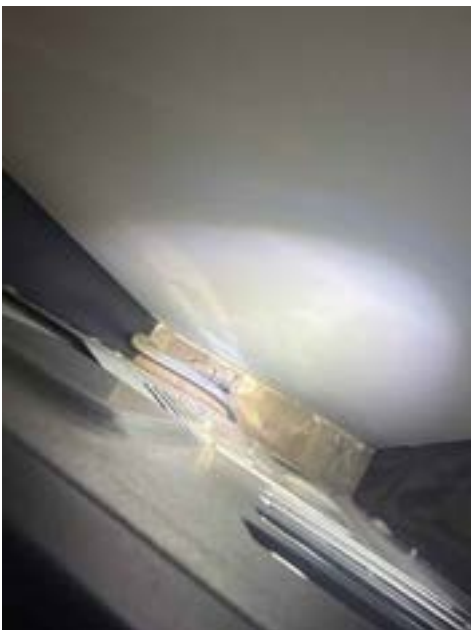
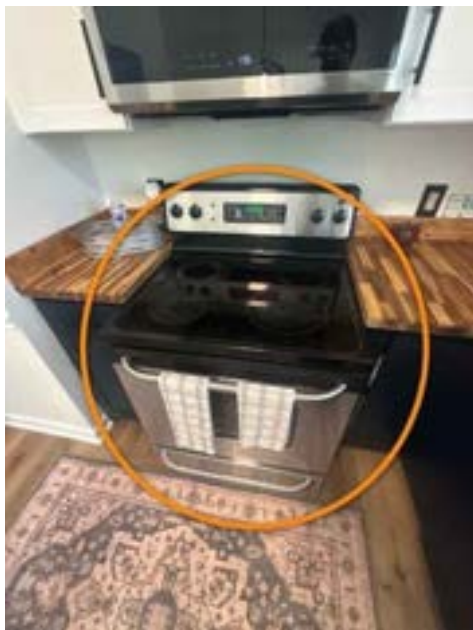
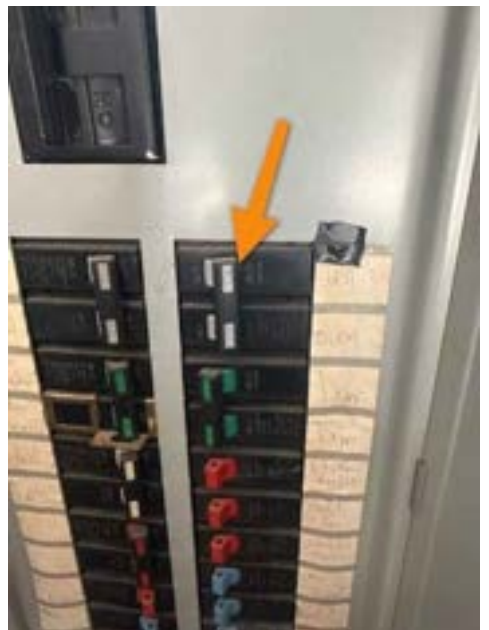
Oven was not plugged in at time of inspection

Contact a qualified handyman.

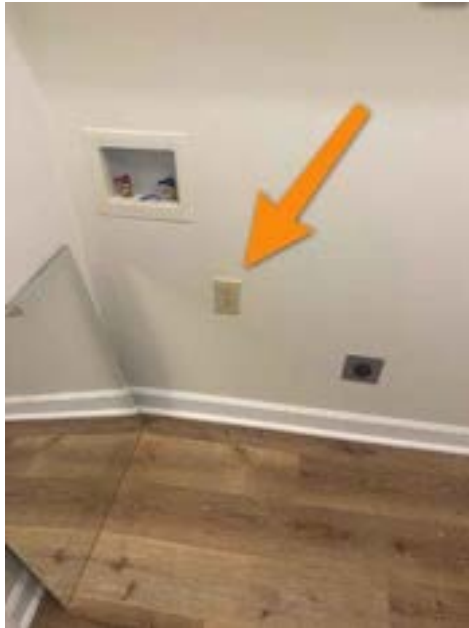
I observed indications that there is missing GFCI protection at the receptacles in the laundry room.

Contact a qualified electrical contractor.

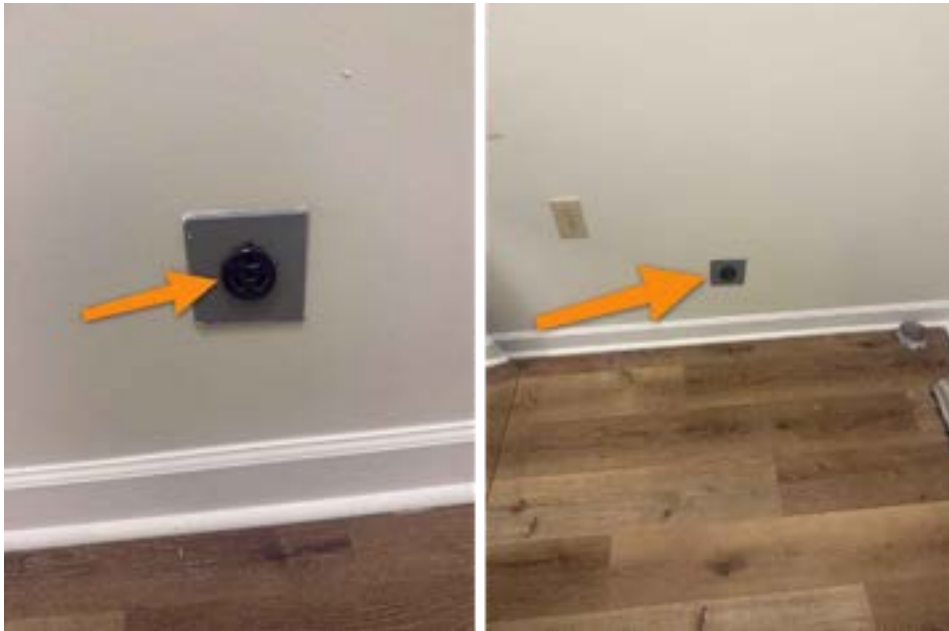
### 14.3.1 Clothes Dryer

I observed an old, 3-prong outlet for the electric dryer.

Contact a qualified electrical contractor.

Electrical contractor confirmed  
electrical systems are consistent  
with building code at time of  
home's construction

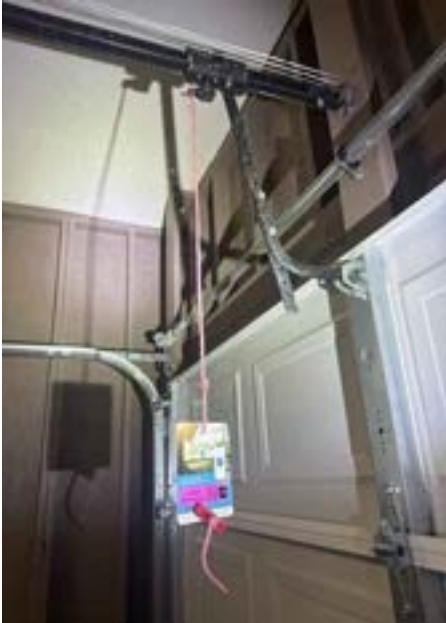
I checked for a manual release handle--a means of manually detaching the door from the door opener.

The handle should be colored red so that it can be seen easily. The handle should be easily accessible and no more than 6 feet above the garage floor. The handle should not be in contact with the top of a vehicle.

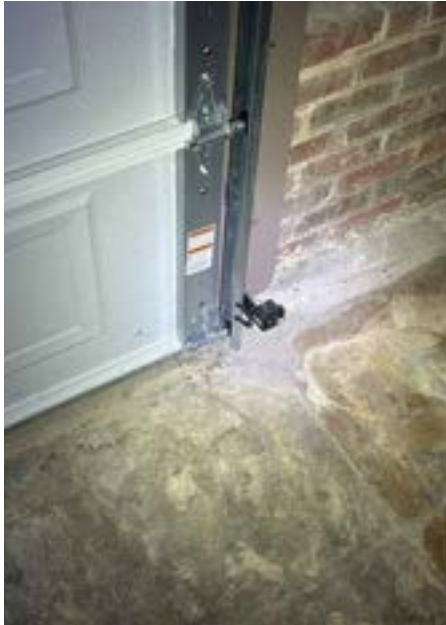
Federal law states that residential garage door openers manufactured after 1992 must be equipped with photo-electric eyes or some other safety-reverse feature that meets UL 325 standards.

I checked to see if photo-electric eyes are installed. The vertical distance between the photo-eye beam and the door should be no more than 6 inches.

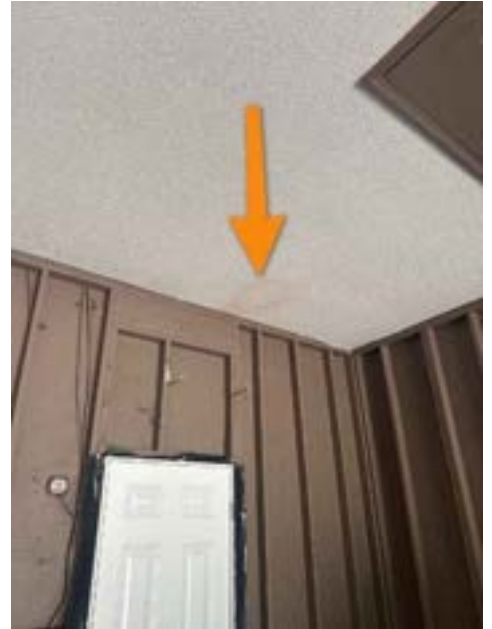
**MOISTURE INTRUSION**

Garage walls showed signs of moisture intrusion. Recommend a

qualified contractor evaluate and find source of moisture to prevent further damage and/or mold.

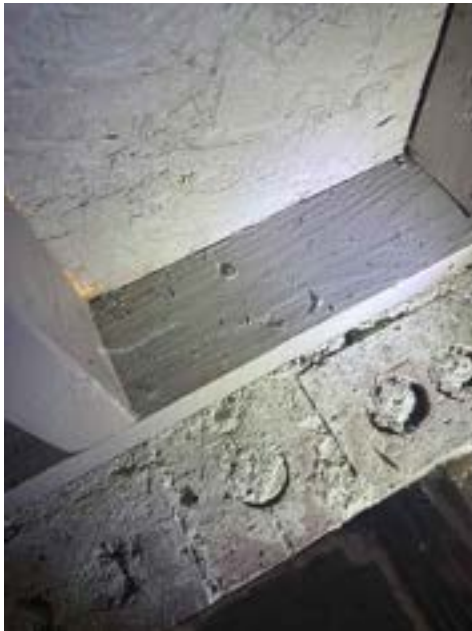
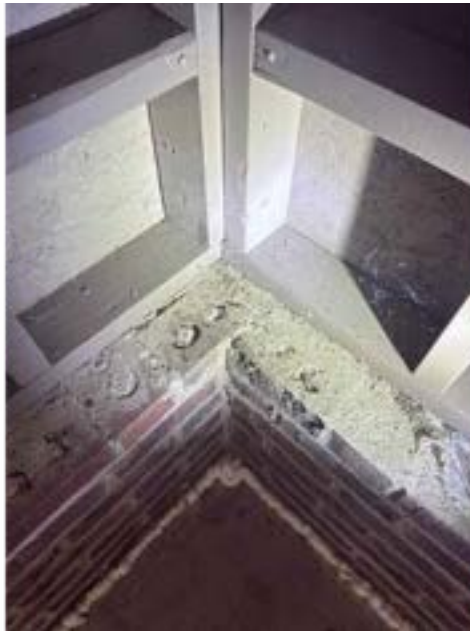
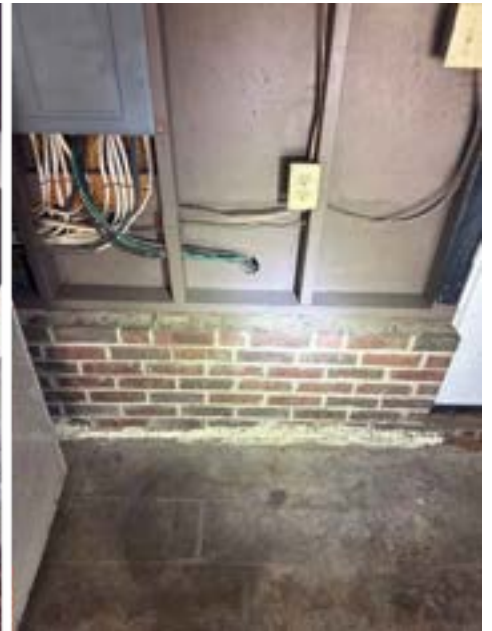
## 15.5.2 Ceiling, Walls &amp; Firewalls in Garage

**MISSING SILL PLATE ANCHOR**

Sill plate anchors are missing at the walls in the garage. Sill plates are the horizontal members that connect the foundation to the framing, and anchors secure them to prevent shifting during seismic activity or high winds. Without proper anchoring, the structure may be vulnerable to lateral movement. A foundation contractor should evaluate the condition and install appropriate anchors to secure the sill plate to the foundation.

Contact a foundation contractor.

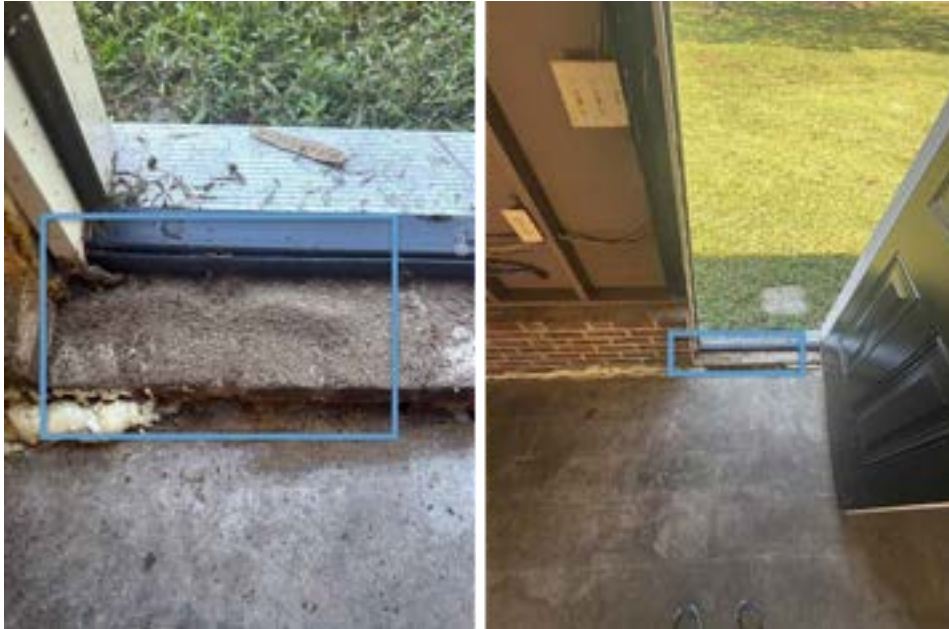
## 15.5.3 Ceiling, Walls &amp; Firewalls in Garage

**PEST INFESTATION****GARAGE**

Ants were observed in the garage during inspection. Pest infestations can cause structural damage over time and may indicate moisture or food sources attracting them. A pest control professional should evaluate the extent of the infestation and recommend appropriate treatment and prevention measures.

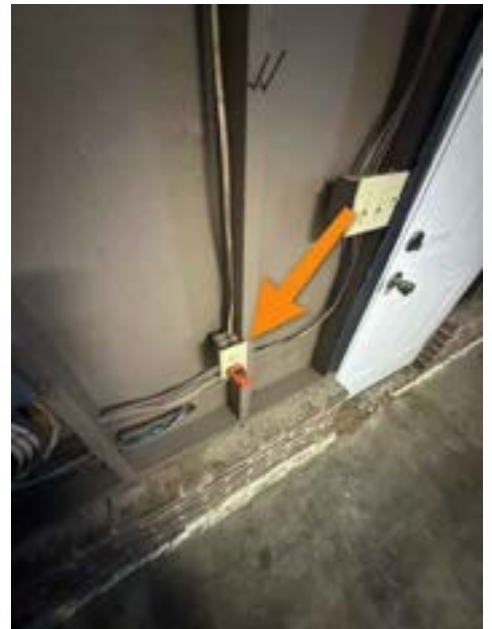
## 15.6.1 Electric in Garage

**MISSING GFCI-PROTECTION IN GARAGE**

I observed a receptacle in the attached garage without GFCI (or ground fault circuit interrupter) protection.

Electrical contractor confirmed  
electrical systems are consistent  
with building code at time of  
home's construction
