## Summary

### A1. Exterior: Wall Cladding

#### A1-1 Main House

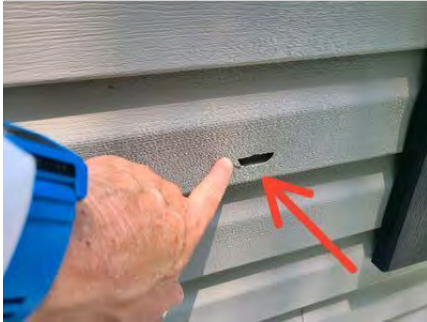
Multiple areas of the vinyl siding have damage which can allow for water/pest penetration into the wall system. The siding system is in need of evaluation and repairs by a licensed general contractor or specialist to ensure the integrity and weathertightness of the system.

Photo - To the right of the front door there is a hole in the siding system.

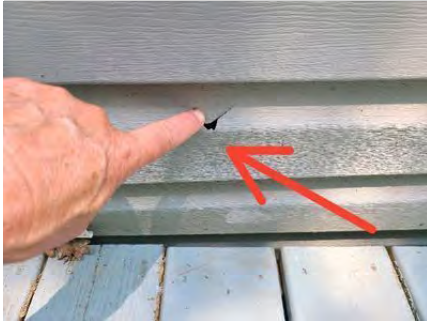
#### (A1-1.2) Main House

Additional photo of damaged siding to the right side of the front door.

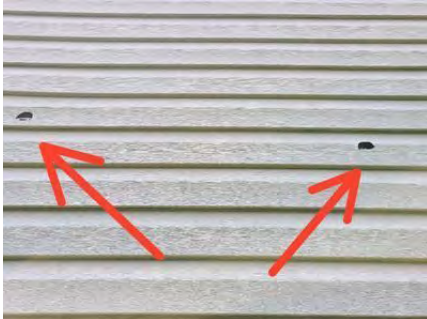
#### (A1-1.3) Main House

Additional photo of holes in the siding on the right side of the home in need of evaluation and repair.

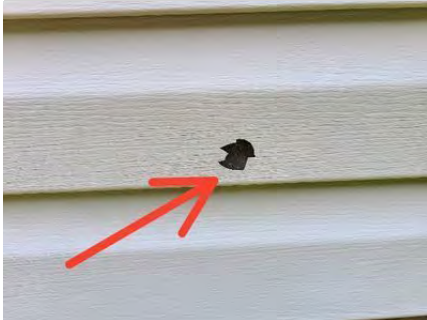
#### (A1-1.4) Main House

Additional photo of hole in the siding on the right side of the home in need of repair.

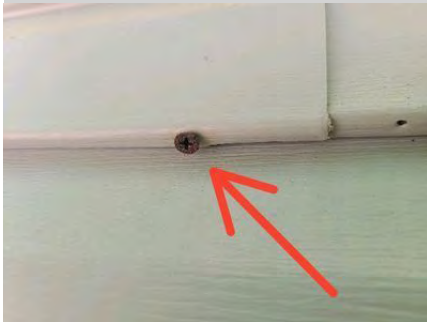
**(A1-1.7) Main House**

Additional photo - Multiple areas throughout the rear of the home exhibit evidence of improper repairs to the vinyl siding system. Fasteners should never be exposed. A licensed general contractor should be consulted for evaluation and repair.

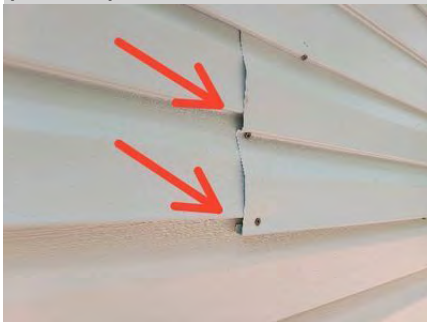
**(A1-1.8) Main House**

Additional photo of improper repair of the siding system at the rear of the home. This repair allows for water penetration into the siding system.

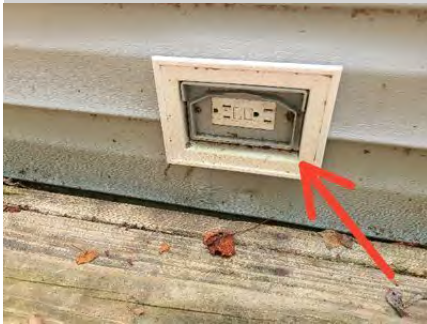
**(A1-1.11) Main House**

At the rear of the home the GFCI receptacle has a broken cover and is exposed to the elements. This poses an electrical safety concern. A licensed electrician or specialist should be consulted for evaluation and repair to ensure the receptacle is in a weather tight enclosure as intended.

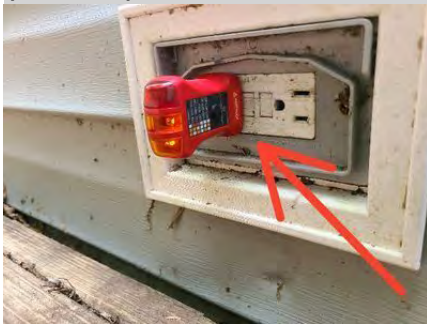
**(A1-1.12) Main House**

The GFCI receptacle at the rear of the home was not functional at the time of the inspection. The unit would not trip when tested. This is an important safety device. A licensed electrician or specialist should be consulted for evaluation and repair.

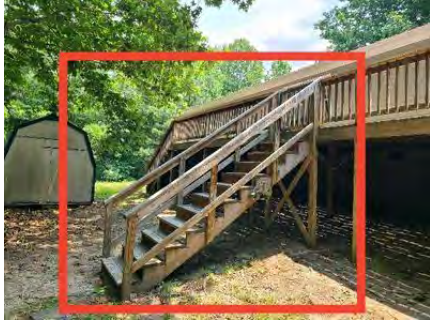
#### (A3-1.2) Deck (Location: Main House Rear)

Additional photo, The rear steps leading to the deck should be considered a safety hazard and not be used. The entire stair system is loose and unstable and poses an immediate safety hazard.

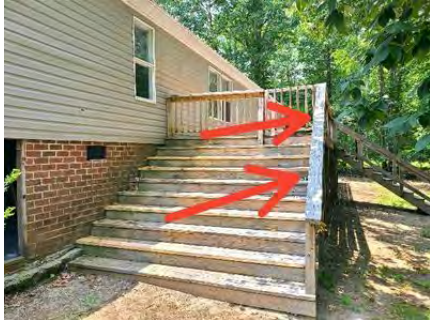
#### (A3-1.3) Deck (Location: Main House Rear)

The top plate or grip that is installed on the handrails for the deck steps is too wide. The top plate should be within a size and thickness so that it can be easily gripped to prevent a fall.

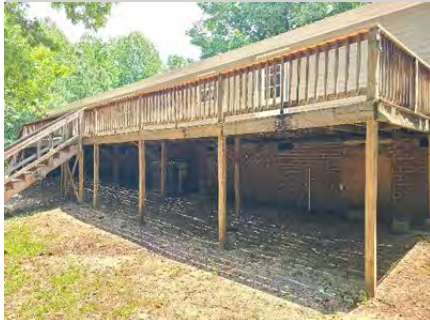
#### (A3-1.4) Deck (Location: Main House Rear)

Additional photo exhibiting evidence of missing cross bracing between the support posts for the entire elevated rear deck system.

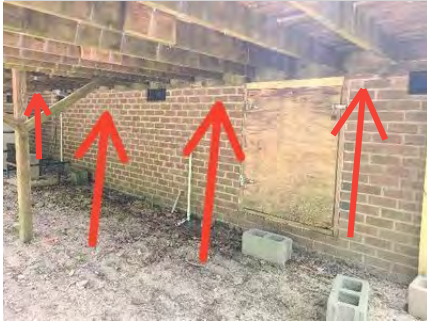
**(A3-1.10) Deck** (Location: Main House Rear)

Additional photo - deck systems on manufactured homes should be completely self-supporting. The rear deck system does not have any support posts along the perimeter wall on the exterior of the home. Safety hazard!

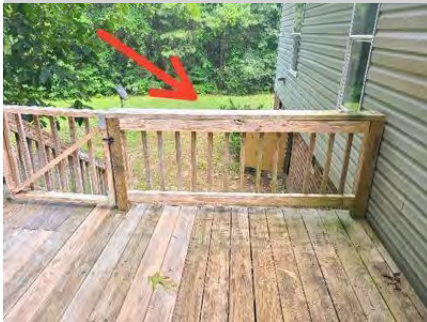
**(A3-1.11) Deck** (Location: Main House Rear)

Additional photo of loose railing system at the rear deck.

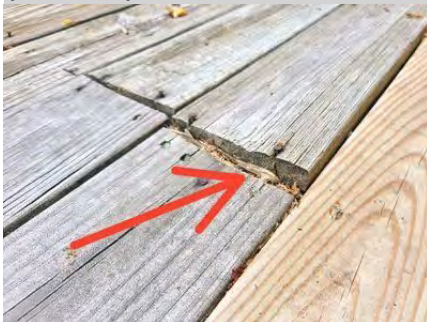
**(A3-1.12) Deck** (Location: Main House Rear)

Additional photo typical of the poor floor board system on the rear deck with raised nails and loose boards and uneven walking surface throughout the flooring system.

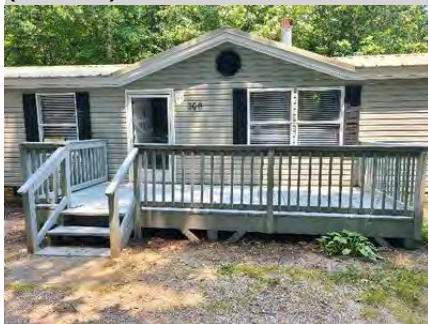
**(A3-2.5) Front Porch** (Location: Main House Front)

Limitation, due to the low height of the front porch system it is not possible to completely evaluate the flooring system. Also, could not confirm if the porch system is self supporting, as required for manufactured homes.

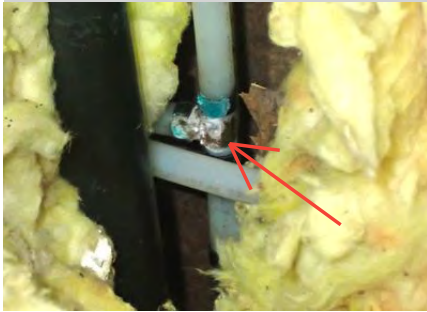
### (D2-1.2) All Accessible Areas

The water distribution line located beneath the vicinity of the 2nd bathroom line is corroded and leaking. Leaks in the water supply lines should be addressed as soon as possible to prevent property damage and flooding. A licensed plumbing contractor should be consulted for complete evaluation of the distribution systems to determine the general condition of the system and make necessary repairs.

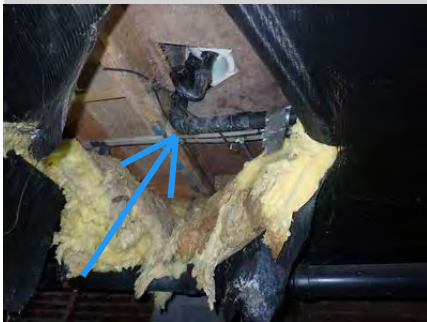
### D3-1 All Accessible Areas

The waste line for the bathtub in the 2nd bathroom is leaking. The waste line needs to be repaired to ensure sanitary conditions. A licensed plumbing contractor should be consulted for a complete evaluation of the waste line systems to determine the general condition of the system and to make necessary repairs.

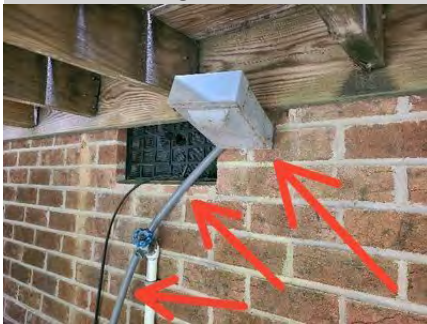
### G1-1 Cooling Unit 1 (Location: Exterior: Closet)

At the rear of the home the electrical disconnect for the air conditioning unit is improperly fastened to the home. The unit was likely moved when the deck system was installed. This condition can allow for direct water penetration into the disconnect which can cause an electrical safety hazard. A licensed electrician or air conditioning specialist should be consulted for evaluation and repair to ensure safe use of the air conditioning system.

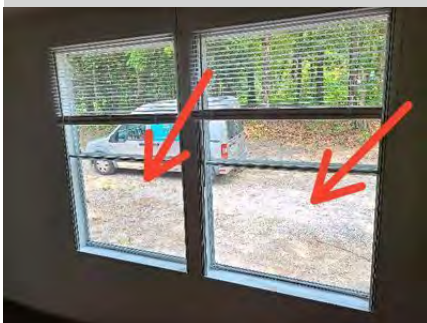
Both lower inside windows in the master bedroom area were missing at the time of the inspection. A specialist should be consulted for evaluation and repair.

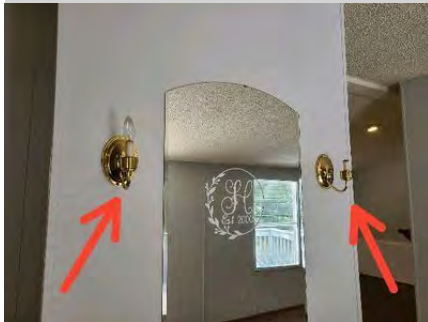
The two light fixtures in the family room area were not operational at the time of the inspection. A specialist should be consulted for evaluation and repair.

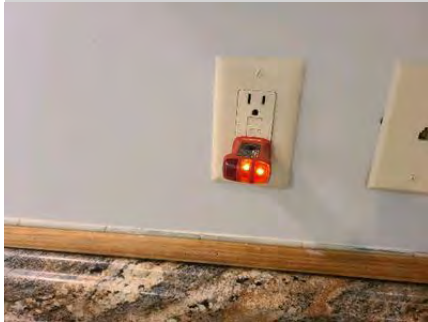
### H2-1 Kitchen

The GFCI receptacle in the kitchen did not test/reset correctly to ensure that it was ground fault protected. GFCI protection is needed to reduce shock in hazardous locations. Corrective repairs are needed.

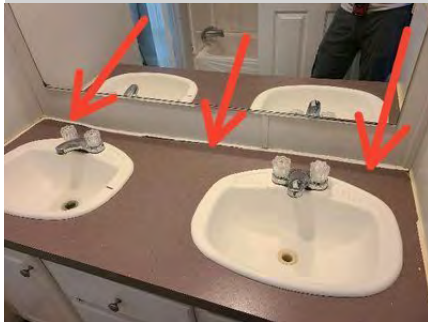
### H3-1 Bathroom 2

The countertop in the second bathroom for the vanity is very loose and buckled behind both sinks for the entire span of the countertop. This suggests there may have been water damage. A specialist should be consulted for a complete evaluation and repair/replacement as needed to ensure the vanity system is functioning as intended.

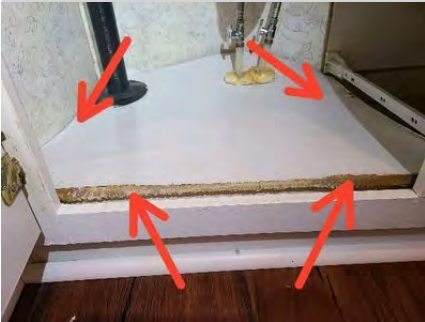
### H3-2 Bathroom: Master

The base cabinet for the master bathroom area is very warped/damaged beneath the two sinks, suggesting a history of water damage. A specialist should be consulted for evaluation and repair or replacement as needed.

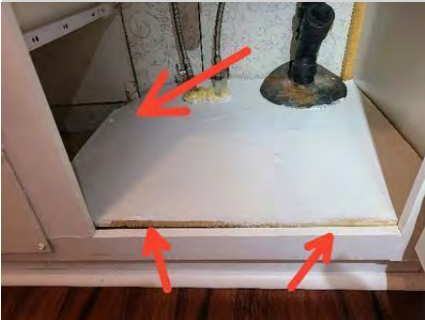
### (H3-2.2) Bathroom: Master

Additional photo of damaged base cabinet beneath the master bathroom sink

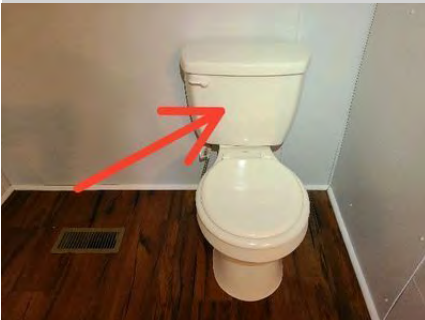
### (H3-2.3) Bathroom: Master

The tank on the toilet in the master bathroom is loose. This can lead to leaks and damage to the home. A licensed plumber or specialist should be consulted for evaluation and repair.

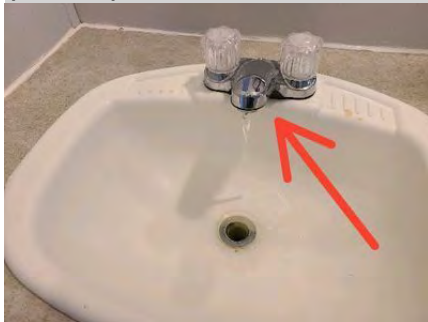
**(H3-2.5) Bathroom: Master**

The left side faucet in the master bathroom was not functioning properly at the time of the inspection. The faucet lost water pressure during use suggesting that there may be a supply line issue, blockage or defect with the faucet unit. A licensed plumber or specialist should be consulted for evaluation and repair.

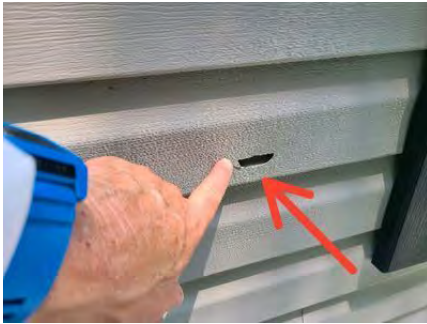
##### (A1-1.1) Main House

Multiple areas of the vinyl siding have damage which can allow for water/pest penetration into the wall system. The siding system is in need of evaluation and repairs by a licensed general contractor or specialist to ensure the integrity and weathertightness of the system.

Photo - To the right of the front door there is a hole in the siding system.

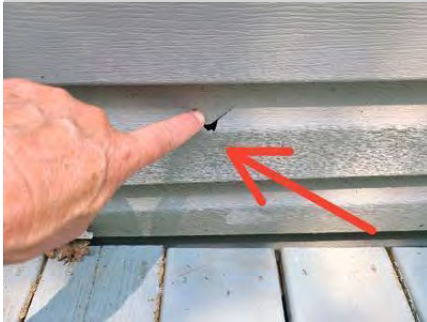
##### (A1-1.2) Main House

Additional photo of damaged siding to the right side of the front door.

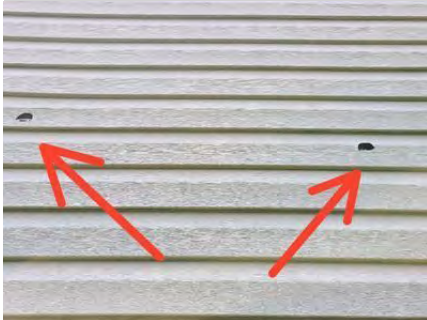
##### (A1-1.3) Main House

Additional photo of holes in the siding on the right side of the home in need of evaluation and repair.

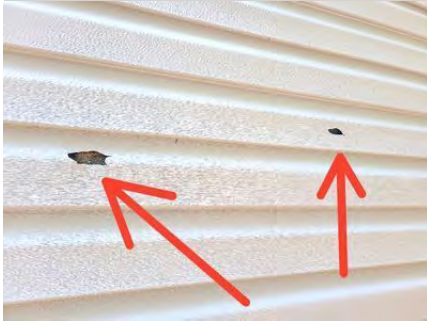
**(A1-1.5) Main House**

Additional photo of damaged siding at the rear of the home.

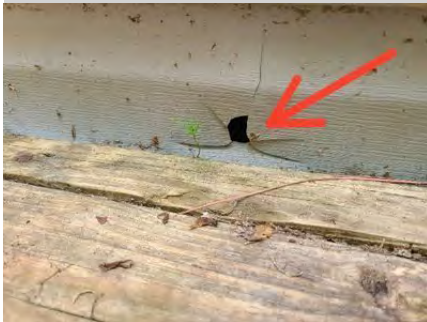
**(A1-1.6) Main House**

Additional photo of damaged siding at the rear deck area of the home.

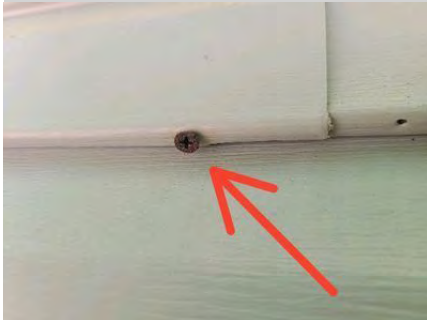
**(A1-1.7) Main House**

Additional photo - Multiple areas throughout the rear of the home exhibit evidence of improper repairs to the vinyl siding system. Fasteners should never be exposed. A licensed general contractor should be consulted for evaluation and repair.

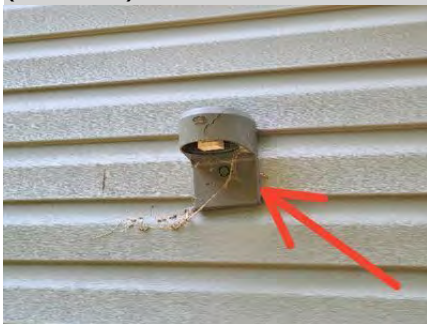
**(A1-1.10) Main House**

The exterior light fixture at the right rear of the home was missing a bulb and not operational at the time of the inspection. Corrective repairs are needed.

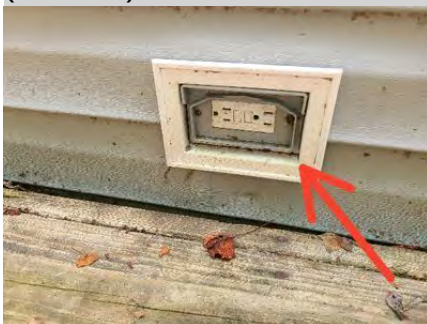
**(A1-1.11) Main House**

At the rear of the home the GFCI receptacle has a broken cover and is exposed to the elements. This poses an electrical safety concern. A licensed electrician or specialist should be consulted for evaluation and repair to ensure the receptacle is in a weather tight enclosure as intended.

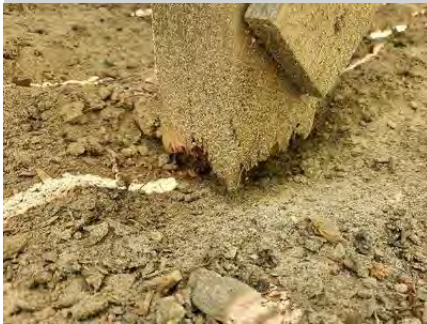
**(A3-1.5) Deck**

Additional photo of a rear deck support post completely decayed and not making contact with the ground.

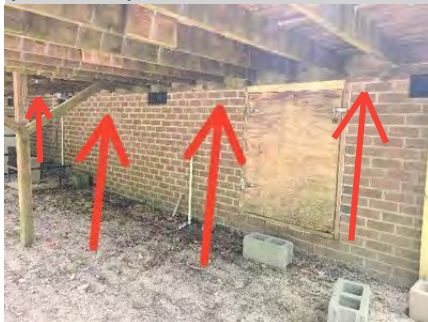
**(A3-1.10) Deck**

Additional photo - deck systems on manufactured homes should be completely self-supporting. The rear deck system does not have any support posts along the perimeter wall on the exterior of the home. Safety hazard!

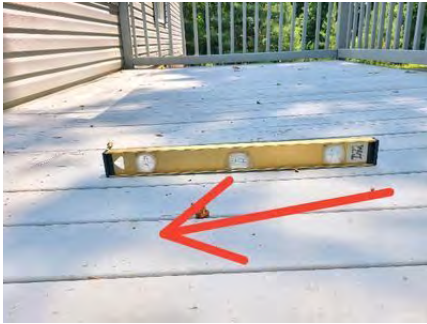
### (A3-2.1) Front Porch

The surface of the front porch has a significant negative slope towards the home. This condition can allow for water to be diverted towards the foundation of the home which can lead to undesirable conditions in the crawl space as well as damage to the foundation system. Additionally, the uneven surface can cause a trip and fall safety concern for egress in and out of the home. A licensed general contractor should be consulted for a complete evaluation and any necessary repairs/replacement of the front porch system to ensure it is safe for use as intended.

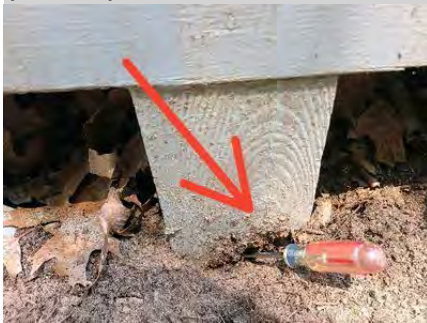
### (A3-2.3) Front Porch

Additional photo of the front center support post for the deck system exhibits evidence of advanced decay.

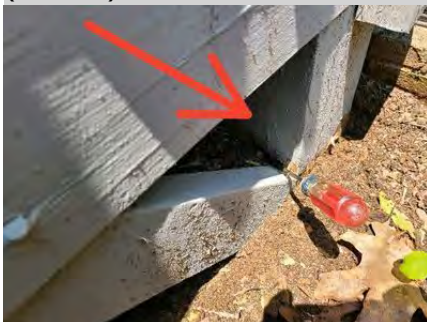
### (A3-2.4) Front Porch

Additional photo of the right rear corner support post for the deck system exhibits evidence of advanced decay.

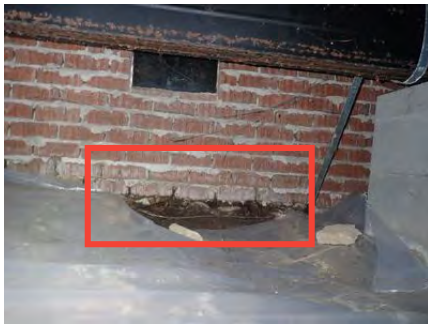
#### (B1-1.1) Main House

In the crawl space, the foundation walls at the front of the home were wet and the soil adjacent to the foundation was muddy from direct water penetration in the area. Direct water penetration damages the foundation, the wood structure, and creates an undesirable environment in the crawl space areas that encourages insects and or fungal growths such as mold/mildew. Water in the crawl space indicates an absent or damaged waterproofing and foundation drain system. Repairs are needed to prevent water penetration. A licensed general contractor should be consulted for further evaluation to determine the source of the moisture and to make necessary repairs.

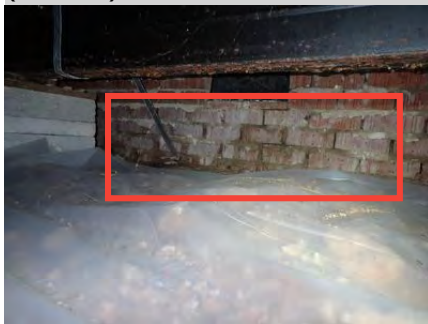
#### (B1-1.2) Main House

Additional photo - wet perimeter brick at front of home from direct water penetration.

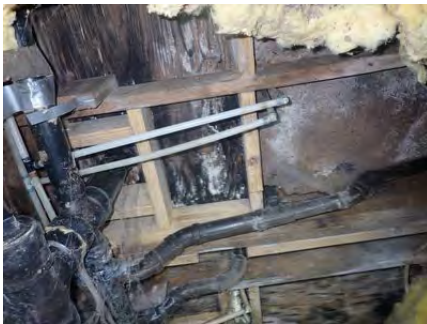
**(B3-1.1) Main House**

A large area of the floor framing and subflooring under the master bathroom/laundry area was noted to exhibit evidence of water damage. Evidence suggests direct water penetration. A licensed general contractor should be consulted for an invasive investigation to determine the source of the water penetration and the extent of the decay make necessary repairs to prevent further damage and undesirable conditions.

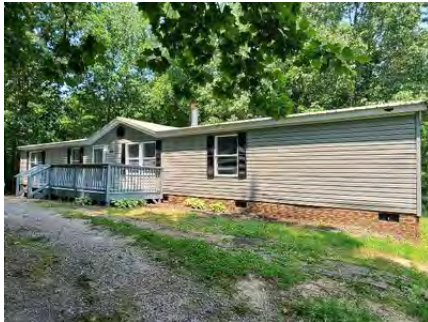
(C2-1.1) Main House

This home does not have a system such as gutters to control roof drainage. Direct drainage to the foundation and cladding from the roof system can result in water penetration into the foundation area and foundation deterioration.. It is recommended that a gutter system with extended downspouts be installed to protect the wall cladding and foundation areas of the home. A licensed general contractor should be consulted for evaluation and installation.

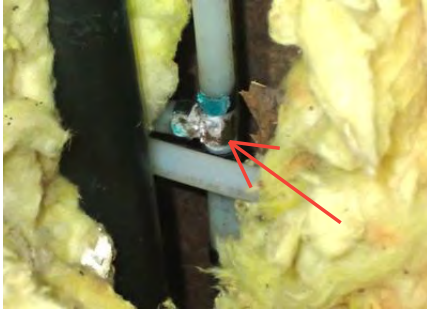
**(D2-1.2) All Accessible Areas**

The water distribution line located beneath the vicinity of the 2nd bathroom line is corroded and leaking. Leaks in the water supply lines should be addressed as soon as possible to prevent property damage and flooding. A licensed plumbing contractor should be consulted for complete evaluation of the distribution systems to determine the general condition of the system and make necessary repairs.

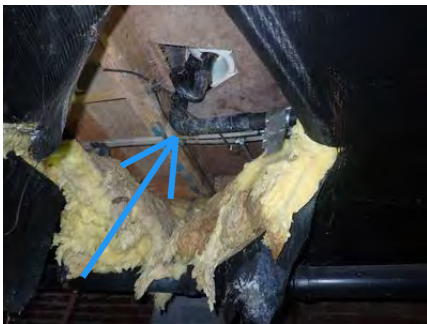
**(D3-1.1) All Accessible Areas**

The waste line for the bathtub in the 2nd bathroom leaking. The waste line needs to be repaired to ensure sanitary conditions. A licensed plumbing contractor should be consulted for a complete evaluation of the waste line systems to determine the general condition of the system and to make necessary repairs.

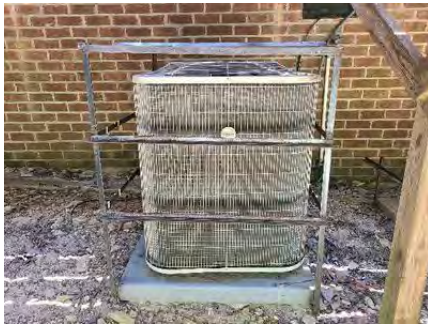
#### (G1-1.1) Cooling Unit 1

Exterior AC unit 2019 manufacturer date.

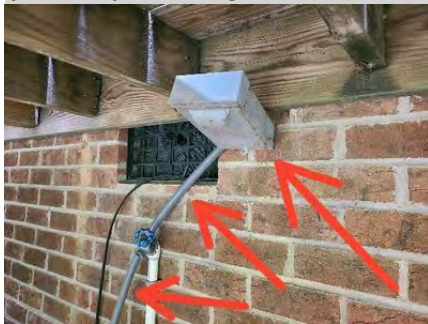
#### (G1-1.2) Cooling Unit 1

At the rear of the home the electrical disconnect for the air conditioning unit is improperly fastened to the home. The unit was likely moved when the deck system was installed. This condition can allow for direct water penetration into the disconnect which can cause an electrical safety hazard. A licensed electrician or air conditioning specialist should be consulted for evaluation and repair to ensure safe use of the air conditioning system.

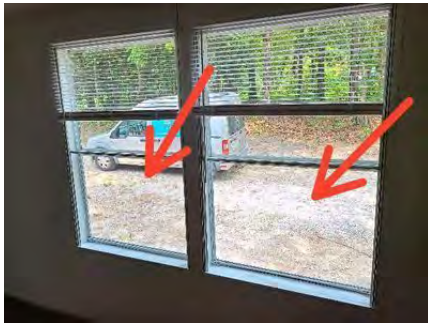
#### (H1-1.1) Bedroom 1: Master

Both lower inside windows in the master bedroom area were missing at the time of the inspection. A specialist should be consulted for evaluation and repair.

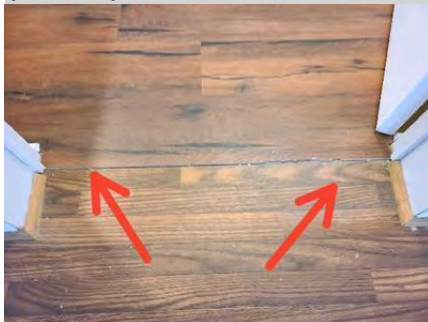
#### (H1-1.2) Bedroom 1: Master

The transition between the flooring system of the master bedroom and the master bathroom is missing a threshold piece to prevent a toe grab/trip concern from the difference in floor levels. Corrective repairs by a specialist are needed.

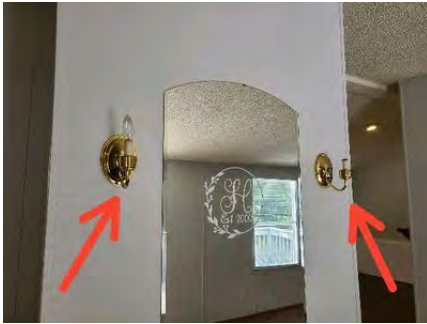
### (H1-6.1) Family Room

The two light fixtures in the family room area were not operational at the time of the inspection. A specialist should be consulted for evaluation and repair.

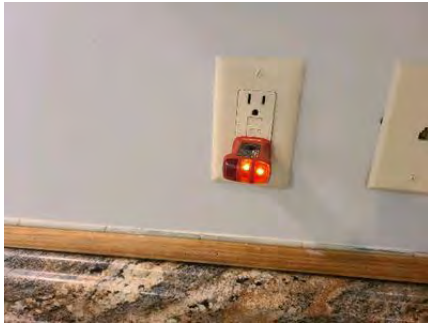
### (H2-1.1) Kitchen

The GFCI receptacle in the kitchen did not test/reset correctly to ensure that it was ground fault protected. GFCI protection is needed to reduce shock in hazardous locations. Corrwctive repairs are needed.

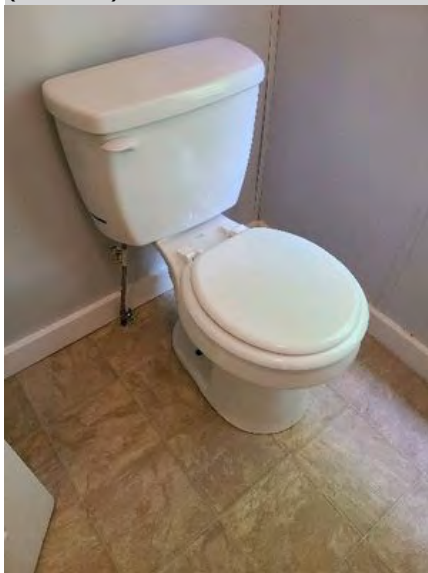
#### (H3-1.2) Bathroom 2

The toilet in the second bathroom was not functional at the time of the inspection. It appears the water to the unit is turned off. A licensed plumber should be consulted for further evaluation and repair to ensure the toilet functions as intended.

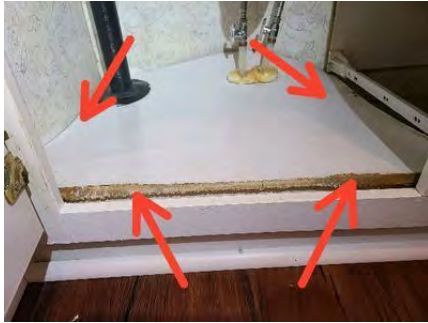
#### (H3-2.1) Bathroom: Master

The base cabinet for the master bathroom area is very warped/damaged beneath the two sinks, suggesting a history of water damage. A specialist should be consulted for evaluation and repair or replacement as needed.

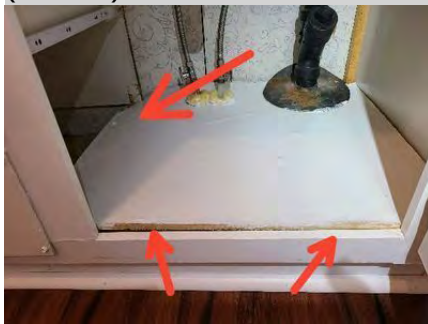
#### (H3-2.2) Bathroom: Master

Additional photo of damaged base cabinet beneath the master bathroom sink

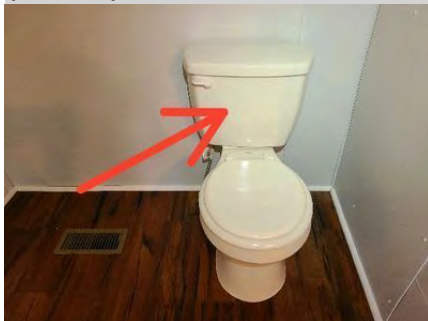
#### (H3-2.3) Bathroom: Master

The tank on the toilet in the master bathroom is loose. This can lead to leaks and damage to the home. A licensed plumber or specialist should be consulted for evaluation and repair.

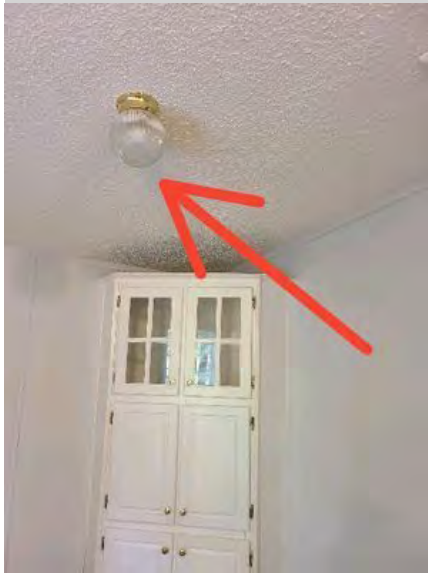
**(H3-2.4) Bathroom: Master**

The overhead light in the master bathroom was not operational at the time of the inspection. Corrective repairs are needed.

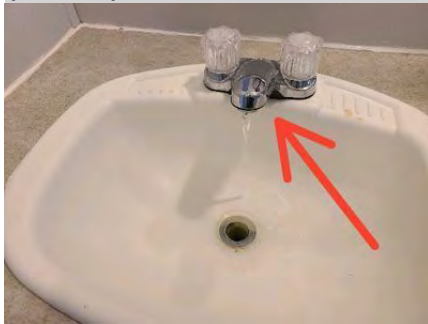
**(H3-2.5) Bathroom: Master**

The left side faucet in the master bathroom was not functioning properly at the time of the inspection. The faucet lost water pressure during use suggesting that there may be a supply line issue, blockage or defect with the faucet unit. A licensed plumber or specialist should be consulted for evaluation and repair.

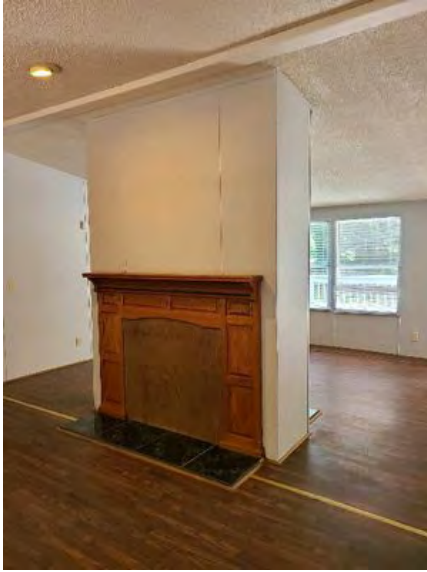
**(H6-1.1) Fireplace: Pre-Manufactured: Metal**

The fireplace area has covers blocking the front on both sides, therefore, the fireplace area could not be inspected. Seller disclosure is advised as to the reasoning for the covering of the fireplace area. Before use of the fireplace system, a licensed Chimney Specialist should be consulted for a complete evaluation of the fireplace firebox, damper system and chimney system to ensure it is clear and safe for use.
