# TABLE OF CONTENTS

HSR Inspection Services, LLC is pleased to submit the enclosed report. This report is our professional opinion based on a visual inspection of readily accessible areas and components of the Home. This report is neither an engineering inspection nor an exhaustive technical evaluation.

**Information: Foundation Type**  
Crawlspace, Manufactured home

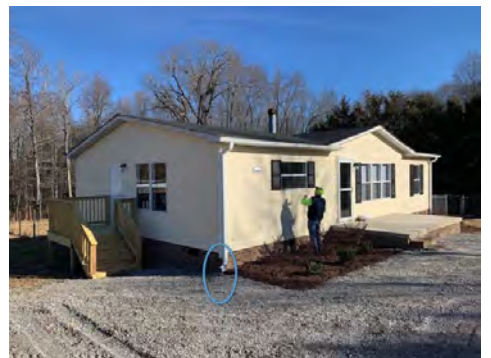
Noted one or more down splash extension/ splash blocks were missing or misaligned, which may allow water to accumulate close to the foundation wall. Recommend correction and periodic maintenance to ensure proper drainage away from the foundation.

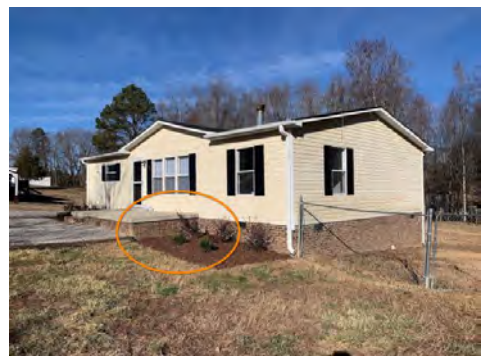
#### GUARDRAIL MISSING 30"

Noted guard rail missing on drop off at or Higher than 30 inches, which may be a potential hazard. Recommended a qualified professional for correction.

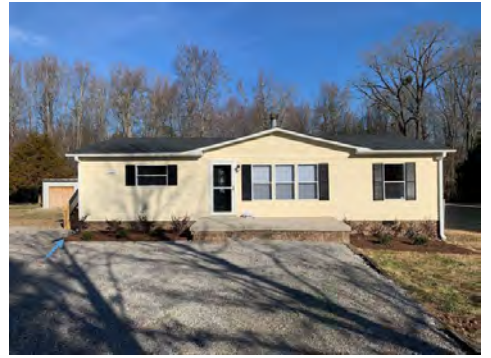
**REVERSE PERIMETER**

The exterior grading was sloping towards the foundation, which may allow water penetration into the crawl space. Recommend monitoring crawl space periodically, especially after heavy rains.

Recommend monitoring.

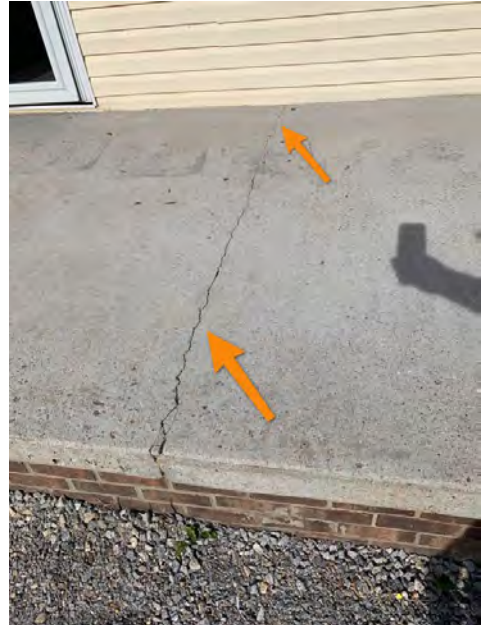
**PORCH SLAB- MINOR CRACK(S)**

Noted minor crack(s) in the porch slab, which is typical of minor settlement. Recommend sealing and monitoring periodically.

Recommend monitoring.

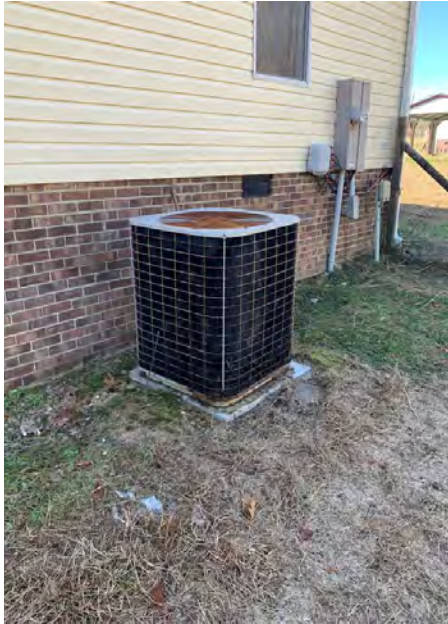
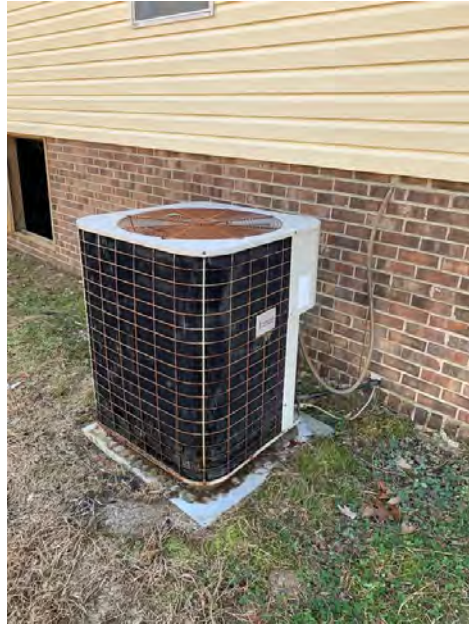
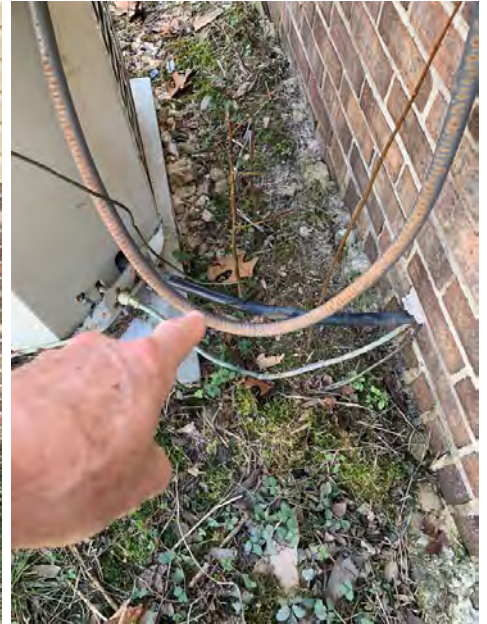
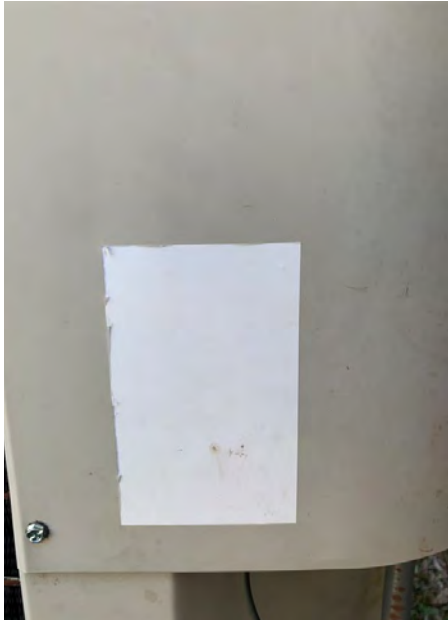
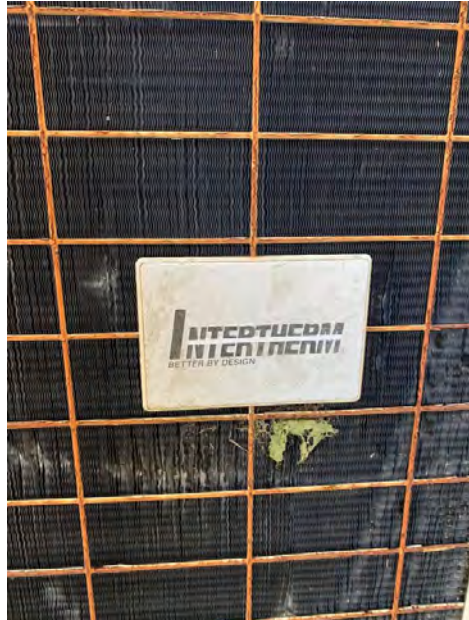
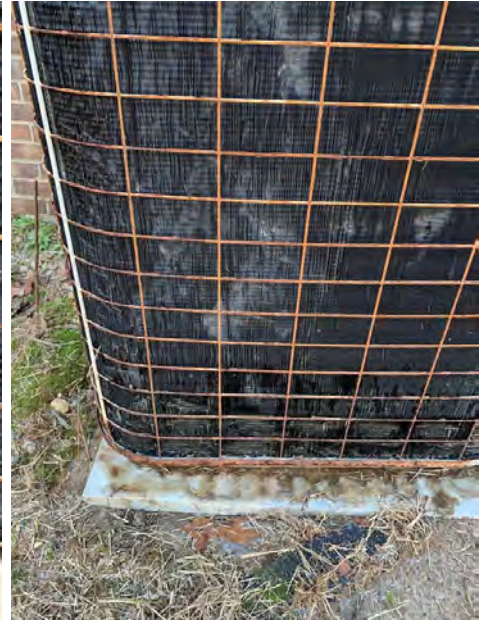
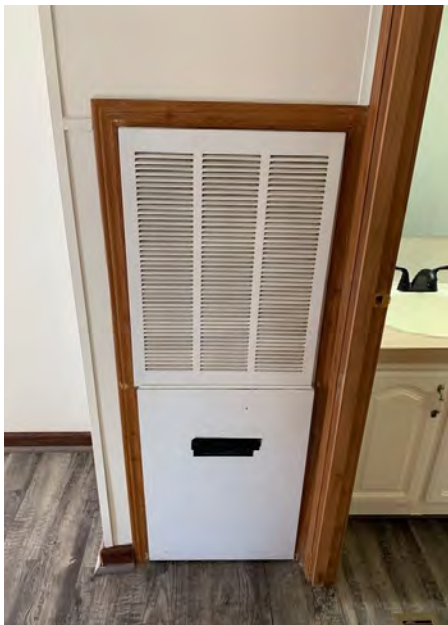
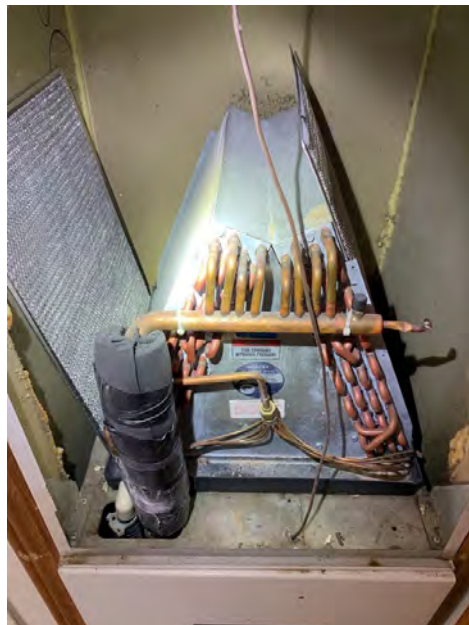
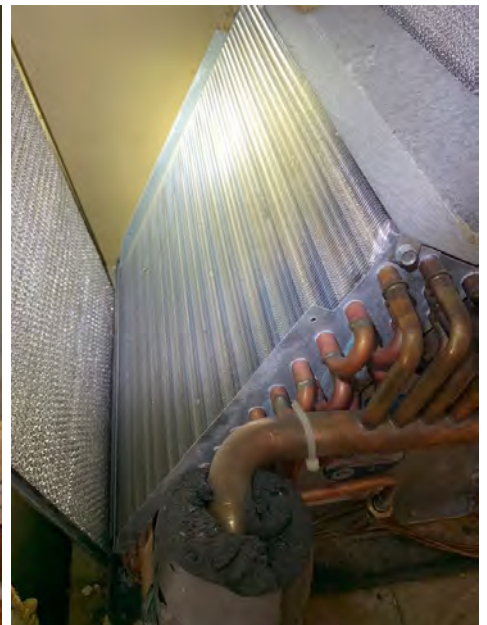
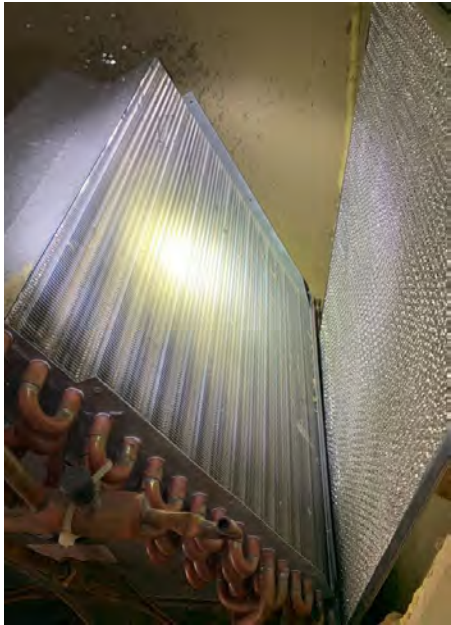
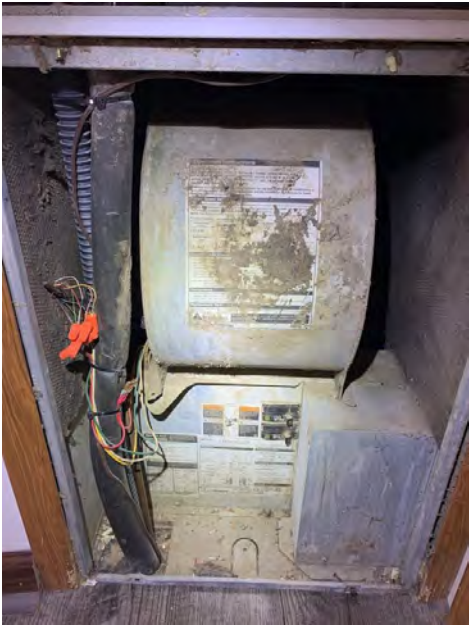
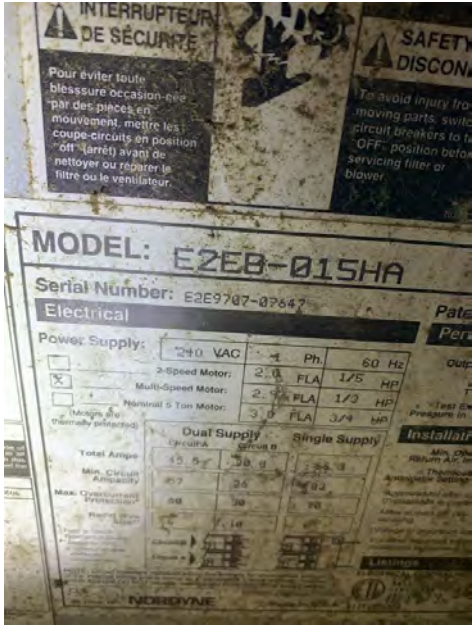
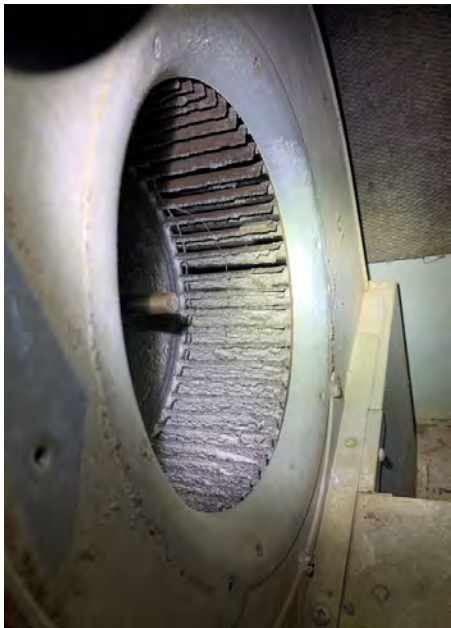
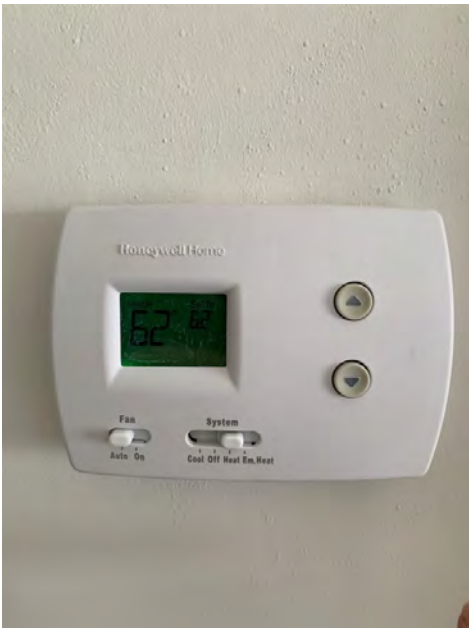
**General: HVAC System Photos**

HVAC system photos included if visible: Condenser/ Air handler/ Duct work/ Package unit.

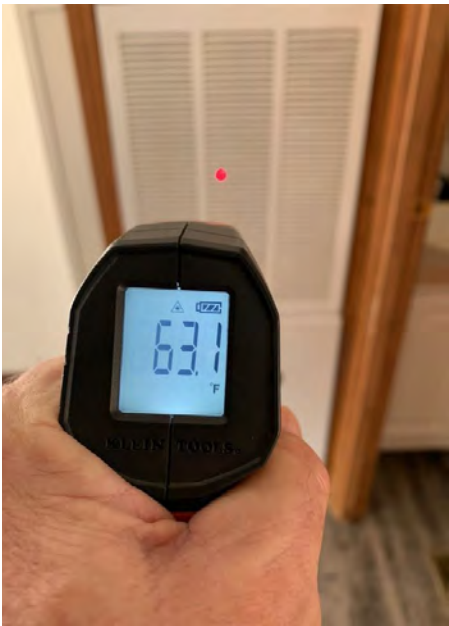
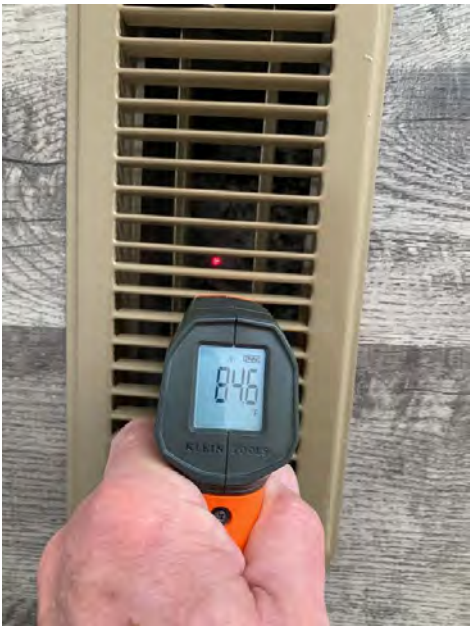
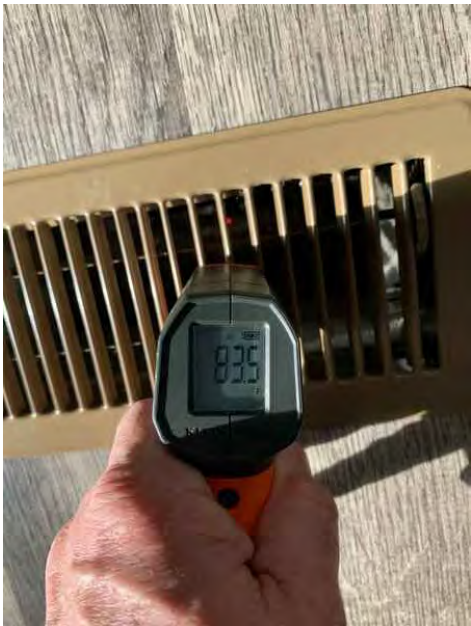
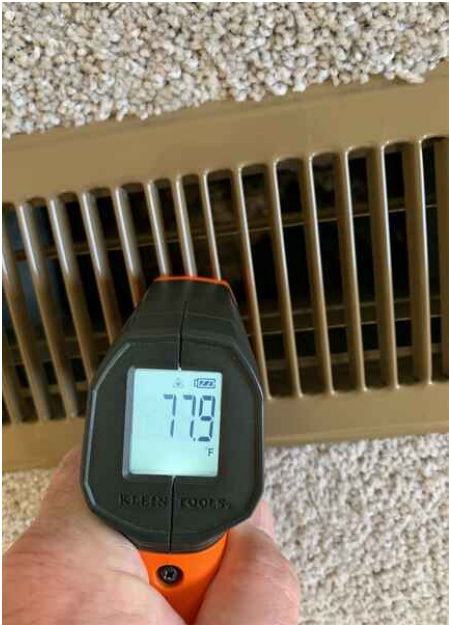
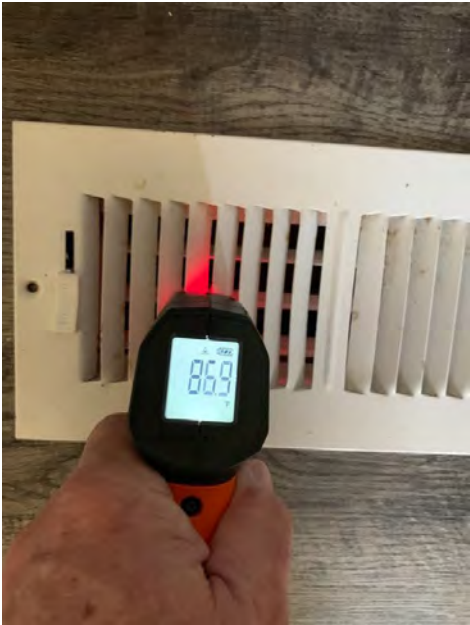
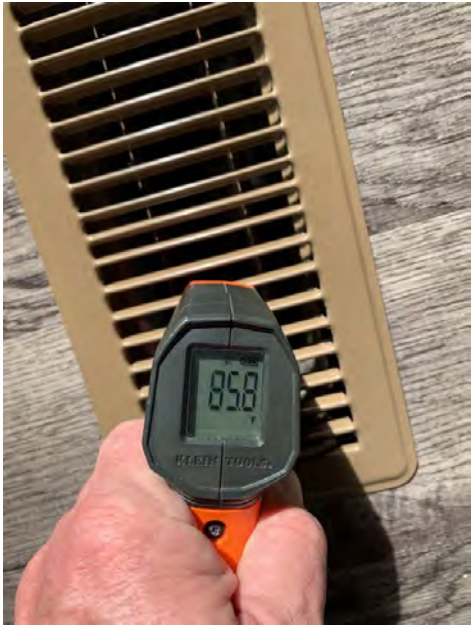
General: Photos temp differential

| <b>General: Temperature Differential</b><br>20 Degrees heating<br><br>This is the number of degrees the system is cooling (or heating) the house air, which is the measured temperature difference between the return and the supply register. Normal range for this number is 14-24 degrees when operating the system, ambient outside temperature may affect the measurement. Higher temperature differentials are expected when run in the heat mode with a gas furnace. As with all mechanical equipment, the unit may fail at any time without warning. | | |

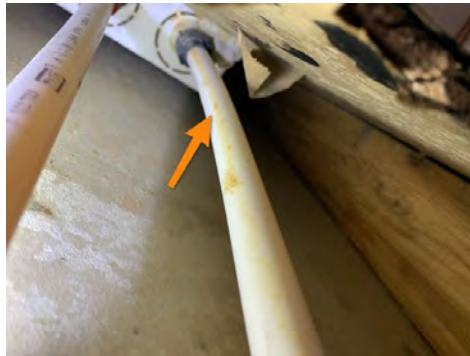
**WATER VALVE LEAKING**

One of the water valves is leaking, which may cause damage to structure. Inspector does not operate shut off valves and valves may not be closed/ open all the way. Recommend evaluation and replacement as necessary.

Contact a qualified plumbing contractor.

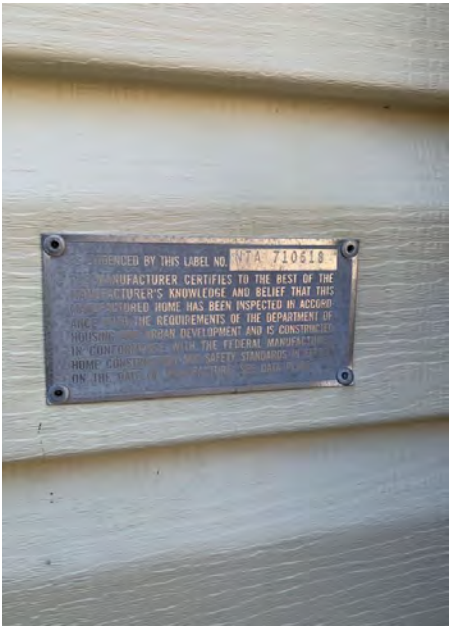
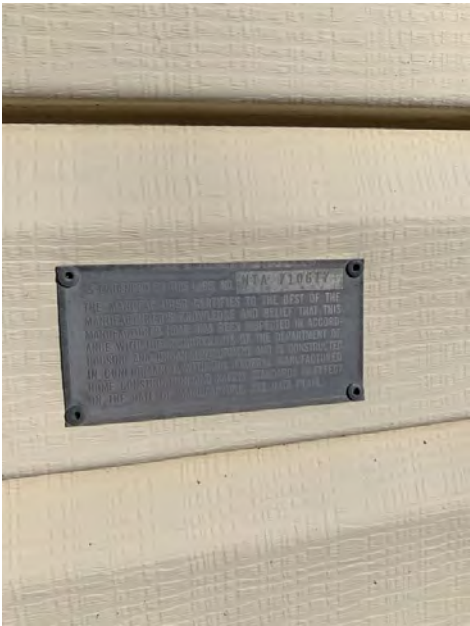
**General: Photos**

The Data Plate includes the manufacturer name, serial number model and date of manufacture, as well as wind, rood load and thermal zone maps. If the Data Plate is missing or the Inspector is unable to locate it, the Inspector must report this in the report and is not required to secure the Data Plate information from another source.

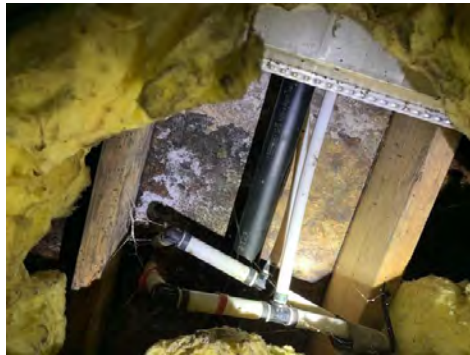
**BELLY WRAP- DAMAGED**

Noted damaged belly wrap underneath the manufactured home, which may affect air quality in dwelling. Recommend a qualified professional repair as needed.

Contact a qualified professional.
