## Septic Inspection

| Transferee Name: | SIRVA | Street Address: | 4660 Hancock Rd |

On June 11, 2024, I was at the property address above to pump out the septic tank and provide a point of sale septic inspection. Prior to my arrival, I obtained the existing septic permit from *Granville County Environmental Health* that showed this 3 bedroom home as having a 1,000 gallon septic tank, a 1,000 gallon pump tank, 2x150 foot twenty-five percent reduction drain lines, and a private well for potable water consumption. Based on what I can determine, the permit was issued on 05/21/2021.

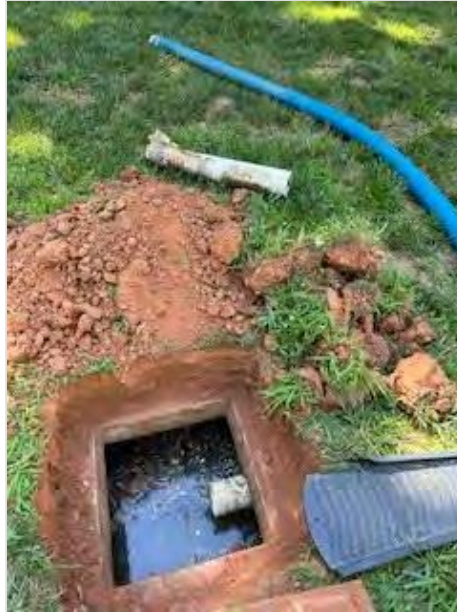
Inlet

On arrival, the female of the home was present. We located the septic tank at the back left corner and dug out the two access lids for pumping. The inlet access measured 8'9" off the back left foundation while the outlet compartment measured 14'7". The tank is 9.5 inches deep. NC Septic Rules require under this permit that the tank access be no deeper than 6 inches or an access riser be installed bringing access to within 6 inches of the ground surface. The tank lids were intact. The inlet plumbing pipe was stubbed into the tank well past the opening, so I cut this pipe off at a proper distance into the tank. After pumping the septic tank, I saw no problems with the tank. The effluent filter was cleaned during this service.

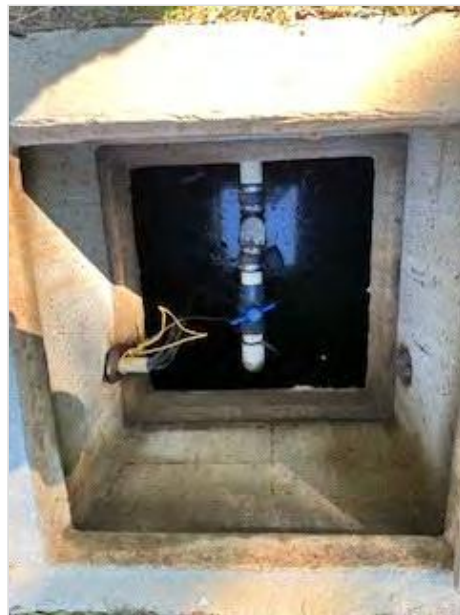
Pump Tank

The pump tank is further away from the home and has a square concrete access riser at grade with the septic control panel adjacent. The Liberty control panel is mounted 7 inches above ground level and is required to be 12 inches above grade. The panel is in very good condition and all of the floats are properly functioning. I noticed Conseal sealant placed around the electrical conduit inside the pump tank riser and also in the original force main outlet hole through the riser that the inspector "corrected" on the permit. I injected water into the ground around these two areas with my water probed and the water poured into the tank because of a poor seal. The pump tank riser is at grade and also in a depressed area. The riser is required to be 6 inches above grade and be watertight. Inside the pump tank, the floats are mounted on the pump discharge piping and at the end of the pump cycle, the pump is not covered. I noted that the valve is mostly closed and there is not a required disconnect union. The banded rubber boots on the check valve does not equal a disconnect union (in my opinion).

- There is leakage around both penetrations of the pump tank riser. This riser is required to be watertight.
- Consider incorporating a disconnect union in the pump discharge piping. Removal of the bands and completely disassembling the check valve is not a similar disconnect device as described in the rules.

**N.C. Septic Rule: 15A NCAC 18A .1952 (E) 3.**  
**Fittings and valves shall be of compatible corrosion-resistant material. A threaded union, flange, or similar disconnect device shall be provided in each pump discharge line.**
