1036 Butterfly Circle  
Wake Forest NC 27587

2/16/2022

Floor 2 Ceiling Home Inspections LLC DBA HouseMaster  
5524 Sapphire Springs Drive  
Knightdale, NC 27545  
919-803-7977

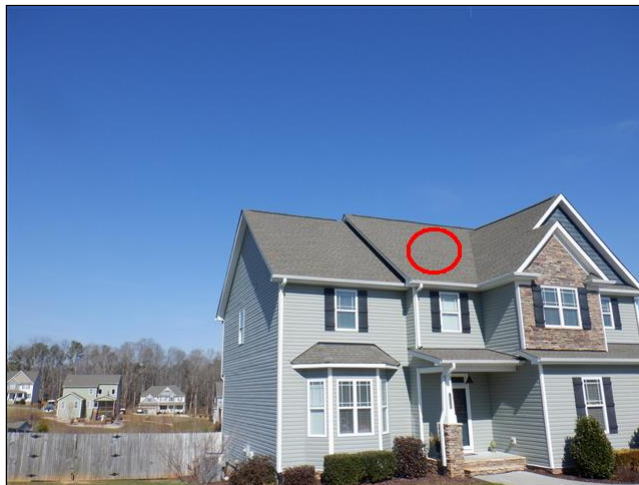
1.0 (1) Lifted shingles noted at the front side of the roof. This is conducive to damage from weather and water intrusion at the roofing elements. Recommend to have a qualified contractor repair as directed.

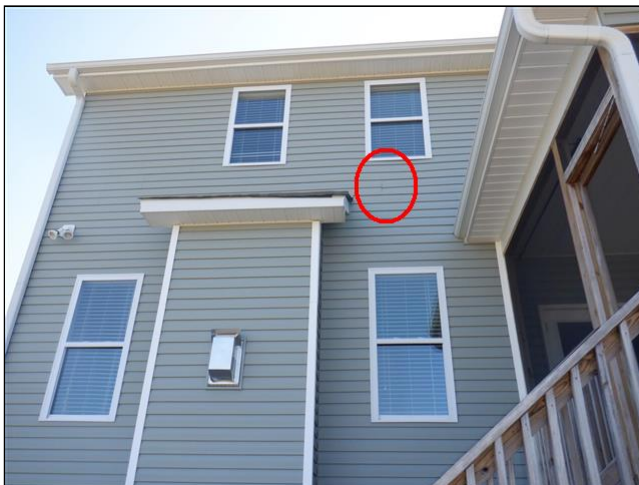
2.1 (Picture 1)

Loose/unsecured siding noted at the back side of the house. This is conducive to damage from weather and water intrusion at the wall cavity. Recommend to have a qualified contractor repair/replace as directed.

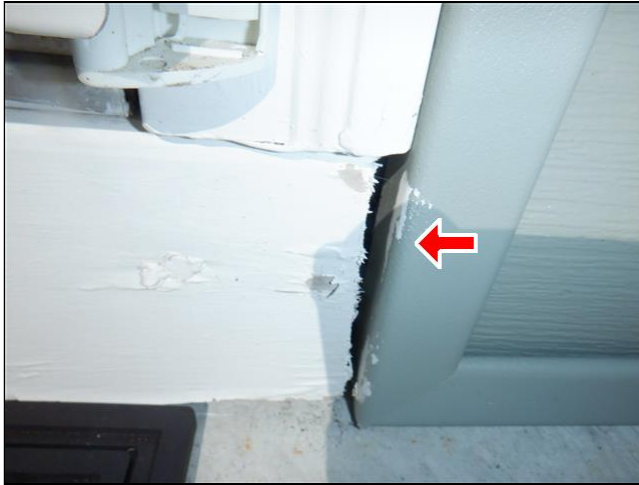
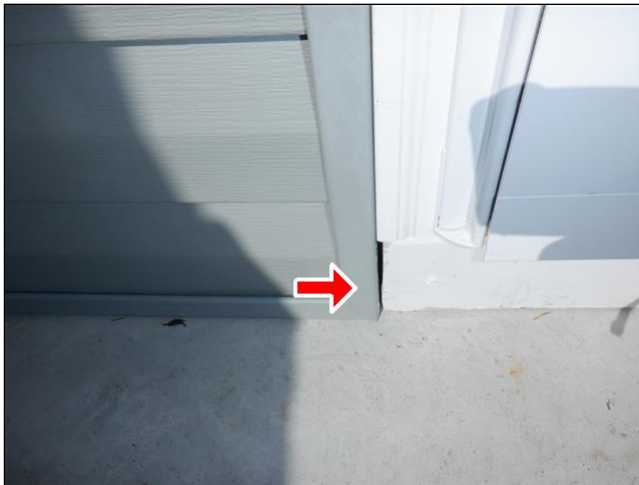
2.4 (2) In Need of Repair: Missing caulking at door trim at front side of the home. Conditions are conducive to water intrusion behind siding, which will damage adjacent elements. Recommend to seal/caulk.

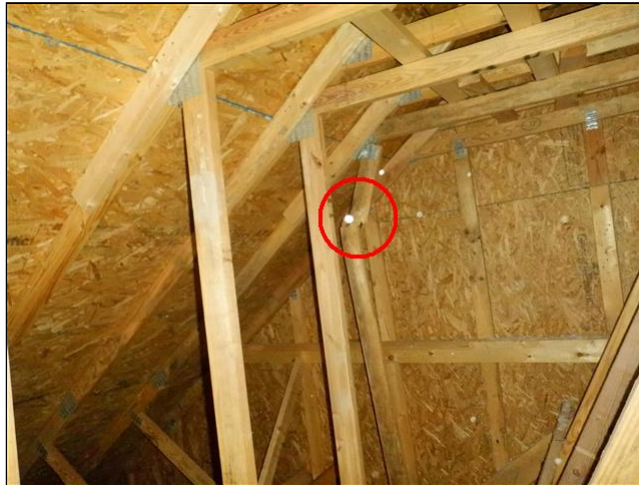
5.0 (Picture 1)

Broken truss framing noted at right side of attic. Truss framing members should not be cut or field-altered without design analysis. Once altered, a change in the loading pattern often dictates that the manufacturer, or engineer, must determine what remedial action is needed.

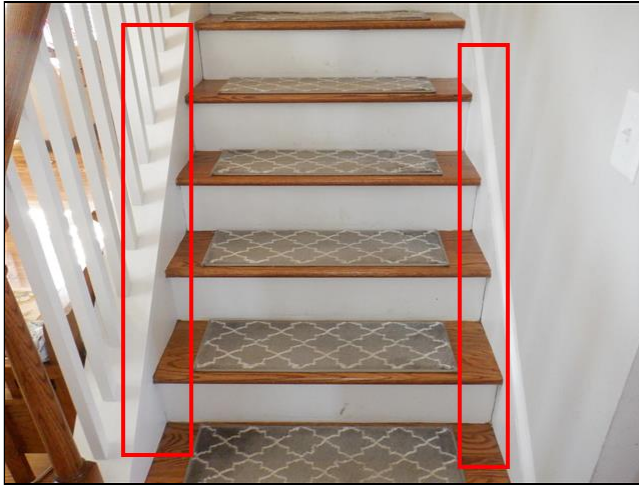
6.3 (Picture 1)

Gaps at risers noted at stairway. Recommend a qualified contractor evaluate/repair as directed due to possible settlement.

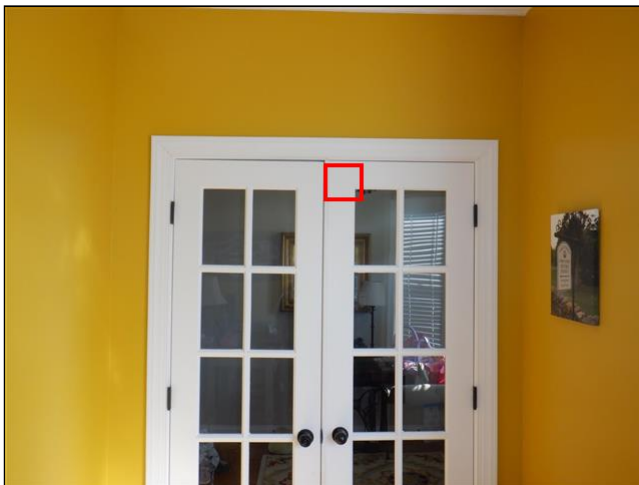
6.6 (1) Locking hardware at office french doors would not engage. Recommend a qualified contractor repair/replace due to lack of function.

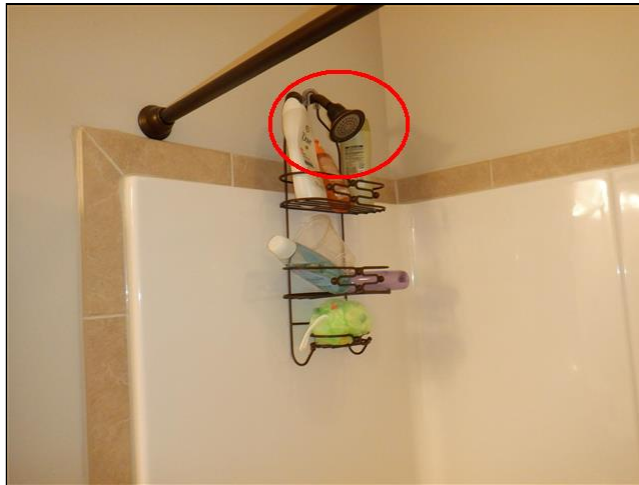
upper level hall bathtub

8.1 (2) Leakage observe at shower head device in upper level hall bath. Full volume of water should be through shower head. Also note that if conditions worsen, water may spray onto wall surfaces causing damage. Recommend Repair

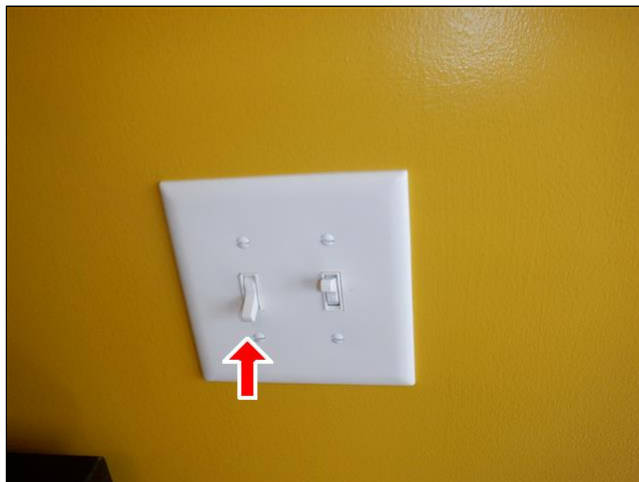
9.4 (Picture 1)

Switch did not operate anything at the office, (possibly pre wired for ceiling fans). Discuss with seller the function of this switch. If none can be provided then recommend to have an electrician evaluate/repair for proper function.

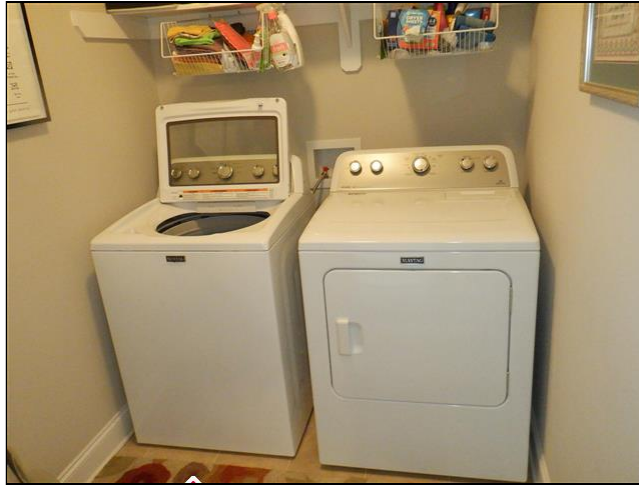
11.7 (Picture 1)

Recommend repair/replacement: Washer emergency drain pan missing at laundry area. Unit is recommended to prevent water spillage at upper level floor.

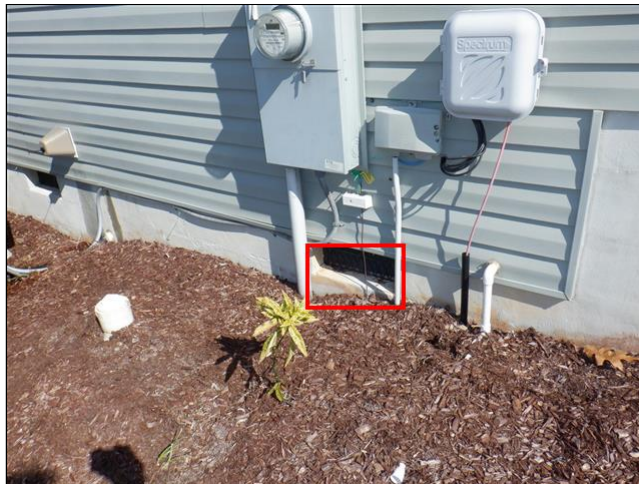
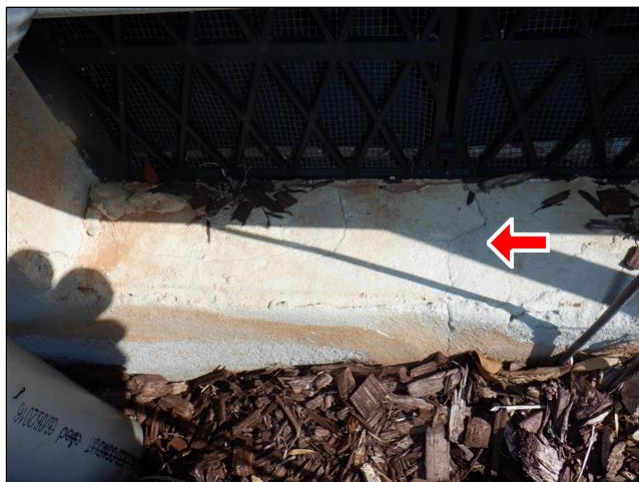
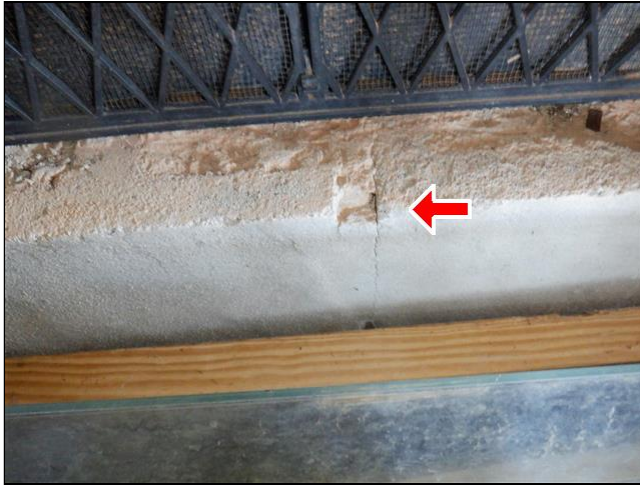
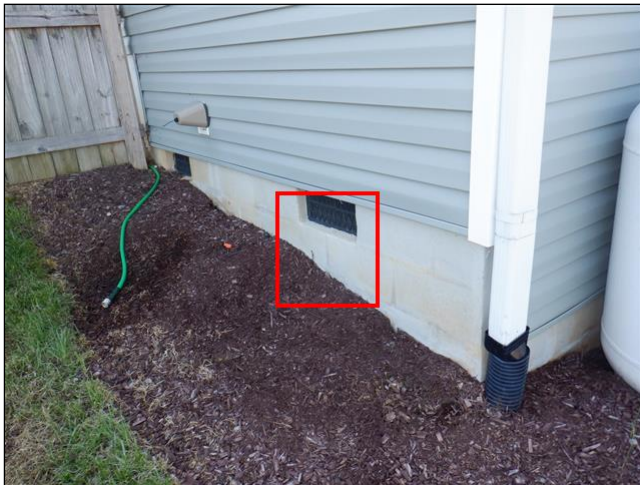
13.0 (1) Cracking noted at the left back and right side of foundation walls. Condition is conducive to possible stress/settlement and water intrusion. Recommend caulk/seal and monitor in the future.

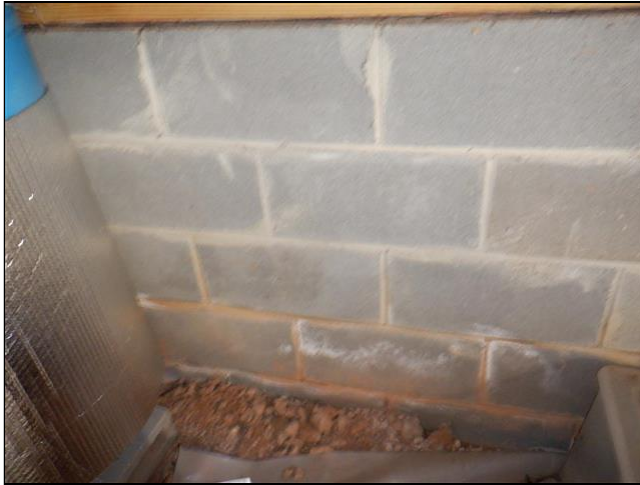
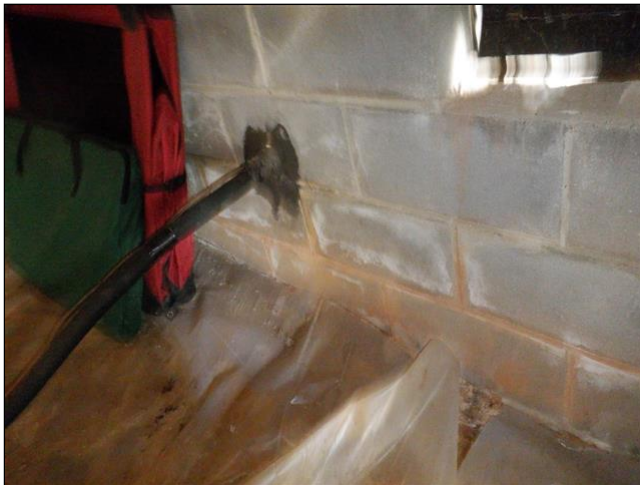
13.0 (2) White efflorescence (powder substance) on block wall indicate moisture is in contact with masonry. This does not necessarily mean that intrusion will occur. Recommend checking gutters, downspout drain lines for proper operation. Efflorescence is found on many homes without water intrusion occurring inside the home. But, it should alert you to the possibility that future steps may be needed.

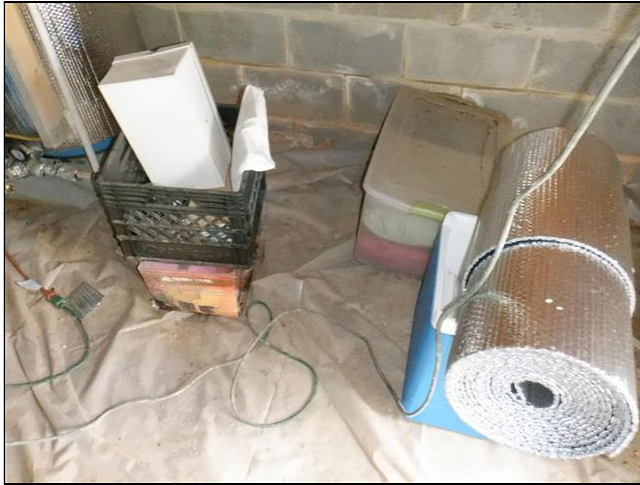
13.4 (Picture 1)

Wood/construction debris/vegetation/cellulose materials and/or storage materials are observed in subgrade areas near or on soil. This attracts undesirable insects and possible causes moisture concerns. Recommend properly removing and disposing to minimize adverse concerns prior to closing.

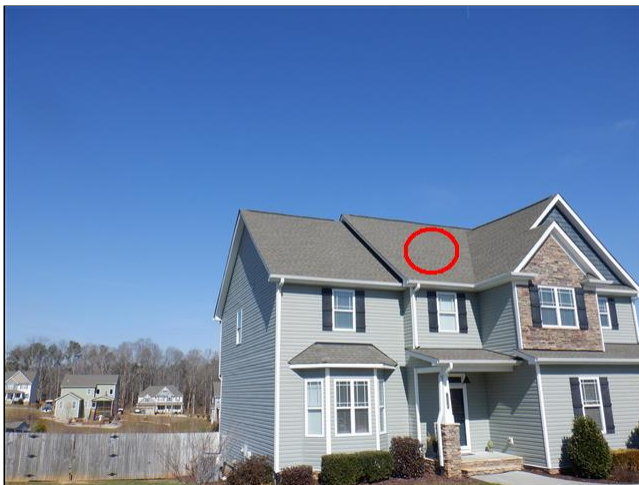
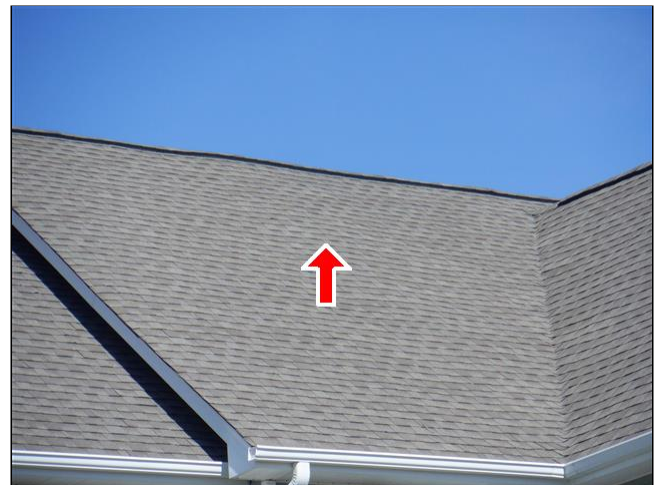
| | ● | | | <b>1.0 ROOFING-MAIN</b><br>(1) Lifted shingles noted at the front side of the roof. This is conducive to damage from weather and water intrusion at the roofing elements. Recommend to have a qualified contractor repair as directed.<br>(2) Loose/missing shingles noted at the back side of the house. This is conducive to water intrusion that will damage the adjacent elements. Recommend to have a qualified contractor repair/replace as directed. |

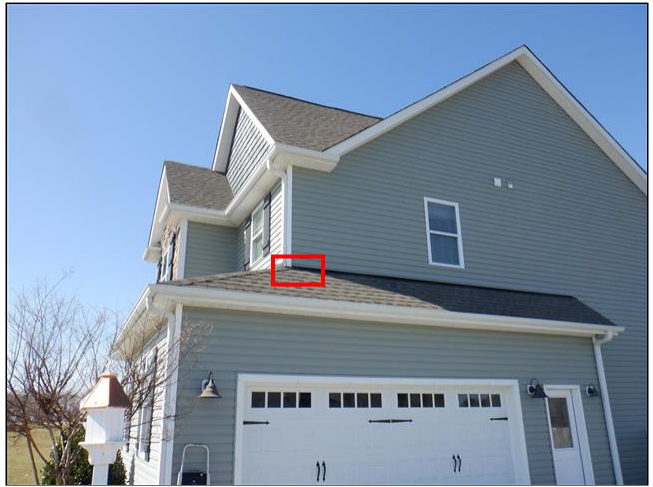
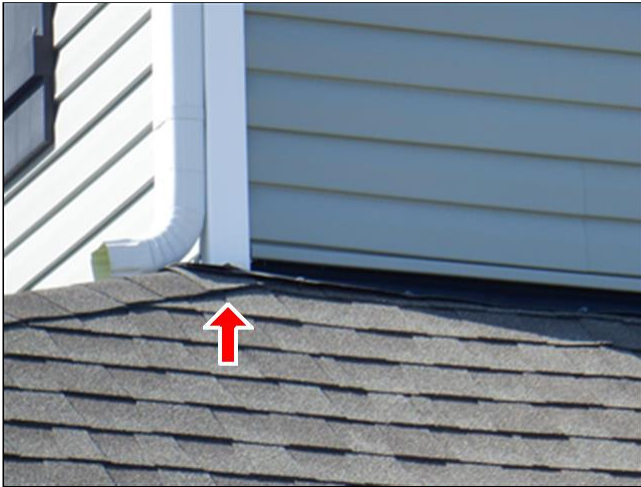
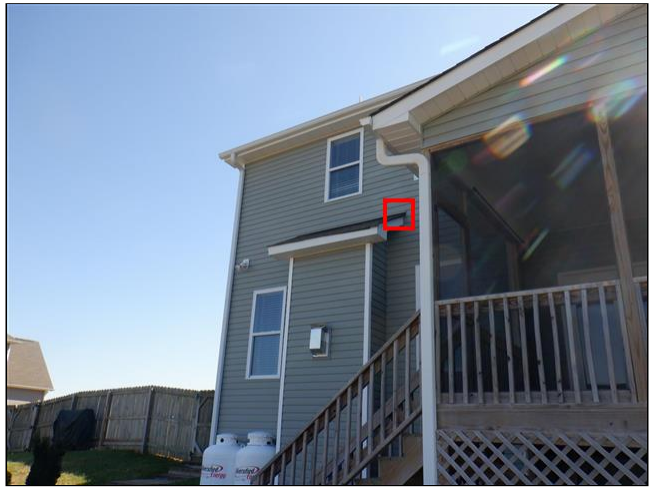
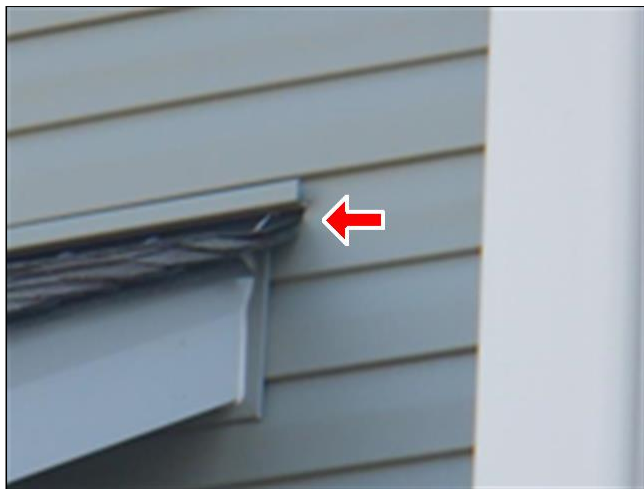
| | ● | | | <b>1.2 EXPOSED FLASHING (s)</b><br>Lifted flashing/nail noted on the right and back side of the house. This is conducive to damage from weather and water intrusion at the roofing elements. Recommend to have a qualified contractor repair/replace as directed. |

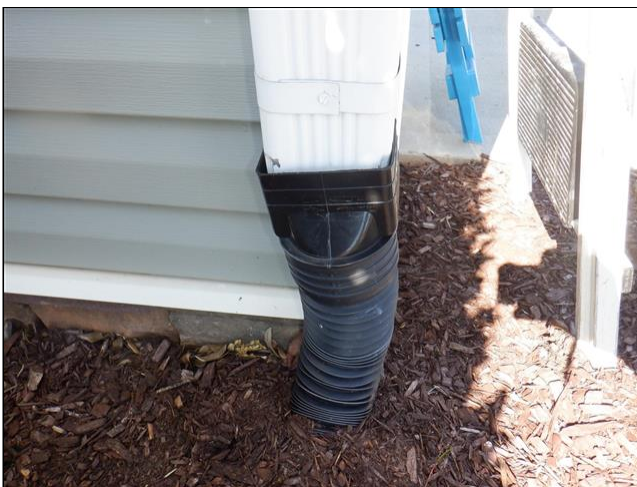
| ● | | | | <b>1.3 RAIN GUTTERS / EAVETROUGHS / DOWNSPOUTS / ROOF DRAINS</b><br>(1) Below ground drain lines for downspouts a limitation to inspection; unable to determine if drains will function properly. Clean out gutter systems on a regular basis to prevent possible rainwater intrusion at foundation walls. Neither the presence nor integrity of underground lines, nor free flow of water through such lines is determinable as part of this inspection.<br>(2) Recommend keeping gutter system clear of leaves and debris to allow proper water run off away from structure to prevent water intrusion to crawlspace. |

1.3(1) RAIN GUTTERS / EAVETROUGHES /  
DOWNSPOUTS / ROOF DRAINS (Picture 1) front  
and rear sides

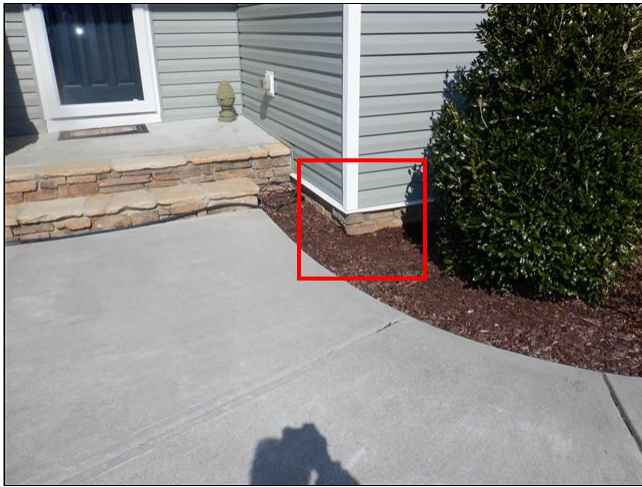
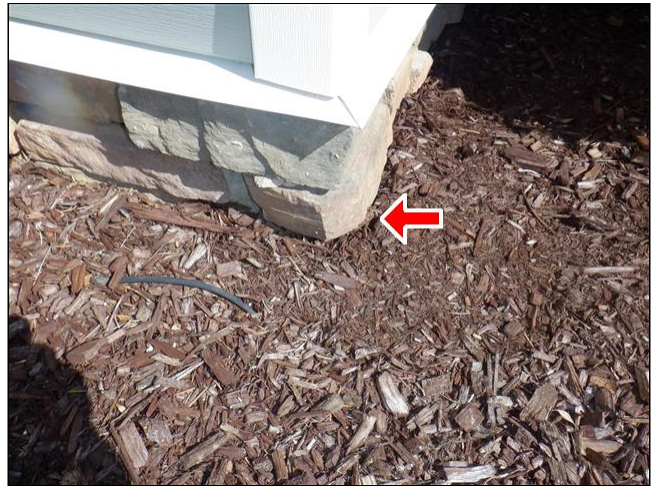
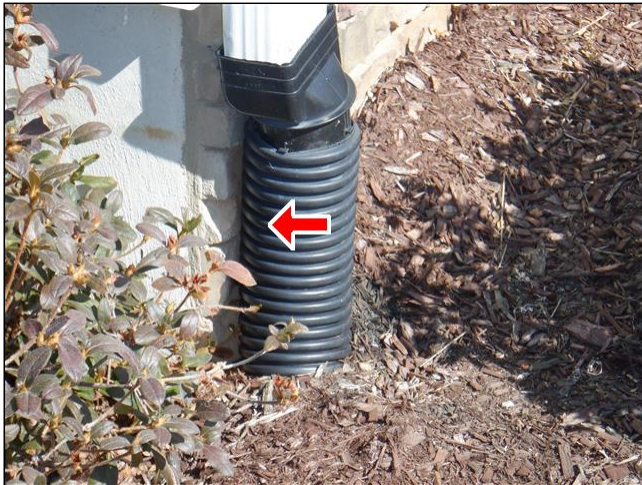
| | | | | | <b>2.0 SIDING - Stone</b><br>Improper clearances were not maintained between stone cladding and the ground and/or paved surfaces to prevent wicking and frost heave problems. Recommend to have a qualified contractor evaluate and repair as directed. |

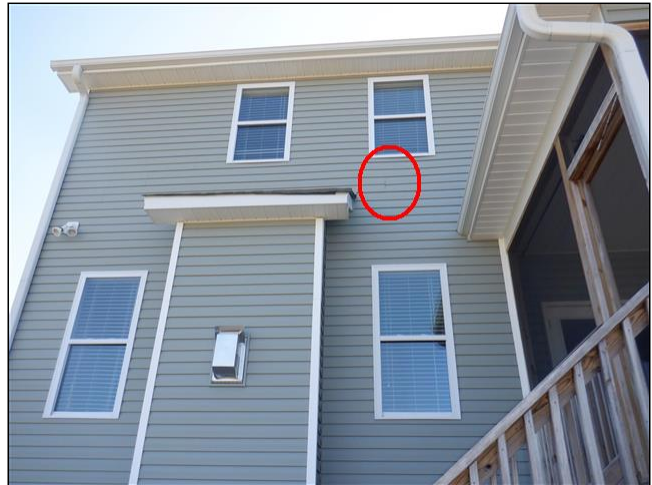
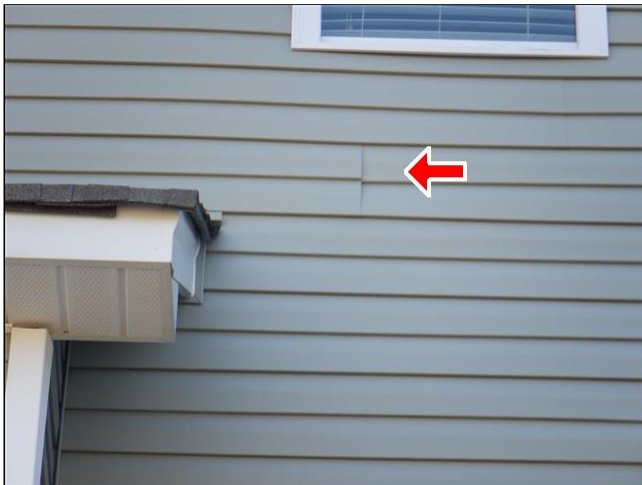
| | | | | | <b>2.1 SIDING-Vinyl</b><br>Loose/unsecured siding noted at the back side of the house. This is conducive to damage from weather and water intrusion at the wall cavity. Recommend to have a qualified contractor repair/replace as directed. |

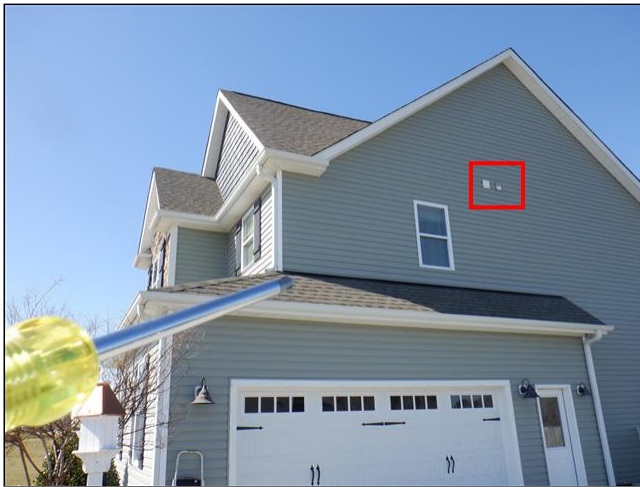
| | | | | | <b>2.7 VENTS</b><br>Damaged vent cover at right side of home. This is conducive to water intrusion at the wall cavity and adjacent areas. Recommend a qualified contractor repair/replace as directed. |

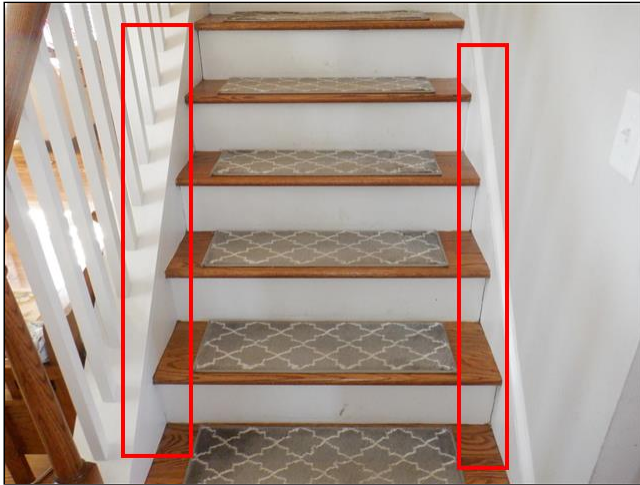
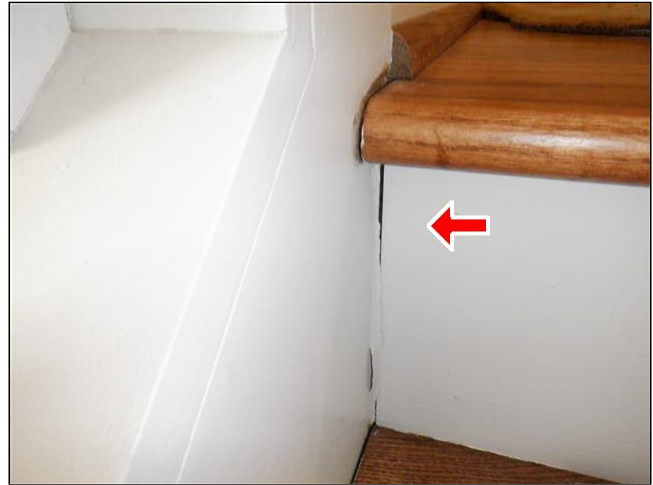
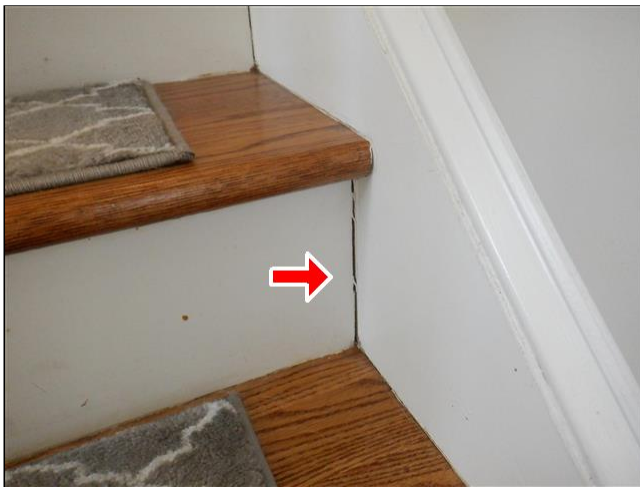
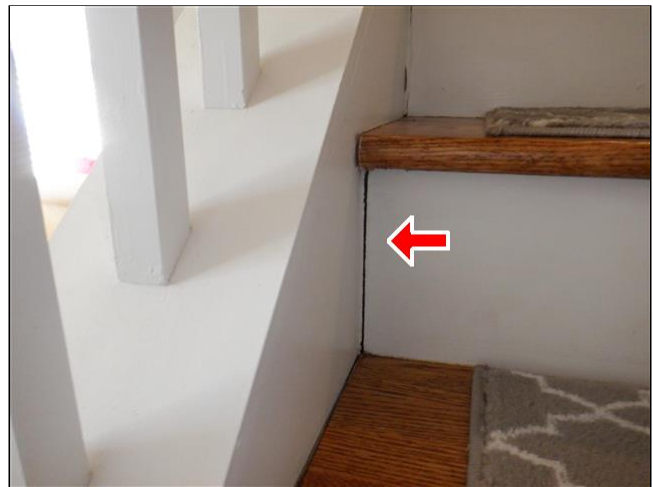
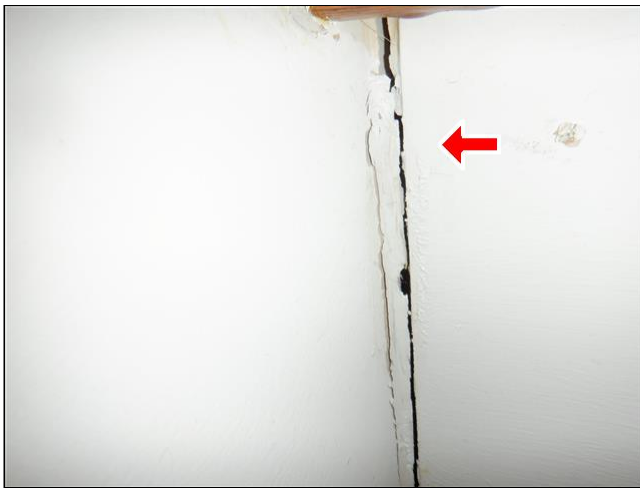
| | ● | | | <b>6.3 STAIRS</b><br>Gaps at risers noted at stairway. Recommend a qualified contractor evaluate/repair as directed due to possible settlement. |

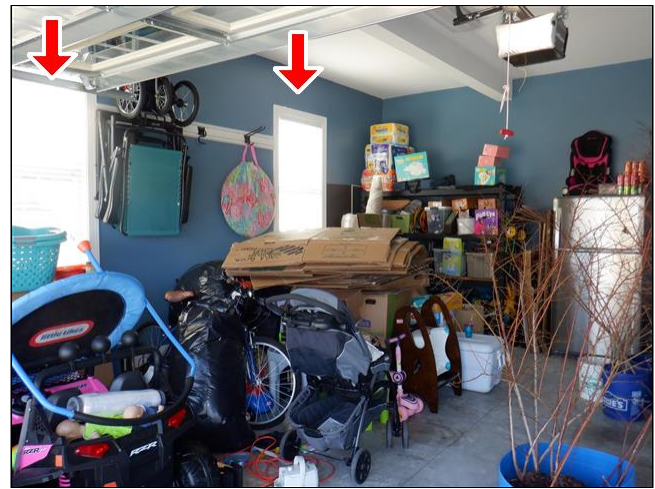
6.5 WINDOWS (Picture 1) garage

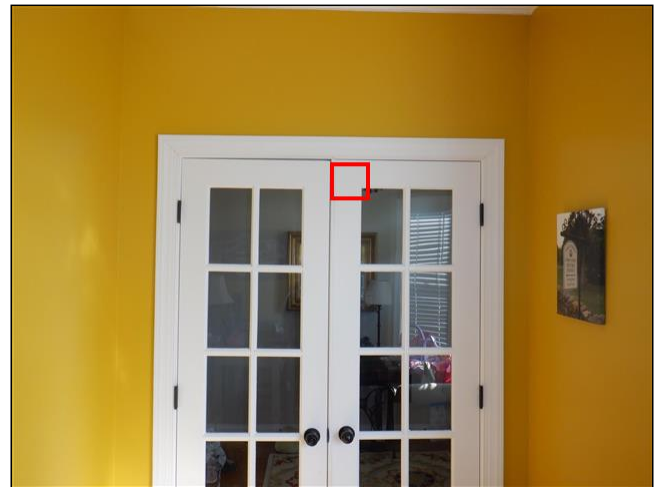
6.6(1) ROOM DOORS (Picture 1)

| | | ● | | <b>6.6 ROOM DOORS</b><br>(1) Locking hardware at office french doors would not engage. Recommend a qualified contractor repair/replace due to lack of function.<br>(2) Various doors not inspected due to personal items stopping the opening and closing of doors.<br>(3) Door does not engage strike plate at right rear bedroom. Recommend repair/adjustment to ensure the door closes properly. |

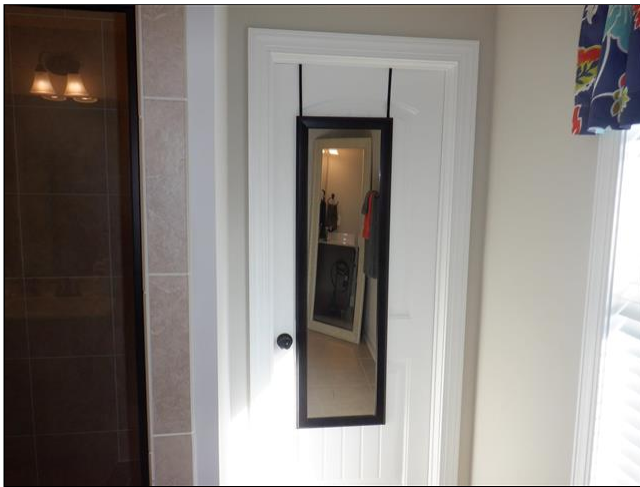
6.6(2) ROOM DOORS (Picture 1) master bathroom closet

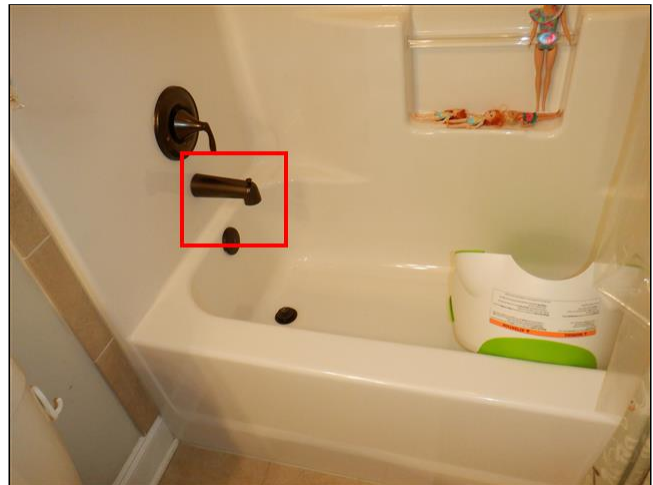
8.1(1) BATHTUB (Picture 1) upper level hall bathtub

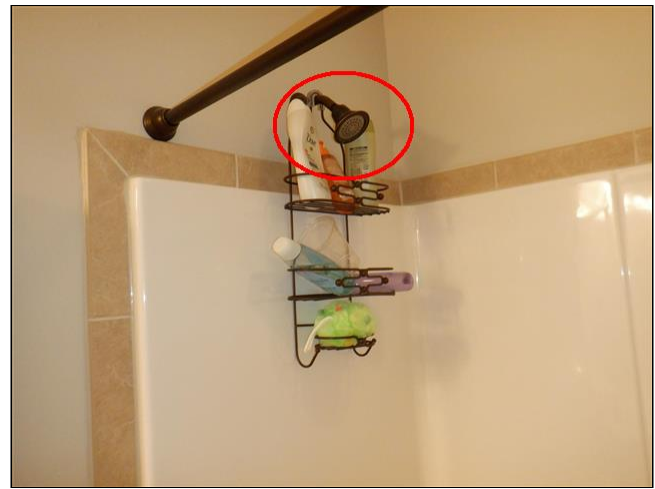
8.1(2) BATHTUB (Picture 1) upper level hall bathtub

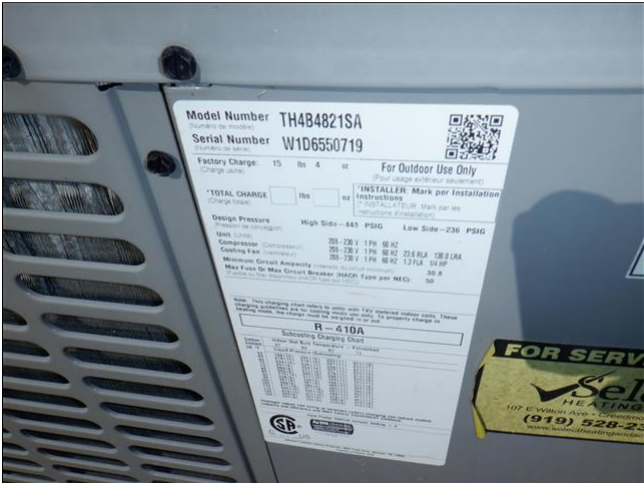
data plate mfg 04/2016

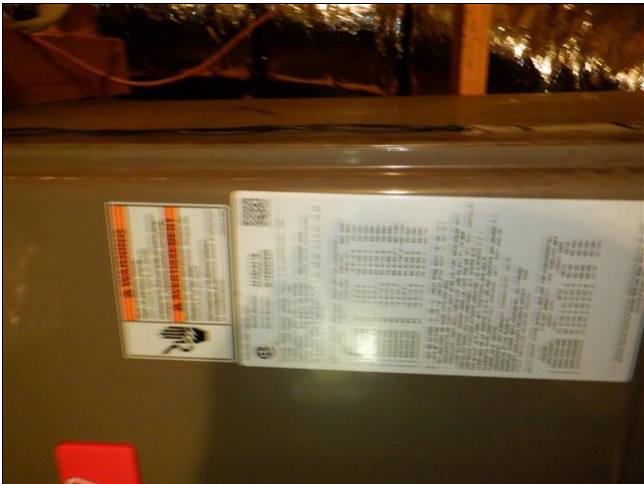
data plate mfg 05/2016

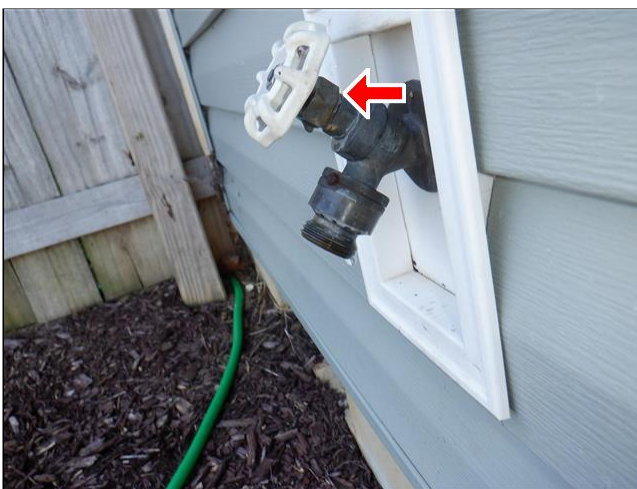
11.5 EXTERIOR FAUCET(S) (Picture 2)

| | ● | | | <b>11.5 EXTERIOR FAUCET(S)</b><br>Hose bib has leakage past stem/packing at the right spigot. Full volume of water should be through spigot. Leakage may result in water penetration and/or damage and does not function as intended. Recommend repair by qualified plumber. |

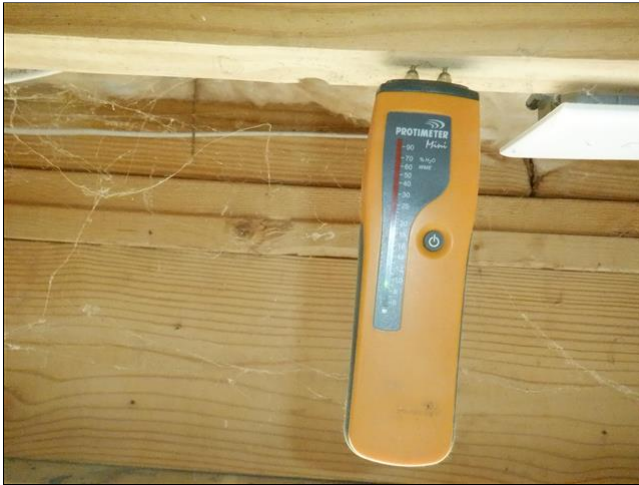
left rear 9% moisture

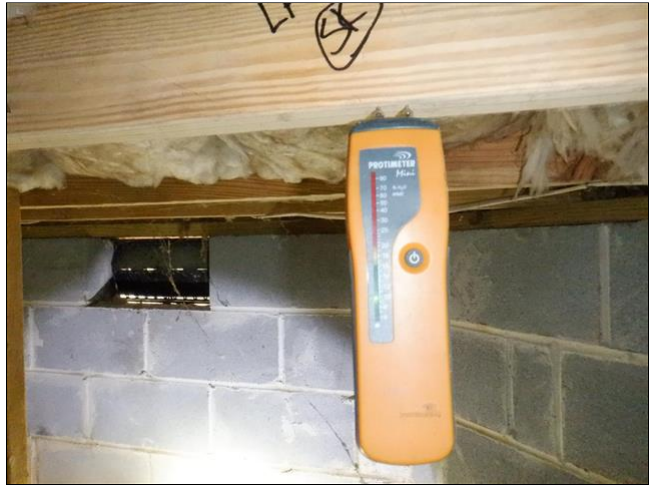
left front 10% moisture

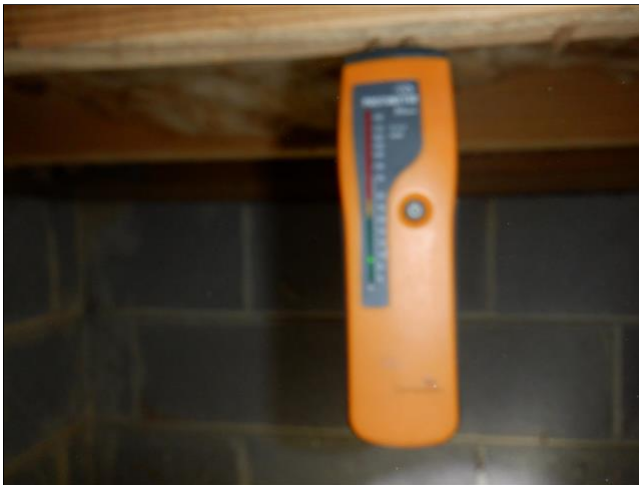
right front 9% moisture

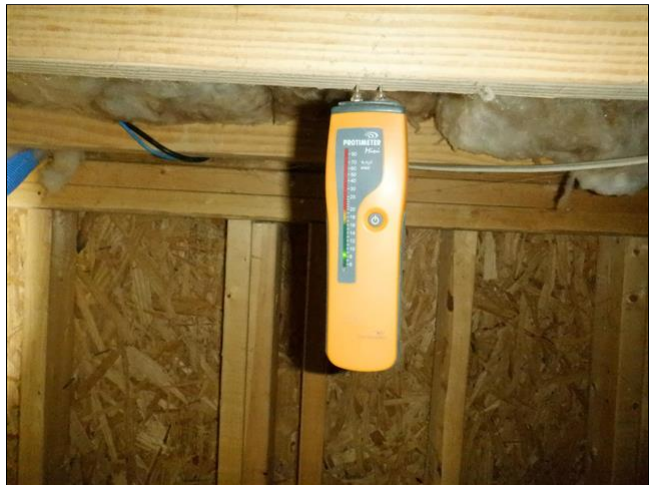
right rear 9% moisture
