**On-site Wastewater Inspection**

**Property Address: 2253 Highway 96, Franklinton, NC , 27525**

**Date of Inspection: June 20, 2025**

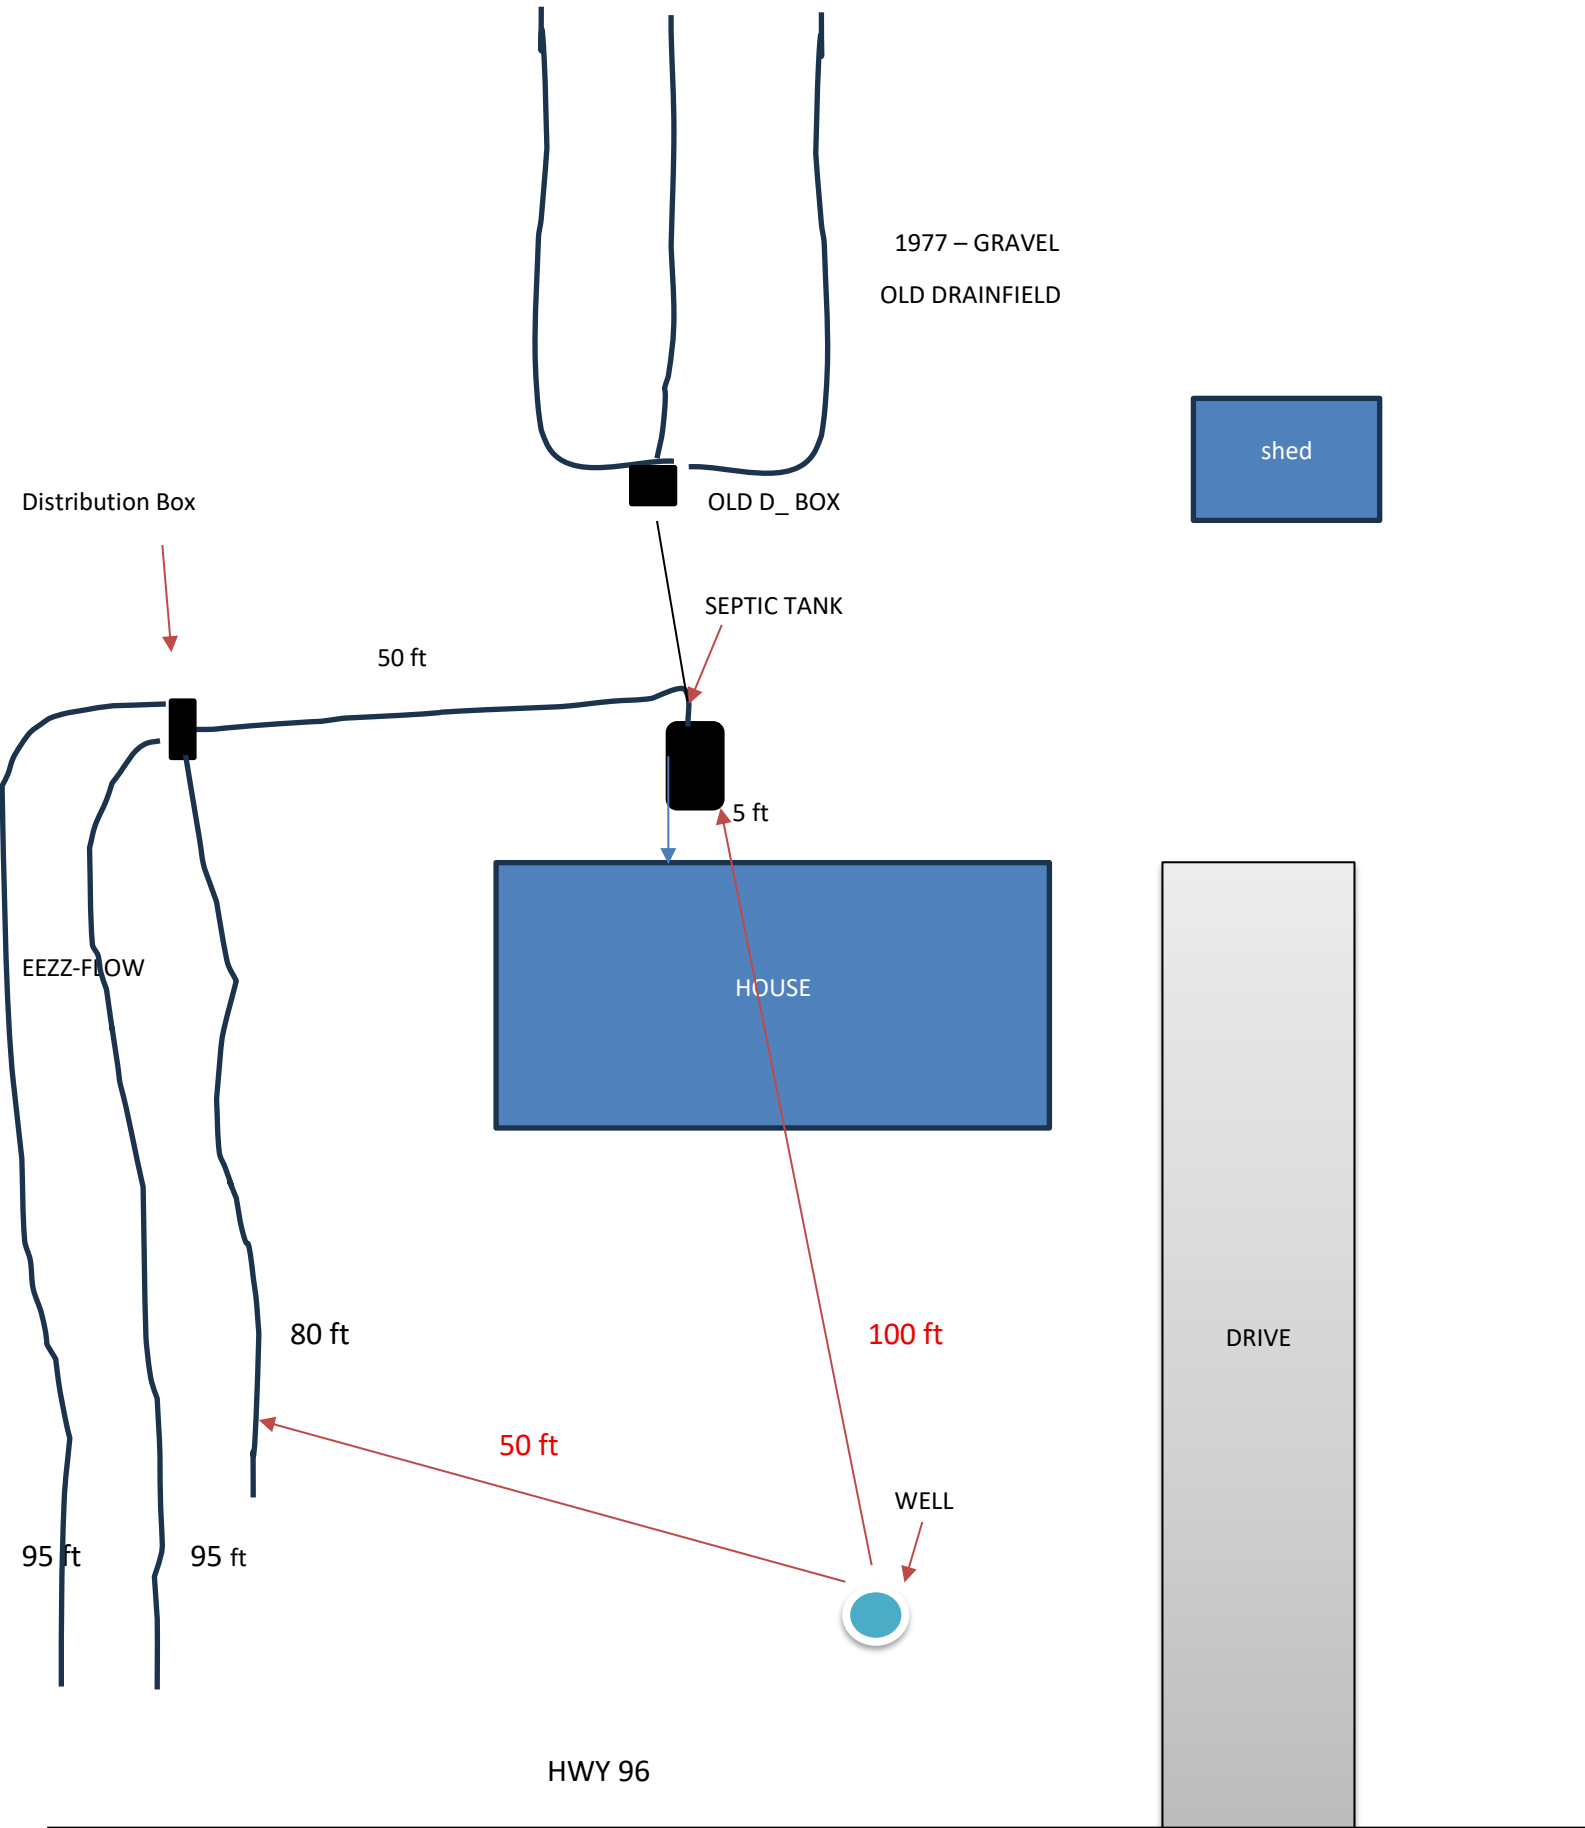
DRAIN FIELD

- TANK WAS NOT PUMPED AT INSPECTION - Recommend Pumping
- Currently there are NO signs of failure or malfunction in the drain field
- Septic tank is original to property

- Original drainfield installed in 1977 and Replacement system installed in 2008
- Unsure of property lines
- Remember it is not a brand-new system, so the normal aging of this system has most likely decreased the drain field's ability to dissipate wastewater effectively during periods of heavy loading. Over time drain fields will decrease in the effectiveness of dissipating wastewater effluent into the surrounding soils and is a naturally occurring aging process of the system. It should be expected (due mostly to age) that this drain field is operating at a lower operating efficiency with respect to its ability to disperse wastewater effluent to the surrounding subsurface soils
