# Property Inspection Report

2776 Jordan Ct  
Creedmoor NC 27522

**Steve Smallman Property Inspections**

| <b>Date:</b> 7/9/2025 | <b>Time:</b> 09:00:00 AM | <b>Report ID:</b> 070925GS4 |

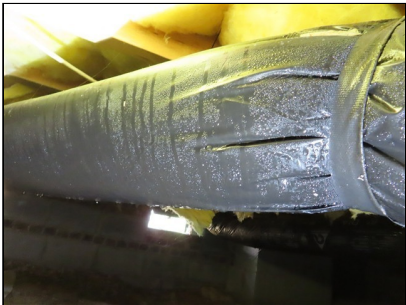
**Investigate Further** There is excessive condensation dripping from the air conditioning ducts and plumbing pipes. This is resulting in water pooling on the top of the moisture barrier. The moisture content at the wood framing was between 24-27%. This is not uncommon in houses with wall vented crawl spaces in the summer months with hot outdoor temperatures and high humidity. If the moisture content at the wood framing stays over 18% for over 30 days, fungal growth may occur on the floor framing. Moisture content at the wood framing over 20% can damage the wood framing members. We recommend that you consult a crawl space moisture management contractor to make recommendations regarding ways to control crawl space moisture.

condensation on ductwork

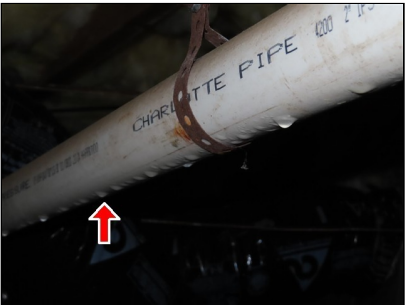
condensation on plumbing pipes

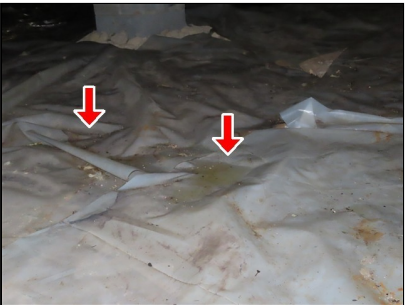
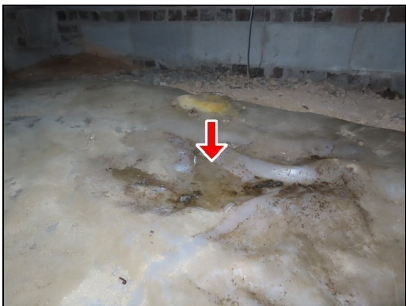
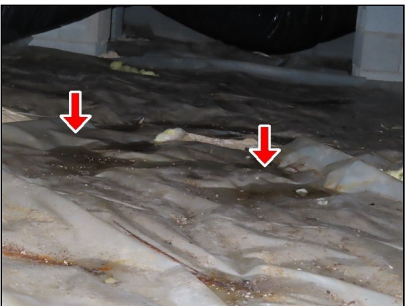
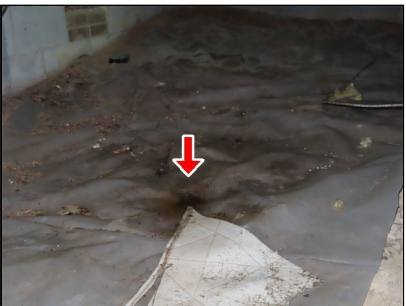
water pooling

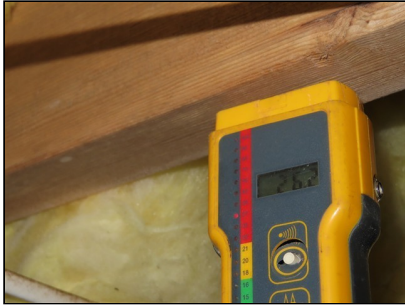
framing moisture over 26%

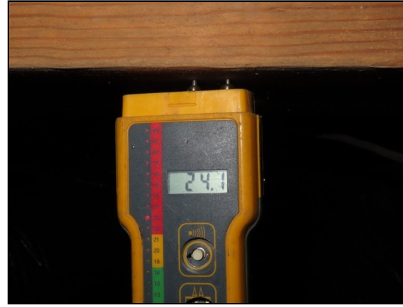
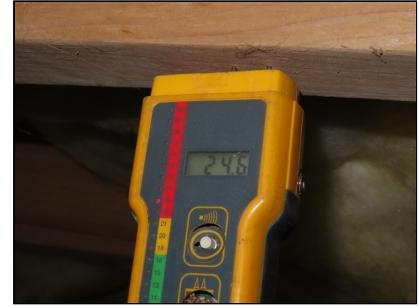
framing moisture over 24%

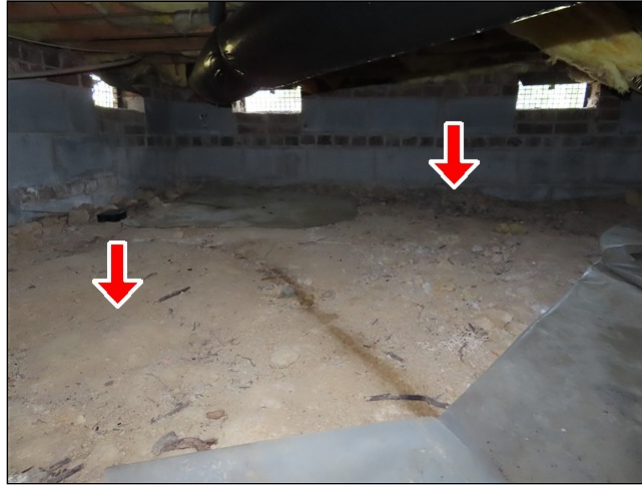
**5 Repair item** There are several areas where the crawl space vapor barrier is missing, damaged, moved aside, leaving the earth floor of the crawl space exposed. The vapor barrier is intended to help control moisture in the crawl space, and these conditions reduce its ability to do so. We recommend that the vapor barrier be repaired by a qualified contractor to cover all exposed earth.

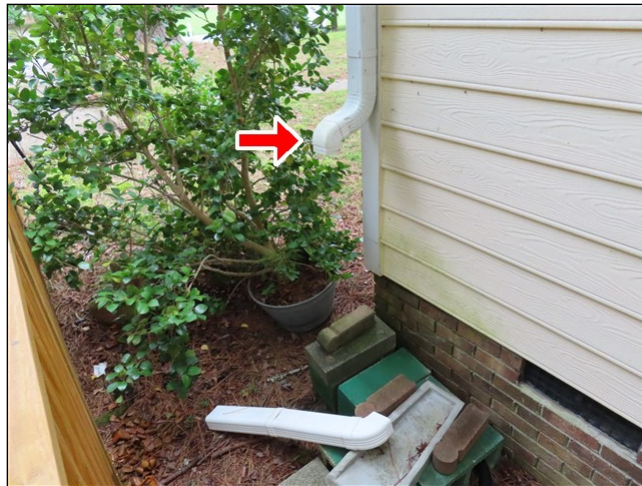
**Repair Item** The gutter downspout at the front right corner of the house does not terminate at grade level. The downspout should be extended and a elbow installed to divert water away from the foundation and crawl space.

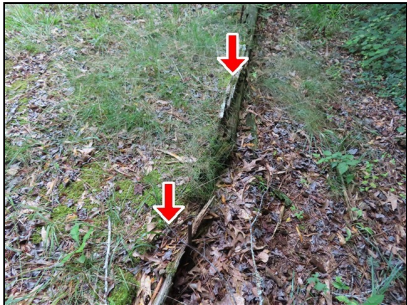
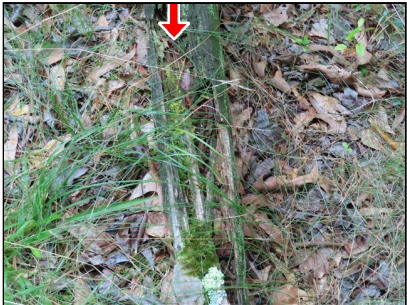
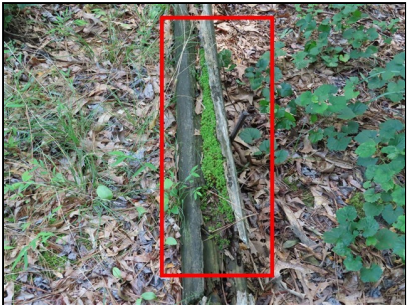
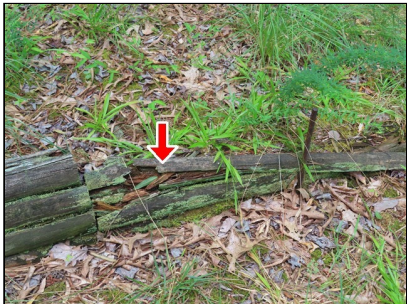
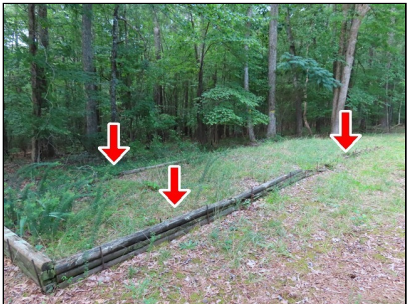
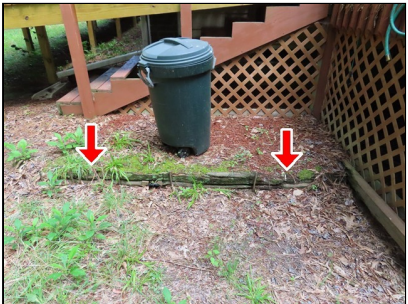
**14 Repair Item** Most of the landscaping timbers at the planter near the middle of the rear yard and around the trash bins are deteriorated to the degree that replacement is needed. Contact a qualified landscaping contractor for repairs.

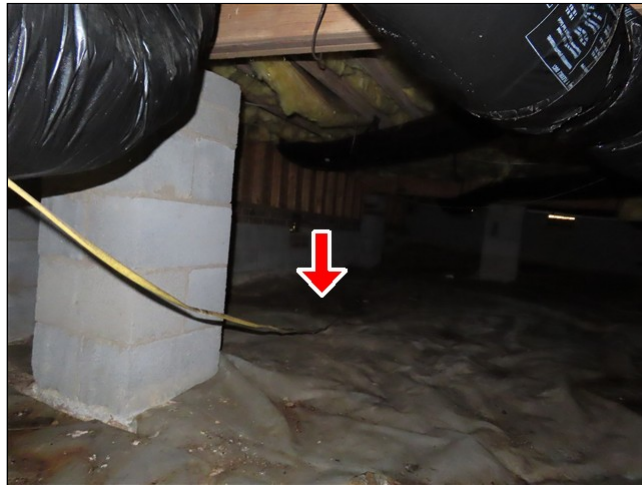
**19 Repair Item** Wiring cables on the ground in the crawl space are subject to mechanical damage and deterioration from the effects of moisture. Location: crawl space from the primary bedroom to the laundry room. All cables are required to be properly secured to the framework of the building.

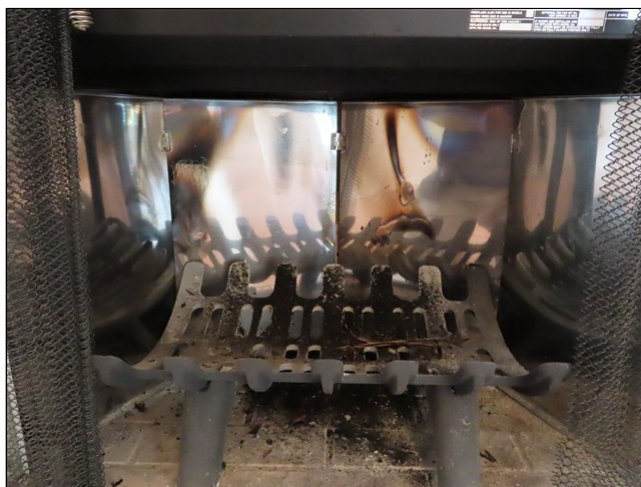
**26 Investigate Further** Reflective panels have been installed inside the fireplace. This blocks are view of the liners inside the firebox. We recommend that the reflective panels be removed and the liners inspected prior to using the fireplace.

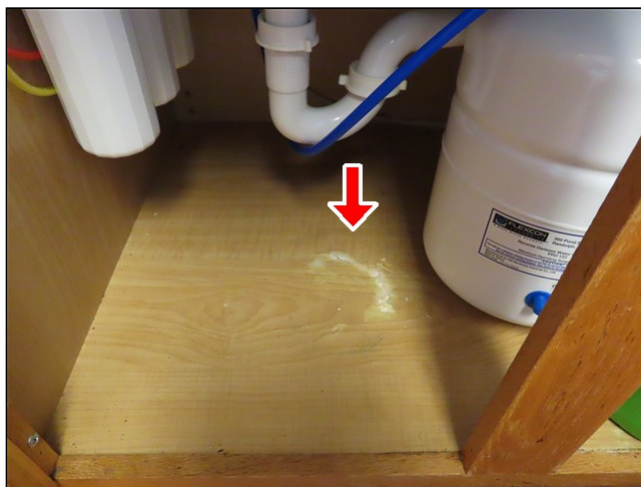
- 30 Repair Item** Deterioration was observed at the bottom panel inside the kitchen sink base cabinet. A qualified carpenter or cabinet repair specialist should be contacted to complete the needed repairs.

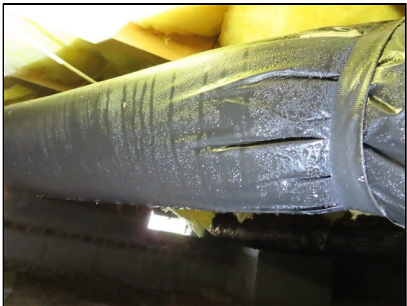
**Investigate Further** There is excessive condensation dripping from the air conditioning ducts and plumbing pipes. This is resulting in water pooling on the top of the moisture barrier. The moisture content at the wood framing was between 24-27%. This is not uncommon in houses with wall vented crawl spaces in the summer months with hot outdoor temperatures and high humidity. If the moisture content at the wood framing stays over 18% for over 30 days, fungal growth may occur on the floor framing. Moisture content at the wood framing over 20% can damage the wood framing members. We recommend that you consult a crawl space moisture management contractor to make recommendations regarding ways to control crawl space moisture.

condensation on ductwork

**Maintenance** We recommend that all homeowners where there is an underfloor crawl space install a humidity monitor in the crawl space to keep track of moisture levels. Simple humidity monitors that use a sensor placed in the crawl space and a base station that can be placed inside the house are available for less than \$100 (google AcuRite or Meade humidity monitor).

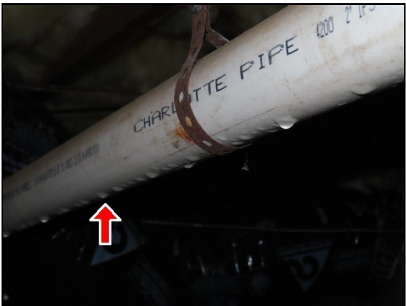
condensation on plumbing pipes

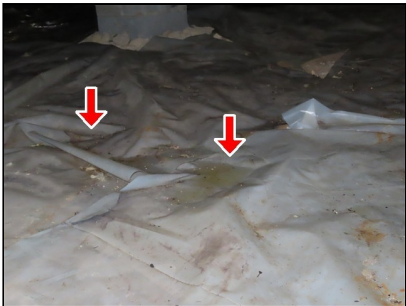
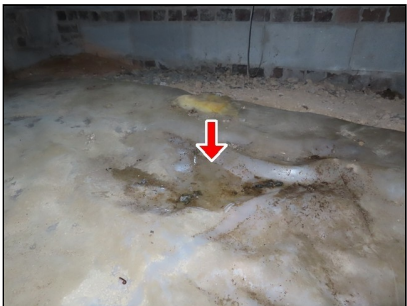
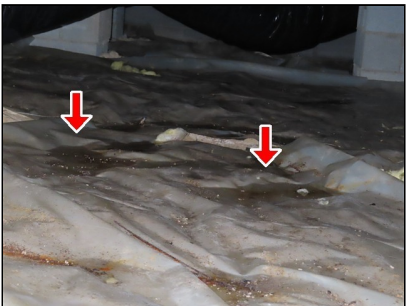
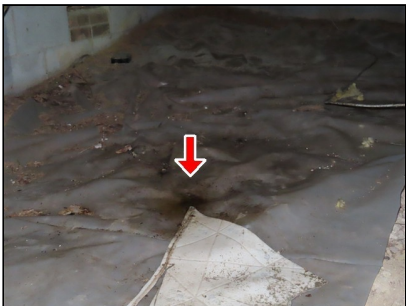
water pooling

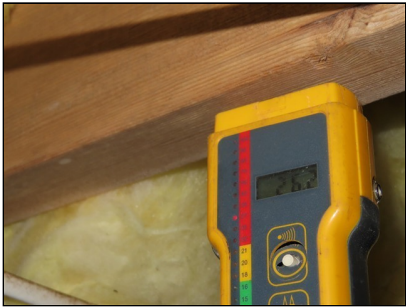
framing moisture over 26%

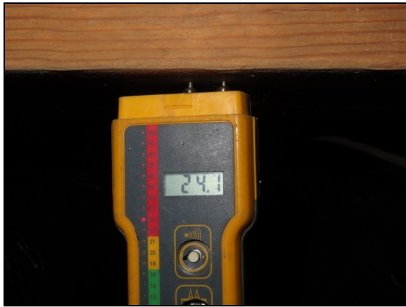
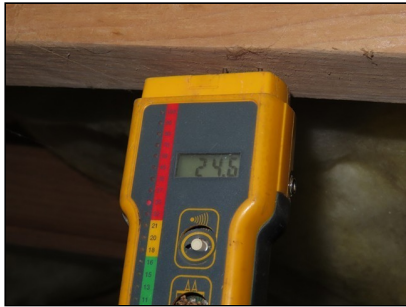
framing moisture over 24%

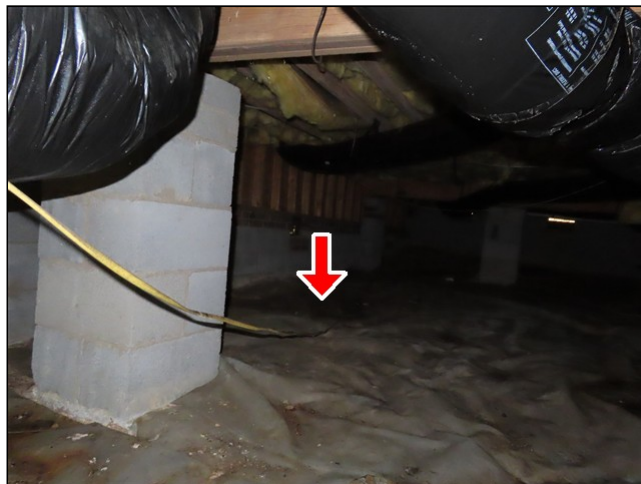
**Repair Item** Wiring cables on the ground in the crawl space are subject to mechanical damage and deterioration from the effects of moisture. Location: crawl space from the primary bedroom to the laundry room. All cables are required to be properly secured to the framework of the building.

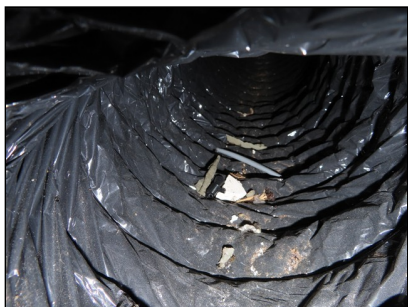
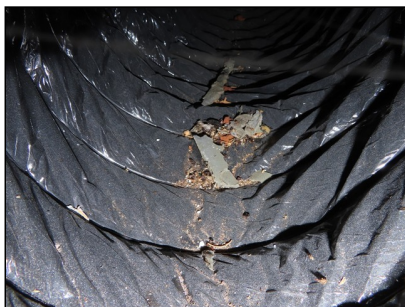
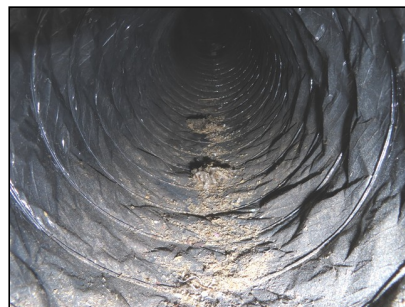
**Repair Item** Dirt and other debris was noted in most of the heating/cooling ducts. This may result in poor air quality in the home. The ducts should be professionally cleaned by a qualified contractor to remove the debris and any other contaminants that may exist.

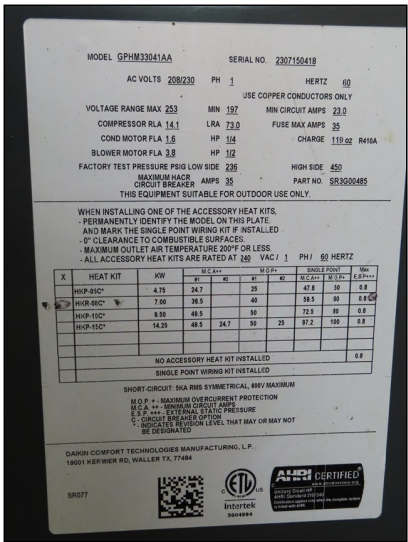
2 1/2 ton 2023

The heat pump was operated in the cooling mode during the inspection using the normal operating controls. The temperature differential was measured and found to be 16 degrees F. This is the number of degrees the system is cooling the house air. Normal range for this number is 14-22 degrees when operating the system during hot weather, higher when ambient temperatures are lower.
