March 6, 2024

Re: Limited Structural Inspection  
270 Wiggins Road  
Louisburg, NC

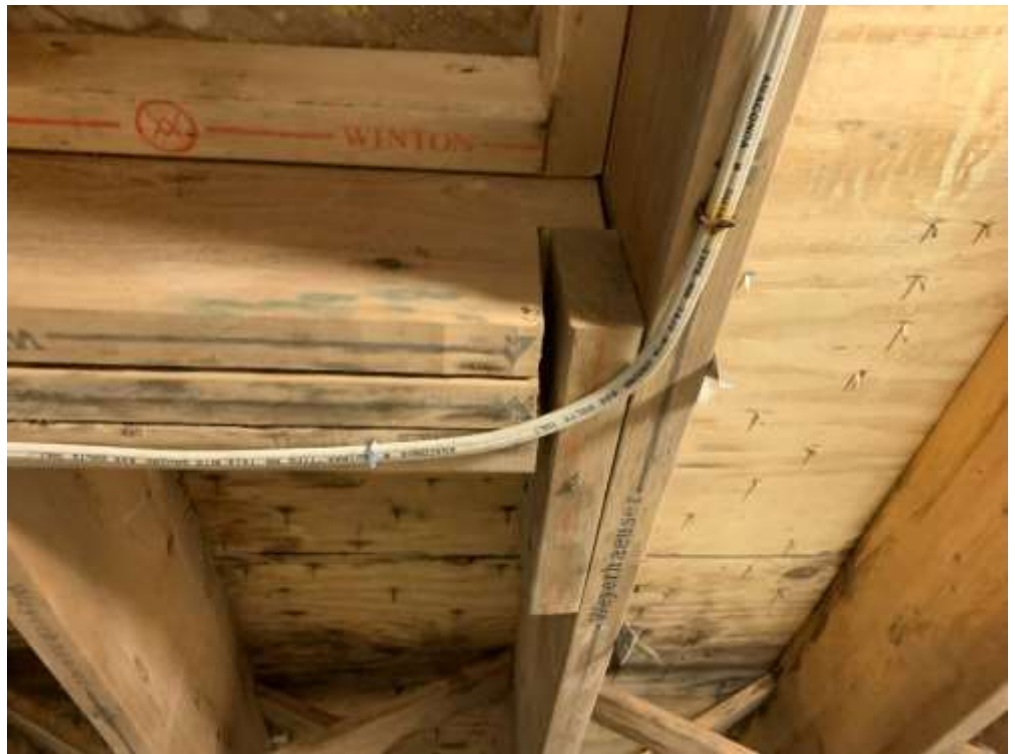
Photo No.  
6

Typical view of  
inadequately  
supported box-out  
header.

7. In regards to the inadequately supported framing ends noted above (Observations #6-7), we recommend installing new pressure-treated 6x6 posts at the left ends of the box-out header to the front and rear of the chimney. The new posts should bear on minimum 12"x12"x8"-thick
