# NCSI

**INSPECTION REPORT:**

**PROPERTY ADDRESS:** 109 Old Watkins Road  
Henderson, NC 27537

**DATE OF INSPECTION:** November 09, 2022

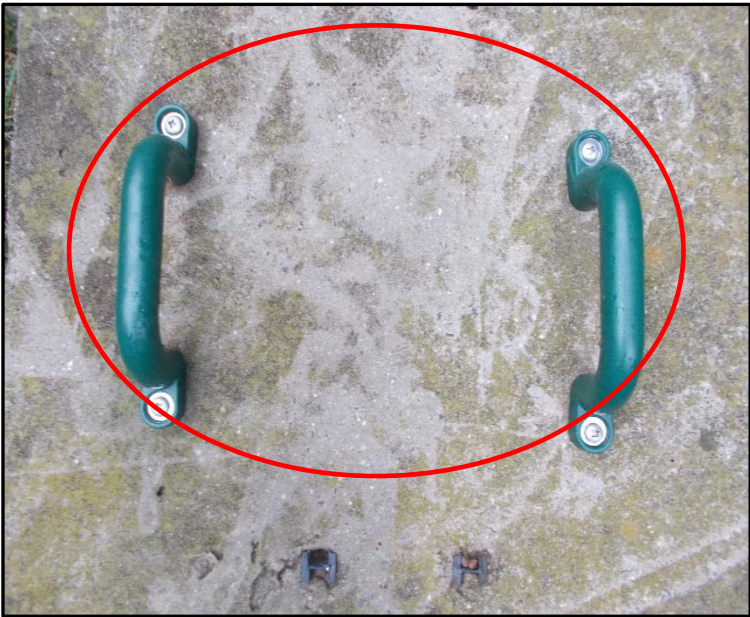
**Example of Repaired Handles:**

- 2). The outlet access lid has a broken wire handle. Concrete lids without handles are very difficult to remove for the purpose of general maintenance. It is recommended that lid be replaced if an adequate and acceptable repair cannot be made (see page 9 for additional information and pictures).

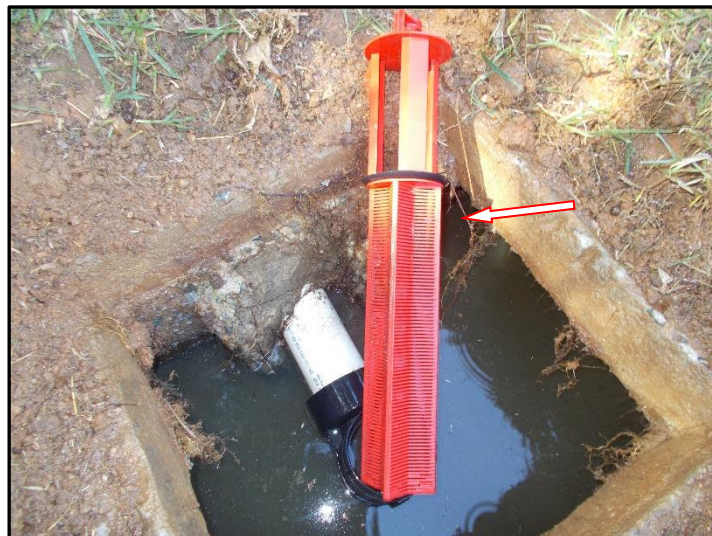
### Example of Retro-fitted with PVC Sanitary Tee with Effluent Strainer:

- 4). Extensive corrosion and deterioration was present around outlet baffle tee. Because of the extensive corrosion and deterioration, pre-cast concrete outlet baffle should be replaced with a PVC Sanitary tee. Effluent strainer is an option, however, strainer is recommended (see page 11 for additional information and pictures).

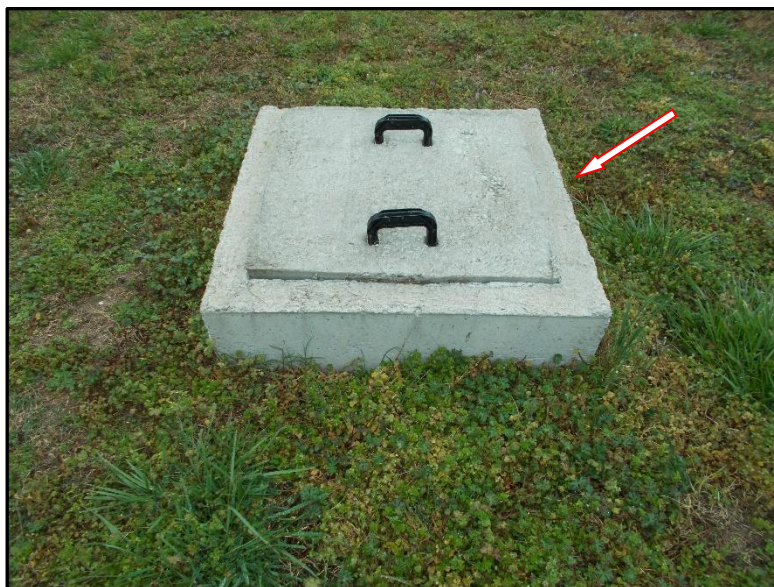
### Example of Risers:

8). Because of the depth that tank is buried beneath the soil surface and the amount of time and difficulty in uncovering the inlet or outlet access lids to pump and clean the tank, it is recommended installing risers over one or both these access openings. FYI: Installing a riser over the outlet access opening would make it easier to remove and clean the effluent strainer, when soiled, if one is added with the addition of an outlet PVC Sanitary Tee (see page 15 for additional information and pictures).

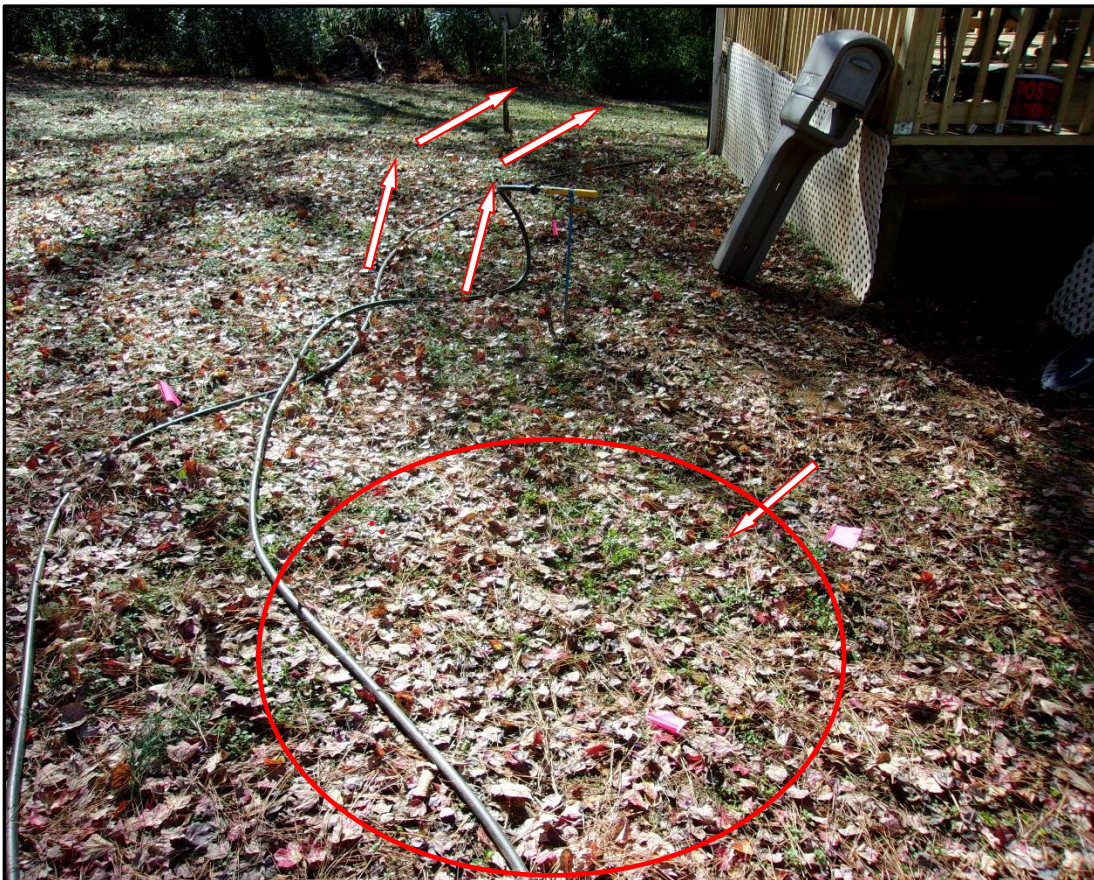
**Nitrification Area (Diagram of lines may not be exact):**

Portions of the nitrification (leach) field were located, and a visual inspection was performed. Nitrification field consists of two (2) lines installed over gravel aggregate laterals, approximately 100 feet in length. Probing confirmed the depth, however, the exact length, or the configuration of nitrification lines were not confirmed. **Septic systems are subterranean, therefore, without exposing the actual nitrification lines and the soil absorption area beneath the lines it is impossible to make an accurate assessment of their overall condition, especially in systems that are, or have been dormant for lengthy periods of time. More accurate assessments are done in homes that are occupied.** Caution should be observed not to disturb the soil in and around the nitrification field and its adjoining repair area. It is always recommended to properly maintain the vegetation growth over nitrification areas. Planting appropriate vegetation over the leaching field is key to allowing a septic system to properly treat household wastewater and ensure the safety of your family and the environment.

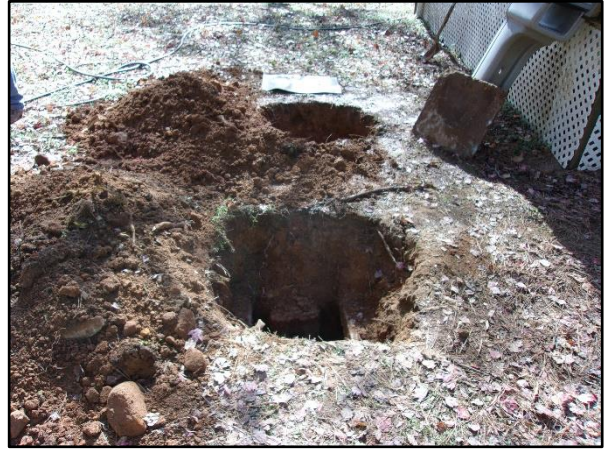
**Distance from Foundation:**

| <b>Feet from Foundation:</b><br><i>NC Code (No Less than 5 Feet)</i> | <input checked="" type="checkbox"/> 15 Feet 6 Inches |

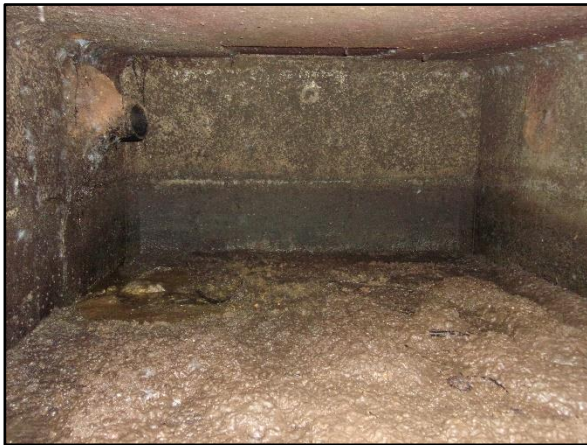
**Interior of Tank:**

- 1). Considering the current depth of mixed solids, sludge, and the thickness of surface scum, in addition to **non-biodegradable materials**, it is recommended that septic tank be pumped and cleaned of roots. FYI: Systems of this age may require pumping more frequently than newer systems. Subject tank should be pumped on a 3-to-5-year rotation, or sooner if necessary (see page 8 for additional information and pictures).

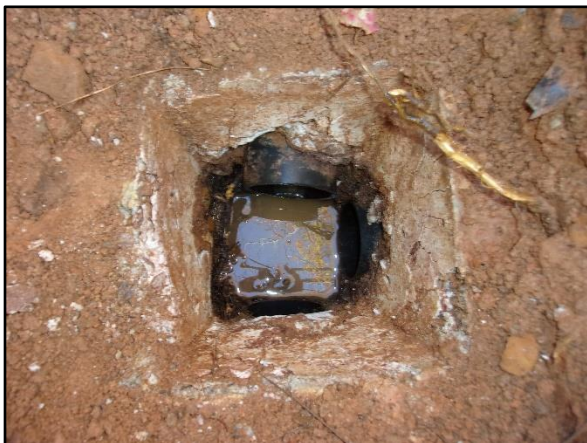
**Distribution Box:**

7). The inspection of the distribution box discovered corrosion and deterioration, in addition to accumulated sand, sludge, and mixed solids. Lid to distribution box also has corrosion and age-related deterioration. At time of inspection, distribution box was partially cleaned, however, not all the debris could be removed. Because of the present condition, it is recommended that Septic Tank Service Provider replace the distribution box and its lid (see page 14 for additional information and pictures).
