**THE FOLLOWING ITEMS SHOULD BE CHECKED FOR EXTENT OF DAMAGE AND/OR REPAIRED BY QUALIFIED REPAIR PERSON**

## Needs Repair / Needs Further Evaluation

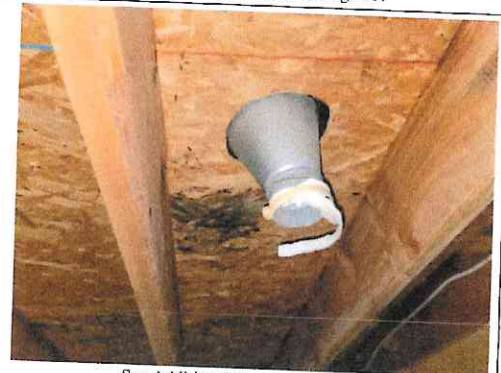
51. Needs Repair: Bathroom Exhaust Vent - Broken Exhaust Duct - One bathroom exhaust duct is broken in the attic at the wall penetration and is currently venting into the attic. This will produce unnecessary moisture that can cause adverse conditions to be present over time. Have a professional HVAC contractor repair broken exhaust duct so that moisture is vented to the exterior of the house.

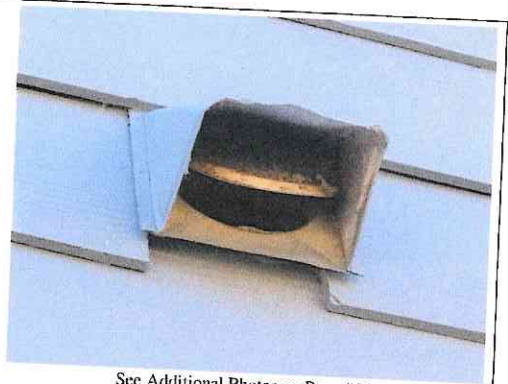
52. Needs Repair: Dryer Vent - Dryer Baffle Stuck Open/Broken - The dryer exhaust vent end cap is not installed properly where it vents through to the exterior of the home. The baffle that closes when the dryer is not operating is partially open at all times. Being open all the time allows air exchange between the exterior and interior of the house, as well as the possibility of vermin getting in the exhaust duct. Have a professional contractor make repairs so that the baffle closes fully when not being used.

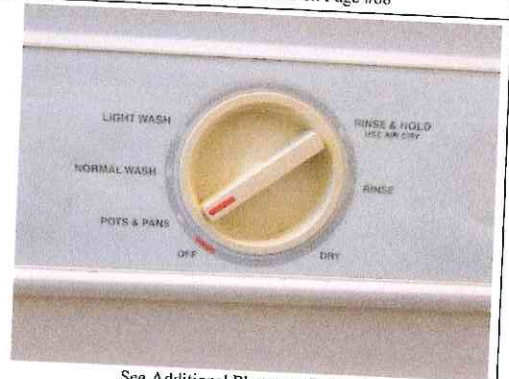
53. Needs Repair: Dishwasher - Control Knob / Dial Not Operating Properly - The dishwasher control knob / dial didn't turn on the dishwasher pots & pans setting. This limits use. Recommend having a professional appliance repair contractor evaluate the dishwasher and repair / replace as necessary.

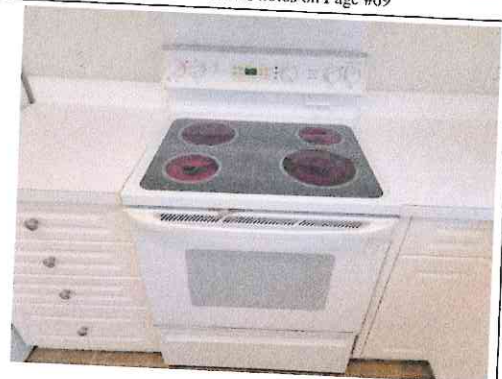
54. Needs Repair: Range - Missing Anti-Tip Bracket - The anti-tip bracket required for safety on all freestanding ranges, was not installed at the time of the inspection. The anti-tip device can prevent personal injury/damage caused by the appliance tipping over due to weight added to the open door. Recommend a professional appliance installation contractor install this anti-tip device as required to prevent damage and personal injury.

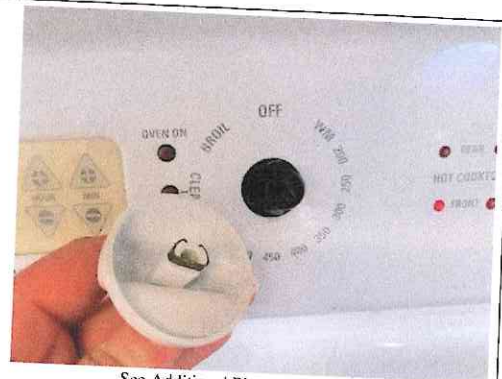
55. Needs Repair: Oven - Adverse Conditions Present - 1) Control Knob / Dial Not Operating - The oven control knob / dial didn't turn on the oven at any setting. This prevents use of the oven. Recommend having a professional appliance repair contractor evaluate the oven and repair / replace as necessary.

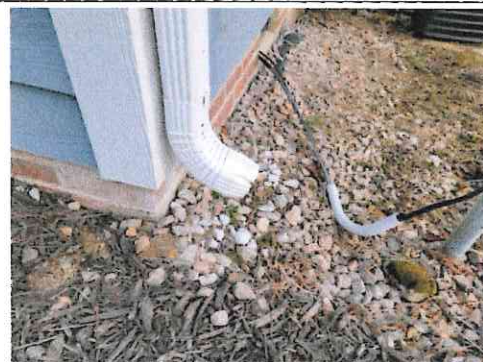
57. Observation/Information: Splash Blocks - Splash blocks are not installed at some/all of the gutter downspout turnouts. Suggest installing splash blocks or plastic pipes at the end of the downspouts from the gutters to divert water further away from the foundation and prevent possible dirt grade washout.

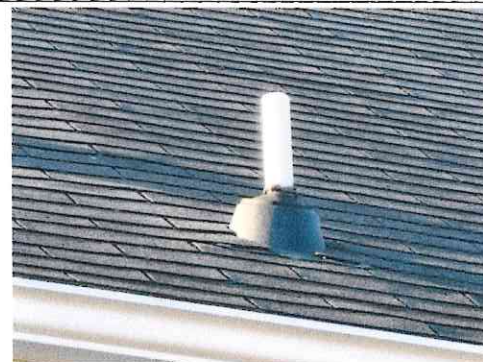
58. Information/Recommendation: Roof Plumbing Vent Pipe Flashings - Plumbing waste pipe flashings are currently in good condition where installed on the roof covering. Typically used, rubber boot flashings, around plumbing vents that penetrate the roof covering last (depending on exposure to UV light) about 8 to 10 years before cracking. No evidence of leaking was observed at these vent pipe penetrations from inside the attic but proper preventive maintenance requires replacement of these flashings half way through the expected life of the roof covering. If documentation cannot be provided by the seller that the flashings have recently been replaced, it is suggested that preventative maintenance/replacement be performed at this time by a professional roofing contractor.

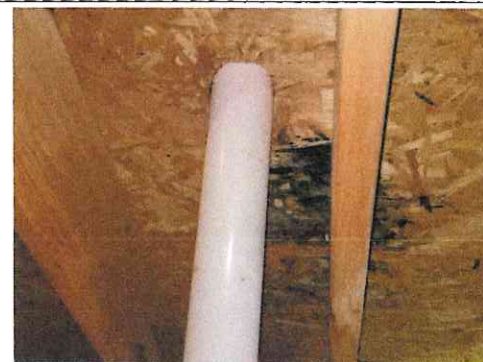
59. Further Evaluation is Suggested - Moisture Penetration - Moisture Stains - Water stains were observed in the attic on the roof sheathing. These stains are assumed to be from leaks before the new roof was installed. Consult the owner about the history of water stains currently present in the attic, or if further concerns are present, suggest that a professional roofing contractor fully evaluate the roof area to determine if additional repairs are necessary.

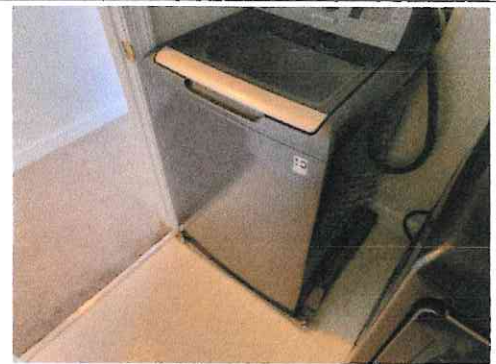
### 60. Needs Repair: Washing Machine Drain Pan Damaged -

The washing machine emergency drain pan installed for the washing machine is damaged and may not hold water. This can result in water damage to the floor/ceiling below this area should the washing machine or lines leak. Suggest that a drain pan be added so that protection against water damage from leaking appliance can be provided.

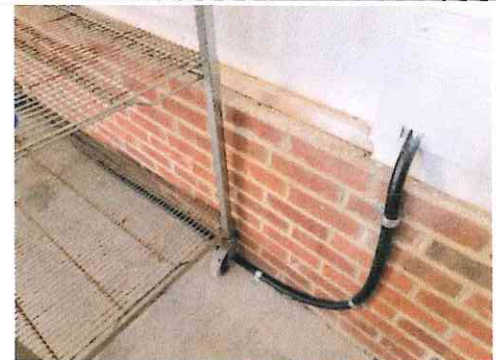
### 62. Needs Repair: Electrical Wiring - Cut Wires / Exposed High Voltage Electrical Wires -

Observed wires / wire conduit coming out of the wall in the garage below the main electrical panel. The wire conduit runs around the perimeter of the garage on the floor and ends next to the garage door. The assumed high voltage electrical wires are cut at the end and are laying on the garage floor. It was not determined if the wires were live, but they were, and should be, treated as such. Loose electrical wires are an electrical hazard / personal safety hazard. Have a professional electrical contractor evaluate and properly terminate the loose electrical wires inside a covered junction box and/or remove the wires. Recommend consulting the homeowner about what these wires used to serve and if the circuit breaker has been turned off.

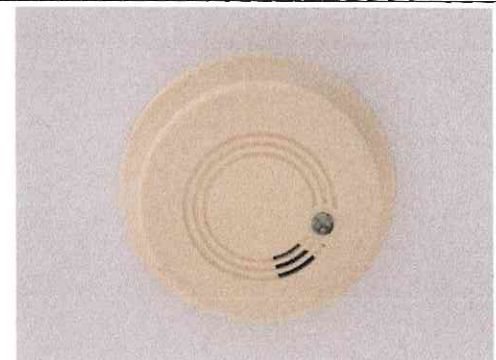
63. Suggestion: Current safety standards require smoke detection in every bedroom and a smoke detector and carbon monoxide detector to be installed within a reasonable distance outside all bedroom entrances. No CO detectors were observed in the home. Only 2 smoke detectors are installed on the ceiling in the 1st floor hallway and 2nd floor hallway. Suggest installing additional detectors as needed for personal safety.

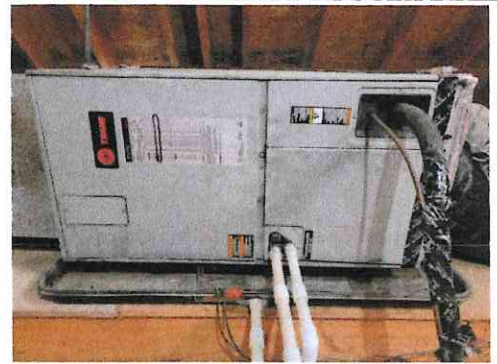
64. Information / Recommendation: Furnace - Potential Recalled Appliance - The RecallChk report indicates that the 2nd floor furnace in the attic is a 90% match as a recalled appliance. The report states the data provided was a close enough match to indicate a potential recall for this appliance. More information may be needed to determine a recall on this appliance. Refer to the Description of the recall found in the RecallChk Report. Recommend further evaluation.

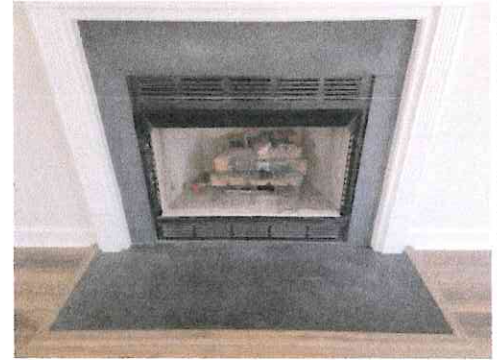
65. Needs Verification of Operation: Gas Not On at the Fireplace - The gas supply was not turned on at the time of the inspection. Further evaluation of the fireplace gas logs is necessary when gas is available in order to verify proper operation is provided.

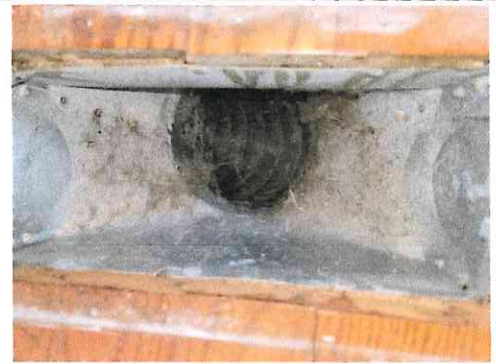
68. Observation/Recommendation: Dirty Ducts - Observed an excessive build-up of debris / fur on the inner supply air ducts on the 1st floor. If there is a person that is hyper sensitivity to fur/dander/dust expected to be living in the house, it is suggested that the duct system be professionally cleaned.
