## SUMMARY

1315 Alpha Rd, Henderson, NC 27536

Evangeline Mitchell  
09/25/2025

Michael Eldredge  
NC HI Lic# 3527  
Eldredge Home Inspection  
9198303588  
meldredge1@gmail.com

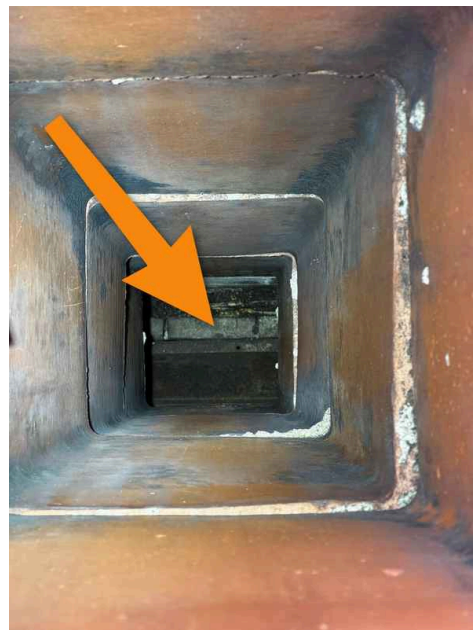
Rainwater falls directly into the fireplace.

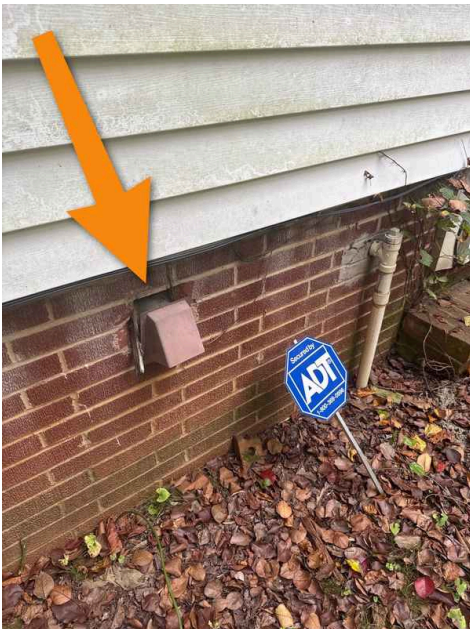
The dryer duct is loose and damaged.

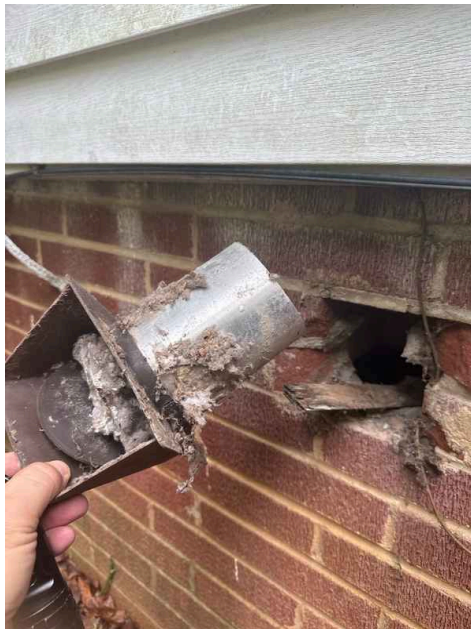
The duct is completely disconnected.

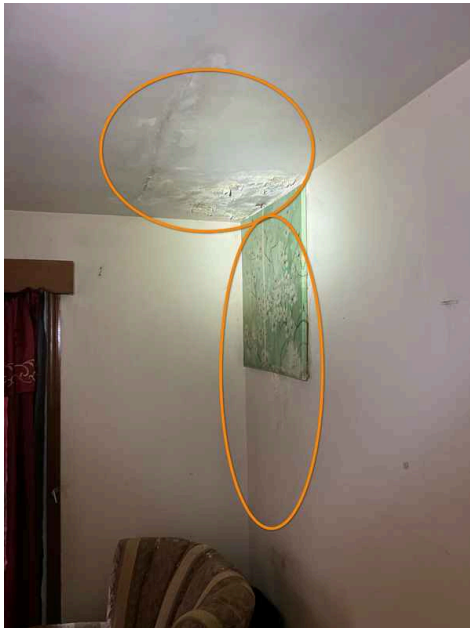
See description for this finding located in the living room.

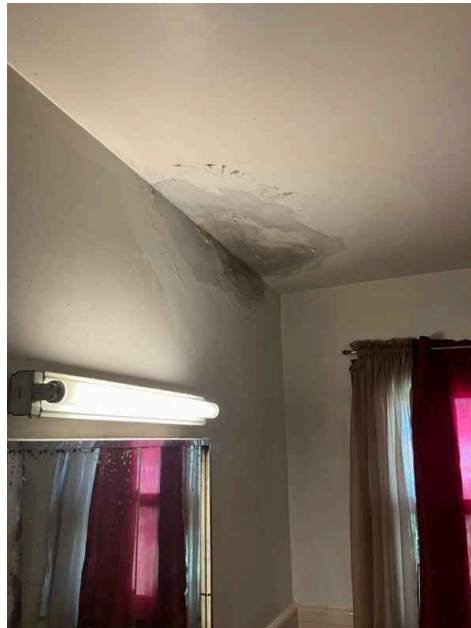
Additional photo of this finding from the bathroom. Mold is present and also likely inside the wall.

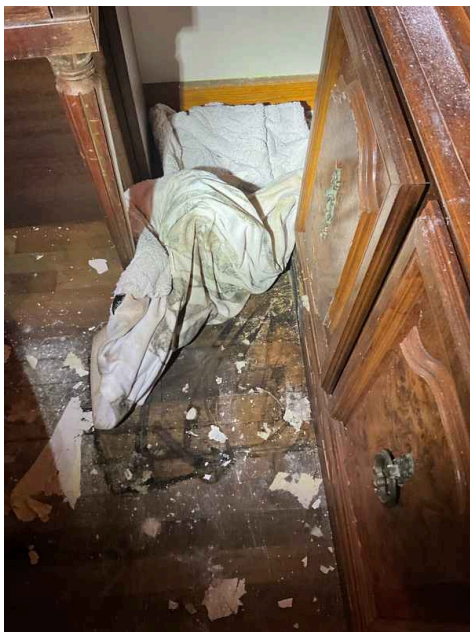
Additional photo of this finding below showing mold and damage.

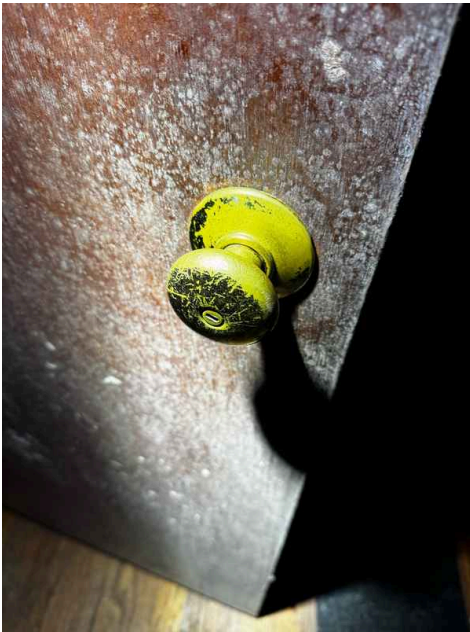
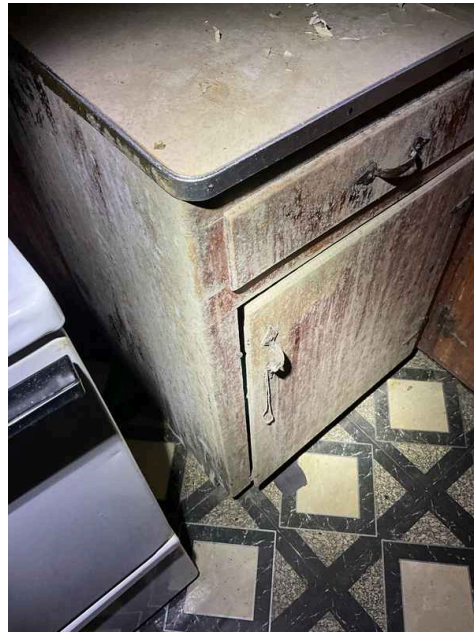
Additional photo of this finding. Sample

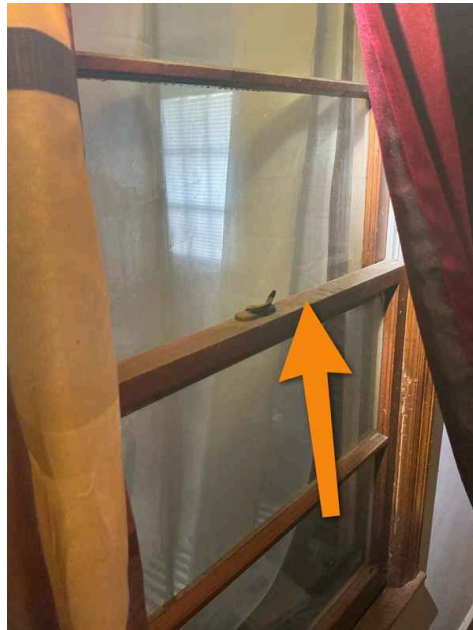
Location of the following finding in the living room.

This window does not align properly and shut properly.

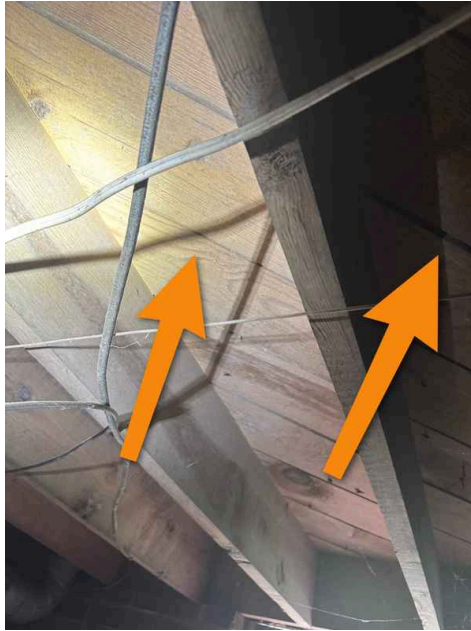
Additional photo of this finding. there is no insulation under any part of the home.

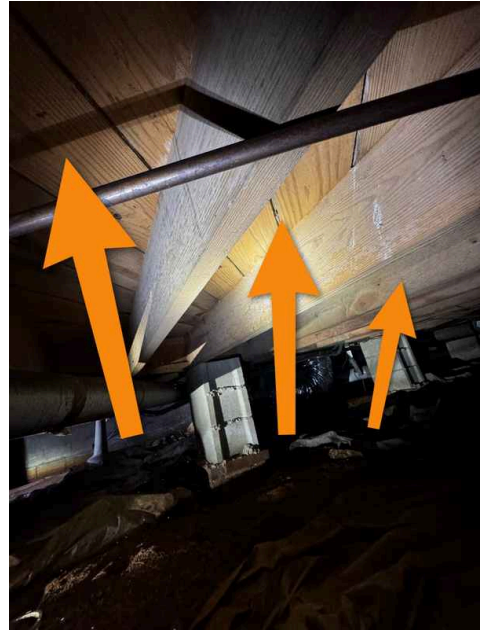
Additional photo of this finding.

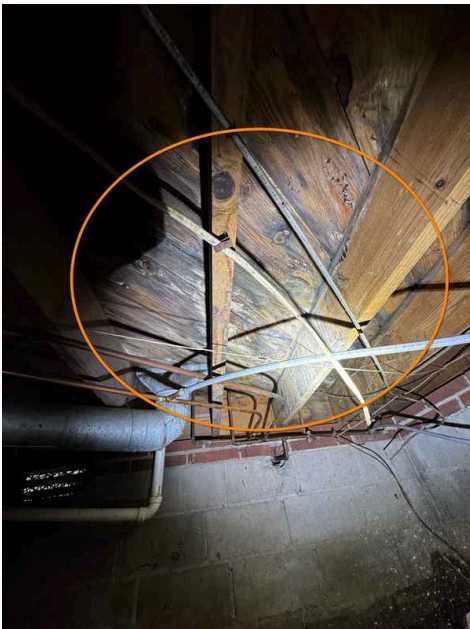
The area in the crawlspace was the most water damage was under the kitchen.

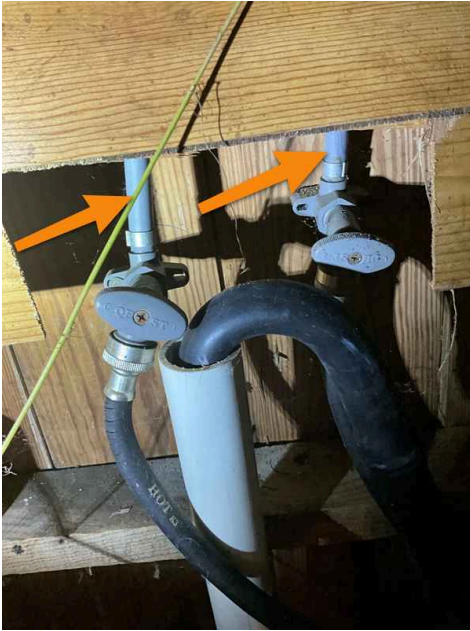
This home has a plumbing supply system that uses polybutylene plastic distribution lines and compression band fittings. Even though plumbing system was installed in many homes from 1978 until mid-1990's, it is no longer manufactured in the original formulation as an approved plumbing system due to a history of material failures. The failures were related to improper installation, improper handling, improper storage, and plastic deterioration due to chemical reactions with the water supply. Due to the nature of this latent defect, it was not possible to adequately assess the condition of the plumbing system during the home inspection. At the time of the inspection the following concerns were noted:

- Plastic fittings (deteriorated)
- Improper support of plumbing lines

See description for this finding located behind the washing machine.

A licensed plumbing contractor should be consulted for a complete evaluation of the plumbing system to determine the significance of this concern and to make necessary repairs.

Contact a qualified professional.

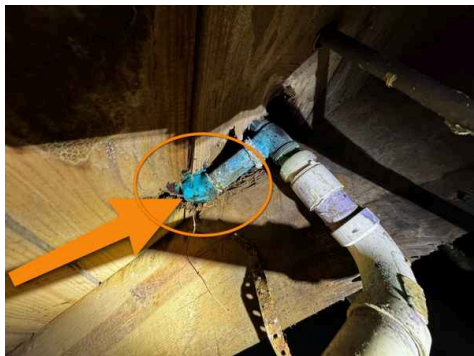
The drain under the tub is leaking.

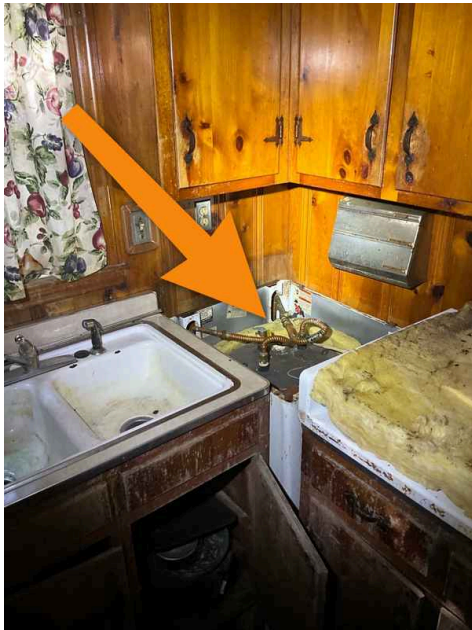
##### **OLD - CORRODED AND LEAKING**

See description for this finding located is in the kitchen.

Contact a qualified professional.

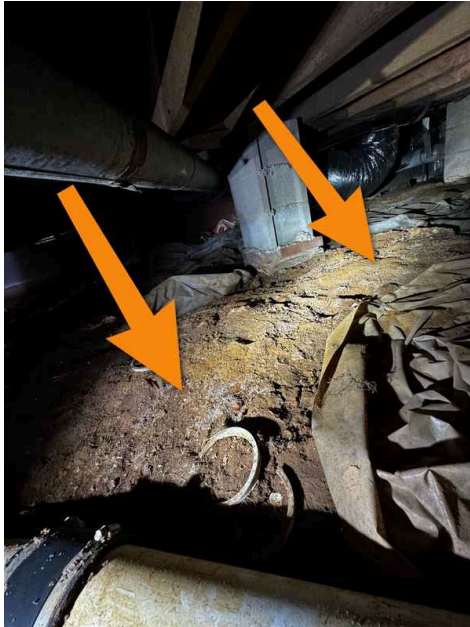
The vapor bar was missing in the majority of areas of the crawlspace.

Contact a qualified professional.

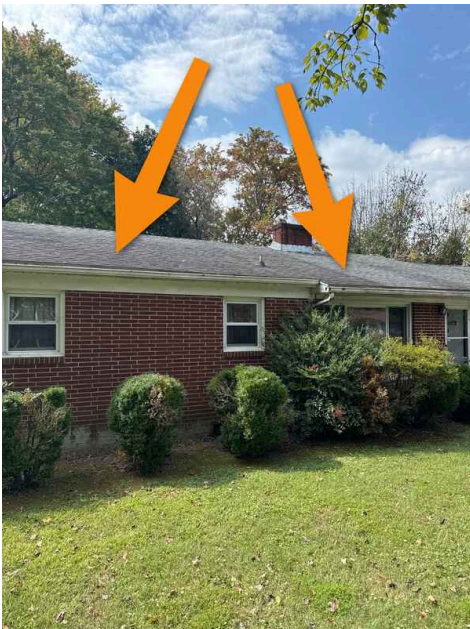
The roof is showing signs of heat damage caused by a lack of ventilation.

Contact a qualified professional.

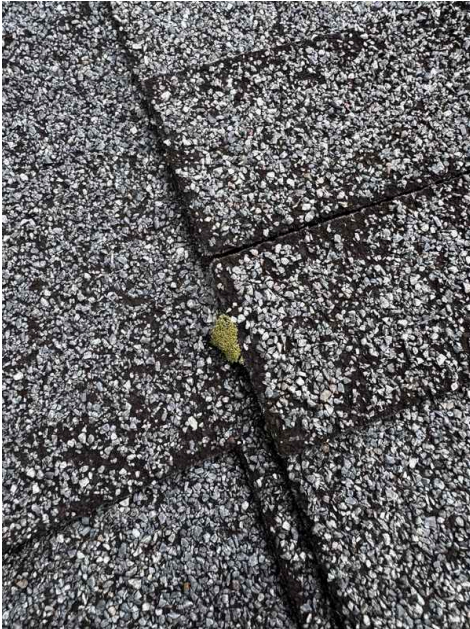
All areas of the roof should be assessed for the same finding.

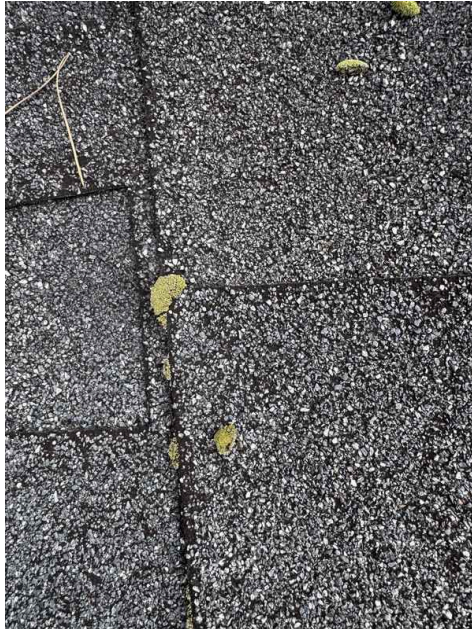
Additional photo of this finding.

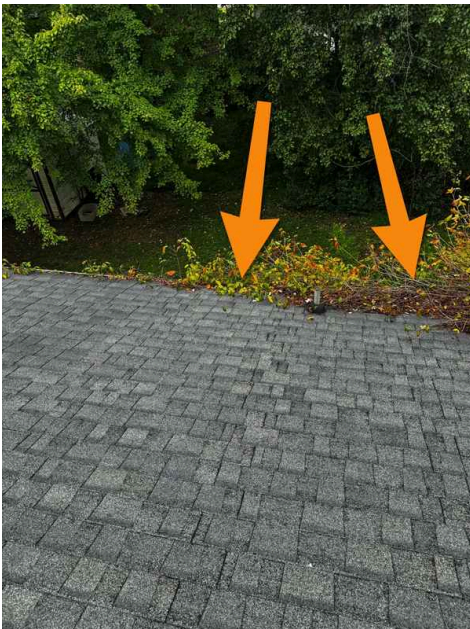
Additional photo of this finding.

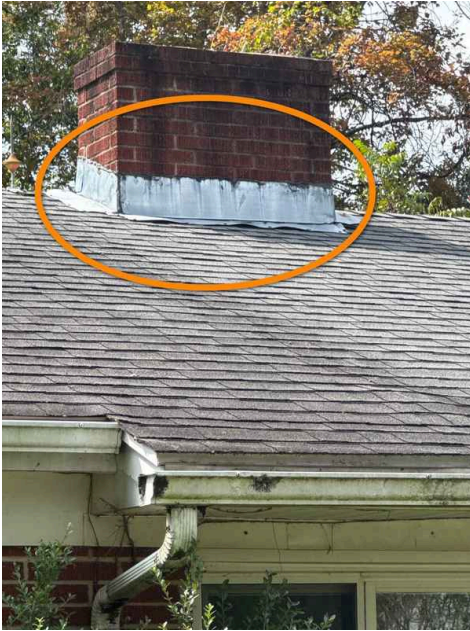
The flashing is not installed correctly and is loose in all areas around the chimney.

Contact a qualified professional.

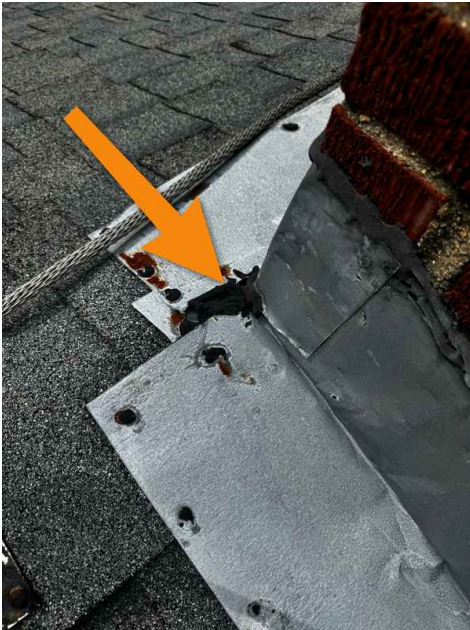
This is a hole and roof leak in the flashing.
