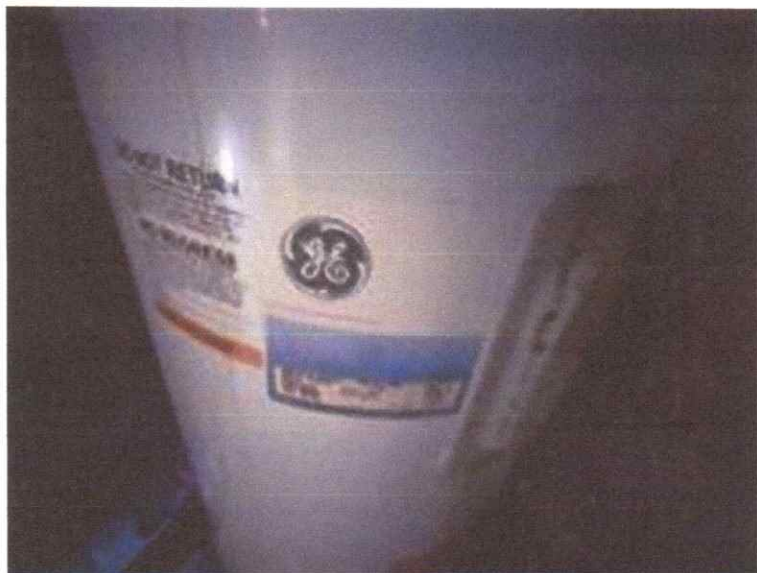
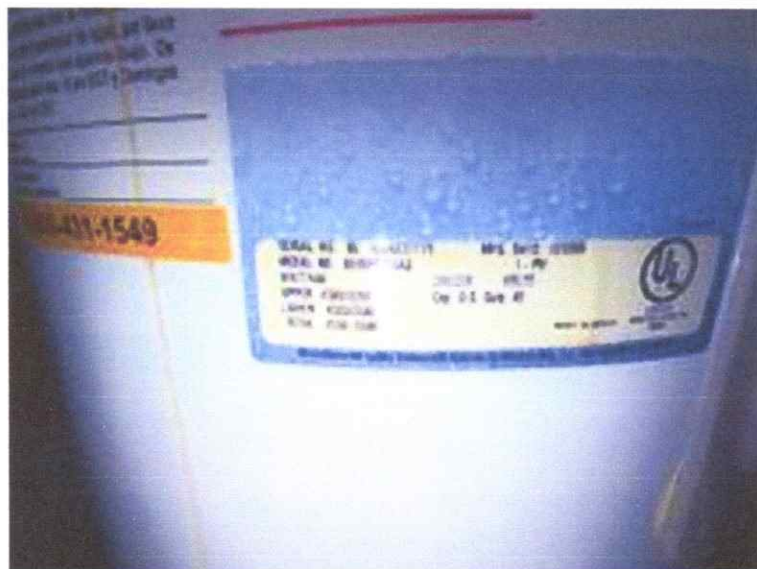
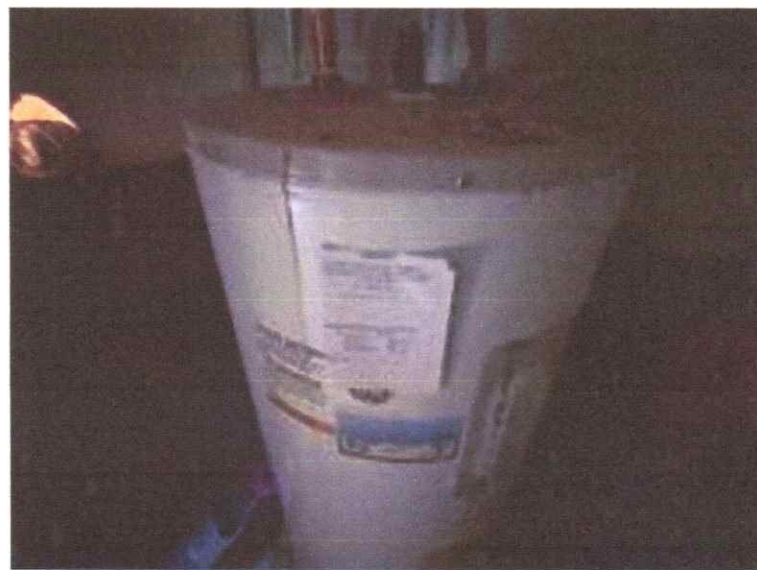
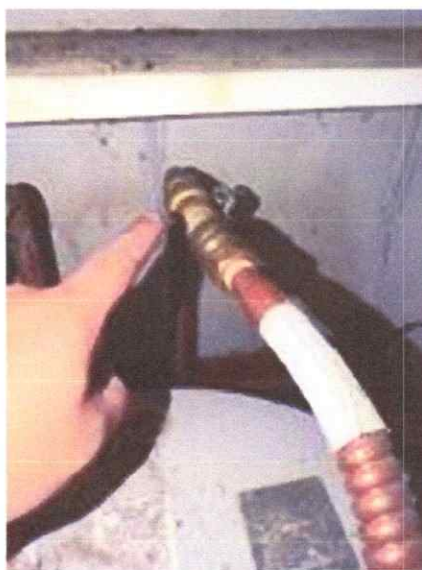
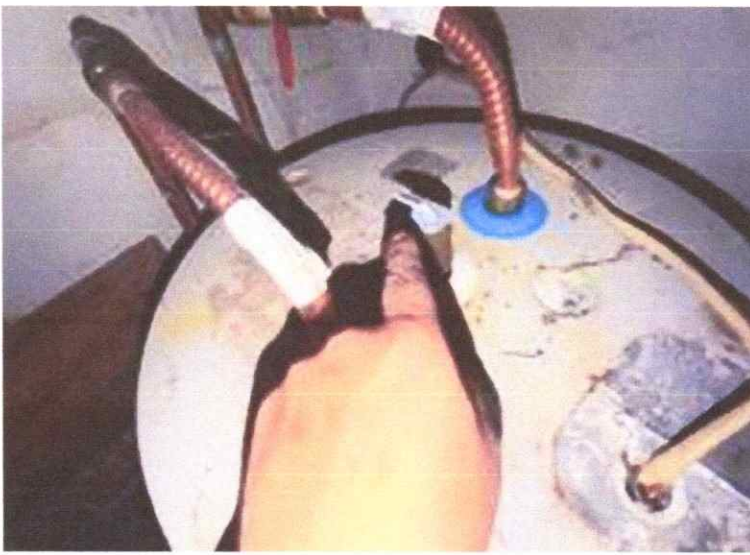
Photo of water heater

The water heater is missing blow off leg to the TPR valve. This allows water to safely discharge in an event valve is set off.

The water heater was leaking from pex shark bight and below it is recommended heater be replaced by a licensed plumber.

The water heater and well compression tank both are leaking and need replaced. There is also missing shower head from main bathroom, due to water heater leaking hot water could not be tested, leaking hose bib, loose toilet and dripping faucets all should be evaluated and repaired by a licensed plumber.
